Benefits of Vibration Analysis for Deployment of Equipment in HLW Tanks – 12341

D. B. Stefanko¹ and J. E. Herbert²

¹Savannah River National Laboratory, Savannah River Nuclear Solutions

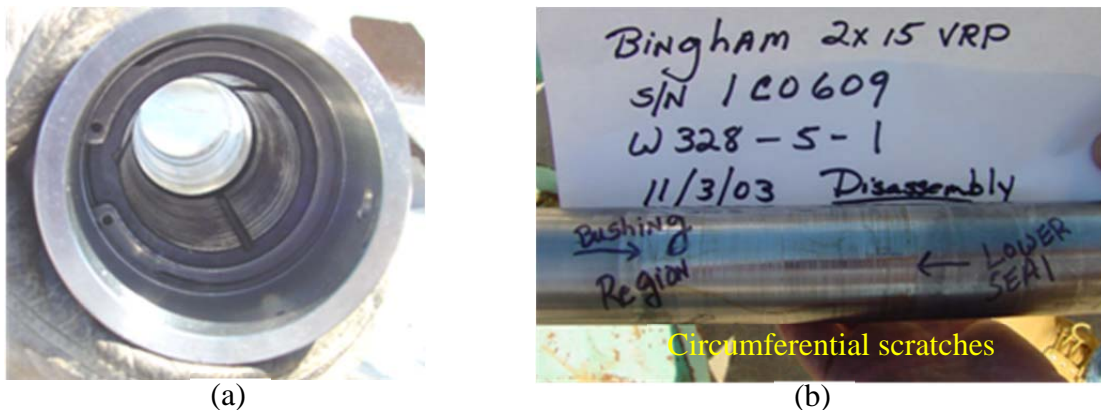
The damage due to vibration is evident in Figure 1(a) and (b). Wear patterns indicate contact between the shaft and bearings, followed by abrasion between bearing particles and the rotating surfaces. The bearings are not flushed, and this stagnant condition prevents adequate removal of any particles from the fluid film, thus accelerating further wear. The primary damaging vibration (for this equipment) was caused by impeller imbalance, but both whirl and resonance are problems with this style pump. Consequently, the reliability of this pump can only be increased by lowering the pump speed or installing tilt pad bearings and machined impellers.

Figure 1. Bearing and shaft damage from contact on a disassembled SRS standard slurry mixing pump.

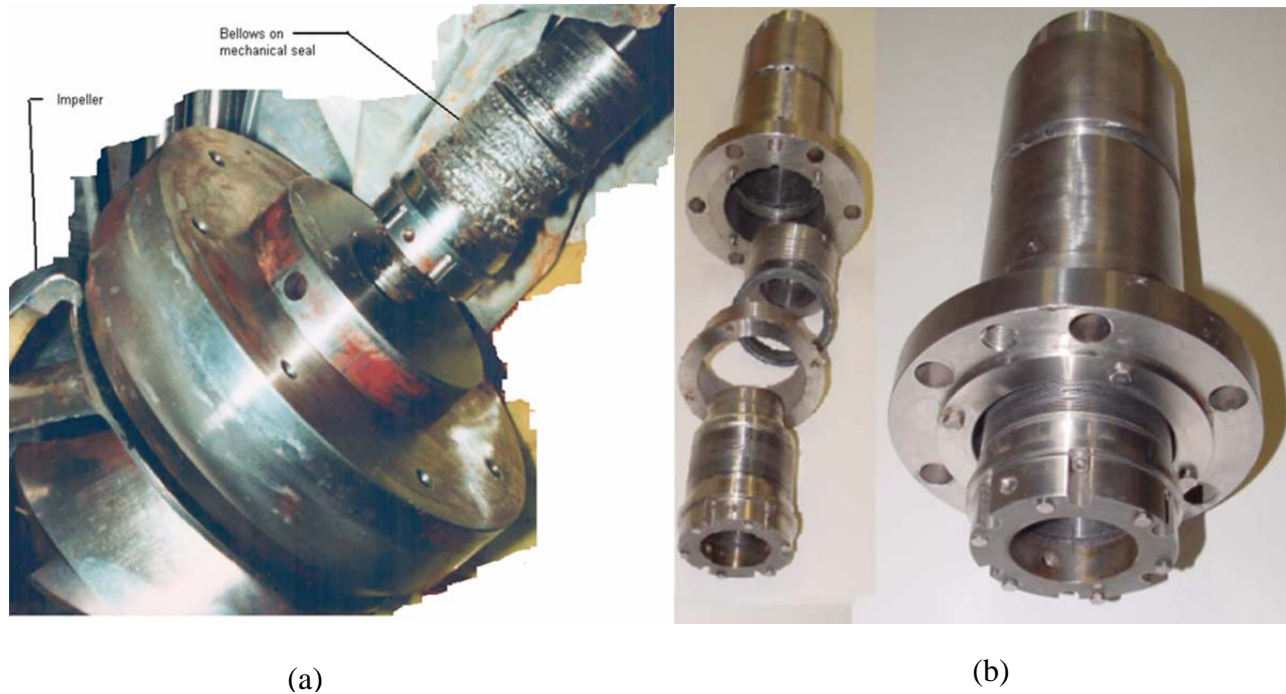
QVSP: A damaged mechanical seal from a QVSP is shown in Figure 2(a). This pump was installed in a HLW tank. A new seal assembly is shown in Figure 2(b) for comparison. The QVSP is essentially the same design as the SRS standard slurry mixing pump but has a larger hydraulic casing, impeller and discharge nozzles (jets). The average life for this style pump was approximately 1000 hours following installation [3]. A leak through the seal started with a small leak rate of 379 to 757 liters per hour (100 to 200 gallons per hour). The pump continued to operate with this leak rate until a sudden increase in leakage occurred. The pump was then shut down.

Two seal failure mechanisms were determined to have occurred. The initial seal failure occurred due to loss of lubricant when the water between the seal faces evaporated due to excessive heat caused by vibration. Essentially the mechanical faces ran in a near dry condition and the seal surfaces spalled and cracked. The other mechanism was due to radial vibration which caused gross damage to the bellows on the seal. To correct the problem on new pumps, the new impellers were machined to replace the cast impellers. Other corrective actions to new pumps include modifications of the shaft diameter to raise the critical shaft speed, intentional deflections (friendly misalignment) of the shaft to reduce whirl, and modifications to the bearings.

Figure 2. Damaged mechanical seal removed from a QVSP installed in a SRS waste tank.

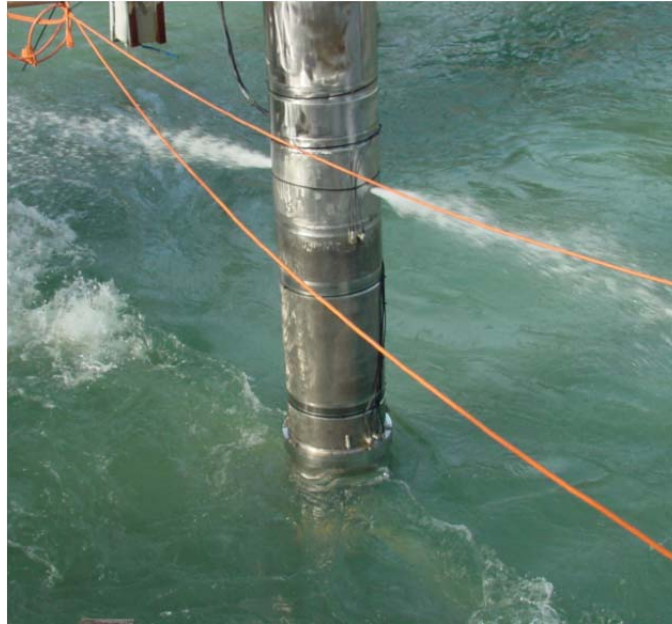
Figure 3. Submersible Mixer Pump during acceptance testing at the SRS Full Tank Facility.

The procurement for designing and fabricating these submersible mixer pumps (SMPs) was awarded to Curtiss-Wright Electro-Mechanical Division, Cheswick, PA. Acceptance testing at the SRS Full Tank Test Facility included vibration analysis. See Figure 3. A concern was identified during the early phase of testing when vibration sensors mounted at the lower radial bearing of the motor were occasionally driven into saturation by high frequencies. Consequently, lower sensitivity sensors and sensors to filter out the high frequency signals were installed for subsequent testing. During testing, one pump had a bearing failure. The corrective action for the failure included redesign of the bearings and fluid flow passages to increase lubricant flow in the bearing regions.

Vibration analysis during acceptance tests resulted in a reliable pump design. Six pumps have been used in SRS waste removal campaigns and, with the exception of one failure; the modified pumps have performed reliably. The pump failure was attributed to operation at the extreme end of the design curve in terms of temperature, speed and tank level while performing chemical cleaning with oxalic acid.

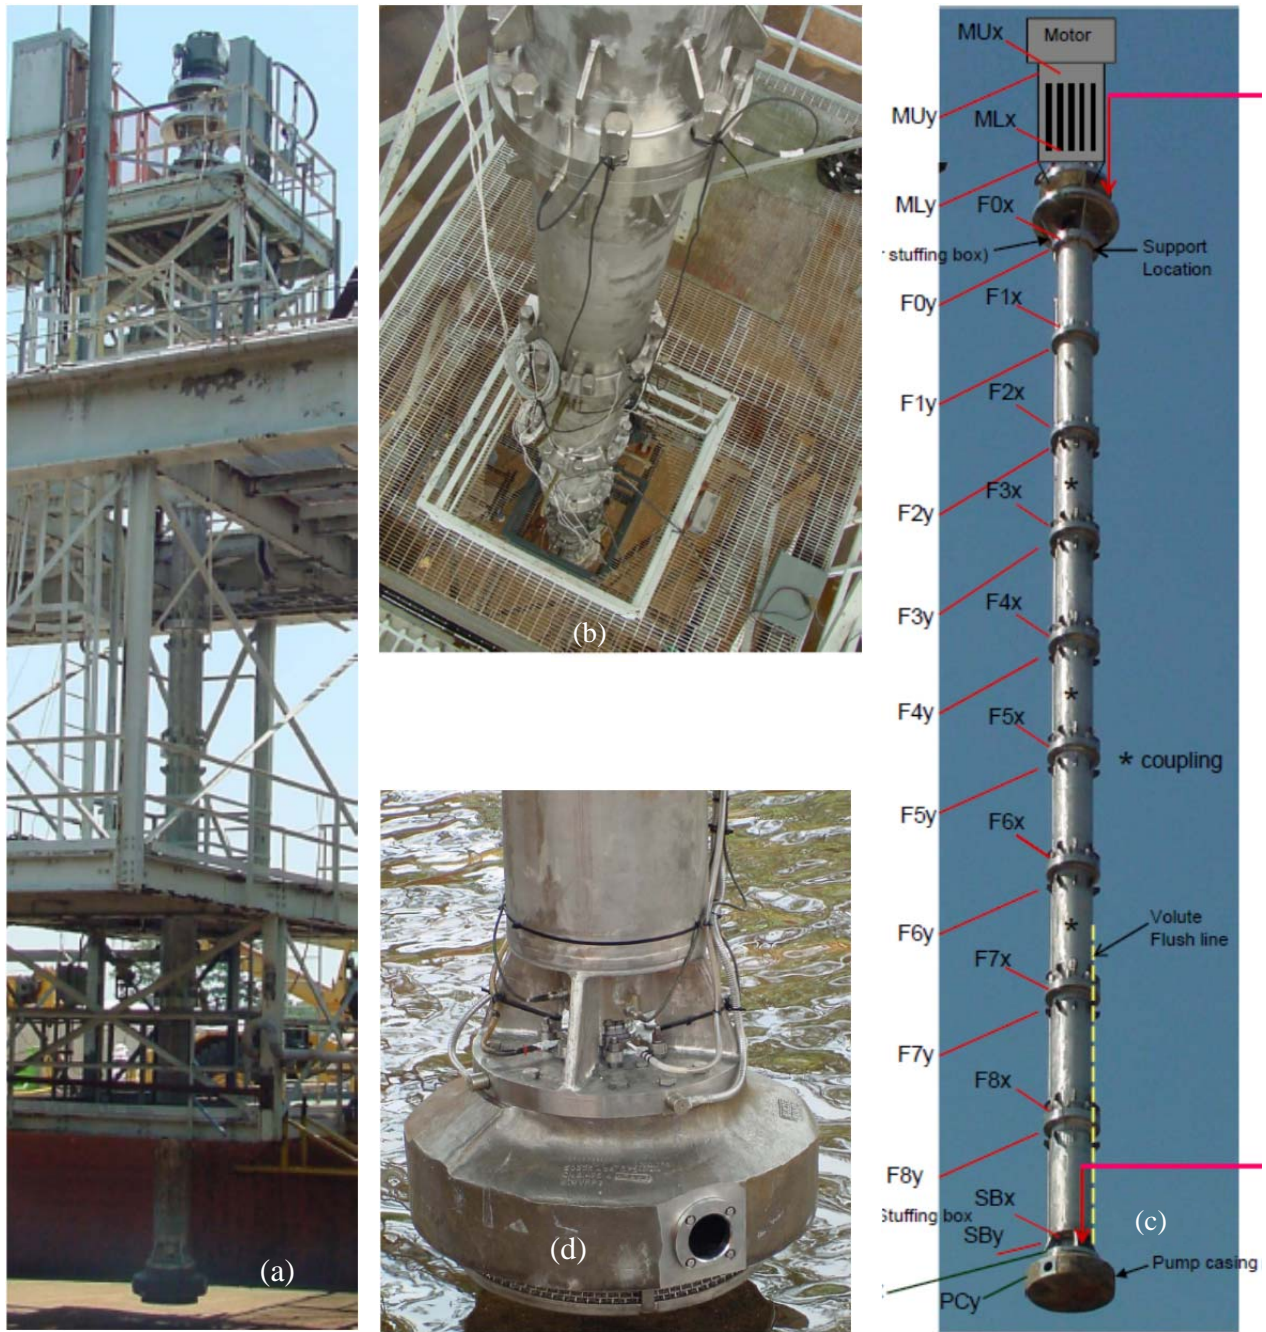
A long-shaft pump, QVSP, is shown mounted on an overhead structural steel platform that spans a 25.9 meter (85 foot) diameter by 2.43 meter (eight foot) full scale one quarter depth HLW test tank. See Figure 4(a). The test facility has several platforms to allow equipment access for attaching vibration analysis sensors, Figures 4 (a) and (b). The locations of typical data collection points along the pump shaft are shown in Figure 4(c). The proximity probes near the bottom are installed in an X-Y configuration targeting the exposed shaft between the support column and pump casing, Figure 4(d).

Figure 4. Typical SRS long-shaft pump instrumented with vibration sensors during pre-deployment testing.

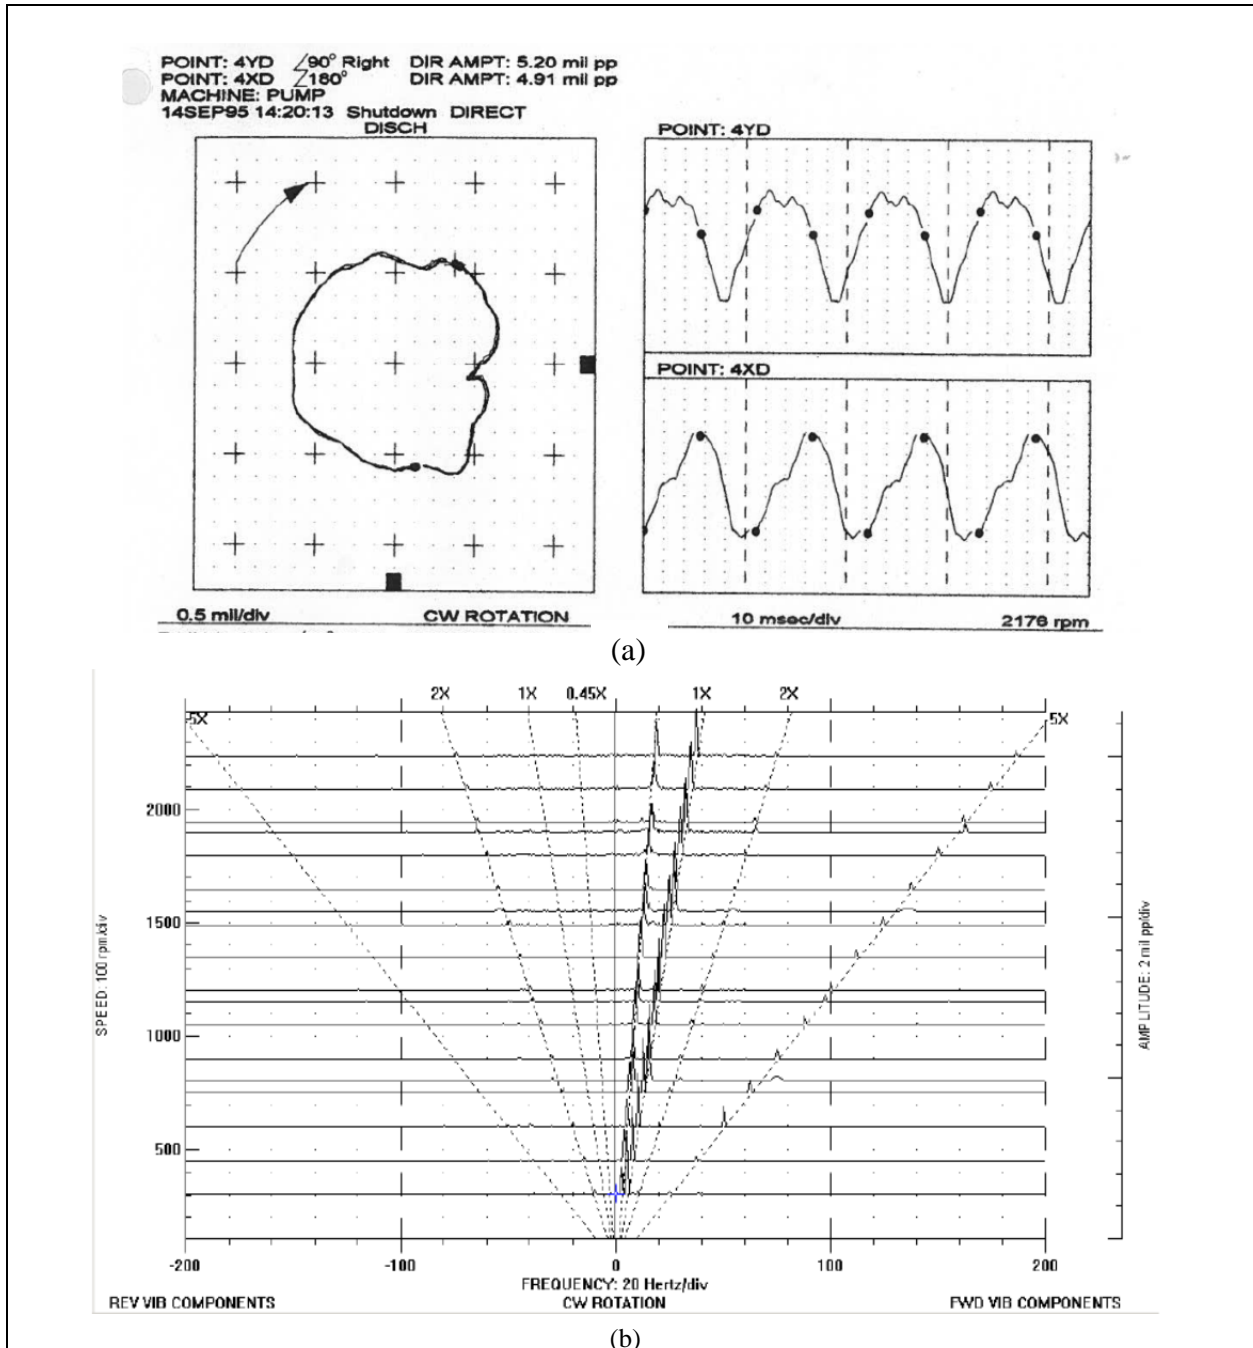
Vibration data from a QVSP is provided in Figure 5. The orbit time base plot and full spectrum cascade plot reveal a significant 1/2X component that is forwarding in precession. This vibration component will change to slightly less than 1/2X during the steady state pump run. The 1X vibration component was observed to be in forward precession during most of the test, except at the beginning when it was in reverse precession. The subsynchronous component in forward precession indicates fluid whirl. The subsynchronous component with reverse precession indicates a periodic rub mechanism or hydraulic influence from the submerged impeller.

The cascade plot in Figure 5 was created during the pump start up. The subsynchronous vibration as the equipment changed operating speed is visible to the left of the 1X order line. The vibration components tracking the 5X order line are due to the impeller and represent the vibrations from blade pass frequency.

Figure 5. Long shaft pump with cylindrical journal bearings (QVSP) orbit time waveform plot indicating fluid whirl and potential rub (a), and full spectrum cascade plot (b) indicating fluid whirl .

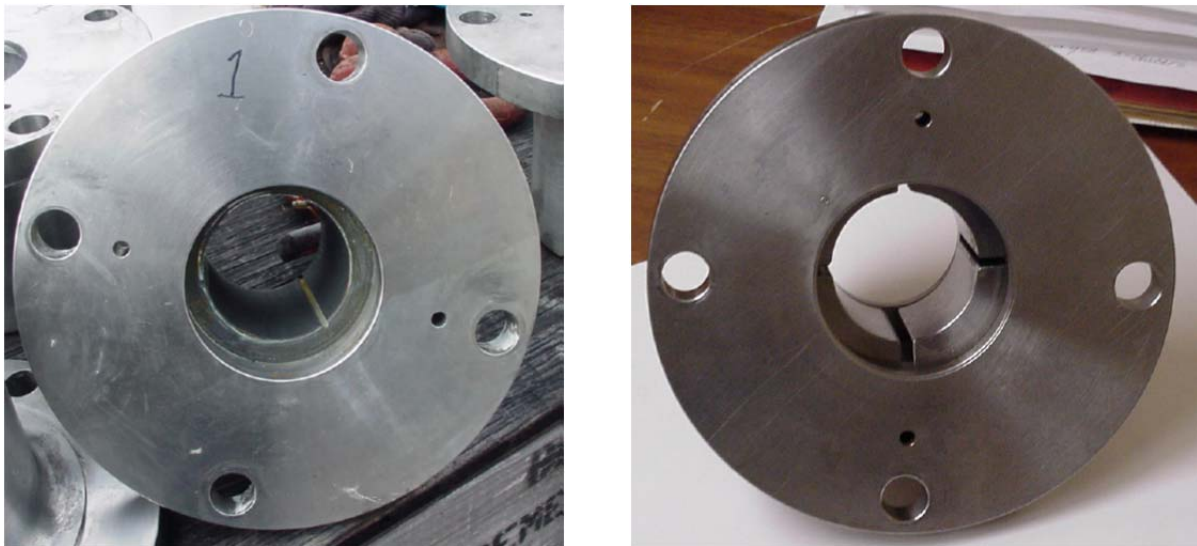
The new bearing design for the LPI slurry mixing pump is illustrated in Figure 6. It is a four pad tilting pad bearing with pivot offset and preload. The new bearings were installed in the 9 remaining pumps which were deployed in Tanks 7-F and 11-H. Each pump was tested for 72 hours to collect vibration data in a similar manner as data collected for the mixing pumps installed in Tank 8-F (i.e., along the column and exposed shaft near the impeller).

Figure 6. Unmodified Lawrence Pump bearing (a), and modified Lawrence Pump bearing (b).

Data analysis indicated that the modifications eliminated the subsynchronous 1/2X vibration along the shaft between the tilting pad bearings and nearly eliminated whirl vibrations in the region where the impeller is supported by one tilting-pad bearing and the process-lubricated journal bearing. This modification resulted in extending the service life of the pump by 10X (1000 to more than 10,000 hours).

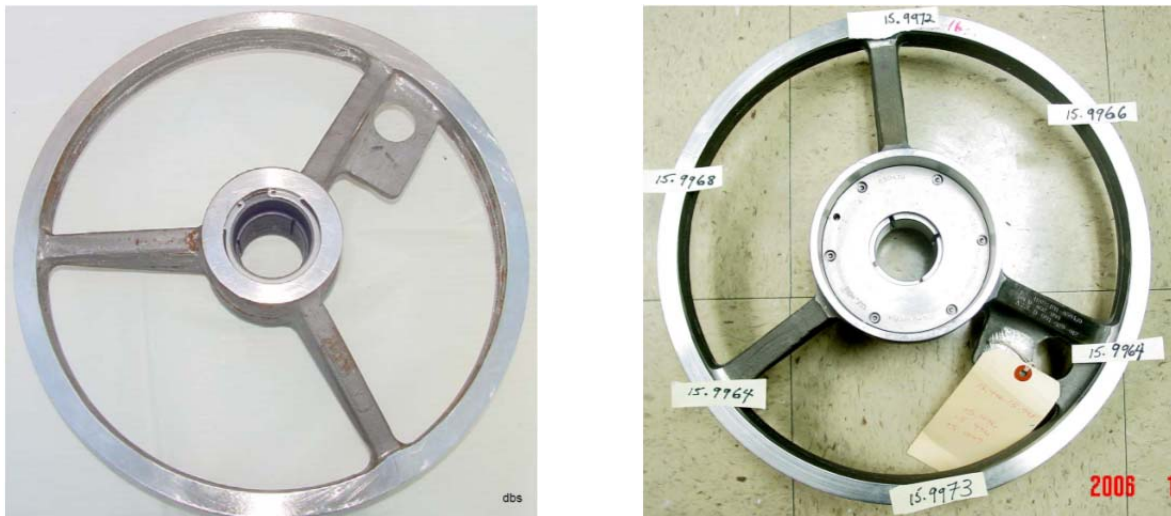
The new style bearing for the QVSP is shown in Figure 7. The new design was a tilting pad bearing with four pads, pivot offset and preload. The new bearings have been installed in 3 QVSPs and at least one modified pump has been installed in a HLW tank.

Figure 7. Unmodified QVSP spider bearing assembly which caused whirl vibration (a), and Modified QVSP spider bearing assembly which eliminated whirl vibration (b).

Vibration data similar to those collected for the unmodified QVSPs were generated and analyzed. The data indicated that the modification virtually eliminated the near 1/2X vibration along the shaft between the tilting pad bearings and the vibration near the impeller. Unlike the LPI slurry mixing pumps, no process-lubricated journal bearing existed for this type of pump where the shaft penetrated the pump casing.

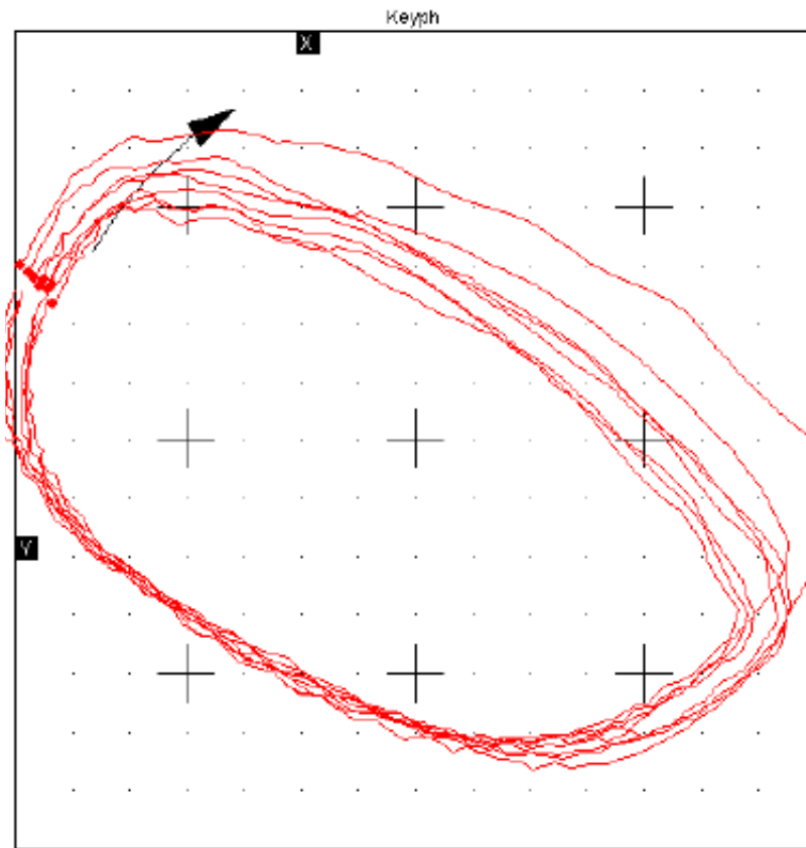
Figure 8. Lower Shaft Orbit for 3H Replacement Evaporator Feed Pump during Pre-deployment testing revealed clearance at process-lubricated bearing was too large. Two vibration probes (X and Y) are indicated on the plot.

The feed pump for the SRS 3H evaporator is also a long-shaft pump with desired service life of 24,000 hours (3 years). The pump design consists of one rolling element bearing at the thrust location, 10 water lubricated journal bearing in the support column, and one process lubricated bearing at the impeller. Vibration testing on the replacement pump for the 3H evaporator indicated that the shaft relative vibration at the lower end of the pump matched the diameter of the process lubricated bearing. See Figure 8. This indicated that the process lubricated bearing at the bottom of the pump was ineffective at controlling the shaft motion. The problem was due to the large diametric clearance between the shaft and impeller bearing. The corrective action implemented for the problem was to tighten the clearance at the process lubricated bearing by adding a sleeve to the shaft.

Vibration analysis was an integral part of extending the predicted service life of this type of pump from 8,000 to greater than 18,000 hr. The pump is still in radioactive waste service and is expected to perform for at least the desired service of 24,000 hours.

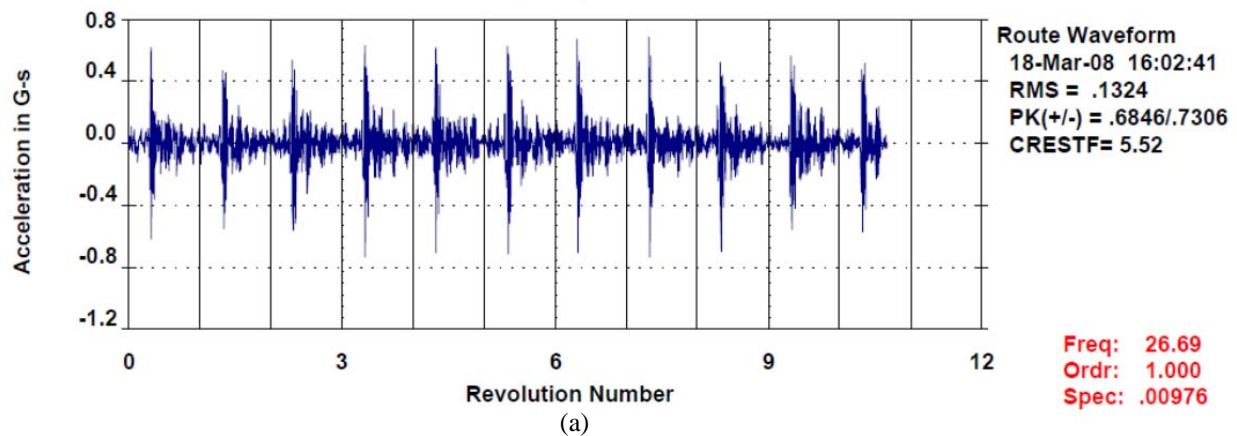
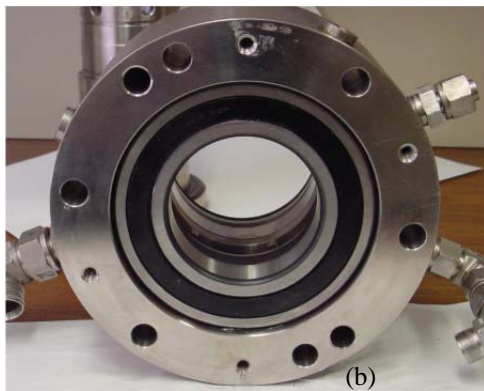
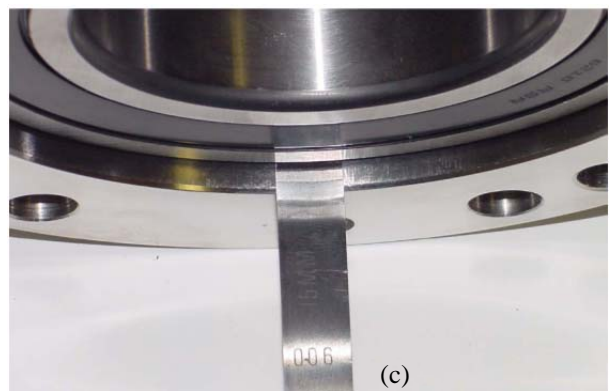
Figure 9. Time waveform for defective LPI pump which indicates impacting between bearing outer race and seal housing (a), Defective upper mechanical seal assembly (b), and tolerance problem (c)

- Defective upper mechanical seals in the LPI slurry mixing pumps. The defective seals were discovered as the result of mechanical testing of a modified LPI slurry mixing pump. The pump modification consisted of replacing the original equipment bearings with tilting pad bearings, and installing a new upper shaft seal. Vibration data were collected from the housing of a defective replacement upper mechanical seal. See Figure 9. The time waveform revealed cyclic/periodic impacting. The pump was shut down and upon disassembly of the mechanical seal, the clearance between the outer race of the rolling element bearing and seal housing was found to be out of tolerance. The corrective action for this malfunction was to machine a new seal housing.
