Benefits of Vibration Analysis for Deployment of Equipment in HLW Tanks – 12341

D. B. Stefanko¹ and J. E. Herbert²

¹Savannah River National Laboratory, Savannah River Nuclear Solutions

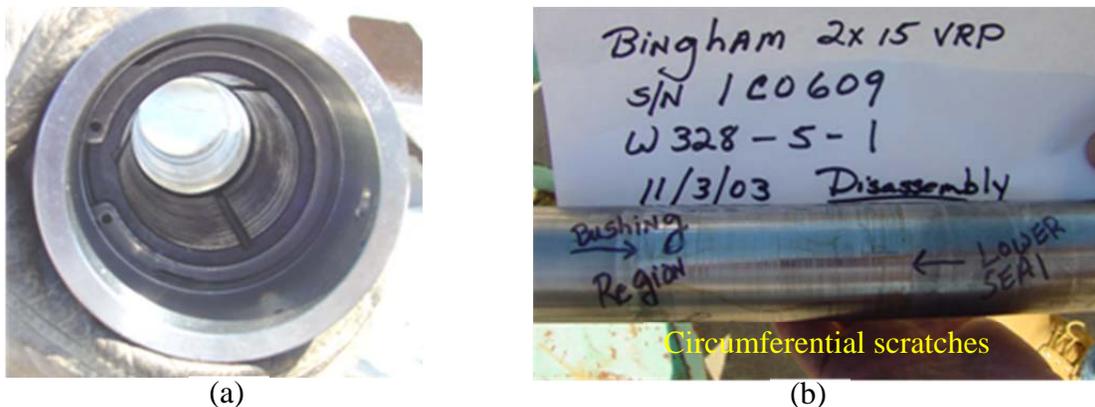
The damage due to vibration is evident in Figure 1(a) and (b). Wear patterns indicate contact between the shaft and bearings, followed by abrasion between bearing particles and the rotating surfaces. The bearings are not flushed, and this stagnant condition prevents adequate removal of any particles from the fluid film, thus accelerating further wear. The primary damaging vibration (for this equipment) was caused by impeller imbalance, but both whirl and resonance are problems with this style pump. Consequently, the reliability of this pump can only be increased by lowering the pump speed or installing tilt pad bearings and machined impellers.

Figure 1. Bearing and shaft damage from contact on a disassembled SRS standard slurry mixing pump.

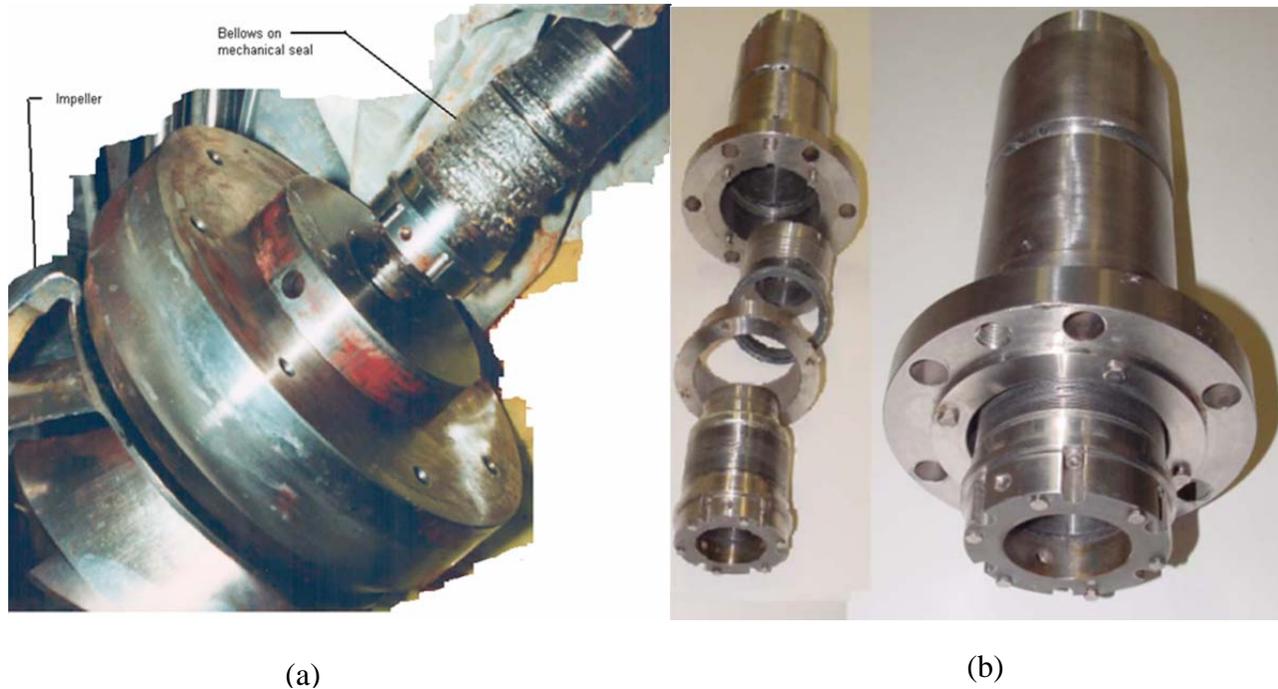
QVSP: A damaged mechanical seal from a QVSP is shown in Figure 2(a). This pump was installed in a HLW tank. A new seal assembly is shown in Figure 2(b) for comparison. The QVSP is essentially the same design as the SRS standard slurry mixing pump but has a larger hydraulic casing, impeller and discharge nozzles (jets). The average life for this style pump was approximately 1000 hours following installation [3]. A leak through the seal started with a small leak rate of 379 to 757 liters per hour (100 to 200 gallons per hour). The pump continued to operate with this leak rate until a sudden increase in leakage occurred. The pump was then shut down.

Two seal failure mechanisms were determined to have occurred. The initial seal failure occurred due to loss of lubricant when the water between the seal faces evaporated due to excessive heat caused by vibration. Essentially the mechanical faces ran in a near dry condition and the seal surfaces spalled and cracked. The other mechanism was due to radial vibration which caused gross damage to the bellows on the seal. To correct the problem on new pumps, the new impellers were machined to replace the cast impellers. Other corrective actions to new pumps include modifications of the shaft diameter to raise the critical shaft speed, intentional deflections (friendly misalignment) of the shaft to reduce whirl, and modifications to the bearings.

Figure 2. Damaged mechanical seal removed from a QVSP installed in a SRS waste tank.

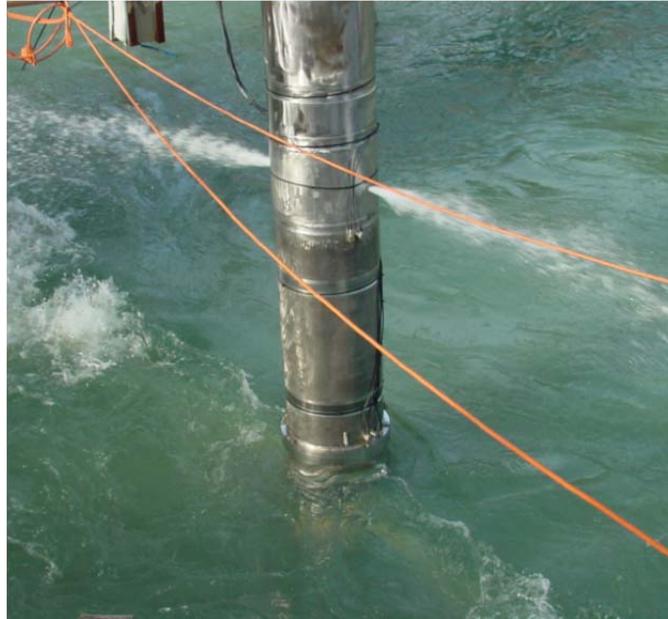
Figure 3. Submersible Mixer Pump during acceptance testing at the SRS Full Tank Facility.

The procurement for designing and fabricating these submersible mixer pumps (SMPs) was awarded to Curtiss-Wright Electro-Mechanical Division, Cheswick, PA. Acceptance testing at the SRS Full Tank Test Facility included vibration analysis. See Figure 3. A concern was identified during the early phase of testing when vibration sensors mounted at the lower radial bearing of the motor were occasionally driven into saturation by high frequencies. Consequently, lower sensitivity sensors and sensors to filter out the high frequency signals were installed for subsequent testing. During testing, one pump had a bearing failure. The corrective action for the failure included redesign of the bearings and fluid flow passages to increase lubricant flow in the bearing regions.

Vibration analysis during acceptance tests resulted in a reliable pump design. Six pumps have been used in SRS waste removal campaigns and, with the exception of one failure; the modified pumps have performed reliably. The pump failure was attributed to operation at the extreme end of the design curve in terms of temperature, speed and tank level while performing chemical cleaning with oxalic acid.

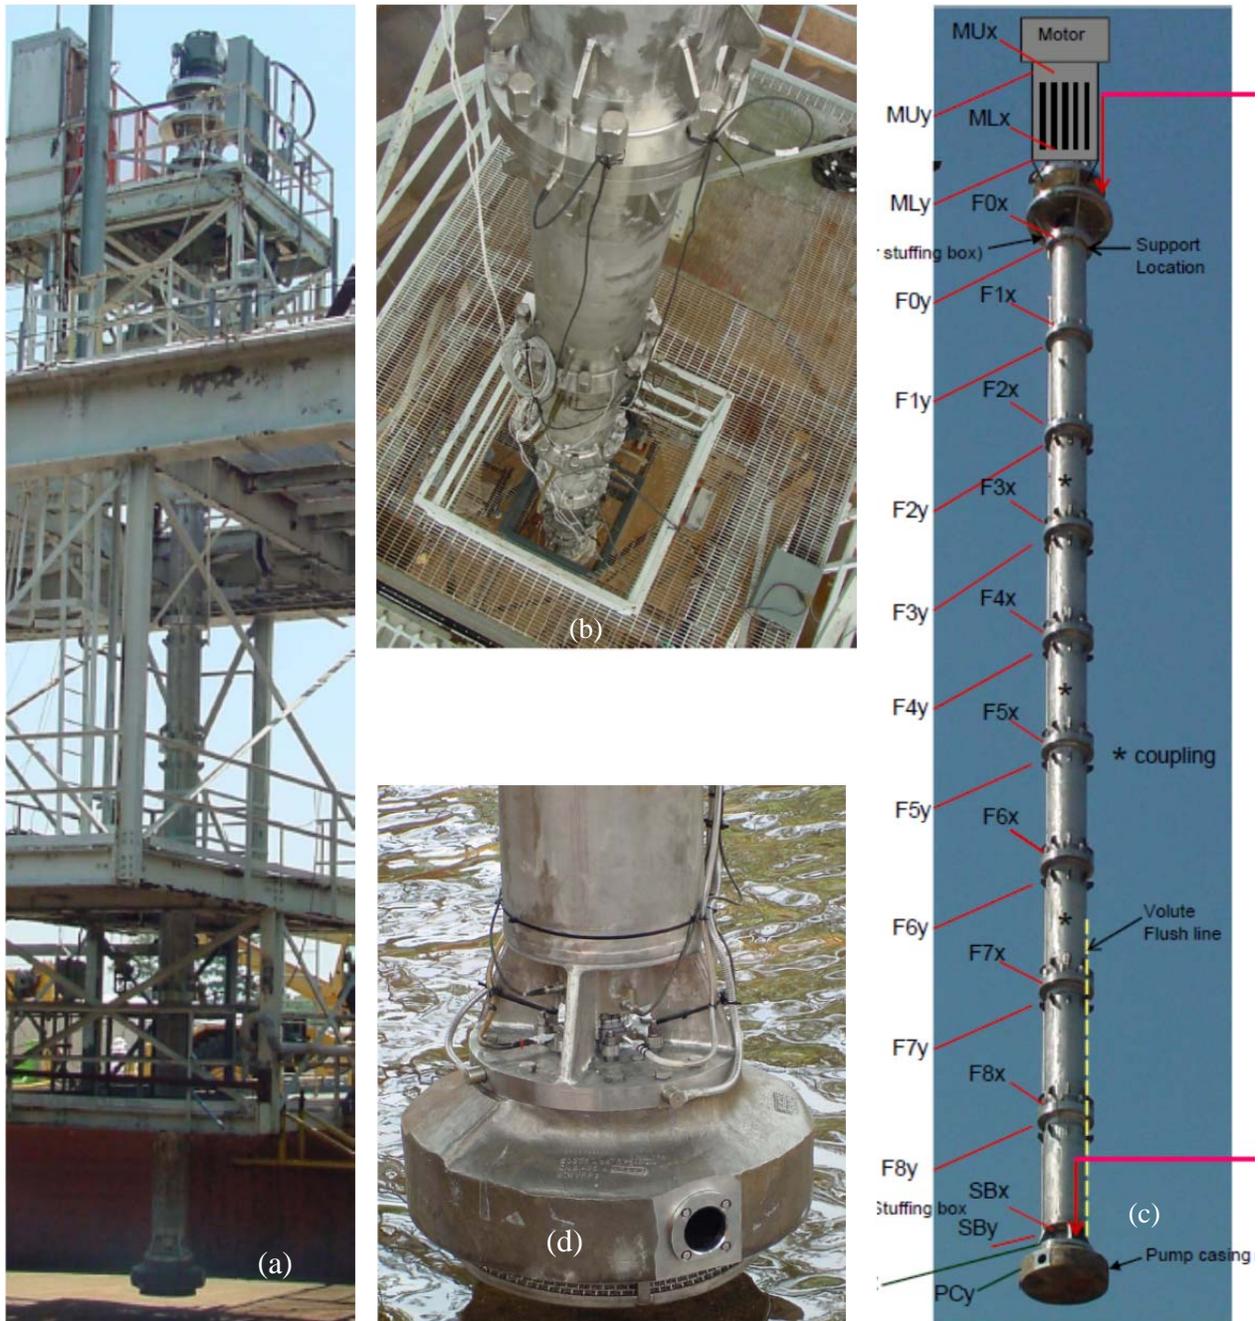
A long-shaft pump, QVSP, is shown mounted on an overhead structural steel platform that spans a 25.9 meter (85 foot) diameter by 2.43 meter (eight foot) full scale one quarter depth HLW test tank. See Figure 4(a). The test facility has several platforms to allow equipment access for attaching vibration analysis sensors, Figures 4 (a) and (b). The locations of typical data collection points along the pump shaft are shown in Figure 4(c). The proximity probes near the bottom are installed in an X-Y configuration targeting the exposed shaft between the support column and pump casing, Figure 4(d).

Figure 4. Typical SRS long-shaft pump instrumented with vibration sensors during pre-deployment testing.

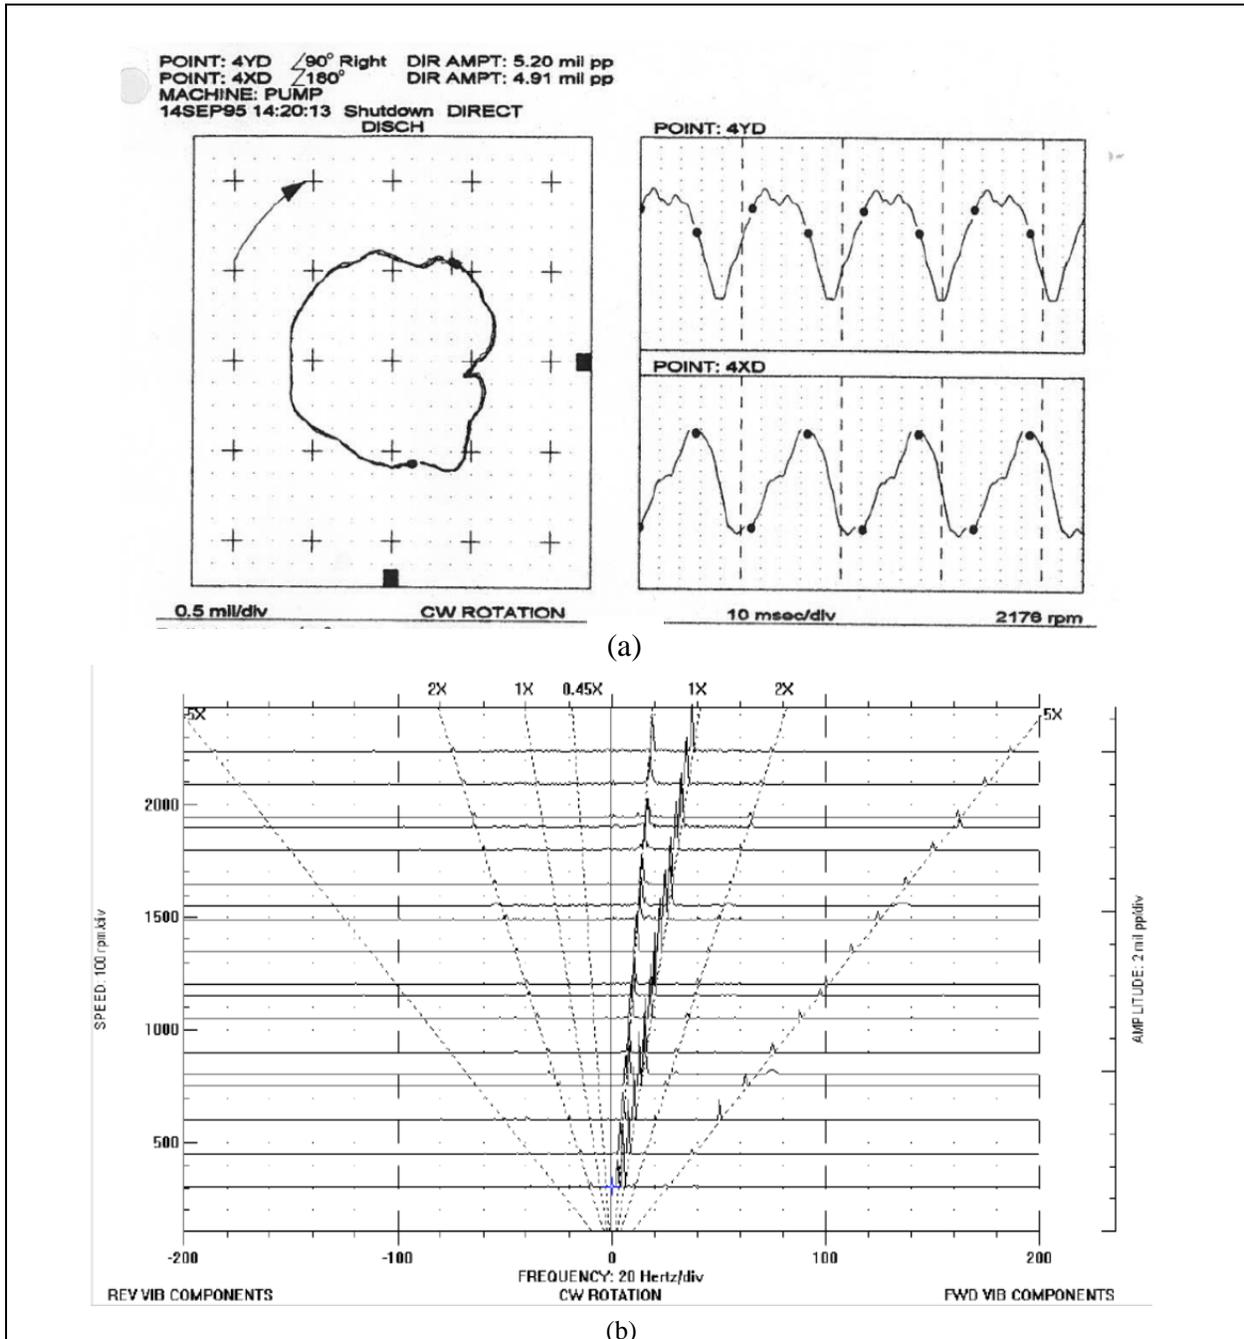
Vibration data from a QVSP is provided in Figure 5. The orbit time base plot and full spectrum cascade plot reveal a significant 1/2X component that is forwarding in precession. This vibration component will change to slightly less than 1/2X during the steady state pump run. The 1X vibration component was observed to be in forward precession during most of the test, except at the beginning when it was in reverse precession. The subsynchronous component in forward precession indicates fluid whirl. The subsynchronous component with reverse precession indicates a periodic rub mechanism or hydraulic influence from the submerged impeller.

The cascade plot in Figure 5 was created during the pump start up. The subsynchronous vibration as the equipment changed operating speed is visible to the left of the 1X order line. The vibration components tracking the 5X order line are due to the impeller and represent the vibrations from blade pass frequency.

Figure 5. Long shaft pump with cylindrical journal bearings (QVSP) orbit time waveform plot indicating fluid whirl and potential rub (a), and full spectrum cascade plot (b) indicating fluid whirl .

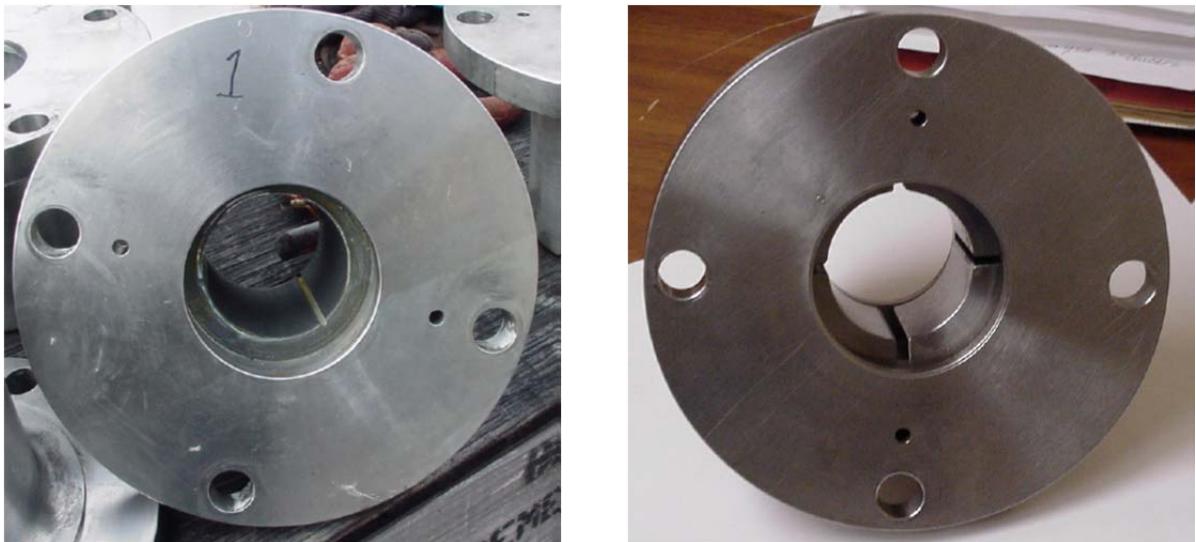
The new bearing design for the LPI slurry mixing pump is illustrated in Figure 6. It is a four pad tilting pad bearing with pivot offset and preload. The new bearings were installed in the 9 remaining pumps which were deployed in Tanks 7-F and 11-H. Each pump was tested for 72 hours to collect vibration data in a similar manner as data collected for the mixing pumps installed in Tank 8-F (i.e., along the column and exposed shaft near the impeller).

Figure 6. Unmodified Lawrence Pump bearing (a), and modified Lawrence Pump bearing (b).

Data analysis indicated that the modifications eliminated the subsynchronous 1/2X vibration along the shaft between the tilting pad bearings and nearly eliminated whirl vibrations in the region where the impeller is supported by one tilting-pad bearing and the process-lubricated journal bearing. This modification resulted in extending the service life of the pump by 10X (1000 to more than 10,000 hours).

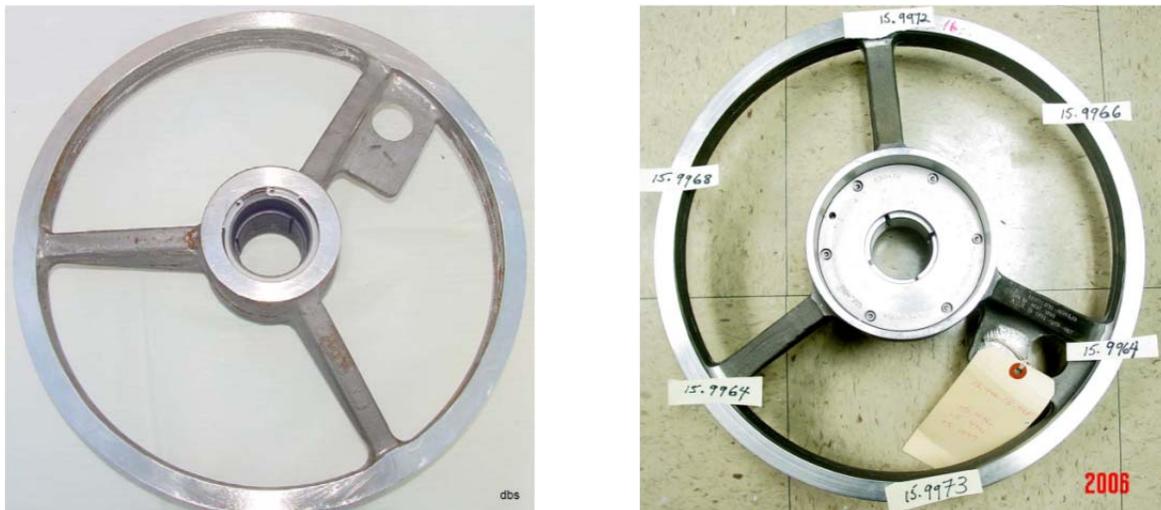
The new style bearing for the QVSP is shown in Figure 7. The new design was a tilting pad bearing with four pads, pivot offset and preload. The new bearings have been installed in 3 QVSPs and at least one modified pump has been installed in a HLW tank.

Figure 7. Unmodified QVSP spider bearing assembly which caused whirl vibration (a), and Modified QVSP spider bearing assembly which eliminated whirl vibration (b).

Vibration data similar to those collected for the unmodified QVSPs were generated and analyzed. The data indicated that the modification virtually eliminated the near 1/2X vibration along the shaft between the tilting pad bearings and the vibration near the impeller. Unlike the LPI slurry mixing pumps, no process-lubricated journal bearing existed for this type of pump where the shaft penetrated the pump casing.

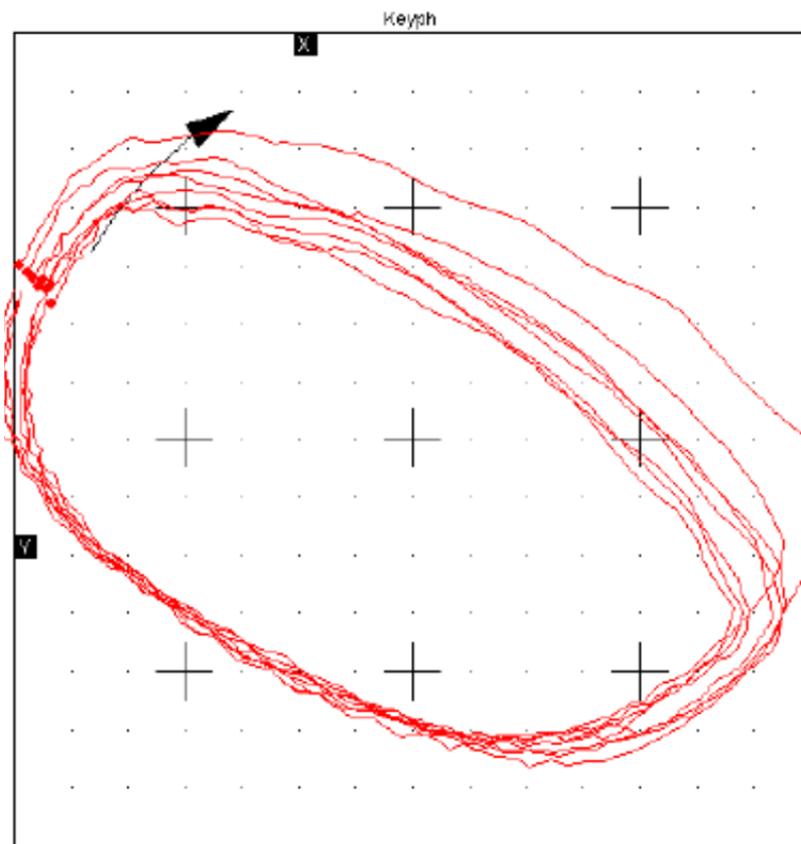
Figure 8. Lower Shaft Orbit for 3H Replacement Evaporator Feed Pump during Pre-deployment testing revealed clearance at process-lubricated bearing was too large. Two vibration probes (X and Y) are indicated on the plot.

The feed pump for the SRS 3H evaporator is also a long-shaft pump with desired service life of 24,000 hours (3 years). The pump design consists of one rolling element bearing at the thrust location, 10 water lubricated journal bearing in the support column, and one process lubricated bearing at the impeller. Vibration testing on the replacement pump for the 3H evaporator indicated that the shaft relative vibration at the lower end of the pump matched the diameter of the process lubricated bearing. See Figure 8. This indicated that the process lubricated bearing at the bottom of the pump was ineffective at controlling the shaft motion. The problem was due to the large diametric clearance between the shaft and impeller bearing. The corrective action implemented for the problem was to tighten the clearance at the process lubricated bearing by adding a sleeve to the shaft.

Vibration analysis was an integral part of extending the predicted service life of this type of pump from 8,000 to greater than 18,000 hr. The pump is still in radioactive waste service and is expected to perform for at least the desired service of 24,000 hours.

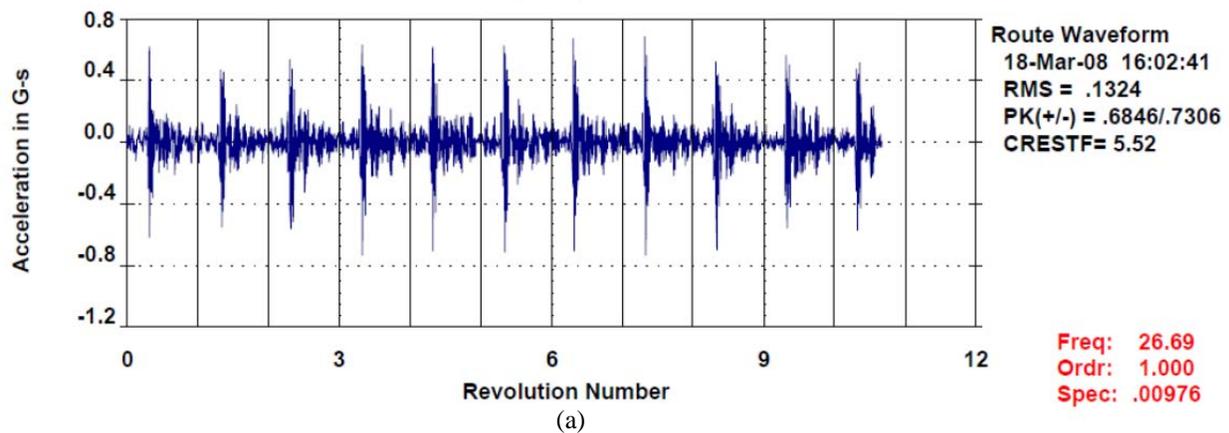
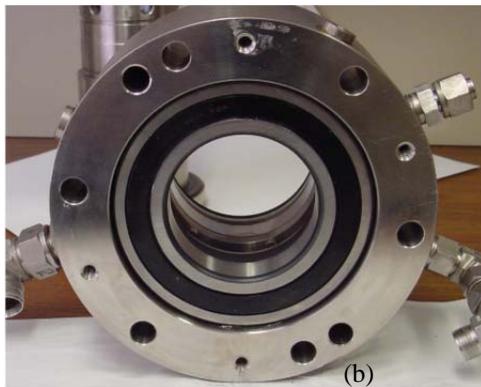
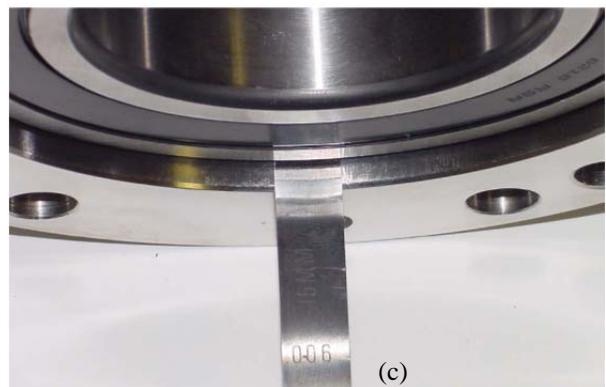
- Defective upper mechanical seals in the LPI slurry mixing pumps. The defective seals were discovered as the result of mechanical testing of a modified LPI slurry mixing pump. The pump modification consisted of replacing the original equipment bearings with tilting pad bearings, and installing a new upper shaft seal. Vibration data were collected from the housing of a defective replacement upper mechanical seal. See Figure 9. The time waveform revealed cyclic/periodic impacting. The pump was shut down and upon disassembly of the mechanical seal, the clearance between the outer race of the rolling element bearing and seal housing was found to be out of tolerance. The corrective action for this malfunction was to machine a new seal housing.

Figure 9. Time waveform for defective LPI pump which indicates impacting between bearing outer race and seal housing (a), Defective upper mechanical seal assembly (b), and tolerance problem (c)
