Evaluation and Recommendation of Saltstone Mixer Auger/Paddles Materials of Construction for Improved Wear Resistance

J. I. Mickalonis
R. D. Torres

July 2012

Savannah River National Laboratory
Savannah River Nuclear Solutions, LLC
Aiken, SC 29808

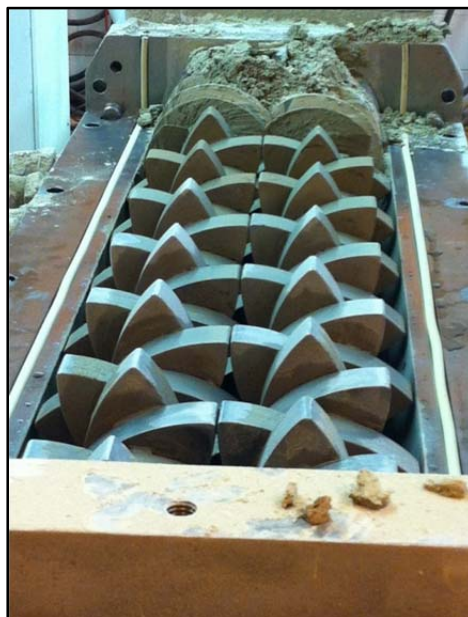
Figure 2-2. Interior of Readco continuous mixer showing premix feed on the augers and the self-cleaning paddles

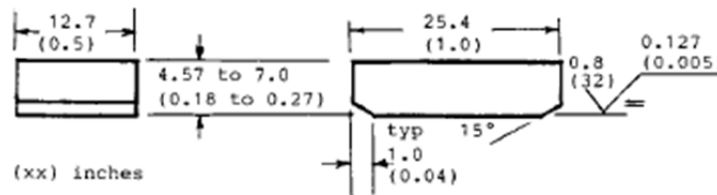
Figure 3-2. Wear Sample Dimensions [3]

Duplicate wear samples were fabricated to the specified dimensions as shown in Figure 3-2. The slurry used in this testing was made from 50% Saltstone dry feed provided by SRNL, composed of 150 g dry feed, 150 g deionized water, and 0.3 ml Daratard 17. The Daratard 17 is used to delay the slurry from setting.

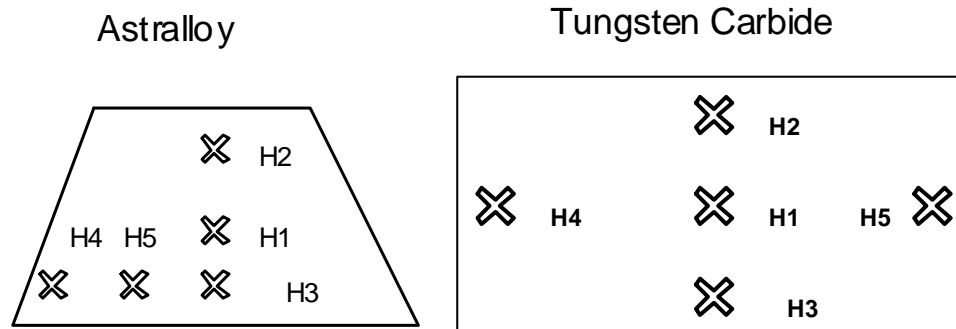
Figure 3-3. Locations of hardness measurements on the Astralloy and tungsten carbide samples

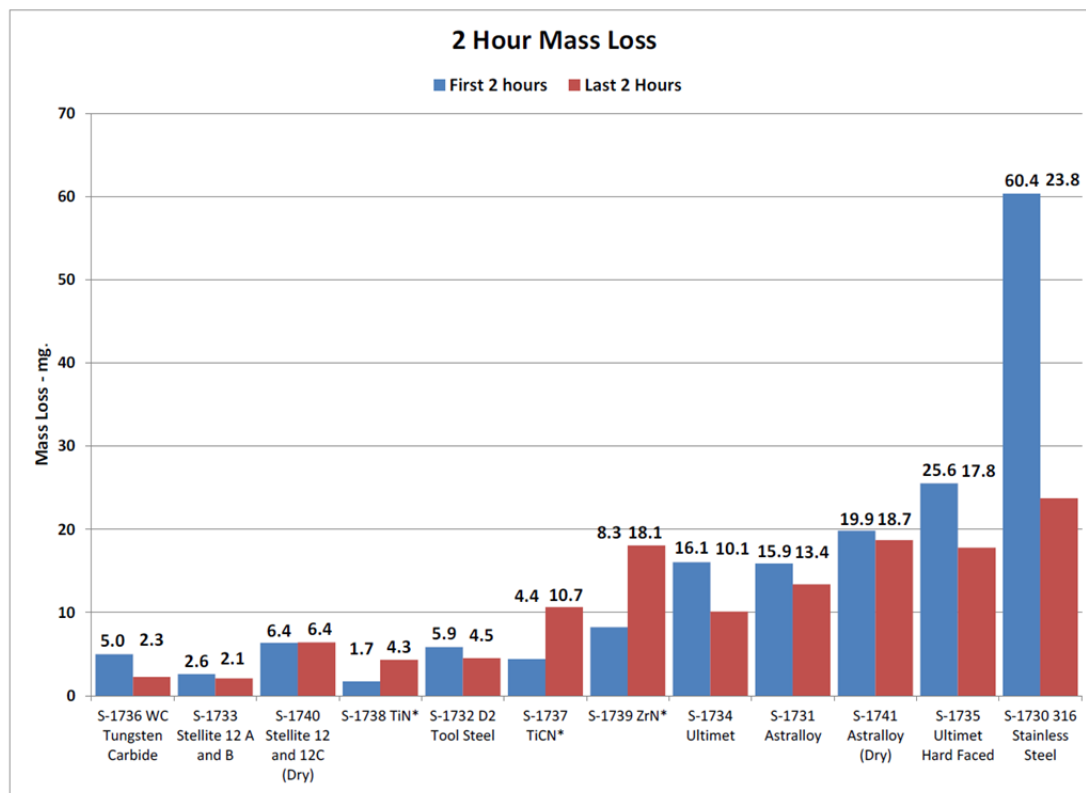
**Figure 4-1. Mass losses during the ASTM G5 wear test for Saltstone mixer candidate materials of construction**

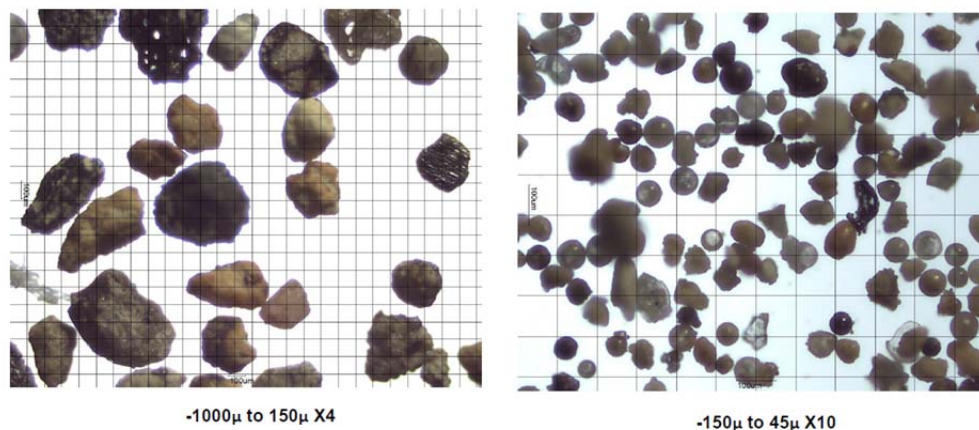
Figure 4-2. Photomicrographs of dry feed constituent particles

Prior to the wear testing the premix was characterized for particle size and shape. The premix had a very high concentration (91%) of fine particulate ($<45\ \mu\text{m}$), which agreed with the results obtained at SRNL (Table 2-1).[9] The particles were essentially spherical with few sharp edges as shown in Figure 4-2.

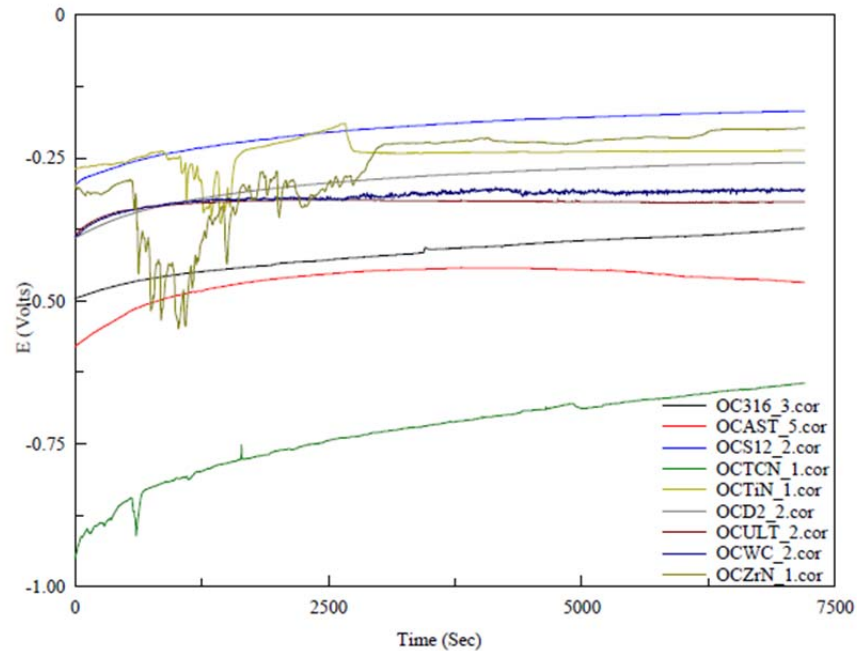
Figure 4-3. OCP stabilization of the candidate materials of construction in slurry with salt solution

The materials of construction showed a broad range of OCP values after the two hours of equilibration as shown by the data in Figure 4-3. The OCP values all became more electropositive, which coincided with the formation of slurry deposits on the sample surface. These deposits made performing the scanned potential techniques difficult.

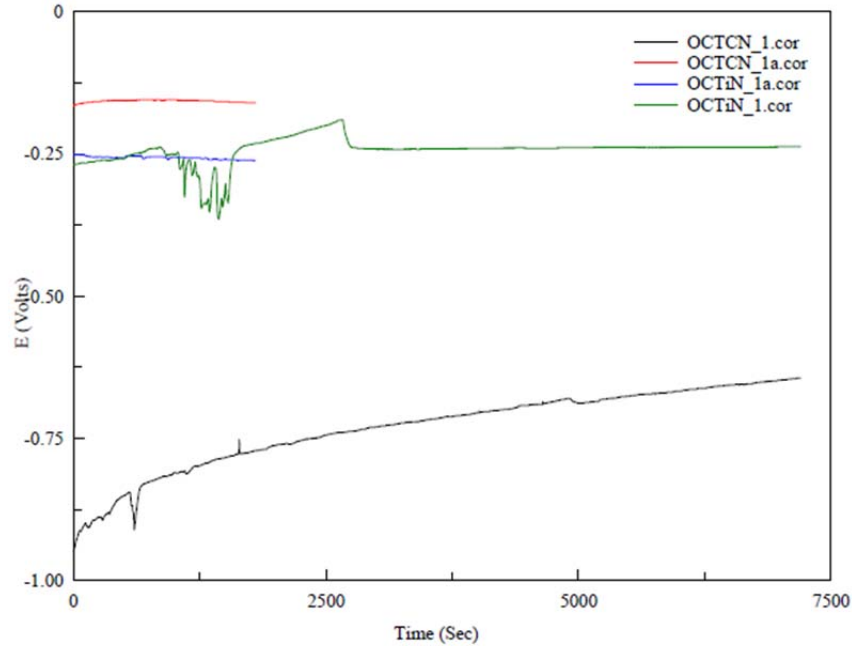
Figure 4-4. OCP stabilization of the TiCN and TiN coating in slurry with salt solution

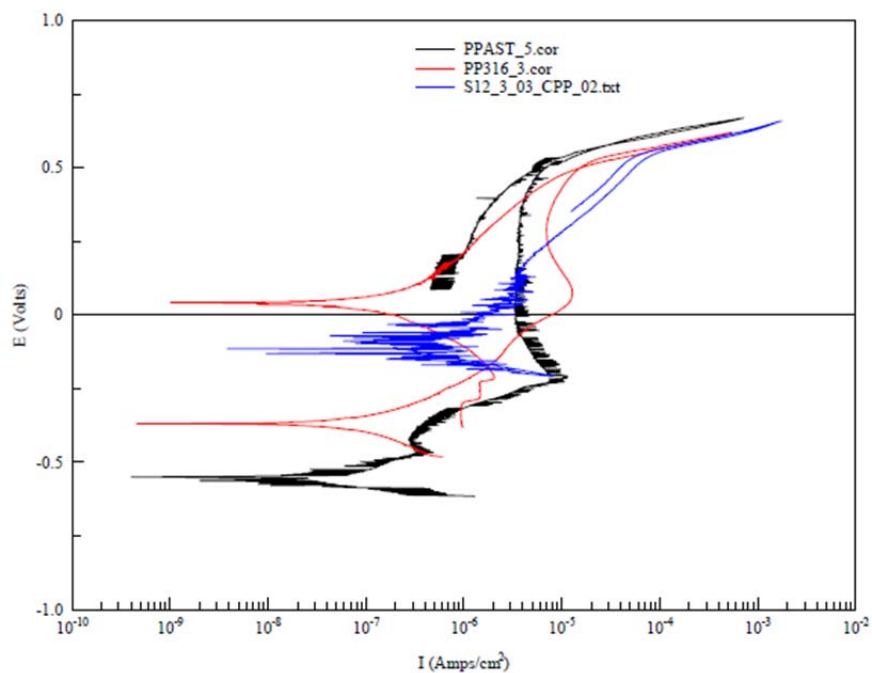
Figure 4-5. CPP Scans for current materials of construction for the Saltstone mixer

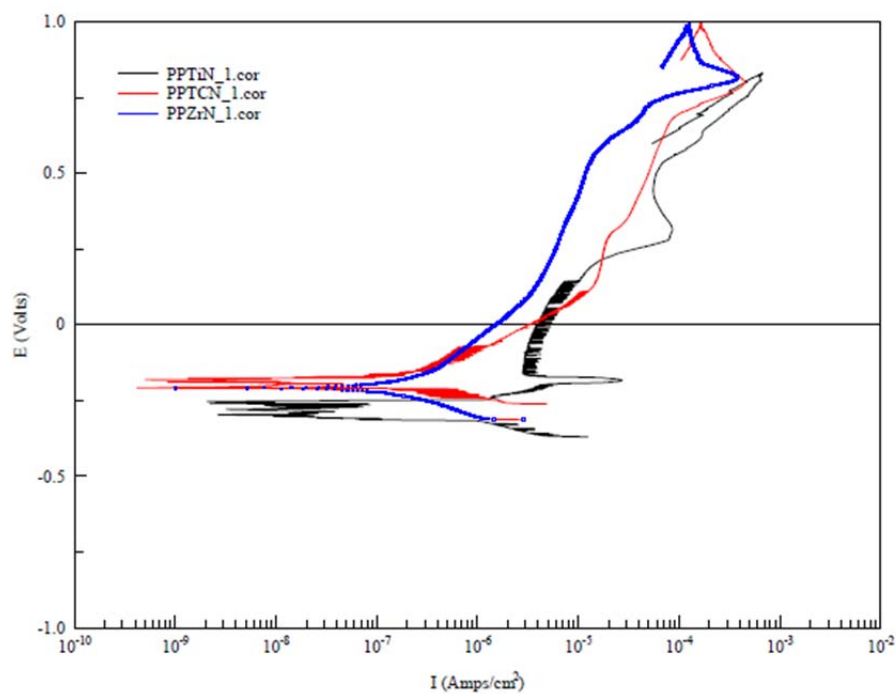
Figure 4-6. CPP scans for candidate PVD coatings for the Saltstone mixer

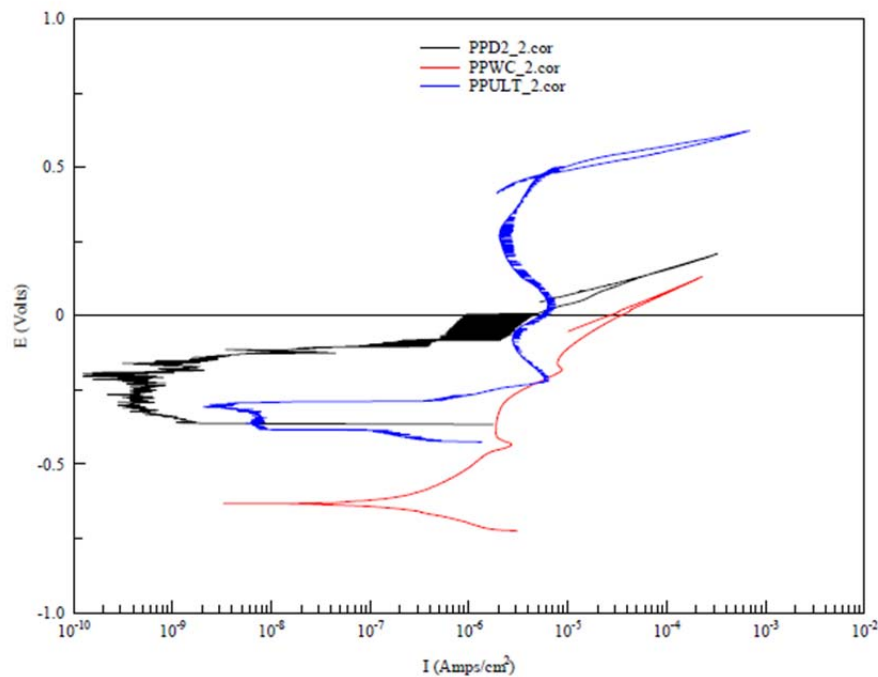
Figure 4-7. CPP scans for candidate materials of construction for the Saltstone mixer

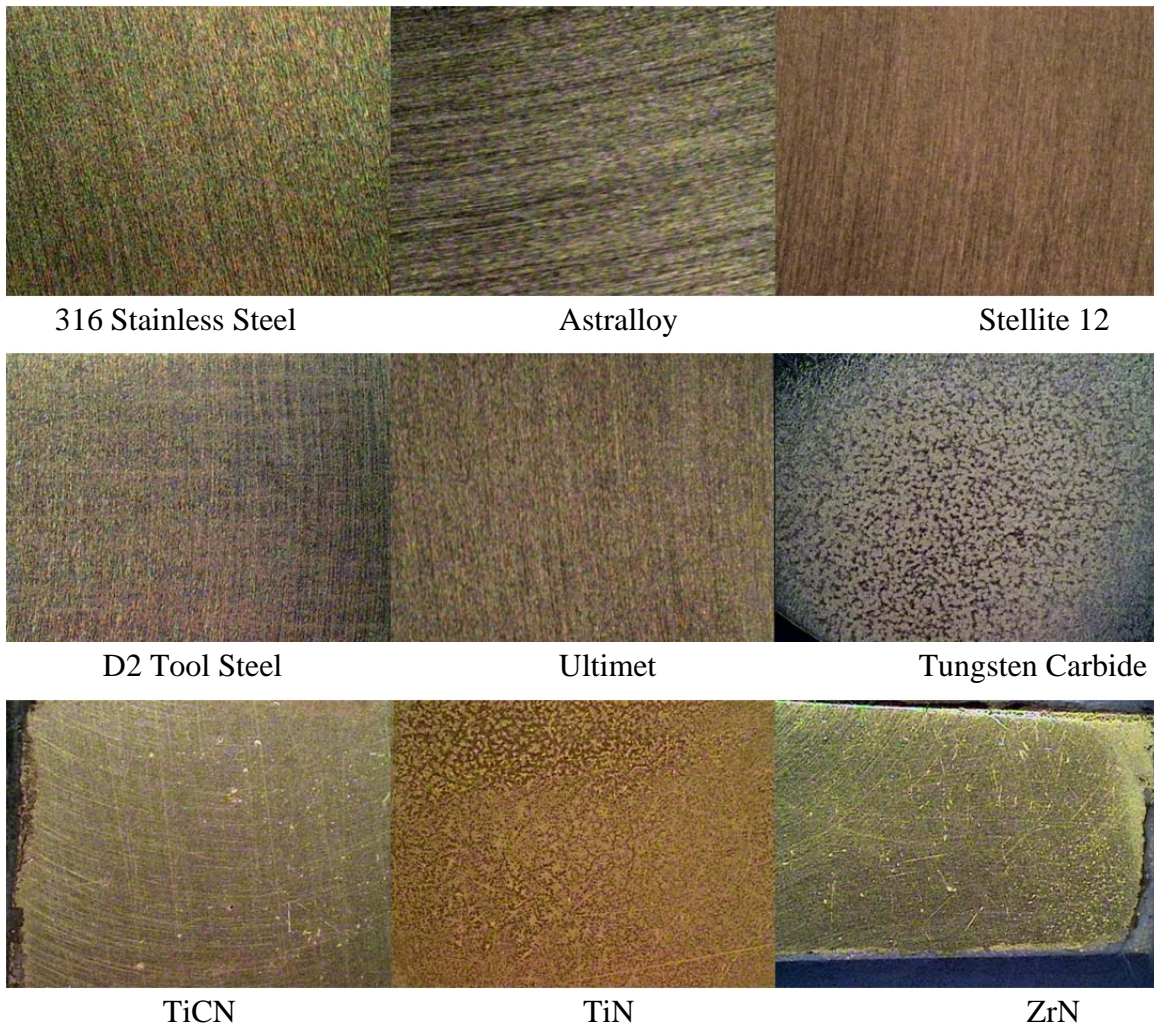
Figure 4-8. Stereomicroscope pictures of the candidate materials of construction after CPP scans (20x)

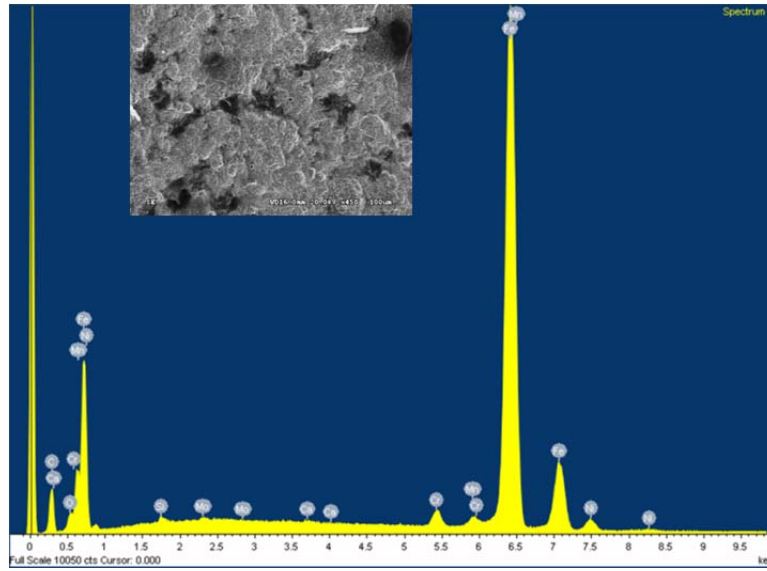
Figure 4-9. SEM micrograph and sum EDS spectrum of Astralloy wear specimens prior to wear testing

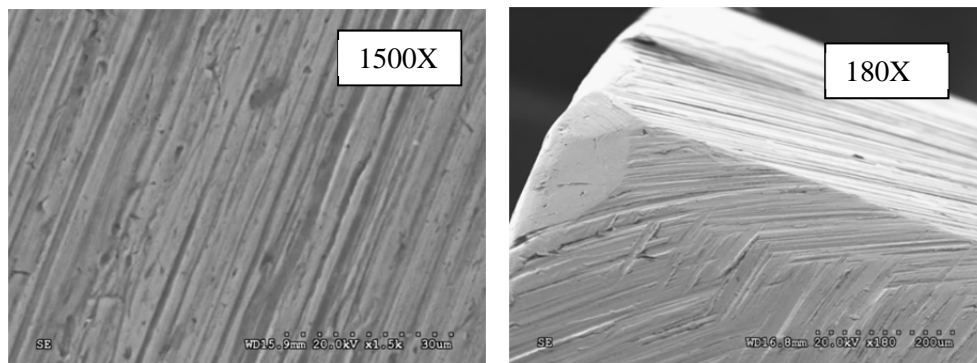
Figure 4-10. SEM micrographs of Astralloy V specimens after slurry premix wear testing

Post-wear testing (slurry followed by premix) SEM micrographs of the Astralloy wear specimens show a fairly smooth surface with mostly unidirectional abrasion lines, with some areas showing varying wear patterns (Figure 4-10). Some deep random scratches were observed and attributed to some of the harder components of the dry feed. The leading edges of the specimen appear rounded and highly worn with some areas showing removed material, which is consistent with the high SAR numbers (SAR=127, wet; SAR=187, dry) for these specimens. Some features resembling filiform corrosion were observed (Figure 4-11) and EDS mapping was performed. The localized oxygen concentrations verified the formation of an iron oxide (Figure 4-12), although when these formed is uncertain.

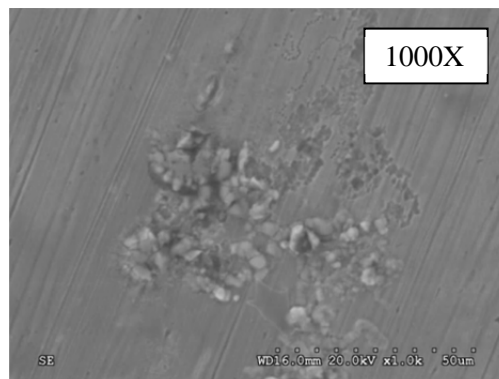
Figure 4-11. Pits and filiform corrosion products observed in Astralloy specimens after slurry/premix wear testing

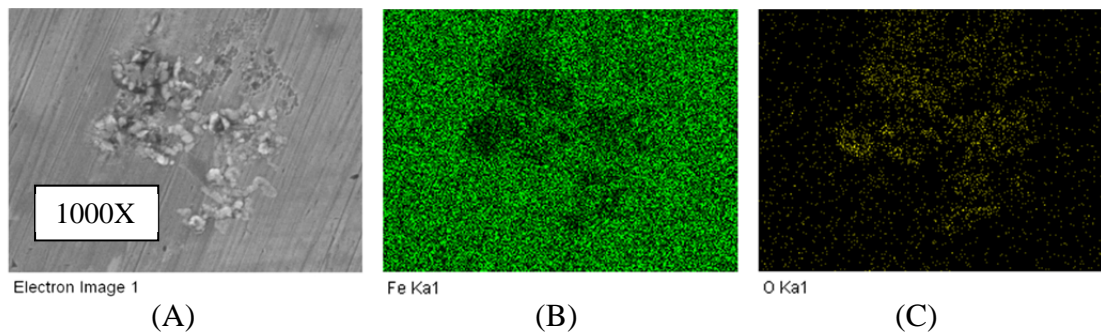
Figure 4-12. EDS mapping of corrosion products observed in the Astralloy surface after slurry/premix wear testing: (A) Secondary electron image; (B) Fe K α line map; and (C) O K α line map

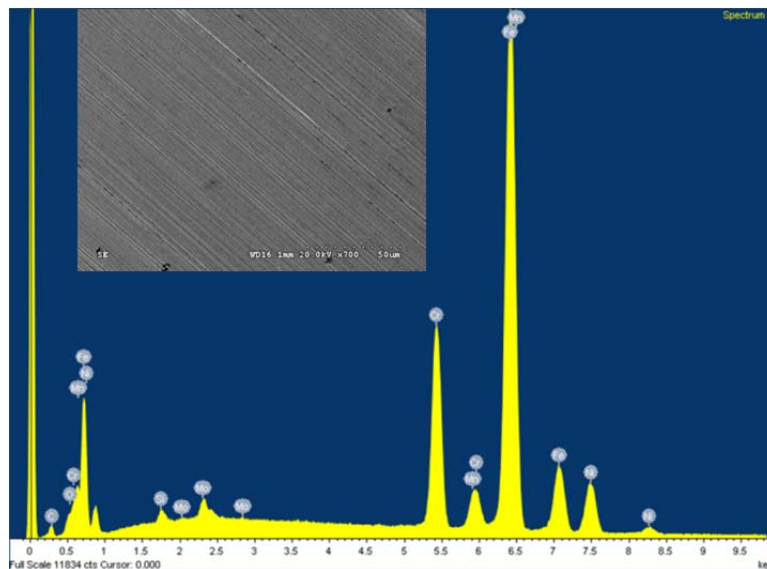
Figure 4-13. SEM micrograph and sum EDS spectrum of 316 specimens prior to wear testing

SEM micrographs of the as-machined specimens showed very smooth surfaces with unidirectional scratch lines and an average width well below 0.5 μm (Figure 4.13). Small pits ($\sim 5\text{-}10\ \mu\text{m}$) could be observed throughout the specimen. The sum EDS spectrum of the surface shows all expected spectral lines for the 316 composition (Table 4-4).

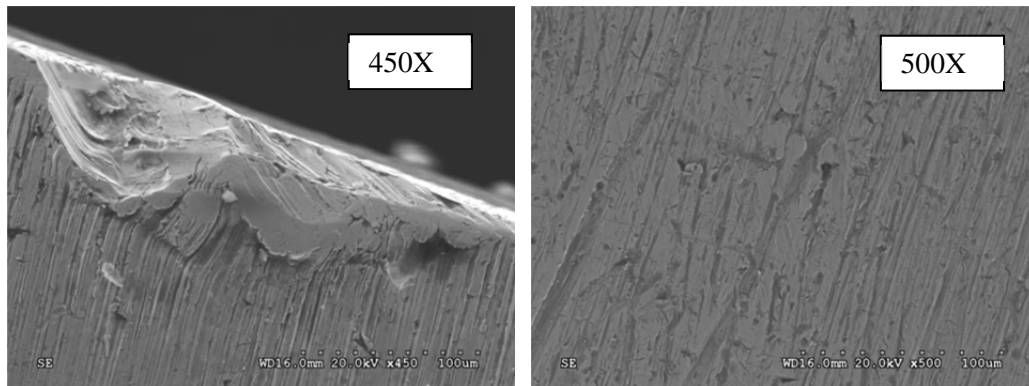
Figure 4-14. SEM micrographs of edge and surface of 316 specimens after slurry wear testing

SEM analysis after slurry abrasion revealed deep gouging and material plowing/removal from the edges of the 316 specimens (Figure 4-14), all consistent with the very high SAR number for these specimens ($\text{SAR}=292$). Moving away from the edges, the samples showed random deep scratches, although the directionality of the wear test could still be observed. Some features observed, as shown in Figure 4-15, were the shaving-like curl of the base metal and salt residues from the testing. The curl appears to have been torn. These observed features are consistent with the low hardness and high ductility of 316.

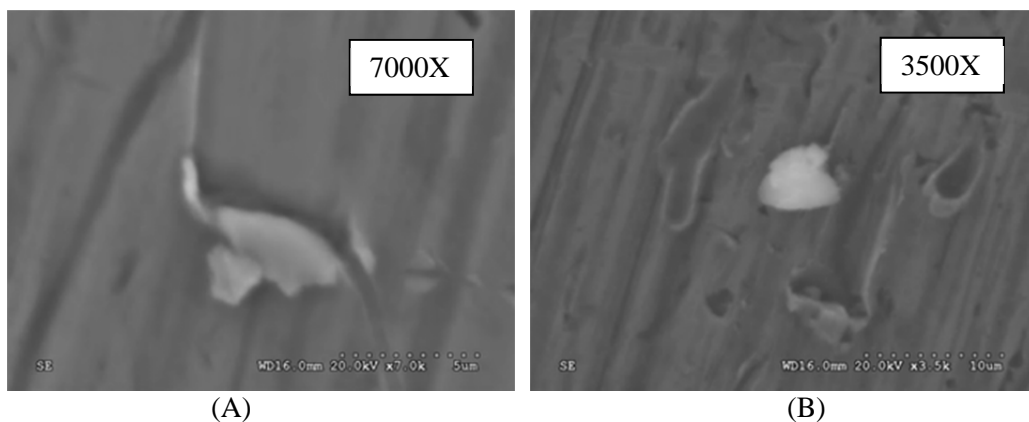
Figure 4-15. Features on the 316 surface after wear testing: (A) metal fold; (B) surface particle

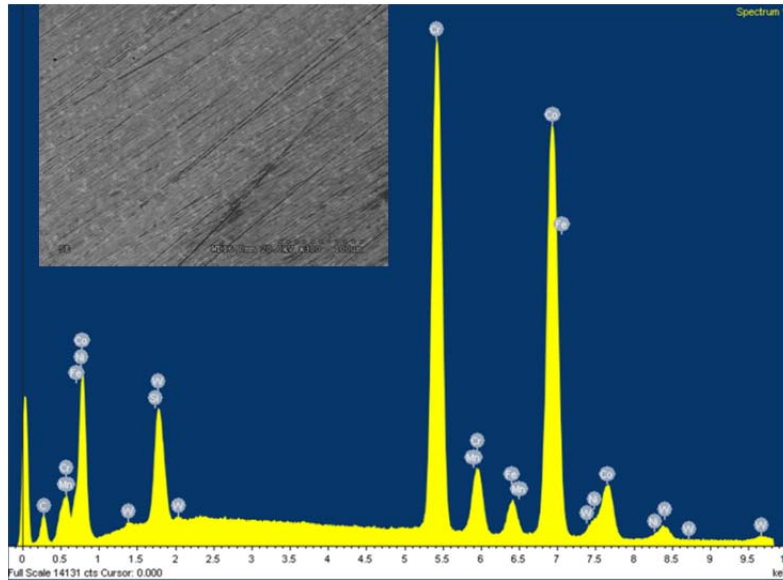
Figure 4-16. SEM micrograph and sum EDS spectra of as-received Stellite 12-overlay (on 316L stainless steel) prior to wear testing

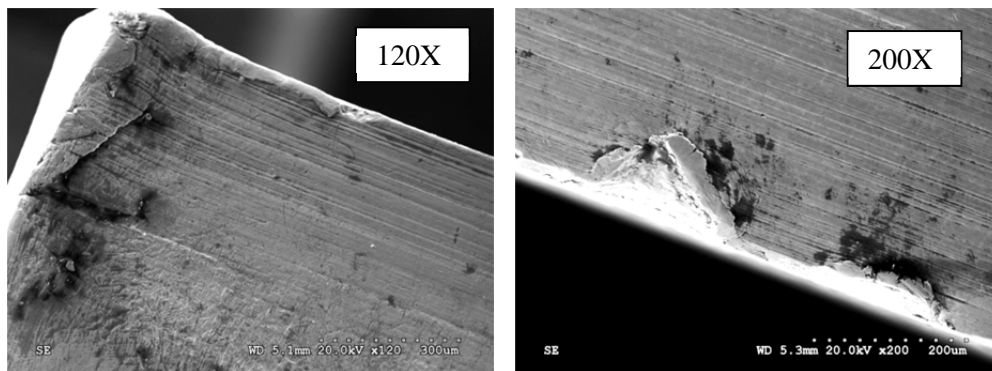
Figure 4-17. Worn edges of Stellite 12-overlay specimens after wear testing

After the wear testing in the slurry, the edges were sharp with some spots of wear, showing heavy gouging and material lifting or removal (Figure 4-17). Wear was not uniform throughout the sample, with some areas exhibiting more aggressive wear from the slurry (~50% and ~75% of total surface area for the two samples). Figure 14-18 shows a comparison of the two distinct regions. Figure 14-18 (A) shows mostly unidirectional surface lines consistent with the starting material (Figure 4-16). Figure 14-18 (B) shows a dendritic and rougher appearance representative of higher worn areas. The revelation of the dendritic microstructure is attributed a differential wear rate between the dendritic (Co-rich alloy) and the interdendritic (carbides) regions, although which has the higher wear rate was not discernible in the microstructural examination.

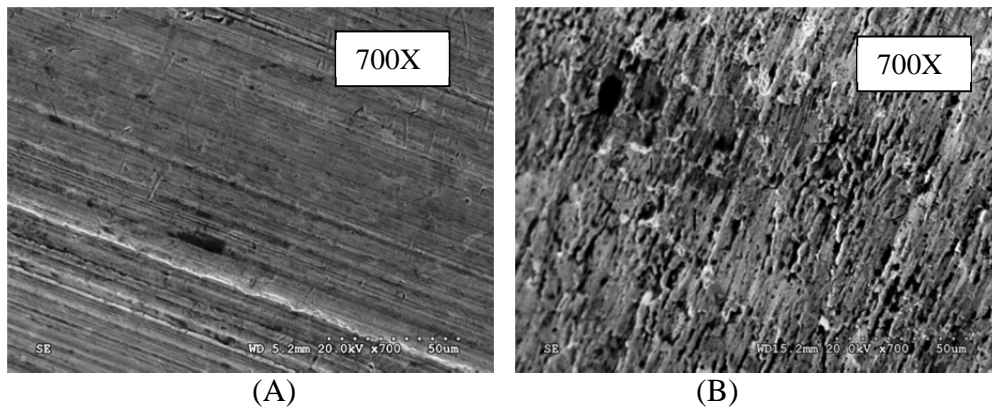
Figure 4-18. Stellite 12 overlay after wear test: (A) surface with less wear; (B) surface with more wear

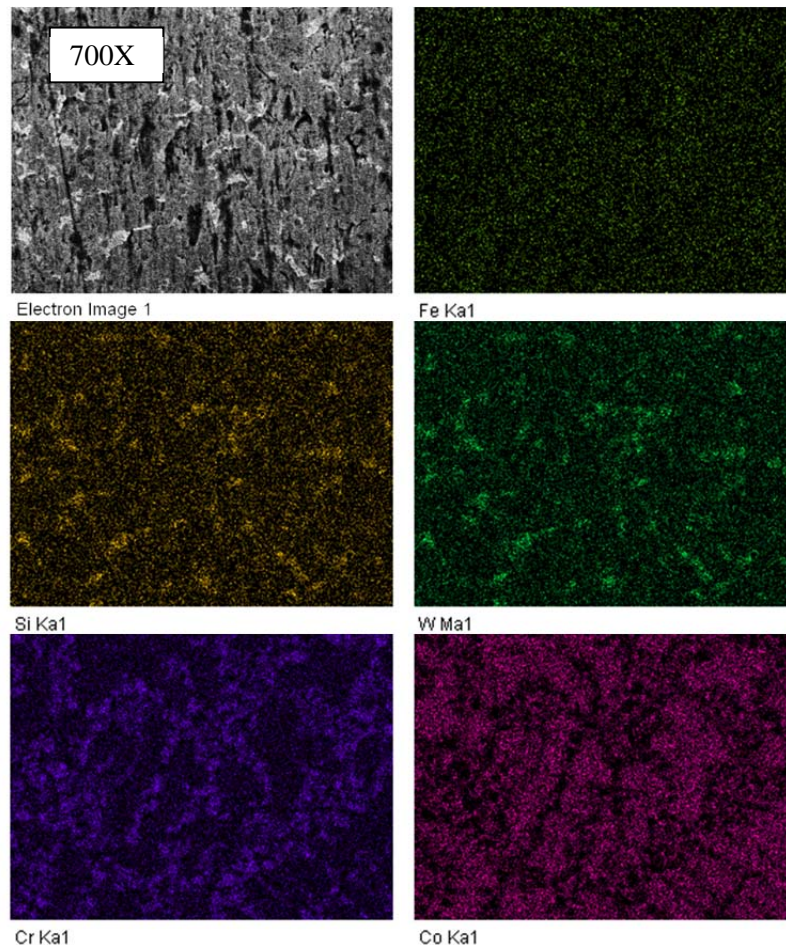
Figure 4-19. EDS compositional maps for high wear region from Stellite 12-overlay sample after wear testing

EDS mapping was performed in some of the higher-wear and dendritic-appearing regions (Figure 4-19). The Stellite hardfacing alloys typically solidify by dendritic growth of a Co-rich composition and the formation of various metal carbides in the interdendritic regions. [22-24] The Fe, C, Mn and Ni maps (not shown) indicated homogeneous surface compositions for these elements. By contrast, the Si and W maps showed segregation, with higher concentrations corresponding to the lighter features in the micrograph (i.e. features with higher secondary electron yields). This could be attributed to the retention of slurry Si particles on the surface. Cr and Co also appear segregated in these dendritic regions as would be expected from the dendritic solidification. Their compositional maps indicate that Co rich areas are highly Cr deficient, and vice-versa, which is in agreement with literature for Stellite alloy solidification [21].

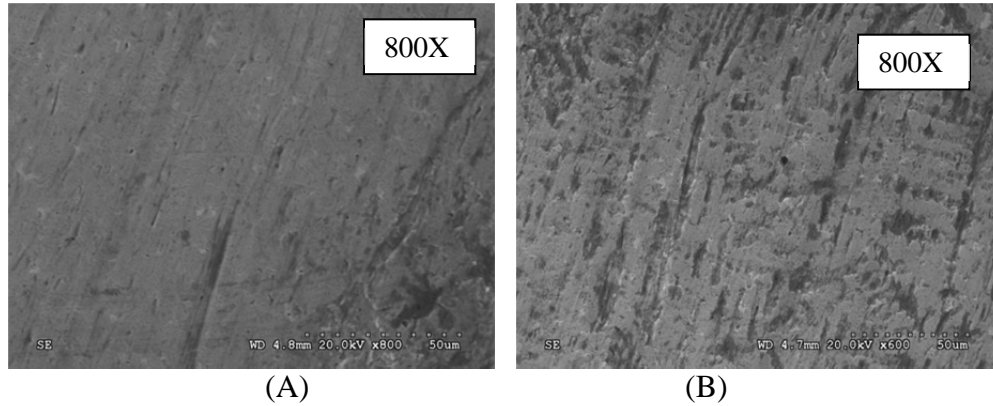
Figure 4-20. SEM micrographs of low (A) and high (B) abrasion regions in Stellite 12 overlay specimen tested under premix conditions

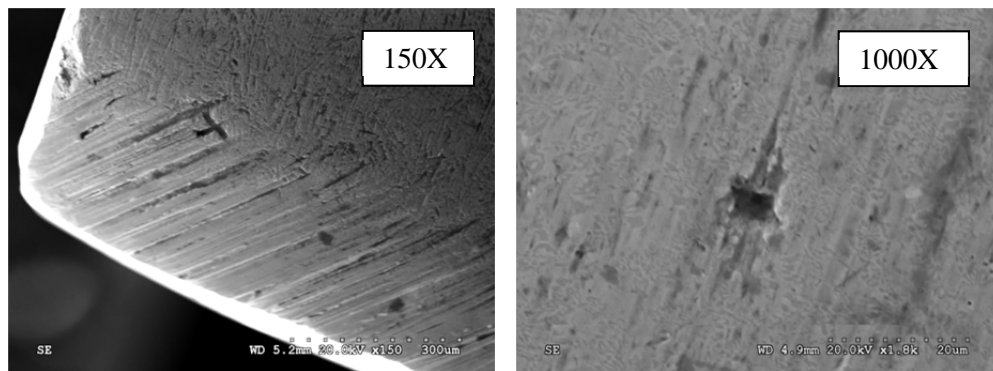
Figure 4-21. SEM micrographs of rounded edges and small gouging observed in Stellite 12 overlay specimen tested under premix conditions

wear regions. The edges of these samples appeared rounded and small gouges/pits could be observed (~5-30 μm) (Figure 4-21). Similar to the Stellite 12 plate (Section 4.4.4), the higher SAR number (SAR=54) of this sample relative to that tested in a wet slurry seems to indicate that the dry premix appears to act as a polishing media enhancing material loss or conversely the liquid in the wet slurry acts as a lubricant.

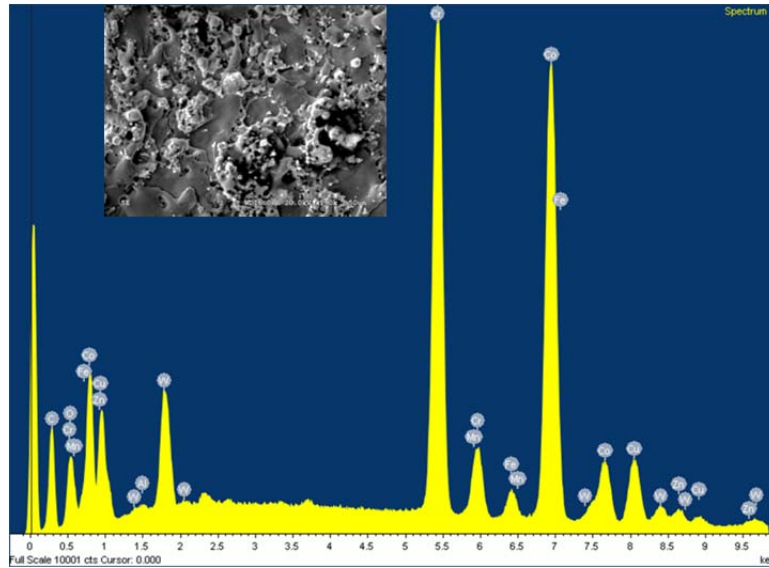
Figure 4-22. SEM micrograph and sum EDS spectrum of EDM-cut Stellite 12 plate prior to wear testing

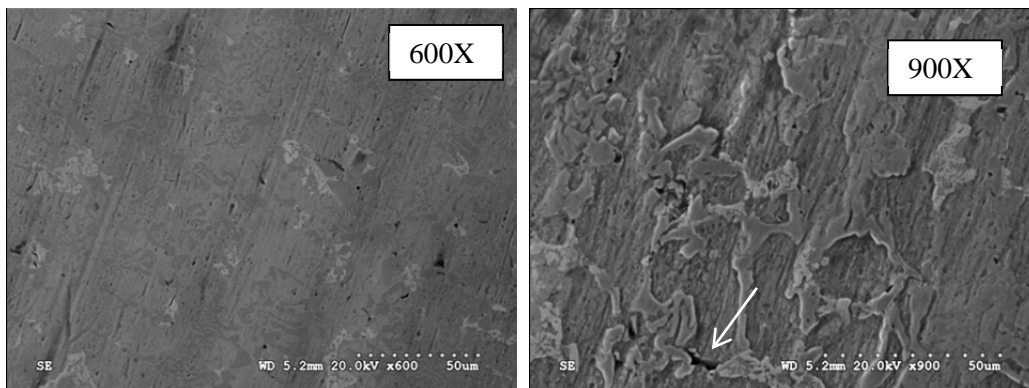
Figure 4-23. SEM micrographs of variable morphology lines/areas in Stellite 12 plate after premix wear testing

23). Abrasion can be seen in one phase. In Figure 4-23, there is also an indication of possible cracking as shown by the white arrow. Some areas (e.g. close to the sample edge – Figure 4-24), show more prominent interdendritic features, suggesting a localized abrasion that removed the Co-rich alloy or the carbide interdendritic region. A higher SAR number (SAR=54) was obtained for this specimen relative to the Stellite 12 overlay sample tested with a wet slurry. Since the plate showed a smoother morphology relative to the latter, the premix may act as a polishing media that enhances material loss or conversely the liquid in the wet slurry acts as a lubricant.

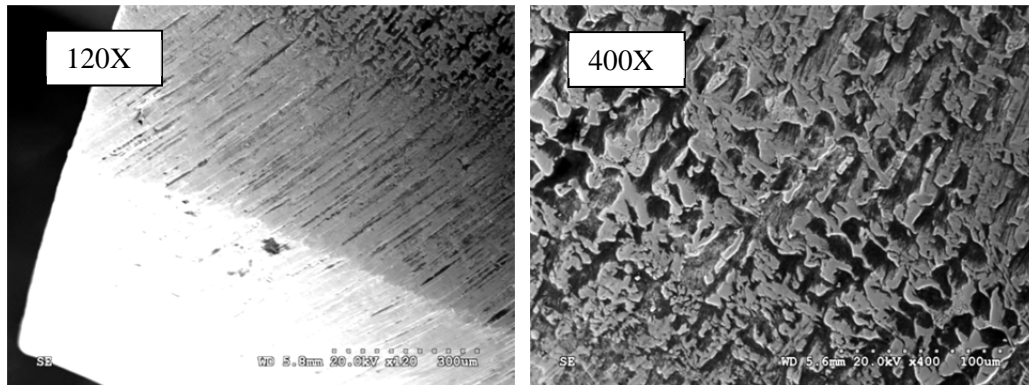
Figure 4-24. SEM micrographs of Stellite 12 plate edge and high wear after premix wear testing

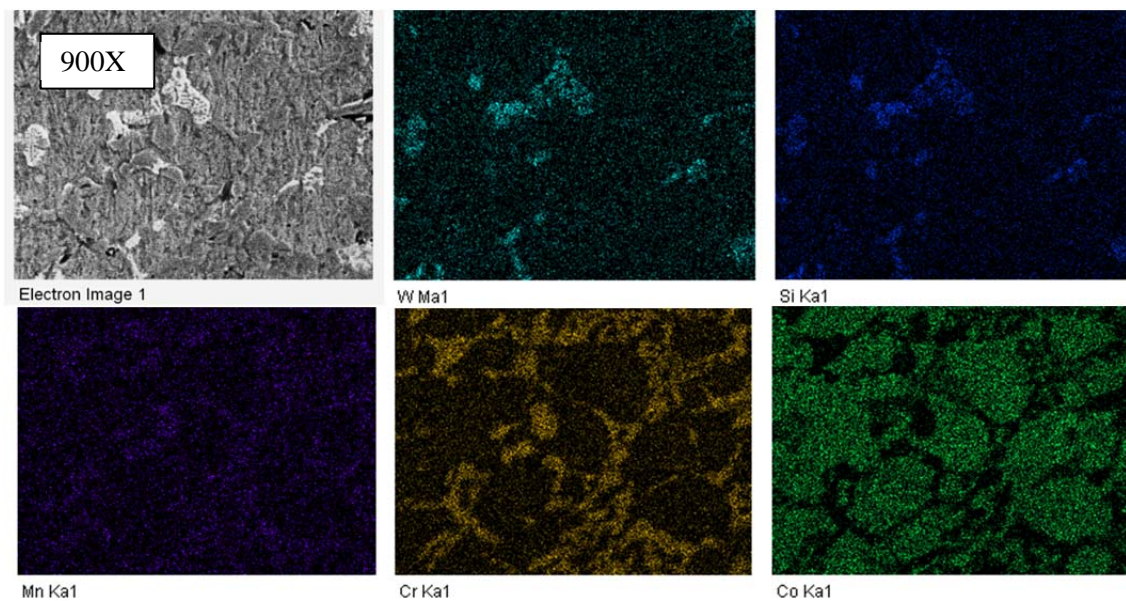
Figure 4-25. EDS compositional maps for high wear region from Stellite 12 plate after wear testing

lighter (higher secondary electron yield) features in the micrograph. This could be the result of Si particles from the slurry retained on the surface. The maps for Mn, W and Cr indicate these elements have high concentrations where Co is deficient, i.e. interdendritic carbides. These are the regions that show less wear in the SEM micrograph of Figure 4-23. These results are consistent with expected microstructure for Stellite alloys. [21] The wear of these alloys is dependent on the size and distribution of the carbides.

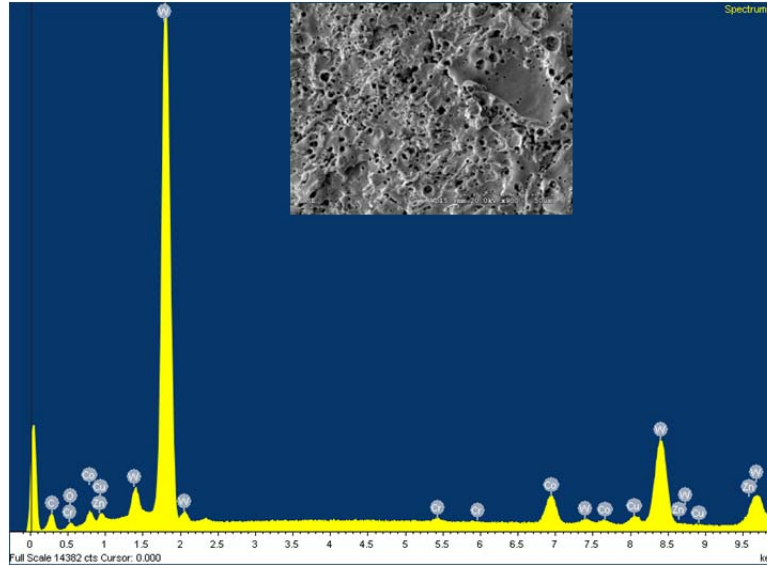
Figure 4-26. SEM micrograph and sum EDS spectrum of surface of as-machined tungsten carbide wear specimen

sum EDS spectra was obtained for a selected area (Figure 4-26), which showed all expected X-ray lines, and is in reasonable agreement with the specification sheet composition. The presence of copper is from the residue of the EDM wire. Table 4-5 listed the EDS composition excluding the Cu and O lines.

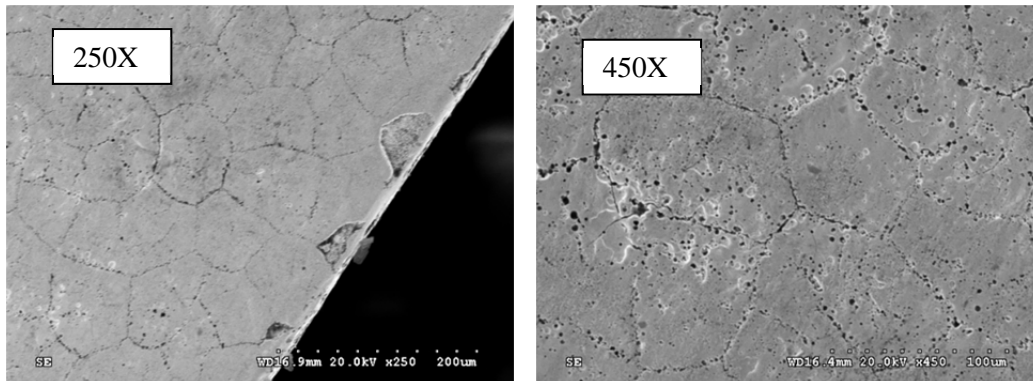
Figure 4-27. SEM micrographs of edge and surface of tungsten carbide samples following wear testing

The beveled edges did not show any enhanced wear or rounding. These features are all consistent with the very low SAR value of these materials (SAR=13).

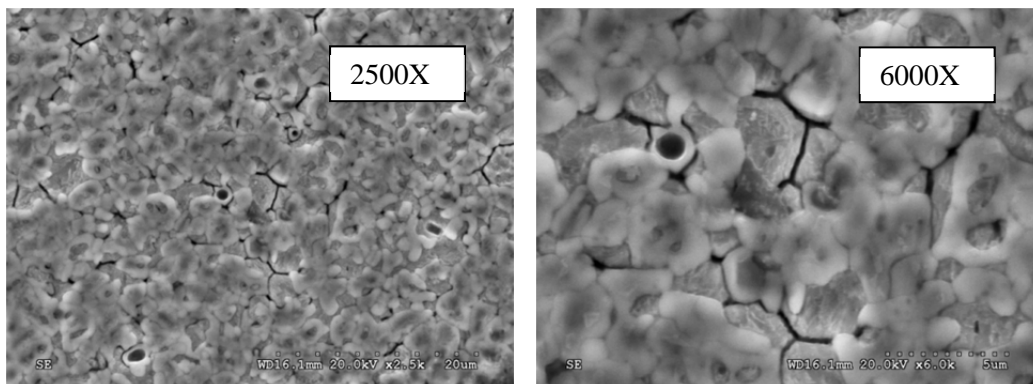
Figure 4-28. SEM micrographs of surface of as-received D2 tool steel wear specimens

D2 tool steel wear specimens were procured from Metal Samples, Inc. Surface roughness of the procured specimens was stated as 32RMS or 0.8 Ra. Figure 4-28 shows images of the as-received specimens, which show a grain structure with an average size of ~5 μm . Some grains appear hollow and a diffuse oxide covers much of the surface. A sum EDS spectrum was obtained over the surface, shown in Figure 4-29. The composition is given in Table 4-5 and is consistent with expected values.

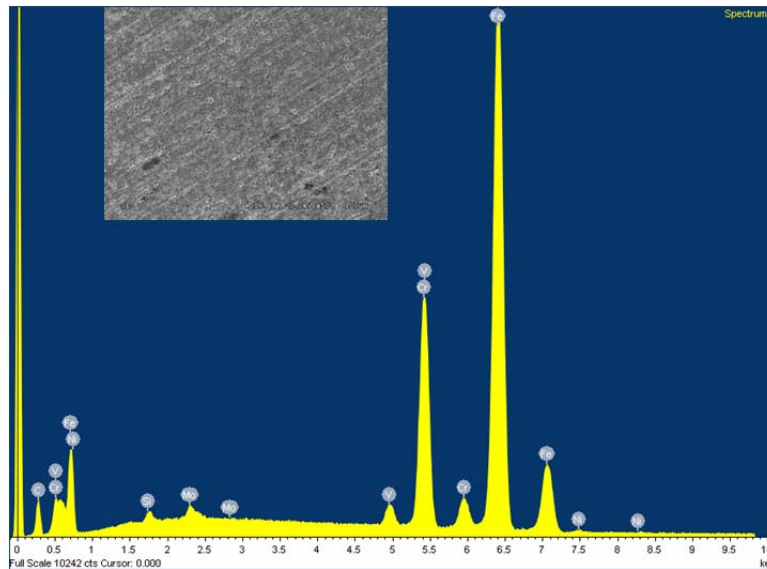
Figure 4-29. SEM micrograph and sum EDS spectrum of surface of as-received D2 tool steel wear specimen

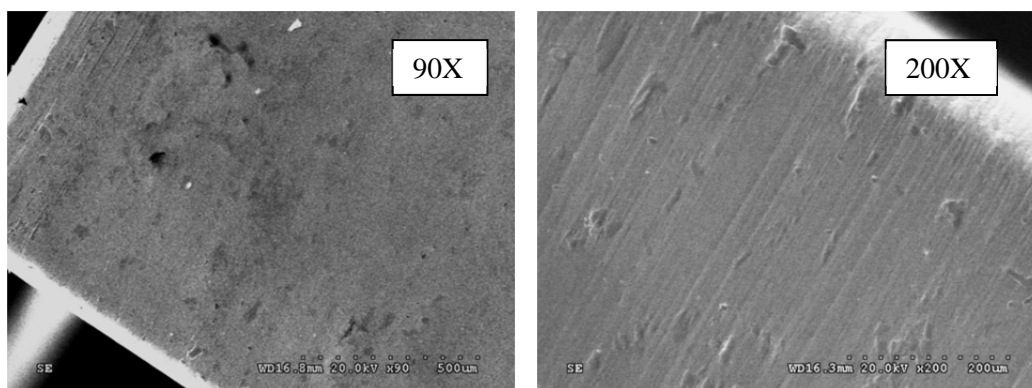
Figure 4-30. SEM micrographs of edges of D2 tool steel samples after wear testing

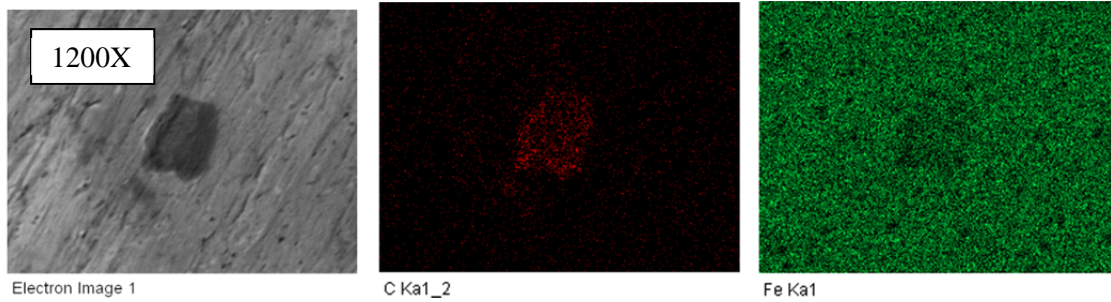
Figure 4-31. EDS compositional maps of dark (low secondary electron yield) features in surface of D2 tool steel specimen following wet slurry wear testing

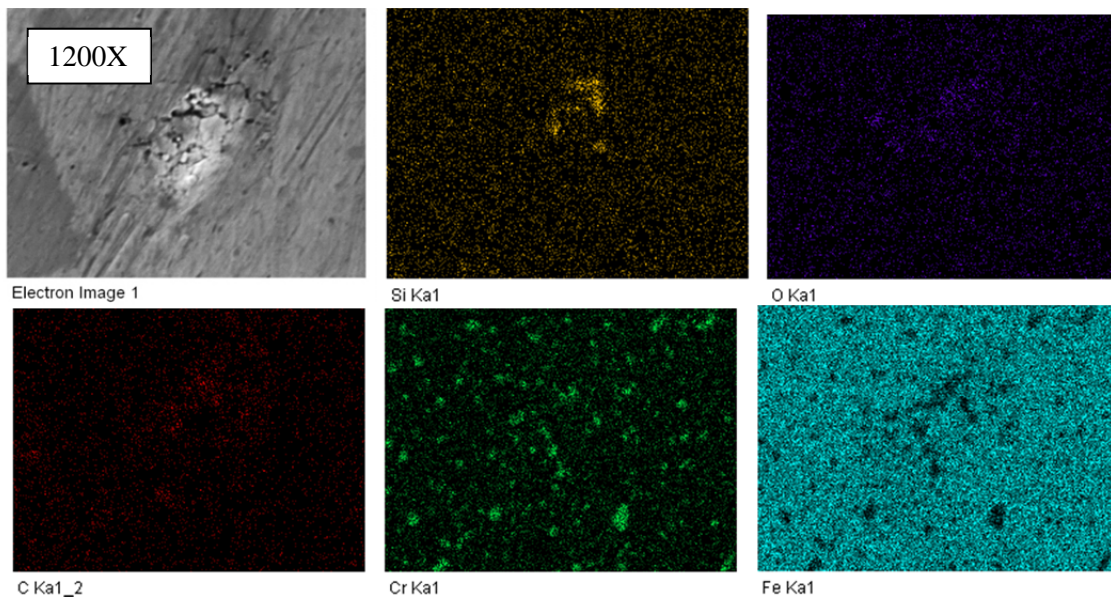
Figure 4-32. EDS compositional maps of light (high secondary electron yield) features in surface of D2 tool steel specimen following wear testing

Randomly shaped particles could be seen on the surface, presumably of slurry origin due to the high contrast (charging) inherent in these slurry particles. Additional dark (low secondary electron yield) and light (high yield) spots could also be observed, which were characterized by EDS compositional mapping. The dark features in the surface are carbon rich (Figure 4-31), while the light features appear to be Si and O rich, most likely a resultant of slurry residue (Figure 4-32).

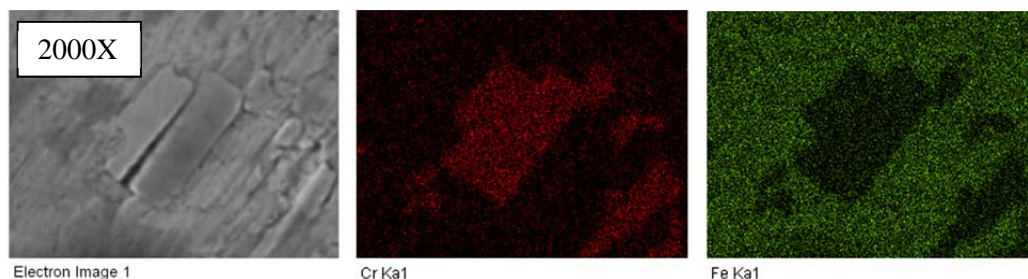
Figure 4-33. EDS compositional maps of raised block features in surface of D2 tool steel specimen following wear testing

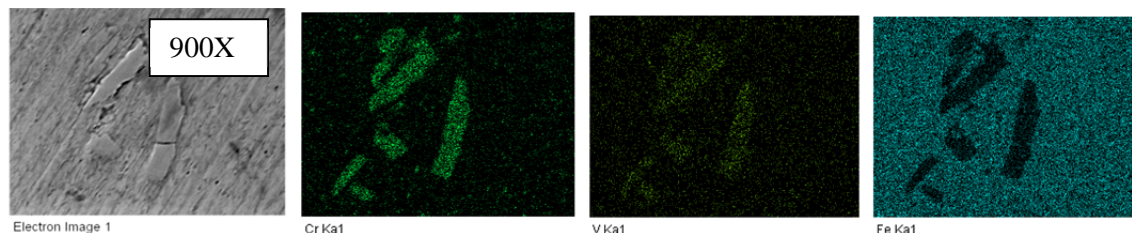
Figure 4-34. EDS compositional maps of raised block features in surface of D2 tool steel specimen following wear testing

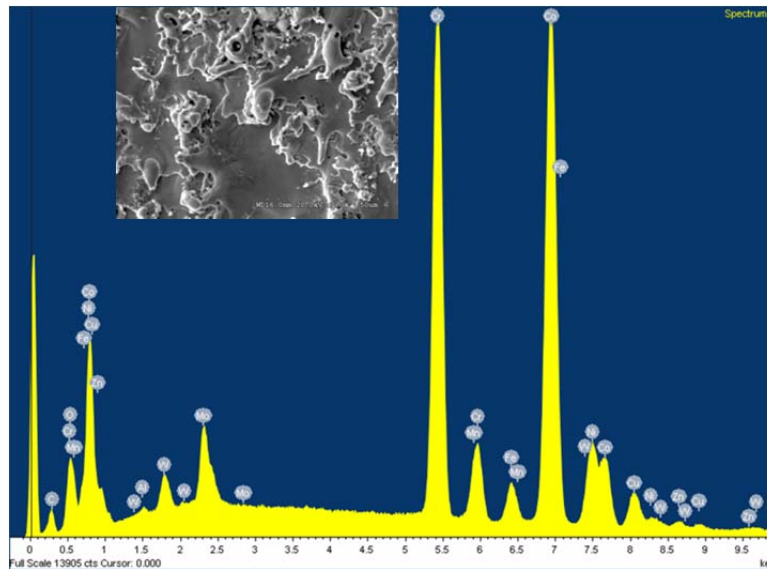
Figure 4-35. SEM micrograph and sum EDS spectrum of surface of as-machined Ultimet wear specimen

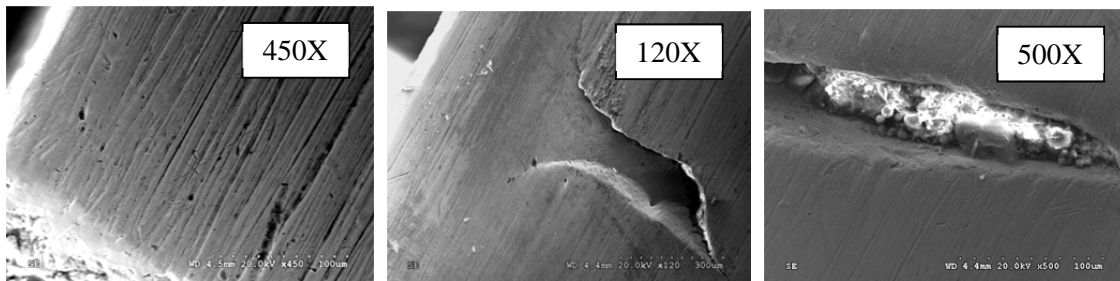
Figure 4-36. SEM micrographs of edge and representative surface of Ultimet steel specimens following wear testing

The Ultimet wear specimens showed highly unidirectional lines with few randomly oriented scratches and deep grooves (Figure 4-36). The edges did not appear preferentially worn with material dislodging. The SAR number for these specimens was 100, a mid-range value for the overall test. The minimal gouging in these samples suggests that material loss was relatively uniform, outside of the weld overlay intersections. The wear test revealed the weld overlay structure of the samples. Crevices depicting the intersection and incomplete fusion of the different overlay passes could be observed (Figure 4-36).

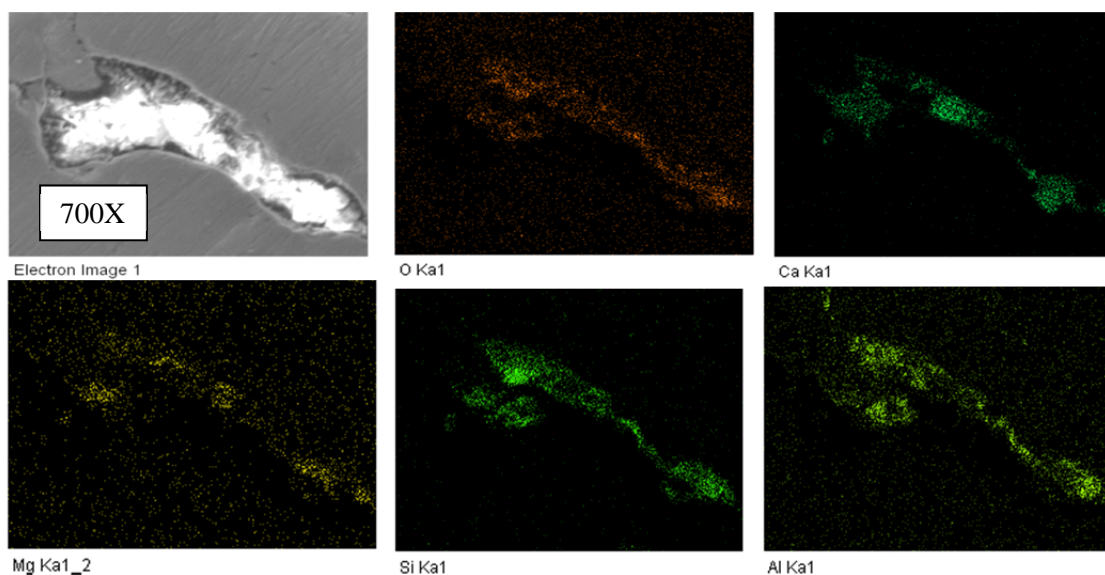
Figure 4-37. EDS compositional maps of material lodged at intersection of weld overlays in Ultimet steel specimens following wear testing

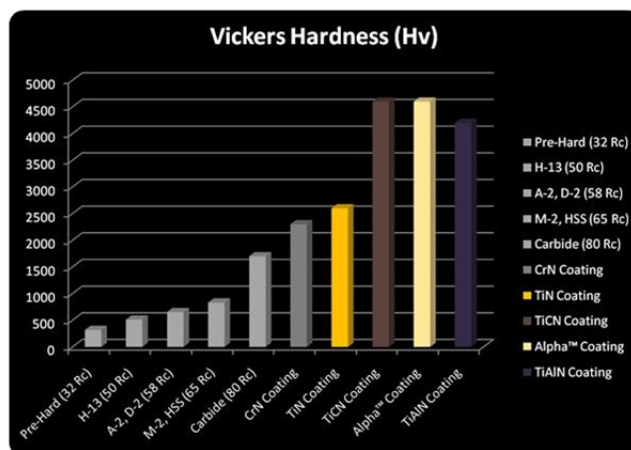
Figure 4-38. Hardness values of common PVD coatings

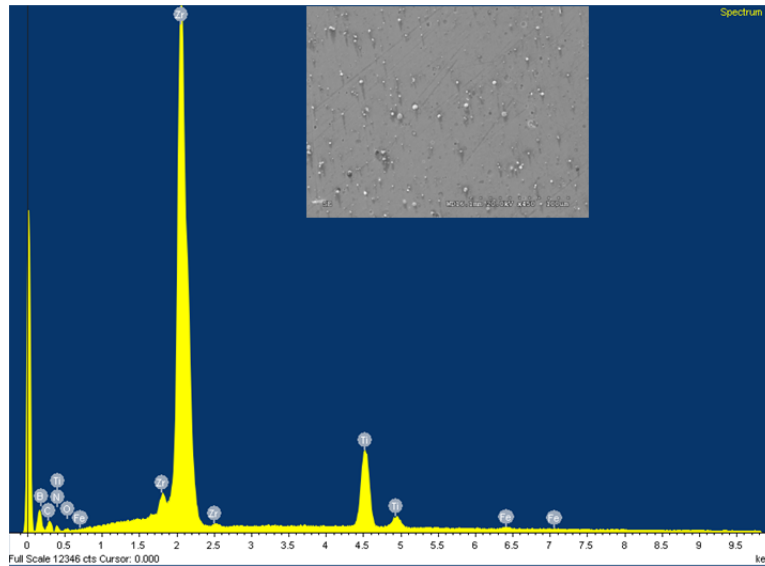
Figure 4-39. Sum EDS spectrum of surface of Alpha™ (ZrN) coated wear specimen
