Evaluation and Recommendation of Saltstone Mixer Auger/Paddles Materials of Construction for Improved Wear Resistance

J. I. Mickalonis
R. D. Torres

July 2012

Savannah River National Laboratory
Savannah River Nuclear Solutions, LLC
Aiken, SC 29808

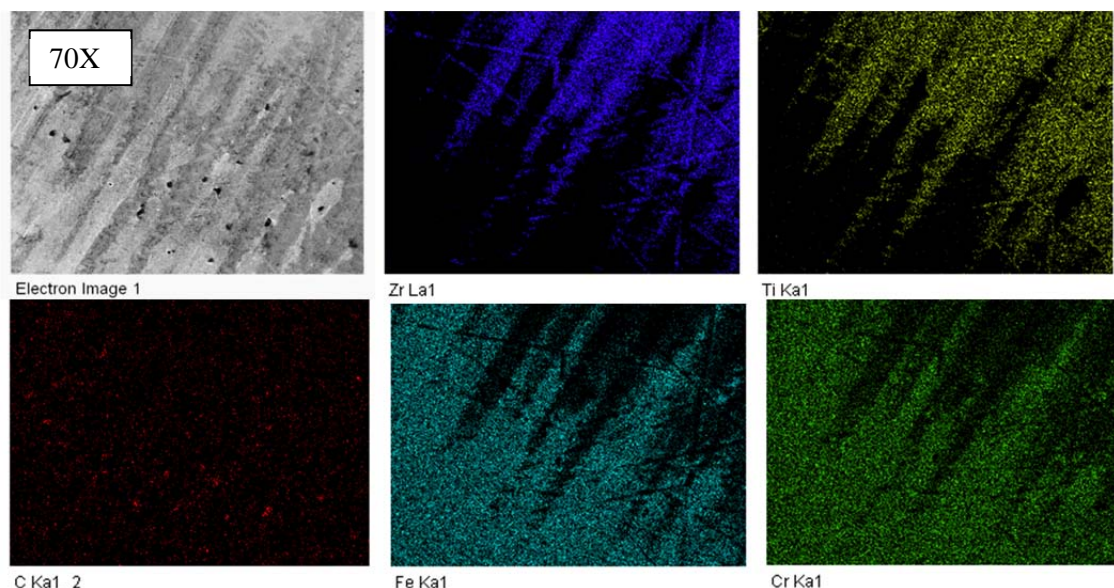
Figure 4-40. EDS compositional maps of surface of Alpha™ coated specimens following wear testing

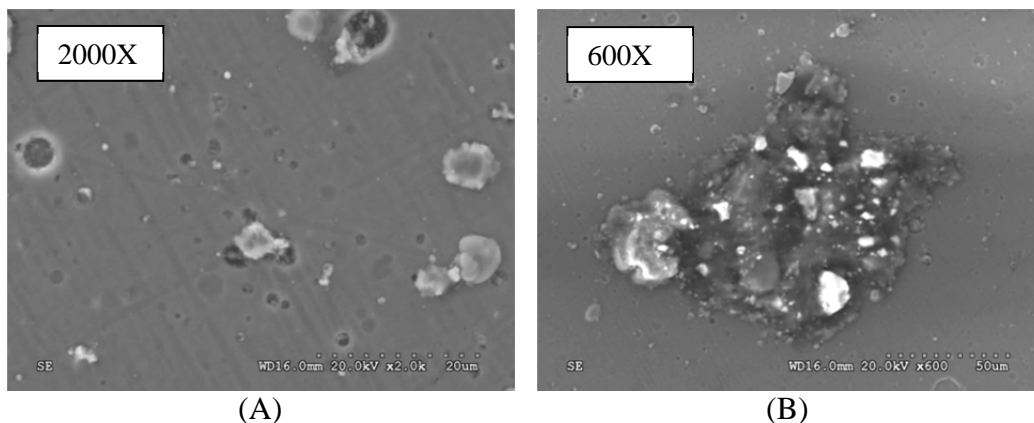
Figure 4-41. SEM micrographs of surface of TiCN coated wear specimens

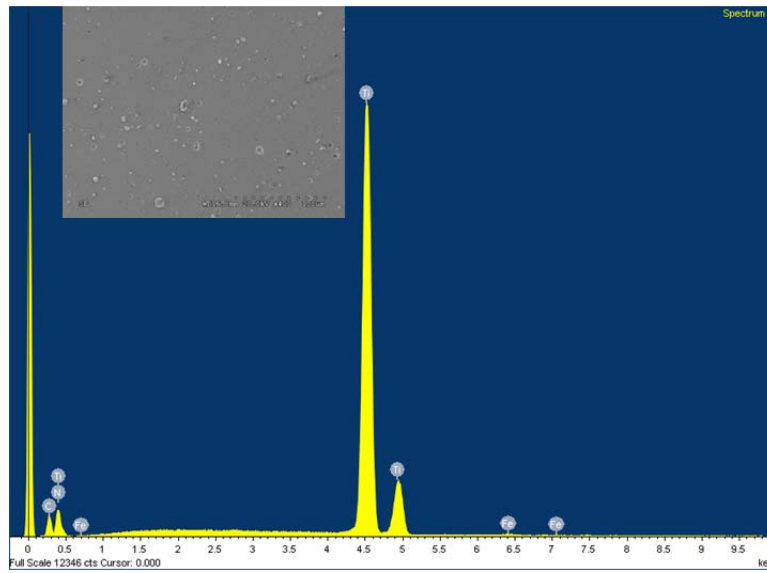
Figure 4-42. Sum EDS spectrum of surface of TiCN coated stainless steel wear specimen

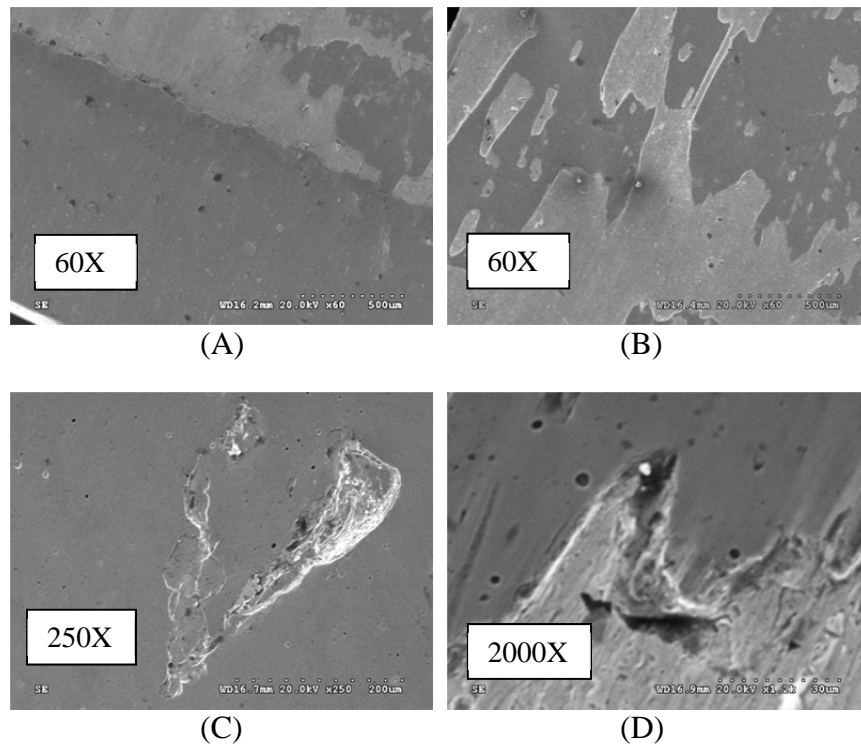
Figure 4-43. SEM micrographs of TiCN coated stainless steel specimens following wear testing: (A) beveled edge; (B) loss of coating; (C and D) surface gouges

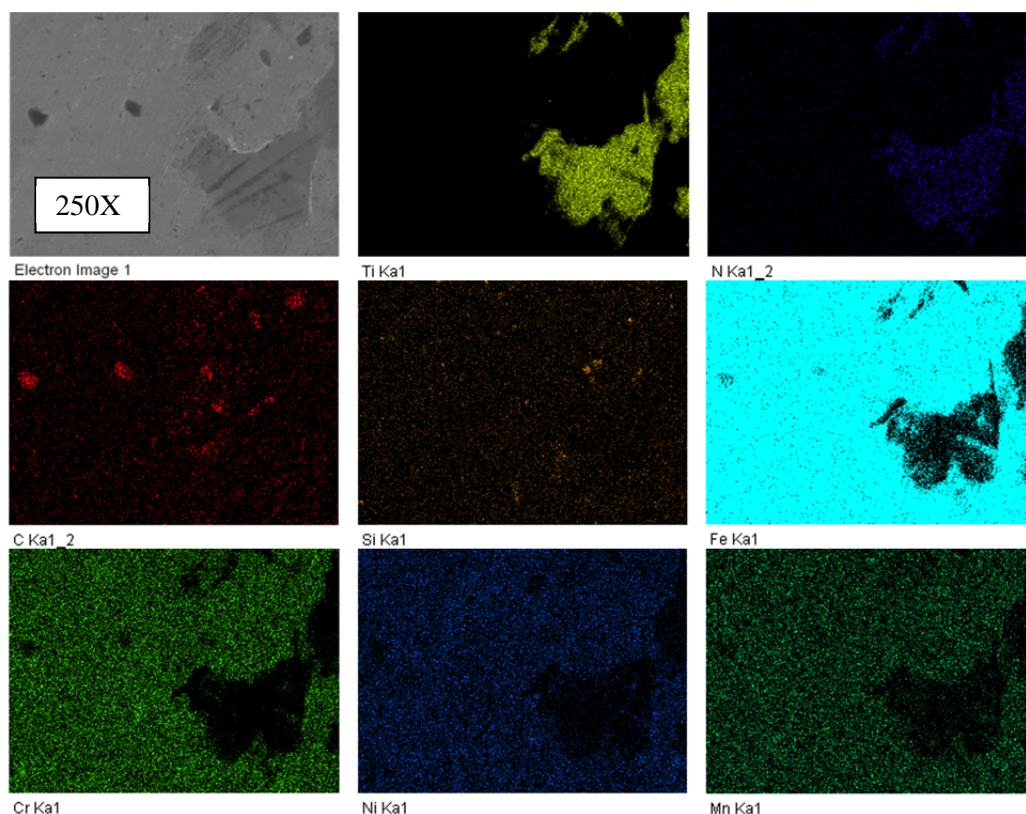
Figure 4-44. EDS compositional maps of surface of TiCN coated stainless steel specimens following wear testing

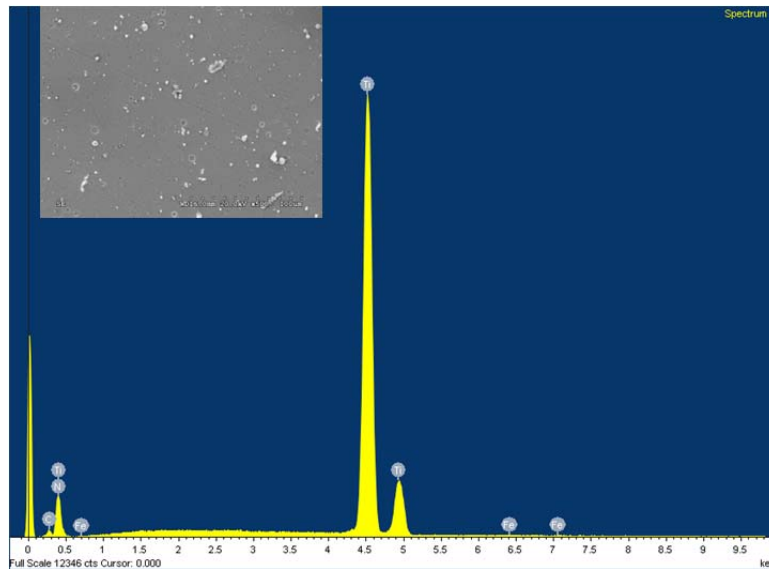
Figure 4-45. SEM micrograph and sum EDS spectrum of surface of TiN coated stainless steel wear specimen

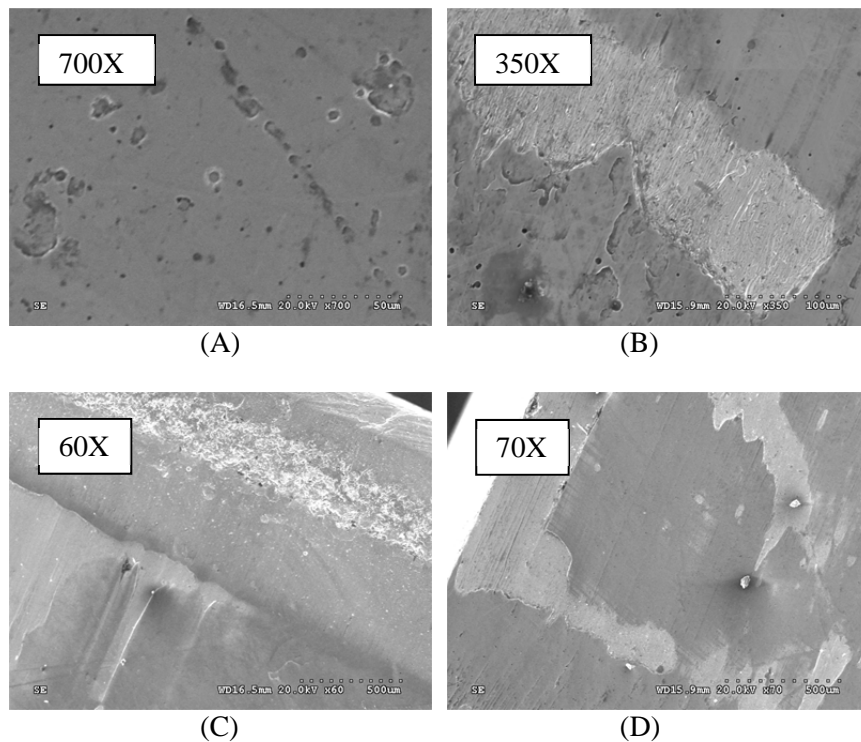
Figure 4-46. SEM micrographs of TiN coated stainless steel specimens following wear testing: (A) low wear with coating intact; (B) medium wear with some coating removal; (C and D) beveled edge

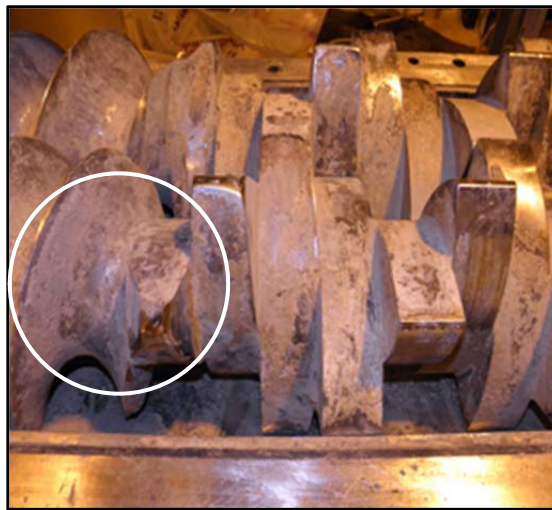
Figure 5-1. Saltstone mixer with worn auger (circled)
