MODEL 9975 LIFE EXTENSION PACKAGE 3 – INTERIM REPORT

W. L. Daugherty

Publication Date: December 2013

Model 9975 Life Extension Package 3 – Interim Report

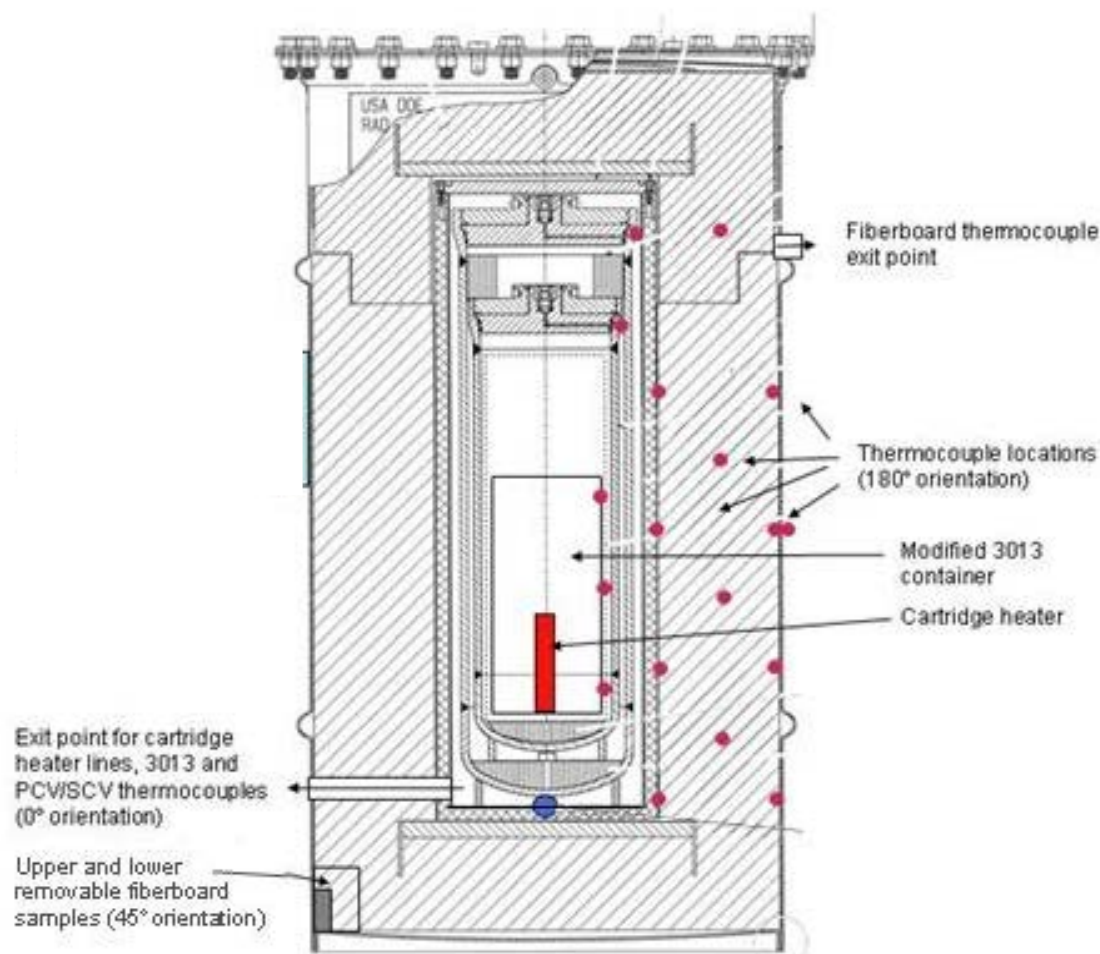
Figure 1. Cross section of 9975 package, showing added instrumentation and examination features.

This life extension package is a 9975 shipping package that was modified to add instrumentation and an internal heat source. An access port for fiberboard sample removal was added to the drum side wall. Thermocouples provide the temperature at a number of locations throughout the package, including the 3013 payload, PCV, SCV, multiple locations within the fiberboard, and drum surface. A sketch showing thermocouple locations is provided in Figure 1.

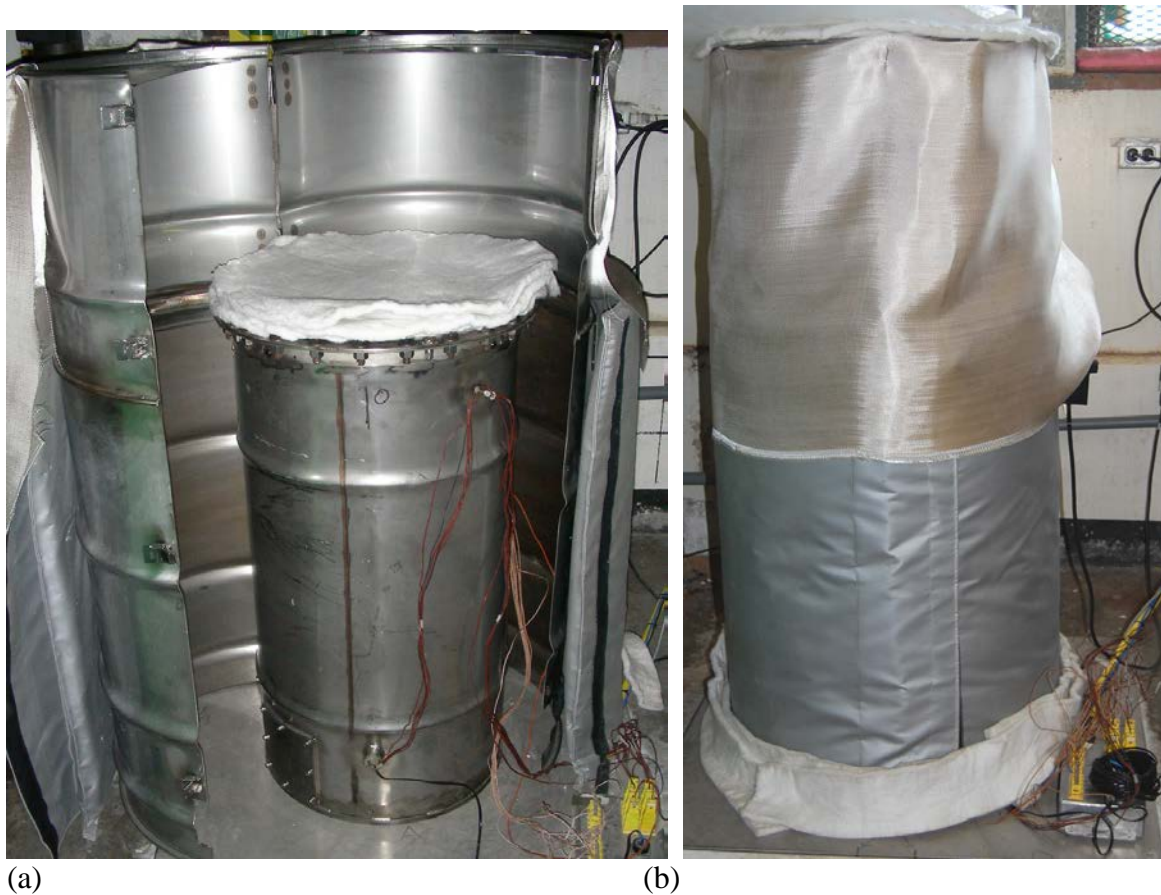
Figure 2. Configuration of LE3 to provide external heat source. In (a) LE3 is seen with insulation on top, inside the modified 55-gal drum. In (b), the 55-gal drum is wrapped with a drum heater and insulation.

Package LE3 was placed within an environment with external temperature control, but no humidity control. A cartridge heater inside a modified 3013 container provides 19 watts internal heat. The external temperature was established by enclosing the package in a modified 55 gallon drum, and placing a drum heater around this larger drum (Figure 2). The external blanket heater was adjusted to provide a maximum fiberboard temperature of ~160°F. This was typically accomplished at a setting of ~100 – 105°F, which produced a drum surface temperature of ~120 – 130°F. This condition approximates the maximum ambient temperature observed in KAMS, and all packages in KAMS contain less than 19 watts. Therefore, this test provides internal temperatures that are conservative to actual conditions in storage.

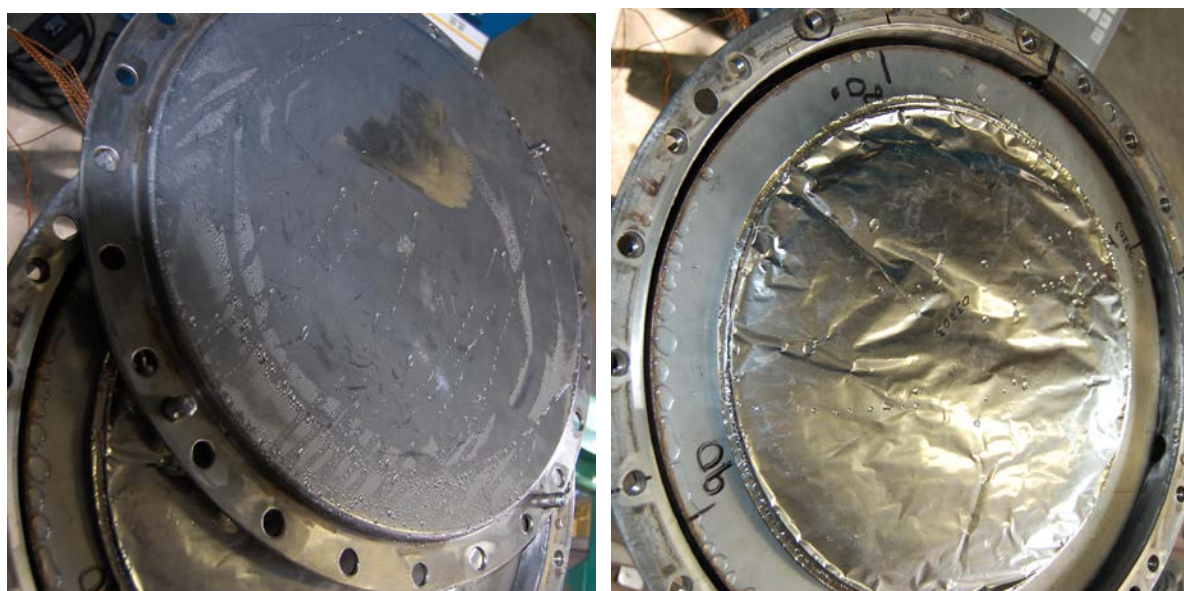
- After 2 weeks in test, liquid condensation was observed on the underside of the drum lid and on the air shield (Figure 3). The moisture level of the bottom fiberboard layers is above saturation ($>38\%$ WME).

Figure 3. Liquid condensate on the underside of the drum lid and on the air shield, observed after 2 weeks in test.

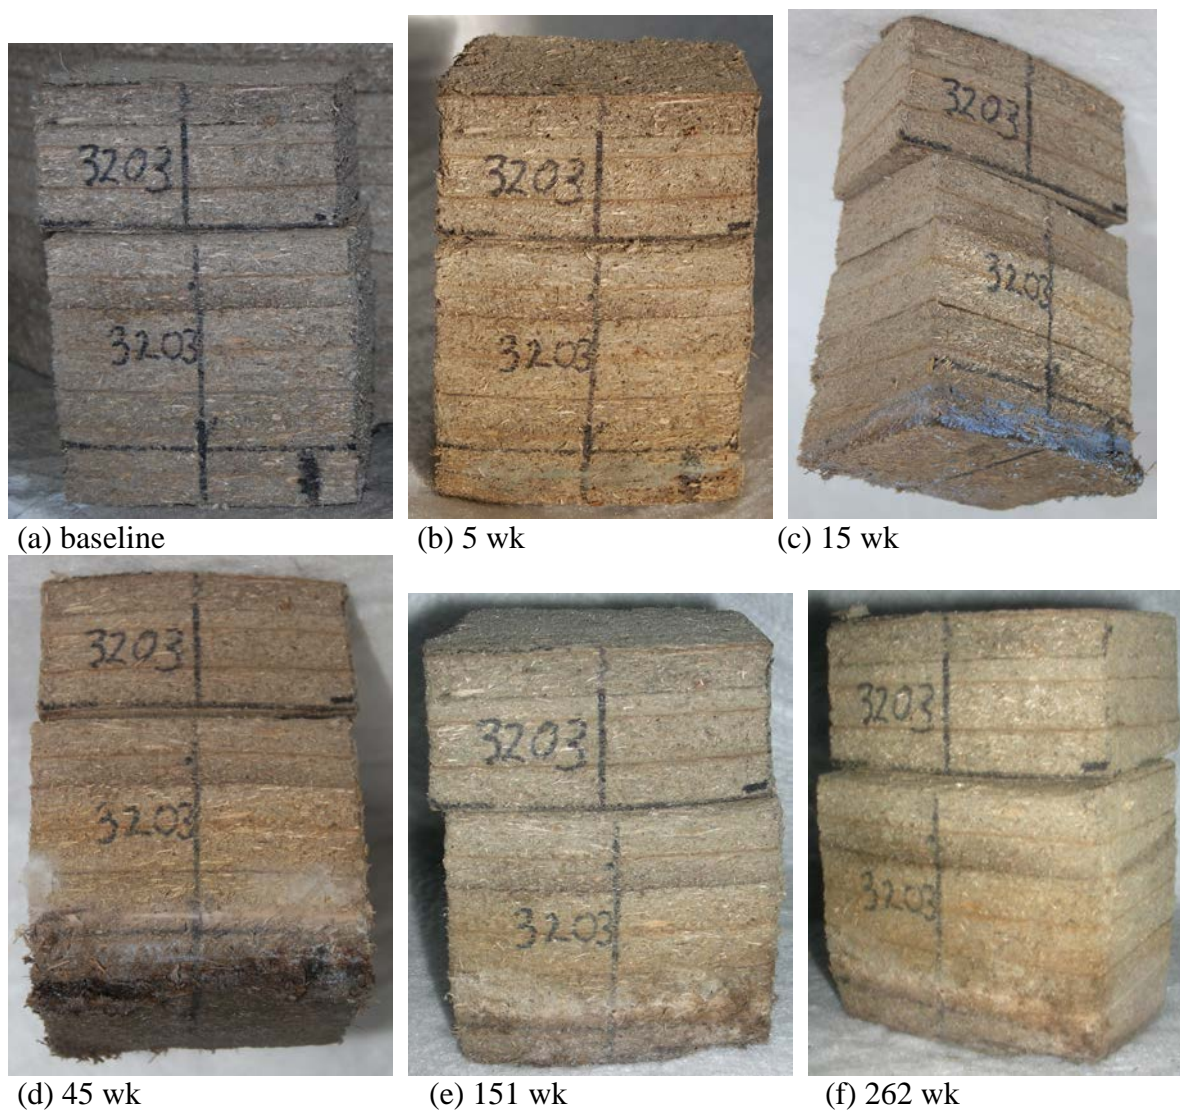
- After 5 weeks in test, mold was observed on the lower layers of the bottom removable fiberboard section. The mold changed color and texture through 45 weeks in test, and gradually became dormant by week 151. Little change has been observed after that. (Figure 4)

Figure 4. Sequence of photographs of small removable fiberboard sections from test LE3.

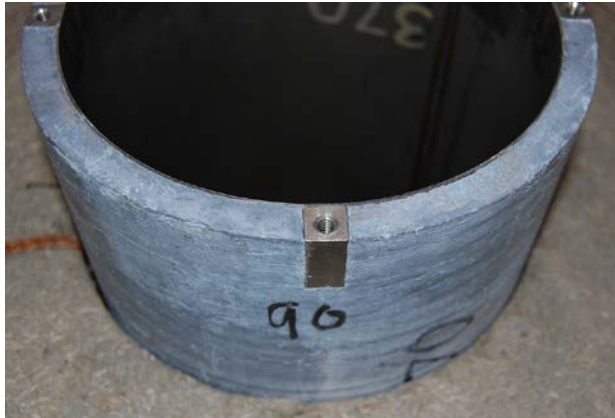
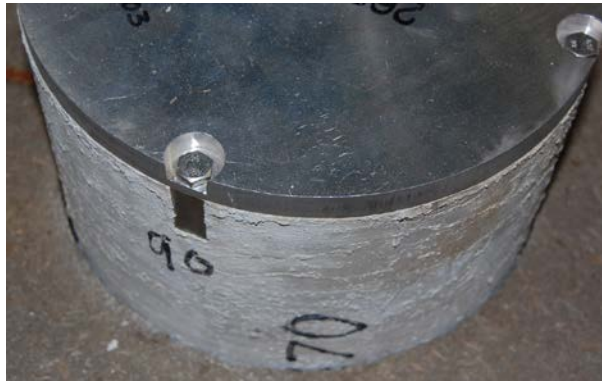
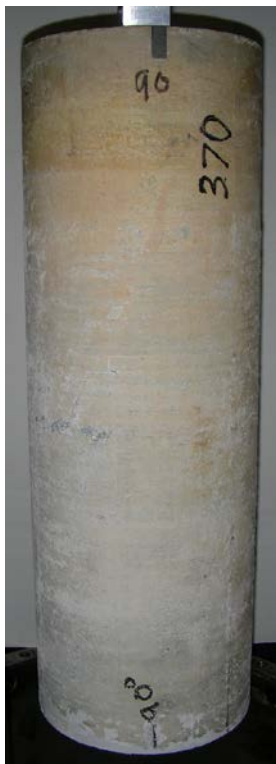
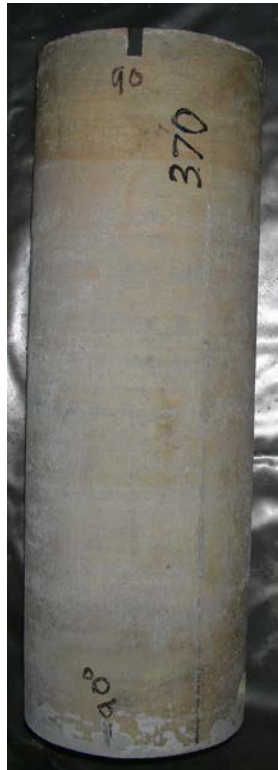
- After 7 weeks in test, increased corrosion of the shield was observed, along with some nodular corrosion deposits. Shield corrosion approached its heaviest visual appearance by 26 weeks, and the upper portion of the shield darkened slightly after that (Figure 5).

The corrosion of the lead shield is also of interest. Significant corrosion product was observed after 7 weeks in test, and was white and nodular (Figure 5). The corrosion product had become somewhat heavier after 26 weeks in test, but did not appear to increase significantly after that. Instead, the appearance began to change slightly in that the upper portion of the shield (adjacent to the upper fiberboard assembly) yellowed slightly (observed after 109 weeks in test) and retained that appearance during subsequent testing. The corrosion typically seen on a 9975 shield is smooth and white. Once the corrosion product on a typical shield is sufficiently thick (a few thousands of an inch), it will begin to loosen and flake off.

Figure 5. Progression of shield corrosion. Corrosion was uniformly heavy by week 26, and the upper portion (adjacent to the upper fiberboard assembly) gradually darkened somewhat by week 109. Very little change has been observed since that time.

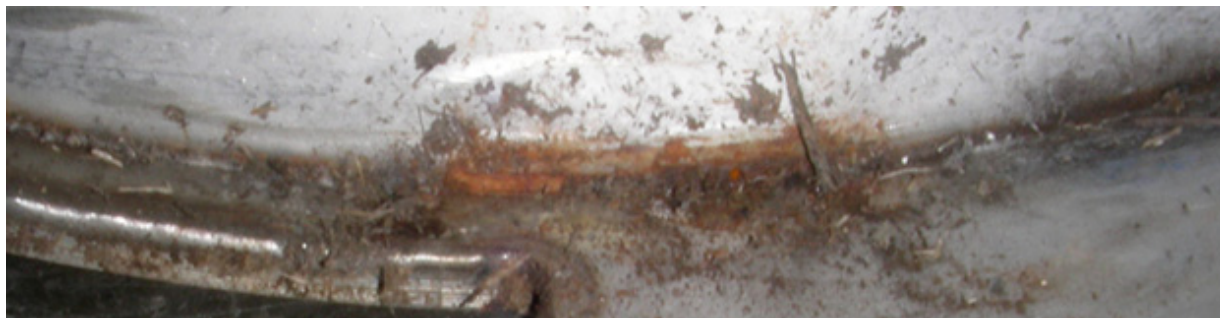
- After 109 weeks in test, corrosion was observed on the drum interior at the bottom crevice (Figure 6).
- After 119 weeks in test, possible corrosion was observed on one stitch weld along the bottom edge of the drum exterior (Figure 7). After 151 weeks, additional corrosion was observed on the same stitch weld and on additional stitch welds.

Figure 6. Corrosion of the drum interior along the bottom crevice, observed after 109 weeks in test.

While limited corrosion was observed on the LE3 drum, it is noted that corrosion also occurred on the drums of the first two life extension packages. In comparison, the LE3 drum began corroding later, and has corroded less than the other two packages. Some of this corrosion may be related to fabrication practices used to modify these drums, although some is also associated with non-modified areas. Corrosion of the stainless steel drum might be expected if moisture migration within the fiberboard leads to the concentration of chlorides on the drum surface, or from biological influences. However, none of the corrosion observed in any of these packages represents a challenge to the drum integrity.

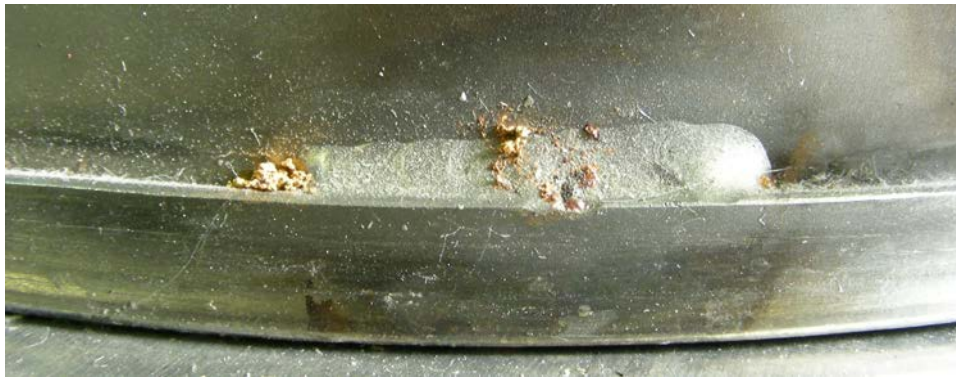
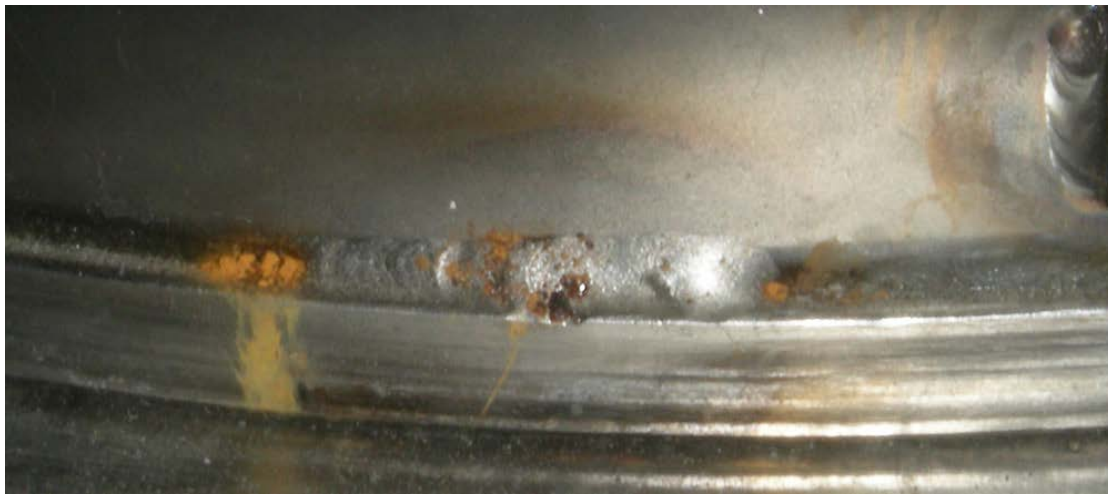
Figure 7. Corrosion of the drum exterior at a stitch weld along the bottom edge, observed after 119 weeks in test (a). After 151 weeks in test, some additional corrosion is observed at this location (b).

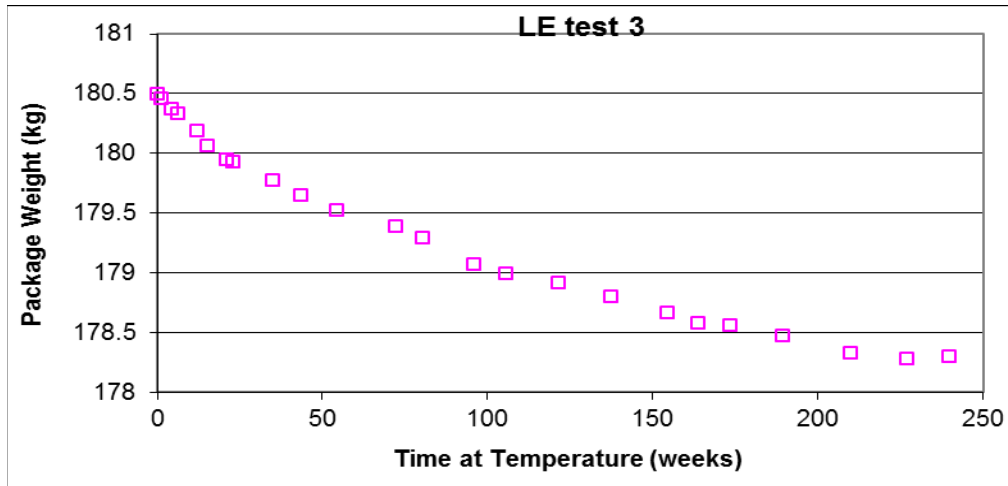
A plot of package weight over time is shown in Figure 9. The weight of the upper and lower fiberboard assemblies was also tracked over time, although it was recorded less frequently. These data are shown in Figure 10, along with fiberboard density values calculated from the weight and dimensions. Two small sections of fiberboard were cut from the bottom of the lower assembly, and are accessible to remove through a hatch on the drum side. These sections are characterized more often than the drum is opened to inspect the upper or lower fiberboard assembly. Weight data for these removable sections are shown in Figure 11.

Figure 9. Package weight of LE3 over time.

Variation in the total weight of the package is summarized in Figure 9. Variation in the weight of the upper fiberboard assembly and the removable fiberboard sections is shown in Figures 10 and 11, respectively. All fiberboard within the package was removed and weighed on relatively few occasions (to minimize the opportunity for inadvertent moisture changes). Additional information regarding fiberboard weight can be obtained from the total package weight, assuming the package weight has changed only as a result of fiberboard weight change and shield corrosion.

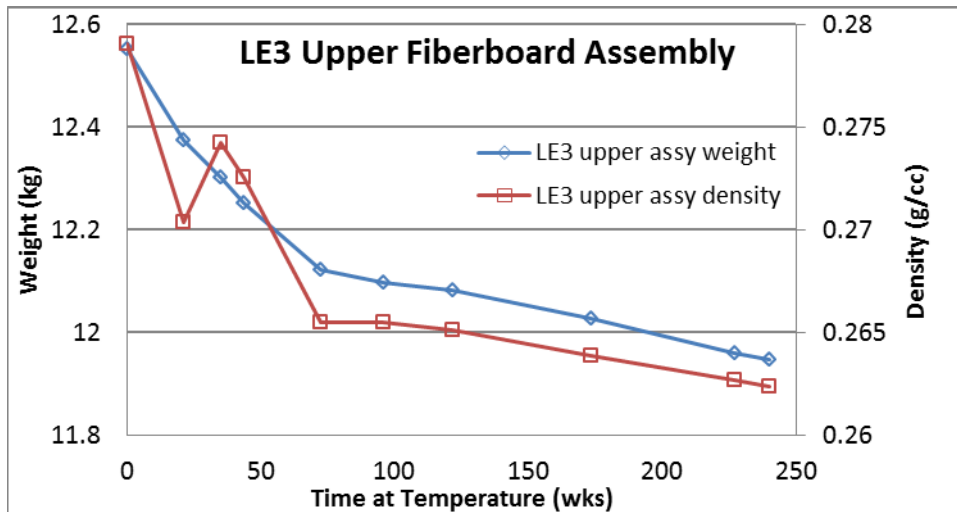
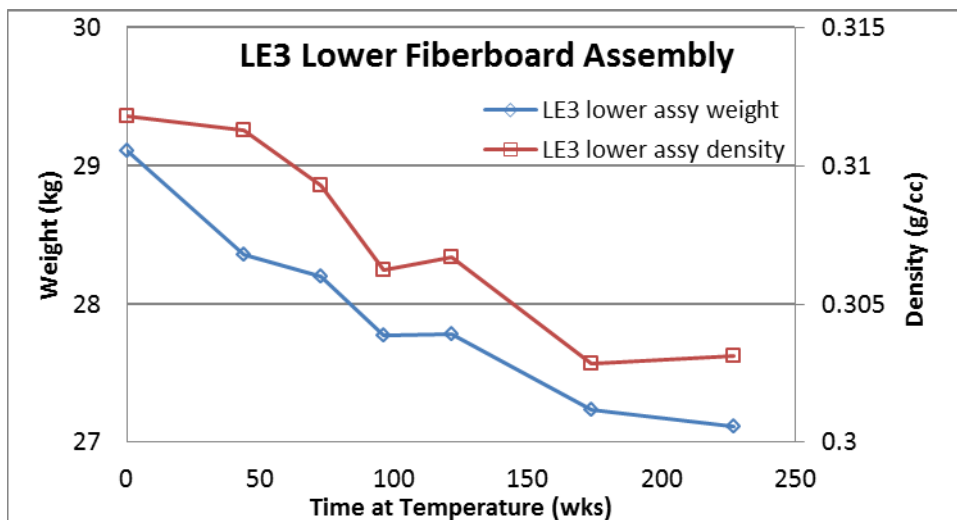
Figure 10. Weight and density variation for LE3 fiberboard assemblies.

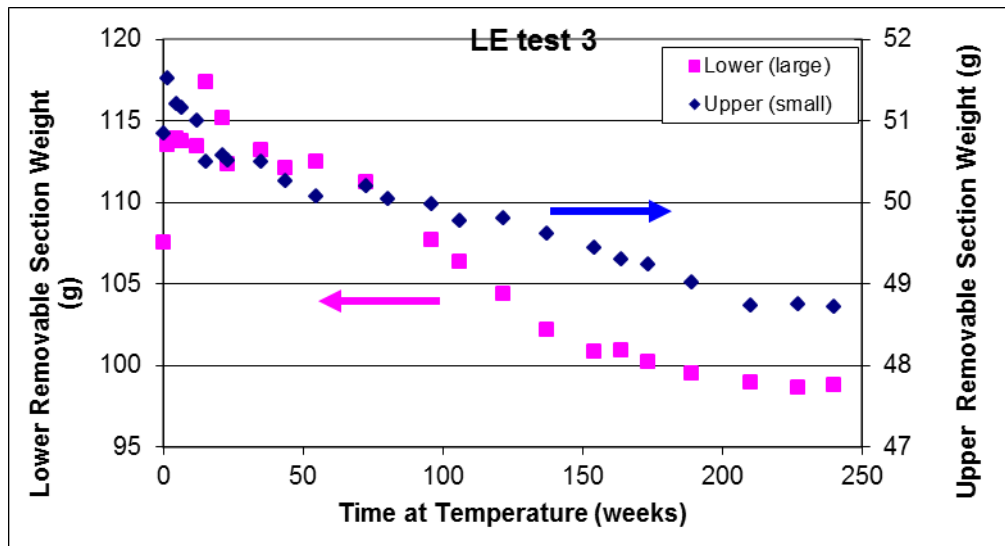
Figure 11. Weight of removable fiberboard sections from life extension test 3.

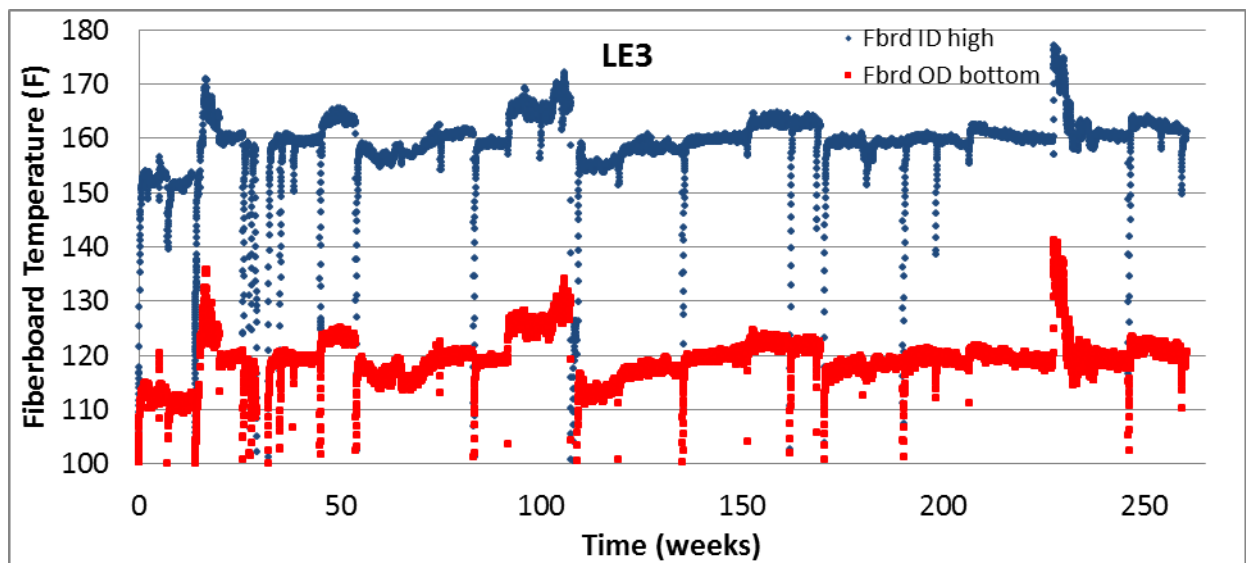
elevation on the OD surface. The temperature vs time data at the highest fiberboard ID and lowest fiberboard OD locations are summarized in Figure 12. It is possible that the fiberboard reached slightly higher temperatures at elevations above the uppermost ID thermocouple. However, the variation among the thermocouples along the ID surface in the central region adjacent to the shield shows a very small gradient (typically < 1°F). Therefore, the recorded temperatures are assumed to provide a reasonable approximation of the maximum fiberboard conditions.

Figure 12. Temperature variation for package LE3 at the hottest (blue symbols) and coolest (pink symbols) instrumented fiberboard locations (highest fiberboard ID location and lowest fiberboard OD location – refer to Figure 1).

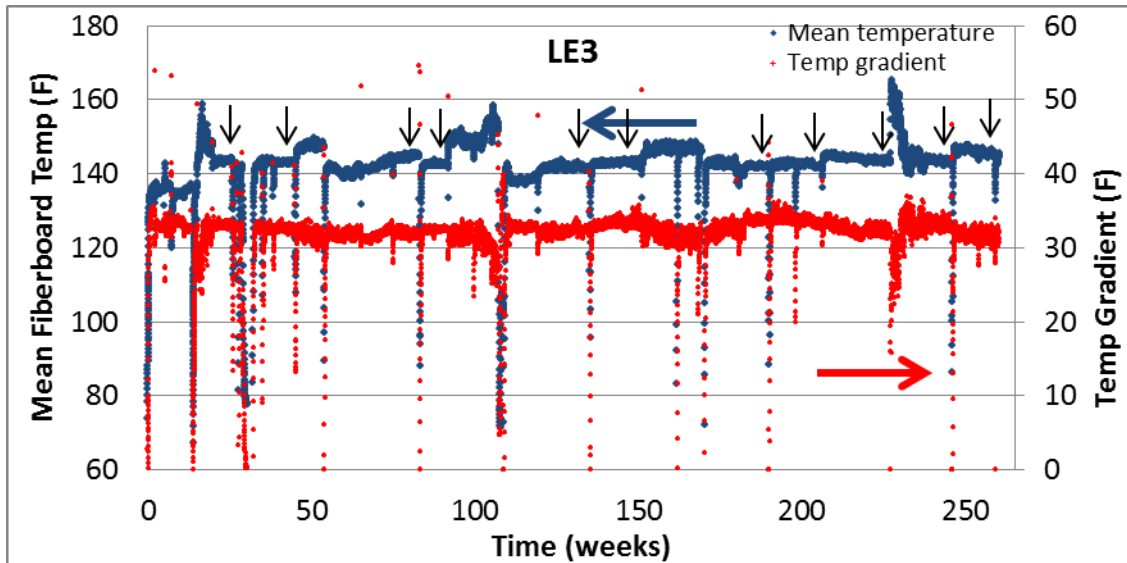
Thermal gradient information was examined at several discrete times during periods of steady state operation indicated by the vertical arrows in Figure 13. The thermal conductivity will vary with changes in the temperature gradient and fiberboard thickness, as described by:

At each of the arrows in Figure 13, the radial temperature gradient and lower assembly thickness are combined per this relationship to get a value proportional to the thermal conductivity (see Table 4). Any change in this value over time is proportional to the change in actual thermal

Figure 13. LE package 3 average radial temperature gradient (red symbols) in the fiberboard based on the upper 2 fiberboard ID thermocouples and the upper 2 fiberboard OD thermocouples, and average fiberboard temperature (blue symbols). The vertical arrows indicate times during steady state operation for which the relative thermal conductivity of the fiberboard was estimated.

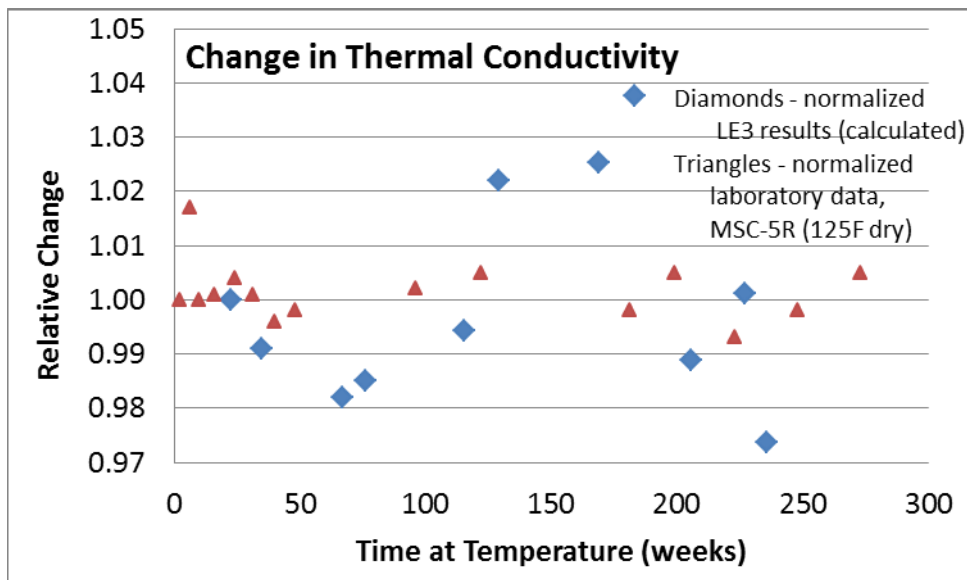
These results are listed in Table 4 and plotted in Figure 14, along with normalized laboratory data for sample MSC-5R conditioned at 125°F and tested at 122°F. In this presentation, the relative thermal conductivity values for LE3 vary, but the overall trend is a very slight increase in thermal conductivity over time (0.21 %/yr). This rate compares favorably with results reported for laboratory samples in Reference 6, including the following:

Figure 14. Relative change in radial thermal conductivity estimated from LE3 thermal gradient data. Comparable data for laboratory sample MSC-5R (conditioned at 125°F) are also shown. The mean test temperature for the laboratory sample was 122°F.

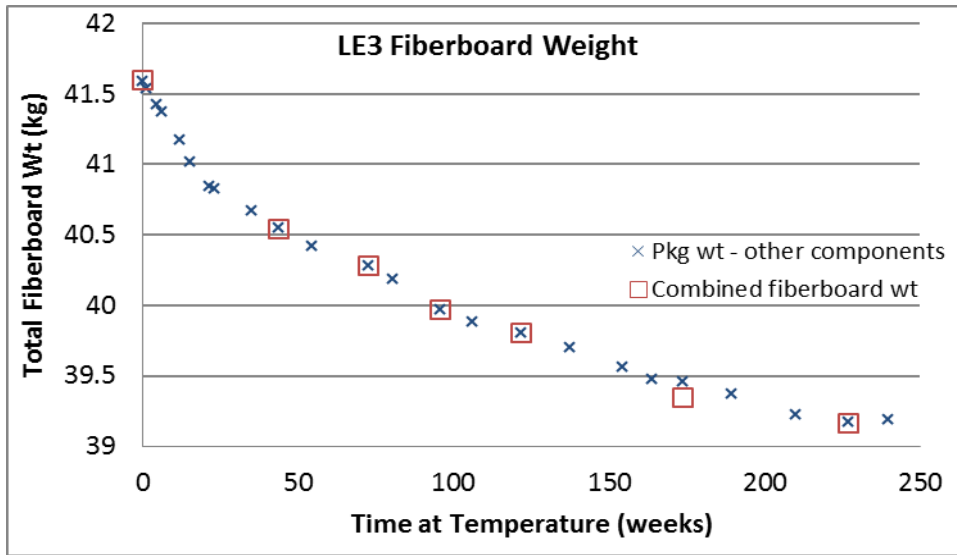
A heavy corrosion layer was noted on the shield after 26 weeks (21.3 weeks at temperature), and was not observed to change significantly during subsequent inspections. If the weight of all fiberboard is subtracted from the total package weight, the remaining components had a combined baseline weight of 138.9 kg. After 43.7 weeks at temperature (the next time all fiberboard was weighed), the remaining components had a combined weight of 139.1 kg. This residual weight has remained approximately constant since that time. This weight gain of ~200g is attributed primarily to shield corrosion. It will be assumed that the shield weight increased uniformly by 200g over the first 26 weeks, and has remained constant since then. Therefore, any additional change in the package weight (after adjusting for shield corrosion) represents fiberboard weight change. The fiberboard weight based on this method is plotted in Figure 15 with the “x” symbols. The red squares in Figure 15 show the combined total weight of all fiberboard sections. There is very good

agreement between the two methods in Figure 15, indicating that the greater amount of data from package weight can be used to represent the change in fiberboard weight as well.

Figure 15. Variation in total fiberboard weight over time based on two methods. The combined fiberboard weight (red squares) is the total weight of all fiberboard sections. The blue “x”s show the difference between the total package weight and all non-fiberboard components.

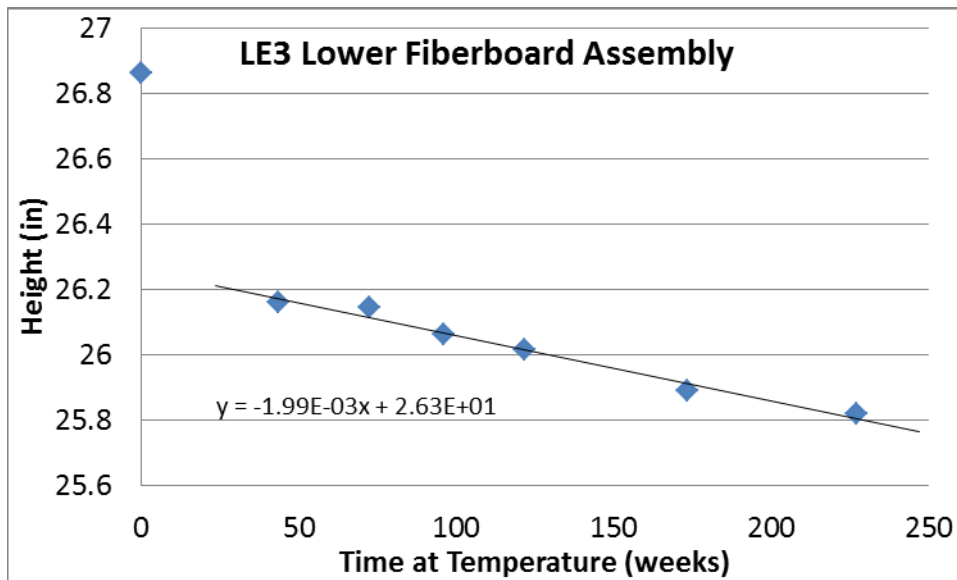
decrease in height of 0.40 %/year (Figure 16). In comparison, the model for fiberboard height [6] predicts a change of 0.3 %/yr at 140F 50%RH, in good agreement with this observation.

Figure 16. Change in height of the lower fiberboard assembly

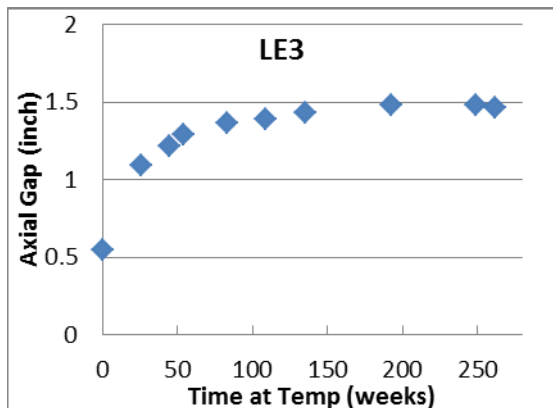
Related to the change in fiberboard height is the change in axial gap at the top of the package. The axial gap is shown in Figure 17. The baseline axial gap is smaller than nominal (0.545 inch vs 0.8 inch). During initial assembly, the axial gap was smaller on one side (0.459 inch) and interfered with drum closure such that the closure bolts were used to pull the lid tight. From this extreme axial gap condition, interpolation of the data indicate the axial gap exceeded 1 inch after ~20 weeks at temperature. This 1 inch threshold is taken as an action point for packages in service to investigate whether significant package degradation has occurred. The axial gap in LE3 continued to increase, with a maximum value of 1.483 inches after 249 weeks at temperature.

Figure 17. LE3 axial gap change over time. Interpolation indicates the axial gap exceeded 1 inch at ~20 weeks

Two conditions have developed that are not consistent with package certification requirements. The axial gap at the top of the package has increased to 1.48 inches, exceeding the 1 inch criterion. In addition, staining and/or corrosion have formed in a few spots on the drum. However, the package remains capable of performing its function.
