The Performance of Underground Radioactive Waste Storage Tanks at the Savannah River Site: A 60-year Historical Perspective

Bruce J. Wiersma, Savannah River National Laboratory

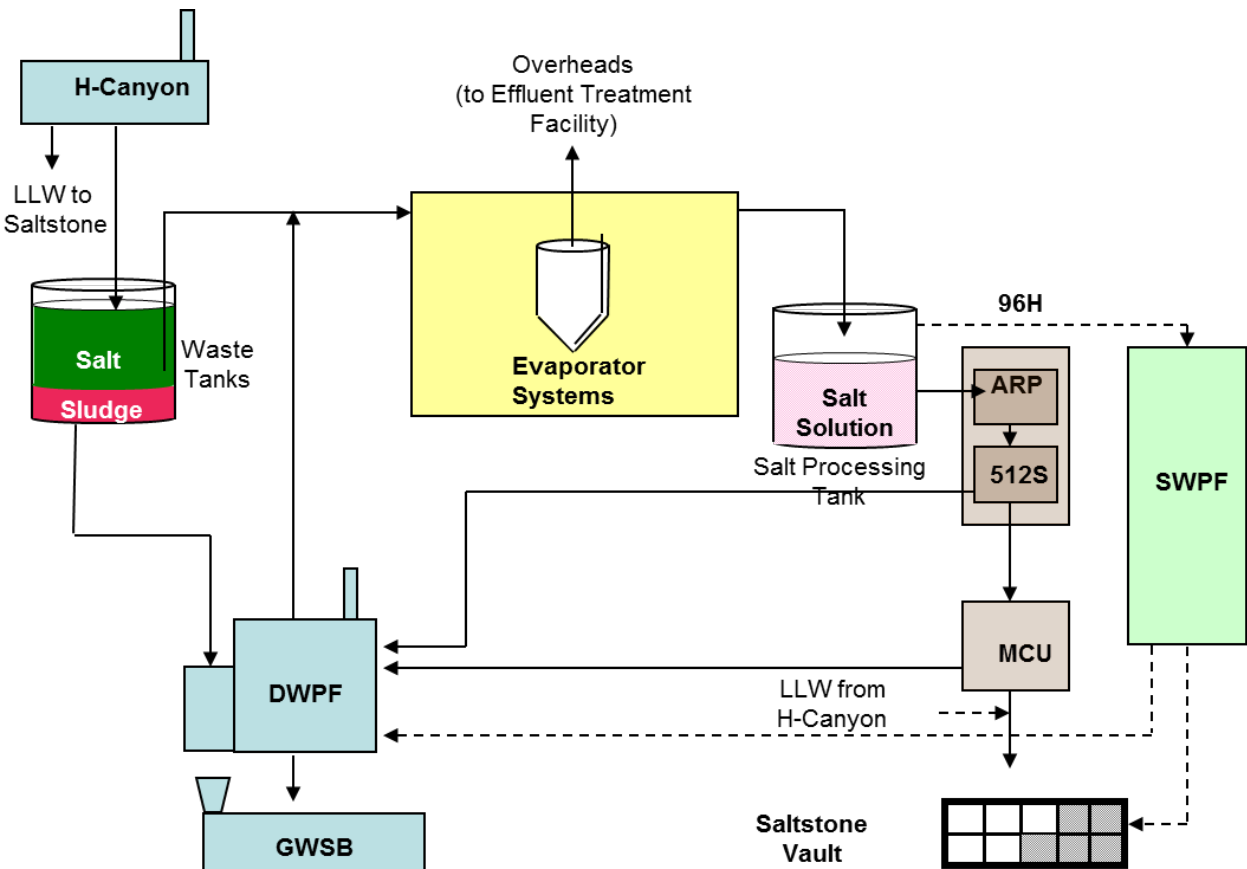
Figure 2. SRS Waste Storage and Processing.

A schematic of the radioactive waste system at SRS is shown in Figure 2. Fresh waste received from the reprocessing canyon is transferred to the waste tanks where it separates into solid (sludge) and liquid (supernate) phases. The supernate is transferred to an evaporator system that reduces the volume of the liquid. As the concentrated supernate cools, salt cake solids crystallize in the bottom of the tanks. Both F- and H-Area tank farms have their own evaporator systems and serve to recover millions of gallons of tank space each year. Without these evaporator systems, SRS would have required 86 additional waste storage tanks to store the waste produced over the site's lifetime.

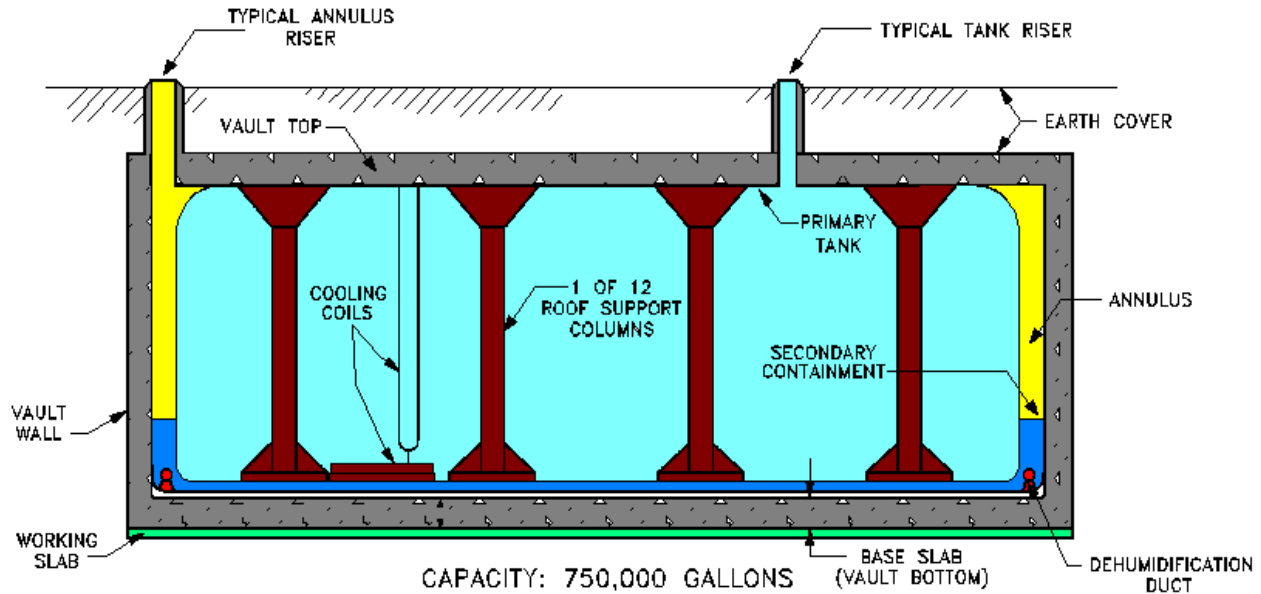
Figure 3. Type I waste tank design.

The tank is surrounded by a concrete vault. The tank and pan are set on a 30 inch thick base slab and are enclosed by a cylindrical 22 inch thick reinforced concrete wall and a flat 22 inch thick concrete roof. There are twelve 2 foot diameter concrete columns within the primary tank to support the roof. Each column has a flared capital and is encased in 1/2 inch thick A285 carbon steel plate. Furthermore, these tanks are buried beneath approximately 8-9 feet of backfilled soil.

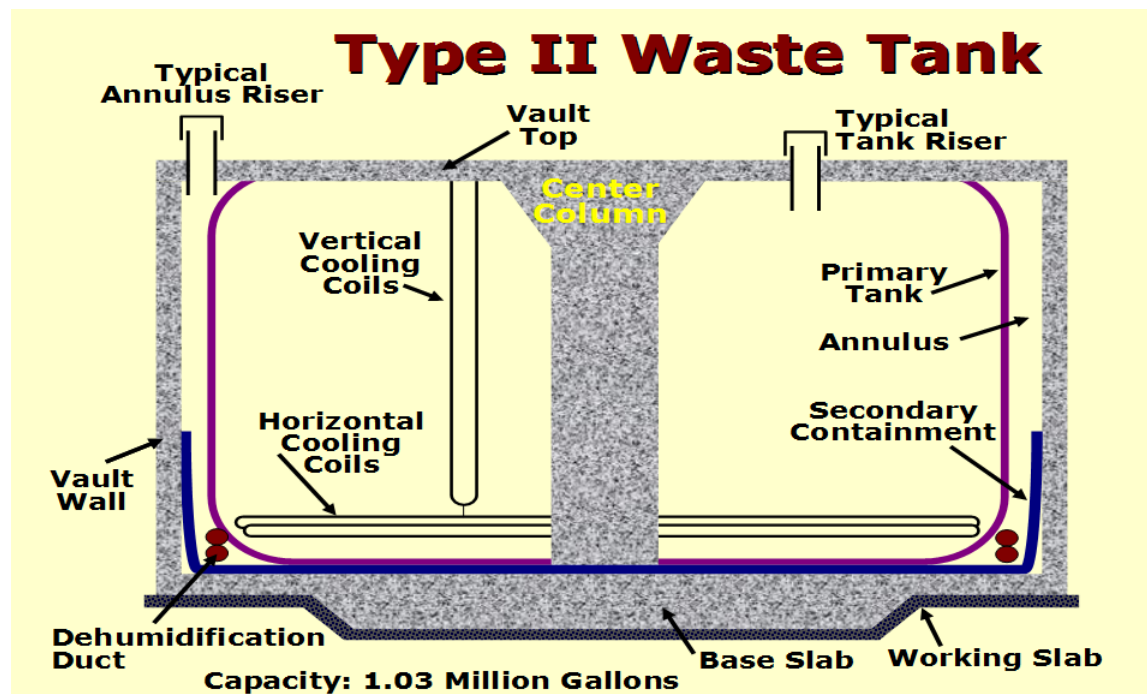
Figure 4. Type II Waste Tank Design

These tanks are also surrounded by a concrete vault. The tank and pan assembly is set on a concrete foundation slab that is 42 inches thick. The primary is enclosed by a cylindrical reinforced concrete wall that is 33 inches thick and a flat concrete roof that is 45 inches thick. The roof is supported by the walls and a central concrete column nestled within the inner cylinder of the vessel. The roof of these tanks, however, is at grade level.

The primary tank and the secondary pan were also fabricated from ASTM A285, Grade B carbon steel plate. The plates were not shop heat treated or stress-relieved to reduce the residual stresses in the weld heat affected zones.

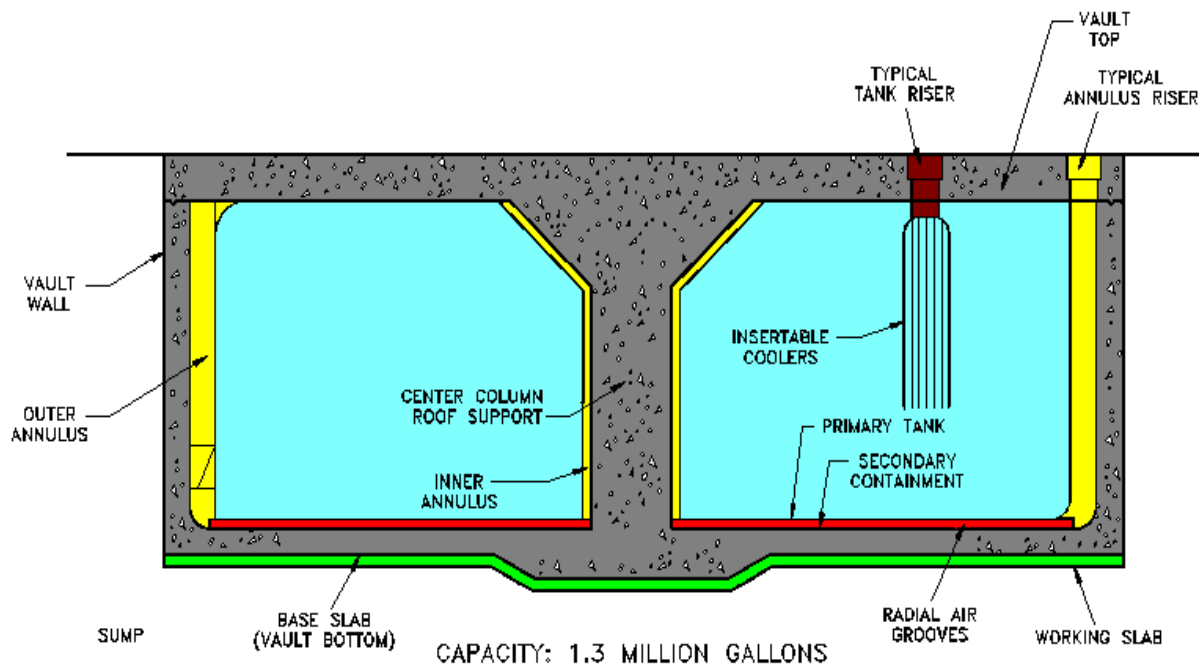
Figure 5. Schematic of Type III Waste Tank

The primary tank rests on a six inch bed of refractory concrete. Beneath the refractory is a 42 inch thick concrete foundation slab. The cylindrical walls of the secondary are enclosed by a 30 inch thick reinforced concrete wall and a 48 inch thick flat reinforced concrete roof. Typically there is three inches of cover above the reinforcement steel. A central concrete column fits within the inner cylinder of the vessel. The roof of these tanks is also at grade level.

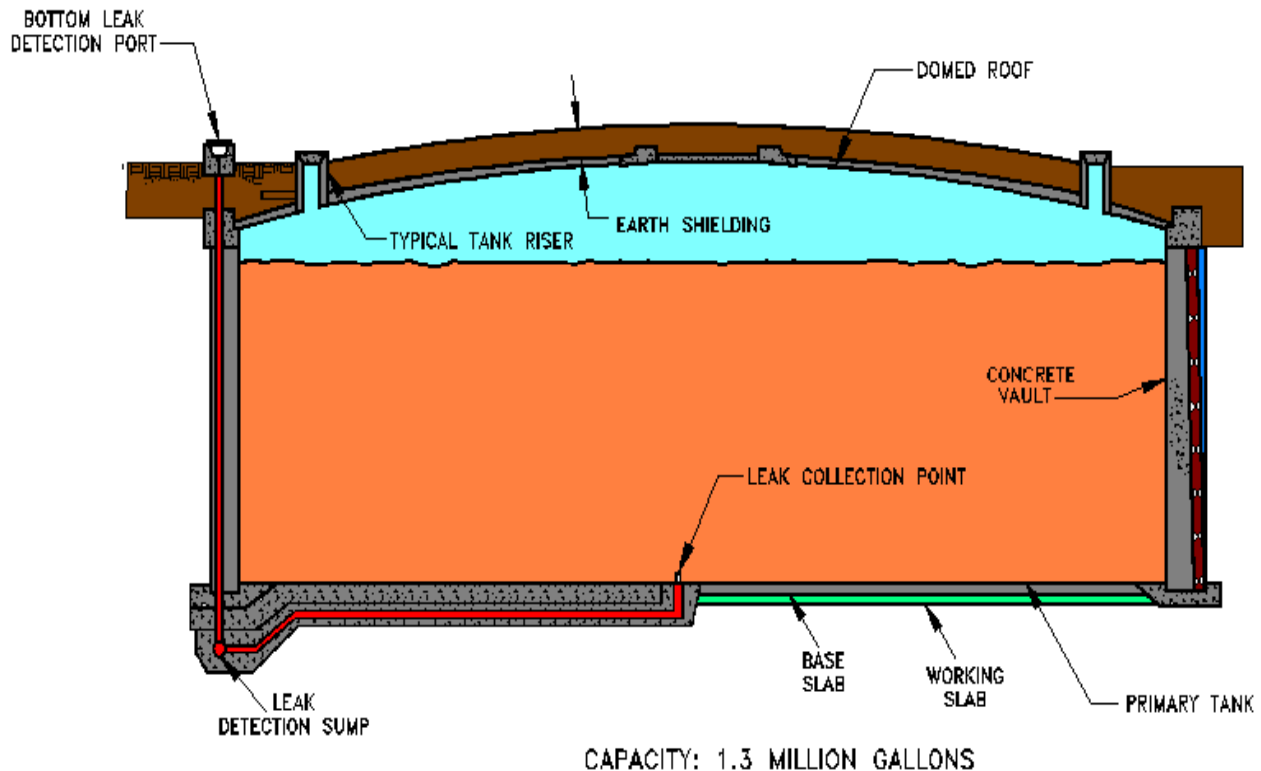
Figure 6. Type IV waste tank design

A285 was also the material of construction for the liner for the Tanks 17F-20F. The plates were not shop heat treated or stress-relieved to reduce the residual stresses in the weld heat affected zones. Tanks 21-24H were constructed from open hearth ASTM A212, Grade B carbon steel (A212). The material is further designated as firebox quality, fully-killed, and suitable for arc welding. This steel designation and grade classifies it as "high tensile strength suitable for locomotive and stationary boilers and other pressure vessels". This steel was also not shop heat treated or stress-relieved to reduce the residual stresses in the weld heat affected zones. The A212 steel was chosen to replace the A285 because of its higher yield stress, yet still suitable ductility, and greater weldability characteristics.

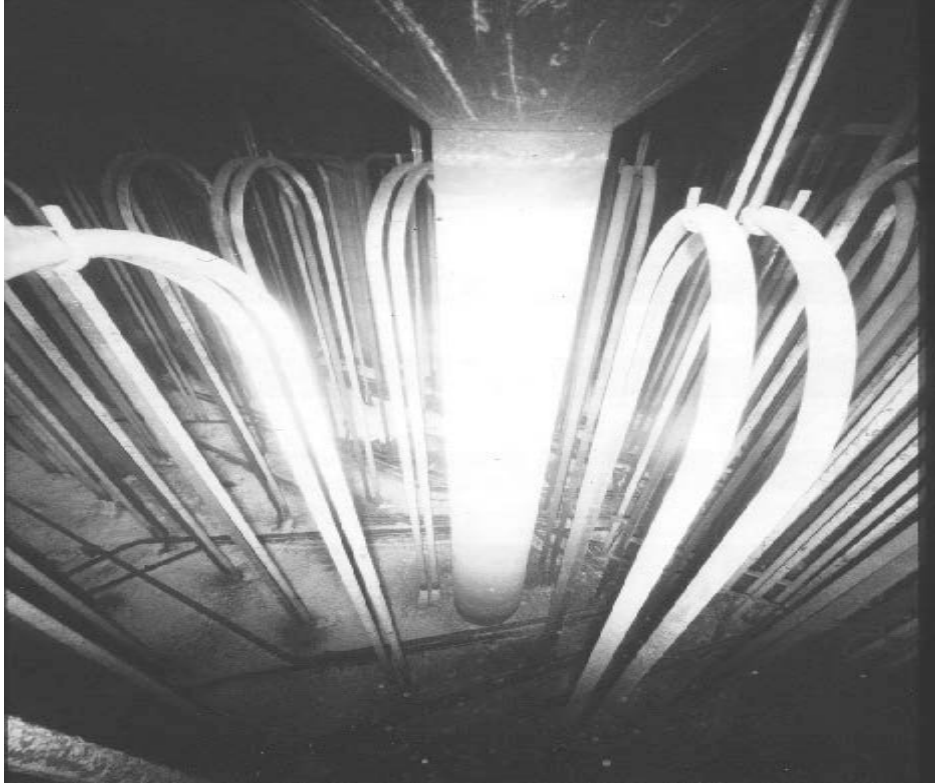
Cooling water that is inhibited with sodium chromate is used to control the temperature of the waste in the tank. There are four types of cooling coil systems installed in the Type I, II, and III tanks. The Type I tanks have 34 vertical pipes uniformly spaced in the tank and two horizontal coils placed near the tank bottom (see Figure 7). The Type II tanks have 40 vertical pipes uniformly dispersed in the tank, two horizontal coils placed near the tank bottom, and two horizontal coils situated in the upper regions of the tank. For Type I and II tanks the vertical coils are supported at the bottom of the tank on four foot triangular centers. The later Type III tanks (25-28 and 36-51) have 23 vertical pipes uniformly distributed throughout the tank. The pipes in these tanks are supported on three foot triangular centers. The earlier Type III tanks (29-35) are cooled by deployable or bundled pipes which are inserted into the tank through risers (see Figure 8). All pipe utilized for the coils, permanent or deployable, is nominally 2 inch diameter Schedule 40 (i.e., 0.154 inch thick).

Figure 7. Vertical and horizontal cooling coils in a Type I waste tank. One of the 12 columns is also visible in the photograph.

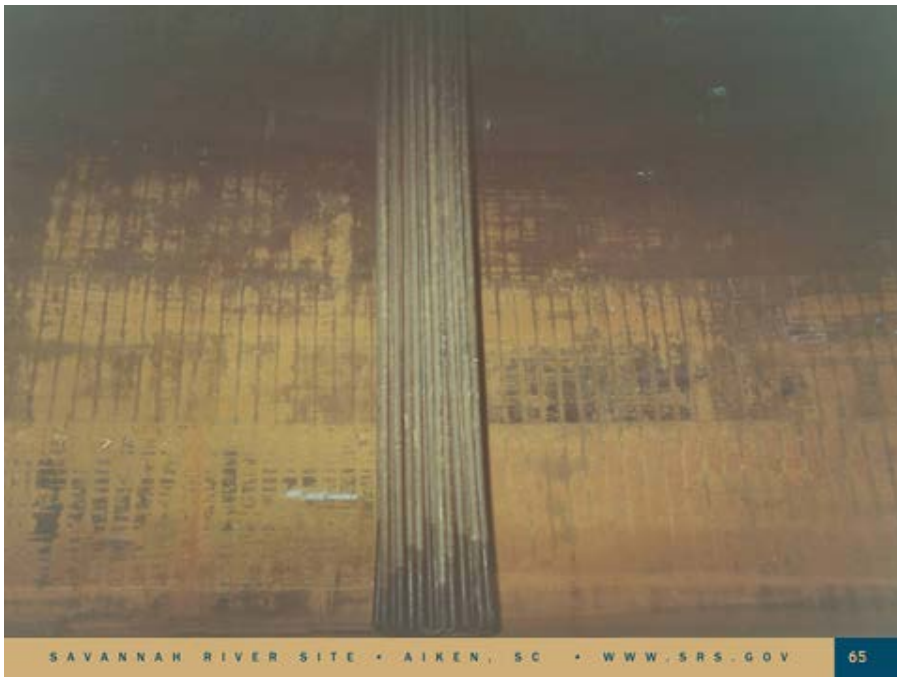
Figure 8. Deployable cooling coils in an early Type III waste tank. The particular coils are a consolidated bundle style.

The cooling coils are fabricated from either ASTM A53 Grade B or ASTM A106 Grade B seamless carbon steel piping. Seamless pipe is a tubular product made without a welded seam. It is manufactured by hot working steel and, if necessary, subsequently cold-finishing the hot-worked tubular product to produce the desired shape, dimensions, and properties. The nominal compositions and tensile properties for each material are shown in Tables 2 and 3, respectively. The cooling coils in the Type I and II tanks tended to be made of A53, while the coils in the Type III tanks were constructed of A106.

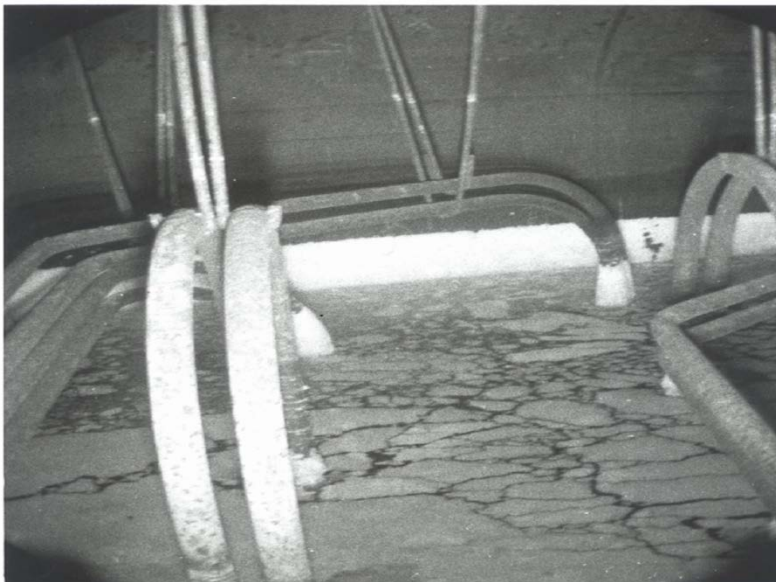
Both HHW and LHW are present in three forms: supernate, sludge, and salt cake. The supernate is a multicomponent aqueous mixture of sodium salts (see Figure 9). In 1972 an extensive program was initiated to investigate the tank-to-tank variations in the supernate compositions [5]. The ranges of constituent concentrations of the HHW supernate (Tanks 1-15) are shown in Table 5. The samples are divided into H-Area and F-Area to reflect the different separation processes in the two areas. The compositions of the HHW were variable from tank-to-tank. Nitrate is the primary aggressive anion in the supernate while hydroxide and nitrite are the main inhibitors.

Figure 9. Supernate present in waste tank.

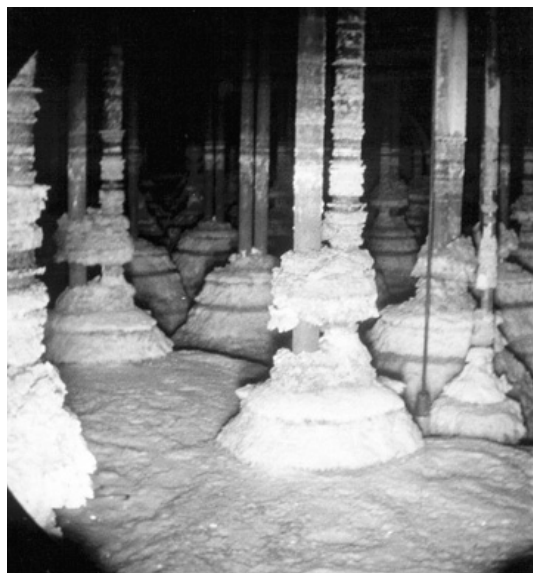
Salt cake is formed as evaporated supernate cools in the waste tank (see Figure 10). The solid crystals which form are rich in NaNO₃, Na₂CO₃, and Na₂SO₄, while the concentrated supernate is richer in NaOH and NaAl(OH)₄. Salt cake contains approximately 78 vol. % salt crystals, which form after the evaporated supernate is cooled, and 22 vol. % interstitial concentrated supernate (i.e., high hydroxide concentration). The composition of the salt varies from tank to tank and is inhomogeneous within a tank. Arithmetic averages of analytical data from samples were used to estimate the saltcake compositions in F- and H-Areas [7, 8]. Table 8 shows the composite salt and concentrated supernate compositions for both of these areas.

Figure 10. Salt cake formation in waste tank and on cooling coils.

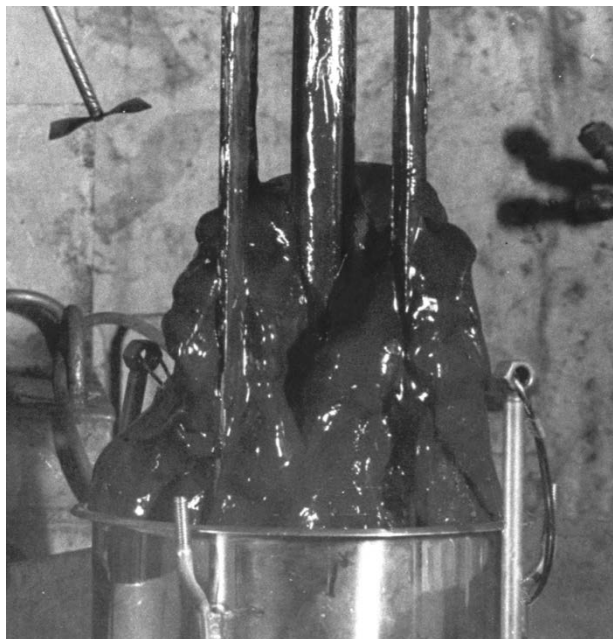
The term sludge refers to the gelatinous insoluble layers which settle from the alkaline waste solutions to the bottom of the tank (see Figure 11). The sludge consists of approximately 20 vol. % solids and 80 vol. % supernate [9]. The solids are complex mixtures of more than 30 elements in the form of hydrous oxides. The most prevalent metal oxides in the sludge are iron, manganese, aluminum and uranium. The sludge solids contain about 80 wt. % soluble salts such as NaNO_3 , NaNO_2 , NaOH , Na_2SO_4 , etc. The majority of the radioactive fission products also remain in the sludge [10].

**Figure 11. Sludge obtained during sampling of waste tank.**

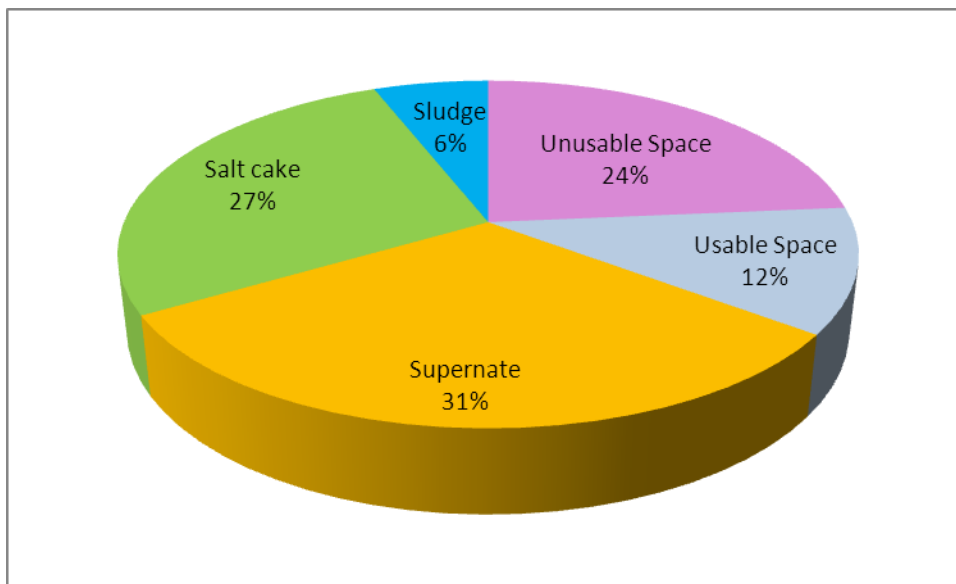
Figure 12. Approximate inventory of waste at SRS as a percentage of total tank volume.

Currently, there is approximately 36 million gallons of waste stored in the tanks [13]. The approximate percentage of each phase of waste is shown in Figure 12. The figure also shows the percentage of usable and unusable space in the tanks. The tanks may have unusable space due to leak sites or flammability concerns. The amount of usable space is equivalent to approximately five Type III waste tanks.

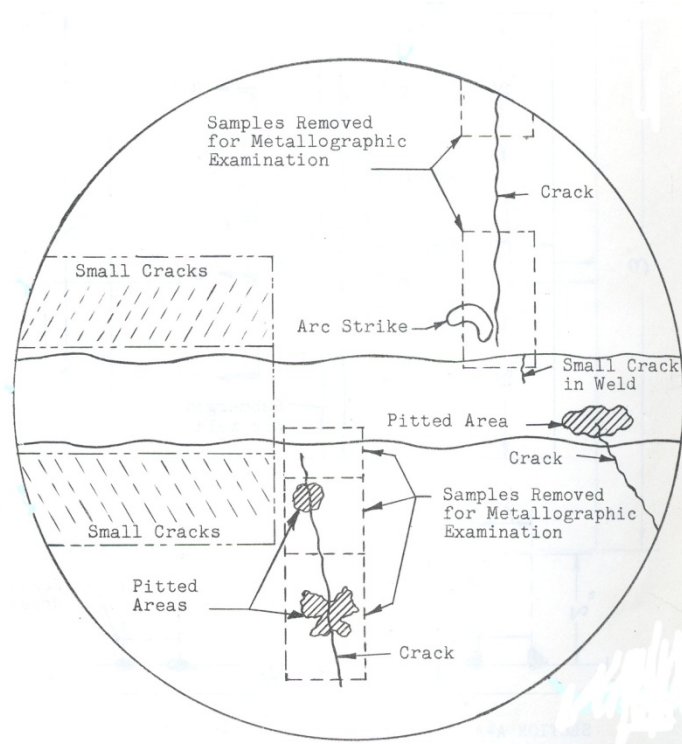
Two disks, each 5 5/8 inches in diameter, were extracted from the wall of Tank 16 in 1961 [14]. The disks were extracted from the horizontal weld between the upper knuckle and the upper primary shell plate and both contained leak sites. The steel at this site had been exposed to radioactive waste for approximately 7 months. Metallographic examination revealed three cracks on one of the samples (see Figure 13), with two of the cracks being through-wall. The cracks were intergranular and essentially perpendicular to the horizontal weld (see Figure 14).

Figure 13. Drawing of interior surface of sample removed from Tank 16H.

Numerous small cracks were observed on the inner surface. These cracks were located in both the knuckle and primary shell plates in bands approximately 0.5 inch wide. The edge of these bands was located between 0.0625 and 0.125 inch from the edge of the weld. The cracks ranged from 0.0625 to 0.5 inch in length and were 0.031 inch deep. Severe stress raisers (e.g., arc strikes, weld beads, weld repairs, etc.) were not required to initiate the cracks, but may have been required to propagate the cracks.

The microstructure of the sample was consistent with the theory that the presence of grain boundary carbides in low carbon steel increases the tendency towards intergranular cracking (see Figure 14). These carbides would be re-dissolved, and hence not present in the weld or immediately adjacent to the weld. This observation would explain why the two major cracks did not propagate into the weld and the numerous surface cracks did not extend into the narrow zone immediately adjacent to the weld.

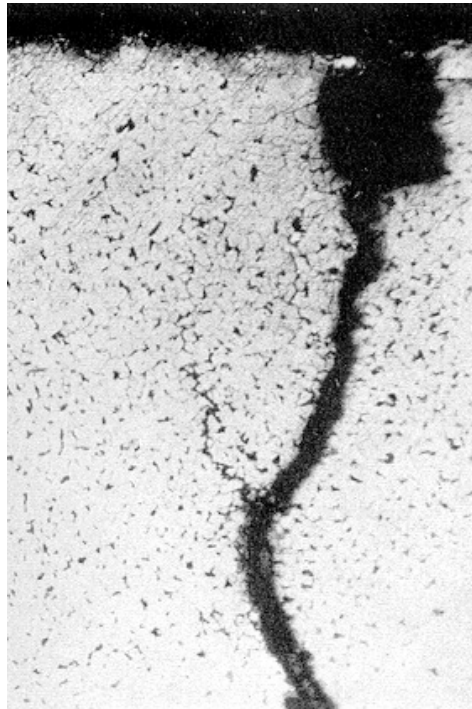
Figure 14. Shallow cracks on interior surface of Tank 16 sample.

Shallow pitting occurred at several locations. The pits were broad and approximately 0.02 inch deep at the site of very tightly adherent deposits. Microscopic pits were associated with the intergranular cracks.

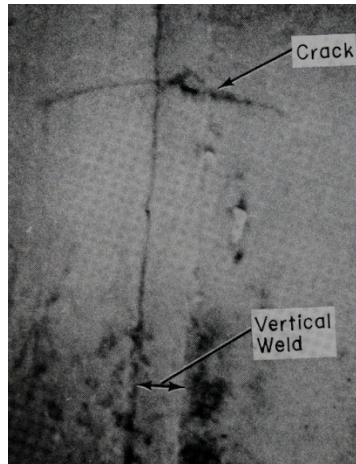
The flaw lengths were also determined. In June 1962, the vertical weld in the upper primary shell beneath an inspection port was sandblasted and then inspected with dye penetrant [15]. Ten large cracks were visible without magnification. The cracks were essentially perpendicular to the weld bead (see Figure 15). Four of the cracks were estimated to be between 4 to 6 inches long. The radiograph of the vertical weld and the photographs revealed exterior surface imperfections as well as internal weld beads. Although three of the cracks appeared to be associated with weld beads, most of the cracks showed no correlation with known fabrication blemishes. One crack appeared to be slightly curved, however, this crack was located next to a repair weld at the intersection of the vertical weld and the middle horizontal weld. All of the cracks appeared to be in a 3-inch zone next to the weld and therefore likely affected by fabrication residual stresses. One crack was observed near a repair weld at the intersection of the vertical and horizontal weld. The crack had an arc like appearance (see Figure 16).

Figure 15. Dye-penetrant testing of stress corrosion crack on vertical weld in Tank 16 [15].

In January 1974, the same weld was sandblasted and re-inspected with dye penetrant [15]. The cracks did not appear to have increased in size since the 1962 inspection. This result indicated that weld residual stresses were the primary crack driving force.

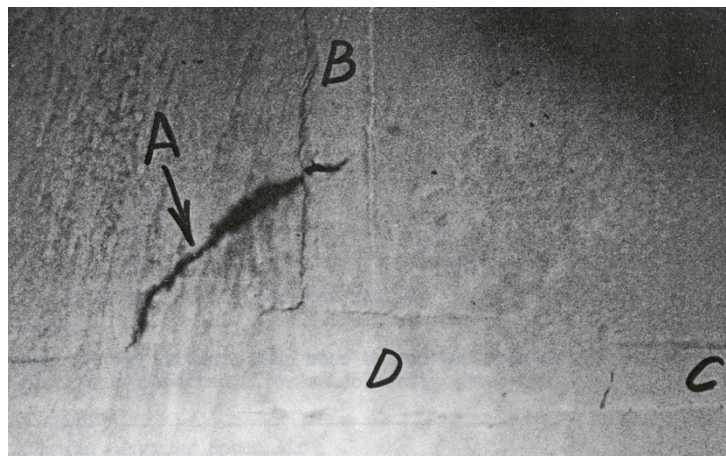
**Figure 16. Dye-Penetrant testing at the intersection of vertical and middle horizontal weld in Tank 16:
A) crack, B) vertical weld, C) middle horizontal weld, D) repair weld [15].**

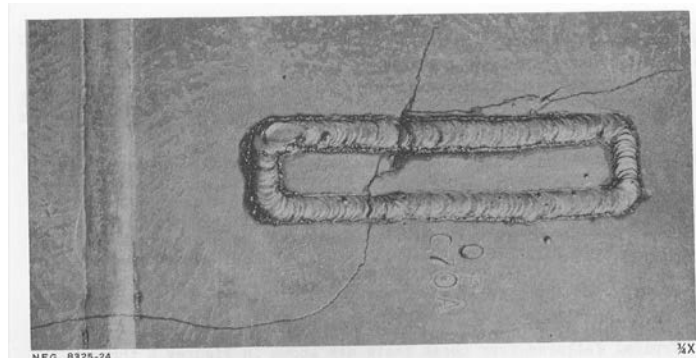
Figure 17 shows the crack pattern associated with a weld attachment. Weld attachments are typically fillet welds rather than full penetration welds. An arc-like crack that curves through the center of the attachment was observed. It is also interesting to note that the attachment redistributes the residual stresses so that the crack that is roughly perpendicular to the seam weld begins to arc. It was difficult to distinguish whether the crack initiated from the seam or the attachment.

Figure 17. Stress corrosion cracking in area near weld attachment [14].

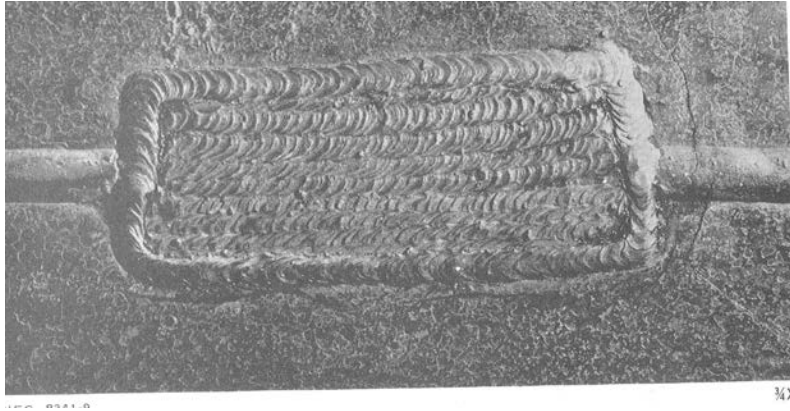
Figure 18 shows the crack pattern associated with a weld repair. A repair weld is performed to remove defects found in weld beads and the base material during pre-service radiography inspections. During repair, a groove is prepared by grinding out the original weld metal. The repair groove is then filled with new metal. The actual repair length, width and depth may vary depending on the defect size. Cracks

were observed proceeding both through and around a repair weld, although the latter was more frequently observed. Typically the crack traces an arc-like path around the repair and then tends to radiate from the corners.

Figure 18. Crack pattern near a weld repair [14].

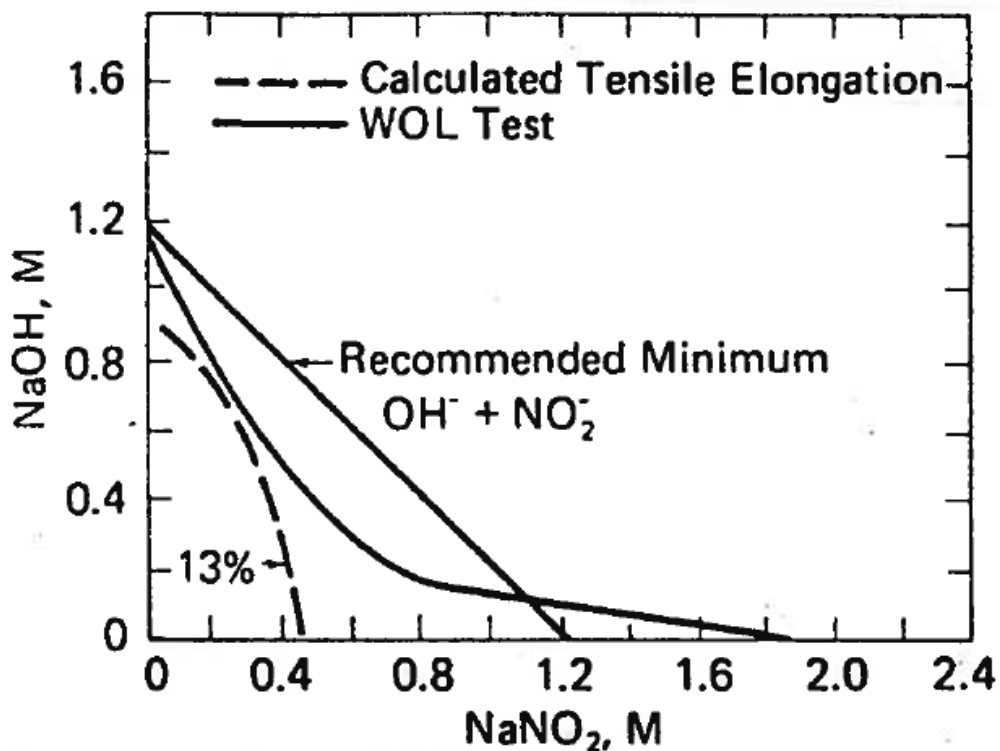
Figure 19. Comparison of WOL and Strain Rate Test Results.

Controls on the solution chemistry were instituted in the late 1970's to preclude the initiation and propagation of SCC for A285 carbon steel. The control limits for supernate with a high nitrate concentration (i.e., greater than 1 M) were based on the results of 1) Impressed current and impressed potential slow strain rate tests, which emphasize the conditions for crack initiation [20] and 2) Modified wedge opening loaded (WOL) specimens with a fatigue pre-crack, which evaluate conditions that cause crack propagation [19]. The tests evaluated the effect of nitrate concentration, hydroxide and nitrite concentrations, and temperature on the susceptibility of carbon steel to SCC. Data from both methods is shown in Figure 19. Good agreement existed for the two approaches in that compositions that cause cracks to form also cause them to grow. The figure also shows the recommended limits for the supernate for nitrate concentrations between 3 and 5.5 M. The supernate chemistry limits that were implemented for the tanks in 1977 are shown in Table 11. These are also the supernate chemistry limits that were adopted for the Hanford waste tanks in the 1980's.

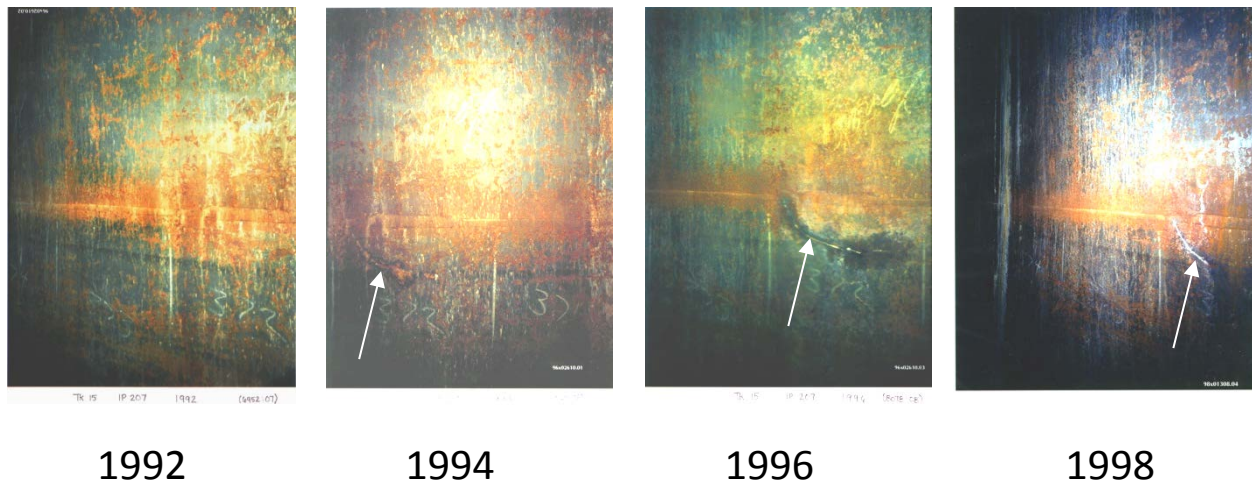
apparent stress corrosion crack in the vapor space of Tank 15H, a Type II waste tank. A series of inspection photographs of Tank 15H (Figure 20) showed that the vertical part of the crack exceeded 1.5 inches and the parallel part exceeded 7.5 inches. This crack may have reached its stationary configuration, as there was no crack growth observed from 1996-2000. This observation qualitatively agrees with the theoretical prediction of no crack growth. The visual re-inspection of Tank 15 in 2000 confirmed the existence of the defect. Ultrasonic inspections in 2002 and 2007 confirmed that a through-wall crack existed. A small amount of crack growth, although still within a region impacted by the weld residual stresses.

Figure 20. Suspected Tank 15 Stress Corrosion Crack Growth

The Tank 15H stress corrosion crack was an unexpected phenomenon due to two reasons: (1) apparent growth of the stress corrosion crack while this region of the tank was not exposed to the bulk solution stored, and (2) an atypical curved length of 15 inches. The stress corrosion crack reference flaw size was previously accepted to be 6 inches in length. Stress corrosion cracking found in the non-stress relieved Type I/II tanks is typically limited to the residual stress fields surrounding fabrication welds. The discovery of new leak sites in the vapor space region of Tanks 5H and 6H, which are two Type I tanks, during refill in January 2000 added another driver to determine stress corrosion cracking parameters in the vapor space.

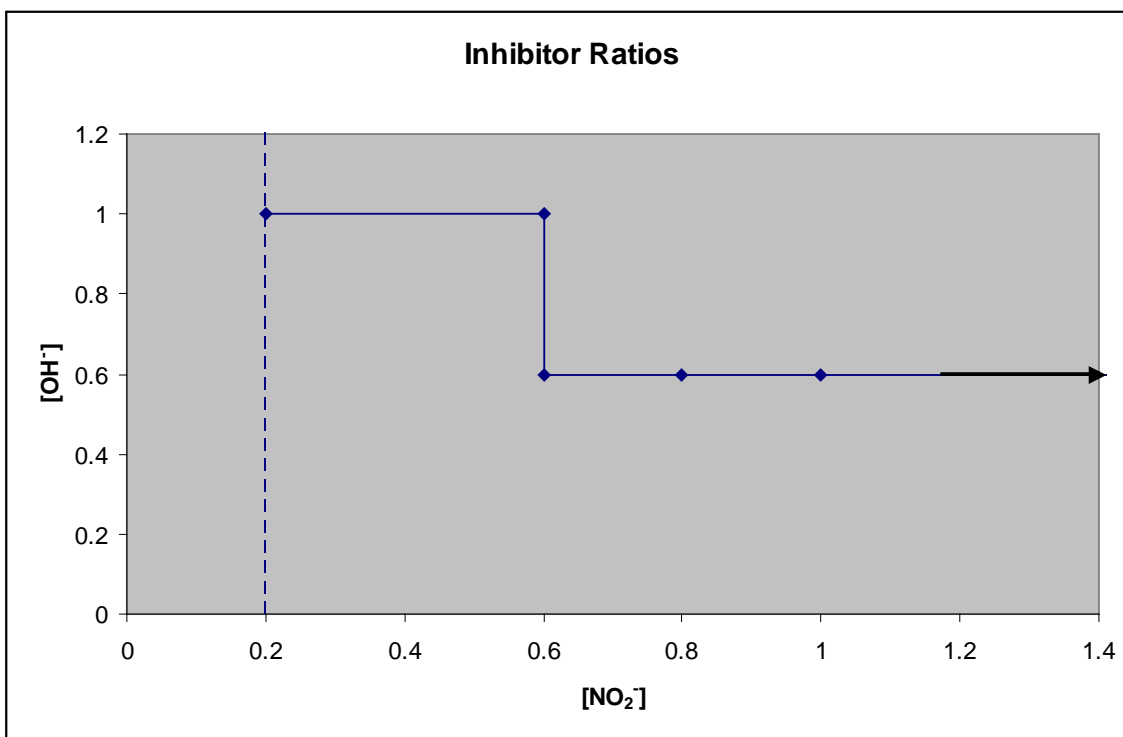
Figure 21. Recommended Option 1 Minimum Hydroxide and Nitrite Requirements

Option 1 of the recommended changes to the chemistry control is a minimum hydroxide concentration of 1 M and a corresponding minimum of 0.2 M nitrite (see Figure 21). As an alternative, Option 2 requires that where the hydroxide concentration falls below 1 M, there is a minimum nitrite concentration of 0.6 M *and* additional requirements on the minimum nitrite concentration as a function of chloride and sulfate. Minimum inhibitor concentrations are to be calculated using chloride and sulfate concentrations measured prior to the most recent decant.

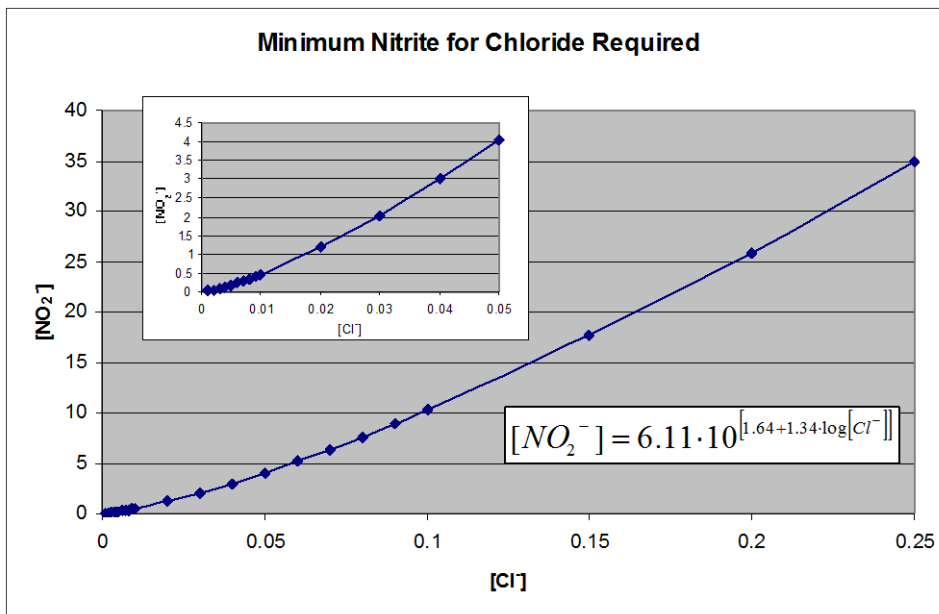
Figure 22. Minimum Nitrite Concentration as Function of Chloride Concentration

The minimum nitrite concentrations as a function of chloride and sulfate are shown in Figure 22 and Figure 23, respectively. The minimum nitrite concentration limit of 0.6 M is reached at a chloride concentration of 0.012 M. This implies that when the hydroxide concentration falls below 1 M, the minimum nitrite concentration is 0.6 M if the chloride concentration is below 0.012 M. However, the

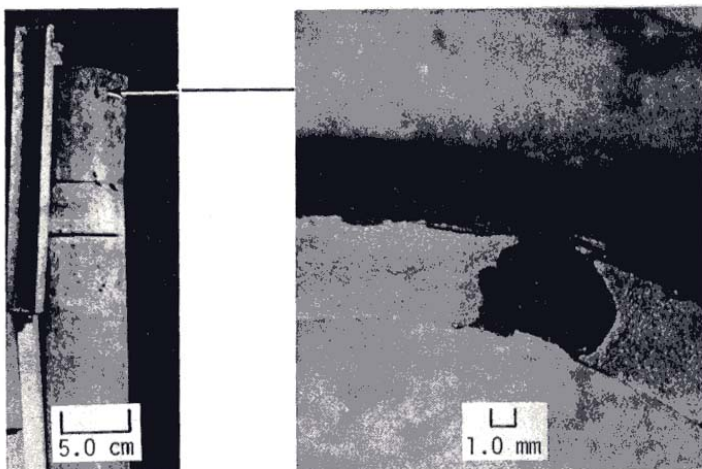
Several coils have failed during tank operations [36]. There are some tanks which have lost as much as 25% of their cooling coils. However, the location, defect size, failure mechanism in most cases has not been precisely determined. Coils from five tanks have been removed and examined metallographically for defects. In 1967, a sixteen inch section was removed from the upper horizontal coil [37]. Leaksites were found in this coil (see Figure 24) and were attributed to pitting from the outside. The size of the pit was approximately 1/8 inch in diameter. Some intergranular attack was also observed beneath the scale formed on the outside. Two coil sections were also removed from the valve house of Tank 16 in 1978 [38]. Since the exterior of the coil was exposed only to air, no corrosion was observed on the outside. The inner surfaces indicated only superficial surface corrosion with a few cases of very mild pitting. No wall thinning was observed. In 1991, sections of failed coils in Tanks 38, 40, and 48 were removed from the valve house [39]. Once again, the inner surface exhibited only superficial surface corrosion and no extensive wall thinning.

Ondrejcin investigated trends and mechanisms for cooling coil failures in Type I and II tanks between 1954-74 [37]. During the first 12 years of operation only one tank, Tank 10, experienced an unsatisfactory cooling coil failure frequency. These failures were attributed to a temporary caustic deficiency in the supernate and were corrected by adding NaOH. From 1967-69, sludge removal operations were carried out in seven of the Type I and II tanks (Tanks 1F-3F, 9H-11H, and 14H). The coils began to fail within a month after the sludge removal operations were initiated (pitting rate of ~ 0.15 inches/month). During this time cooling coil failures dramatically increased (~10/tank-year). The failures were attributed to pitting which resulted from exposure to dilute waste that is low in caustic and nitrite inhibitor and relatively high in sulfate dissolved from the sludge. The failures were hypothesized to occur in the creviced regions of the cooling coil supports. After the tanks were restored to normal chemistry (between 1970-74), failures occurred at a decreased rate (~0.067/tank-year). However, this rate was three times greater than the failure rate that had occurred prior to sludge removal (~0.023/tank-year). The higher failure rate after return to normal chemistry was attributed to coils which were damaged during sludge removal, but had not failed until later.

FIGURE 3. Perforated Upper Horizontal Cooling Coil, Tank 2F

Figure 24. Leak site in horizontal cooling coil in a Type I tank.
