Corrosion Impact of Alternate Reductant on DWPF and Downstream Facilities

SRNL-STI-2014-00281, Revision 0

Keywords: *Glycolic acid, DWPF, steels, high-nickel alloys, corrosion*

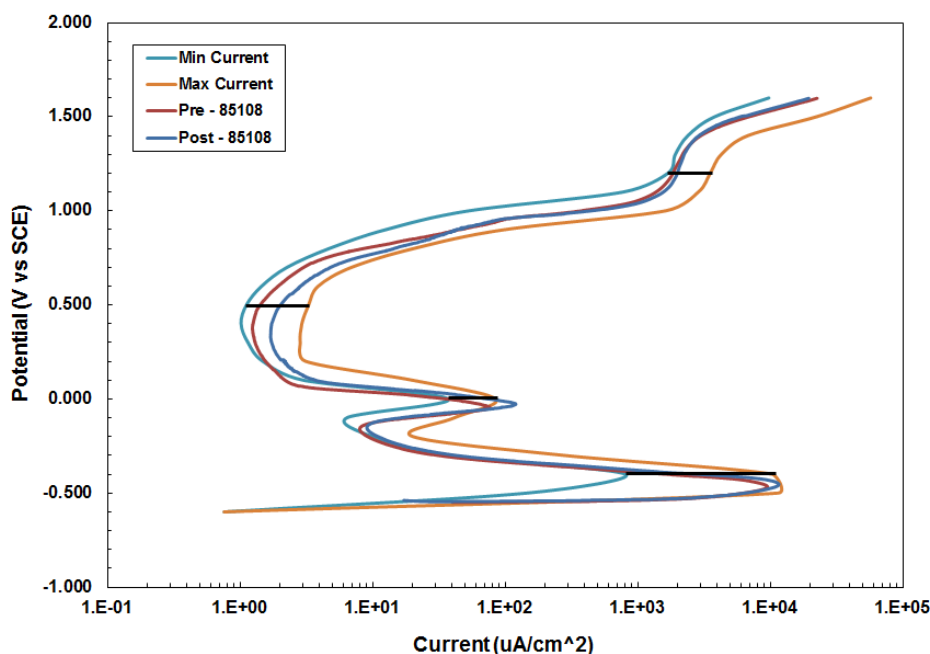
Figure 2-1 Polarization results from a ASTM G5 standardized test performed with potentiostat SN 85108 that was used during the alternate reductant testing

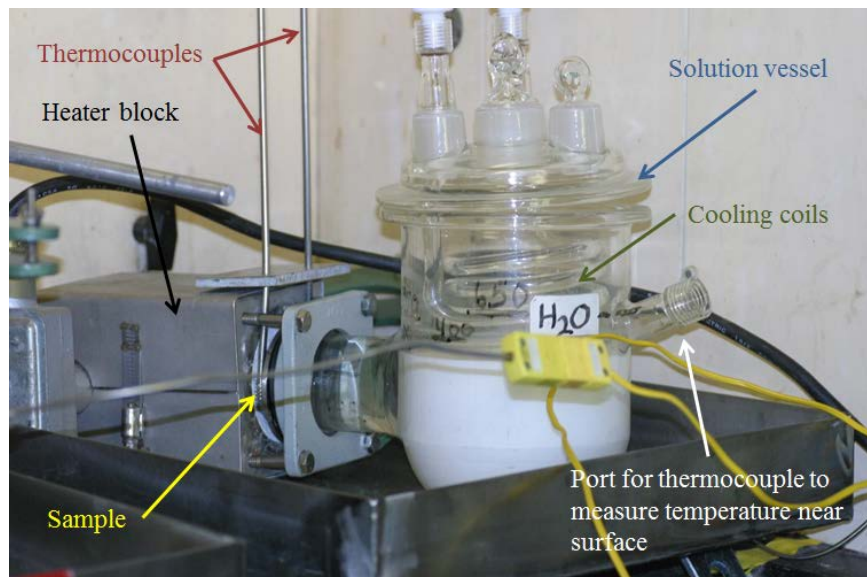
Figure 2-2 Hot-wall test apparatus for corrosion testing under heat transfer conditions

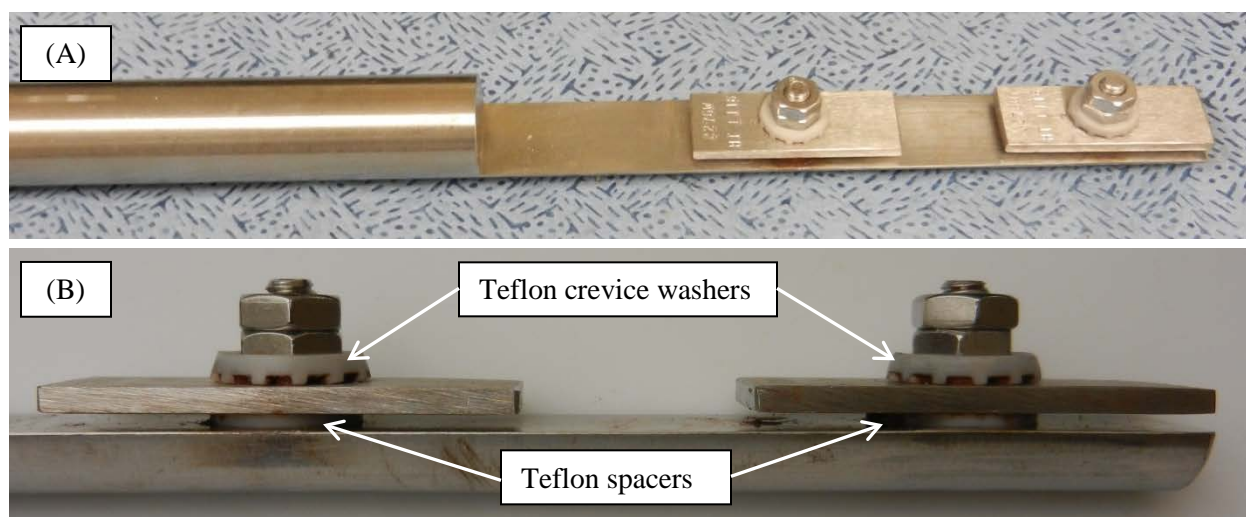
Figure 2-3 Coupon rack used for scale demonstration testing of the CPC in the 22L vessel: (A) top view and (B) side view

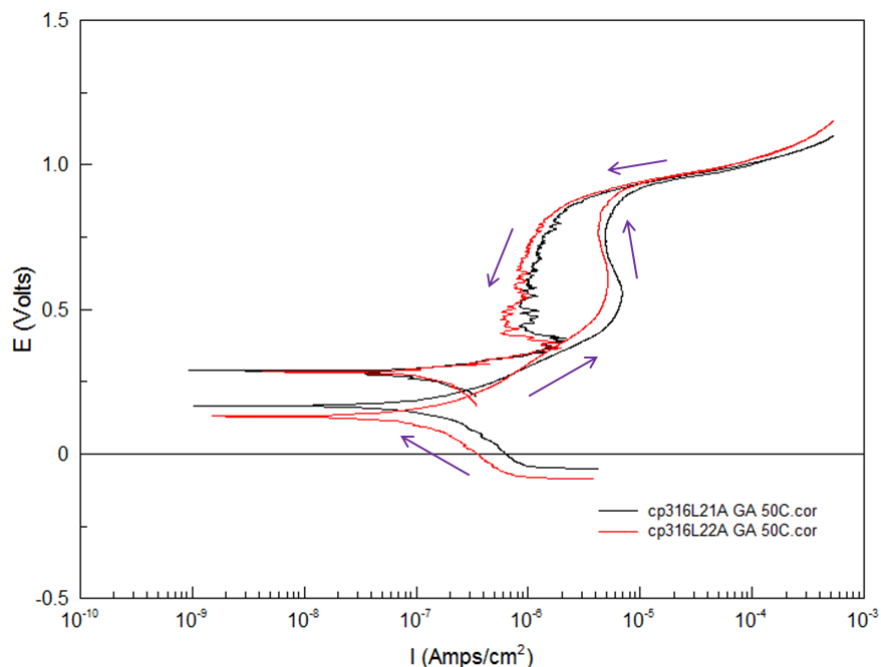
Figure 3-1 CPP scans of 316L in 70% glycolic acid at 50 °C (arrows indicate direction of potential scan)

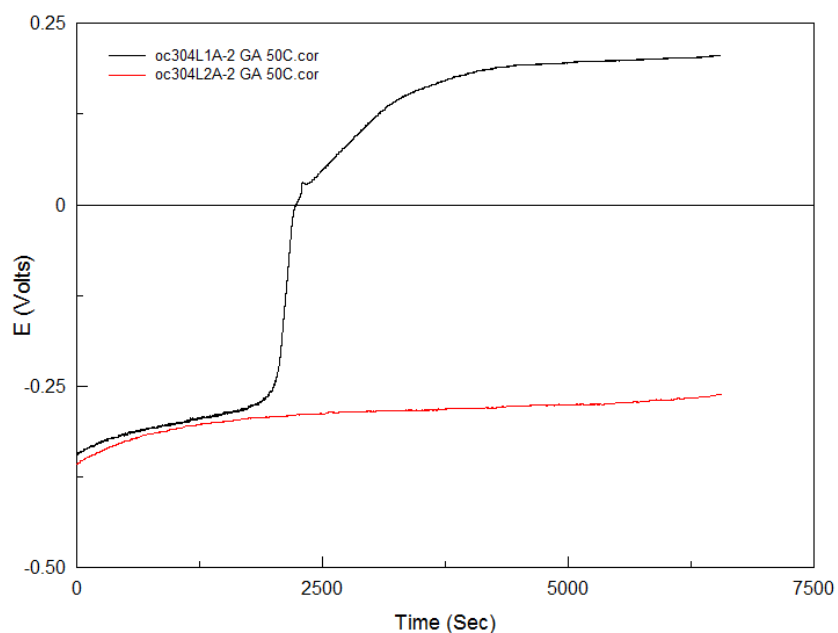
Figure 3-2 OCP versus time scans of 304L in 70% glycolic acid at 50 °C

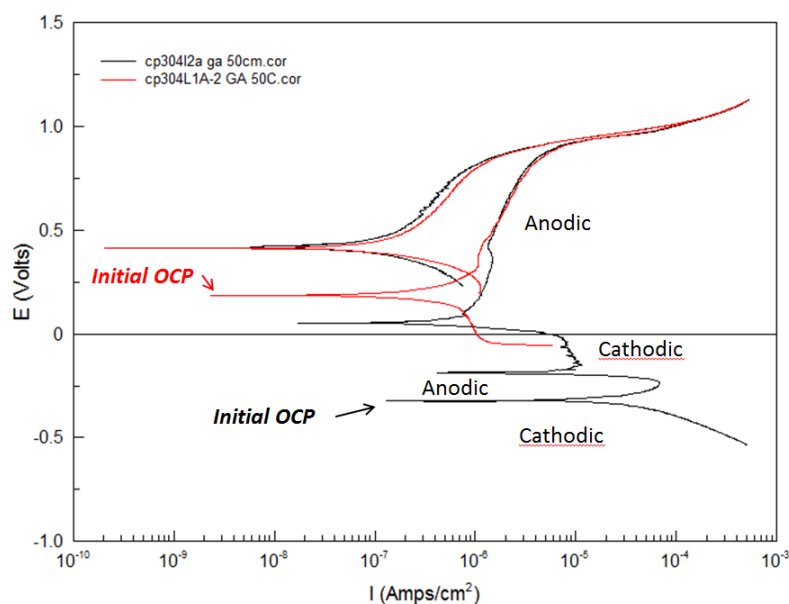
Figure 3-3 CPP scans of 304L in 70% glycolic acid at 50 °C with two different starting OCPs

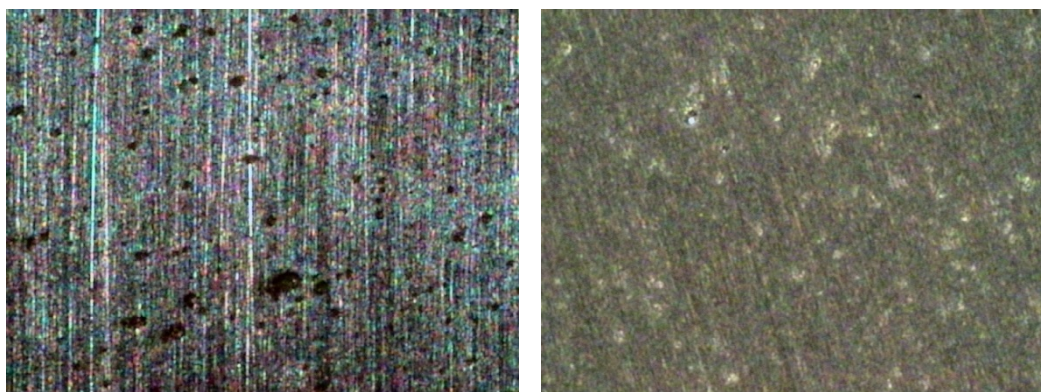
Figure 3-4 Stereomicroscope images for 304L samples taken after electrochemical testing in 70% glycolic acid at 50 °C: (A) 304L1A-2; and (B) 304L2A (CPP scans shown in Figure 3-3)

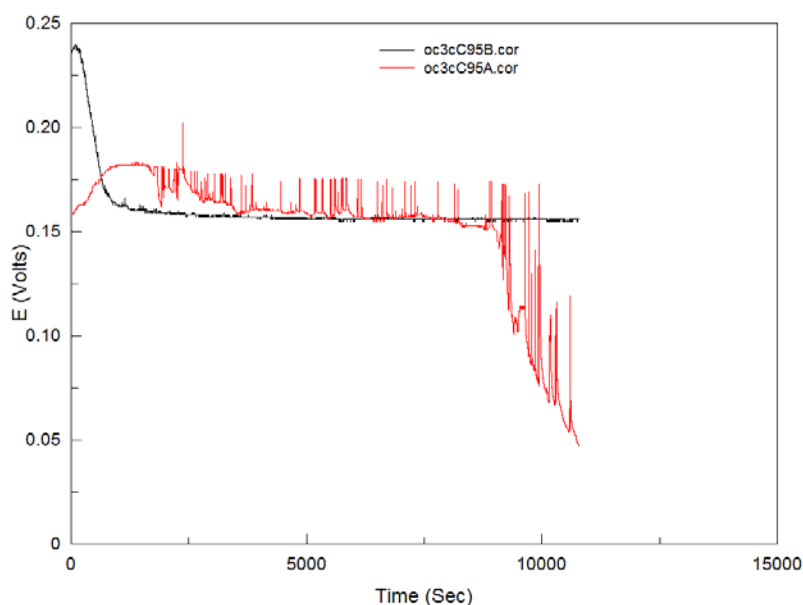
Figure 3-5 OCP monitoring of C276 in SRAT/SME supernate with sodium glycolate and high levels of iron and aggressive species at 95 °C

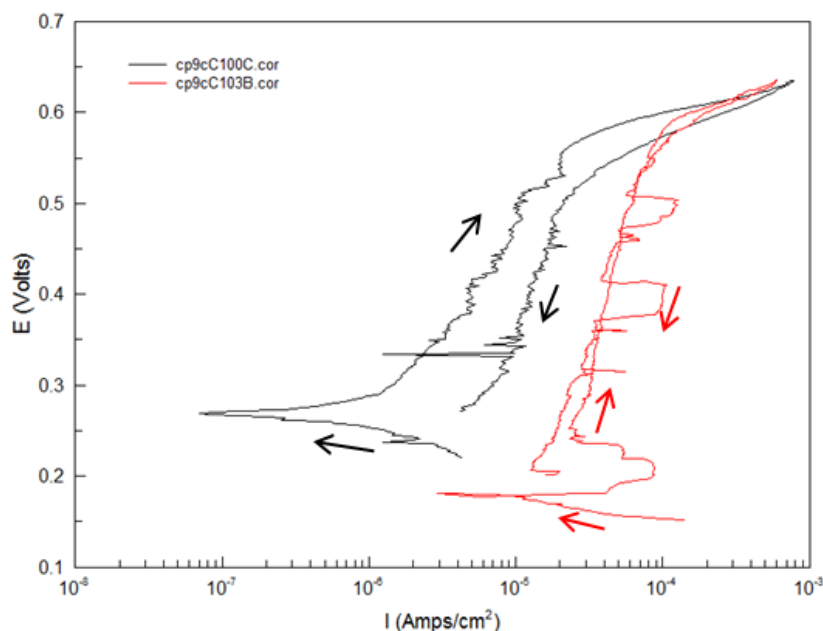
Figure 3-6 CPP scans of C276 in SRAT/SME supernate without sodium glycolate and with high levels of iron and aggressive species at 99 °C (arrows indicate direction of potential scan)

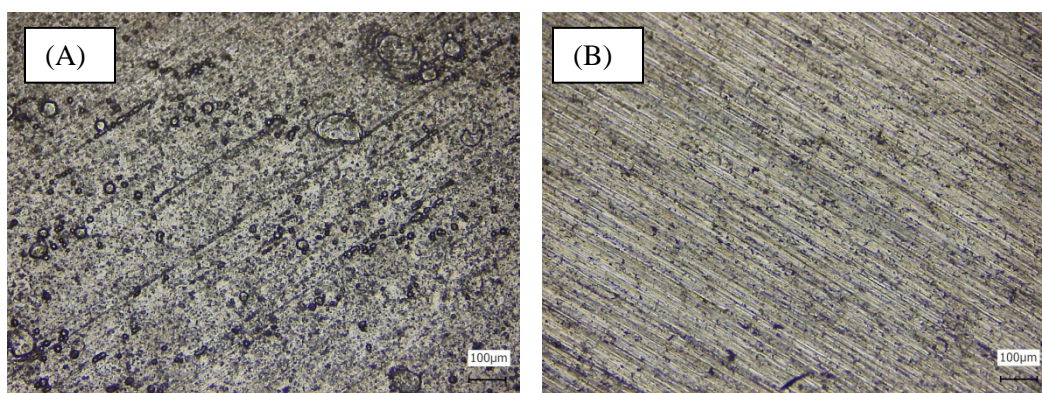
Figure 3-7 Post-test photographs of C276 in Category 2 solutions: (A) with sodium glycolate and low level of aggressive species (condition a); and (B) without sodium glycolate and low levels of iron and high levels of aggressive species (condition b)

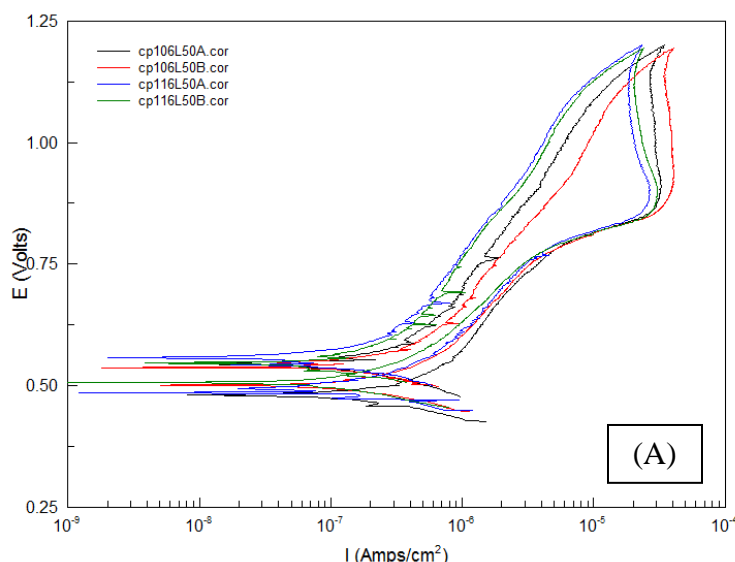
Figure 3-10 CPP scans for 316L (A) and 304L (B) in SRAT/SME condensate with (green and blue curves) and without (red and black curves) sodium glycolate at 50 °C

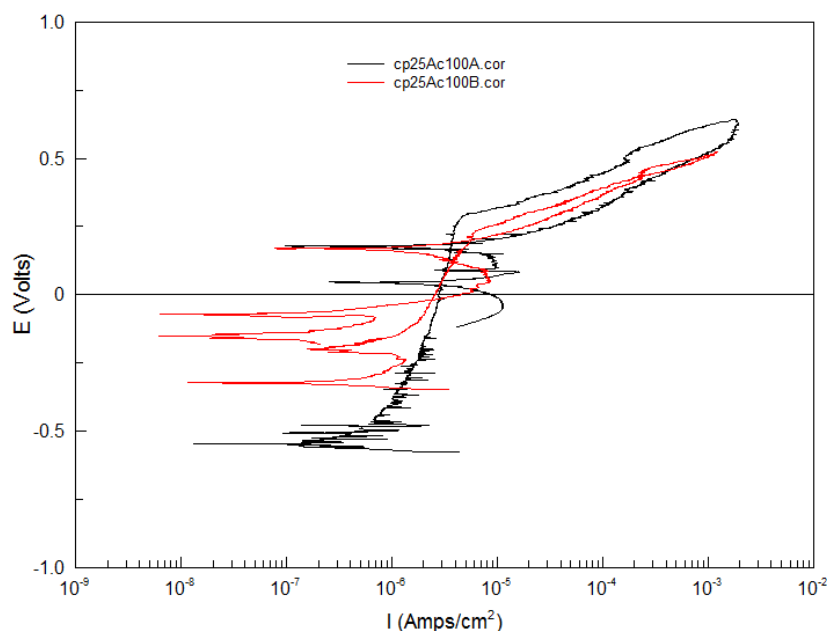
Figure 3-11 CPP scans for AllCorr in the DWPF recycle solution at pH 8.1 with 10 g/L sodium glycolate at 100 °C

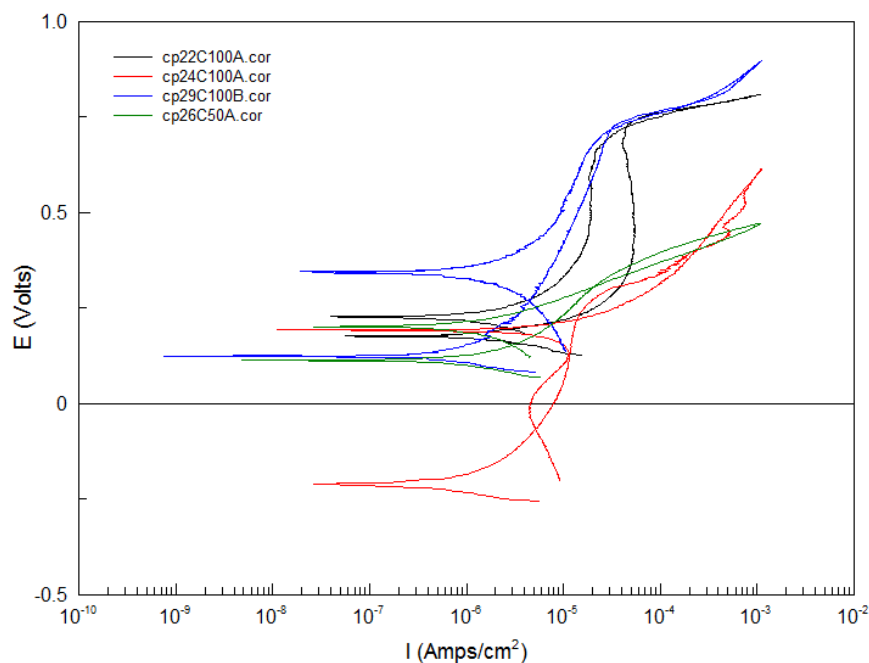
Figure 3-13 CPP scans for C276 in the pH 1.5 DWPF recycle solution with (10 g/L, cp22C100A) and without (CP29C100B) the glycolate anion, the pH 8 solution with glycolate (10 g/L, cp24C100A) at 100 °C, and the pH 12.4 solution at 50 °C with glycolate (10 g/L, cp26C50A)

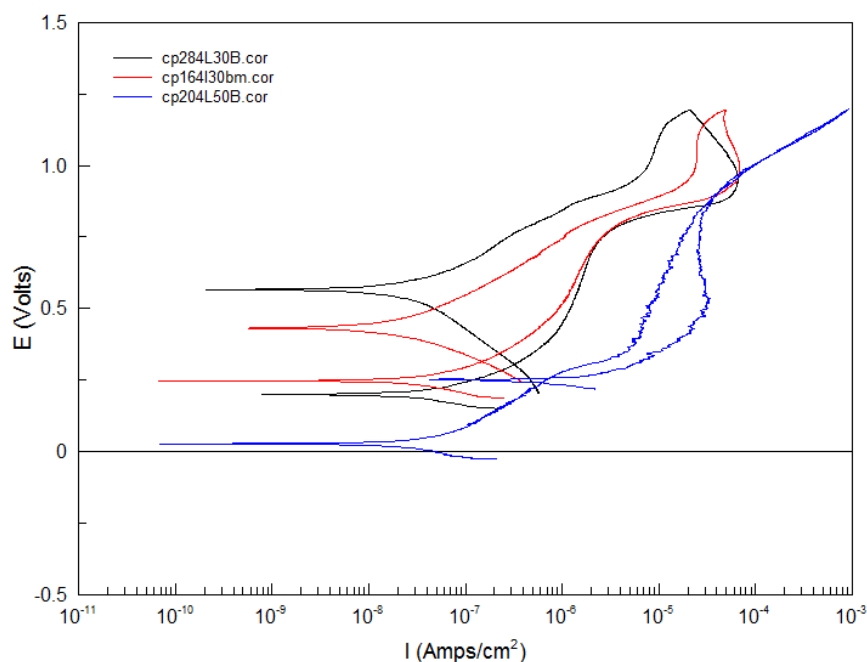
Figure 3-14 CPP scans for 304L in the pH 1.5 DWPF recycle solution with (10 g/L, cp164L30bm) and without (cp284L30B) the glycolate anion and the pH 8 solution with glycolate (10 g/L, cp204L50B) at 50 °C

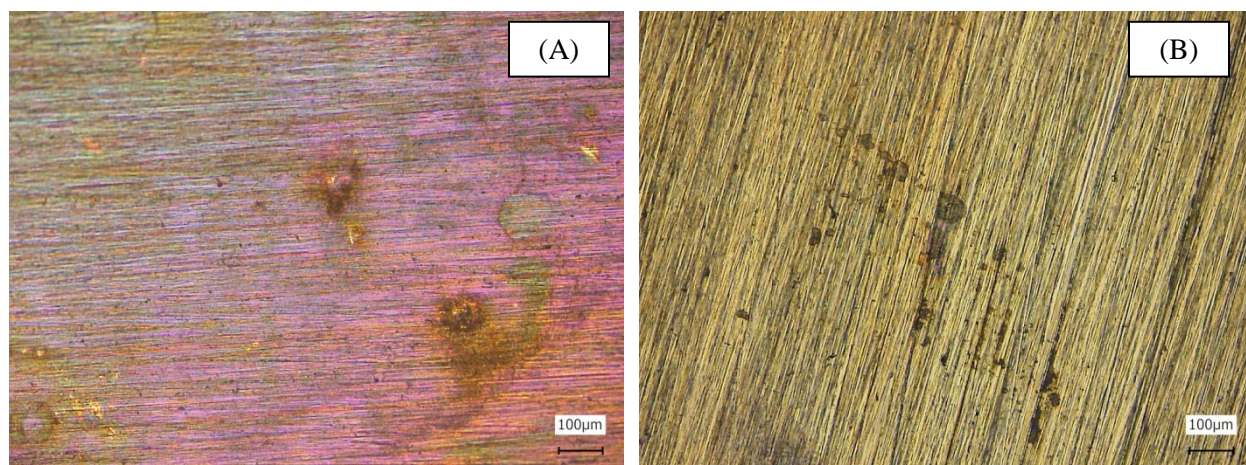
Figure 3-15 Photographs of two 304L samples tested in the pH 7.7 DWPF recycle solution with 10 g/L sodium glycolate at 30 °C: (A) 204L30A and (B) 204L30B

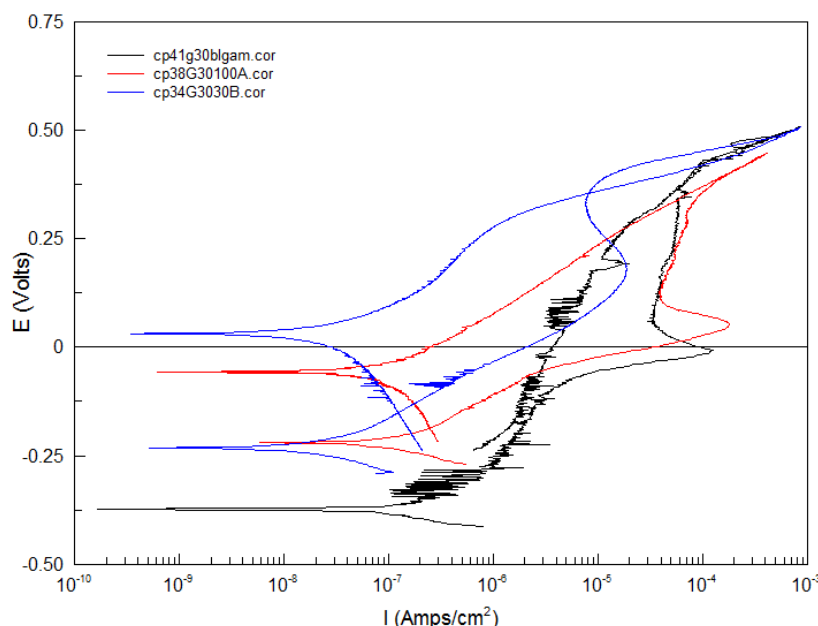
Figure 3-16 CPP scans for G30 in the basic recycle solutions with (10 g/L, cp38G30100A) and without (cp41G30blgam) the glycolate anion at 100 °C and at 30 °C with glycolate (10 g/L, cp34G3030B)

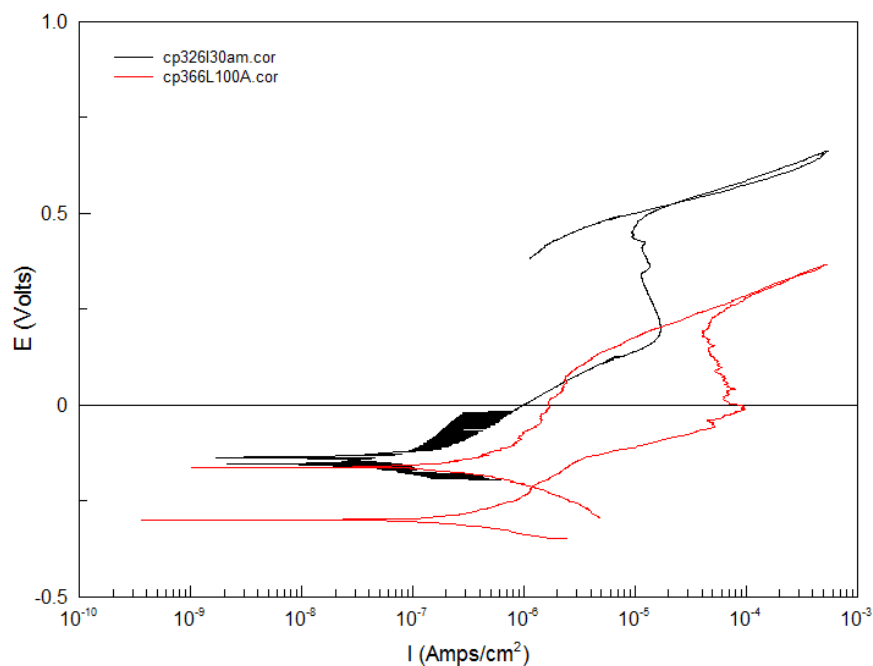
Figure 3-17 CPP scans for 316L in the basic recycle solutions with 10 g/L sodium glycolate at 30 °C (cp326L30am) and at 100 °C (cp366L100A)

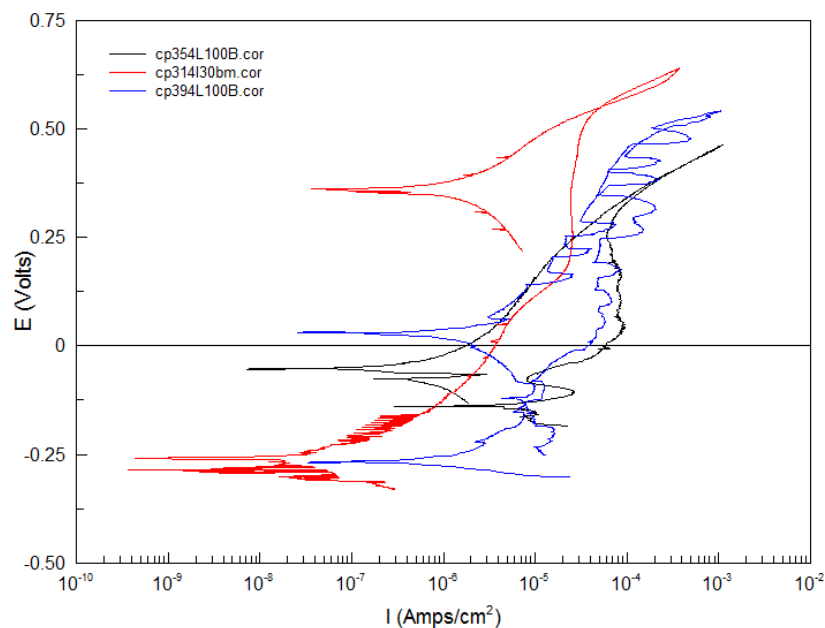
Figure 3-18 CPP scans for 304L in the basic recycle solutions with (10 g/L, cp354L100B) and without (cp394L100B) the glycolate anion at 100 °C and at 30 °C with glycolate (10 g/L, cp314L30bm)

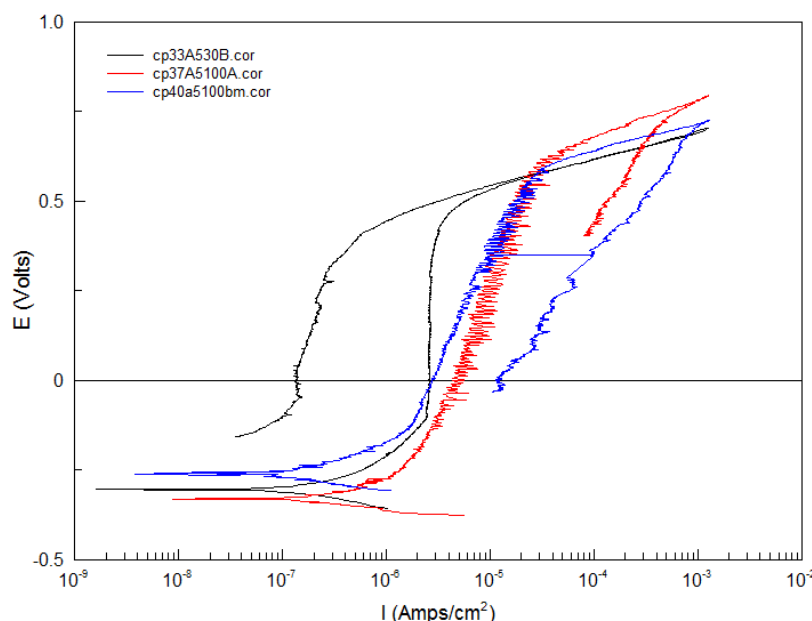
Figure 3-19 CPP scans for A537 in the basic recycle solutions with (10 g/L, cp37A5100A) and without (cp40A5100bm) the glycolate anion at 100 °C and at 30 °C with glycolate (10 g/L, cp33A530B)

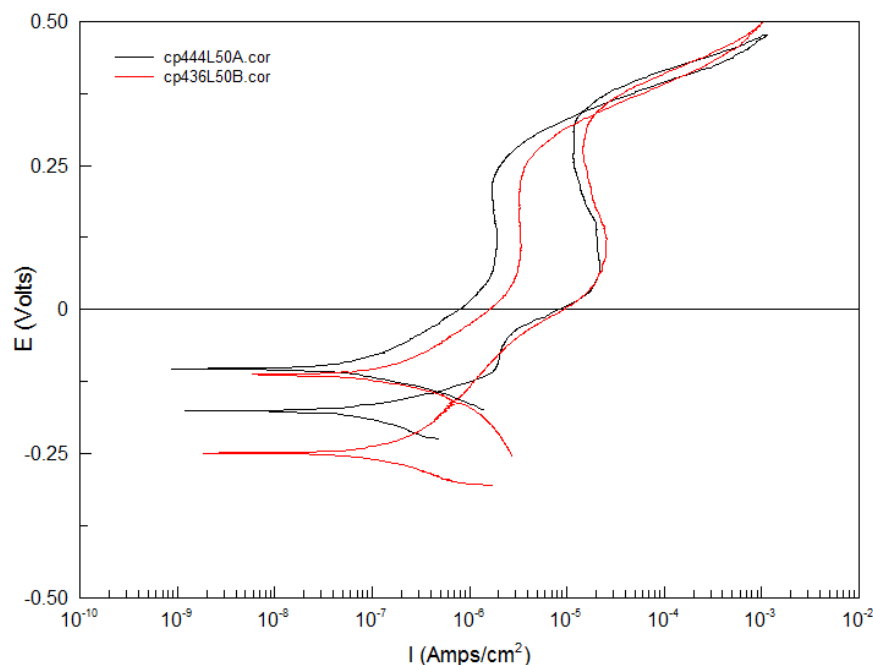
Figure 3-20 CPP scans for 304L (cp444L50A) and 316L (cp436L50B) in the salt processing solutions with 10 g/L sodium glycolate at 50 °C

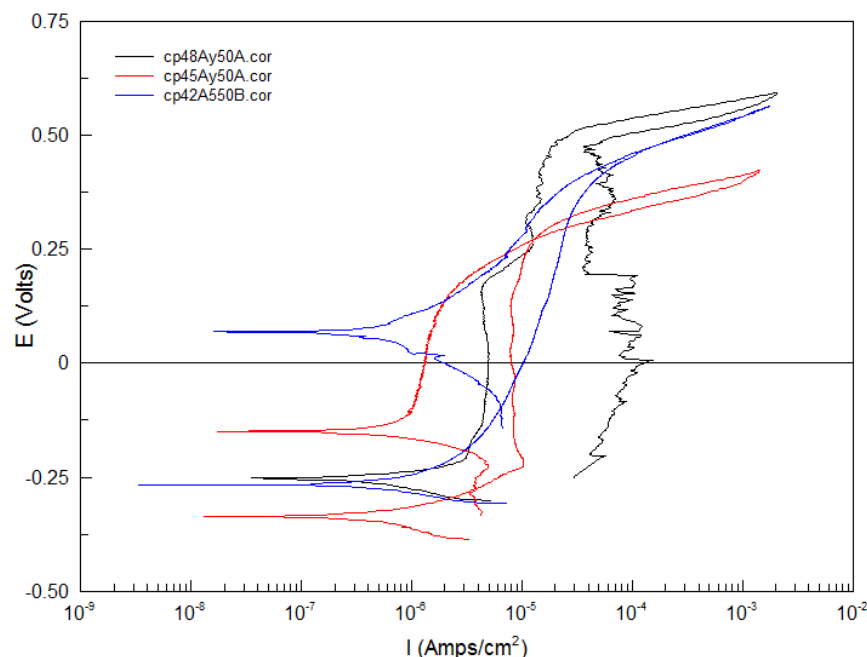
Figure 3-21 CPP scans for A537 (cp42A550B) and Astralloy (cp45Ay50A) in the salt processing solutions with 10 g/L sodium glycolate and Astralloy (cp48Ay50A) with no glycolate anion at 50 °C

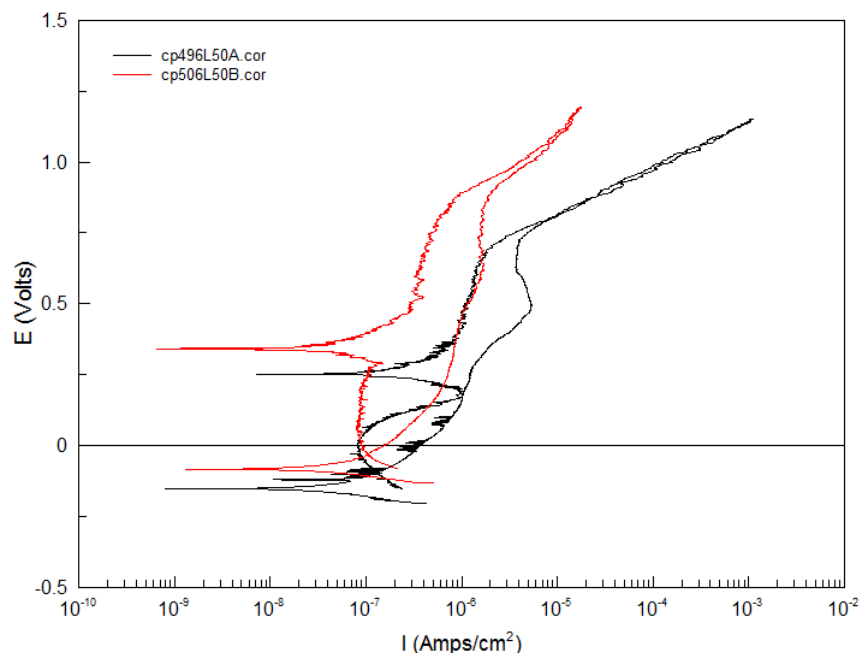
Figure 3-22 CPP scans for 316L in 10 mM boric acid with (cp496L50A) and without (cp506L50B) 10 g/L sodium glycolate at 50 °C

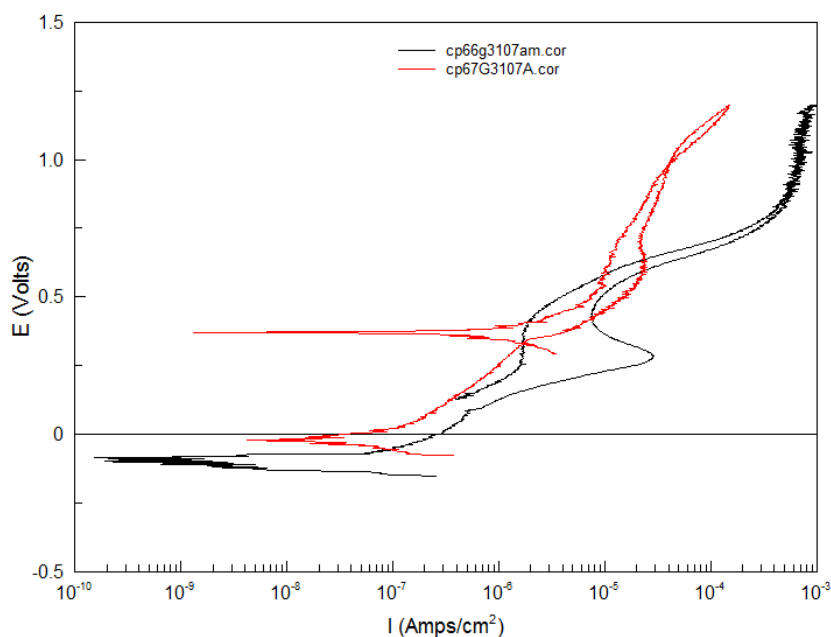
Figure 3-23 CPP scans for G3 in a dilute waste chemistry with (cp66G3107A) and without (cp67G3107A) 0.033 g/L sodium glycolate at 107 °C

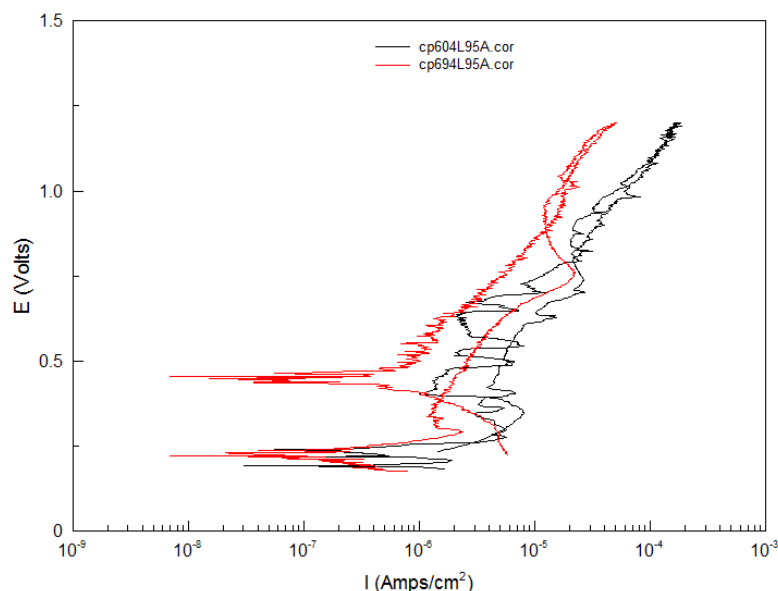
Figure 3-24 CPP scans for 304L in a dilute waste chemistry with (cp604L95A) and without (cp694L95A) 0.033 g/L sodium glycolate at a pH 3 and 107 °C

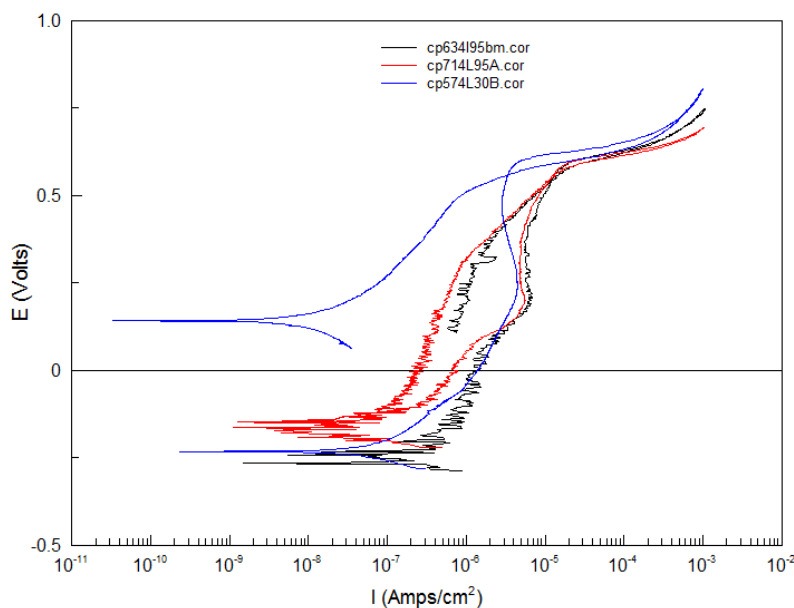
Figure 3-25 CPP scans for 304L in a dilute, pH 12 waste chemistry with (cp634L95B) and without (cp714L95A) 0.033 g/L sodium glycolate at 95 °C and with (cp574L30B) 0.033 g/L sodium glycolate at 30 °C

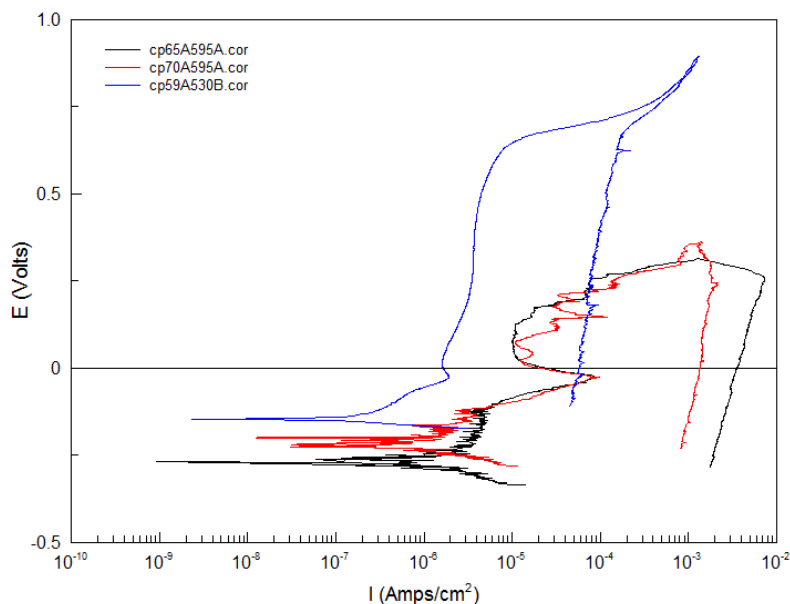
Figure 3-26 CPP scans for A537 in a dilute, pH 12 waste chemistry with (cp65A595A) and without (cp70A595A) 0.033 g/L sodium glycolate at 95 °C and with (cp59A530A and B) 0.033 g/L sodium glycolate at 30 °C

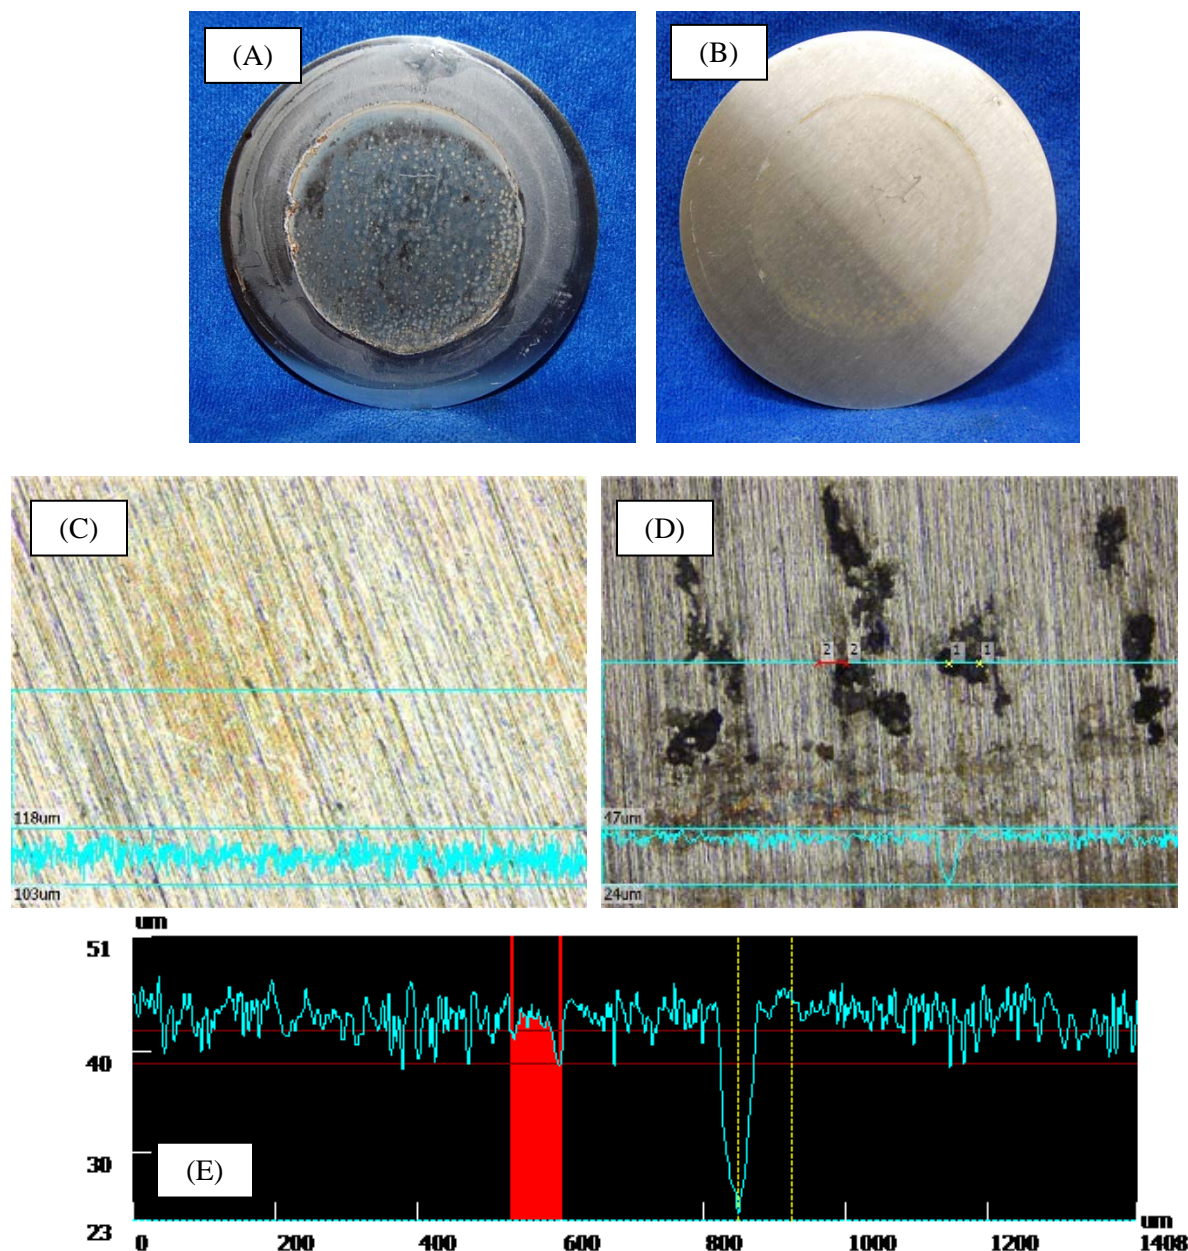
Figure 3-29 G3 hot-wall sample after 27 days exposed to a dilute waste chemistry: (A) 35-mm photograph before cleaning; (B) 35-mm photograph after cleaning; (C) LCM laser image of surface at sample center; (D) LCM laser image of surface near gasket; (E); LCM height scan showing pit depths under gasket

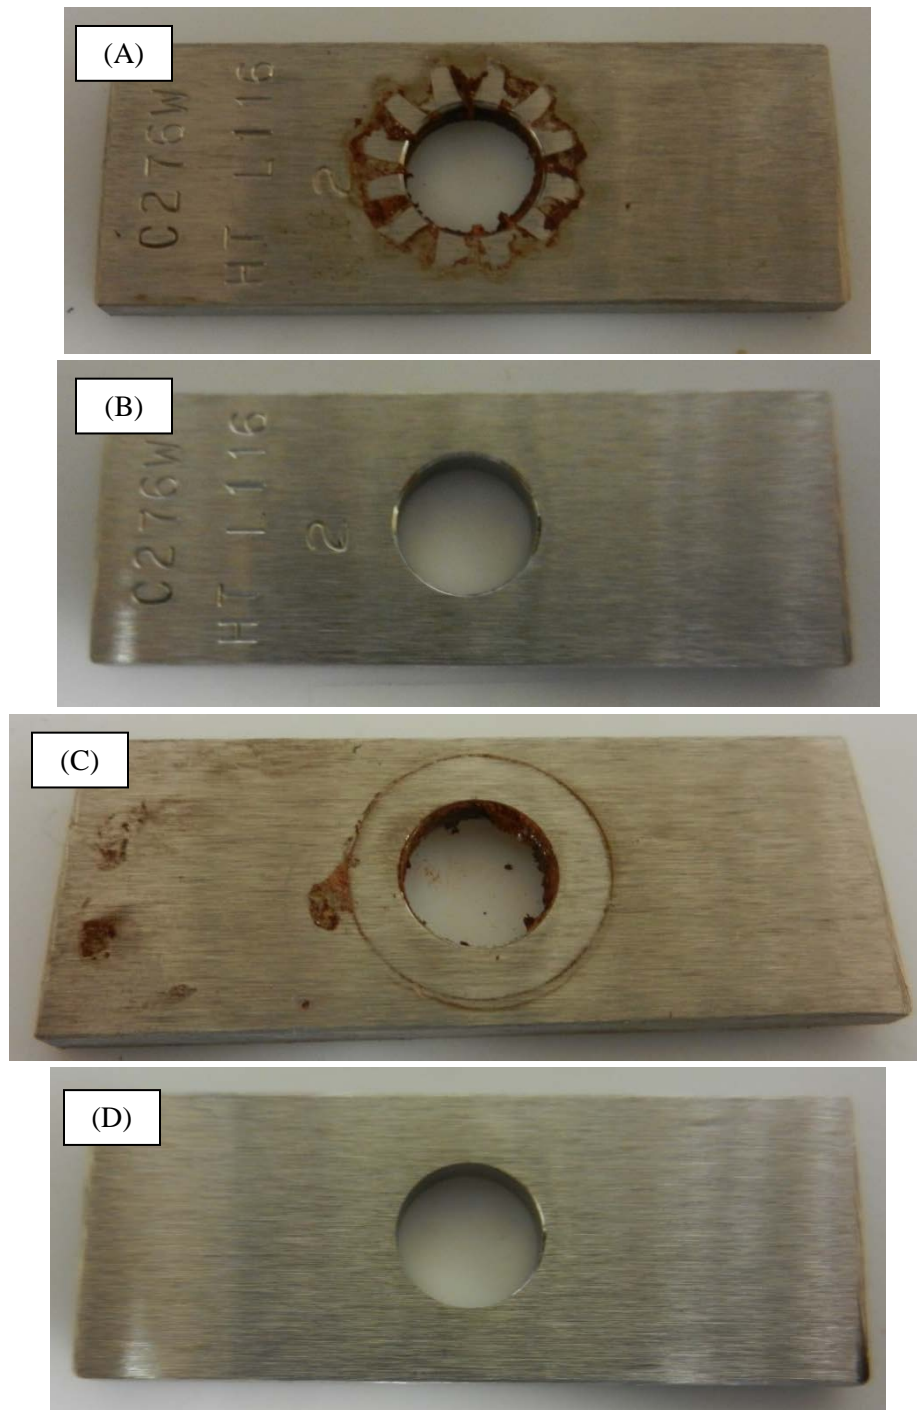
Figure 3-31 Photographs (35-mm) of C276 coupon #2 after exposure during the 22-L CPC testing (A) front before cleaning; (B) front after cleaning; (C) back before cleaning; and (D) back after cleaning

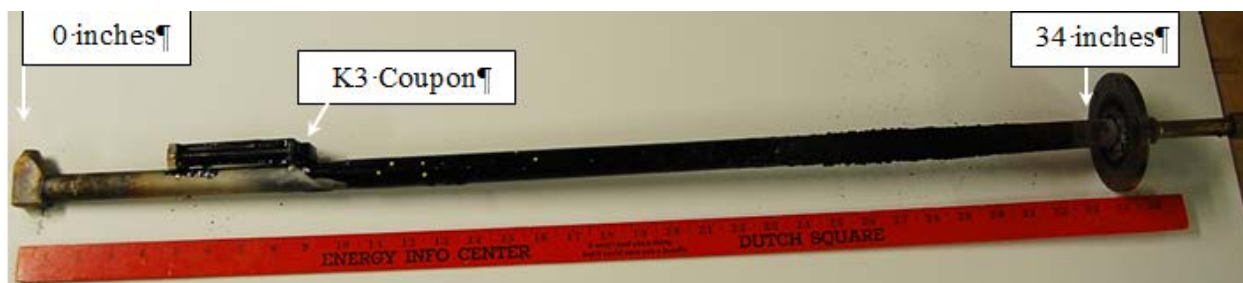
Figure 4-1 Glass-coated I690 bubbler in post-test condition showing location of refractory K-3 coupon

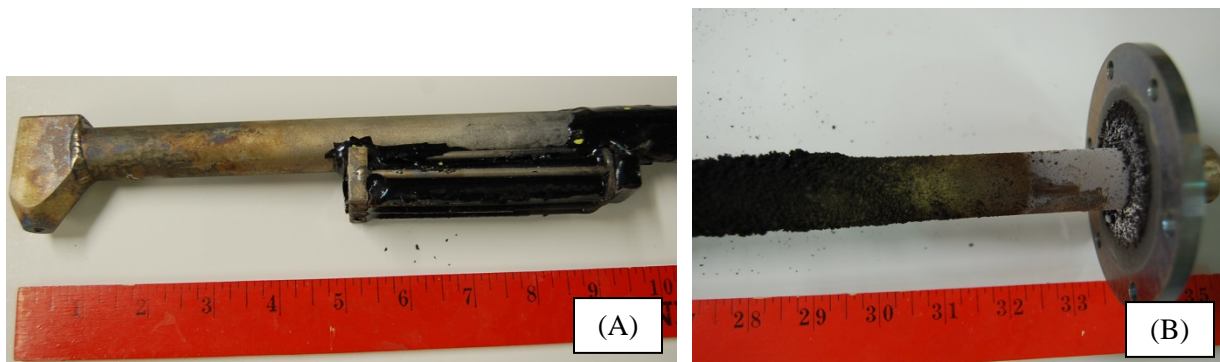
Figure 4-2 Glass-coated I690 bubbler in post-test condition: (A) glass-coated K-3 refractory coupon in I690 holder and (B) flange and bubbler tube in the vapor space region

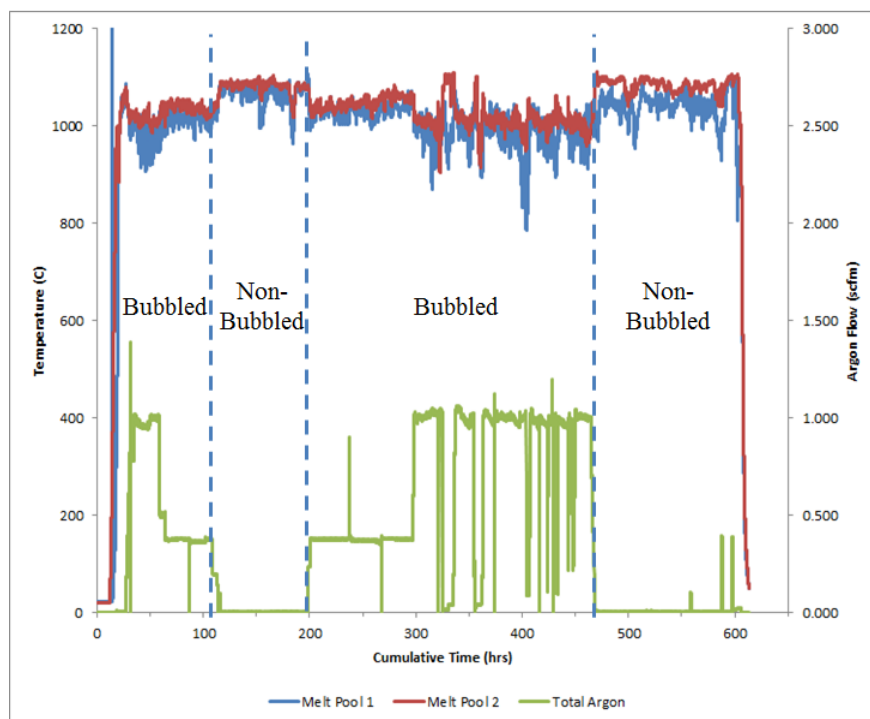
Figure 4-3 CEF temperature profile and argon flow rate during the 25 day CEF glycolic acid flowsheet campaign

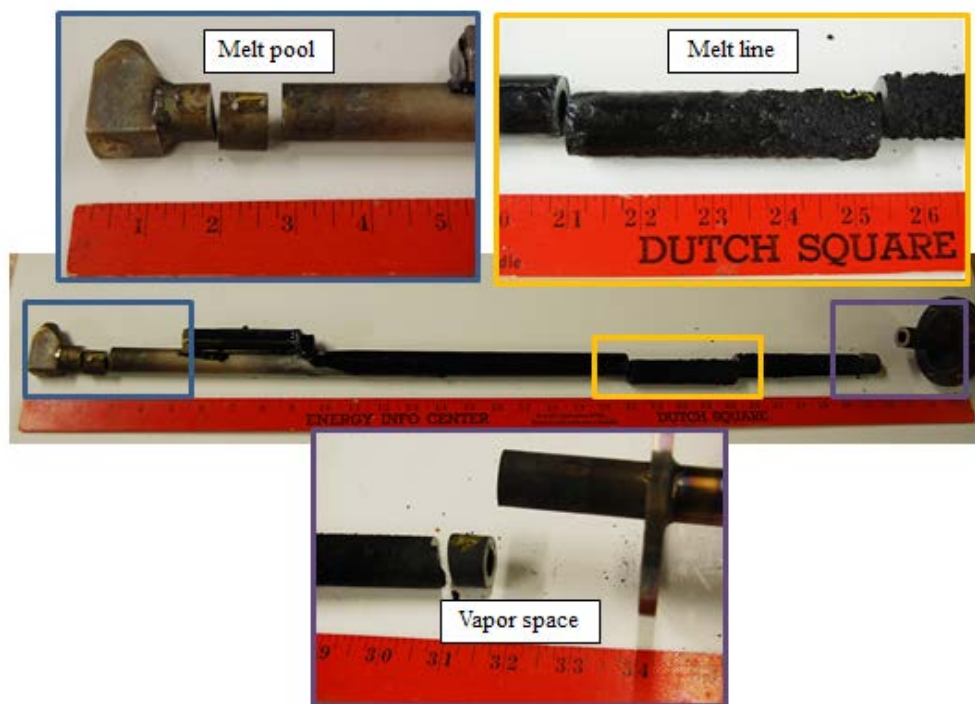
Figure 4-4 Photographs showing final sectioning of the 690 bubbler for the samples taken from the melt pool, melt line and vapor space regions

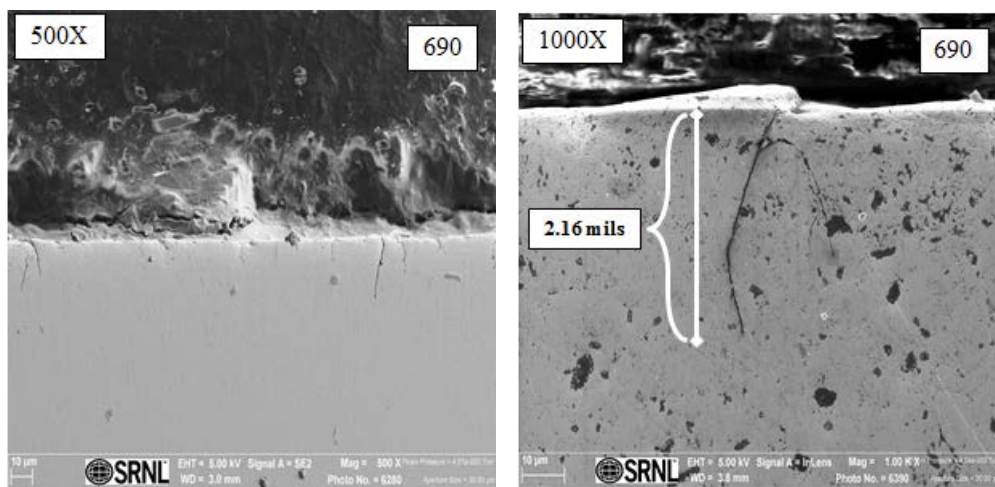
Figure 4-5 SEM images of the inner diameter surface of an as-received, unexposed section of I690 pipe where shallow cracks, approximately 2 mils deep, are visible below the deformed metal which appears to be a lap

Cracks observed on the interior of the as-received pipe and the CEF bubbler originated from the fabrication process. Although the surface defects were shallow, they reduce the effective wall thickness and can act as stress concentrators. The presence of these cracks did not affect the results of this test but their presence in actual DWPF melter bubblers could limit their service lives.

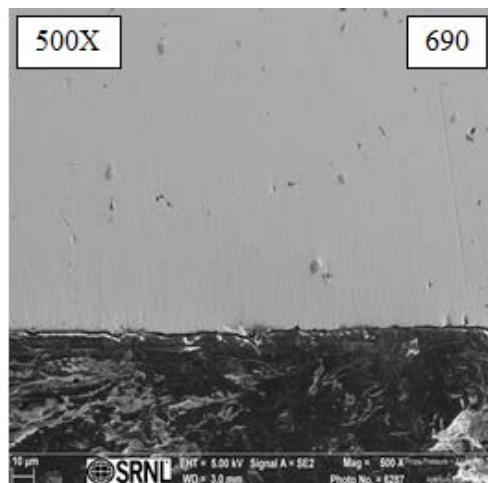
Figure 4-6 Secondary electron image of the outer diameter surface of an as-received, unexposed section of I690 pipe, where no cracking visible on surface

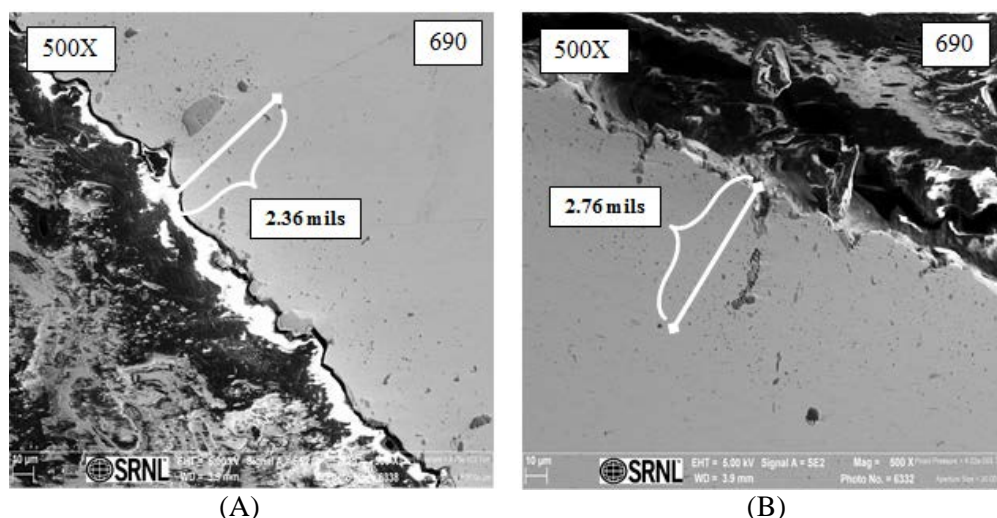
Figure 4-7 Secondary electron images of the outer (A) and inner (B) diameter surfaces of the melt pool regions (White bars indicate the average depth of internal attack)

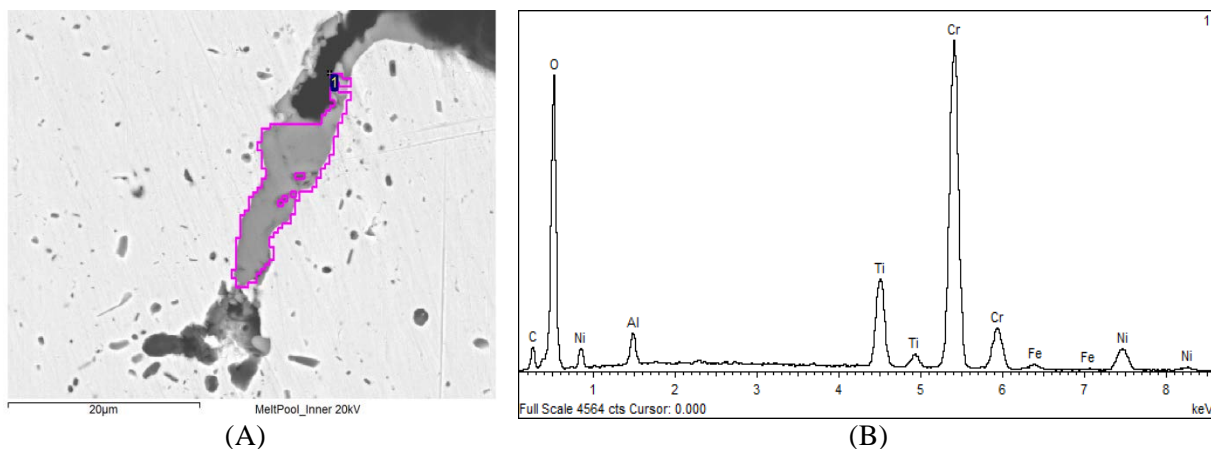
Figure 4-8 Crack on inner surface of the melt pool sample: (A) Secondary electron image and (B) EDS spectrum showing chromium oxide inside the crack

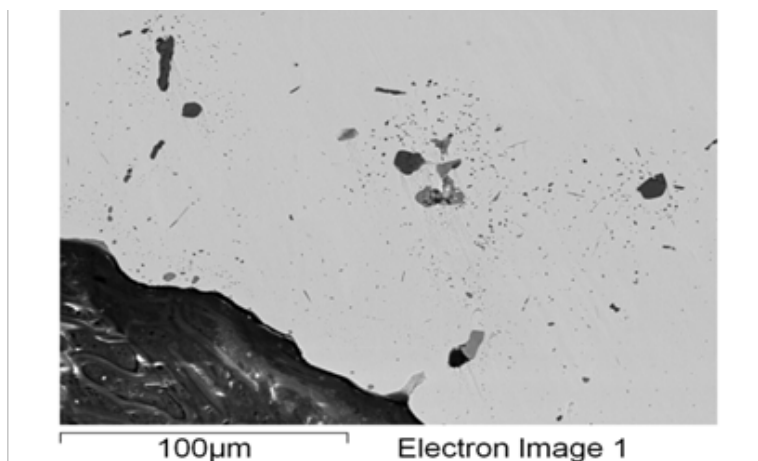
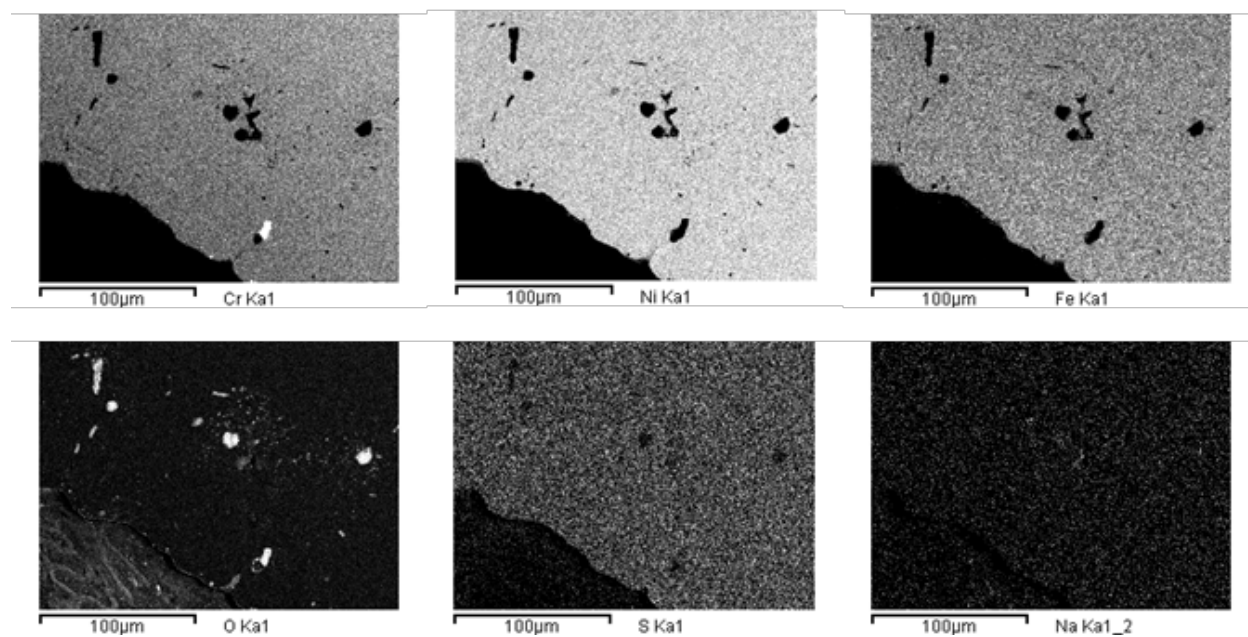
Figure 4-9 Secondary electron and dot map images for various elements from the melt pool outer surface. Note the diffusion of sulfur and oxygen into the metal lattice
