Corrosion Impact of Alternate Reductant on DWPF and Downstream Facilities

SRNL-STI-2014-00281, Revision 0

Keywords: *Glycolic acid, DWPF, steels, high-nickel alloys, corrosion*

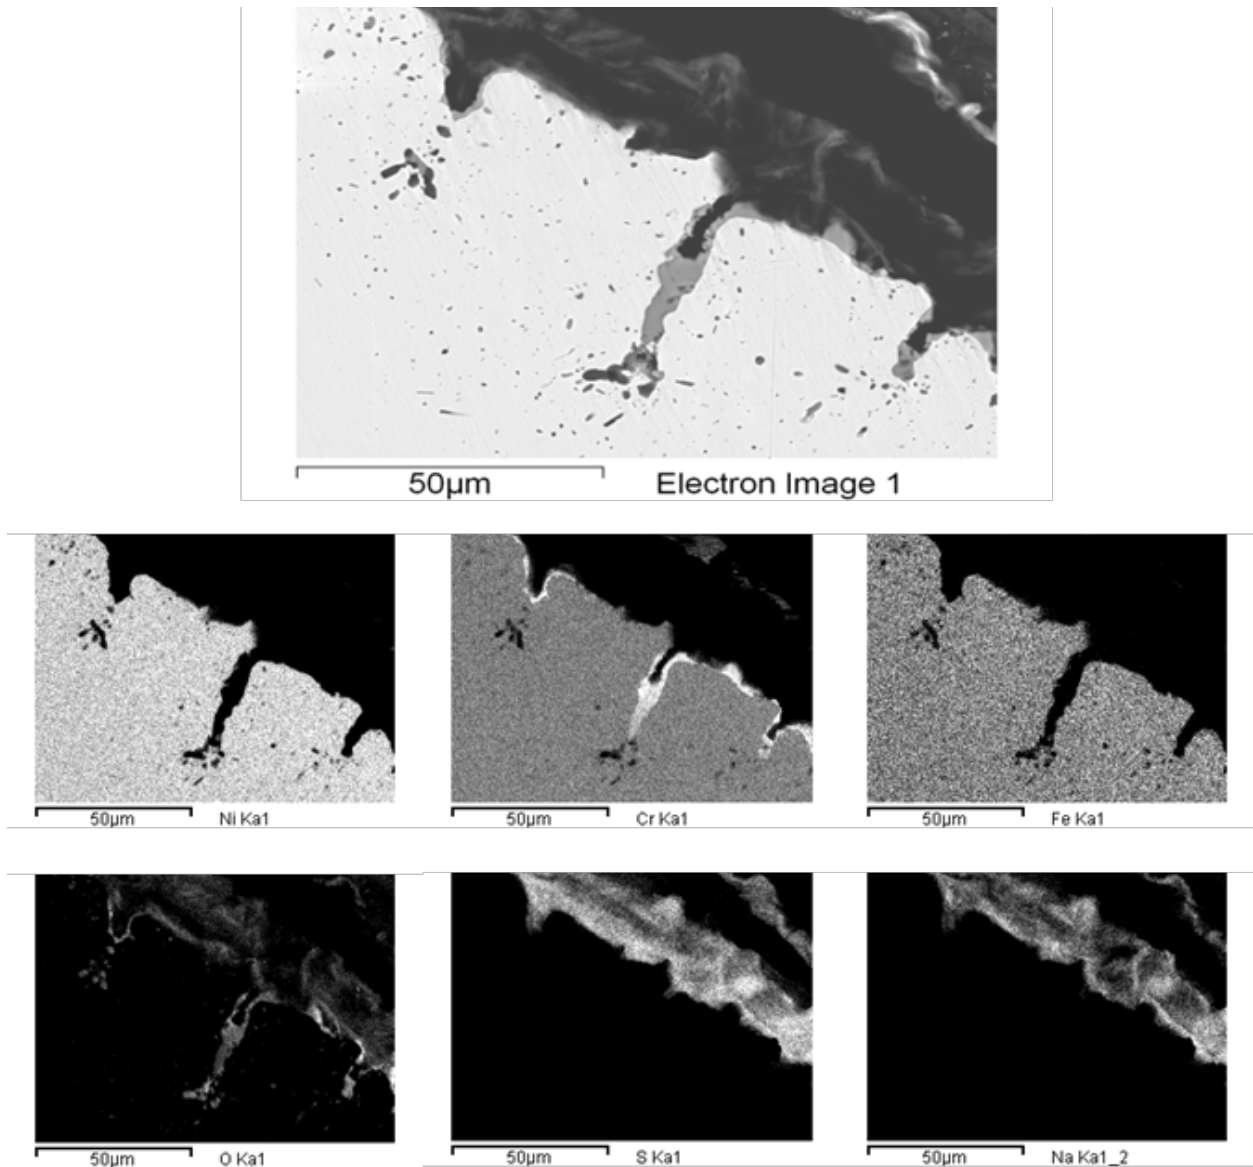
Figure 4-10 Secondary electron and dot map images for various elements from the melt pool inner diameter surface. Note the diffusion oxygen into the cracks and metal lattice. Sulfur is just present on the surface. Only a small amount of oxygen had diffused into the metal matrix (see arrow)

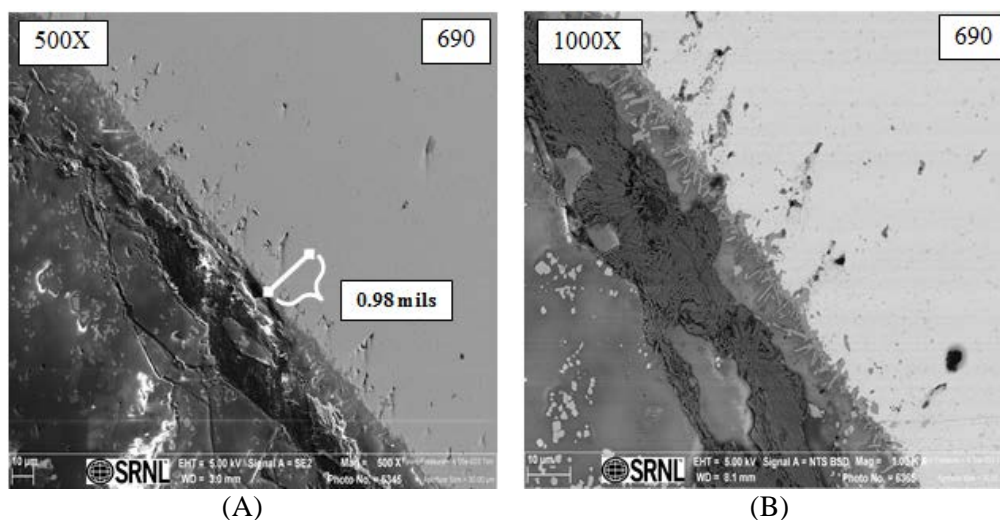
Figure 4-11 Secondary electron (A) and backscattered images (B) of the outer diameter from the melt line region. Rods visible along the metal surface shown in the BS image contain sulfur

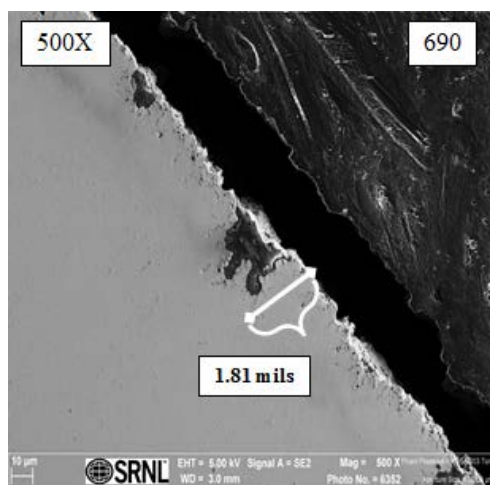
Figure 4-12 SEM secondary electron image showing cracks on the melt line inner diameter surface

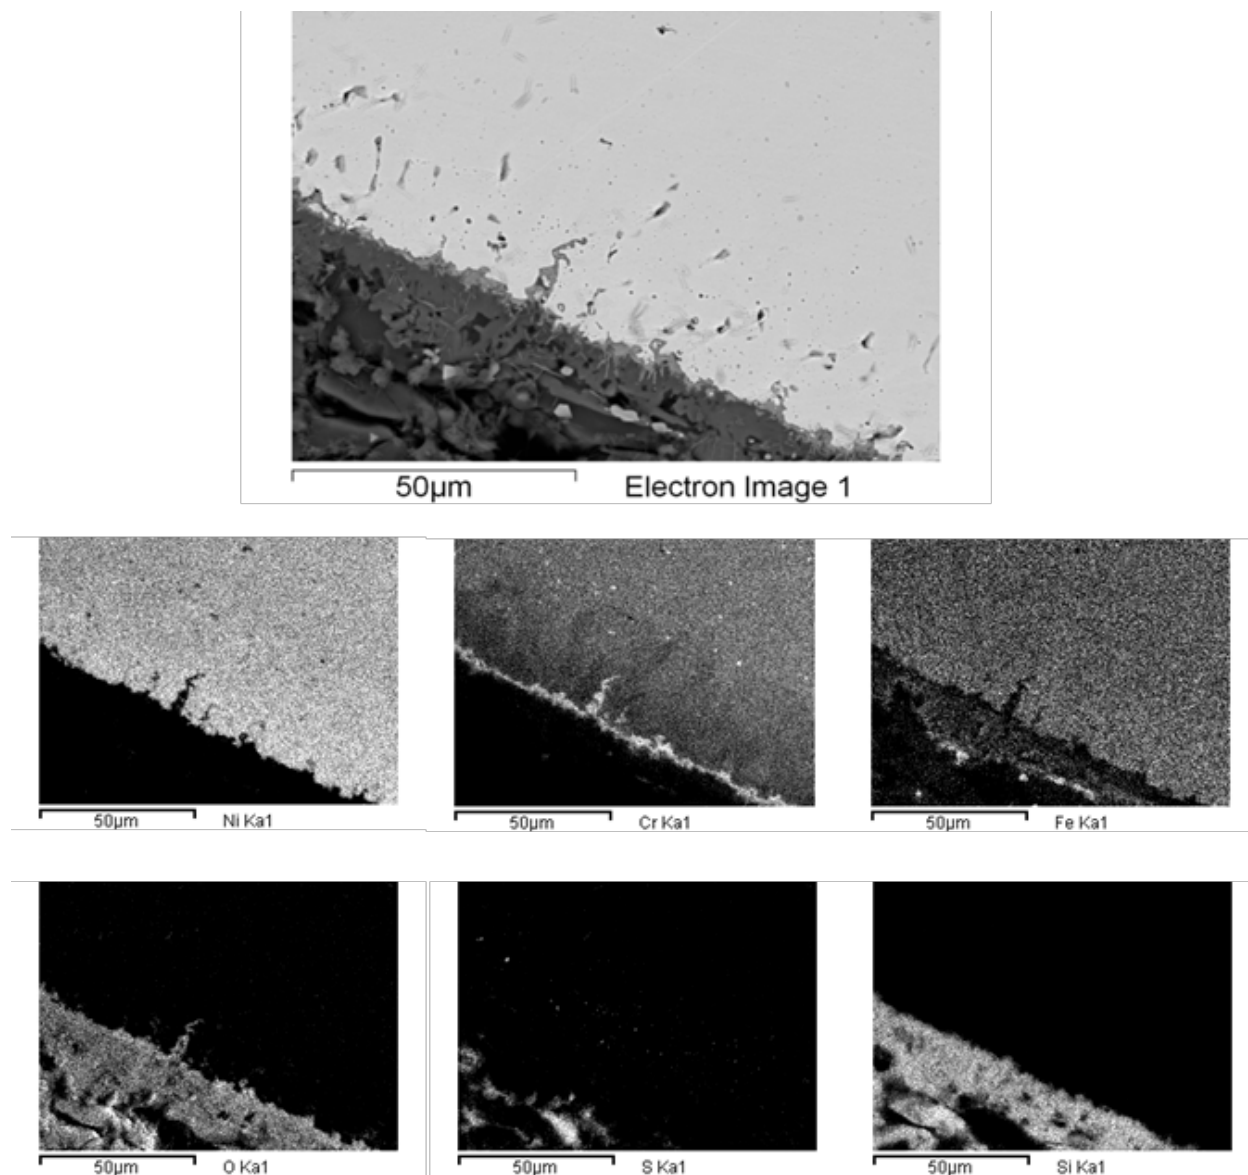
Figure 4-13 Secondary electron and dot map images for various elements from the melt line outer surface. Chromium oxide is evident at the metal/glass interface. Sulfur is also present in the glass but small regions are found in the metal matrix (see arrow). Chromium depletion is evident as shown by slightly darker region at the near-surface region (see arrow)

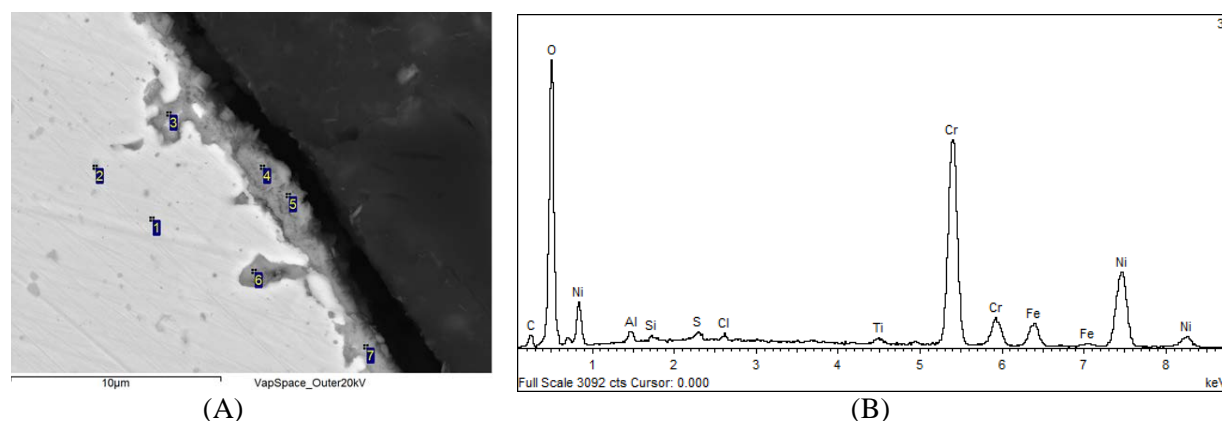
Figure 4-15 Cracks on outer surface from the vapor space region: (A) Secondary electron image and (B)EDS spectrum showing chromium oxide inside the crack (trace amounts of Cl and S were also observed)

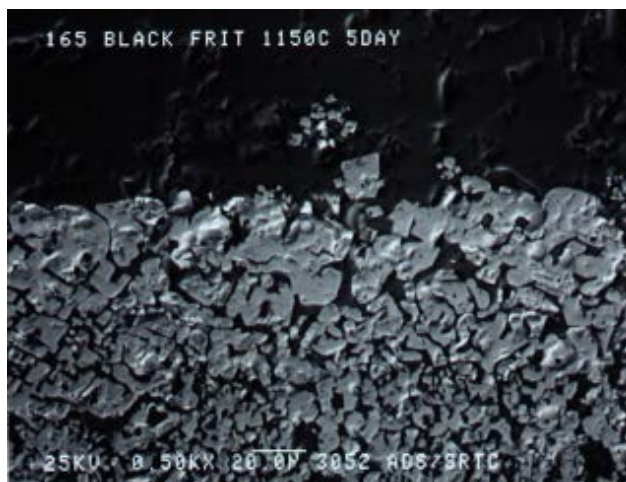
Figure 4-18 An enlarged SEM image of the outer corrosion layer (region #6 of Figure 4-17) of the K-3 refractory showing the breaking away of the Fe-Cr-Mn-Ni rich corrosion layer, which is an insoluble $\text{NiMn(Fe,Cr)}_2\text{O}_4$ rich spinel and may be adherent to the melter refractory wall or spall off and fall to the bottom of the melter creating bottom deposits

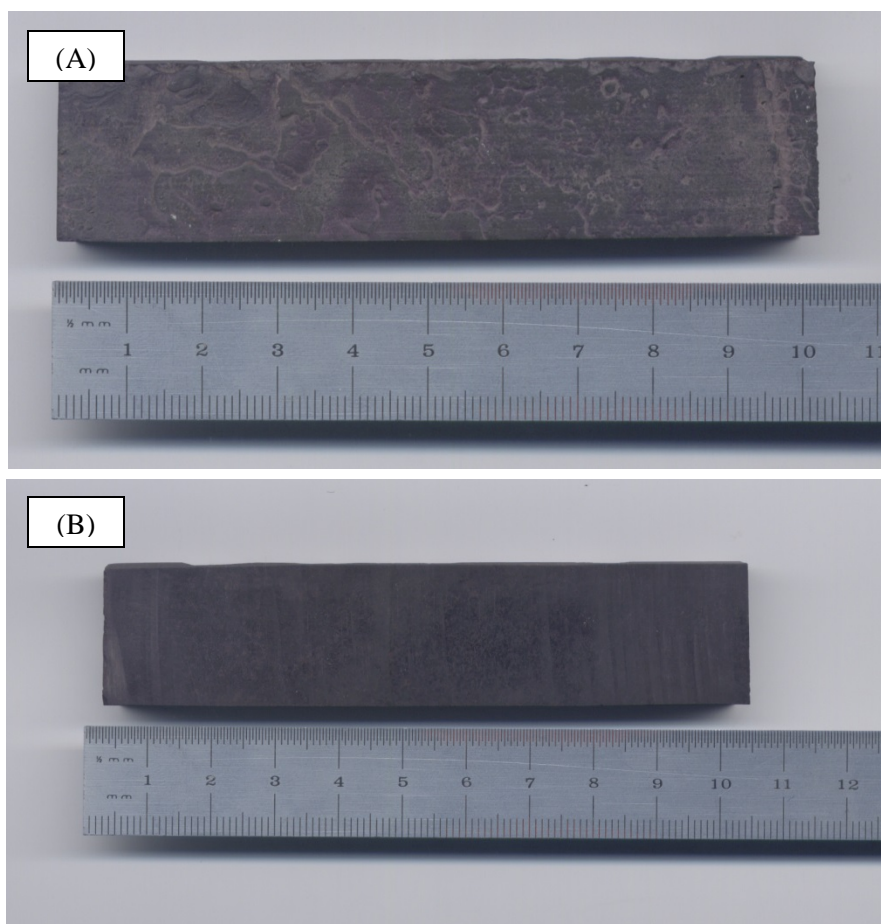
Figure 4-19 Hot wall side (A) of K-3 refractory brick versus the as cut side (B) of the refractory brick

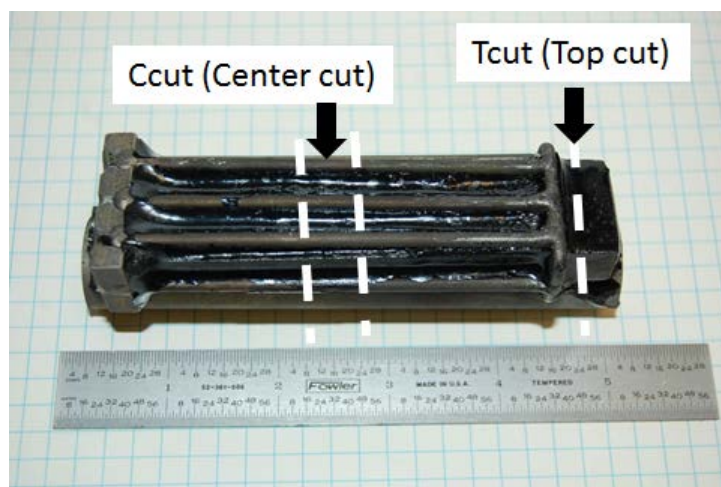
Figure 4-20 K-3 refractory in the I690 cage after removal from the CEF melter (Note the region that was sectioned for SEM analyses to maintain the glass-refractory contact zone)

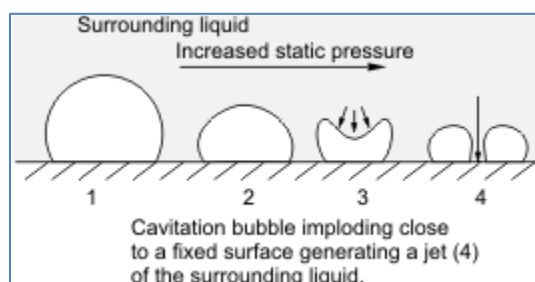
Figure 4-21 Mechanism by which cavitation bubbles implode close to a fixed surface

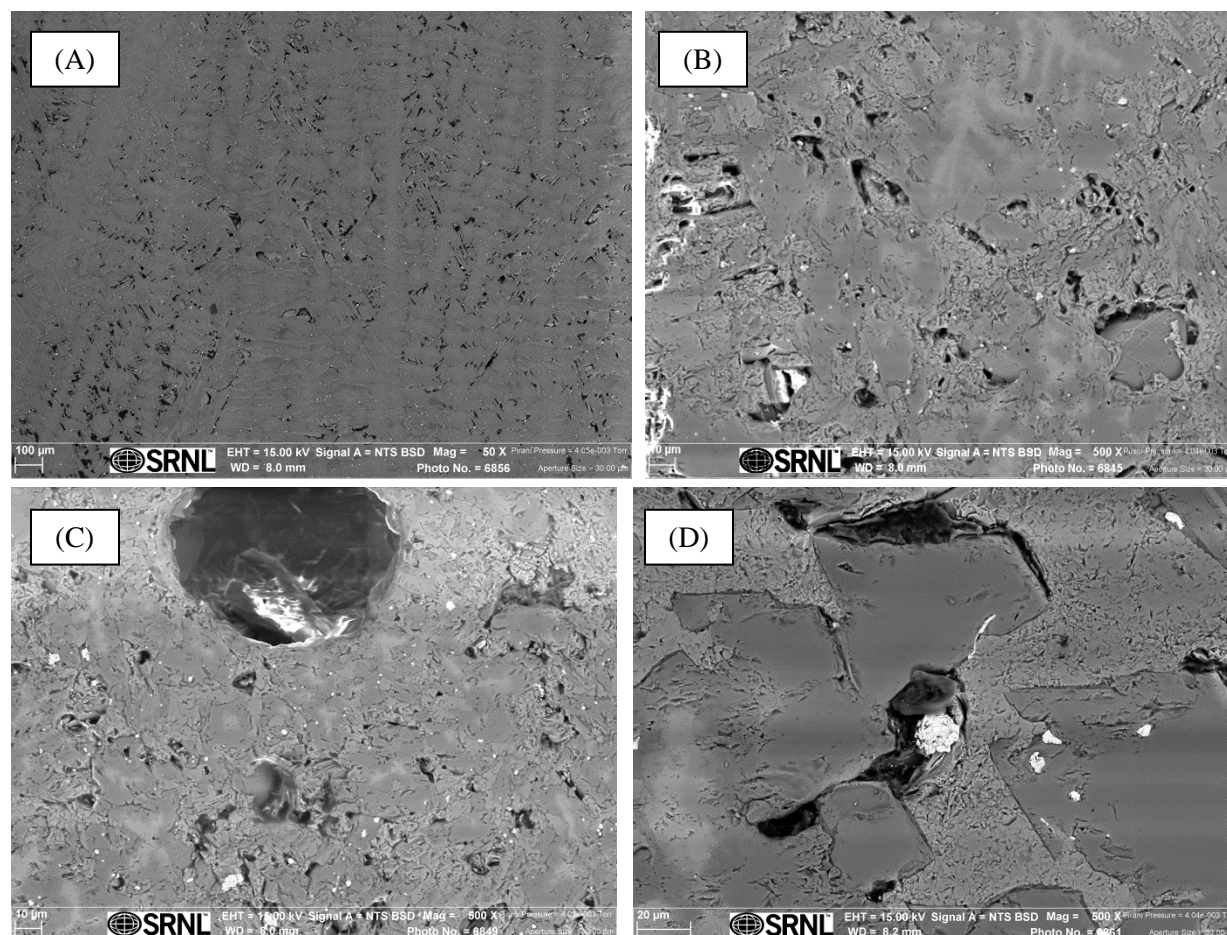
Figure 4-22 Open porosity of the K-3 refractory, as received, at different magnifications: (A) 50x; (B) 500x; (C) 500x; and (D) 500x (Note that in picture (D) the bright “spots” are Fe^0 which is used in refractory processing.)

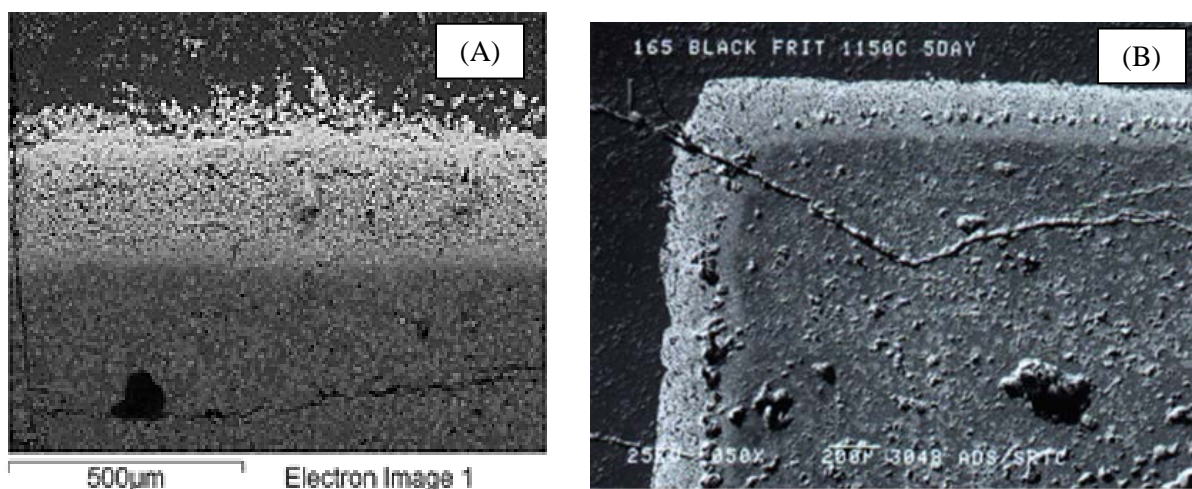
Figure 4-23 (A) SEM of the K-3 refractory corrosion coupon immersed in glass made from glycolic acid feed from frit 418 for 25 days at ~1150°C; (B) SEM of the K-3 refractory corrosion coupon immersed in glass composed of DWPF black frit glass 165 for 5 days at 1150°C (Note the thick corrosion layer which is composed of two layers separated by a row of circular bubble-like precipitates. The outer layer is more porous and is designated the corrosion or “average loss” layer. The inner layer is termed the penetration layer)

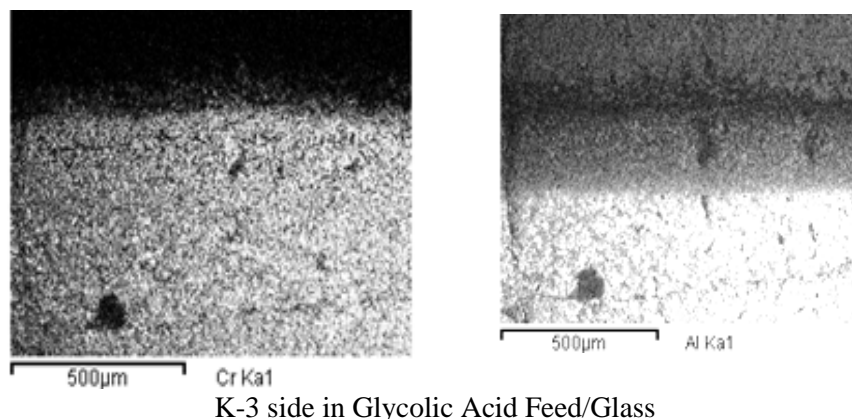
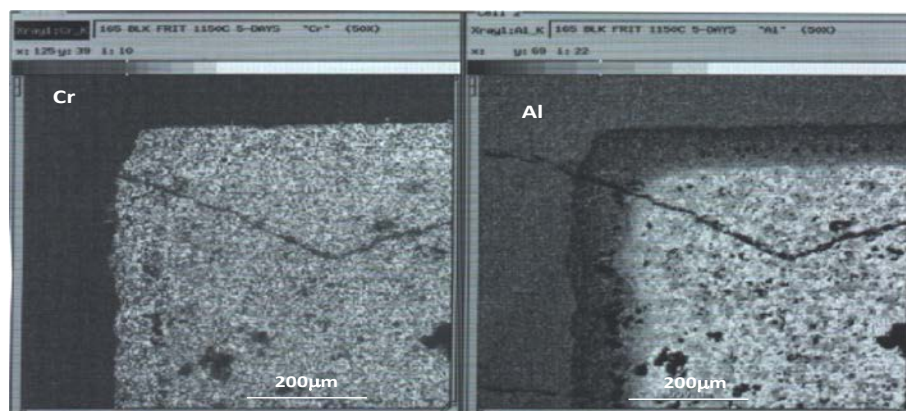
Figure 4-24 X-ray maps showing enrichment (brighter outer rim image) in Cr in the corrosion layer corresponding to Figure 4-23 and showing depletion (darker outer rim image) in Al in the corrosion layer

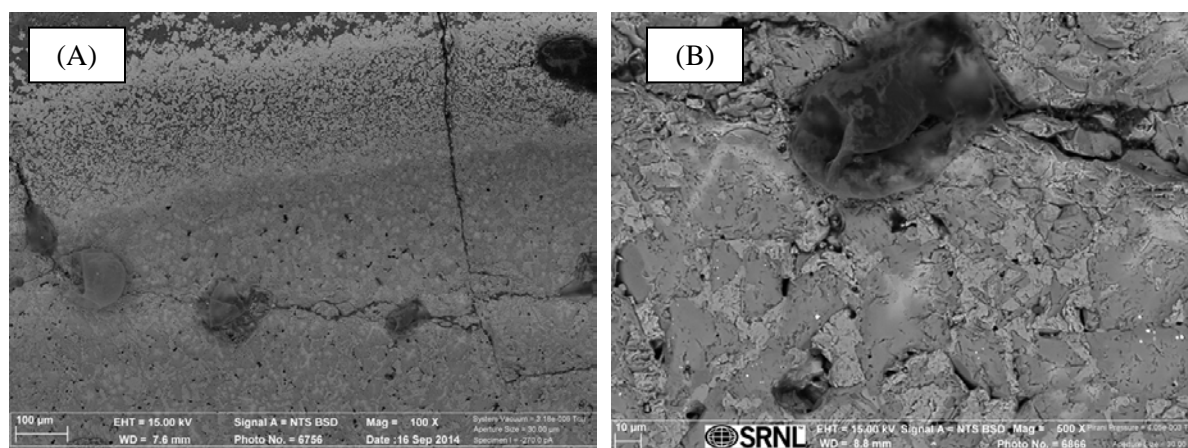
Figure 4-27 Hot-face of the K-3 refractory block that was in contact with the glass: (A) 100x and (B) 500x

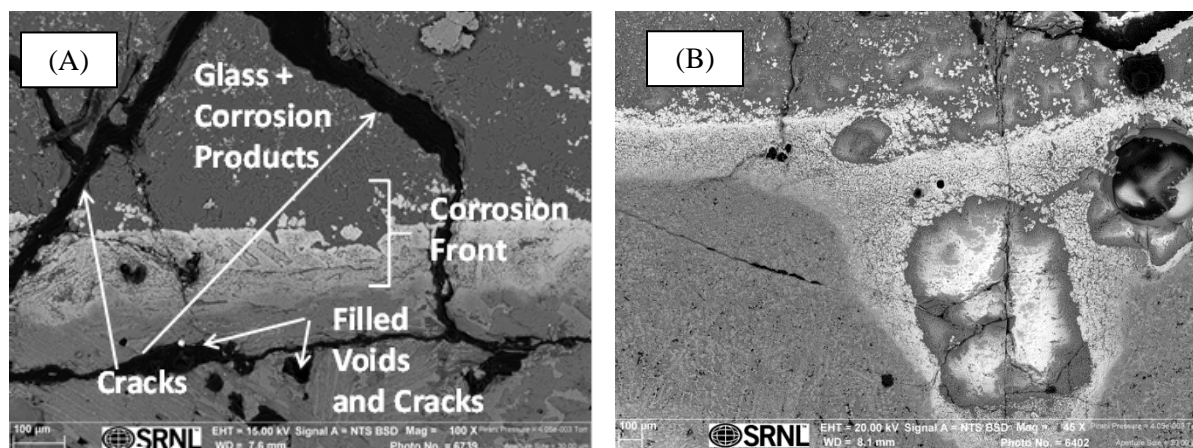
Figure 4-28 Cracks, voids and cavitations in the K-3 refractory (Note how deeply the cracks and cavitation penetrate into the refractory): (A) 100x and (B) 40x

5. The cavitation is likely due to the proximity of the refractory coupon to the bubbler orifice but the cracking is related to the Fe^0 depletion caused by excessive nitric acid used in the glycolic acid CEF campaign.

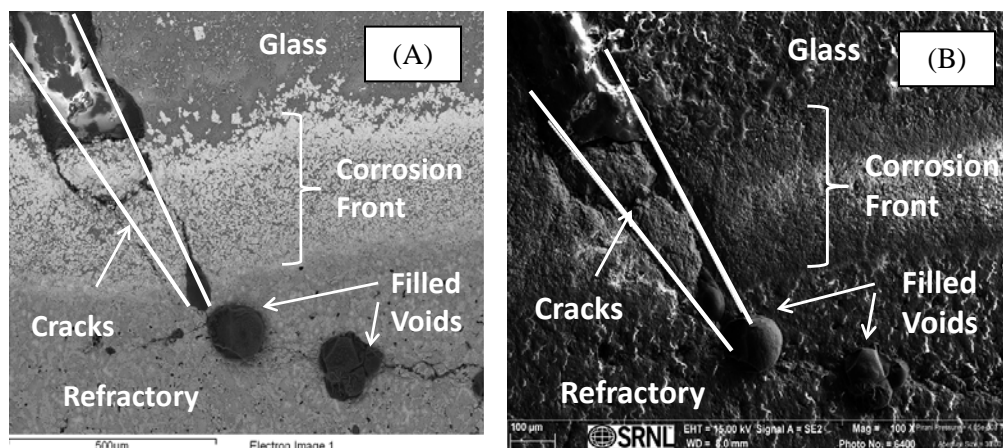
Figure 4-29 Cracks and filled voids along the cracks that are deep below the corrosion front in back scattered electron (A) image and secondary electron (B) image, where the secondary electron image shows that the voids are filled with a secondary phase

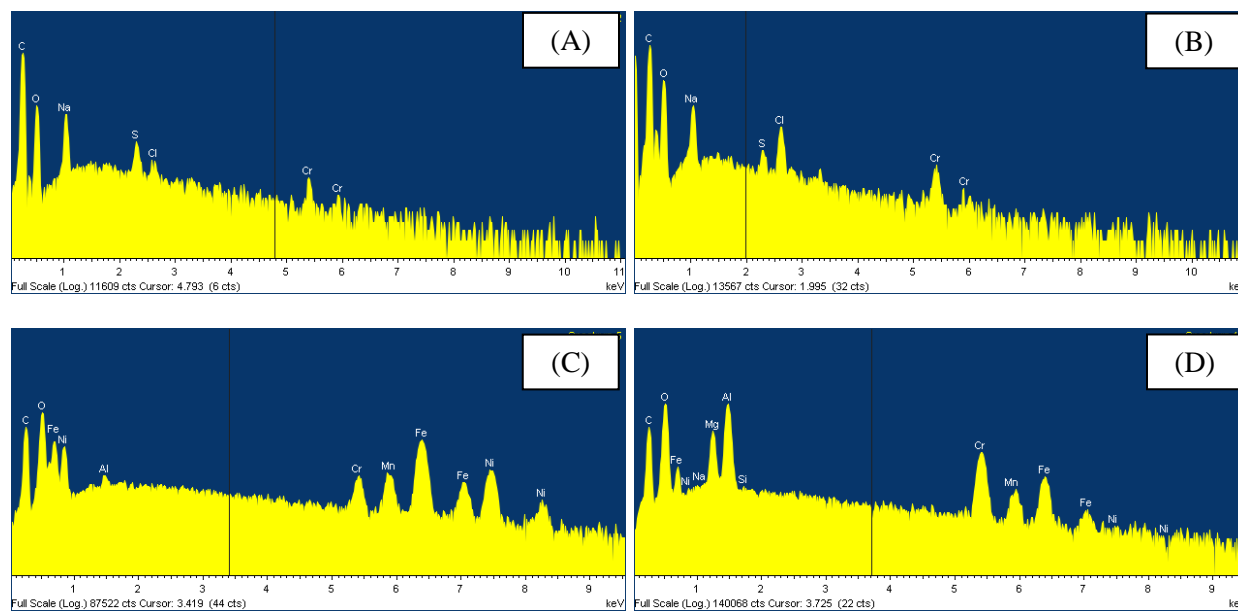
Figure 4-30 Results of EDS analyses of the different phases in Figure 4-29: (A) upper void; (B) lower void; (C) glass; and (D) refractory

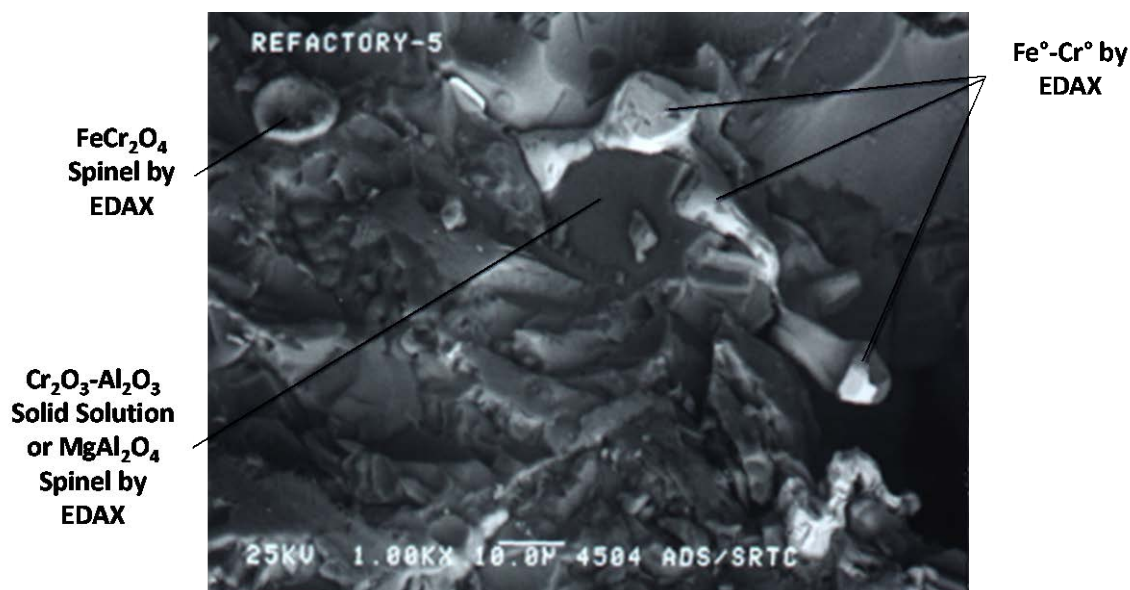
Figure 4-31 Phase morphology and composition of Monofrax™ K-3 refractory (Note fluid looking $\text{Fe}^\circ\text{-Cr}^\circ$ metallic phase that follows the grain boundaries of the other oxide phases) [26]

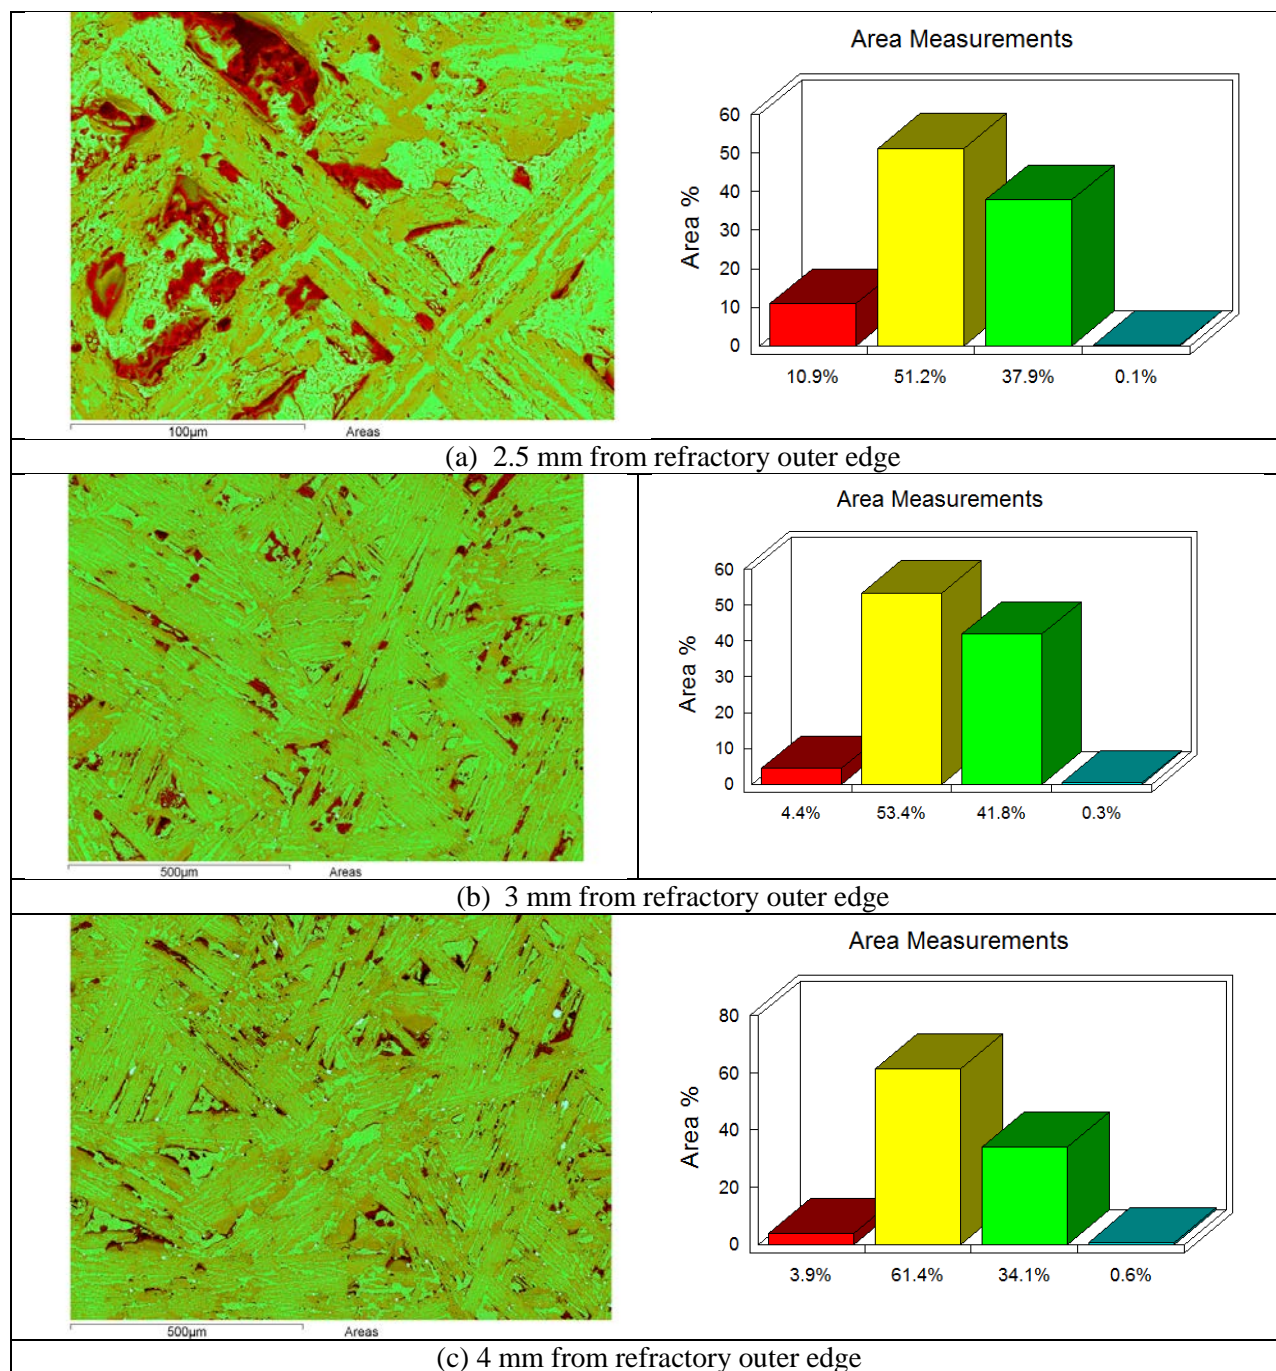
Figure 4-33 Phase contrast SEM with semi-quantative area measurements of each phase. The smallest phase indicated by the darkest color on the far right of each graph represents metallic Fe
