SRNL Shelf Life Studies – SCC Studies at Room Temperature

November 2014

SRNL-STI-2014-00418, Revision 0

Keywords: *3013 plutonium
storage, stress corrosion
cracking, pitting*

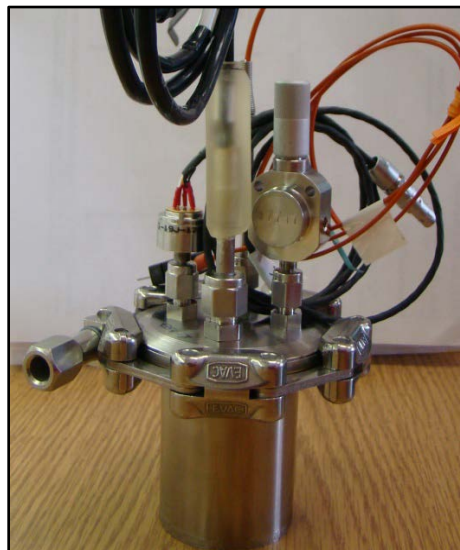
Figure 3-2 Test vessel with pressure sensor, humidity probe, thermocouple, and gas sampling capability

The test vessels as shown in Figure 3-2 were fabricated from 304L. A design flange with a welded bottom, approximately 2 in. diameter and 2.5 in. tall, was used for the bottom section. The vessel lid flange had Swagelok fittings welded in place for a thermocouple, pressure sensor, humidity probe, and a valve for gas sampling. The pressure sensors were purchased from General Electric (Billerica, MA) and were modified by welding to a 0.125-in. adapter. The humidity probes and thermocouples were supplied by EdgeTech (Marlborough, MA) and Omega (Stamford, CN), respectively.

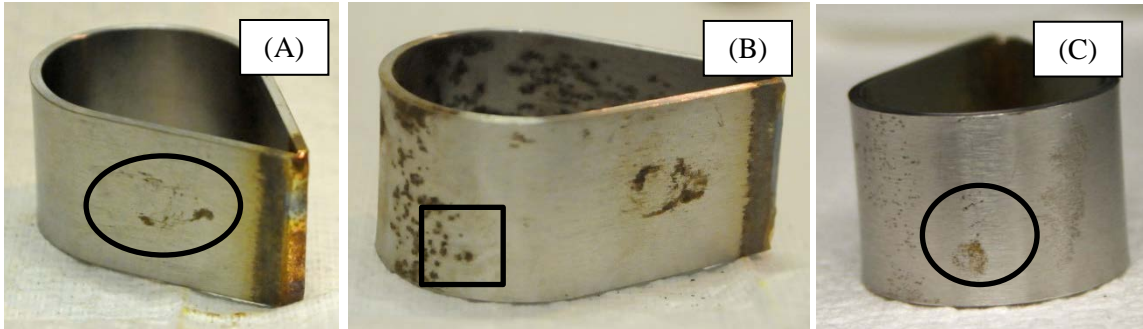
Figure 5-3 Photographs of Vessel B teardrop coupons after 405-day exposure: (A) TD19, vapor exposure, as-is condition (circled area shows corrosion); (B) TD15, oxide/salt contact, as-is condition; and (C) TD15 after nitric acid cleaning

Vessel B pressure and humidity had an inverse trend with an initial pressure drop and humidity rise followed by a pressure increase and humidity drop. The vessel was found to have leaked with oxygen and nitrogen as found in the post-test gas analysis. The teardrop coupon (TD15) in contact with the oxide/salt mixture experienced more corrosion than the coupon exposed only in the vapor space (TD19) as shown in Figure 5-3 (A) and (B) for the as-is condition. The TIG closure weld on both coupons had more significant corrosion products than the coupons from Vessel A. Numerous pits can be seen on TD15 on both the interior and exterior surfaces.

The region of attack in the middle of the teardrop faces (circled in Figure 5-3 (A) and indicated by arrows in Figure 5-1 (A) and (C)) was examined more closely on the stereomicroscope and SEM where this attack was found to be pits. Similar markings were found on coupons from Phase II, Series 1 [4]. The pitting can be seen in Figure 5-8 for TD19, the vapor-exposed coupon. As can be seen some pits still have corrosion products inside (indicated by arrows in Figure 5-8 (A)). The pit morphology and bimodal population appear similar to those on TD15. This pitting is believed to be associated with the work hardening of the surface that occurs at these local spots during the bending of the coupon around the mandrel.
