**EXAMINATION OF BEETLE-INFESTED SHIPPING PACKAGE 9975-03996**

Savannah River National Laboratory  
Materials Science & Technology

Publication Date: September 2014

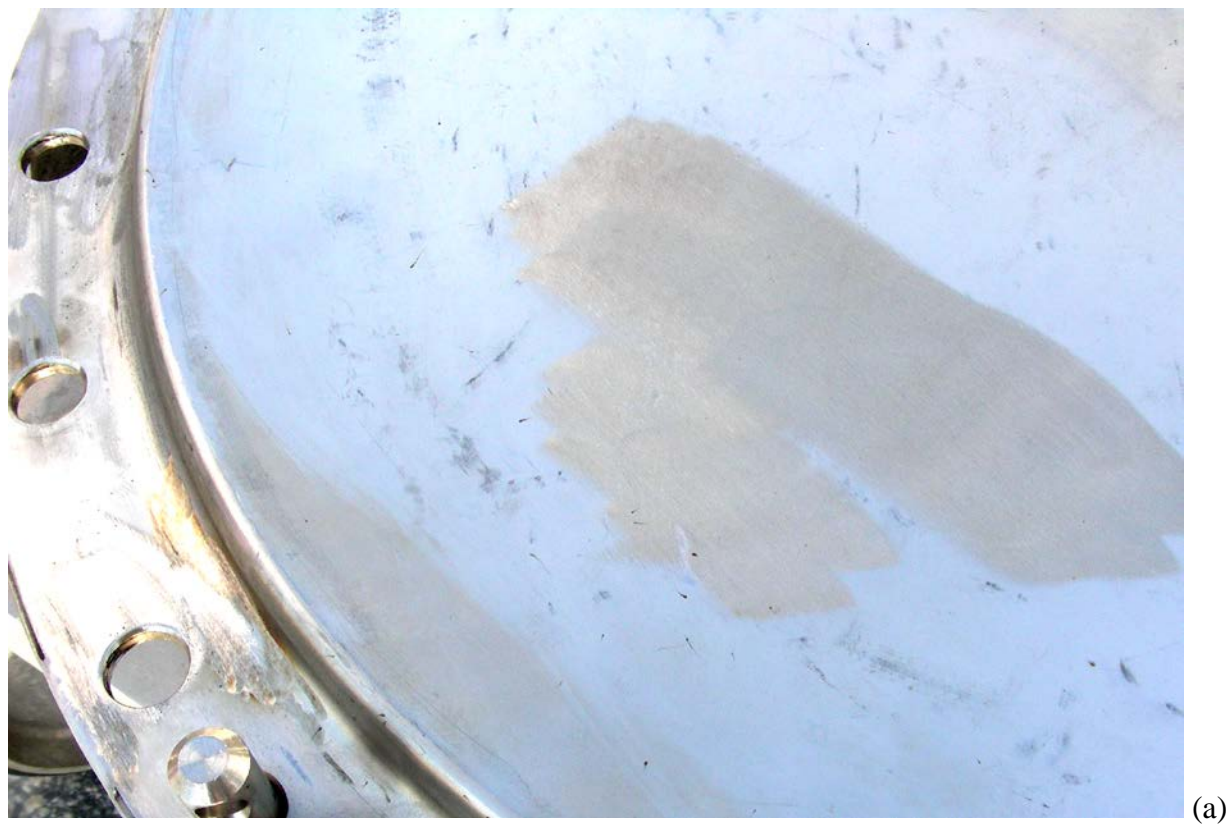
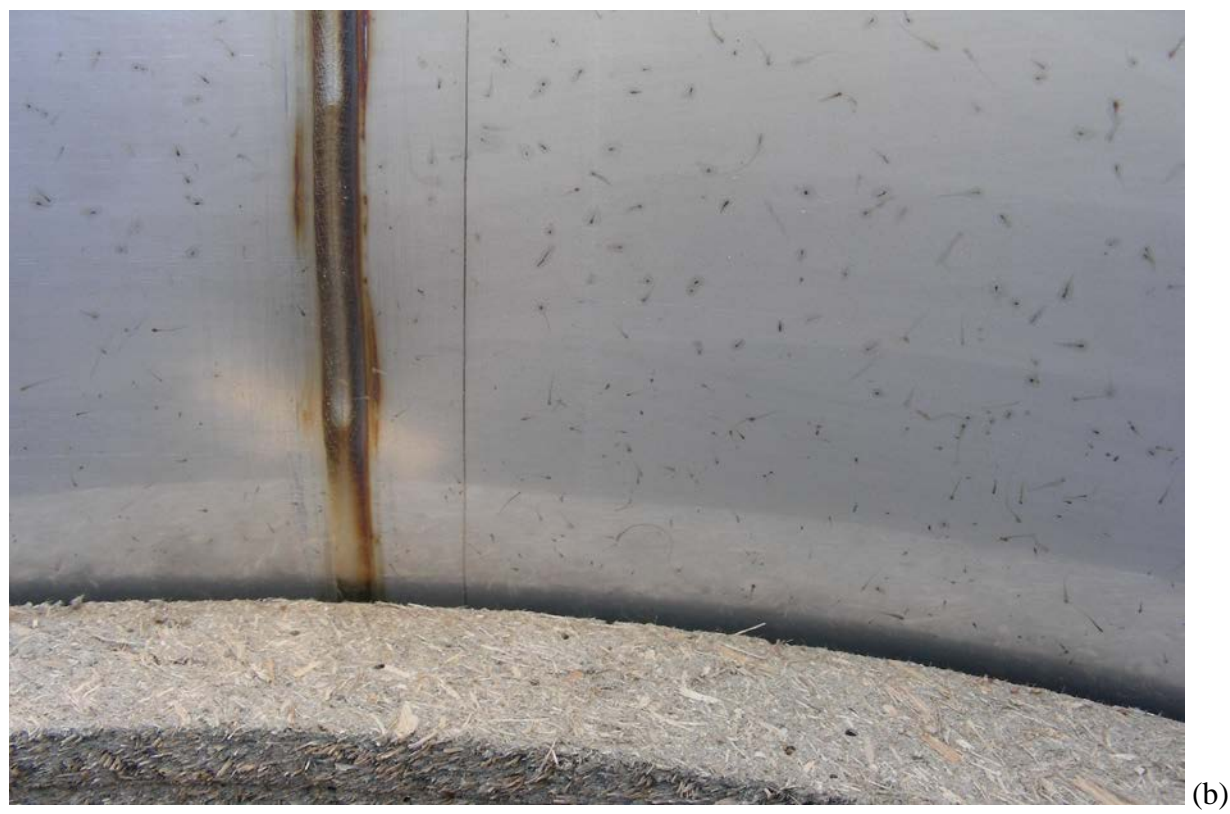
Photographs were taken to document the extent of infestation damage, and to compare to the damage observed in 2012. Figure 1 shows the extent of “tracks” (from beetle droppings) observed on the drum and lid interior surfaces in 2014. Figure 2 shows a similar density of tracks on the air shield surfaces observed in 2012. In Figure 3, a portion of the air shield that was photographed during both inspections shows no difference in the tracks within the boxed region.

Figure 1. Lid underside (a) and drum interior (b) showing “tracks” of beetle droppings, photographed in 2014

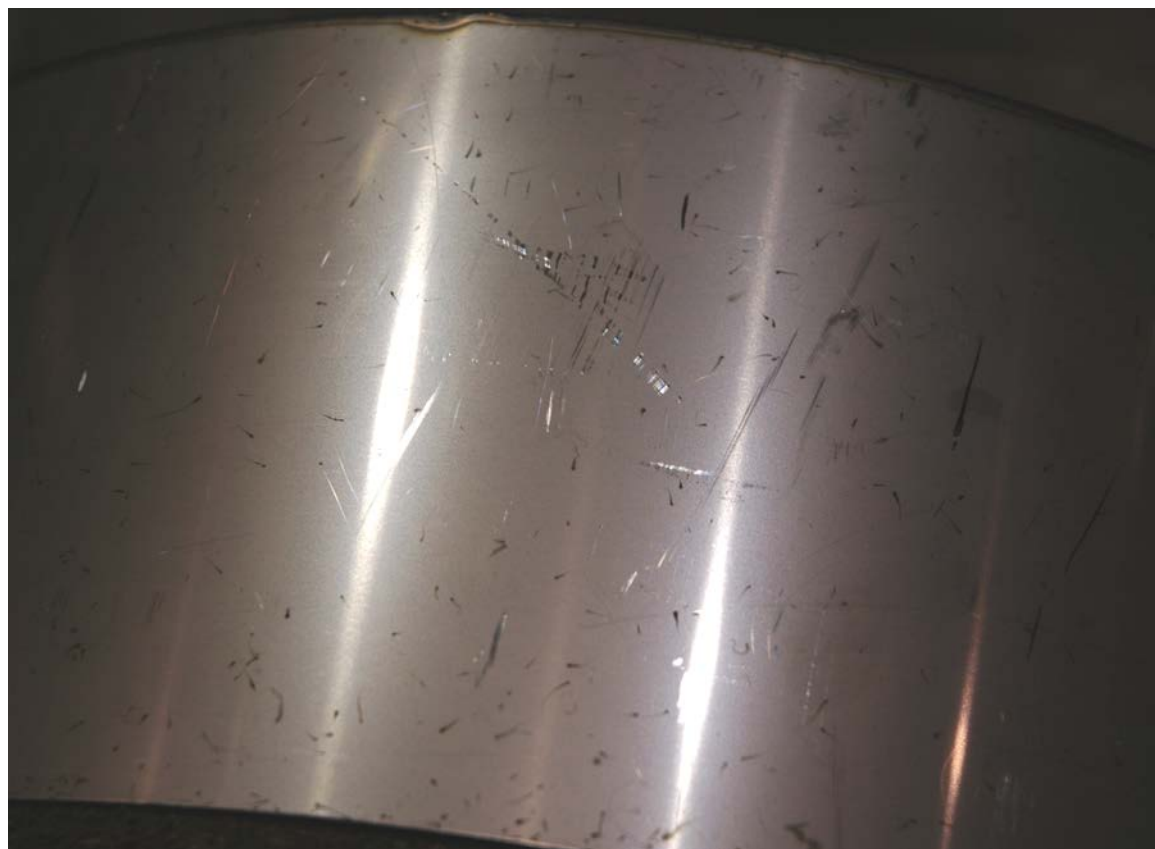
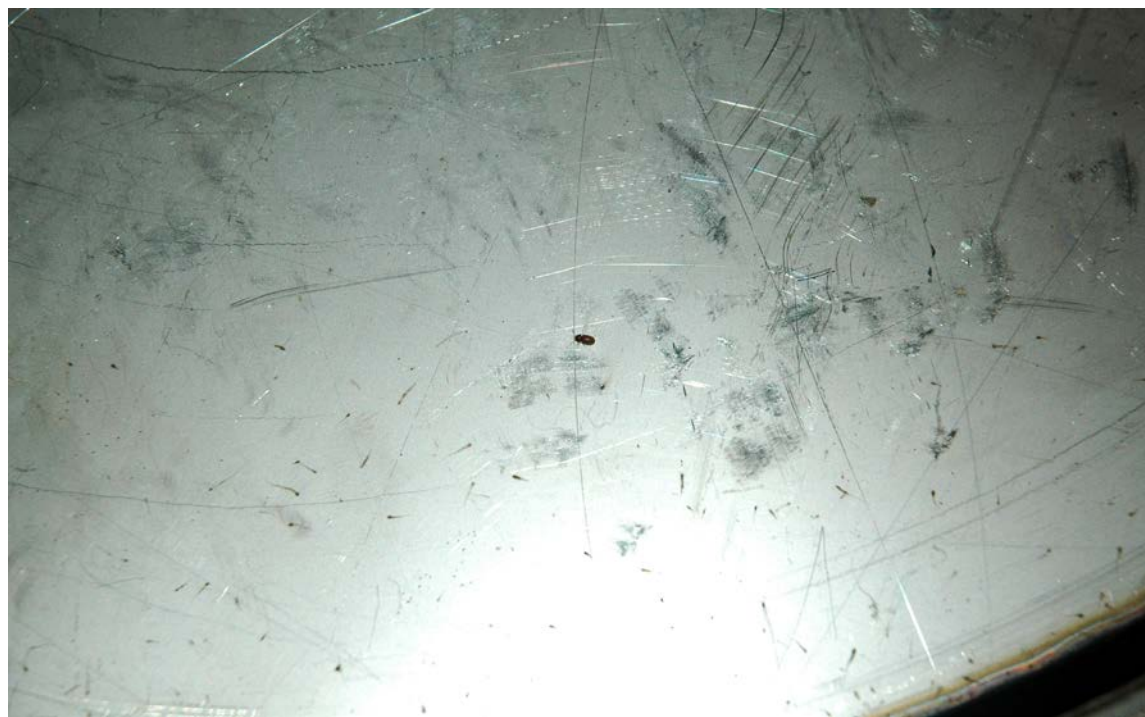
Figure 2. Air shield side (a) and top (b) surfaces showing tracks of beetle droppings, photographed in 2012 in K Area

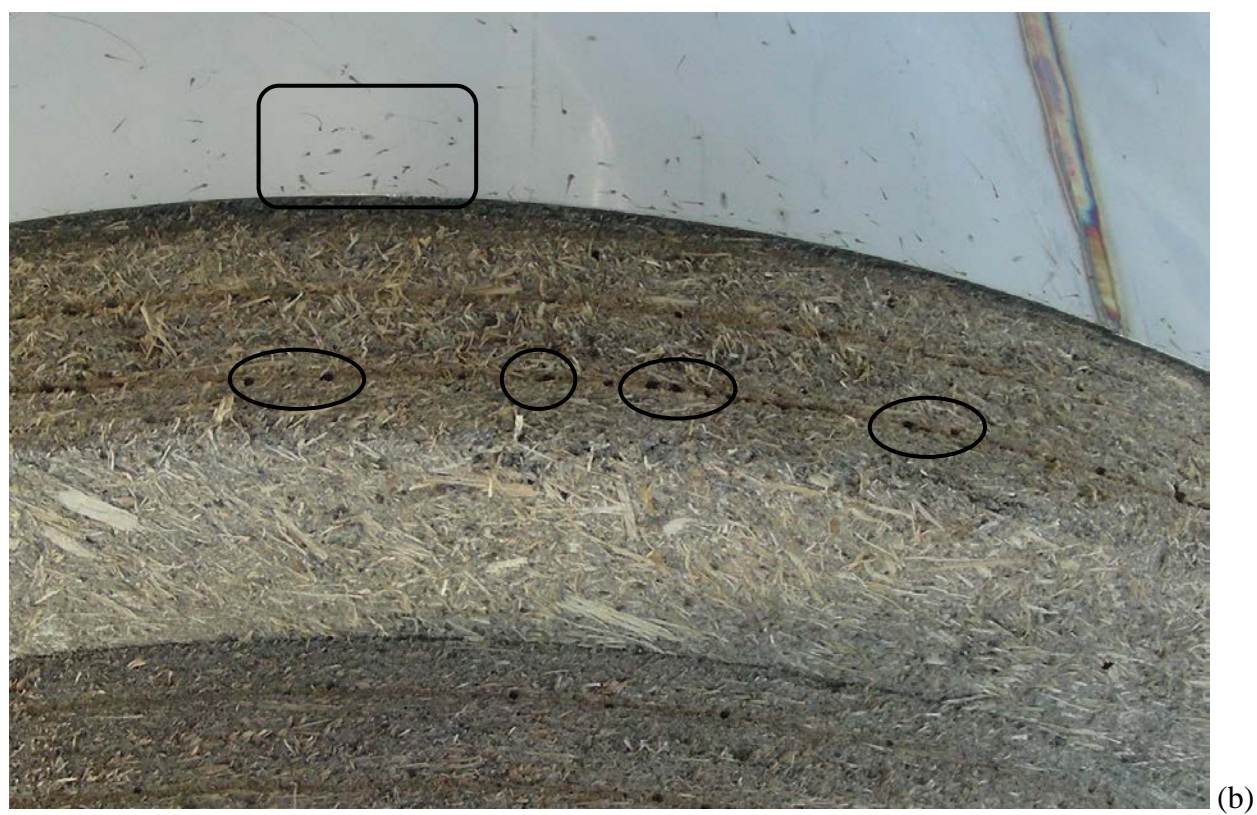
Figures 3 and 4 show one side of the upper fiberboard assembly which was photographed during both examinations (the air shield weld seam provides a common reference point). Many of the beetle penetrations observed in 2014 were also present in 2012 (the circled features in these photographs), with little additional damage observed in 2014.

Figure 3. Side of upper fiberboard assembly comparing damage from 2012 (a) and 2014 (b). The circles highlight some of the damage observed both times. The tracks within the boxes are essentially unchanged over the 2 year period.

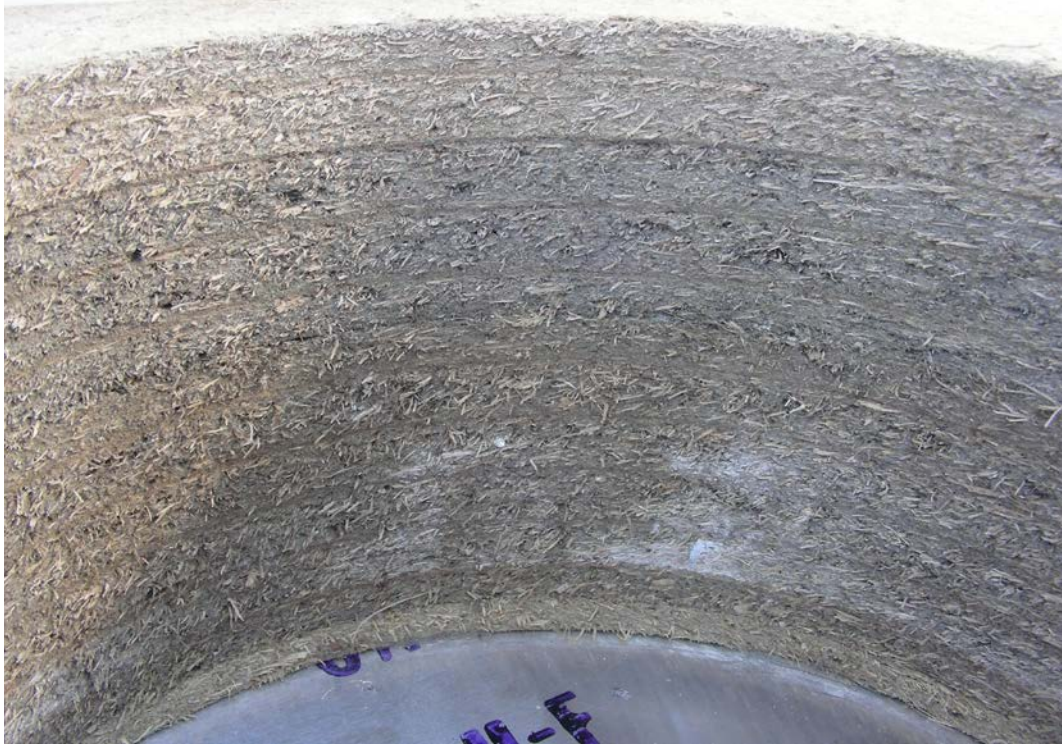
No beetle-related damage was observed on the ID surfaces of either the upper or lower fiberboard assemblies (Figures 5 and 6), although some frass (a combination of uneaten fiberboard particles, beetle droppings and dead beetles) was found in the bottom interior of the lower assembly. It is assumed that this frass dropped down from the top surface of the lower assembly during handling, since some frass was observed in this area during both examinations (Figure 7). The pattern of damage limited to the outer regions is consistent with the observations of the two infested packages from Hanford, in which the damage was generally confined to the outer 2 inches or so [1, 3], although much deeper damage was observed in the bottom layers of the second Hanford package.

Figure 5. Upper fiberboard assembly ID surface, showing no beetle damage.

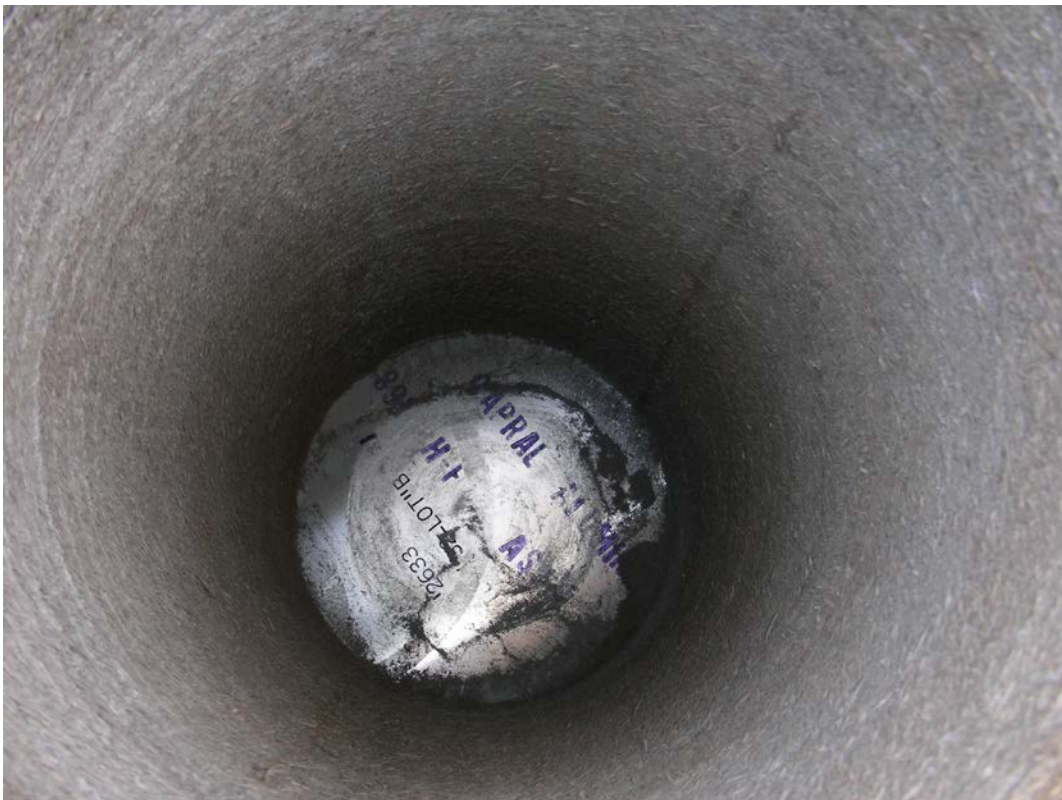
Figure 6. Interior of lower fiberboard assembly showing no beetle damage, but a modest amount of frass has fallen to the bottom.

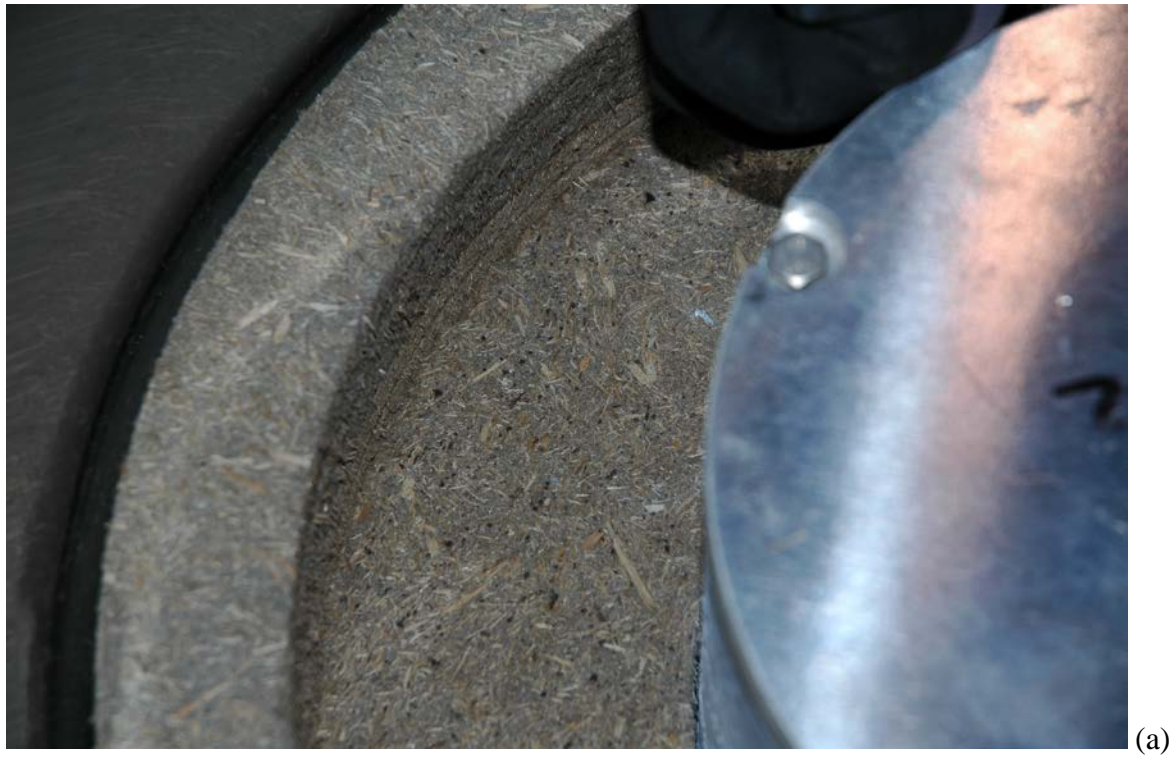
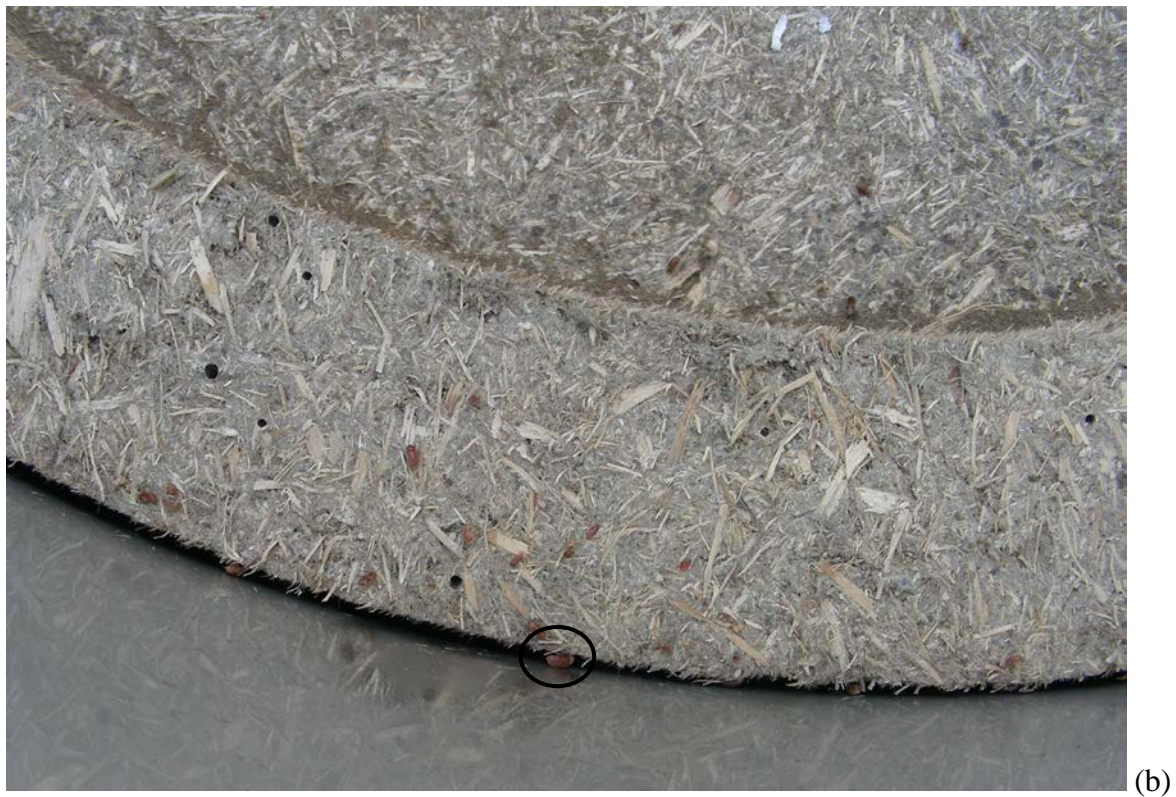
Figure 7. Top surface of lower fiberboard assembly from 2012 (a) and 2014 (b). A modest amount of frass (brown powder) has collected on these horizontal surfaces. Note the dead beetle adjacent to the drum (circled).

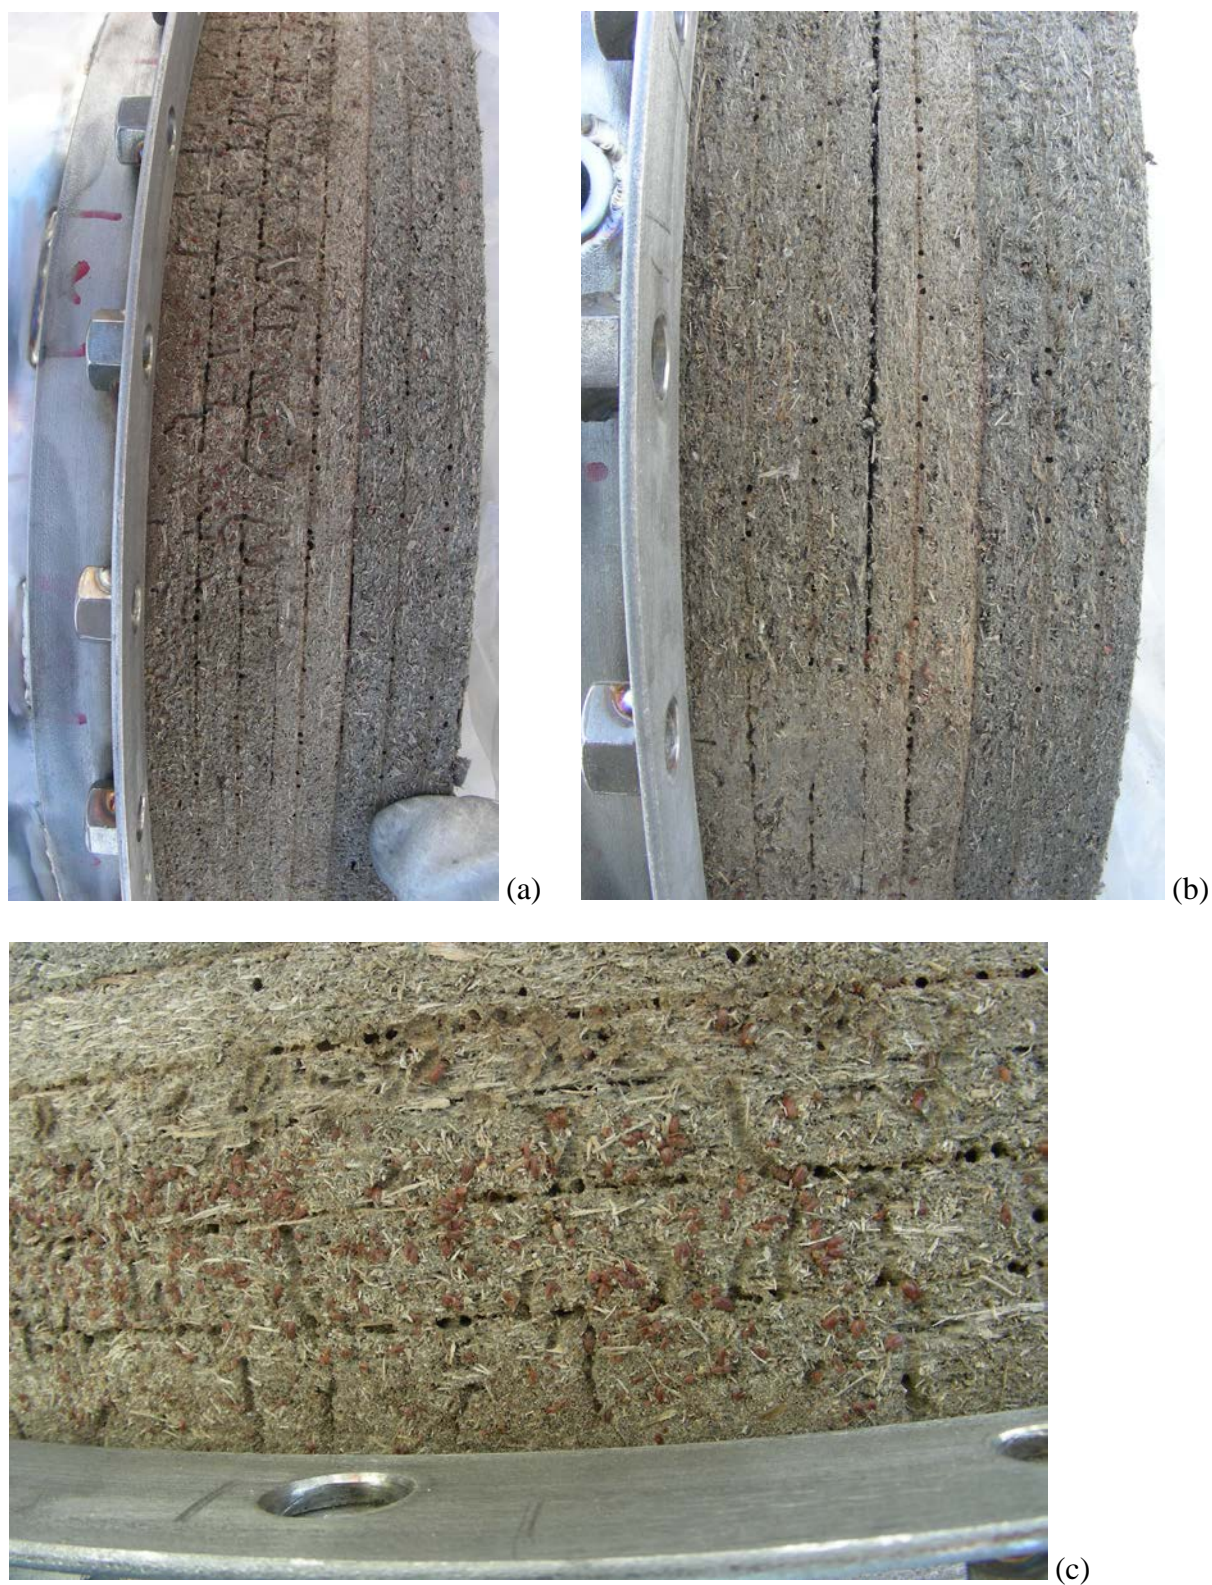
The remainder of the lower fiberboard assembly was not examined in 2012. The lower assembly was removed for a more complete inspection in 2014. The lower assembly did not slide out easily as is normally the case. Rather, two large hooks were used to engage the ID surface of the assembly and significant effort was required to pull it out. Figure 8 shows the lower assembly partially withdrawn, and reveals that frass had built up between the fiberboard and drum on one side, providing a very tight fit. As the lower assembly was removed into a plastic bag (to contain any live beetles), a significant amount of frass was also captured in the bag (Figures 9 and 10).

Figure 8. Lower fiberboard assembly partially withdrawn from drum. The view in (a), and the detail in (c) show the extent of frass buildup on one side which made the fiberboard very difficult to remove.

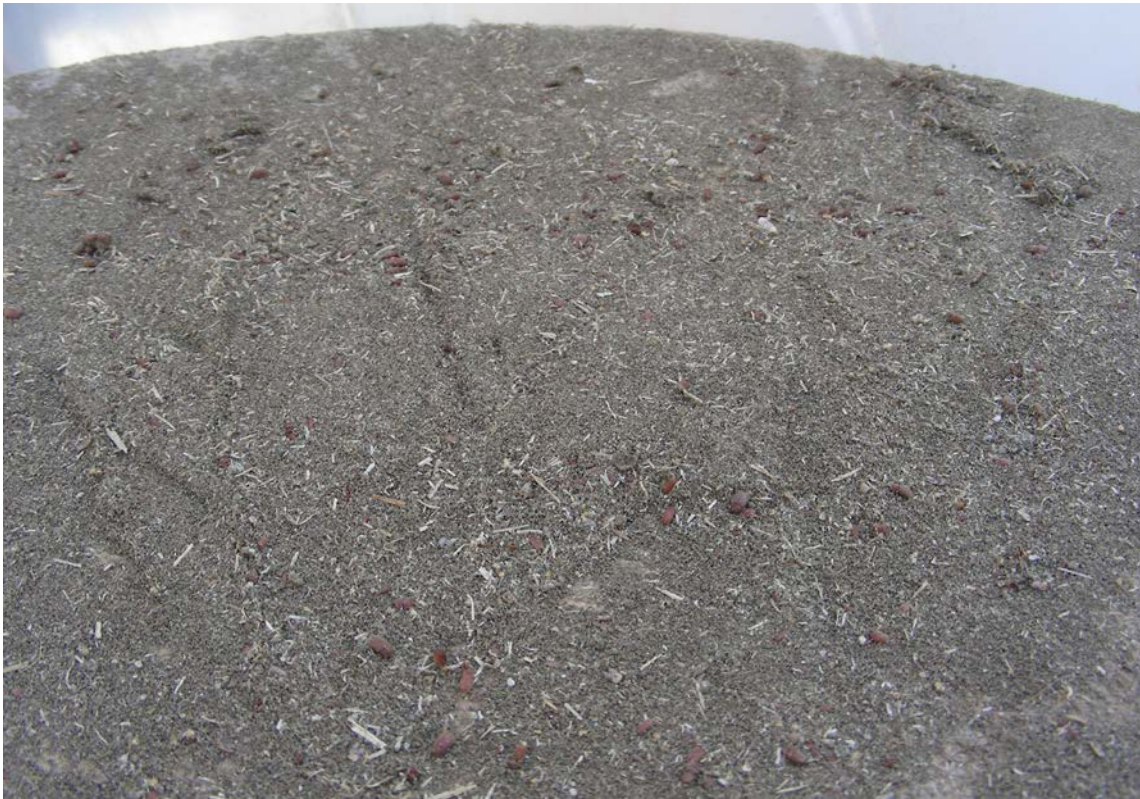
Figure 9. Some of the frass found after removing the lower fiberboard assembly from the drum.

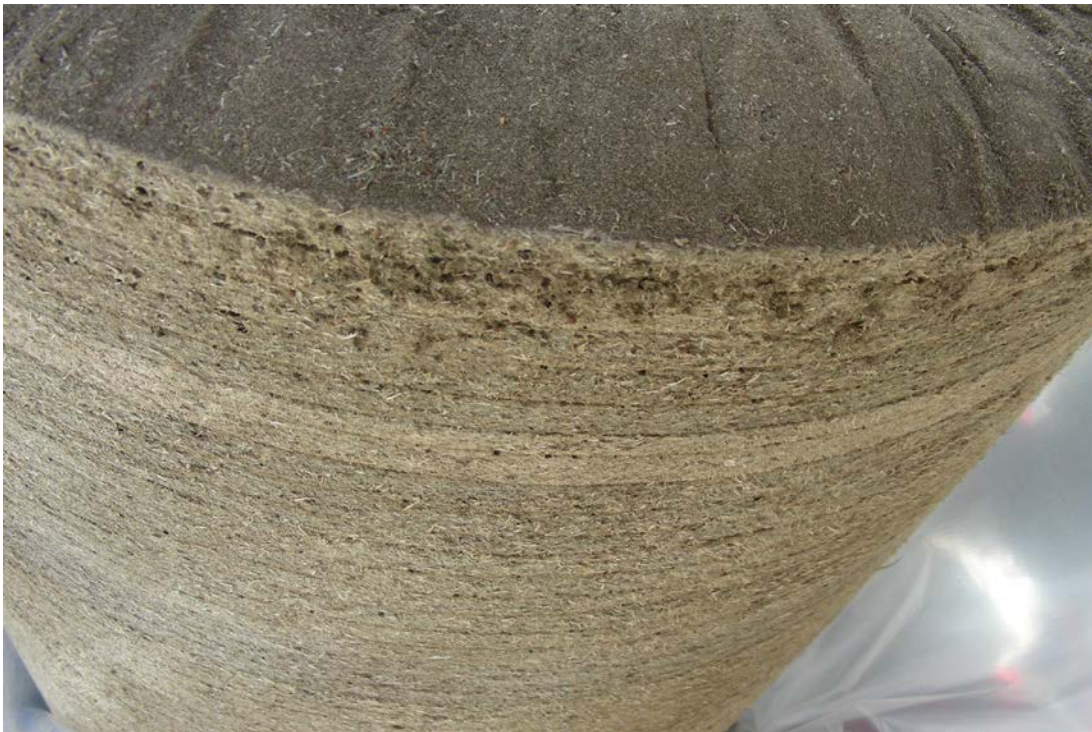
In addition to the frass, significant beetle damage was observed in the lower fiberboard assembly (Figures 10 and 11). While the degree of damage varied over the fiberboard surface, the overall extent of damage was more severe than in the upper assembly.

Figure 10. Bottom and side of the upside-down lower fiberboard assembly, showing frass and beetle damage.

Based on information provided by a Clemson University entomologist (Dr. Robert Bellinger) [6], the remaining beetles were killed by exposure to low temperature. This same method was previously used with the second Hanford package. The package was moved to 786-A and placed in an environmental chamber on May 14, 2013. The chamber was cooled to 0 °F (-18 °C) for a planned hold time of 9 days. Due to the timing and personnel availability, the actual hold time

was 13 days. The package was transported to 717-A on June 12, 2014, and delivered to the Packaging Technology and Pressurized Systems group for replacement of the fiberboard and recertification of the package. Transportation and freezing of the package were coordinated by M. Phillips (EES).

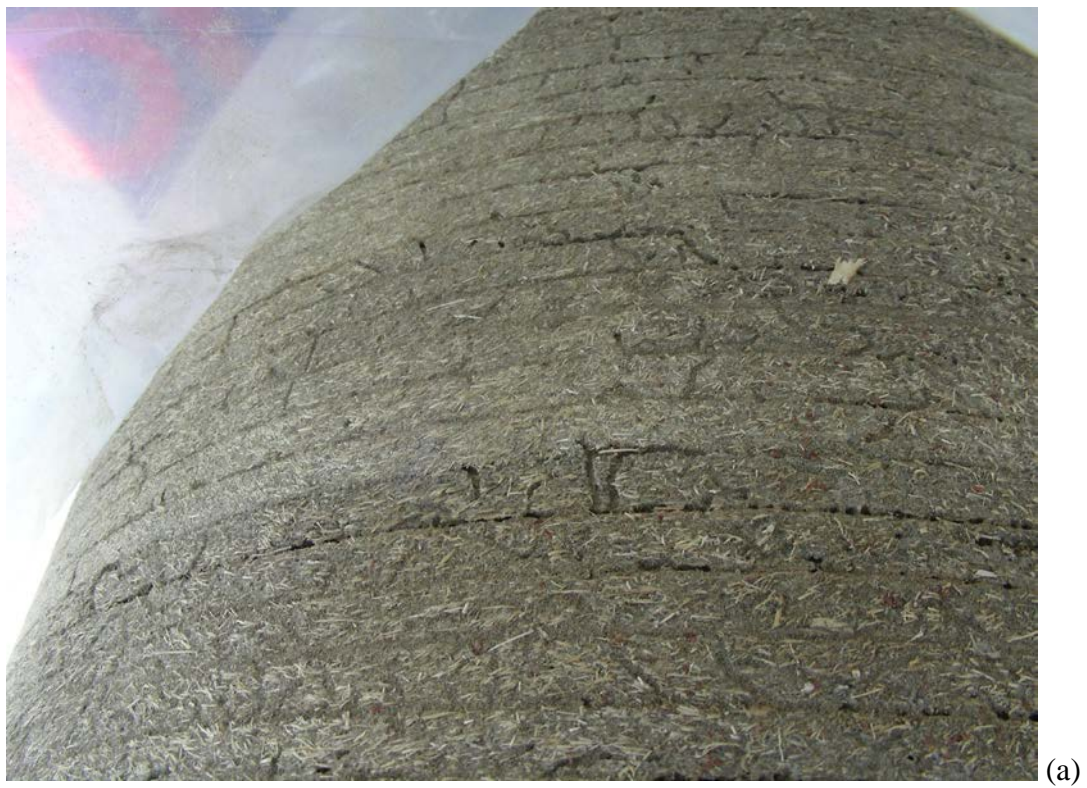
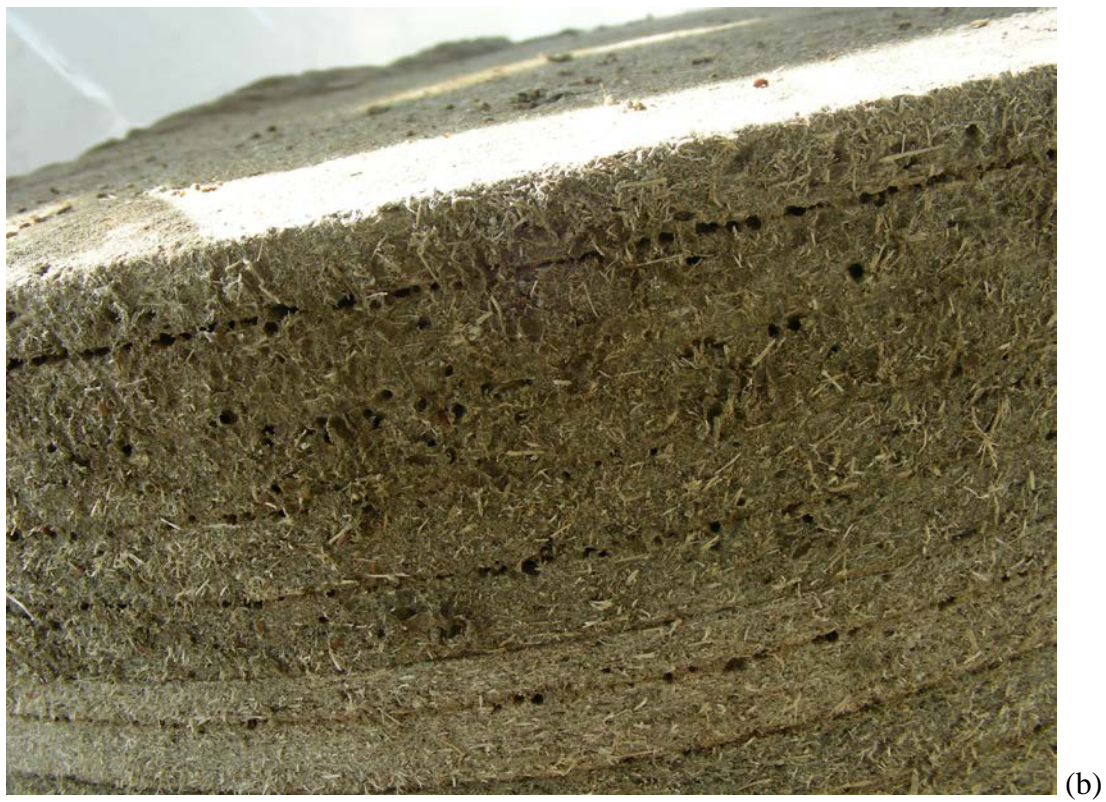
Figure 11. Additional photographs of the side (a) and bottom (b) of the upside-down lower fiberboard assembly.
