Results for Actinide Removal Process 512-S Guard Filter Analyses

SRNL-STI-2014-00518, Revision 0

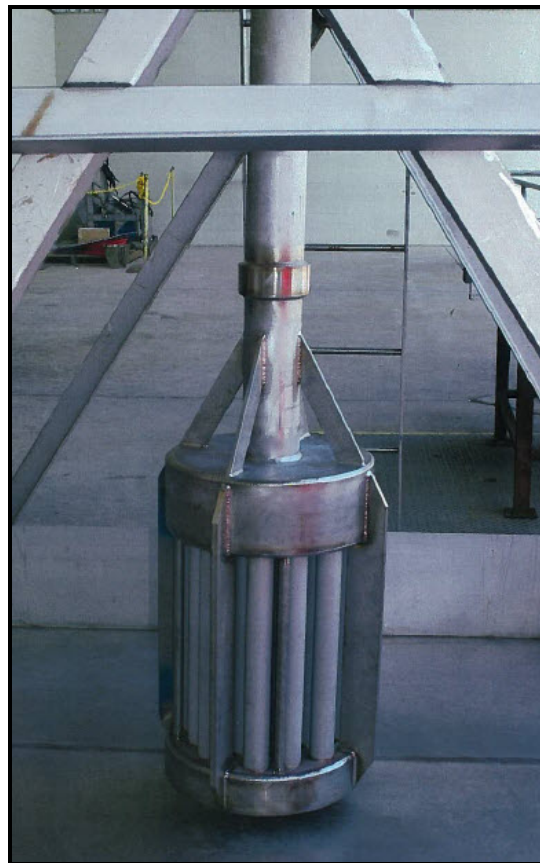
Figure 1-2 512-S Secondary Filter or Guard Filter

The secondary filter is downstream of the CFF. The secondary filter is a dead-end filter constructed of 21 sintered metal filter tubes with a 0.5 μm nominal rating, with a total surface area of 16.5 ft^2 . The tubes are made from 316 stainless steel and are also manufactured by Mott®. The filter elements sit inside the LWHT.

Filter 1 processed approximately 187,000 gallons of Tank 49 material composed of Salt Batch 7a (SaB7a). Filter 2 processed approximately, 487,000 gallons of Tank 49 material composed of Salt Batch 6d (SaB6d) and the first six batches of SaB7a. The primary filter was changed between the end of SaB6d and the start of SaB7a. Prior to receipt by SRNL, Filter 2 was rinsed with water, while Filter 1 was not rinsed.

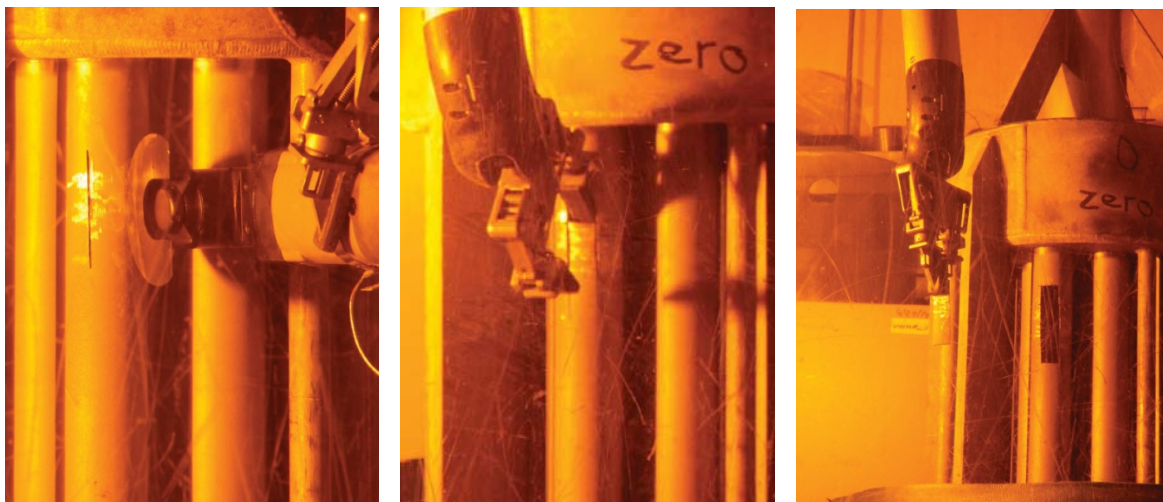
Figure 2-2. Shielded Cells Sampling Sequence for 512-S Filter 2 Coupon Collection. From left to right: cutting, pulling, and removal of a coupon.
