Laboratory Simulation of Vapor Space Corrosion in Radioactive Waste Storage Tanks

R. E. Fuentes and B. J. Wiersma
Savannah River National Laboratory
SRS Road 1A
Aiken, SC, 29808
USA

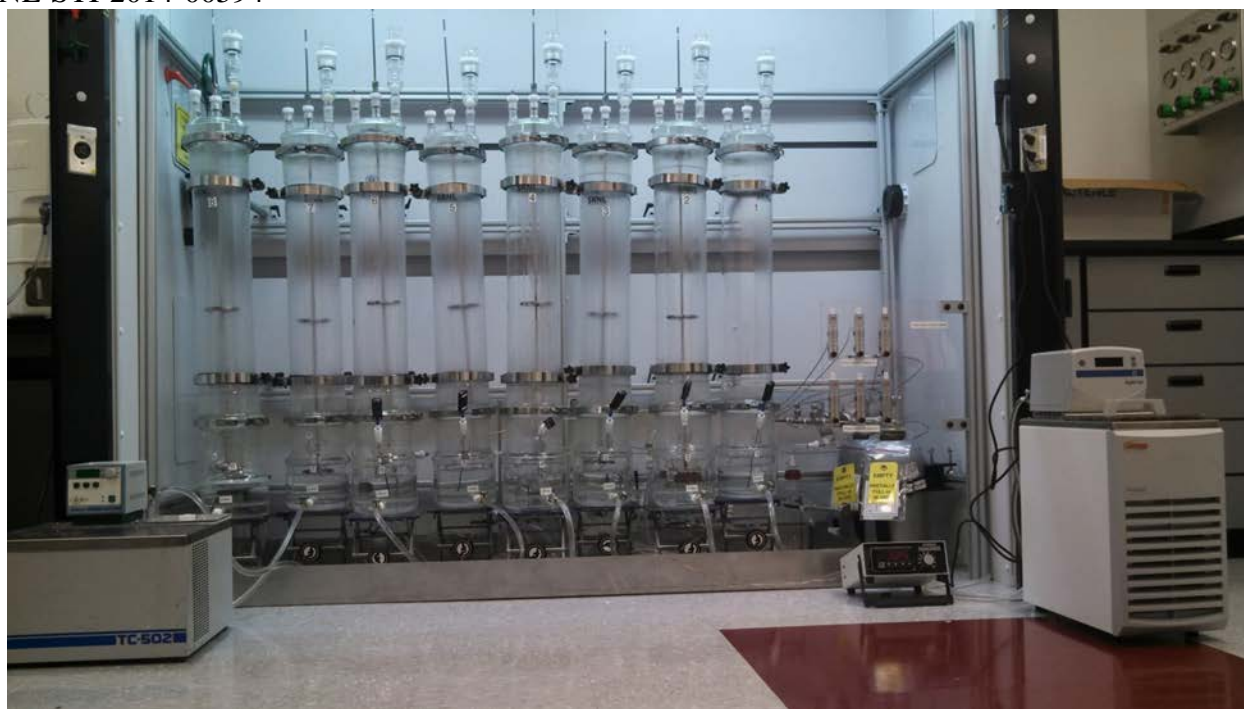
The apparatus that was used for these tests is shown in Figure 3. The chamber for these tests is a 1 meter by 15 cm diameter glass cylinder. Inside the cylinder is a movable ring stand with the rings located at three different levels. At the bottom of the cylinder is a glass bowl that contains approximately 1.5 liters of the test solution of interest. The gas, in this case ammonia, passes through a bubbler that contains the solution of interest, enters the near the bottom of the cylinder just above the solution, and exits the top of the cylinder. The flow rate for the gas was adjusted to 5 cc/min. The temperature of the solution in the bowl was controlled to 40 °C utilizing a water circulator.

Figure 3: Vapor Space Corrosion Test Apparatus.

For the tests, the coupons were positioned at three different levels above the liquid simulant. The wire tie on the sample was wrapped around rings that were fixed at these levels.

Level 1: Prior to the test, the coupons were dipped in the simulant and then dried to form a salt film on the surface. The coupons were then suspended approximately 3 cm above the liquid level. Once every two weeks, the coupons were dipped into the simulant for approximately 5 minutes, then removed and allowed to dry above the simulant. This level is representative of a vapor space region of the tank that experiences periodic wetting/drying. This sequence could occur due to: a) waste transfers into and out of the tank, b) splashing due to flushing operations, and/or c) solution “creep” above the liquid air interface.

Level 2: Prior to the test, the coupons were dipped in the simulant and then dried to form a salt film on the surface. The coupons were then suspended approximately 8 cm above the liquid. This level is representative of a vapor space region of the tank that at one time was exposed to waste, but now has infrequent or no contact with the waste. However, this region is exposed to the humidified air and the ammonia gas.

Level 3: This set of coupons was not exposed to the solution prior to testing. The coupons were suspended approximately 1 meter above the liquid. This level is representative of a vapor space region that is only exposed to the humidified air the ammonia, and any vapors from the solution.

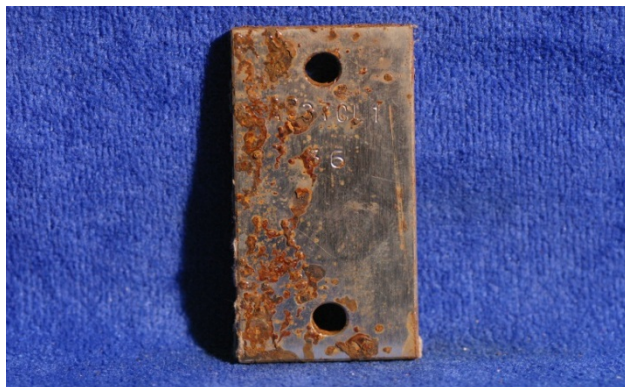
Figure 5: Coupon removed from Level 2 after 1 month exposure above Solution 1 at 40 °C with no ammonia in vapor space.⁷
