H-Canyon Recovery Crawler

August 2015

SRNL-STI-2015-00355, Revision 0

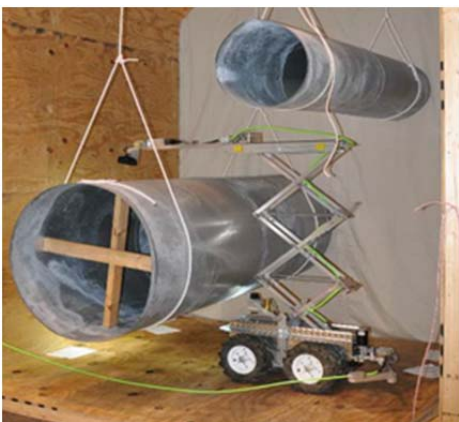
Figure 1 - 2014 Inspection Crawler

Figure 1 shows the 2014 Inspection Crawler during testing and Figure 2 shows the 2015 RC.

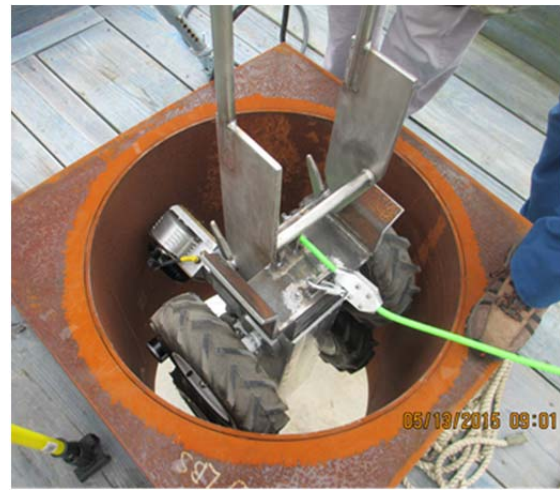
**Figure 11 - Recovery Crawler in Manway on
Long Lifting Bail**

13	Remove the Spray Wand and use the hoist to raise the Recovery Crawler through the Manway. Use the hoist to place the crawler on the platform deck on its wheels.	Pass	Rigging demonstrated the transition from the long lifting bail to the short chain and removing the RC from the manway and placing it on the scaffolding. Figure 11 show the RC in the manway on the long lifting bail.

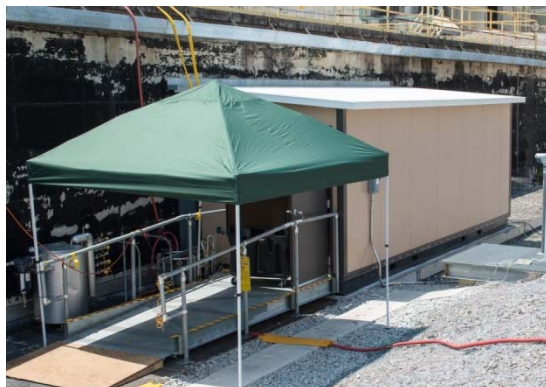
Figure 12 - Building 294-2H

The team deployed the Recover Crawler from building 294-2H, see Figure 12. The building provided containment when the manway cover was off and the Contamination Area to Radiological Buffer Area transition. The portable tent outside the building provided a cool down location and covered the breathing air halo and ice barrel. The crew trailer, observation trailer, generators, water tank, and Spray Wand water pump were located up the hill to the North of 294-2H, see Figure 13. The portable breathing air compressors were located to the East of the water tank, just out of frame in Figure 13.

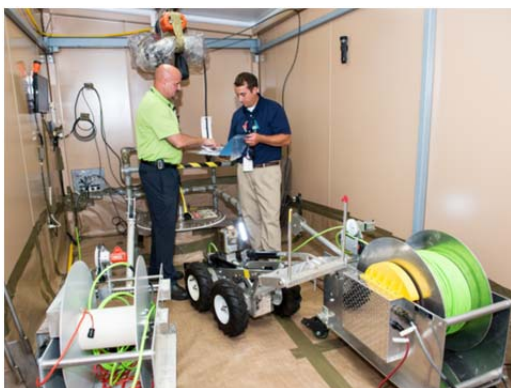
Figure 14 - Inside 294-2H

Figure 14 shows inside the 294-2H building before the team opened the manway. Items shown include: the RC, both IC and RC cable reels (IC reel is empty, cable in tunnel), video monitor on the left wall, and the bulkhead plate on the back wall. Figure 15 shows the four SRNL control positions inside the control trailer. From left to right, the IC controls, cable reel controls and 294-2H camera controls, RC controls, and Digital Video Recorder controls. The second crew trailer, or observation trailer, provided a cool down area for the workers and large video monitor that showed all active camera views for visitors.

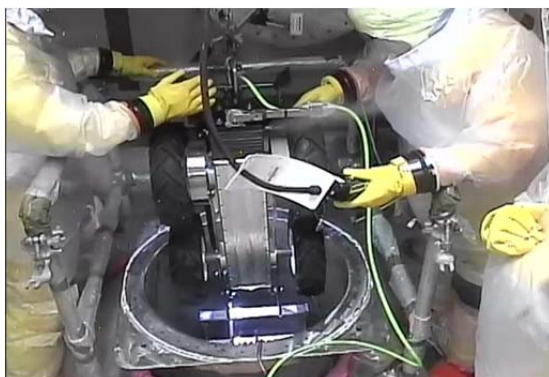
Figure 16 - Recovery Crawler Entering Manway

Figure 16 shows the RC entering the manway. Due to the low ceiling in the 294-2H, the RC forks had to be raised to allow the crawler to pass over the manway edge, but the forks had to be positioned straight down in order to fit the RC through the 30 inch inner diameter manway. Once through the manway, the

team raised the RC forks to help transition the RC from a vertical orientation to on its wheels. The dose rate into the manway was 2.0 mrem/hour beta and 0.6 mrem/hour gamma.

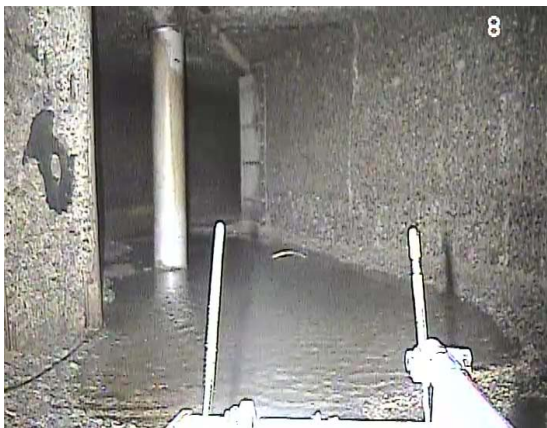
Figure 17 - RC Approaching Puddle

Once the RC reached the CAEX tunnel floor and operated properly, the team installed a temporary manway cover. This cover reduced the air flow through the manway and a slot in the cover allowed the IC and RC cables to pass through. The team drove the RC West towards the IC and soon encountered a large puddle. Figure 17 shows the RC approaching the puddle and Figure 18 shows the RC in the puddle. The IC encountered this puddle, so the team planned to traverse the puddle. The team drove the RC into the puddle and had trouble exiting the puddle on the left side of the column in Figure 17. After several attempts, the RC got stuck. Team members had to reenter 294-2H and pull the RC out of the mud by pulling on the tether. The RC tether is rated for 2,500 pounds of pulling force, so pulling on the tether was the backup plan if the RC got stuck. After the team pulled the RC from the puddle, the team decided to exit the puddle in a different location, on the right side of the column shown in Figure 17. After a few attempts, this new route worked and the RC continued West towards the IC.

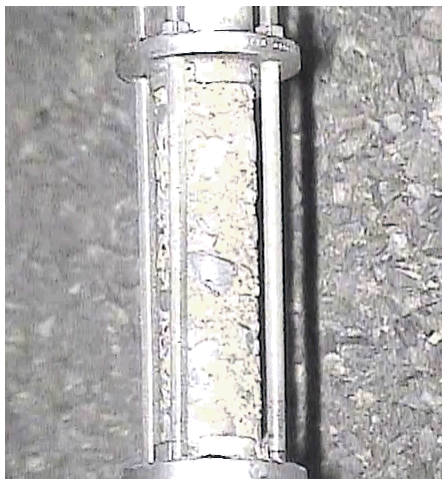
Figure 19 - Concrete Coupon

After passing the puddle, the RC came to a concrete sample coupon that was placed in the tunnel in 2012. The RC stopped before, next to, and after the coupon to zoom in and get a good view. Figure 19 shows the entire sample and Figure 20 shows a close up view.

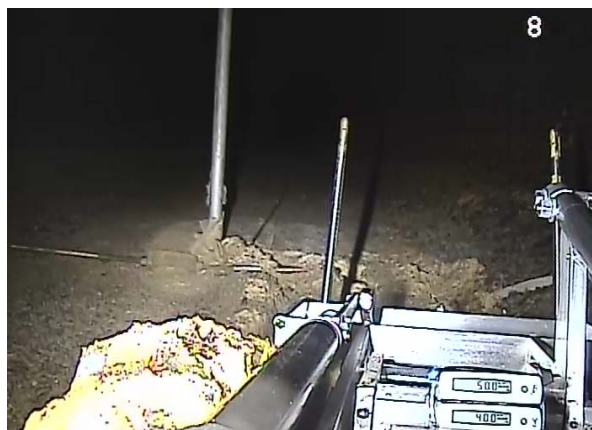
Figure 21 - Pipe Hanger

The RC encountered a pipe hanger lying across the tunnel, see Figure 21. The vertical pipe in Figure 21 previously housed a probe and the pipe hanger is obscured by the debris on the ground. It took several attempts to cross the pipe hanger. The RC front wheels would get over the hanger, but all the RC wheels would spin when the back wheels got to the hanger. The ruts shown in Figure 21 were made from attempts to drive over the hanger. The team tried to move the pipe hanger with the RC forks, but these attempts were not successful. The RC passed the hanger by driving close to the North wall (right side, away from the probe).

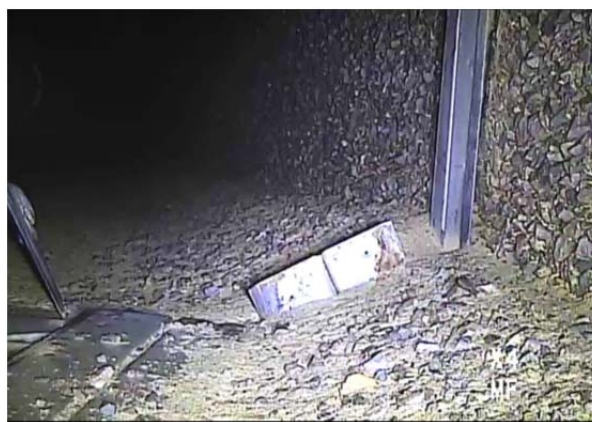
Figure 22 - Typical Expansion Joint Covers

The RC encountered several expansion joint covers, these are rectangular sheet metal pieces lying on the floor near the expansion joints. Figure 22 shows some typical expansion joint covers. The RC did not have any issues crossing over these covers.

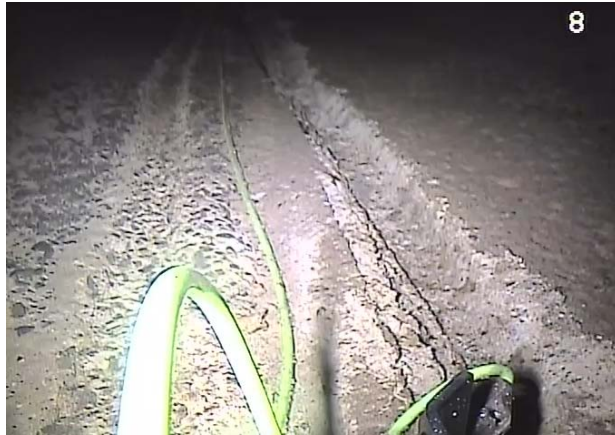
Figure 23 – Typical Wheel Ruts

Figure 23 shows typical wheel ruts in the debris on the floor. Other challenges the RC faced included: 25 to 30 miles per hour wind, acid vapors, and beta and gamma radiation. Figure 24 shows the IC laying on its left side in the CAEX tunnel.

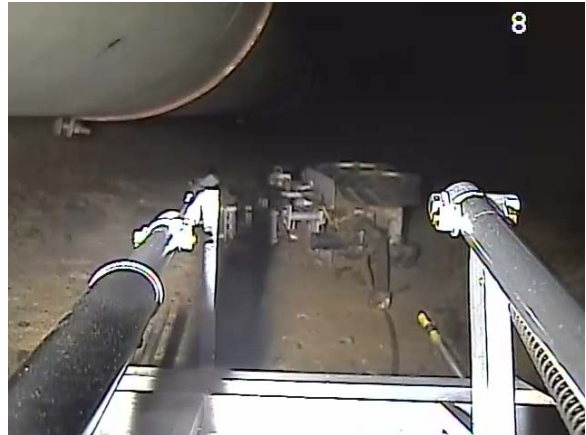
Figure 24 - IC on its Left Side

The plan to upright the IC included sliding the RC forks under the IC, engaging the IC left side lifting bail with the RC fork, raising the IC scissors and camera above the debris, lowering the IC scissors, retracting the camera slide, and finally rolling the IC to its wheels. The team tried to engage the IC lifting bail, but

these efforts were not successful. The team used the RC to move the IC in attempt to get the forks to the lifting bail, but again these efforts were not successful. Later analysis theorized that the IC scissors latch added after the IC was delivered to SRS, interfered with the RC forks/arms and preventing the forks from reaching the lifting bail.

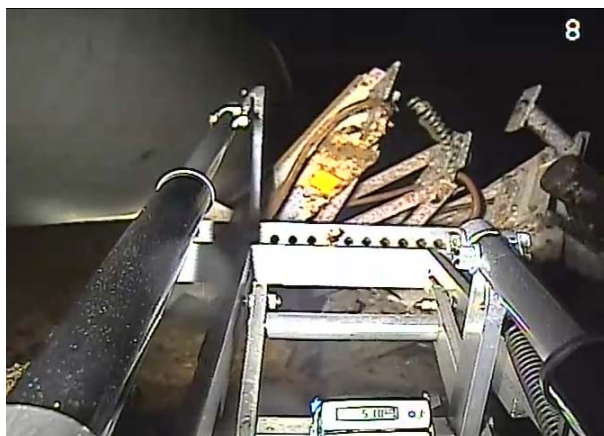
Figure 25 – RC Lifting IC

After the team saw the IC scissors components and saw no hint of scissor movement when the scissor actuator was driven, the team decided to engage the RC forks on the IC scissor components to upright the IC. Figure 25 shows the IC being lifted up and Figure 26 shows the IC on its wheels. The up righting process required a coordinated effort between the IC and RC drivers. The IC driver was driving the wheels in reverse and the RC driver was lifting the forks and driving forward. The team developed this method during the deployment with several trial and error iterations. The team spent about 5 hours working to get the IC on its wheels.

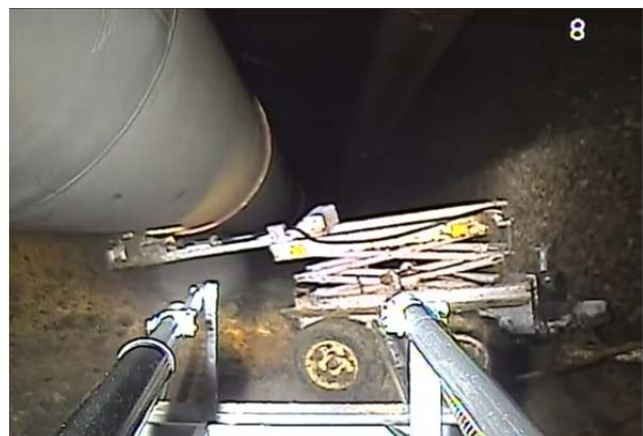
Figure 26 - IC on its Wheels

Figure 26 also shows the IC on its wheels, but the camera is lodged under the 36 inch diameter pipe. The team used the RC forks to push the scissors down, but the scissors only moved down a few inches. The IC driver tried to back the IC away from the pipe, but the IC would not move. The IC scissors and camera slide did not move either. The RC driver used the forks to lift the IC rear wheels in an attempt to free the IC camera, but this was not successful. The IC driver tried to skid turn the IC away from the pipe and this freed the IC from the pipe. Since the IC tether was all around the IC, the team drove the IC further into the tunnel to clear the cable.

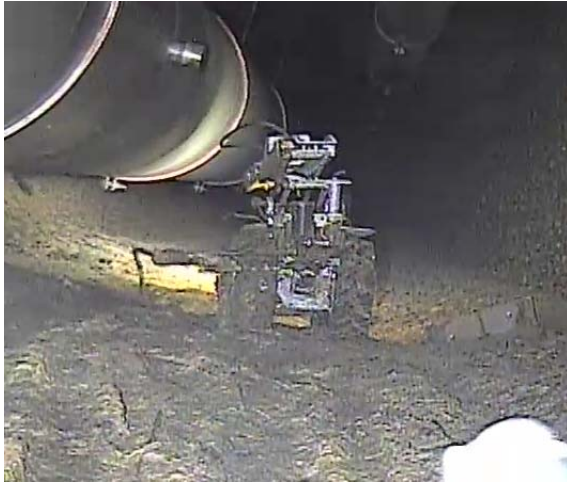
Figure 27 - IC on Expansion Joint Cover

The team reviewed the IC functionality and noted the scissors lift didn't work, the camera slide didn't work, and the camera images were blurry. The team decided that the IC was not going to perform valuable tunnel inspections in this condition, so the plan was to return the IC to the manway. The IC travelled approximately 20 feet in reverse towards the manway and had trouble getting traction on an expansion joint cover. Figure 27 shows the IC struggling on the expansion joint cover. While trying to get over the expansion joint cover, the cover sank suddenly and the IC fell on its left side under the large diameter pipe. Figure 28 shows the IC on its side after this fall.

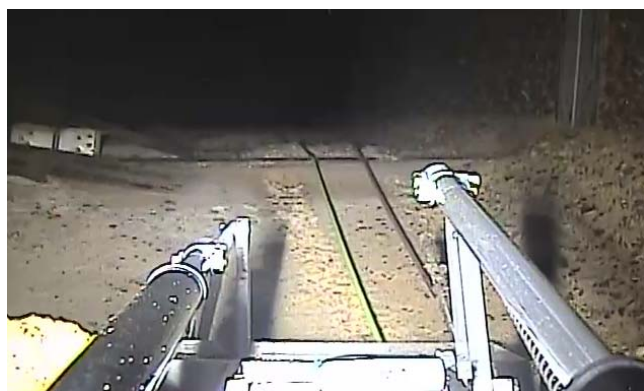
Figure 31 - Expansion Joint

The RC had trouble getting over the expansion joint covers near the pond. Figure 31 shows this expansion joint and note the RC had no problem crossing this joint on the way into the tunnel. The front wheels would get over the joint, but the back wheel would get stuck on the joint and the RC front end would raise up. The team decided to turn the RC around and back over the joint. This technique was successful during testing. While turning the RC around, the tether got tangled in the RC axles. The team felt pulling on the cable at this point wouldn't help, so the RC driver continued the turn and drove over the joint in reverse on the first try. The RC approached the pond in reverse and stopped at the top of the hill. At this point, water was observed dripping from the ceiling near the support column and falling into the pond. Figure 32 shows the support column top and the area where the team observed water dripping.

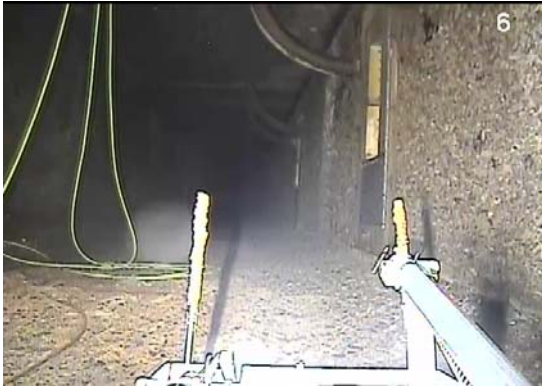
Figure 33 - RC Passing the Manway

The RC driver turned the RC around and drove to the manway. Figure 33 shows the green RC cable hanging from the manway and an air inlet into the old sand filter, building 294-H. The RC drove approximately 150 feet past the manway to the new sand filter, building 294-1H. At this location, there is a steep drop and the team felt the RC would not get back up over the drop. Figure 34 shows the view from the location where the RC stopped.

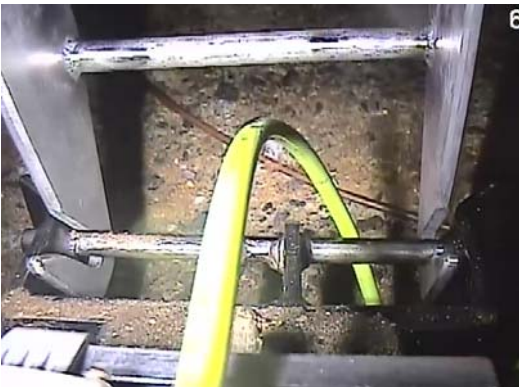
Figure 35 - Lifting Bail Grabbing the RC

The RC drove backwards to the manway while the operators pulled the tether up into the manway. When the RC was below the manway, the RC driver raised arms and forks, the Riggers lowered the lifting bail, grabbed the RC, and raised it off the tunnel floor. Figure 35 shows the lifting bail grabbing the RC. While the RC was suspended in the Tunnel, the operators used the Spray Wand to decontaminate the RC. Figure 36 shows the spray wand, the two lower lights, lower camera, and red water hose. Not shown are the upper camera and the joints that allow the Spray Wand to be collapsed for storage and insertion with a low ceiling.

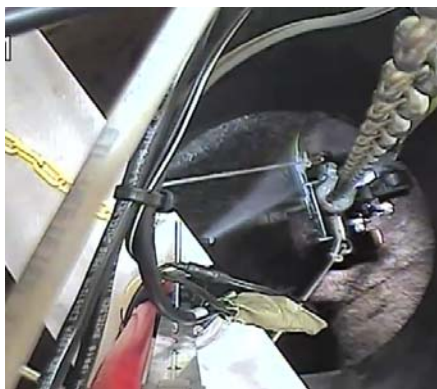
Figure 37 – Spray Wand Decontaminating the RC

Figure 37 shows a view from the upper Spray Wand camera looking down through the manway. The chain holding the lifting bail/RC and the water spray can be seen hitting the left rear wheel. Figure 38 shows a view from the RC camera. The water spray is being directed at the right front wheel. Once the RC appeared to be clean, the Riggers raised the RC up into the manway and allowed it to dry. Since the manway cover plate was off, air passed through the manway and dried the RC in approximately twenty minutes.

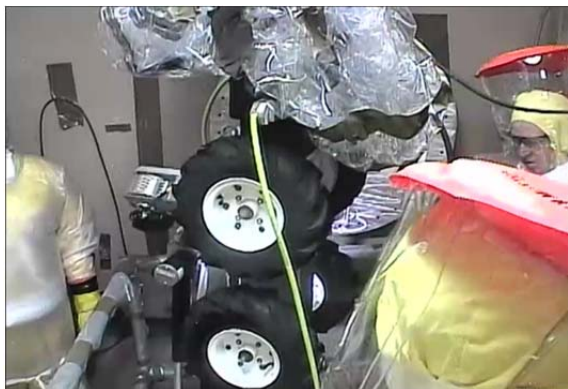
Figure 39 - First RC Bag Being Installed

As the Riggers raised the RC from the manway, Radiation Control personnel took several smears to ensure safe dose rates. The RC dose rates after the decontamination were 6,000 dpm/100 cm² alpha, 10,000 dpm/100 cm² beta/gamma. While the RC was hanging in 294-2H, personnel lowered the first bag down over the RC. This bag had been staged on the hoist before the deployment began. Figure 39 shows the first bag being lowered onto the RC while it hangs over the manway.

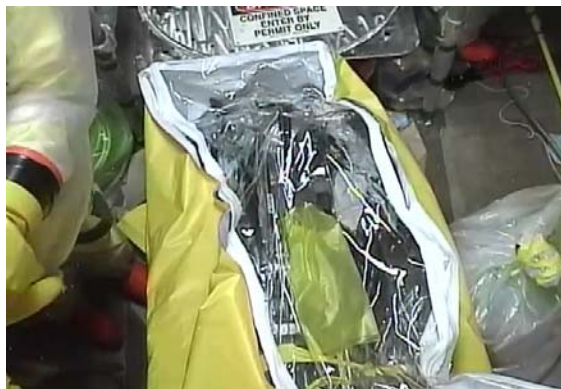
Figure 40 - RC in Custom Storage Bag

Operators cut and disposed as waste the RC tether that went into the tunnel. Both tether ends with connectors were saved in case wire color to pin numbers had to be verified in the future. Operators placed the bagged RC into a custom design storage bag. Figure 40 shows the RC in this custom bag. The RC was left in the building 294-2H until it is needed in the future.

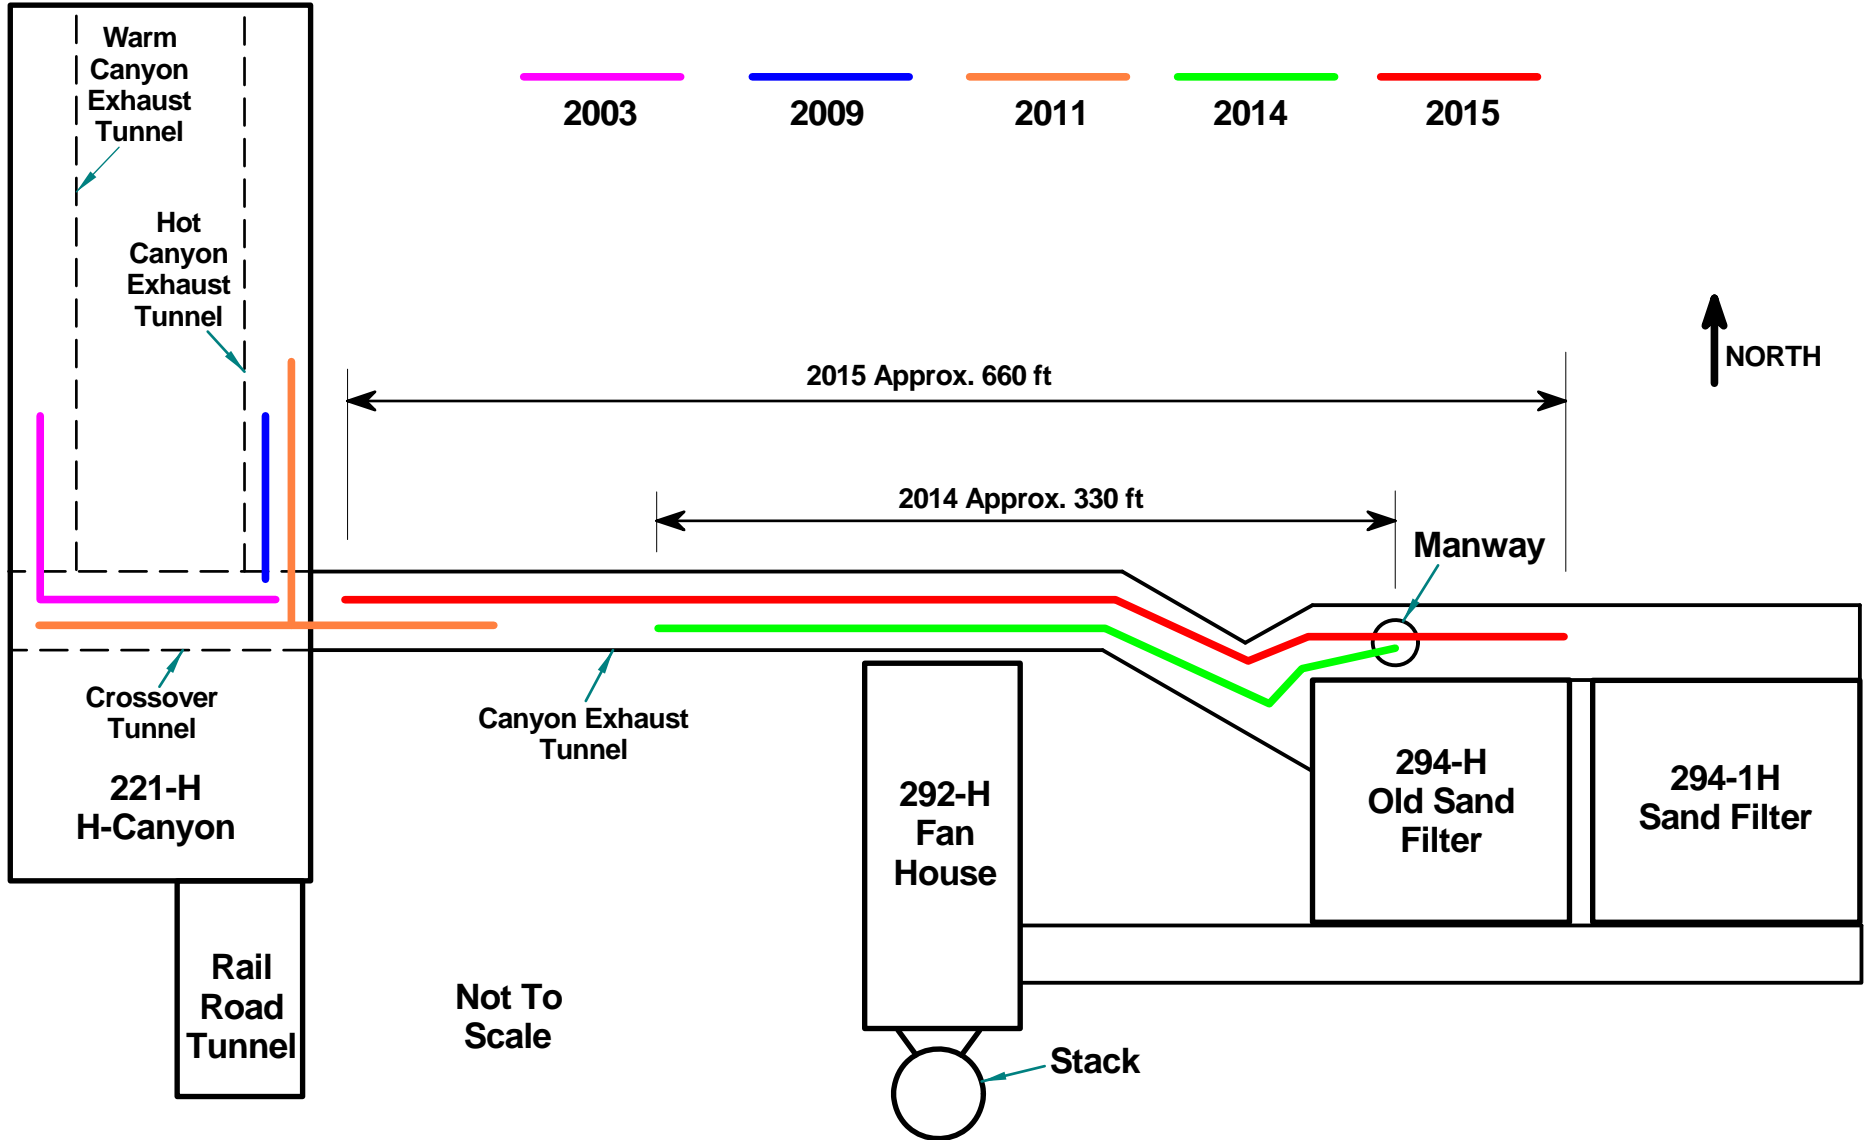
Appendix E - H-Canyon Exhaust Tunnel Crawler Routes

Appendix E shows all the H-Canyon Air Exhaust Tunnel inspection routes including the 2015 Recovery Crawler route. Note that the 2003, 2009, and 2011 crawlers entered from H-Canyon while the 2014 and 2015 crawlers entered from the manway in building 294-2H.
