Robotic Challenges and Deployments in an Active Fume Exhaust Tunnel

Steven Tibrea, Luther Reid, Eric Kriikku

Research & Development Engineering
Savannah River National Laboratory
Aiken, South Carolina
steven.tibrea@srnl.doe.gov

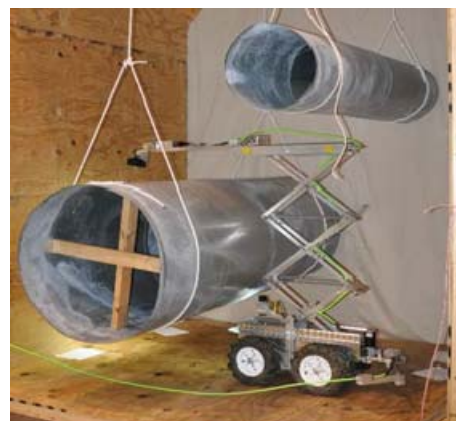
Figure 2. Inspection Vehicle during testing.

In June of 2014, SRS deployed an Inspection Vehicle (IV) in the CAEX tunnel to inspect the walls and ceiling. The IV was a commercially available sewer inspection vehicle with a custom scissors lift and slide to maneuver the inspection camera up and over the large duct in the tunnel. Figure 2

shows the IV positioning the camera above the large duct during testing.

During the 2014 IV deployment, the IV camera extension jammed with debris causing the IV to be top heavy. As a result, the IV tipped over and came to rest on its left side with the inspection camera under the under the large duct. The IV was not able to stand itself back up, so it was left in the CAEX tunnel.

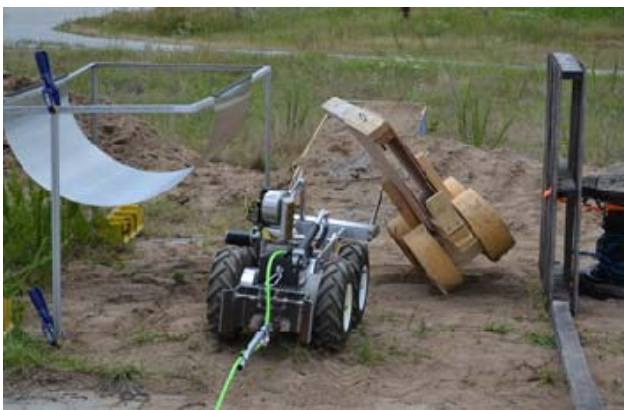
Figure 3. Recovery Vehicle up righting the mockup Inspection Vehicle.

In 2015, SRS decided to procure, test, and deploy a remote vehicle to recover the 2014 IV that tipped over in the CAEX tunnel. SRS wrote a procurement specification for a Recovery Vehicle (RV) and awarded a contract to a commercial company. The RV design was based on a standard sewer inspection vehicle with custom arms and forks added to the front. The arms and forks would be used to upright the 2014 IV. SRS tested the RV in May of 2015 and made some modifications based on test results. Figure 3 shows the RV up righting a mockup IV during testing. The wood on the right represents the tunnel wall and the metal on the left represents the large duct in the tunnel.

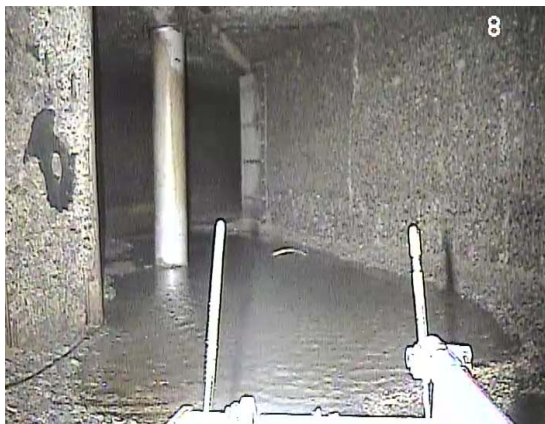
Figure 4. Large puddle in the CAEX tunnel.

The team deployed the RV through the 762 millimeter diameter access port on June 9, 10, and 11, 2015 in the CAEX Tunnel. The RV struggled with some obstacles in the tunnel, including a large water puddle, a pipe hanger laying on the ground, expansion joint covers that had fallen to the ground, and the concrete debris (i.e. sand and gravel) on the floor. Figure 4 shows the large water puddle from the RV camera and the puddle was approximately 330 millimeters deep.

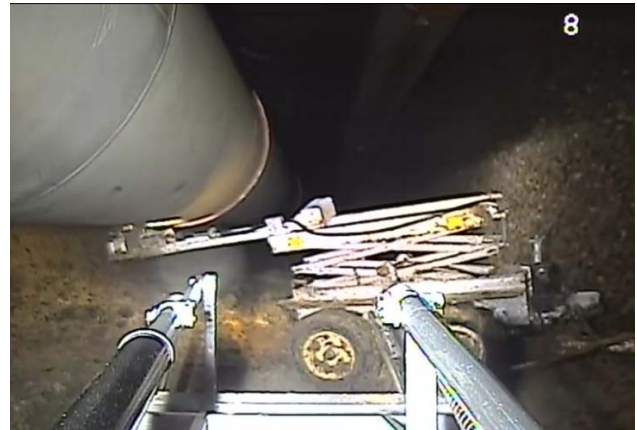
Figure 5. IV on its wheels.

The RV passed the obstacles and drove to the IV. The team spent approximately five hours working to upright the IV and eventually got the IV on its wheels. Figure 5 shows the IV on its wheels and note the IV camera is stuck under the large duct. The IV scissors lift and camera extension were not operating, so the team determined the IV would not be able to perform tunnel inspections in this condition. The plan was to move the IV out of the pathway and inspect the tunnel with the RV.

The IV travelled approximately 3 meters and struggled to drive over a piece of sheet metal. Unfortunately the IV tipped over trying to pass this obstacle. The team decided to leave the IV in this location and inspect the tunnel with the RV.
