# Impact of Glycolate Anion on Aqueous Corrosion in DWPF and Downstream Facilities

J.I. Mickalonis

December 2015

SRNL-STI-2015-00482, Revision 0

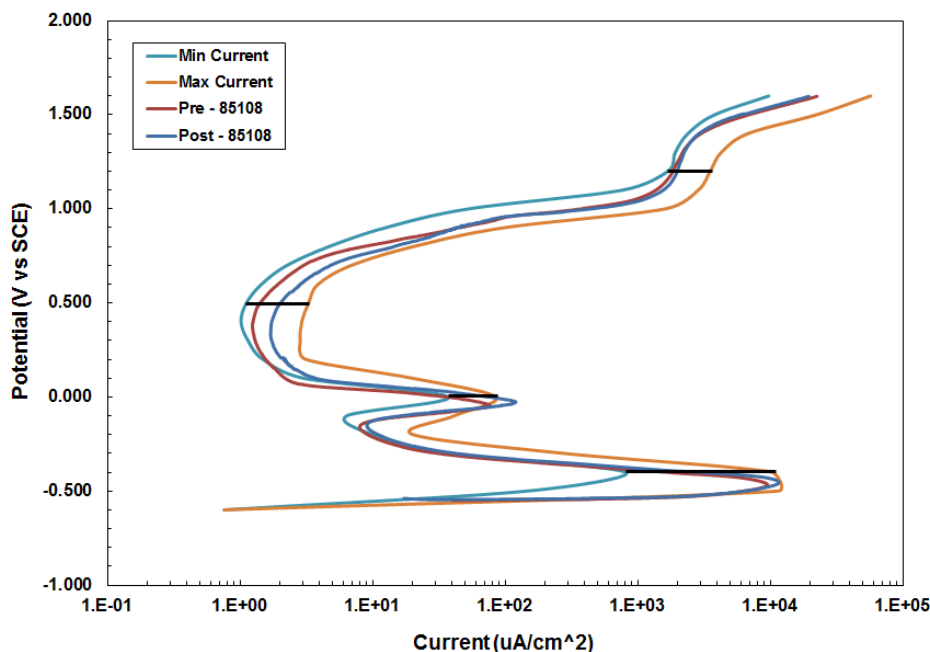
**Figure 3-1. Polarization results from a ASTM G5 standardized test performed with potentiostat SN 85108 that was used during the alternate reductant testing**

The potentiostat performance was verified following the test guidelines given in ASTM International G5 standard test method [6]. The data shown in Figure 3-1 for one of the potentiostats demonstrates that for a standardized test condition (430 stainless steel in de-aerated 1N sulfuric acid at 30 °C) the measured currents are within the acceptable minimum and maximum ranges both prior to and at the conclusion of testing. The other potentiostats had similar acceptable behavior.

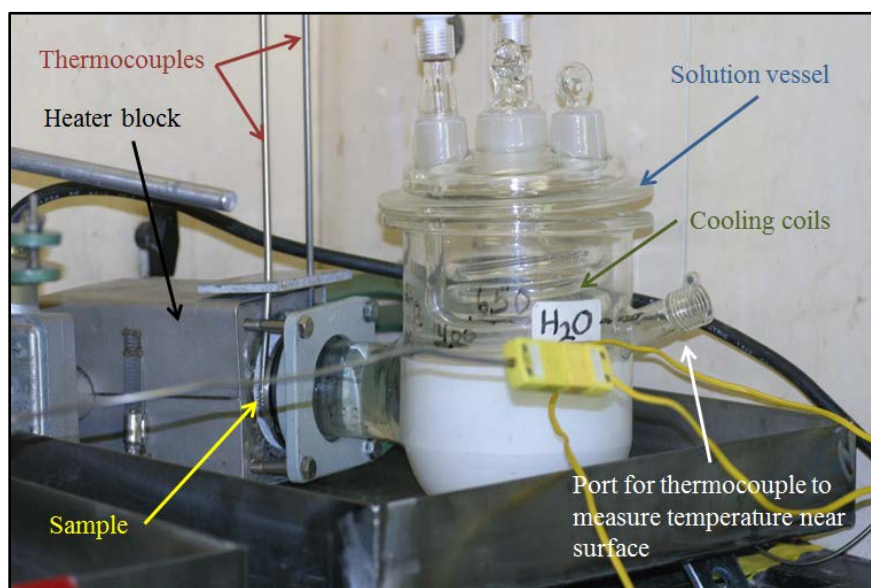
**Figure 3-2. Hot-wall test apparatus for corrosion testing under heat transfer conditions**

Hot-wall tests are performed to determine corrosion rates for materials exposed to solutions under heat transfer conditions. The hot-wall test was discussed in greater detail in Reference 5. The hot-wall apparatus is shown in Figure 3-2. The sample is clamped in position with the heater block on one side and the glass vessel, which contains the solution, on the other. A gasket made of ethylene propylene diene terpolymer is used to form the seal between the sample and the glass vessel. Solution volume was approximately 2.5 L. Solution levels dropped during testing due to evaporation and were replenished on an alternating schedule between fresh solution and distilled water so as not to concentrate constituents.

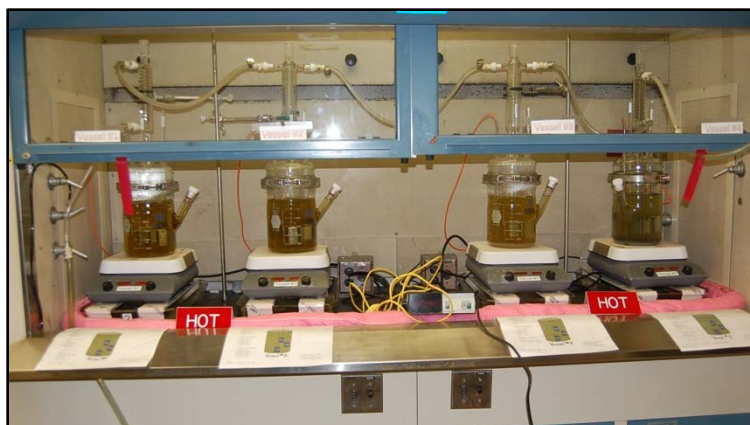
**Figure 3-3. Coupon immersion test setup**

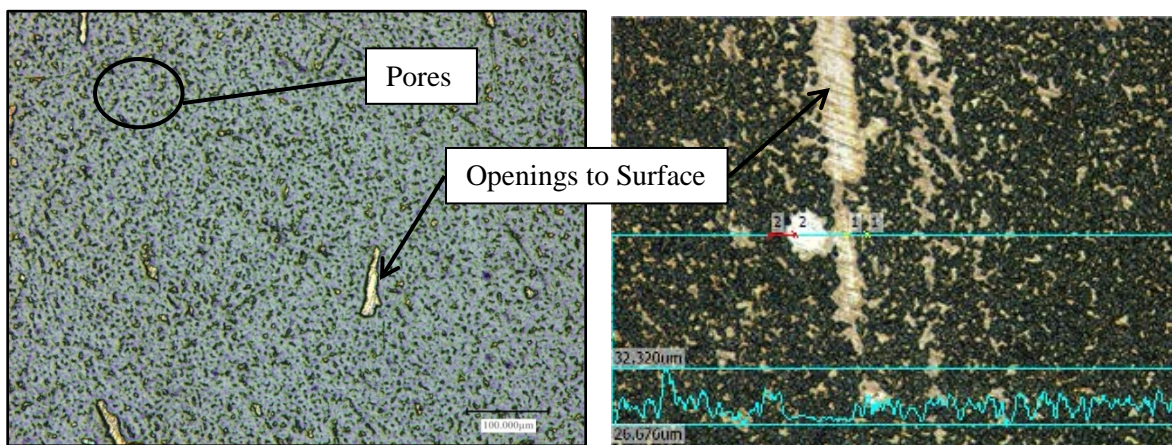
**Figure 4-3. Mn-rich coating that formed on C276 sample during CPP scan in formic-based CPC simulant: (A) center of coating and (B) near scratch made through coating**

The C276 samples tested in the formic-based simulant developed a coating, which needed to be removed prior to examination for pits. The coating was 1.5-3  $\mu\text{m}$  thick. Based on x-ray fluorescence data, the coating had a significant manganese peak. This coating had pores and openings as shown in the photograph in Figure 4-3 (A). The determination of openings and pores was made through laser confocal height scans near edges and scratches made in the coating as shown in Figure 4-3 (B). These openings may have allowed crevice-type conditions to occur that led to the observed pitting.

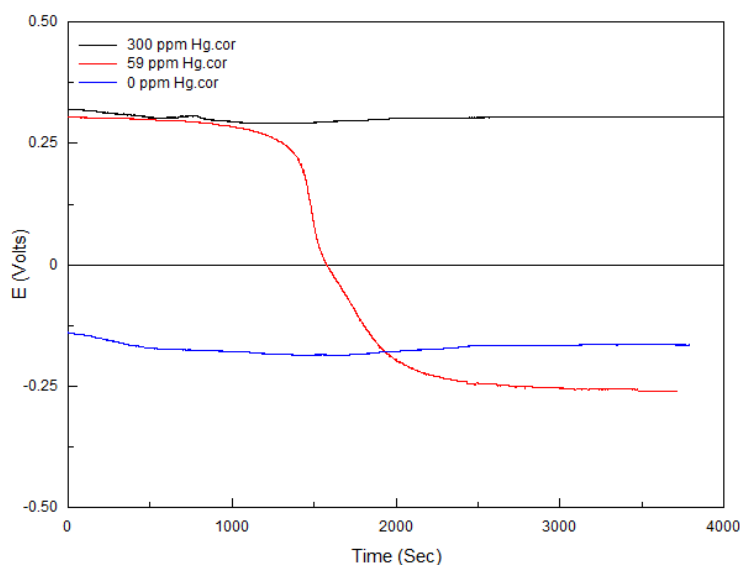
**Figure 4-4. Open-circuit potential measurements over time in glycolic-based solutions showing the impact of mercury concentration**

When mercury is present in a sufficiently high concentration, the OCP,  $E_{\text{corr}}$  and the entire CPP scan are shifted to more electropositive potentials. In Figure 4-4, the OCP measurements prior to CPP scans are shown for three different mercury concentrations (Tests #2 (0 ppm Hg), #2-Hg (59 ppm Hg), and #4-Hg (323 ppm Hg) in Table 4-3). For Test #2-Hg, the initial mercury concentration was 59 ppm and after electrochemical testing was 21 ppm. When sufficient mercury is present the OCP is maintained at values greater than 0.0 V. When no mercury is present the OCP values always stayed below 0.0 V. At intermediate concentrations, the OCP values transition from greater than 0.0 V to less than 0.0 V. The inference from this data is that the soluble  $\text{Hg}^{+2}$  is reduced with time (i.e. possibly the formation of mercuric chloride ( $\text{HgCl}_2$ ), although these particular solutions had low to no chloride) and not replenished.

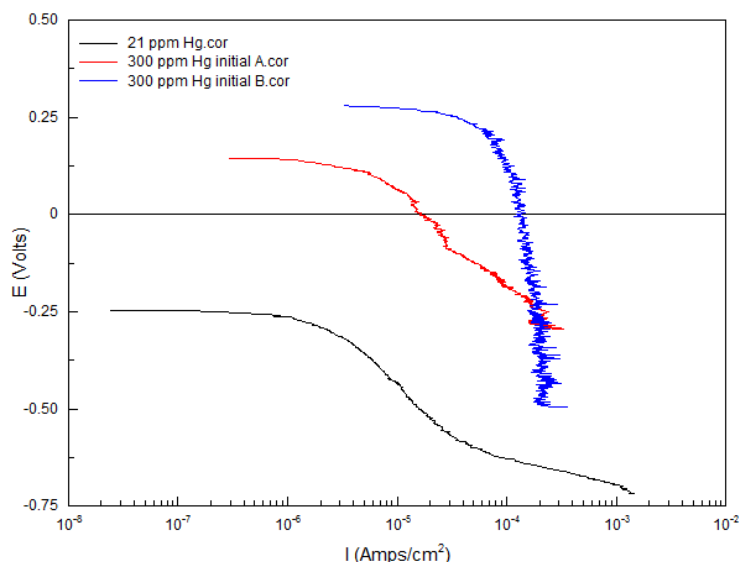
**Figure 4-5. Cathodic polarization curves at high and low mercury concentrations**

Cathodic polarization scans were performed to investigate the difference in cathodic reactions that might be occurring under these different conditions. The same solutions that were used for the CPP scans were used for these tests. The after test concentration of mercury was not measured for Test #4 so the initial is given in the figure. The two batches of solution for Test #4 (300 ppm Hg initial A and B), however, appear to have slightly different mercury concentrations as indicated by the lower starting potential for A than B. The presence of mercury in solution at sufficient concentration appears to aid in the depolarization of the surface for the oxygen reduction reaction, which may be the driver for the higher corrosion rate observed in mercury-containing solutions. Mercury reduction on the surface is not expected since it was not observed on the surface after testing, thereby localized cathodes do not form to drive pitting corrosion.

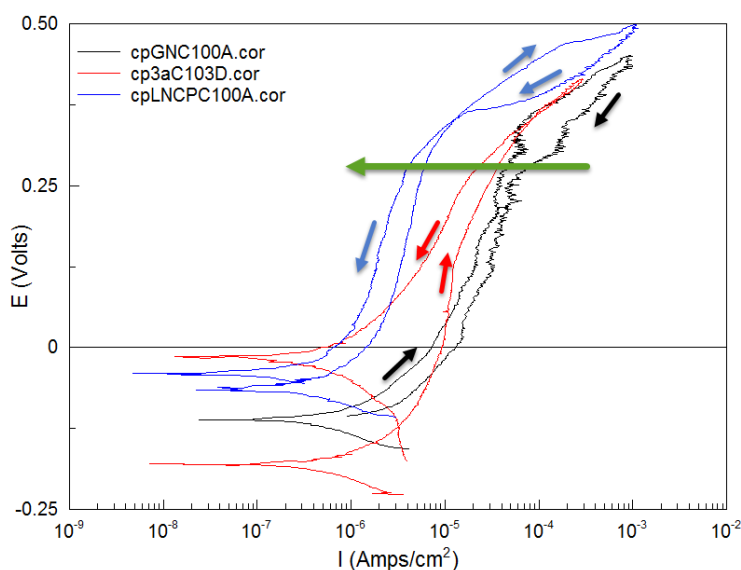
**Figure 4-6. Effect of nitrate concentration on the CPP scans for C276 in glycolic-based solutions at boiling (arrow indicates decreasing nitrate concentration from 92,700 to 34,237 ppm)**

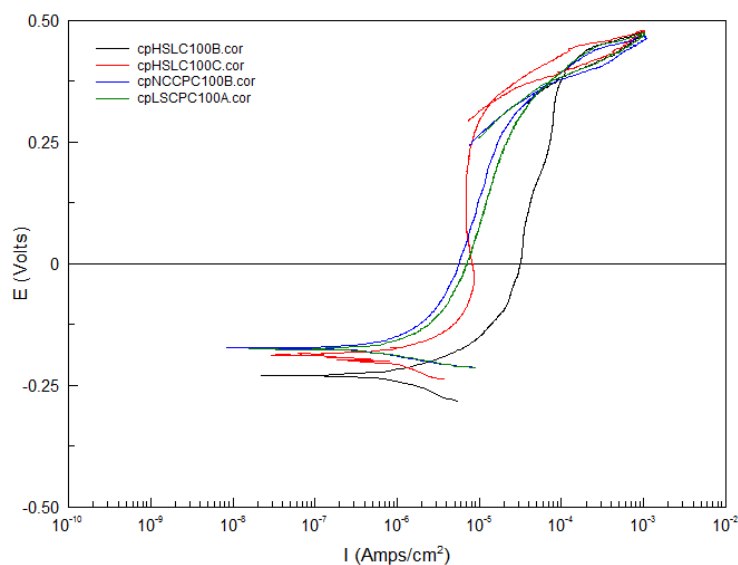
**Figure 4-7. CPP scans for C276 in boiling glycolic-based solutions with different sulfate concentrations, ranging from 507 to 5571 ppm (chloride concentration ranged from 0 to 35 ppm)**

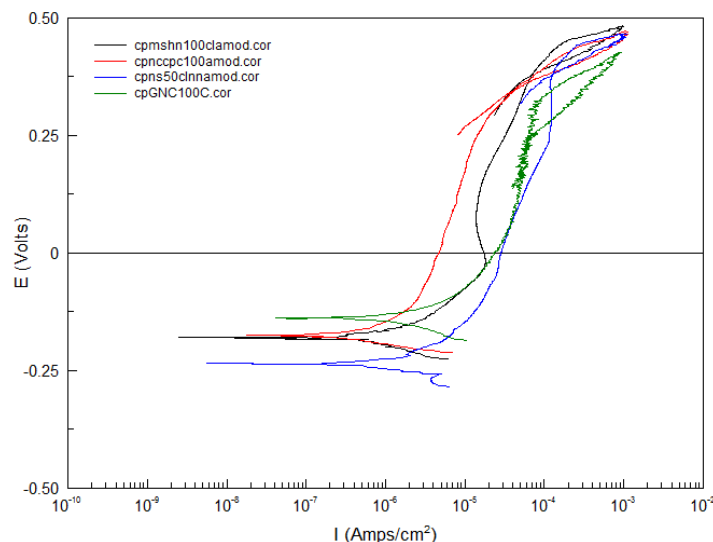
**Figure 4-8. CPP scans for C276 in boiling glycolic-based solutions with different chloride concentrations, ranging from 0 to 874 ppm (sulfate concentration ranged from 2000 to 2635 ppm)**

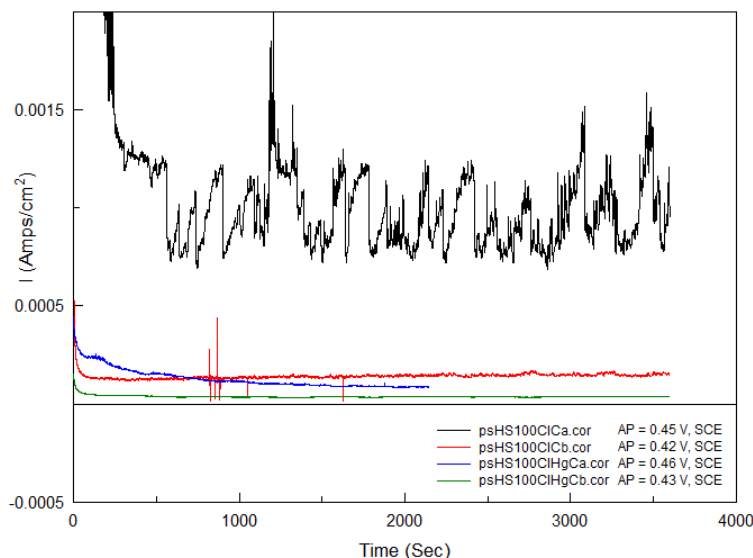
**Figure 4-9. Chrono-current traces for potentiostatic tests at potentials within the positive hysteresis loop for boiling glycolic-based solutions with and without mercury**

A series of potentiostatic test were conducted at applied potentials (AP) within a positive hysteresis loop (greater than the  $E_{pp}$ ) to determine if pitting was found to occur at times longer (one hour) than during a CPP scan (1-2 minutes to pass through the potential range of the loop). The test solutions contained approximately 57500 ppm nitrate, 5600 ppm sulfate, and 100 ppm chloride, and were with and without mercury (Solutions from Tests #1 and #1-Hg in Table 4-3). Figure 4-9 shows the chrono-current traces, which in general started at the highest current value for the trace and quickly dropped to a lower constant value. This type of trace is consistent with a material undergoing general corrosion. A chrono-current trace for pitting would be increasing because as pits develop more current is generated at the expanding surface area.

The chrono-current trace in the mercury-free solution at an AP of 0.45 V differed slightly from the others in that large current transients were observed. The source of these transients is not known, however, pitting transients have similar characteristics. The current is on the order of 1 mA which suggests these transient could be indications of pitting. Meta-stable pitting transients or passivating pits have transients that are 1-2 orders of magnitude lower than those observed [15]. However, pitting was not observed on the sample. Other sources for these transients may be reactions of solutions species on the sample surface.

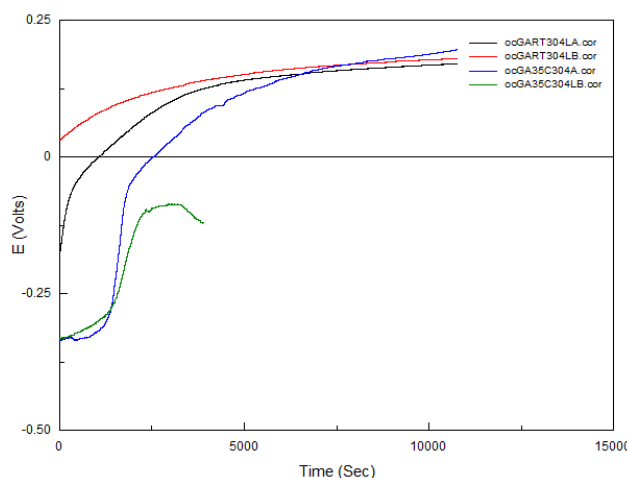
**Figure 4-10. Open-circuit potentials of 304L stainless steel in 70% glycolic acid at room temperature and 35° C**

room temperature only the more noble potential occurred as shown in Figure 4-10. The different OCPs again were associated with different LPR corrosion rates, 0.05 mpy at 0.2V and 0.42 mpy at -0.123V. At room temperature the average LPR corrosion rate was 0.08 mpy.

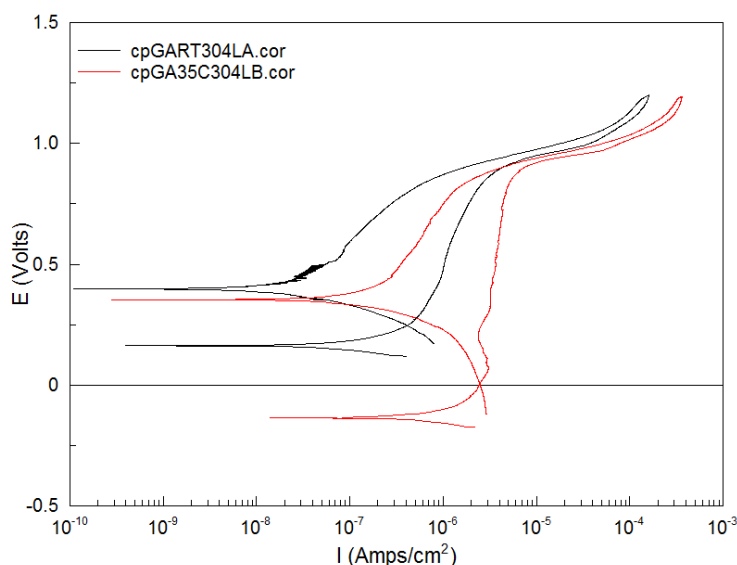
**Figure 4-11. CPP scans for 304L in 70% glycolic acid at room temperature and 35° C**

The CPP scans also depended on the initial OCP value as shown by the data in Figure 4-11. The more active OCP value ( $< 0.0$  V, cpGA35C304LB.cor) has a CPP scan with a greater  $i_p$  value as well as a possible transition in state of the surface oxide or cathodic reaction occurring at the surface. The CPP scan with a passive OCP ( $> 0.0$  V, cpGART304LA.cor) was independent of temperature and all showed simple passive polarization curves.

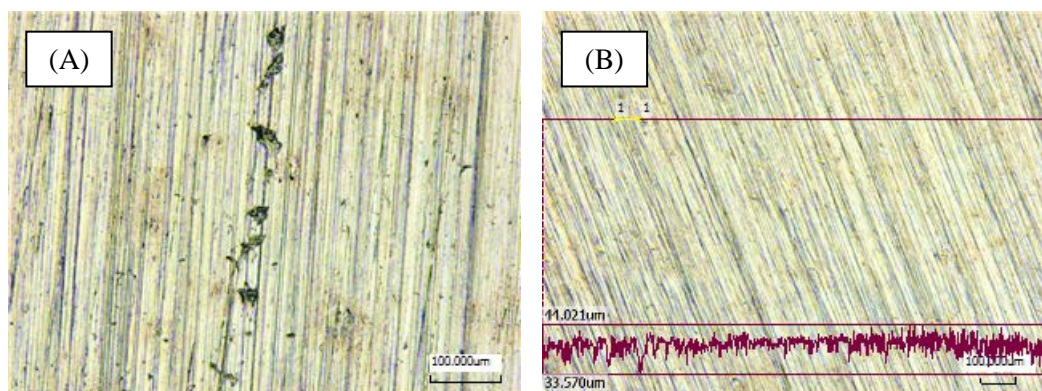
**Figure 4-12. Micrographs of 304L stainless steel after electrochemical testing in 70% glycolic acid at (A) room temperature and (B) 35 °C**

few pit-like features were located as shown by the micrograph in Figure 4-12 (B). Their depth ( $\sim 5 \mu\text{m}$ ) was difficult to differentiate from variability in the surface morphology as shown by the laser height scan in Figure 4-13. With a negative hysteresis in the CPP scans, these pits are most likely metastable pits that initiated and passivated. Pit growth; however, is not determined from these types of electrochemical tests.

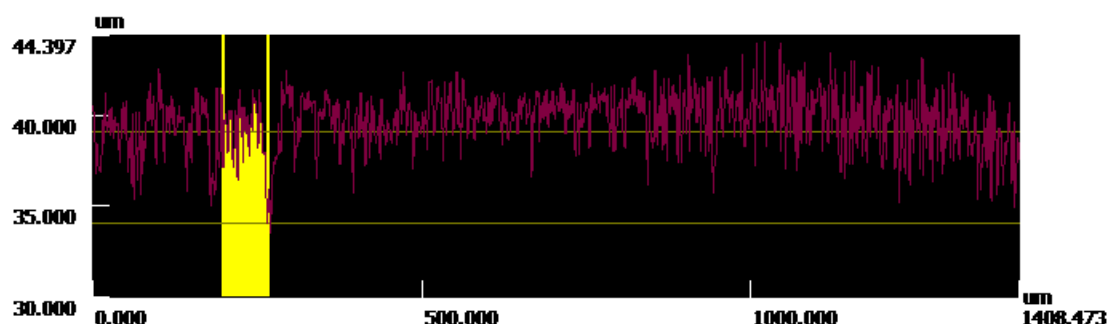
**Figure 4-13. Laser-height scan for 304L stainless steel after electrochemical testing in 70% glycolic acid at 35 °C (for micrograph in Figure 4-12 (B))**

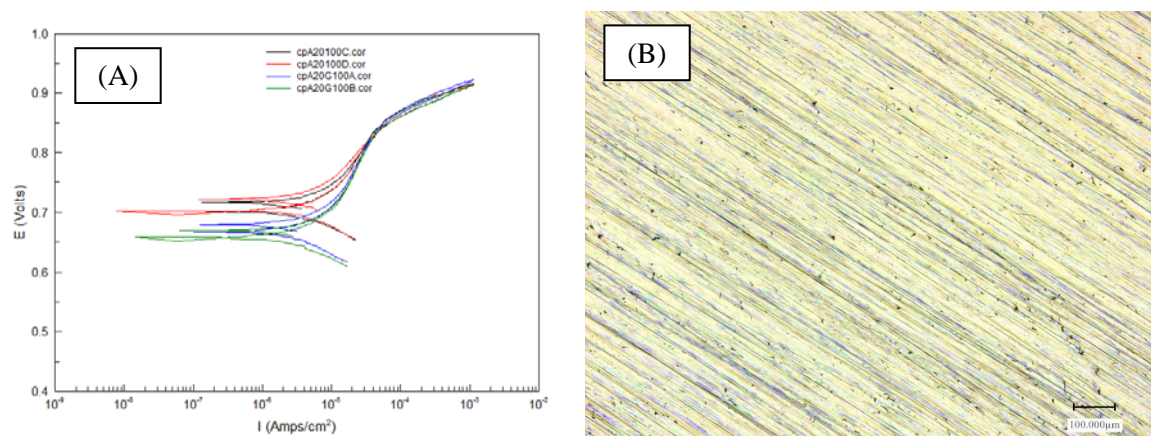
**Figure 4-14. Alloy 20 in a boiling 12.5% nitric acid solution: (A) CPP scan for solutions with and without the glycolate anion and (B) micrograph of sample surface tested in solution containing the glycolate anion**

In the REDC, equipment is decontaminated using a 12.5% nitric acid solution. As equipment is cleaned the soak solution is expected to build up in glycolic acid at some unknown rate from residual glycolate on equipment. For testing purposes, that concentration was taken at slightly greater than the initial estimated maximum concentration that would be carried over in the off gas components of the CPC (10 g/L). Alloy 20 is the principal MoC since it is the material for the soak tank. The test solution was boiled since future requirements may include a hot solution, which would be accomplished by using a steam lance. Electrochemical tests both with and without added sodium glycolate to the boiling 12.5% nitric acid solution showed passive behavior with no pitting observed on the sample after testing. General corrosion rates were also similar with average rates of 3.1 mpy and 3.3 mpy for the solutions with and without added sodium glycolate, respectively. Figure 4.14 shows the CPP curves for both sets of samples and a micrograph of a sample surface tested in the glycolate-bearing nitric acid solution. If additional contaminants and aggressive species (chloride and sulfate) are expected to increase with continual re-use of solutions, additional testing should be considered.

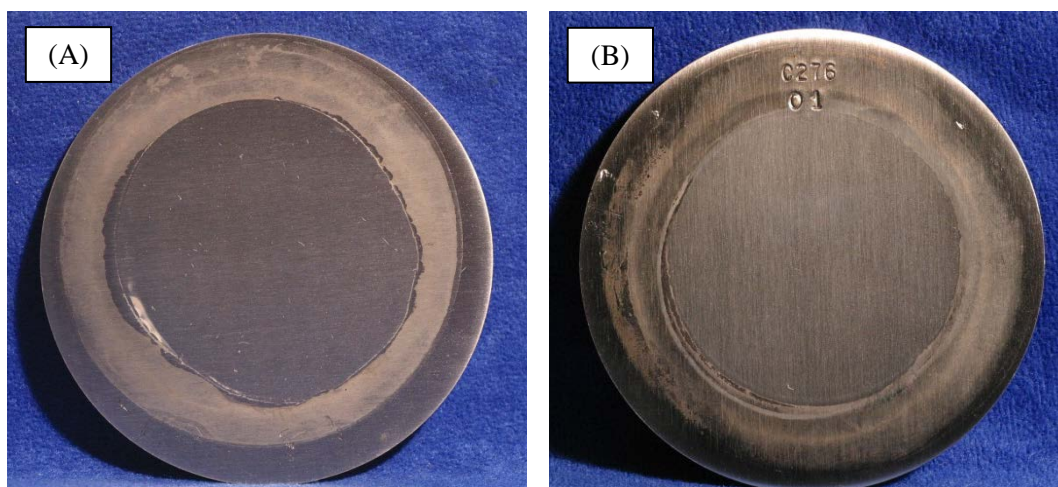
**Figure 4-15. Post-test photographs of C276 hot-wall test samples after month exposure at boiling conditions: (A) follow-up test sample; and (B) first phase test sample**

The C276 sample in the glycolic-based solution during the follow-up testing had similar results to the first data set, where pitting was observed. No significant deposits formed on the surface; deposits were generally limited to the gasket perimeter as seen in the post-test photographs in Figure 4-15 for the samples from both tests. Measured pit depths of the few located on the sample were slightly smaller than those measured for the first phase data set (7-8 μm) but were of the same order of magnitude. The smaller depths might be associated with the lower chloride concentration used during the follow-up testing.

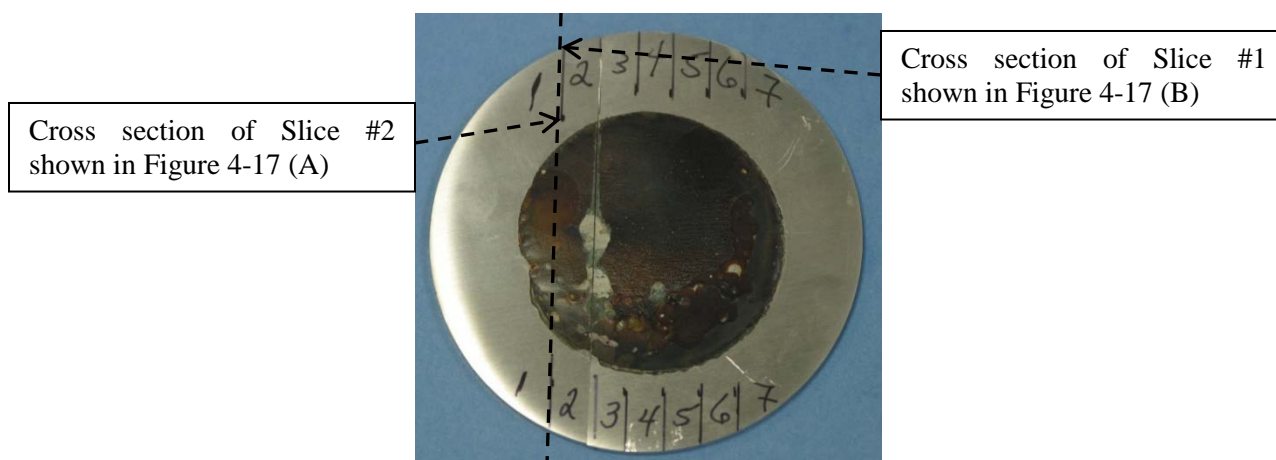
**Figure 4-16. C276 hot-wall test sample after exposure to a formic-based solution showing sectioning prior to examination for localized corrosion (only one cut shown)**

obtain some indication of the presence of localized corrosion, the sample was sectioned with an electric discharge machine into a number of slices as shown in Figure 4-16. The cut edges of each slice were then examined in cross-section along the coating/metal interface for the presence of any pitting or crevice corrosion.

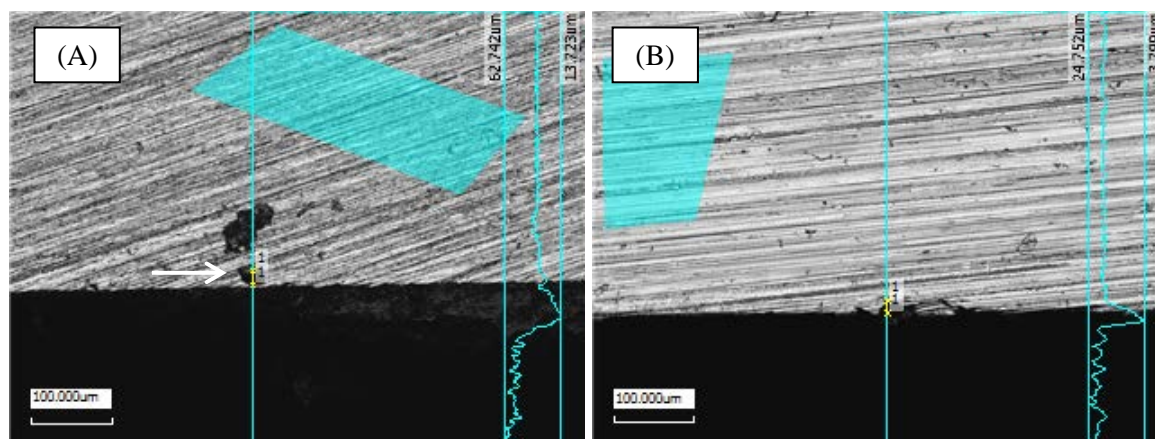
**Figure 4-17. C276 hot-wall sample after testing in the formic-based SRAT/SME supernate: (A) cross-sectional view (400x) of Slice #2 showing sub-surface pit; (B) cross-sectional view (400x) from Slice #1 showing surface pit**

In the initial analysis of these slices, the sample was thought not to have pitted. This result seemed inconsistent with electrochemical results discussed previously and the coupon immersion results discussed in Section 4.3. After a review of the analysis method for the LCM data and changes in the processing of the laser data from the LCM, pitting was identified on the slices. Two examples are shown in Figure 4-17 from Slices #1 and #2 (shown in Figure 4-16). In Figure 4-17 (A) a subsurface pit was identified (indicated by the arrow) on Slice #2, while in Figure 4-17 (B) a surface pit was identified on Slice #1.

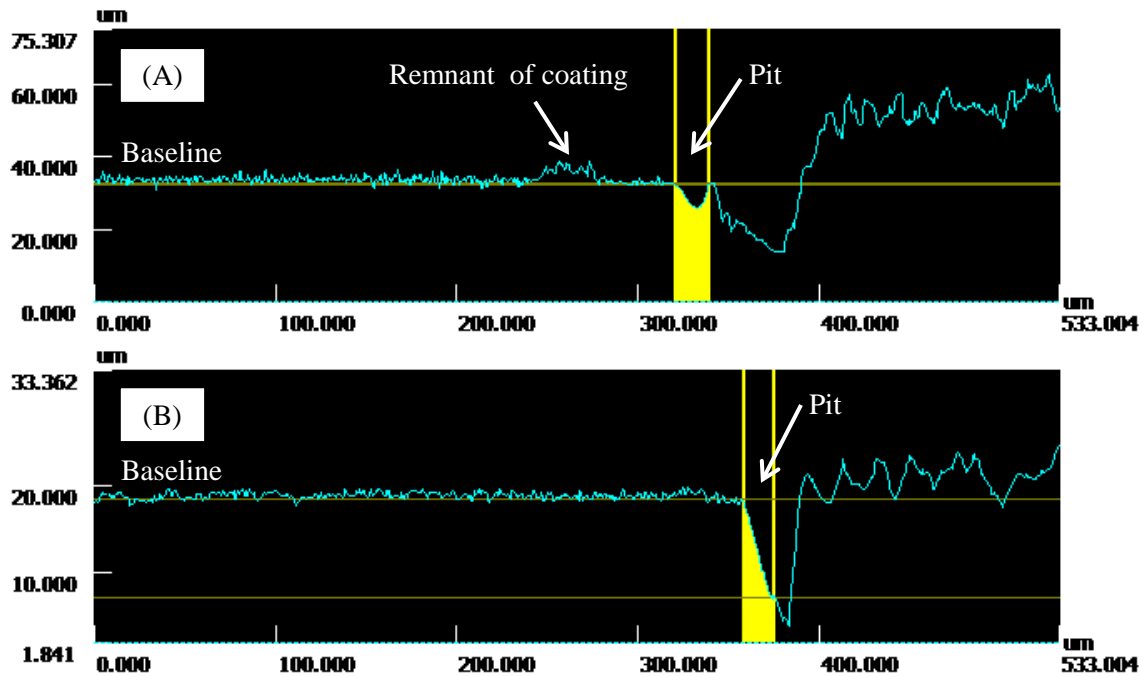
**Figure 4-18. C276 hot-wall sample after testing in the formic-based solution: (A) profile line shown in Figure 4-17(A) through sub-surface pits; and (B) profile line shown in Figure 4-17 (B) through surface pit**

decipher since the coating had separated from the sample, i. e. possible crevice. The pit depth was measured at approximately 11  $\mu\text{m}$ .

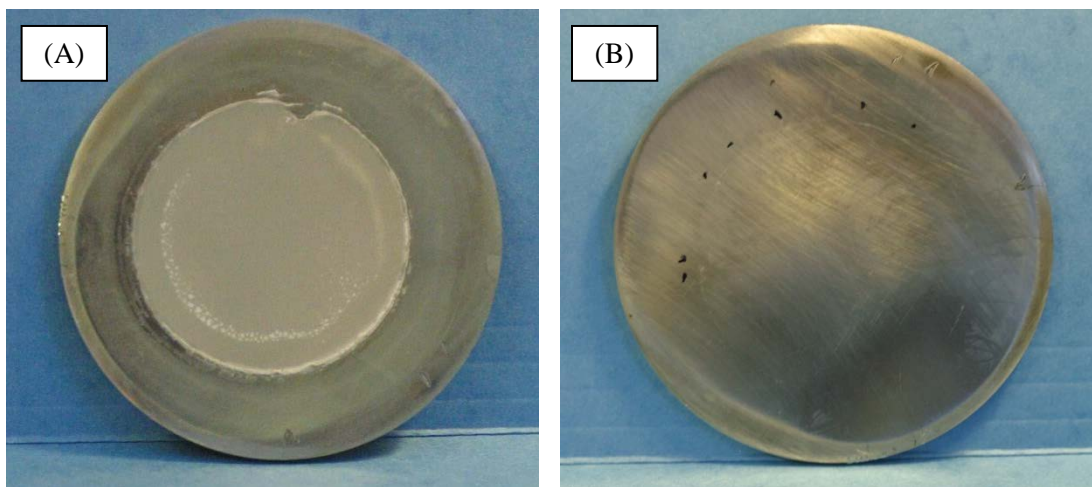
**Figure 4-19. G30 hot-wall samples exposed to a boiling basic concentrated recycle solution: (A) post-test photograph showing silicon-rich film; and (B) post-cleaning photograph after removal of film (black spots showing locations of observed pitting)**

The G30 samples tested in basic concentrated recycle solution were used to evaluate degradation for the 2H evaporator. In both tests (with and without the glycolate anion), a film formed on the sample. X-ray fluorescence results showed the film to be primarily composed of silicon. The silicon was likely from the glass test vessel, which was etched during the testing in these high pH solutions. Figure 4-19 shows the sample for the glycolate-containing solution before and after cleaning the sample.

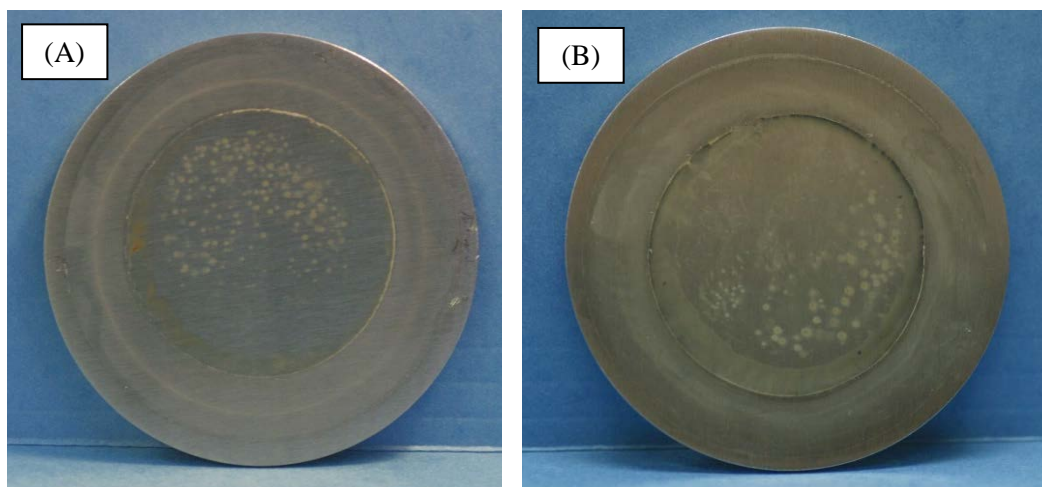
**Figure 4-20. Post-test photographs of G3 hot-wall sample exposed to a boiling dilute waste solution with (A) and without (B) the glycolate anion**

Similar to the G30 hot-wall samples, the G3 hot-wall samples tested in a dilute waste solution with and without the glycolate anion had a similar post-test appearance as well as pit characterization. Figure 4-20 shows the post-test photographs of the G3 hot-wall samples. Their appearance was also similar to the G3 sample tested initially [2]. The spots in the center had pits in only some cases and only after exposure to the solution with the glycolate anion. Most of the pits were generally associated with deposits. The pit depths as shown in Tables 4-5 and 4-6 for the follow-up tests as well as the first phase data set are of the same order of magnitude and not considered different.

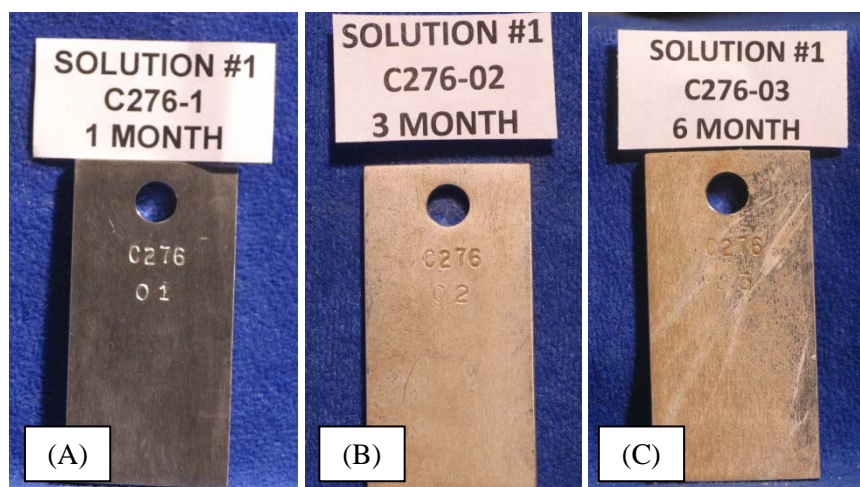
**Figure 4-21. Photographs of C276 coupons from the coupon immersion test after (A) 1 month, (B) 3 months, and (C) 6 months exposure in Solution #1**

With increasing time in the test, coupons had an increasing buildup of deposits or a coating on the surface. The coating appeared to be similar for the glycolic-based solutions and different for the formic-based solution. The formic-based supernate had the most coating, which was also the most difficult to remove during cleaning after the test. Coatings formed in glycolic-based solutions were somewhat brittle and easily removed. These features are shown in Figures 4-21 and 4-22. Figure 4-21 shows the coating development on C276 in Solution #1 over the six-month exposure, the other MoCs had similar increases in coating coverage. Figure 4-22 shows welded C276 coupons from each solution (#1 through #4) at the end of the six-month exposure. The scratch on the welded C276 coupon exposed to Solution #1 was from tweezers and is an indication of the coating ease of removal. All the six-month coupons from Solution #3, which was a glycolic-based solution, actually produced a darker coating not previously observed on coupons removed from Solution #3. The reason for the change is not known, but could be attributed to the mercury addition at the half way point in the test.

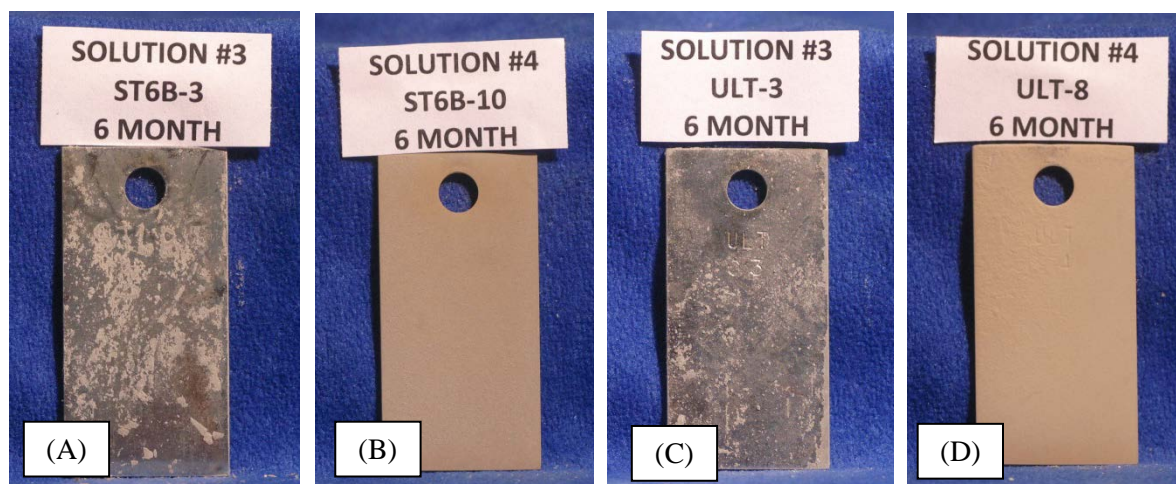
**Figure 4-23. Photographs of five-month exposure coupons: (A) Stellite 6B in Solution #3; (B) Stellite 6B in Solution #4; (C) Ultimet in Solution #3; and (D) Ultimet in Solution #4**

On all the coupons removed during the immersion test, corrosion was not obvious. After the debris or coating was removed, grinding marks were still clear and there was minimal surface roughening. Generally, the biggest impact was from the cleaning process when plastic scrapers were needed to remove remnant coating. The lack of corrosion can be seen in the photographs shown in Figures 4-21 and 4-22 for the C276 coupons and in Figure 4-23 for Stellite and Ultimet coupons removed after five-month exposures in Solutions #3 and #4 (a glycolic- and formic-based solution, respectively, with 50 ppm chloride and 2000 ppm sulfate). Note that the coating on the coupons exposed to Solution #3 was easily removed and came off during handling.

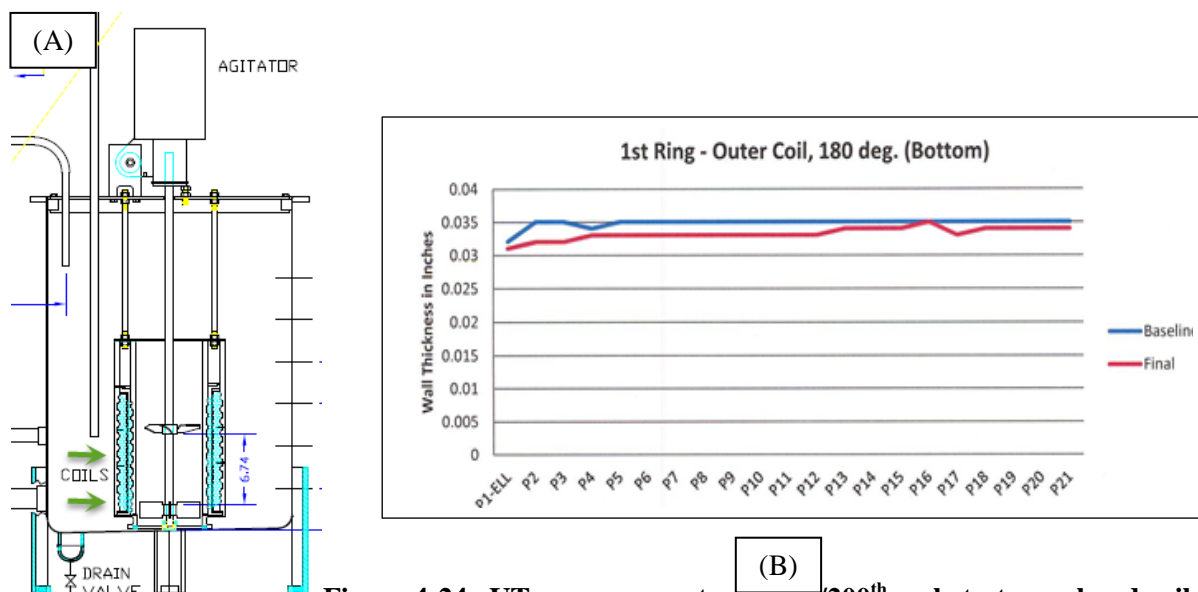
**Figure 4-24. UT measurements of the 1/200<sup>th</sup> scale test vessel and coils: (A) vessel diagram with arrows showing coil measurement location; and (B) UT thickness measurements for lowest (1<sup>st</sup>) ring of the outer coil welds along the bottom surface (180° position)**

The largest wall loss was found on the inner and bottom surfaces of lowest ring of the heating coils and just below the bottom head to shell weld of the vessel [19, 20]. Figure 4-24 (B) shows the UT measurements along the bottom surface of the lowest ring before (baseline) and after (final) the test. The ring wall losses were approximately 2-3 mils. No wall loss was measured for the coil lengths that were located between the agitator blades. The location of these losses was similar to those observed on the DWPF SME coil assemblies and where erosion is the primary degradation mode. Several circumferential welds for the coils also showed no wall loss. The loss of the vessel wall thickness below the weld was 2 mils.
