# Impact of Glycolate Anion on Aqueous Corrosion in DWPF and Downstream Facilities

SRNL-STI-2015-00482, Revision 1

**Keywords:** *glycolic acid, formic acid, DWPF, corrosion, high-nickel alloys, stainless steels*

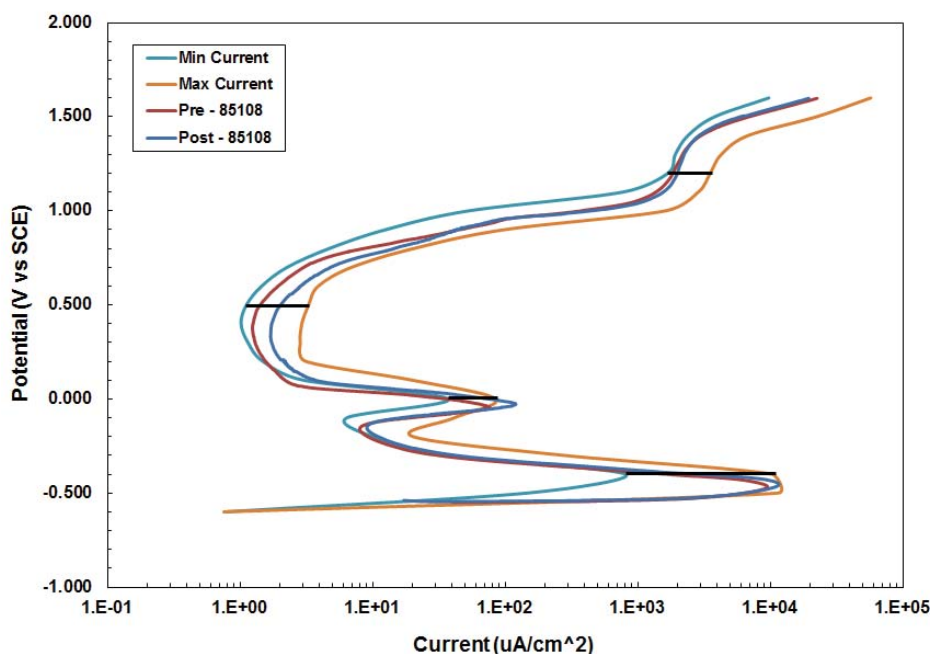
**Figure 3-1. Polarization results from ASTM G5 standardized tests performed with potentiostat SN 85108 that was used during the alternate reductant testing**

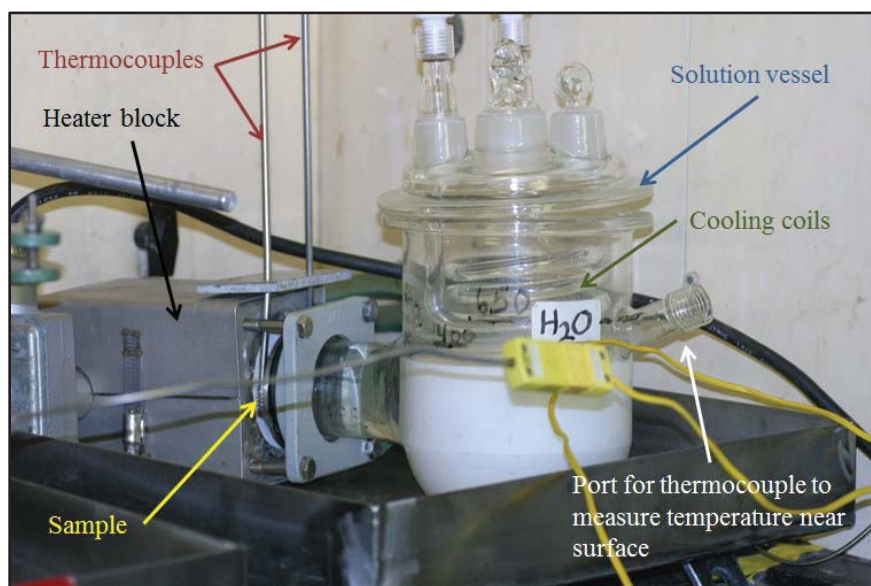
**Figure 3-2. Hot-wall test apparatus for corrosion testing under heat transfer conditions**

Testing was performed on MoCs for the heating coils in the CPC vessels (C276), the tube bundle and warming coils for the 2H Evaporator (G30) and the heater for the ETF Evaporator (G-3). Samples, which were procured from Metal Samples (Munford, AL), had surfaces prepared with a 600-grit silicon carbide paper. Samples were 3-inch diameter and had a thickness of 1/8 to 1/16 inch. The solutions used to clean the samples after testing were nitric acid solutions from 0.1 M up to 2.0 M. The sample tested in the formic-based solution had a tenacious coating on the exposed surface at the conclusion of the test. Other cleaners, including sodium hydroxide (pH 14) solutions and glycolic acid, were tried but were ineffective. At the conclusion of the hot-wall test and after cleaning, the samples were examined for corrosion using a LCM. Laser scans were taken to characterize any localized corrosion and the condition of untested material surfaces.

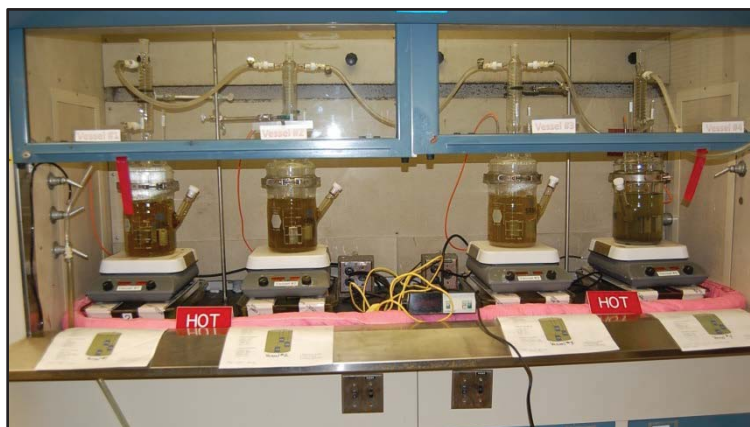
**Figure 3-3. Coupon immersion test setup**

The test solutions were based on the results from the electrochemical testing and were chosen to bracket a range of sulfate concentrations since it was shown to be the dominant aggressive species for localized corrosion. The chloride concentration has typically been below 100 ppm (mg/L) for the DWPF sludge batches and HLW processing at the SRS is not expected to introduce additional chloride species that would increase the concentration in the waste. Three glycolic-based compositions and one formic-based composition were chosen. Besides the reductant, the sulfate, nitrate, chloride, and mercury concentrations were also variables. The solution chemistries are discussed further in Test Solutions.

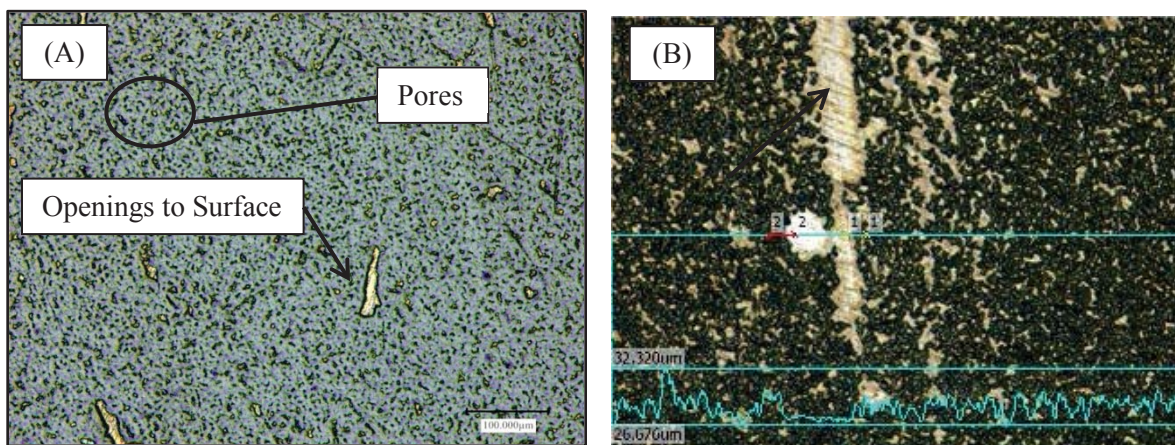
**Figure 4-3. Mn-rich coating that formed on C276 sample during CPP scan in formic-based CPC simulant: (A) center of coating and (B) near scratch made through coating**

The C276 samples tested in the formic-based simulant developed an adherent coating, which needed to be removed prior to examination for pits. The coating was 1.5-3  $\mu\text{m}$  thick. Based on x-ray fluorescence data, the coating had a significant manganese peak. This coating had pores and openings as shown in the photograph in Figure 4-3 (A). The determination of openings and pores was made through laser confocal height scans near edges and scratches made in the coating as shown in Figure 4-3 (B). These openings may have allowed crevice-type conditions to occur that led to the observed pitting.

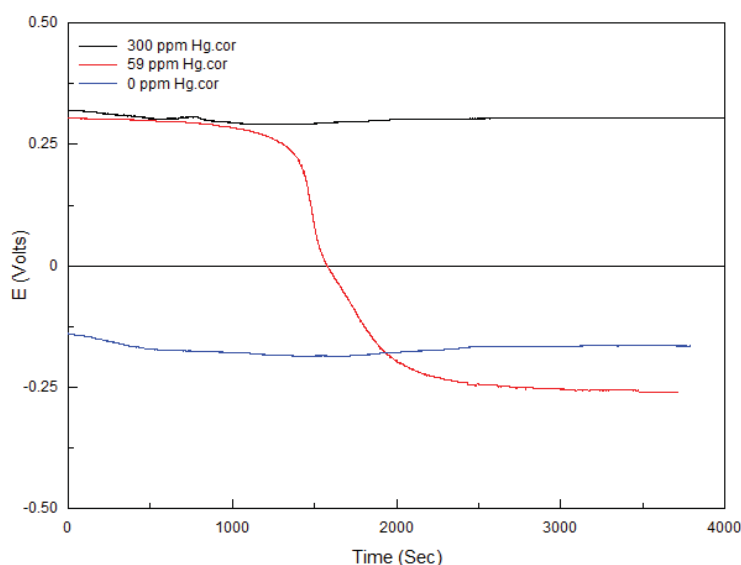
**Figure 4-4. Open-circuit potential measurements over time in glycolic-based solutions showing the impact of mercury concentration**

When mercury is present in a sufficiently high concentration, the OCP,  $E_{\text{corr}}$  and the entire CPP scan are shifted to more electropositive potentials. In Figure 4-4, the OCP measurements prior to CPP scans are shown for three different mercury concentrations (Tests #2 (0 ppm Hg), #2-Hg (59 ppm Hg), and #4-Hg (323 ppm Hg) in Table 4-3). For Test #2-Hg, the initial mercury concentration was 59 ppm and after electrochemical testing was 21 ppm. When sufficient mercury is present the OCP is maintained at values greater than 0.0 V. When no mercury is present the OCP values always stayed below 0.0 V. At intermediate concentrations, the OCP values transition from greater than 0.0 V to less than 0.0 V. The interpretation of this data is that the soluble  $\text{Hg}^{+2}$  is reduced with time. The mercury decrease may be from the formation of mercuric chloride ( $\text{HgCl}_2$ ), although these particular solutions had low to no chloride.

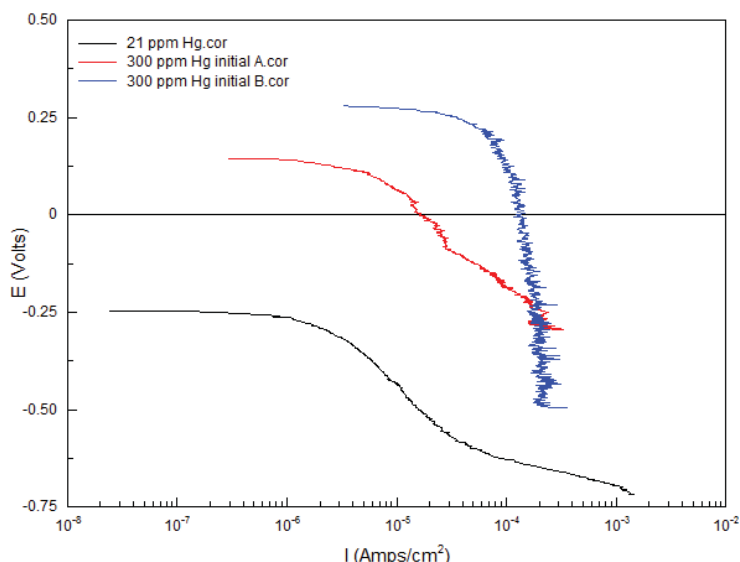
**Figure 4-5. Cathodic polarization curves at high and low mercury concentrations**

solutions as shown in Table 4-3. This increase in corrosion rate, however, is dependent on other constituents in solution. At high sulfate or nitrate concentration there is not an increase in corrosion rate. More study will be needed to delineate the impact of mercury in these solution chemistries.

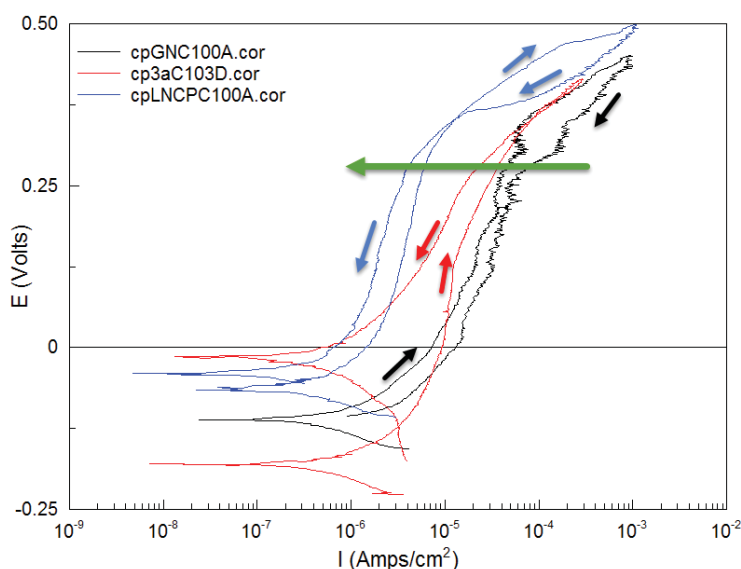
**Figure 4-6. Effect of nitrate concentration on the CPP scans for C276 in glycolic-based solutions at boiling (arrow indicates decreasing nitrate concentration from 92,700 to 34,237 ppm)**

The CPP scans shown in Figure 4-6 through Figure 4-8 for glycolic-based solutions have positive hystereses similar to that observed for the CPC glycolic-based simulant from the 22-L scale up testing (Figure 4-3). The potentials at which reverse scan currents are greater than the forward scan currents are close to the vertex potential (potential at which the scan reverses direction) and not  $E_{\text{corr}}$ , i.e.  $E_{\text{rp}}$  is greater than 200 mV from  $E_{\text{corr}}$ . Therefore, pitting would not be expected during service in these type solutions [12].

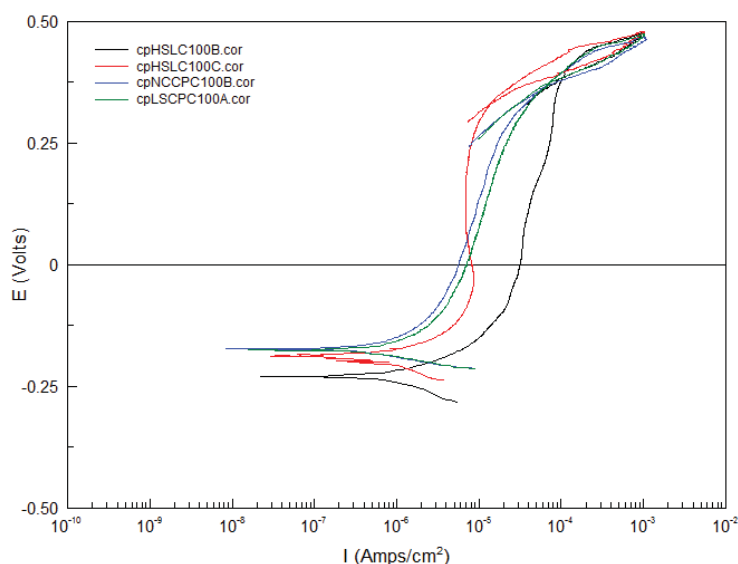
**Figure 4-7. CPP scans for C276 in boiling glycolic-based solutions with different sulfate concentrations, ranging from 507 to 5571 ppm (chloride concentration ranged from 0 to 35 ppm)**

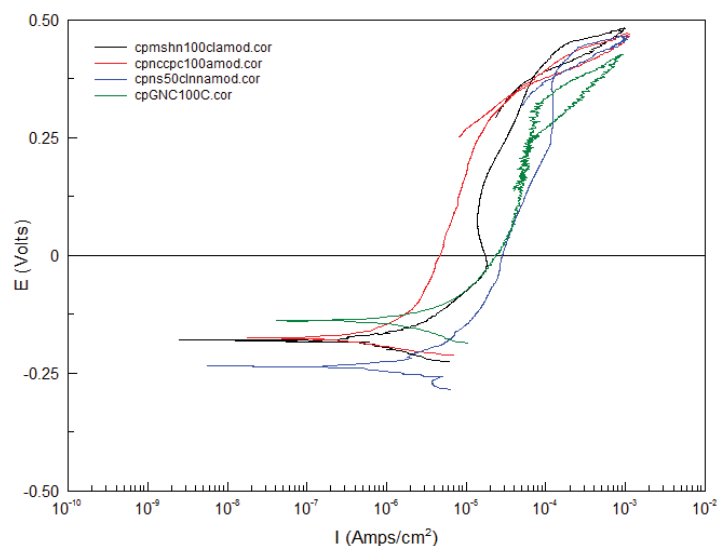
**Figure 4-8. CPP scans for C276 in boiling glycolic-based solutions with different chloride concentrations, ranging from 0 to 874 ppm (sulfate concentration ranged from 2000 to 2635 ppm)**

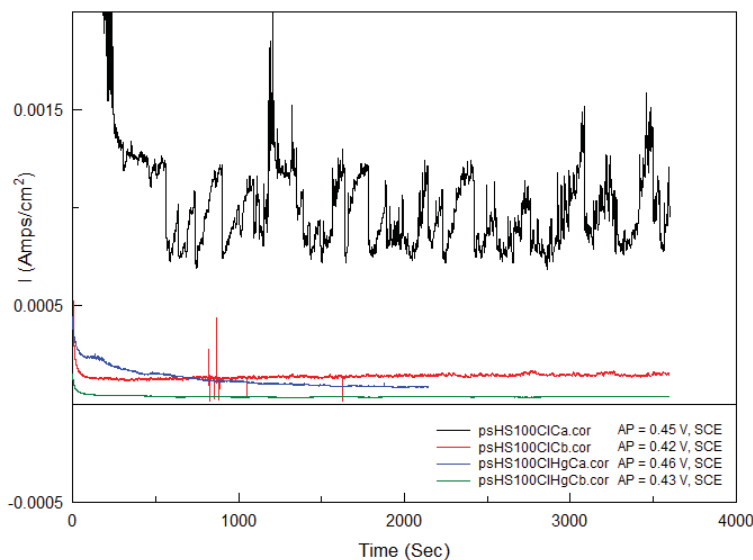
**Figure 4-9. Chrono-current traces for potentiostatic tests at potentials within the positive hysteresis loop for boiling glycolic-based solutions with and without mercury**

A series of potentiostatic test was conducted at applied potentials within a positive hysteresis loop (greater than the  $E_{rp}$ ) to determine if pitting was found to occur at times longer than during a CPP scan (60 minutes versus 1-2 minutes to pass through the potential range of the loop). The test solutions contained approximately 57500 ppm nitrate, 5600 ppm sulfate, and 100 ppm chloride, and were with and without mercury (Solutions from Tests #1 and #1-Hg in Table 4-3). Figure 4-9 shows the chrono-current traces, which in general started at the highest current value for the trace and quickly dropped to a lower constant value. This type of trace is consistent with a material undergoing general corrosion. A chrono-current trace for pitting would be increasing because as pits develop more current is generated at the expanding surface area.

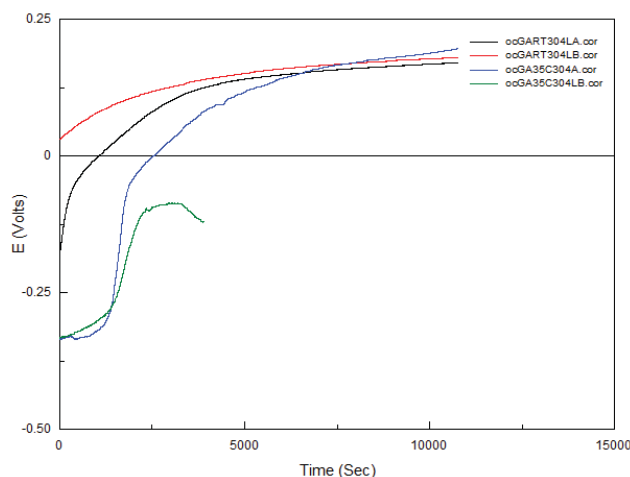
**Figure 4-10. Open-circuit potentials of 304L stainless steel in 70 wt% glycolic acid at room temperature and 35° C**

different OCPs again were associated with different LPR corrosion rates, 0.05 mpy at 0.2V and 0.42 mpy at -0.123V. At room temperature the average LPR corrosion rate was 0.08 mpy.

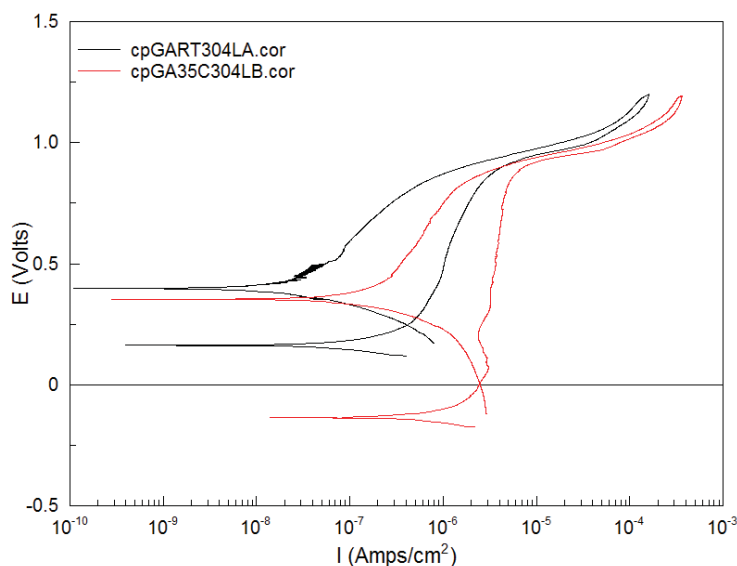
**Figure 4-11. CPP scans for 304L in 70 wt% glycolic acid at room temperature and 35° C**

The CPP scans also depended on the initial OCP value as shown by the data in Figure 4-11. The more active OCP value ( $< 0.0$  V, cpGA35C304LB.cor) has a CPP scan with a greater  $i_p$  value as well as a possible transition in state of the surface oxide or cathodic reaction occurring at the surface. The CPP scan with a passive OCP ( $> 0.0$  V, cpGART304LA.cor) was independent of temperature and all showed simple passive polarization curves.

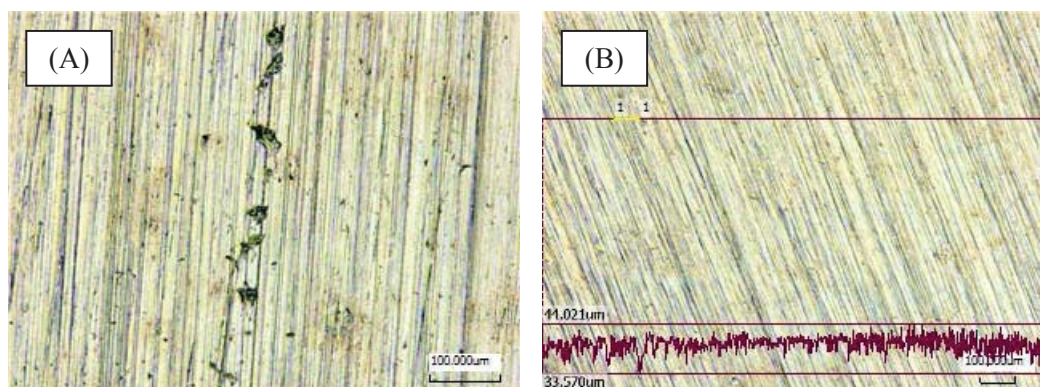
**Figure 4-12. Micrographs of 304L stainless steel after electrochemical testing in 70 wt% glycolic acid at (A) room temperature and (B) 35 °C**

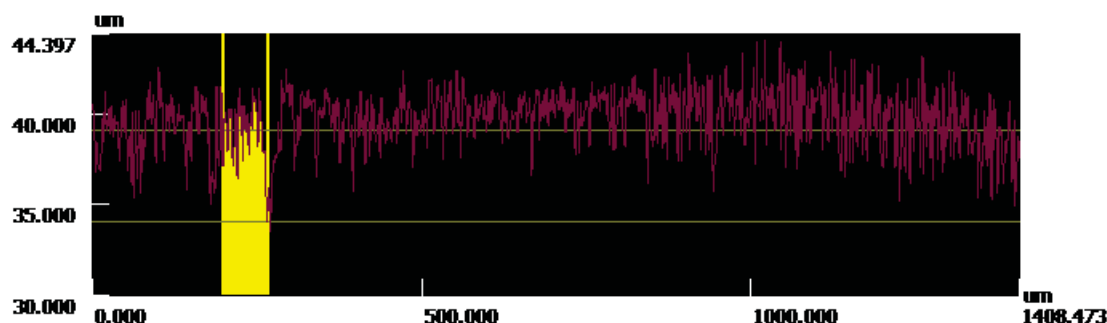
**Figure 4-13. Laser-height scan for 304L stainless steel after electrochemical testing in 70 wt% glycolic acid at 35 °C (for micrograph in Figure 4-12 (B))**

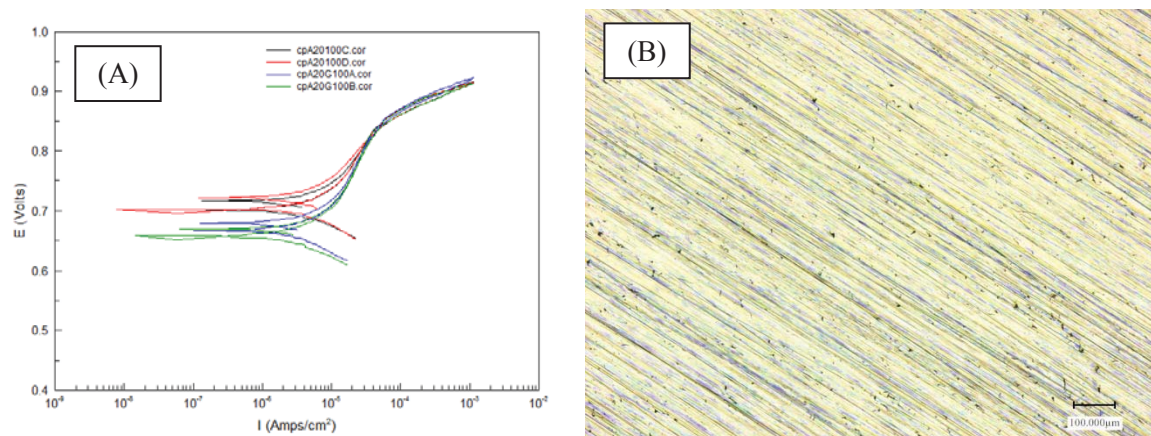
**Figure 4-14. Alloy 20 in a boiling 12.5 wt% nitric acid solution: (A) CPP scan for solutions with and without the glycolate anion and (B) micrograph of sample surface tested in solution containing the glycolate anion**

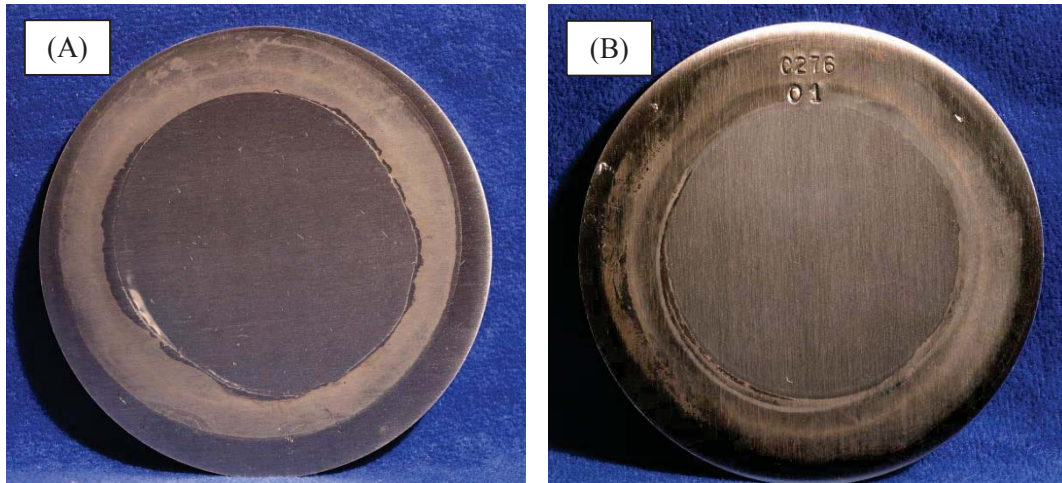
**Figure 4-15. Post-test photographs of C276 hot-wall test samples after month exposure at boiling conditions in glycolate-based solutions: (A) follow-up test sample; and (B) first phase test sample**

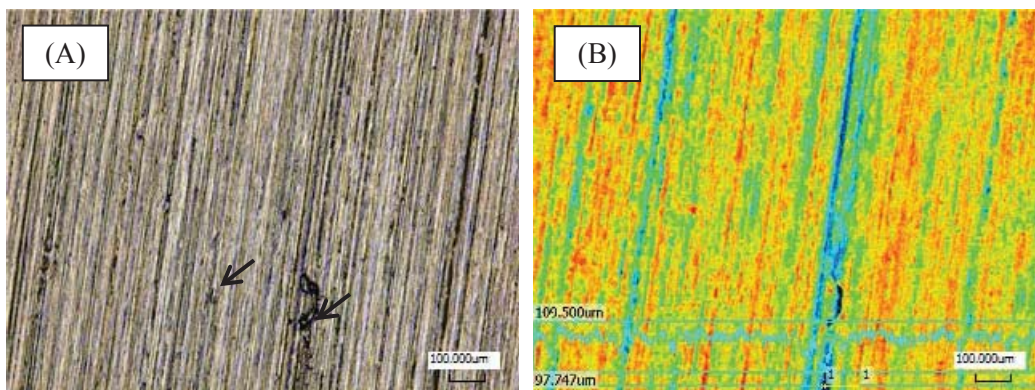
**Figure 4-16. Photographs of as-received C276 hot-wall test sample (arrows identify pit-like features): (A) laser-optical image; and (B) height scan where red is highest point and dark blue is lowest**

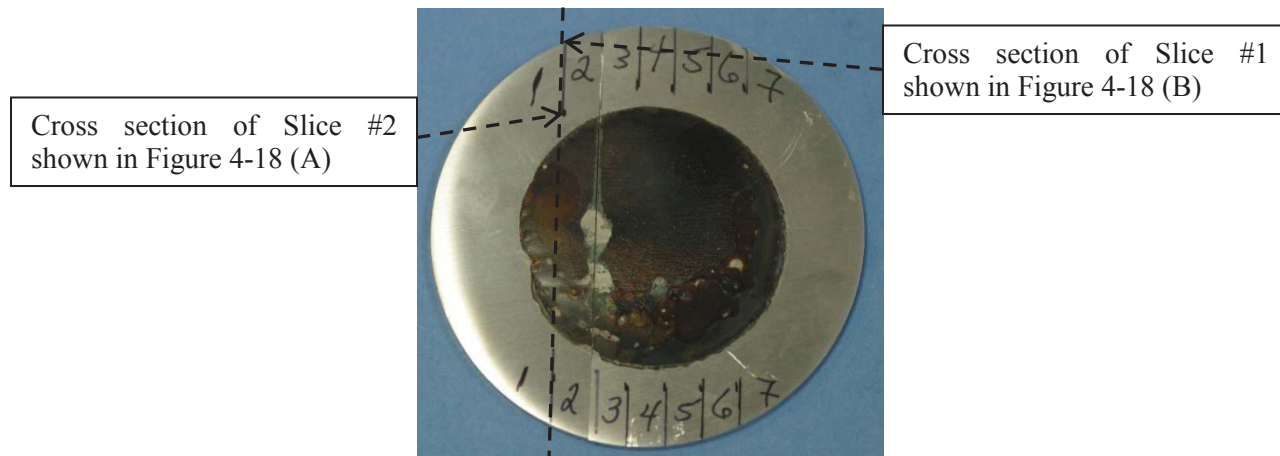
**Figure 4-17. C276 hot-wall test sample after exposure to a formic-based solution showing sectioning prior to examination for localized corrosion (only one cut shown)**

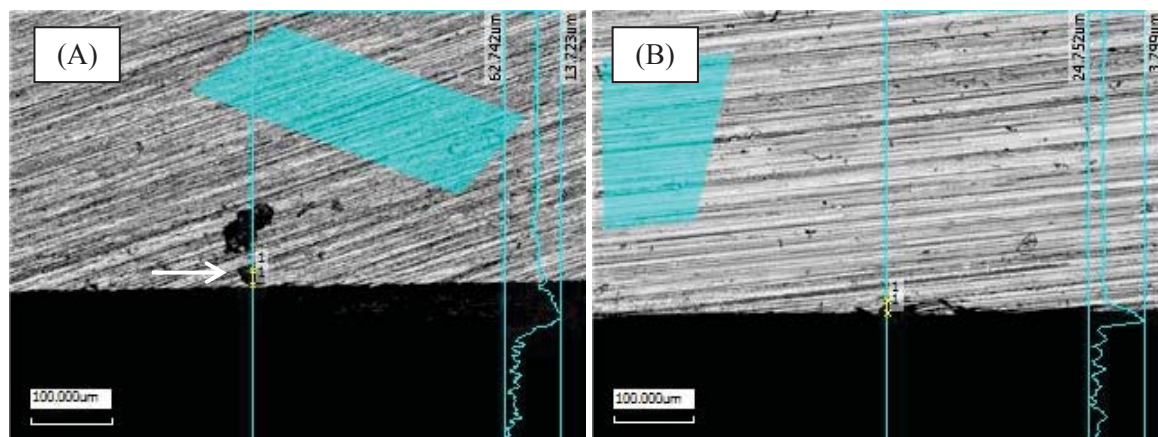
Figure 4-18. C276 hot-wall sample after testing in the formic-based SRAT/SME supernate: (A) cross-sectional view (400x) of Slice #2 showing sub-surface pit; (B) cross-sectional view (400x) from Slice #1 showing surface pit

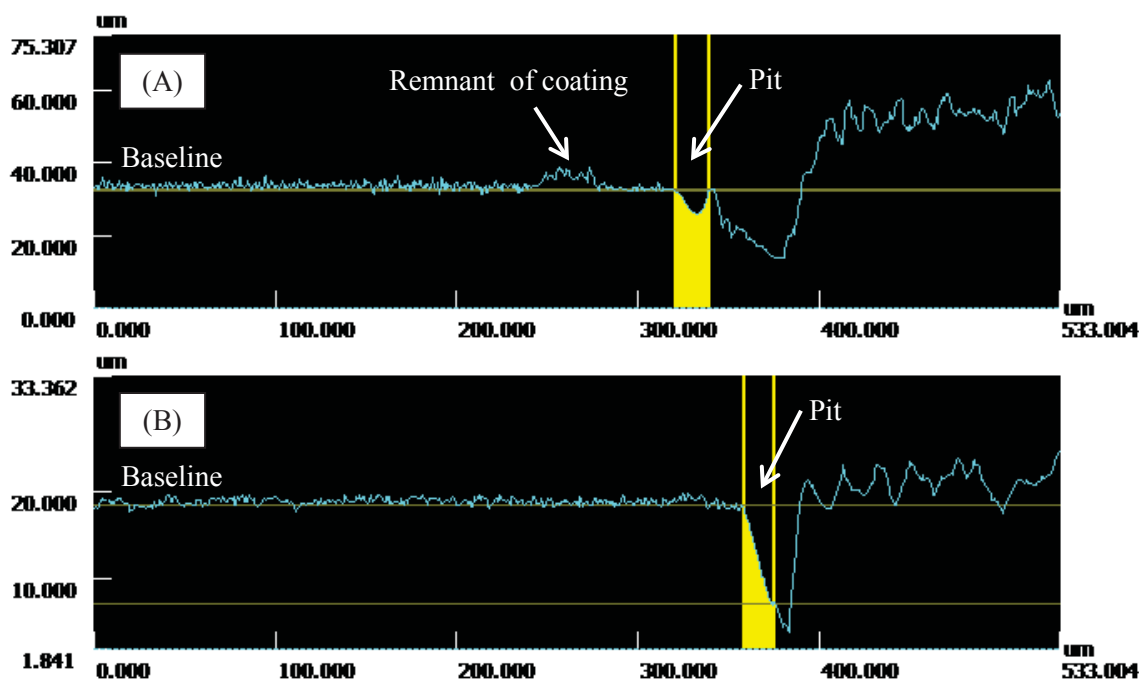
Figure 4-19. C276 hot-wall sample after testing in the formic-based CPC solution: (A) profile line shown in Figure 4-17(A) through sub-surface pits; and (B) profile line shown in Figure 4-17 (B) through surface pit

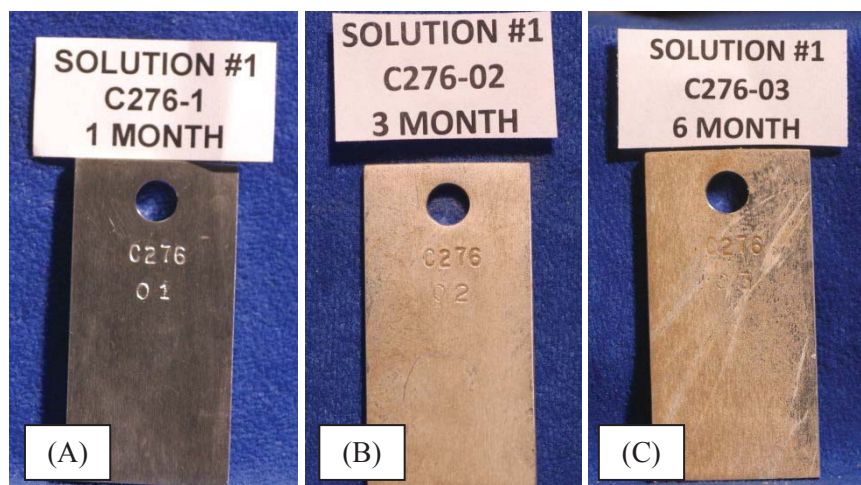
**Figure 4-20. Photographs of uncleaned C276 coupons from the coupon immersion test after (A) 1 month, (B) 3 months, and (C) 6 months exposure in Solution #1**

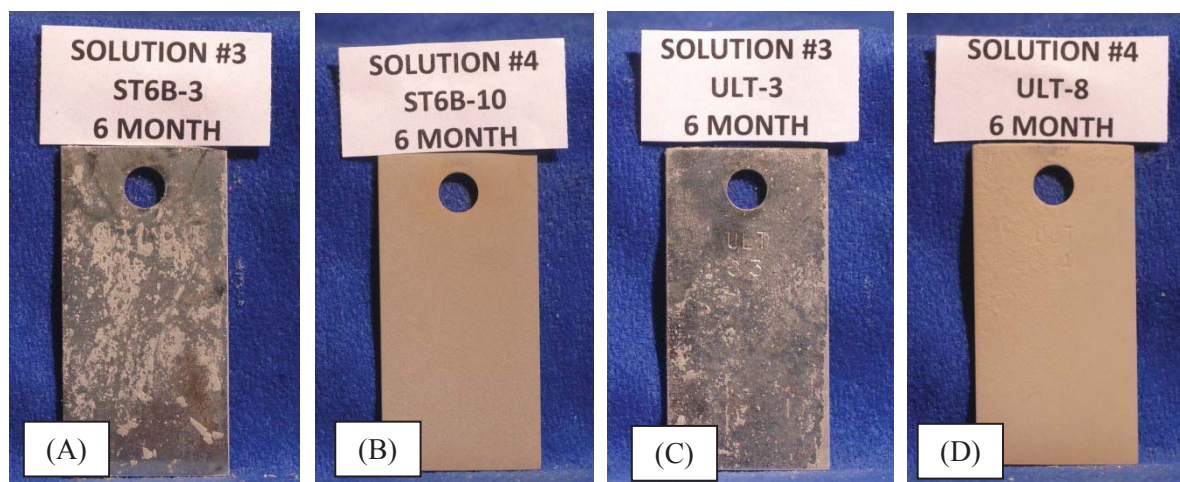
**Figure 4-22. Photographs of uncleaned five-month exposure coupons: (A) Stellite 6B in Solution #3; (B) Stellite 6B in Solution #4; (C) Ultem in Solution #3; and (D) Ultem in Solution #4**

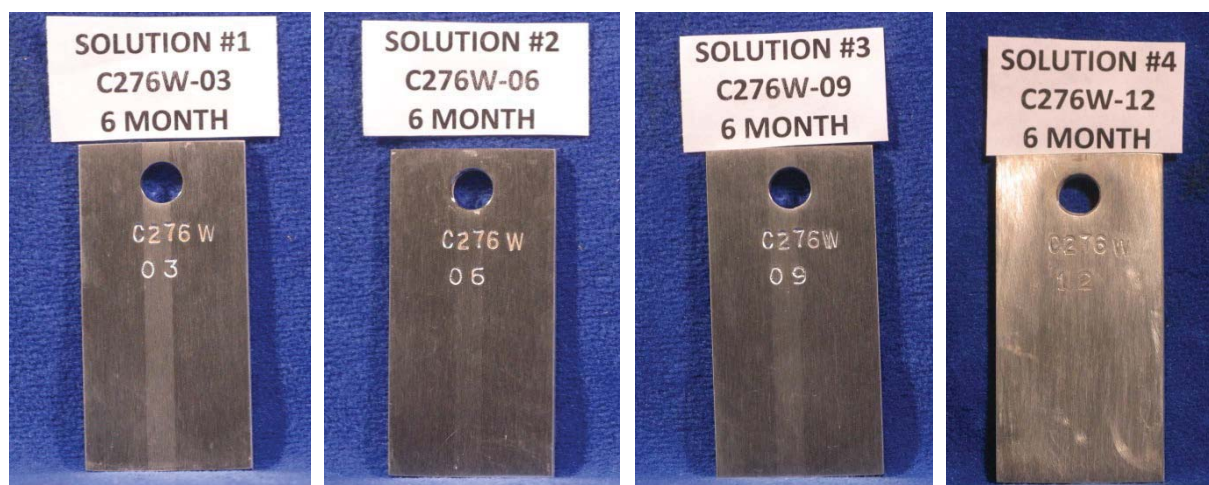
**Figure 4-23. Photographs of cleaned welded C276 coupons from the coupon immersion test after six-month exposure in (A) Solution #1, (B) Solution #2, (C) Solution #3, and (D) Solution #4**

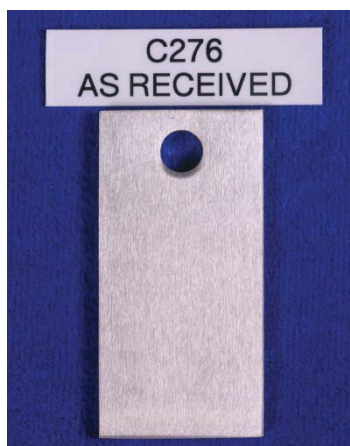
**Figure 4-24. Photograph of as-received C276 coupon prior to testing**

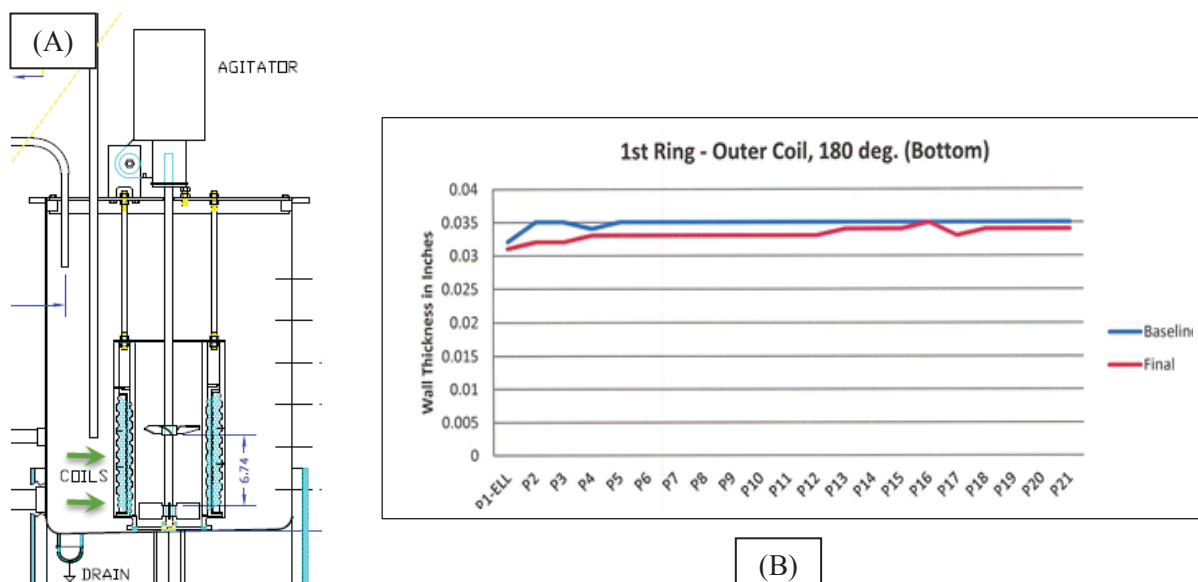
**Figure 4-25. UT measurements of the I/200<sup>th</sup> scale test vessel and coils: (A) vessel diagram with arrows showing coil measurement location; and (B) UT measurements for lowest (1<sup>st</sup>) ring of the outer coil welds along the bottom surface (180° position)**

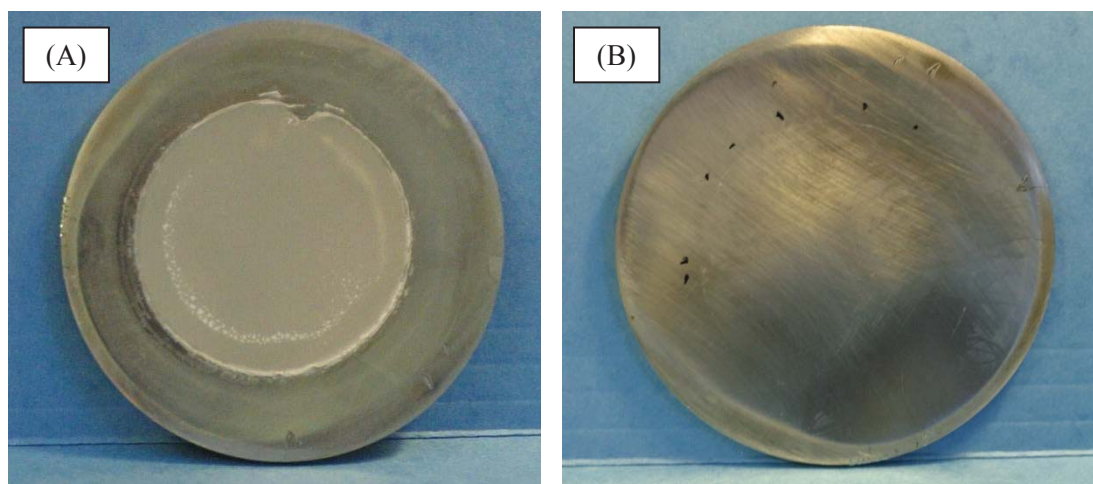
**Figure 5-1. G30 hot-wall samples exposed to a boiling basic concentrated recycle solution: (A) post-test photograph showing silicon-rich film; and (B) post-cleaning photograph after removal of film (black spots showing locations of observed pitting)**

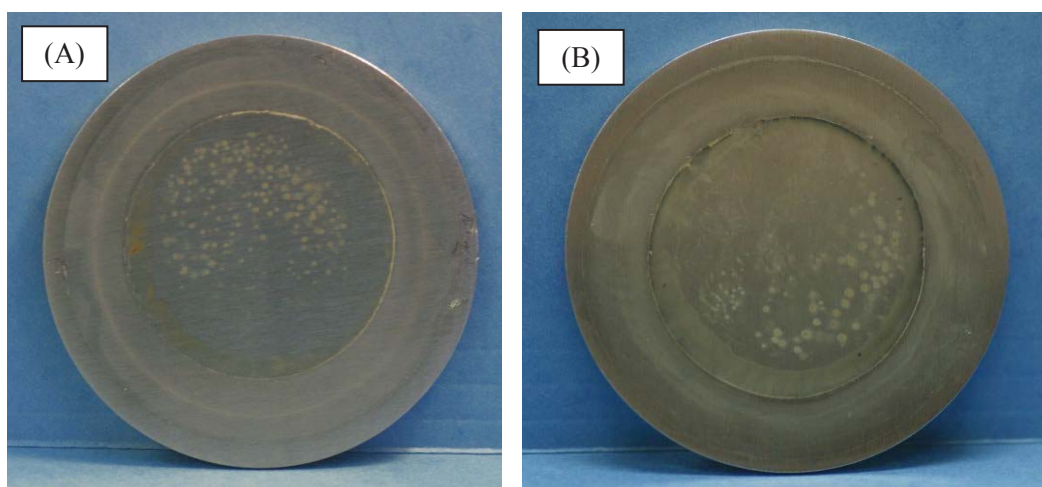
**Figure 5-2. Post-test photographs of G-3 hot-wall sample exposed to a boiling dilute waste solution with (A) and without (B) the glycolate anion**

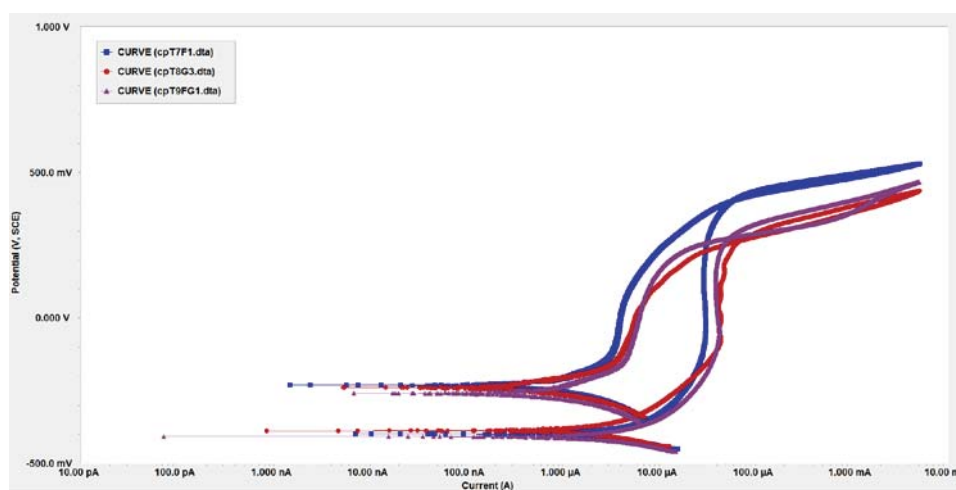
Figure 6-1. CPP scans for Tests #7-#9 showing negative hysteresis

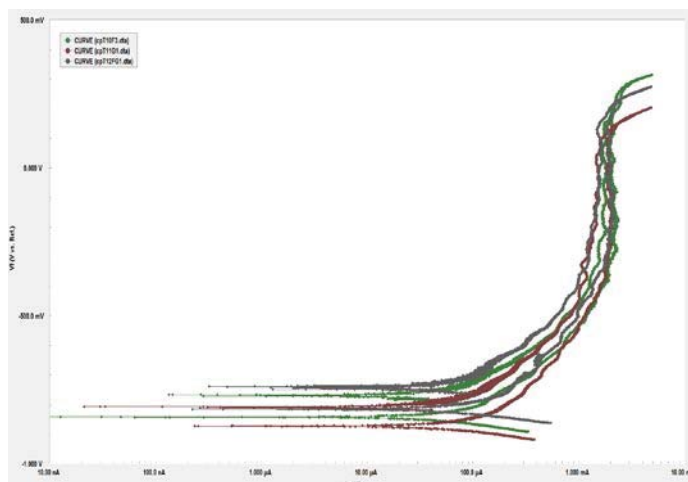
**Figure 6-2. CPP scans for Tests #10-#12 showing no hysteresis**

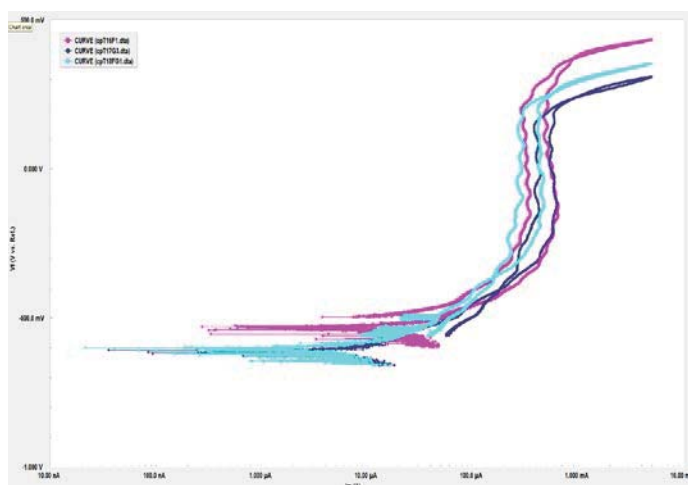
**Figure 6-3. CPP scans for Tests #16-#18 showing mixed hysteresis**

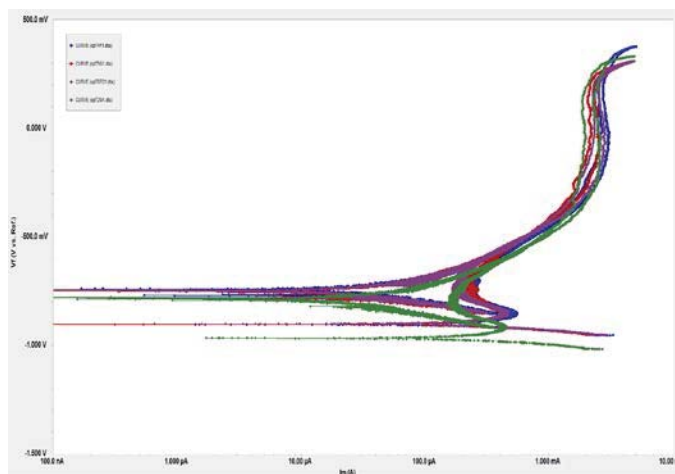
Figure 6-4. CPP Scans for Tests #4 - #6 which contain a reductant and Test #29 which has no reductant

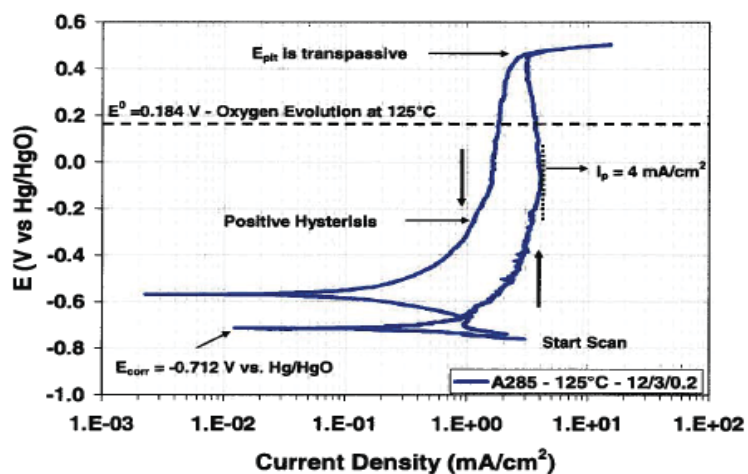
Figure 6-5. CPP scan for A285 carbon steel at 125 °C in a solution with 12M hydroxide, 3M nitrate, and 0.2M nitrite [24]

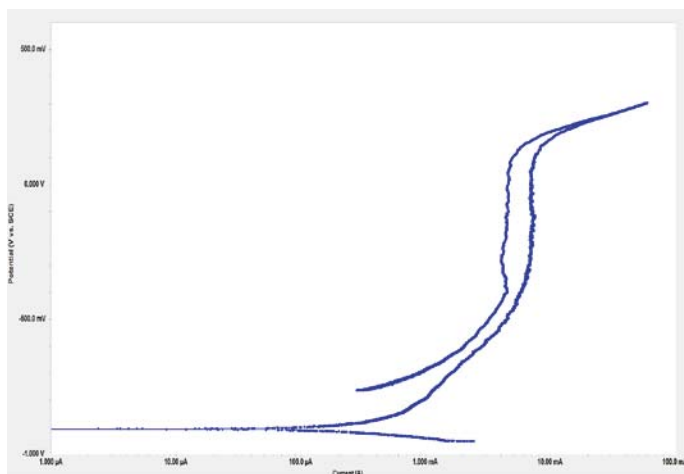
Figure 6-6. CPP scan for A537 carbon steel at 115 °C in a solution with 10M hydroxide, 0.75M nitrate, 1M nitrite, 0.07M formate, and 0.13M glycolate

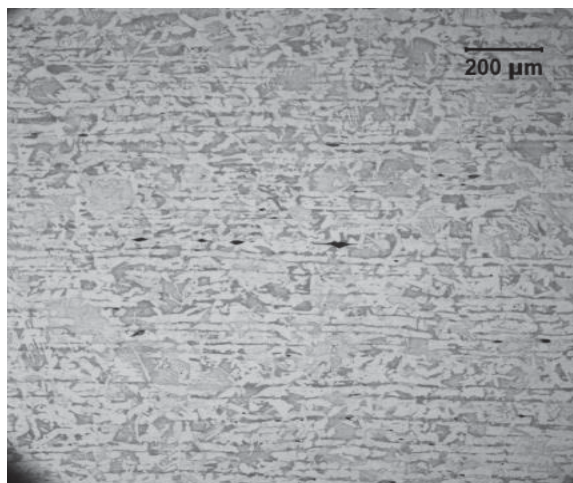
**Figure 6-7. Photomicrograph of bullet-shaped test sample fabricated from AARTC128 carbon steel showing manganese sulfide inclusions (elongated black particles) [28]**

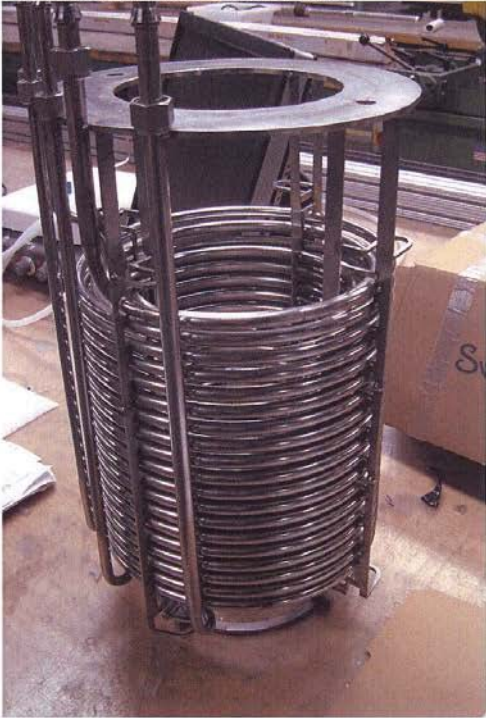
see Pgs. 2-7					
<div style="display: flex; align-items: center;"> <div style="margin-right: 20px;"> <input checked="" type="checkbox"/> ACC. <input type="checkbox"/> REJ. <input type="checkbox"/> N/A         </div> <div>           MINIMUM READING OBTAINED            .030" (coil), .022" (circ. weld)         </div> </div>

REMARKS - Provide details concerning nature of reduction in wall thickness. List all other M&TE used, M&TE#, and due dates. See pages 2-7 for details. Note that portions of welds are less than full penetration (prior internal video inspection), this explains the lower thickness value in the weld joint.					
					PAGE <div style="border: 1px solid black; padding: 5px; display: inline-block;">           1 OF 7         </div>

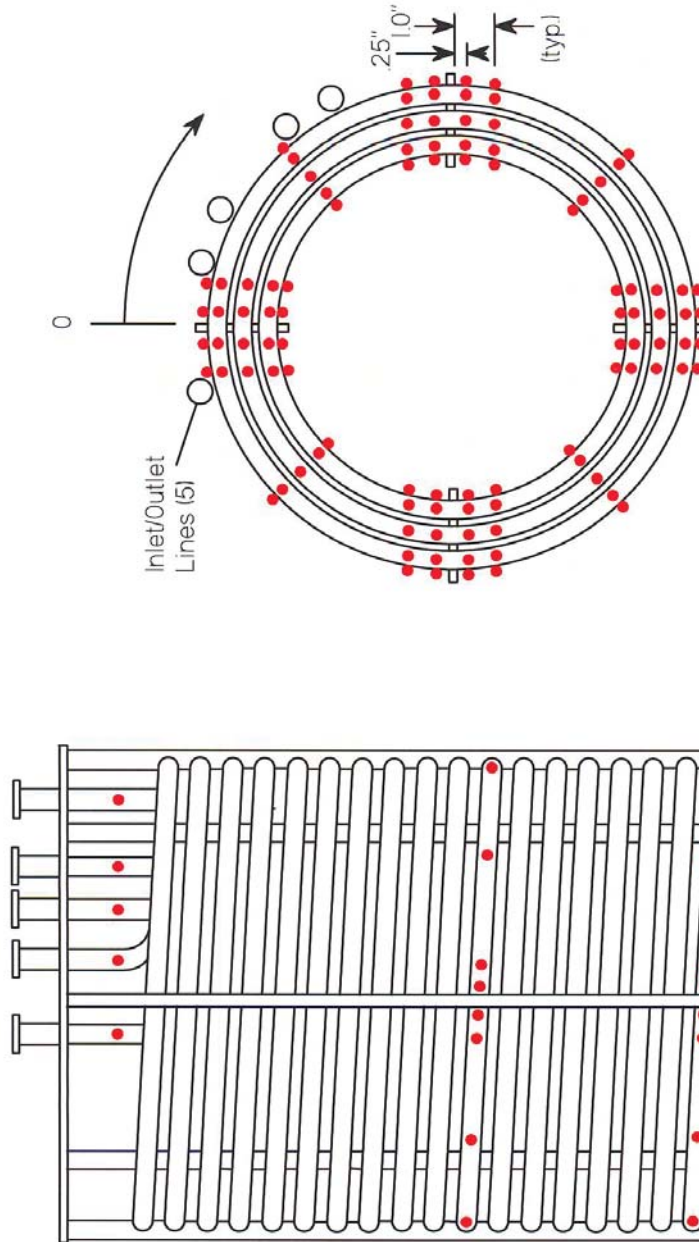
UT Locations, Small Scale SME Mockup

Progression - start at bottom ring elbows  
(locations on inlet/outlet line elbows and radial  
weld locations are not shown)

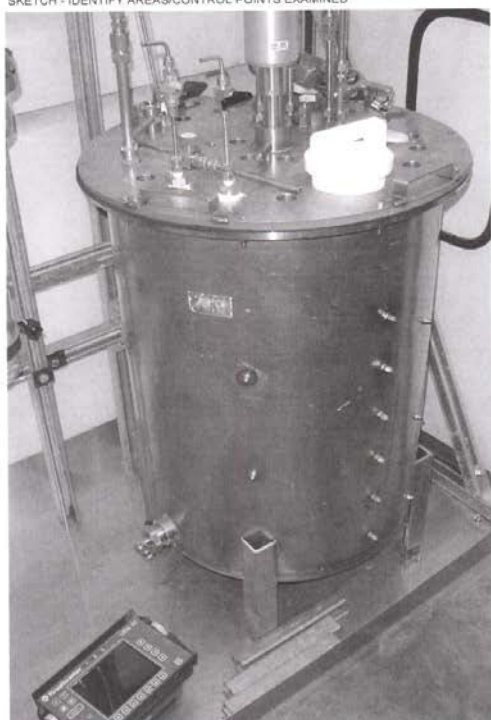
see page 2													
<input type="checkbox"/> ACC. <input type="checkbox"/> REJ. <input checked="" type="checkbox"/> N/A		MINIMUM READING OBTAINED .049" (bottom head)

REMARKS - Provide details concerning nature of reduction in wall thickness. List all other M&TE used, M&TE#, and due dates. See page 2 for details.													
										PAGE 1 OF 2

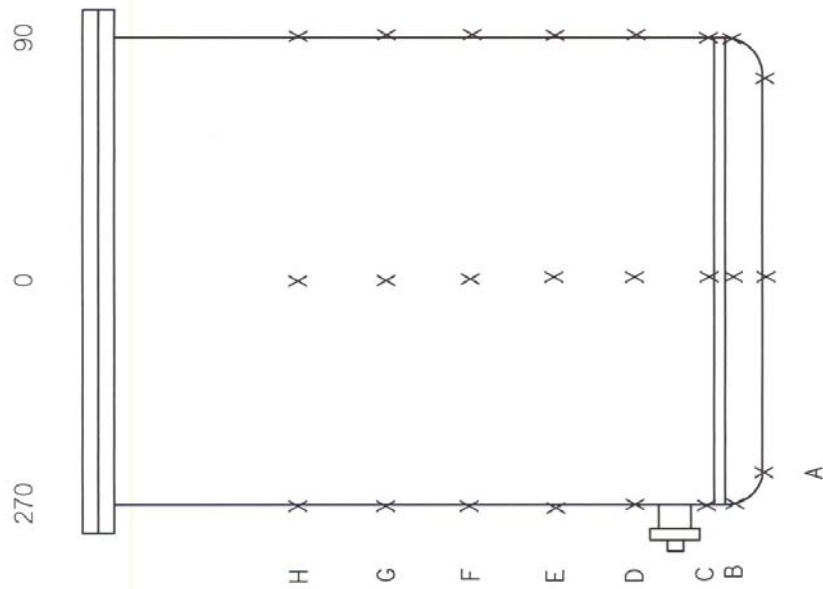
0	90	270
A	0.055	0.055	0.055
B	0.049	0.049	0.049
C	0.073	0.073	0.072
D	0.072	0.072	0.072
E	0.072	0.072	0.072
F	0.072	0.072	0.072
G	0.071	0.072	0.072
H	0.072	0.071	0.072

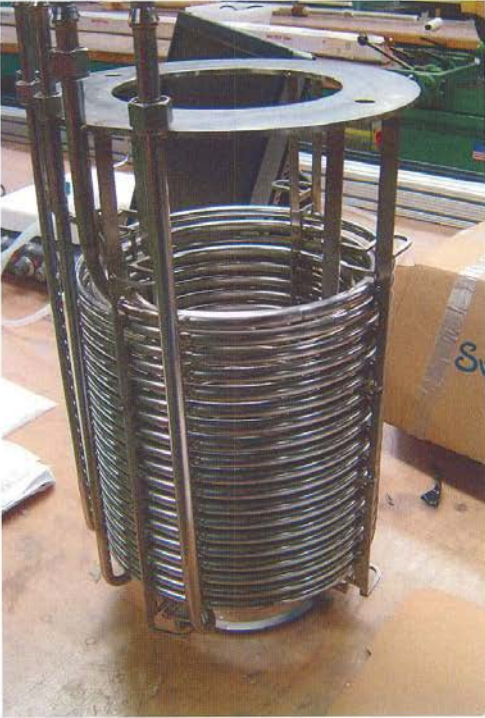
EXAMINATION RESULTS				
Location	0°	90°	180°	270°
see pg. 2-10				
Hand-drawn sketch of a coil with a diagonal line from bottom-left to top-right <div style="position: absolute; left: 20%; top: 40%;"> <p style="font-size: 2em; color: red; transform: rotate(-45deg); margin: 0;">N</p> <p style="font-size: 2em; color: red; transform: rotate(-45deg); margin: 0;">A</p> </div>				
<div style="float: right; font-size: x-small;">SKETCH - IDENTIFY AREAS/CONTROL POINTS EXAMINED</div>

<input checked="" type="checkbox"/> ACC. <input type="checkbox"/> REJ. <input type="checkbox"/> N/A		MINIMUM READING OBTAINED <b>.030" (coil), .022" (circ. weld)</b>

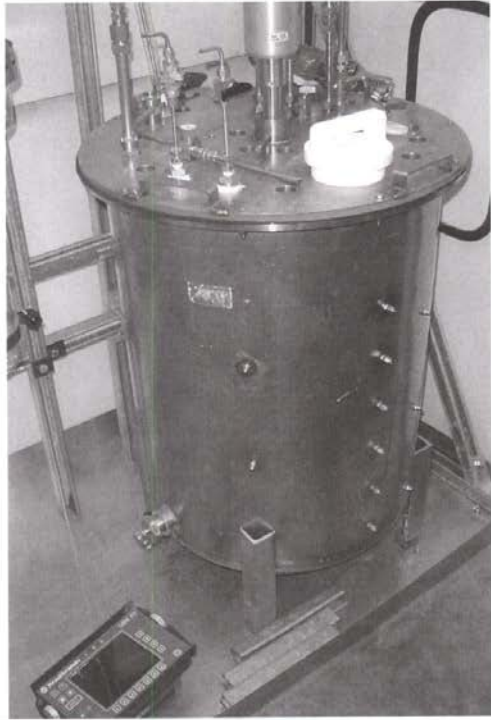
see page 2					
<div style="display: flex; justify-content: space-between;"> <div> <input type="checkbox"/> ACC.   <input type="checkbox"/> REJ.   <input checked="" type="checkbox"/> N/A         </div> <div>           MINIMUM READING OBTAINED  <b>.047" (bottom head)</b> </div> </div>

REMARKS - Provide details concerning nature of reduction in wall thickness. List all other M&TE used, M&TE#, and due dates. These are followup or "final" measurements after 2 weeks run time. See Page 2 for comparison with baseline measurements.					
					PAGE <div style="text-align: center;">1 OF 2</div>

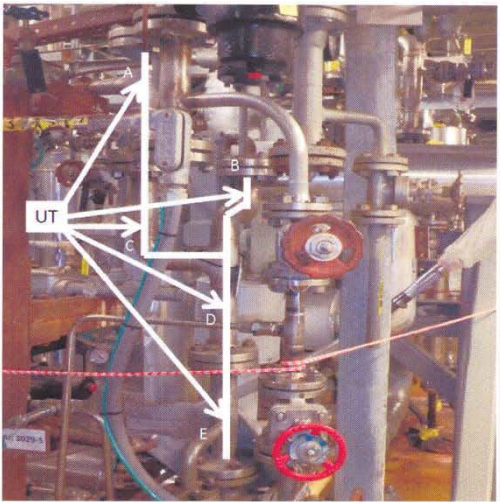
A	0.143"-0.152"				
B	0.129"-0.133"				
C	0.143"-0.133"				
D	0.146"-0.150"				
E	0.137"-0.143"				
		MINIMUM READING OBTAINED 0.129"			
REMARKS - Provide details concerning nature of reduction in wall thickness. List all other M&TE used, M&TE#, and Due Dates. Readings taken in areas identified by engineering in picture above. Thickness readings obtained around circumference of pipe and provided above in a range.
