Impact of Glycolate Anion on Aqueous Corrosion in DWPF and Downstream Facilities

SRNL-STI-2015-00482, Revision 2

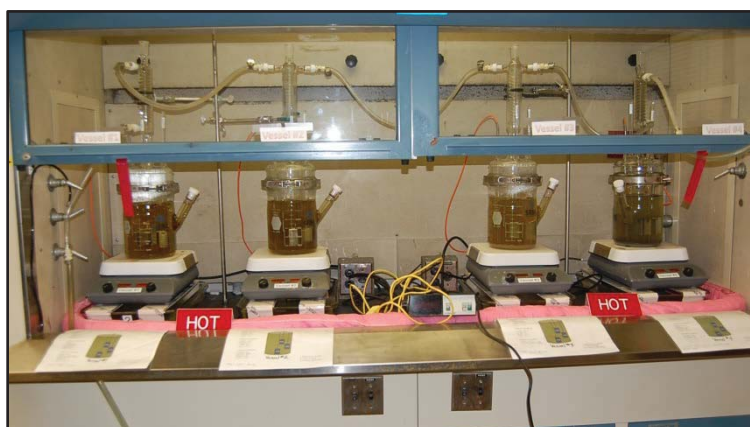
Figure 3-3. Coupon immersion test setup

The test solutions were based on the results from the electrochemical testing and were chosen to bracket a range of sulfate concentrations since it was shown to be the dominant aggressive species for localized corrosion. The chloride concentration has typically been below 100 ppm (mg/L) for the DWPF sludge batches and HLW processing at the SRS is not expected to introduce additional chloride species that would increase the concentration in the waste. Three glycolic-based compositions and one formic-based composition were chosen. Besides the reductant, the sulfate, nitrate, chloride, and mercury concentrations were also variables. The solution chemistries are discussed further in Test Solutions.

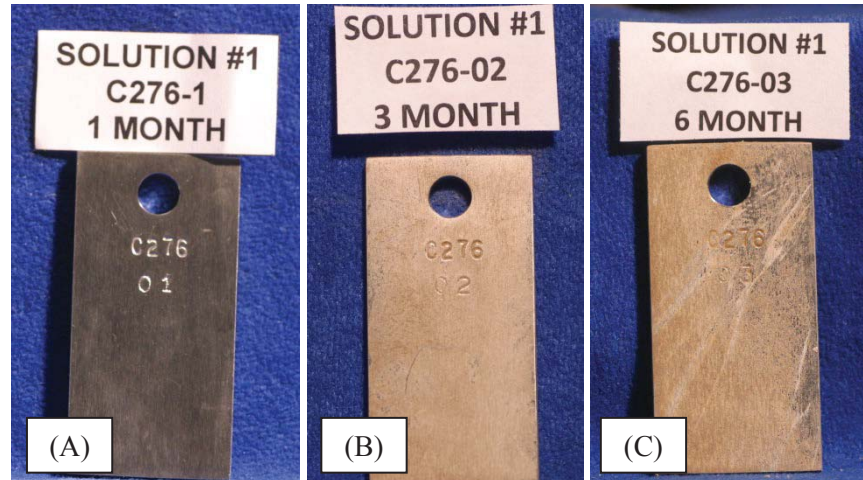
Figure 4-20. Photographs of uncleaned C276 coupons from the coupon immersion test after (A) 1 month, (B) 3 months, and (C) 6 months exposure in Solution #1

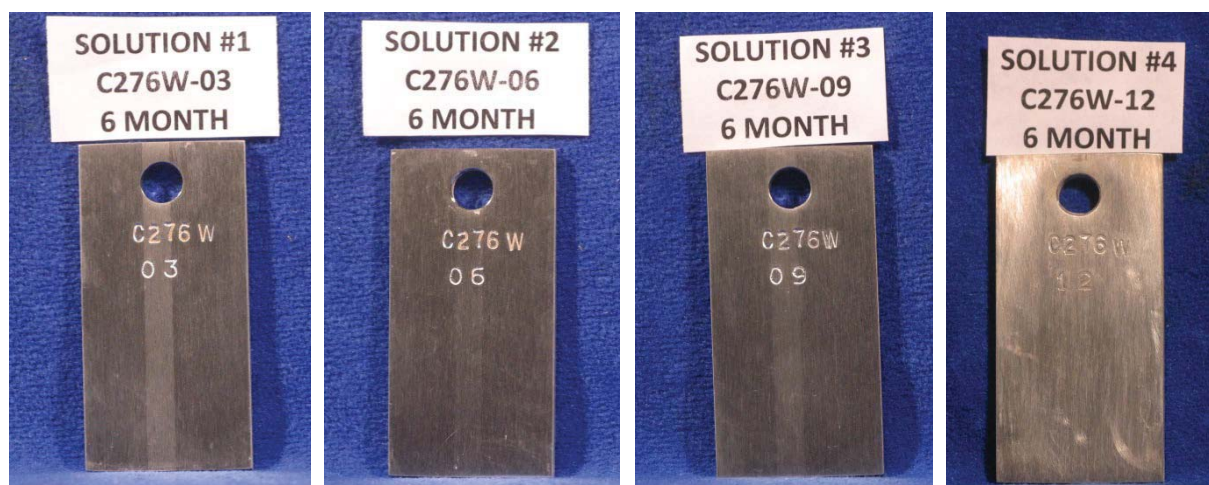
Figure 4-23. Photographs of cleaned welded C276 coupons from the coupon immersion test after six-month exposure in (A) Solution #1, (B) Solution #2, (C) Solution #3, and (D) Solution #4

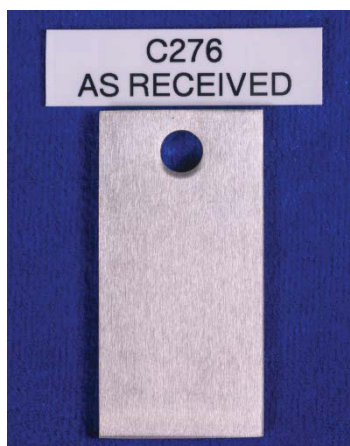
Figure 4-24. Photograph of as-received C276 coupon prior to testing
