# Characterization of Solids Deposited on the Modular Caustic-Side Solvent Extraction Unit (MCU) Coalescer Media Removed in October 2014

SRNL-STI-2016-00080, Revision 0

In February 2015, Savannah River National Laboratory (SRNL) received a Strip Effluent (SE) coalescer (FLT-304) from MCU. That coalescer was first installed at MCU in July 2014 and removed in October 2014. While processing approximately 31,400 gallons of strip solution, the pressure drop steadily increased from 1 psi to beyond the administrative limit of 20 psi. The physical and chemical analysis was conducted on this coalescer to determine the mechanism that led to the plugging of this coalescer.

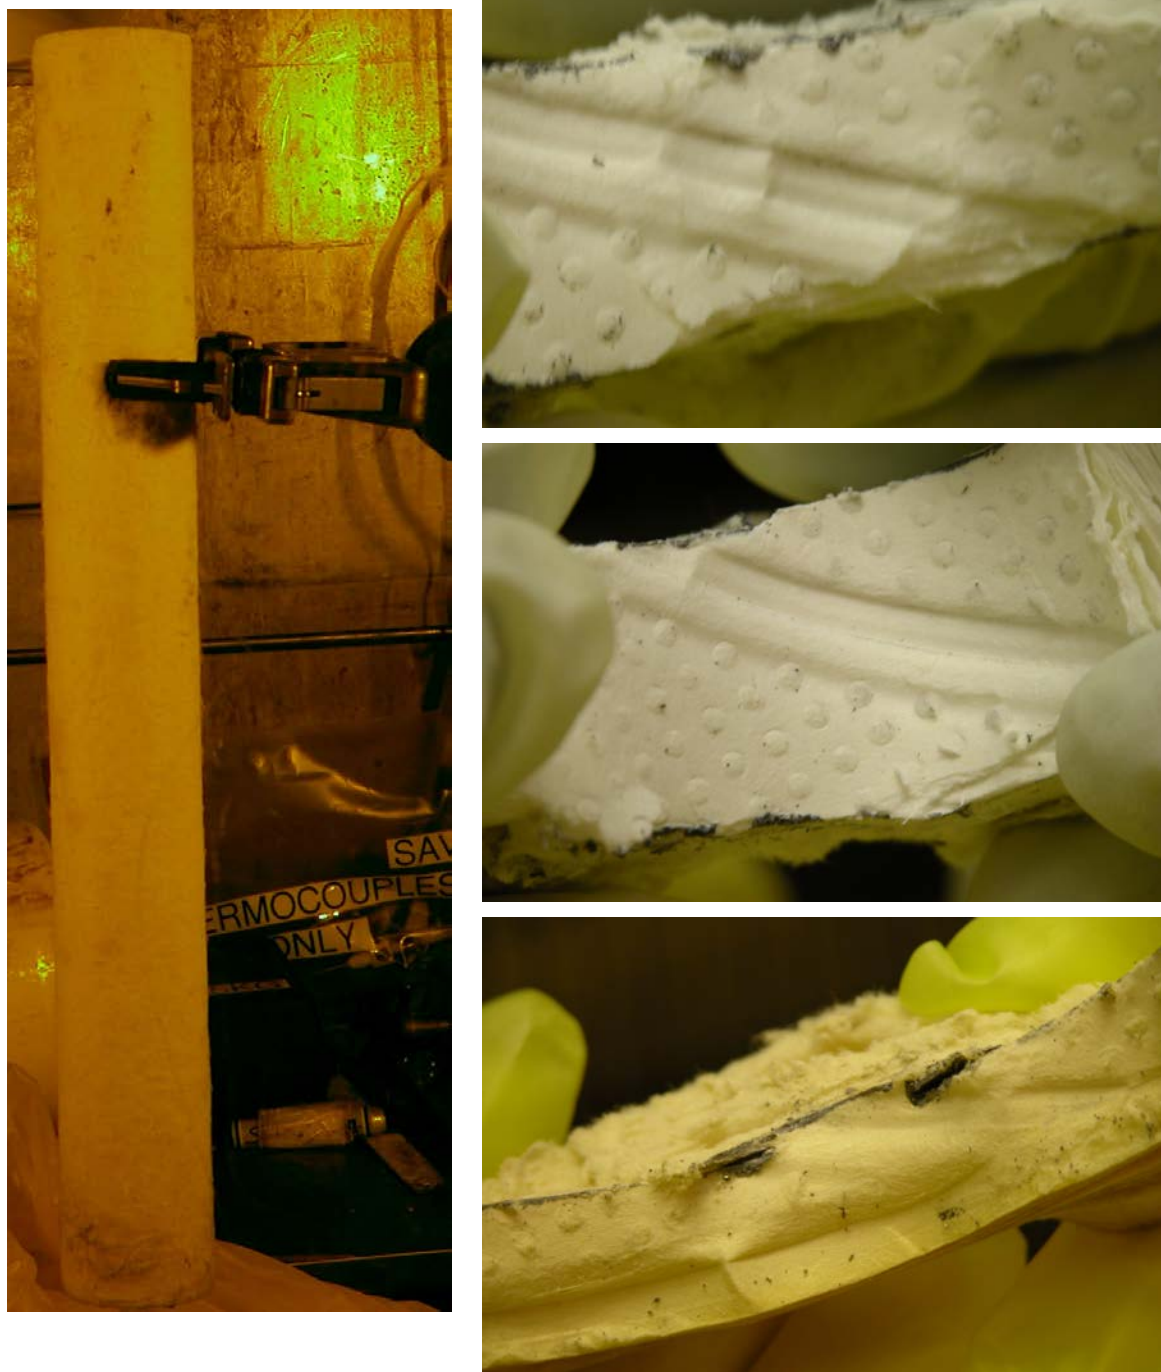
Upon arrival at SRNL (February 2015), the coalescer was placed in the Shielded Cells, where it was visually inspected for “gross” flaws and /or defects. No such abnormalities were found (See Fig. 2). The coalescer was then prepared for leaching and chemical analysis. Six one-inch wide “ring” segments of the coalescer were removed (cut). Three rings were cut from the closed-end of the coalescer and the other three from the middle. A picture of a cut ring from the SE Oct 2014 coalescer is shown in Figure 2. A closer look at one of the coalescer pieces is shown in Fig 3. The rings inner surfaces appeared clean. A set of two “ring” segments (one from the closed-end and one from the middle) were submitted to the laboratory “as is,” for solids characterization by XRD, Fourier Transform Infrared (FTIR) spectroscopy, SEM, and EDS. A second set of two “rings” were placed in its own “leaching bottle” and immersed in 400 mL of 3 M nitric acid at ambient temperature and under quiescent conditions. The remaining set of two “ring” segments was placed in 400 mL of deionized and double-distilled (DI-DD) water. The

**Figure 2. A picture of the October 2014 SE coalescer sent to SRNL. The coalescer is relatively clean**
