Continuing the Evaluation of All-Metal Valves for Use in a Tritium Environment

September 2018

SRNL-STI-2018-00525, Revision 1

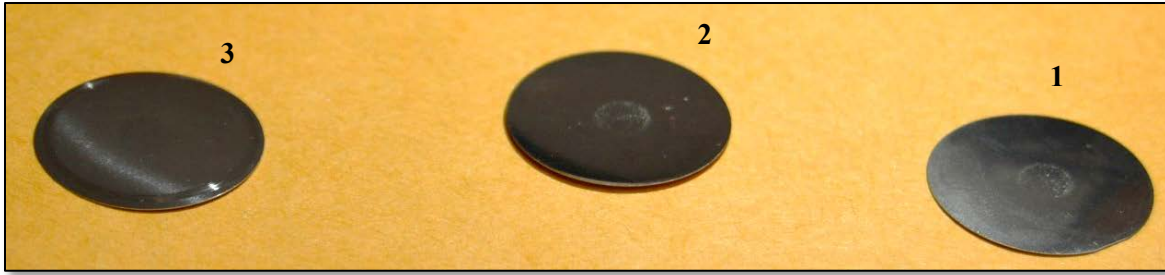
Valves TV04 and TV07 were disassembled and analyzed to understand the failure mechanism of the valves. Figure 2-5 and Figure 2-6 are photographs of post-test valve TV07 diaphragms with valve diaphragm locations illustrated in Figure 2-7. Visual inspection of the diaphragms did not show obvious signs of damage indicating valve failure. The diaphragms do have some markings showing the interaction with the actuator button seat; valve TV04 diaphragms showed similar markings but are not included here.

Figure 2-5. Diaphragms of TV07 Facing the Fluid: Top (3), Middle (2), and Bottom (1)

Figure 2-6. Diaphragms of TV07 Facing the Actuator: Top (3), Middle (2) and Bottom (1)

Nitrogen cycled failed valves TV04 and TV07 both failed the body leak rate criteria after 500,000 cycles or more, but no direct causality could be assigned to the failure mechanism. The only commonality between TV04 and TV07 was each valve had vacuum on the outlet of the valve during cycling. However, each valve having a “twin” valve (same test conditions and valve orientation) with each having a greater cycle life (at least 750,000 cycles) than the failed valve demonstrates no common failure mechanism for these valves.

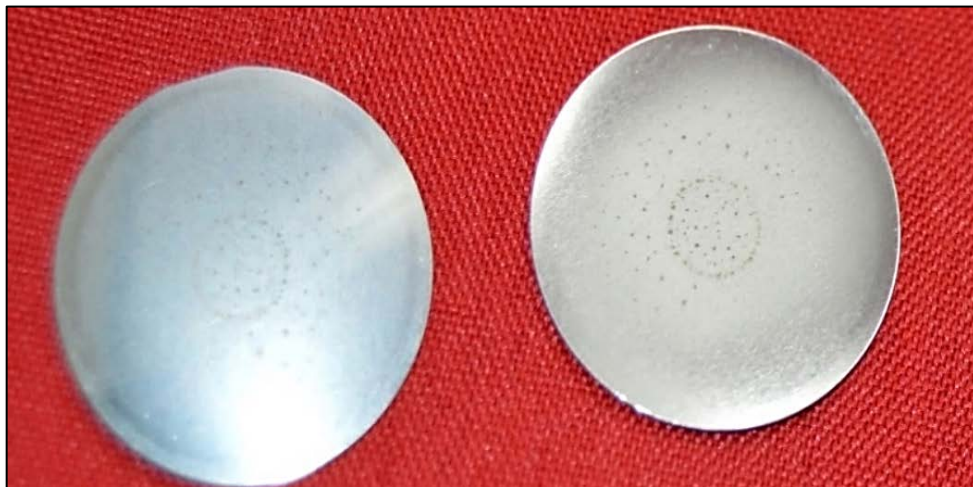
Figure 2-8. Diaphragms from TV01 Showing Spotting After Failure

Figure 2-8 shows signs of spotting on the top and bottom of the diaphragms for TV01 [9]. TV01 diaphragms were examined using a scanning electron microscope (SEM) after they were cycled 100,000 times because the spots were not present in valves that were not cycled. By utilizing the SEM equipped with an energy-dispersive X-ray spectroscopy detector (EDS), the surface was imaged to identify the source of the contamination.

Of the seven valves cycled in nitrogen, TV01 failed the 4.0×10^{-9} STD cc He/sec leak rate criteria when tested after 20,000 cycles – well less than the anticipate cycle life of 100,000 cycles. The valve failure was attributed to polymeric debris embedded in the diaphragm. This conclusion is further supported by the valve body leak rate of TV01 meeting the leak rate criteria while other valve failures had body leak rates exceeding the leak rate criteria.

The manifold placement of TV01 closest to the test gas supply supports supposition manifold debris, up to the gas supply, may have primarily entered this valve causing early failure. The failure and subsequent recovery of valve performance by valves TV04 and TV05 after installation of filters in the test manifold demonstrates that control of particulates in the process lines is important for reliable valve operation.

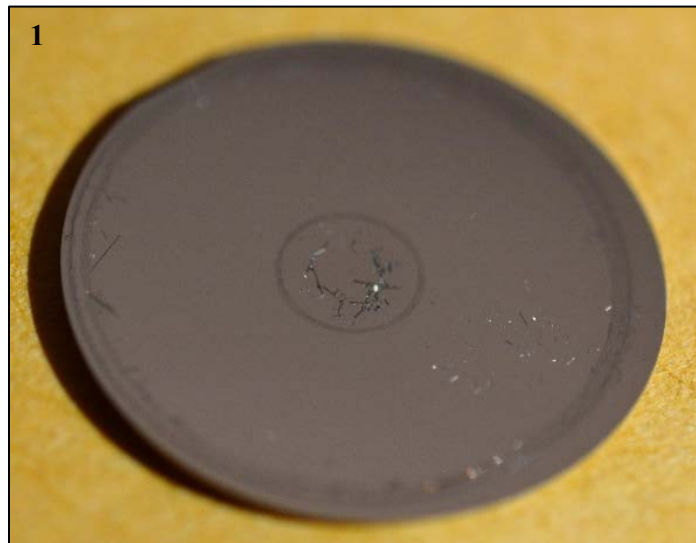
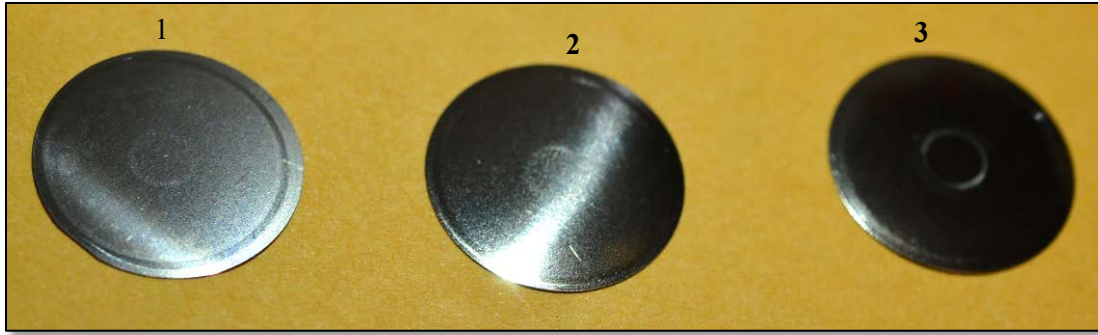
However, the diaphragm of Valve HV05 showed a surface modification compared to that of both the uncycled valves and HV01 after failure on the surface facing and closest to the vacuum, as shown in Figure 2-17. There is evidence of extensive surface anomaly towards the center of the

diaphragm as well with some unknown defects towards the edge, shown in the enlarged view of Figure 2-18. The middle diaphragm also had some surface modifications on the outer edge as well. The dulling/lack of luster on the fluid facing side of the valve is an artifact of the photography and the angle of photograph to show the defects, the valves appear similar on both sides. The backside of HV05, facing the actuator, appears unchanged after with minimal damage from cycling, which is viewed in Figure 2-19. No additional characterization of HV05 has been performed to identify the potential root cause of the valve leak rate failure.

Figure 2-17. Diaphragms of HV05 Facing the Fluid: Bottom (1), Middle (2), and Top (3)

Figure 2-18. Fluid Facing-Bottom Diaphragm from HV05, Visible Surface Modifications to the Middle of the Diaphragm and Outer Edge

Figure 2-19. Diaphragms of HV05 Facing the Actuator: Bottom (1), Middle (2), and Top (3)

It is not clear if cycling the valves in hydrogen, at elevated temperature, or some other factor contributed to the hydrogen cycled valves having an apparent lower cycle life than nitrogen cycled valves. Surface irregularities were present on a diaphragm of a failed valve, but no cause was determined. The use of 99.95% hydrogen (500 ppm impurities) may have created reaction products on the diaphragm of the valves which inhibited sealing of the diaphragm with the valve body, but further examination of the diaphragms would be needed to support this conjecture.
