# **Hanford Double Shell Waste Tank Corrosion Studies – Final Report FY2018**

August 2019

SRNL-STI-2019-00014, Revision 0

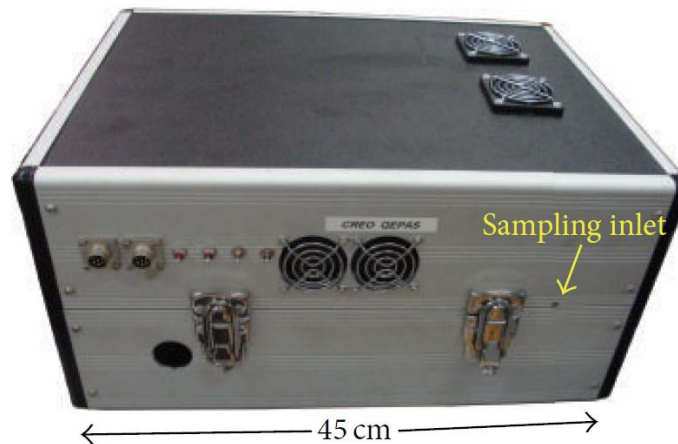
**Figure 3-2 Modular QEPAS sensor package developed by Viola et. al that measures approximately 17 in x 13 in x 9 in. [10]**

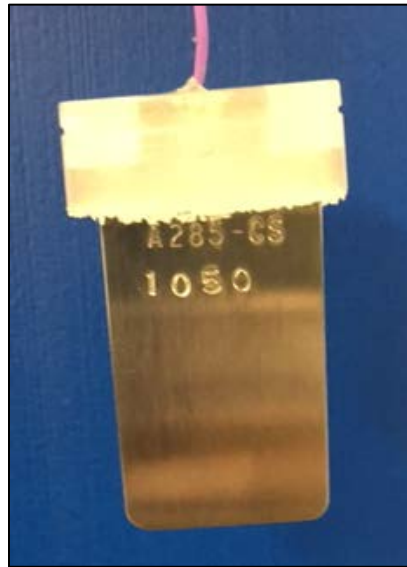
Coupons 2 inch long, 1 inch wide and 0.063 inch thick (Metal Samples part number CO101) with a 0.1875 inch hole at the top were used for long-term immersion testing. The coupons were requested to be ground to a 600 grit finish. To measure electrochemical response on 25 of the coupons, used for complete immersion, a wire was attached to the sample by threading it into the hole and mounting it with epoxy (EpoKwick from Buehler). Figure 4-1 shows a picture of a coupon mounted in epoxy connected with a purple coated wire.

**Figure 4-1 Rectangular coupon used in immersion testing mounted in epoxy and electrically connected using a purple coated wire (engraving error for the carbon steel as A285).**

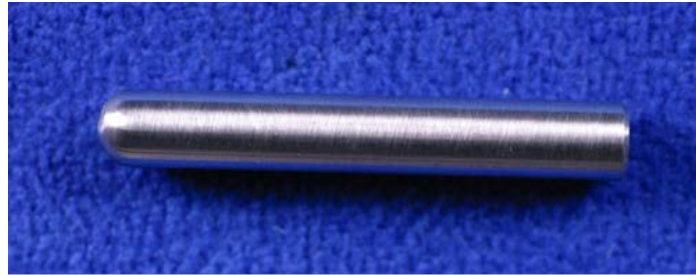
The electrochemical testing was performed by using electrodes in “bullet” shape with dimensions: 0.188 inch in diameter and 1.25 inches long (Metal Samples Company part number EL-400). In Figure 4-4, it shows a picture of the sample after being ground and rinsed. Before testing, a drill was used to rotate the sample and grind it to a uniform 600 grit finish. After, the sample was rinsed with distilled water and acetone. The bullets were examined visually for any defect and to ensure that the sample had a uniform surface preparation. The sample was then attached to a stainless-steel rod protected by a glass holder. A polytetrafluoroethylene (PTFE) fixture was used to prevent liquid contact with the stainless-steel rod and therefore to ensure electrical isolation.

**Figure 4-4 Side picture of the “bullet” shape sample**

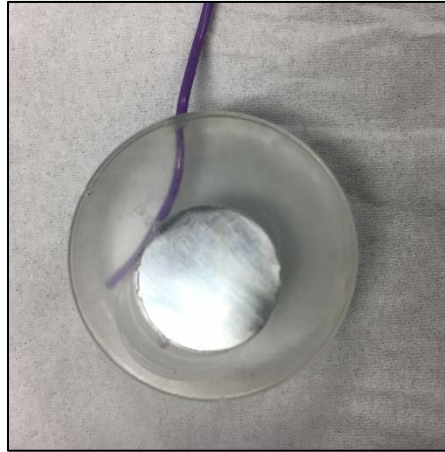
Circular coupons were sectioned from the railcar carbon steel stock of material. The coupons were 0.625 inch diameter with a thickness of 0.125 inch and were ground to a 600 grit finish at each side. The coupons were then engraved to identify them with a number from 1 to 24. A coated wire was placed in a lateral position to be able to hang the coupons with no electrical connection to the coupon. The coupons were mounted with a two-part clear epoxy solution (EpoKwick from Buehler) so that one face of the coupon was exposed. Prior to using the coupons, they were rinsed with distilled water, then acetone. The coupons are shown in Figure 4-7.

**Figure 4-7 One coupon mounted in epoxy cold mount with wire**

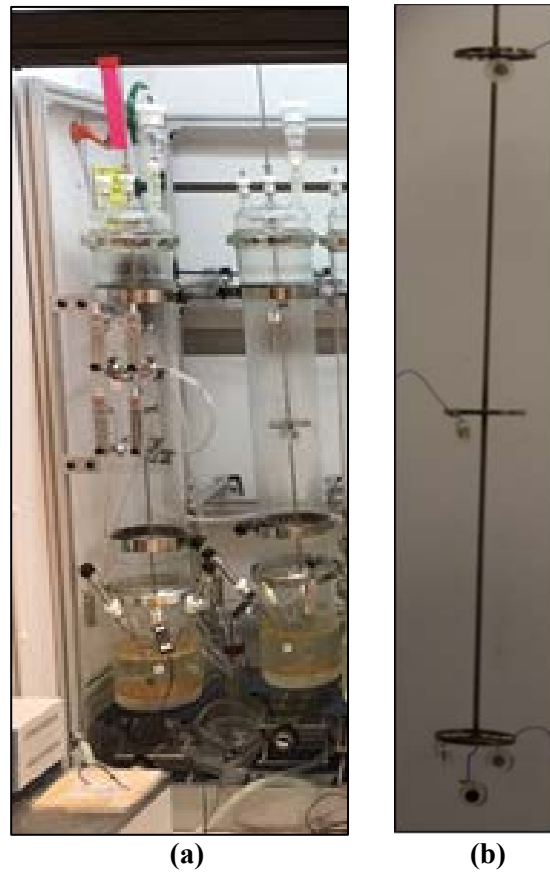
Level 3: Top or high level. This set of coupons was not exposed to the solution prior to testing. The coupons were suspended approximately 36 inches above the simulant. This level is representative of the secondary liner bottom plate region that is only exposed to the humidified air and any volatile species from the solution.

**Figure 4-8 Images of the (a) experimental configuration, and (b) steel rod to suspend the coupons inside the vessel containing electrolyte.**

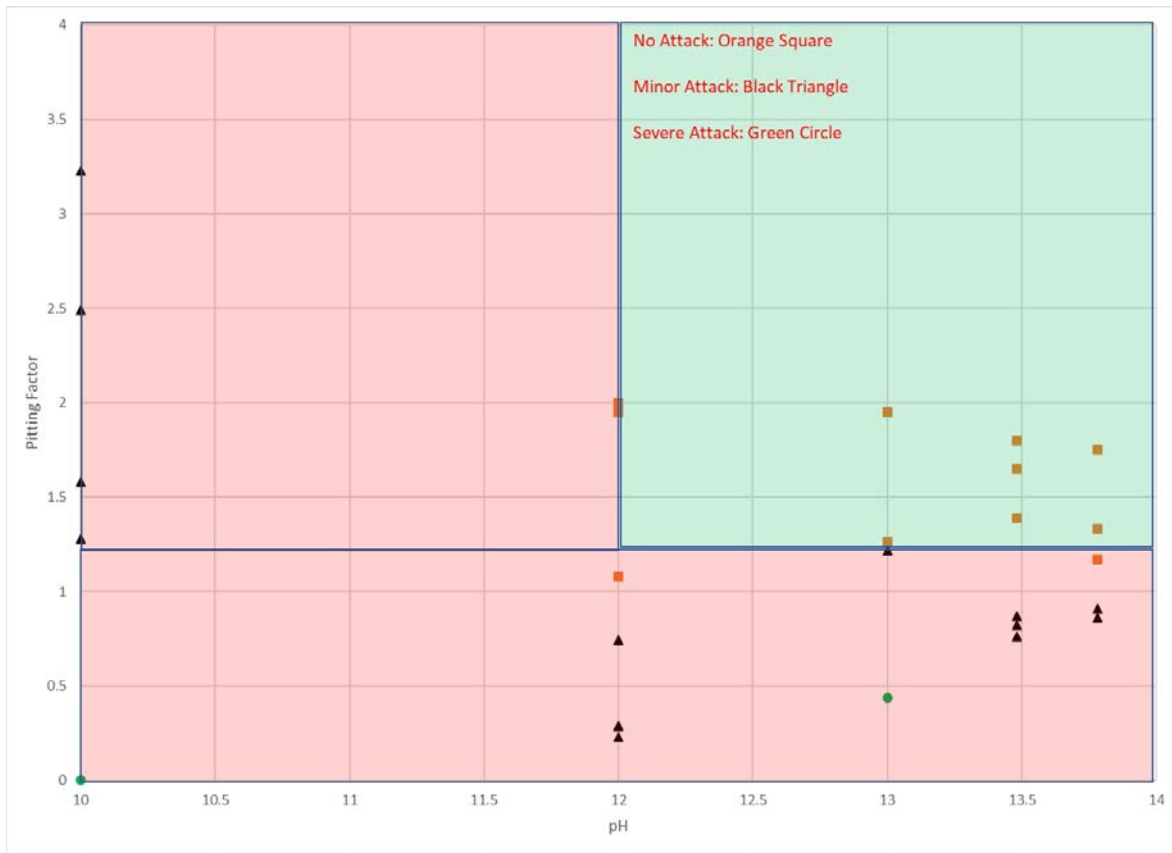
Figure 5-1 shows the areas where LAI corrosion is potentially significant. The hydroxide concentration, represented in terms of pH, is plotted against the pitting factor. The red area represents areas where the coupons indicated severe or minor corrosion, while the green area represents areas where the coupons indicated essentially no corrosion. There was one result, Test 3, that was near the boundary, however, this again was only superficial attack. The plot shows regions of concern, in red, that are similar to what was observed based on the previous CPP tests [20].

**Figure 5-1 Chemistry envelope for liquid air interface corrosion based on coupon test results.**

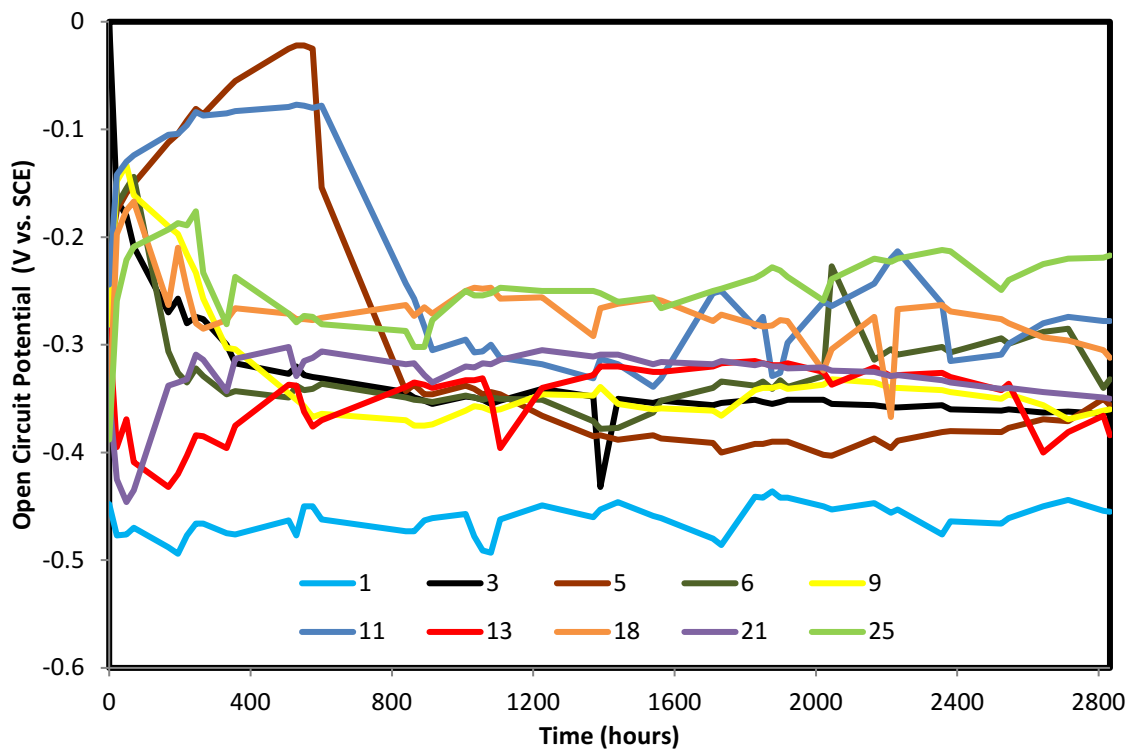
**Figure 5-2 OCP transients versus time of completely immersed coupons in solution**

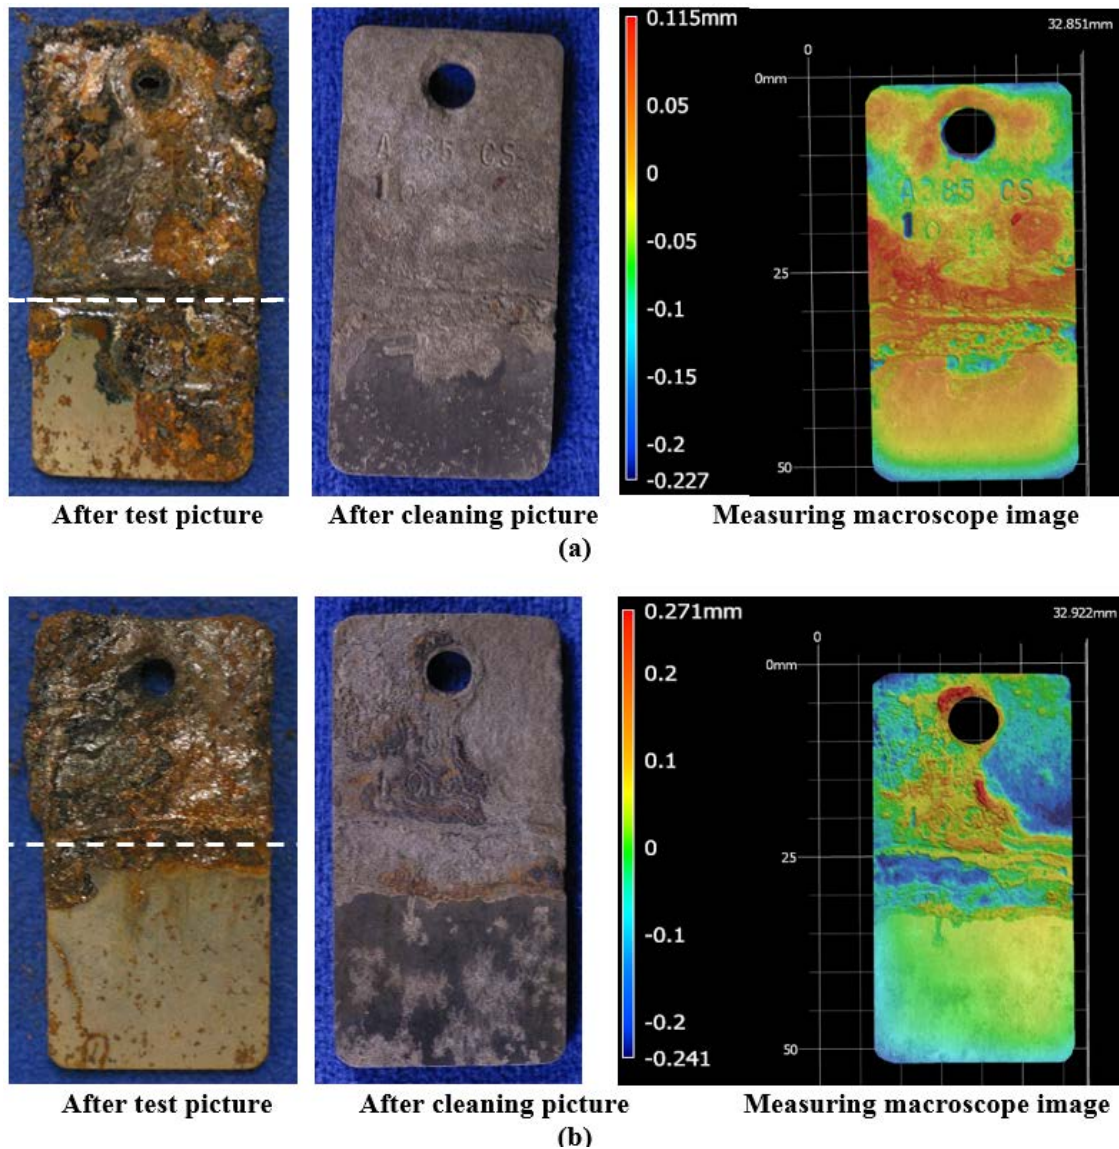
Comparing pictures and 3-D measuring macroscope images, only coupons exposed in solution 1 and 2 showed significant pit depth around LAI after 4 months. The images are presented in Figure 5-3. The measuring macroscope images indicate localized corrosion at the solution line and above with penetration depths at a range of 0.05 to 0.2 mm at minor deep areas and correspond to around 2.0 to 7.9 mils.

**Figure 5-3 Picture after test, after cleaning and 3-D measuring macroscope image of coupon 1001 (a) and coupon 1003 (b) exposed in Solution 1 and 2, respectively (engraving error for the carbon steel as A285).**

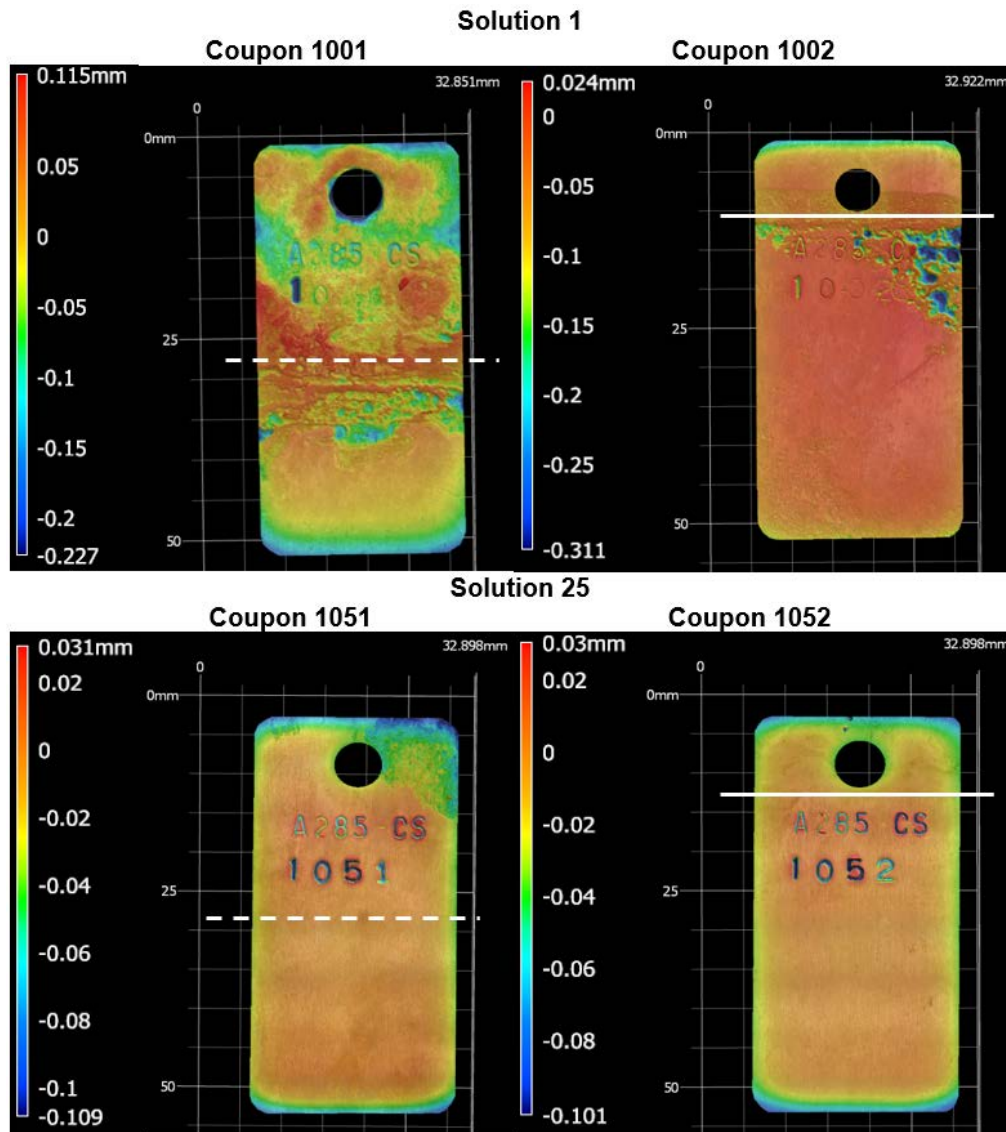
of 0.31 mm (12.2 mils) on the upper right side and shallow general attack at the lower left side with a range of depth of 0.1 to 0.2 mm (3.9 to 7.9 mils). The coupons immersed in solution 25 (i.e., coupon 1051 and 1052) showed no signs of corrosion with only a shallow region corresponded to VSC at the upper right corner of coupon 1051 with maximum depths of 0.05 mm (2.0 mils). Pit depths for all the remaining coupons in immersed areas were all less than 1 mil. The long term corrosion test showed that the combination of pitting factor can help predict the corrosive environment to some extent, but additional measures such as maintaining a high hydroxide concentration in the solution are critical for corrosion inhibition of carbon steel.

**Figure 5-4: Measuring macroscope images of partial and complete immersed coupons for highest and lowest corrosion rates obtained from selected coupons (engraving error for the carbon steel as A285).**

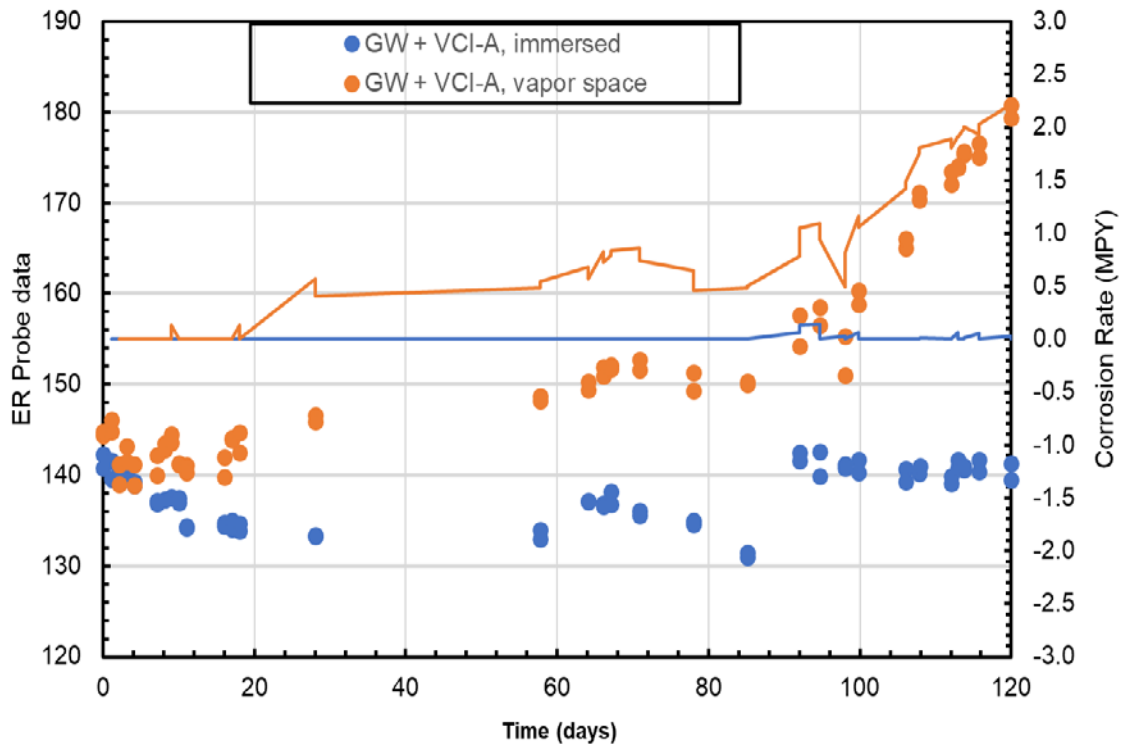
(a) ER Probe Data and Corrosion Rates

Figure 5-6 (a) VCI-A (VpCI-337) experiment ER probe data, and corresponding corrosion rates. Filled circles are the ER probe measurements and solid lines represent the corrosion rates. Images of the ER Probes After Completing the Experiment: (b) Probe that was Immersed in Solution, (c) Probe that was Placed in Vapor Space of the Experimental Setup

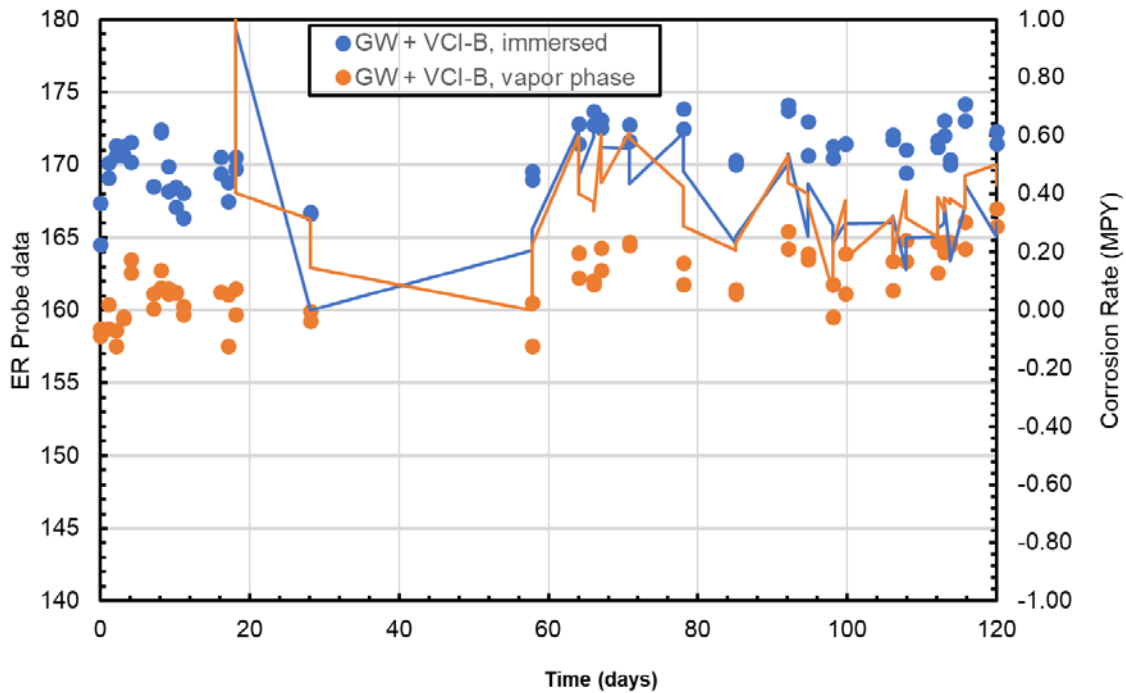
(a) ER Probe Data and Corrosion Rates

Figure 5-7 (a) VCI-B (VpCI-609 + VpCI-645) experiment ER probe data, and corresponding corrosion rates. Filled circles are the ER probe measurements and solid lines represent the corrosion rates. Images of the ER Probes After Completing the Experiment: (b) Probe that was Immersed in Solution, (c) Probe that was Placed in Vapor Space of the Setup

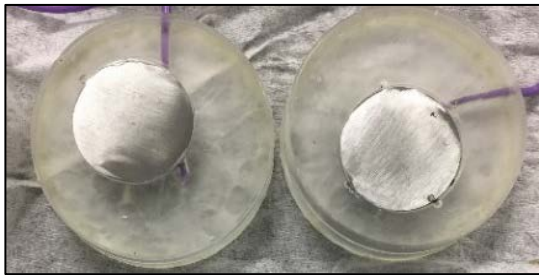
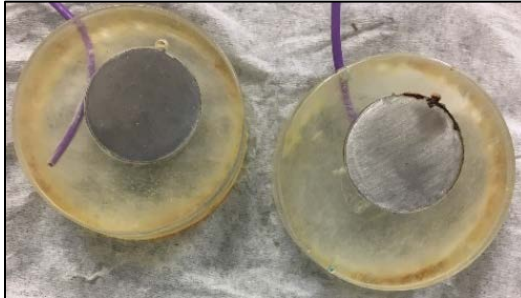
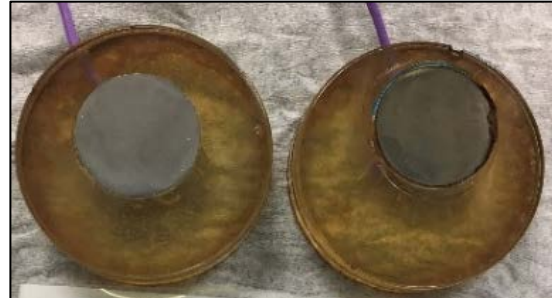
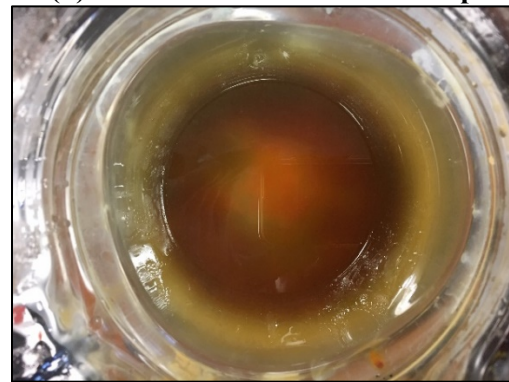
Figure 5-8 Images of the Post-test Coupons and Test Solution for GW + VCI-A

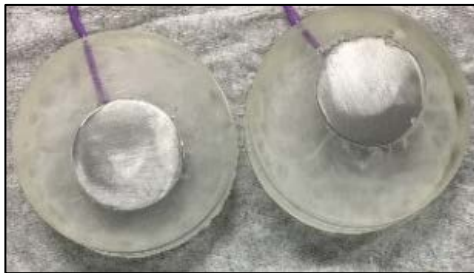
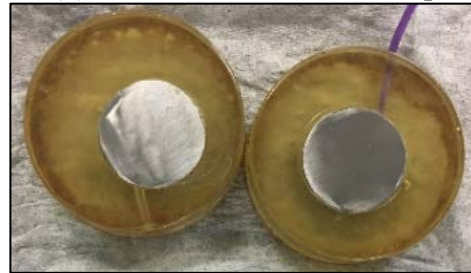
Images of the coupons exposed to GW + VCI-B environment are presented in Figure 5-9. The images also include photographs of test solution samples collected after completion of the experiment. It was observed that a white substance precipitated out and floated on top of the test vessel. In addition, a yellowish-brown substance precipitated at the bottom of the test vessel. Images of the test solution during the test, and samples of the test solution are shown in Figure 5-9. A sample of the white substance was collected in a vial and is shown in Figure 5-9(g). In addition, test solution from bottom of the test vessel was collected and is shown in Figure 5-9(h). Additional analysis will be conducted to determine composition and cause of precipitated substances.

(e) Test Solution with Focus on White Floating Substance

(f) Test Solution with Focus on Precipitants

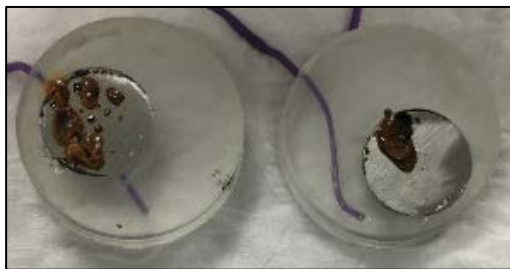
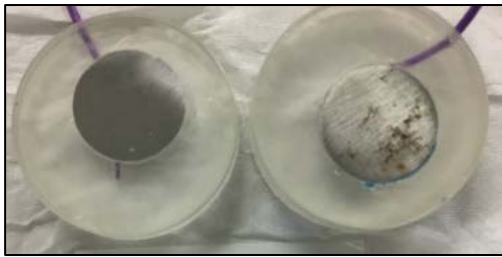
Images of the GW + CaCO<sub>3</sub> coupons are presented in Figure 5-10. Several coupons experienced extensive corrosion. Coupons were cleaned with Clarke's solution to remove corrosion products and measure accurate mass losses. Several coupons exhibited patch and pitting corrosion. Those coupons were surface profiled using a 3-D measuring microscope. Images and surface contours of those coupons are presented in Figure 5-11. The mass-loss and surface profile data were used to estimate corrosion rates. The mass-loss data were used to estimate surface average corrosion rates. The surface profile data were used to identify maximum pit depth which was then used to estimate the pitting rate by normalizing the pit depth on an annual basis. The corrosion rate data is listed in Table 5-8.

**Figure 5-10 Images of the coupons in GW + CaCO<sub>3</sub> experimental setup**

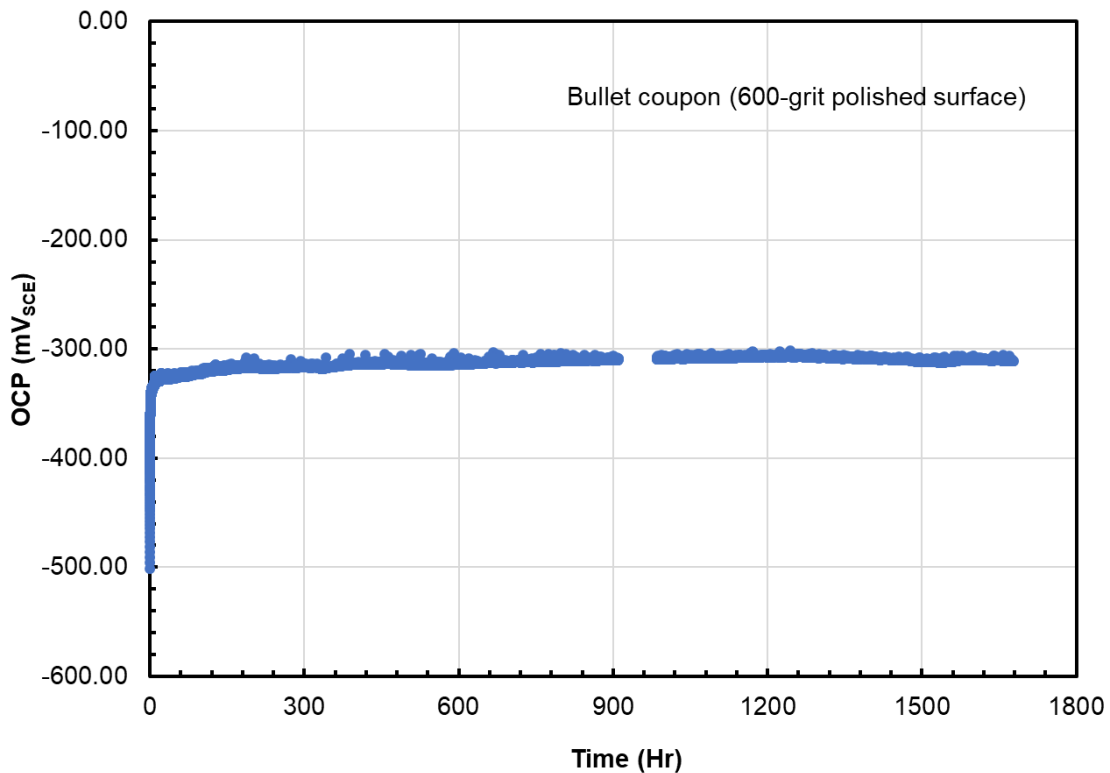
**OCP Drift:** The OCP data for the three coupons were collected for 120 days. The data for the bullet coupon are presented in Figure 5-14. As in the figure, the initial OCP is approximately  $-500 \text{ mV}_{\text{SCE}}$ . The potential quickly rose to  $-320 \text{ mV}$  and then stabilized at around  $-310 \text{ mV}$  after several days.

**Figure 5-14 OCP data for the bullet coupon (600-grit ground surface)**

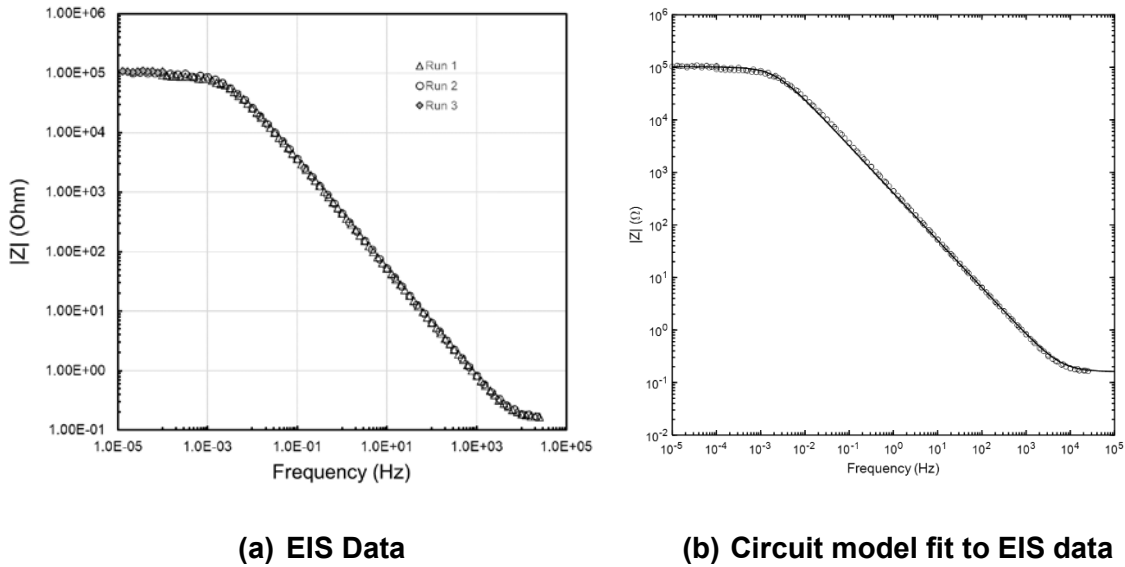
and constant phase element. Layout of the circuit model is shown in Figure 5-17. Circuit model fit to the bullet coupon's impedance data is shown in Figure 5-16(b).

**Figure 5-16 Bode Plot of Bullet Coupon (a) EIS Data and (b) Circuit Model Fit to EIS Data**

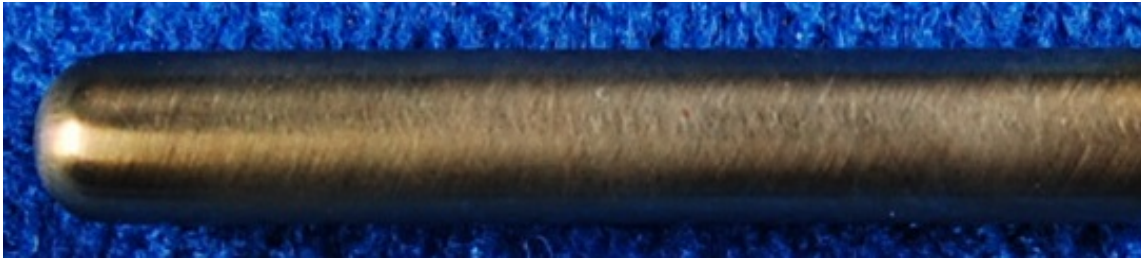
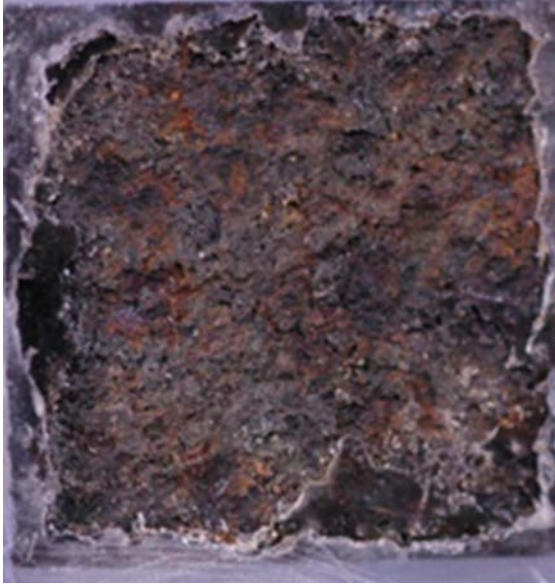
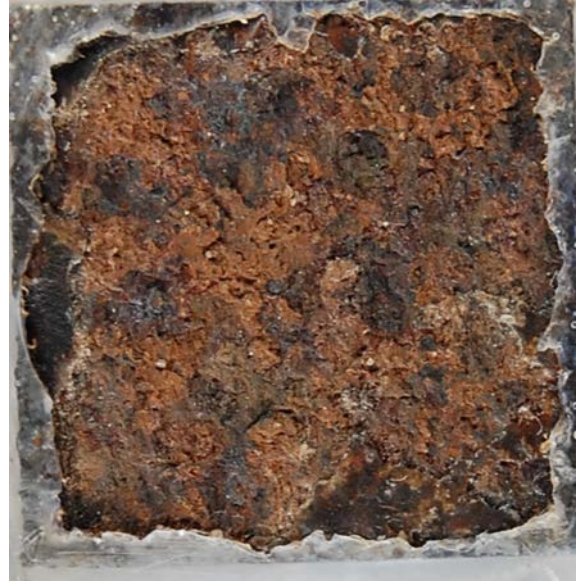
**Figure 5-21 Images of (a) Bullet coupon after OCP hold plus CPP, (b) Mill-Scale Coupons Before, and (c) Mill-Scale Coupon after OCP hold plus CPP**

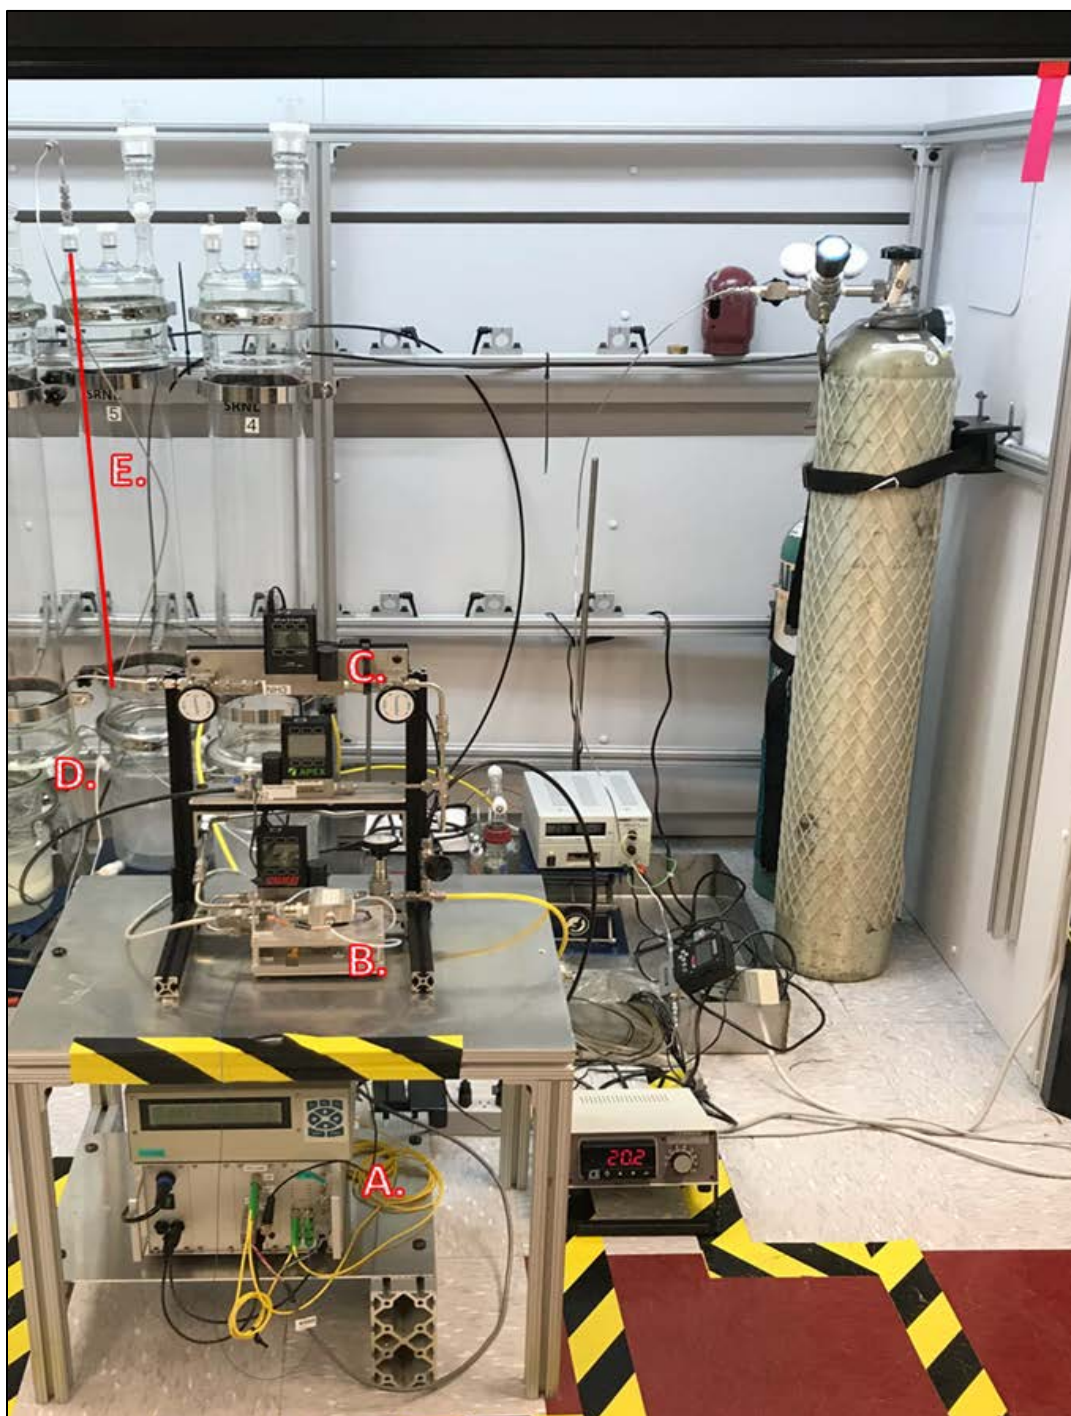
**Figure 5-26 QEPAS system, gas control manifold, and VSC test setup, (A) electronics and laser housing, (B) QEPAS cell, housing the ADM, (C) gas control manifold, (D) gas input from ammonia cylinder, and (E) ammonia sampling probe for VSC measurements.**
