Characterization of Oxide Films on Aluminum Materials following Reactor Exposure and Wet Storage in the SRS L-Basin

March 2019

SRNL-STI-2019-00058, Revision 0

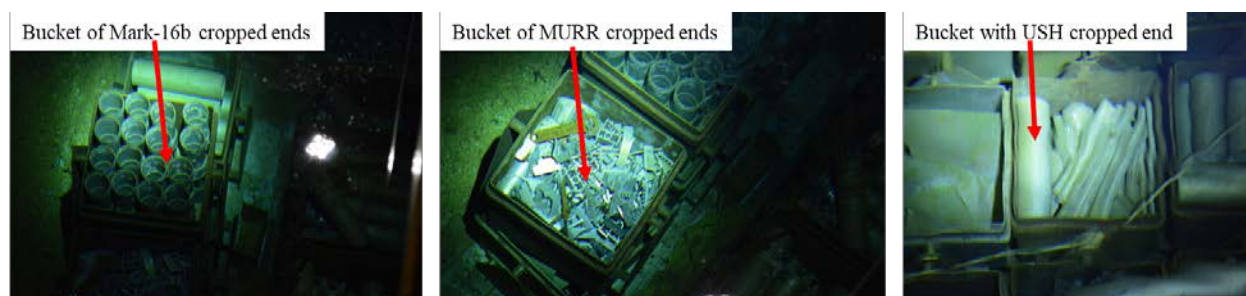
Figure 2 Scrap and croppings in wet storage in L-Basin.

Figure 2 shows the cropping pieces in their respective storage bins in L-Basin prior to retrieval for shipment to SRNL. One cropping each from a MURR fuel element, USH, and a Mark-16B assembly were collected (Figure 3, left), transferred underwater to a shipping cask on 8/22/2018 and 8/23/2018, and then shipped to A-area in late August 2018. Pieces were drip-dried on 8/29/2018 in the SRNL shielded cells facility.

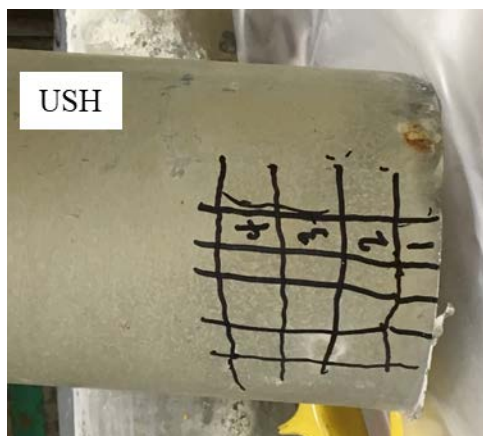
Figure 6 USH cropping marked for cutting of samples

Once at SRNL, the Mark-16b and USH croppings were removed from the cask and allowed to drip dry for several hours on 8/29/2018. Then the Mark-16b and USH croppings were double bagged and J-sealed and stored until 12/10/2018, when the bag was opened, and samples were cut and sent for analysis. Figure 6 and Figure 7 show the regions of the USH and Mark-16B croppings, respectively, where the samples were cut for analysis. To make the USH samples from the USH cropping, straight-cut aviation snips were used to cut a roughly square piece from the edge, which was cut into smaller pieces, with the grid for the samples shown in Figure 6, and dispositioned like the MURR pieces. To make the Mark-16B samples from the Mark-16B cropping, large bolt cutters were used to cut 5 pieces from the water inlet shown in Figure 7 and dispositioned like the MURR pieces, except the extra piece was also kept as a spare. XRD for both USH and Mark-16B was completed 12/13/2018, and SEM/EDS plan-view was completed on 01/09/2019.
