# Results of the SRNL Studies of the MCU Strip Effluent Coalescers

SRNL-STI-2019-00272, Revision 0

## EXECUTIVE SUMMARY

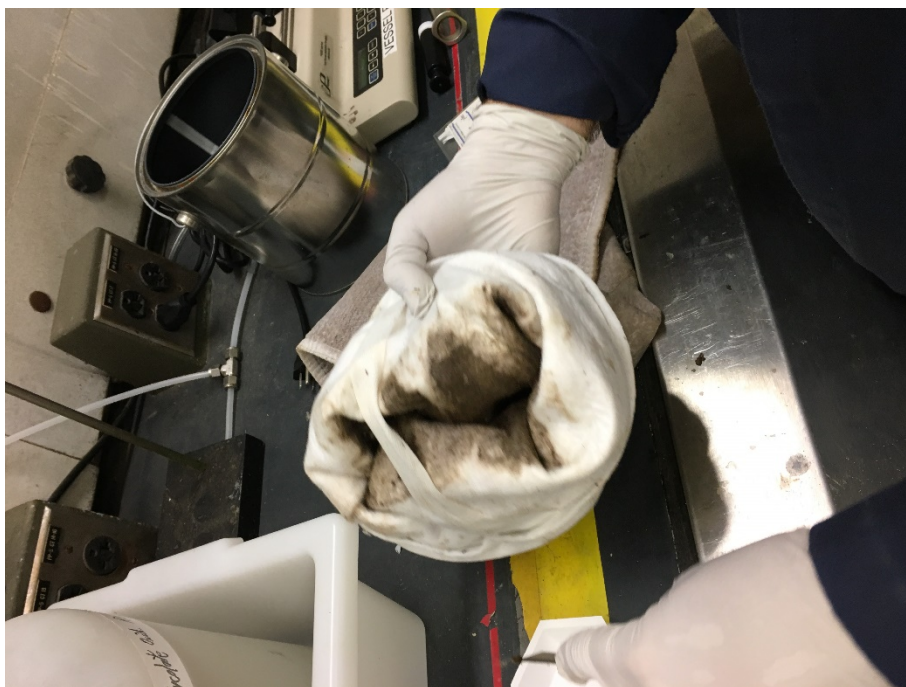
**Figure 1. The 7/30/2018 Flush Filter Sock (Sample 2A)**

Figure 1 shows the flush sock from between the Augusta Industrial Pumper Truck and the PECMC trailer. The filter sock was lightly contaminated with what looked to be specks and clumps of dirt like material, brown in color.

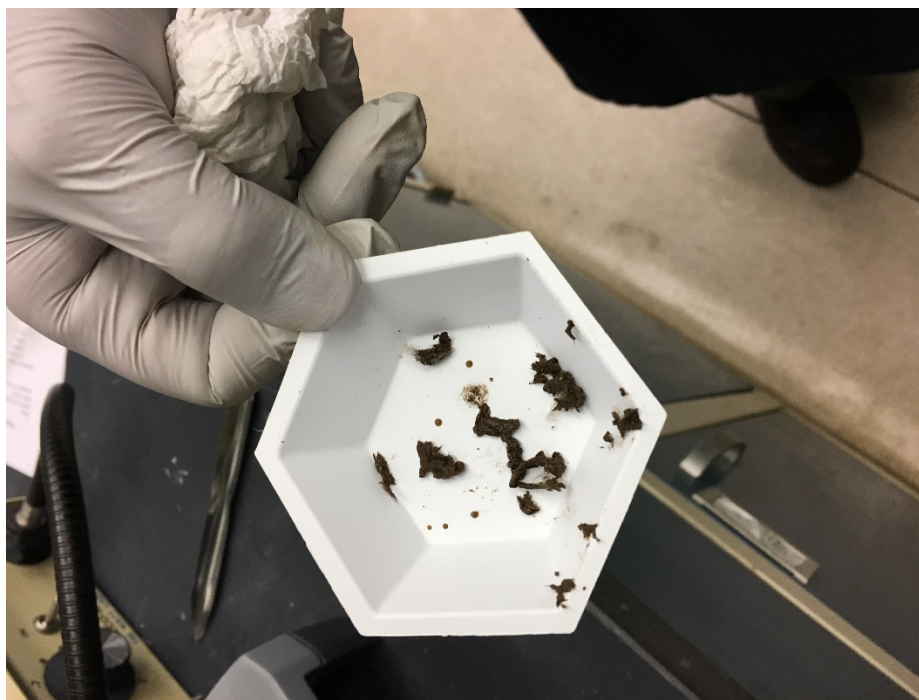
**Figure 2. Flush Solids (Sample 2A) from the 7/30/2018 Flush Filter Sock**

Some of the more available material was removed with a spatula (Figure 2).

While containing some of the filter sock fibers, most of the material looked and felt like mud. Several attempts were made to dissolve the solids in a variety of solutions. Deionized water, 3M nitric acid, 3 M, 6 M, and 12 M NaOH were all used to dissolve the solids. In each case, ~0.1 grams of solid were placed in a poly bottle with 30 mL of each solution. The suspensions were shaken by hand and allowed to sit. Over a period of two weeks, there was no evidence of significant dissolution in any of the solutions. A sample of this same material was then sent for aqua regia digestion, and then analyzed by ICPES (Table 6).

The largest result was iron and, with the corresponding nickel and chromium results, is most likely due to steel fines. The aluminum, calcium, sodium and silicon are likely from clays or dirt. The copper, manganese and zinc are possibly from metal piping and plumbing. The phosphorus could be from phosphate. The source of the magnesium is uncertain. The ICPES results seem to indicate external contamination (dirt, rust, etc.) from outside of MCU.

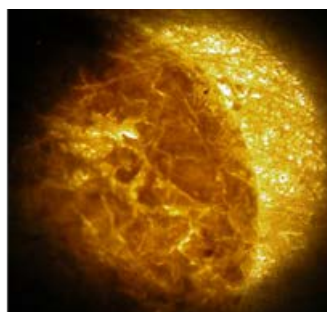
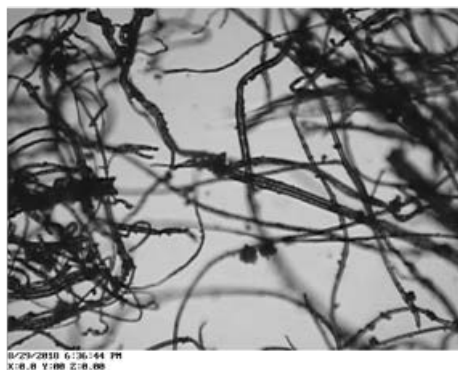
**Figure 11. SEC2 Slice After Solvent Washing**

To further investigate the amide signal, two coalescer pieces were washed; one with dichloromethane, ( $\text{CH}_2\text{Cl}_2$  – a polar solvent), the other with acetone (polar solvent). Both solvents were effective in removing the Modifier and sec-butyl phenol. The acetone wash was effective in removing the water. The coalescer pieces were much cleaner after both washes. An optical image and infrared analysis of the washed coalescer piece is shown in Figure 11. As can be seen in Figure 11, particulates remained in the “dark” and “light” areas of the coalescer. The chemical analyses indicate that the particulates are more closely related to microorganisms than to suppressor degradation products.

Picture of boundary between highly and lightly fouled sections. Even after solvent washing, fouling is evident. The dark (highly fouled) areas are the sections over the core perforations.

Under further magnification, particles can be noted – bacteria.

Individual fibers are removed from the bulk and examined under magnification

Even after solvent washing, evidence of bacterial fouling remains.
