***Crack Growth Rate and Large
Plate Demonstration of Chloride-
induced Stress Corrosion
Cracking in Spent Nuclear Fuel
Storage Canisters***

***Prepared for
U.S. Department of Energy
Spent Fuel and Waste Science and Technology***

***Poh-Sang Lam
Andrew J. Duncan
Robert L. Sindelar
Savannah River National Laboratory***

September 30, 2019
Milestone No. M3SF-19SR010201052
SRNL-STI-2019-00561

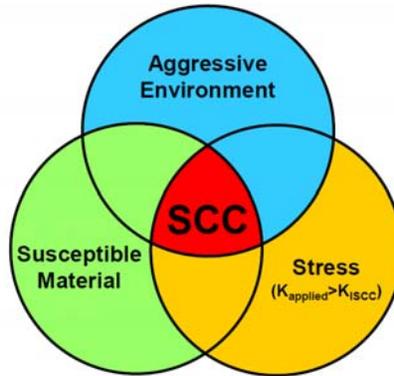
Figure 1. Criterion of stress corrosion cracking

the threshold Mode I (opening mode) stress intensity factor (denoted by K_I). Note that K_{ISCC} is considered as a material property for a material under certain environmental conditions, below which SCC cannot occur. Phenomenologically, stress corrosion cracking typically has a dependency on $K_{applied}$ (or denoted by K_I for short) as shown in Figure 2, where Phase I represents the SCC initiation stage, Phase II is the primary SCC growth regime, and Phase III is the region where catastrophic failure would occur.

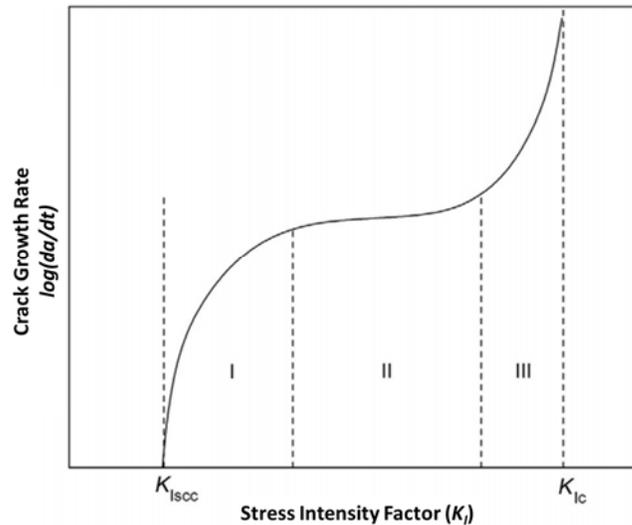
Figure 2. Dependence of crack growth rate (da/dt) on stress intensity factor (K_I is the Mode I stress intensity factor, K_{ISCC} is the threshold for stress corrosion cracking, and K_{IC} is the fracture toughness of the material)

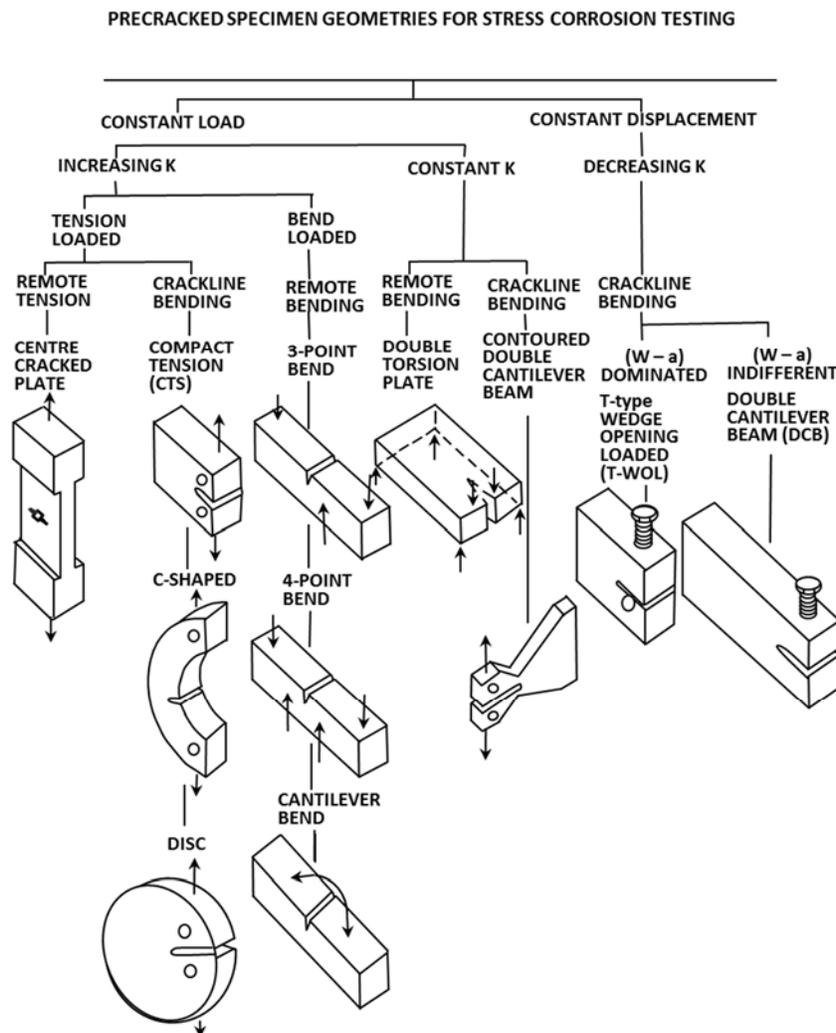
Figure 3. Pre-cracked specimen geometries for stress corrosion testing (Courtesy of Naval Research Laboratory, Washington, DC) [27]

Stress corrosion cracking experiments under CISCC conditions have been carried out. Theoretically, the CGR test data are fitted into Eq. (1) as a prediction tool to establish flaw re-examination intervals should flaws be detected on the canister. Figure 3 shows various geometries and loading modes for CGR test specimens, which were proposed by U. S. Naval Research Laboratory [27]. From Figure 3, the constant displacement, decreasing K , wedge opening loaded (WOL) compact tension specimen was selected for CISC testing at SRNL (i.e., bolt-load CT specimen).

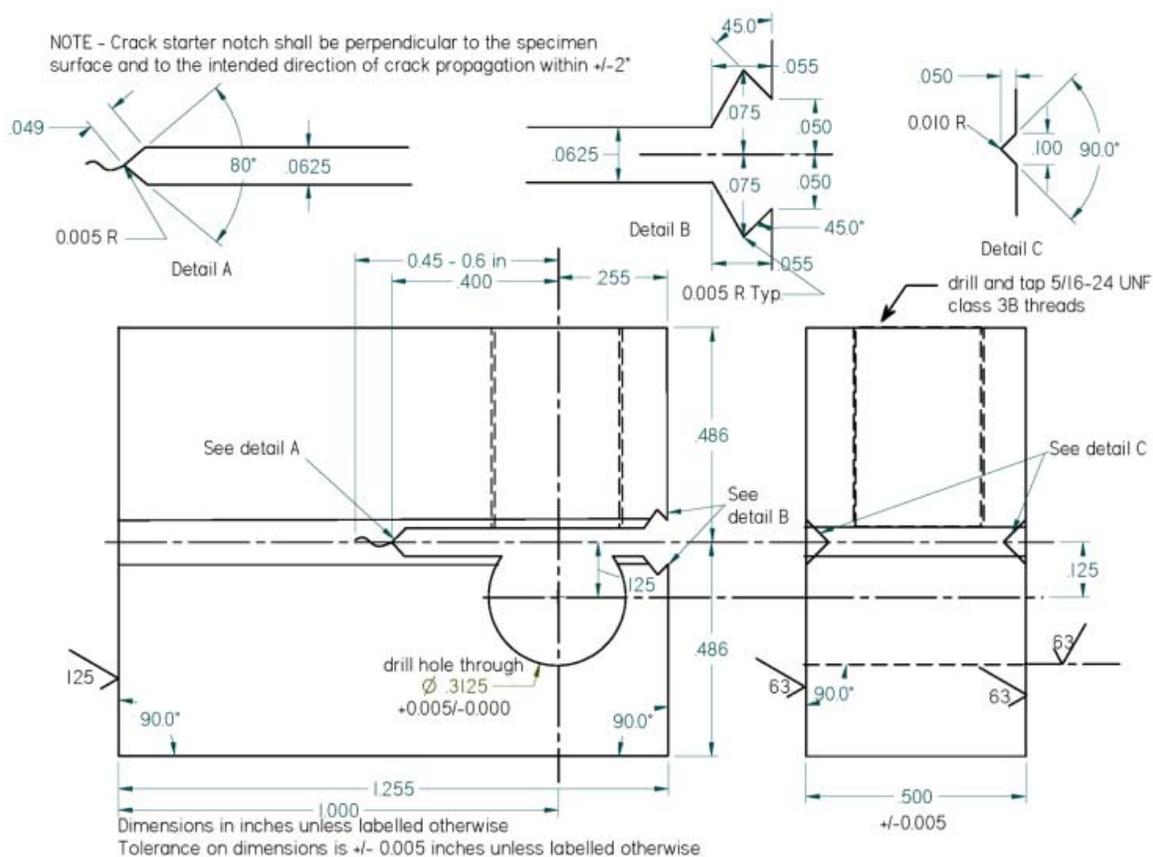
Figure 4. ASTM E1681 bolt loaded compact tension specimen design with 10% side groove on each side of the specimen

The bolt-load compact tension specimens used for SRNL testing were either machined from archival 304 stainless steel plates (Section 2.2) or from plates cut from a dual certified 304/304L stainless steel full-size mockup canister (Section 2.3). The specimen design, as shown in Figure 4, is based on ASTM E1681 “*Standard Test Method for Determining Threshold Stress Intensity Factor for Environment-Assisted Cracking of Metallic Materials.*” The width (W) between the bolt centerline and the back plane is 25 mm, the total height ($2H$) is 25 mm, and the thickness (B) 12.7 mm with 10% side groove on each side [11-14].

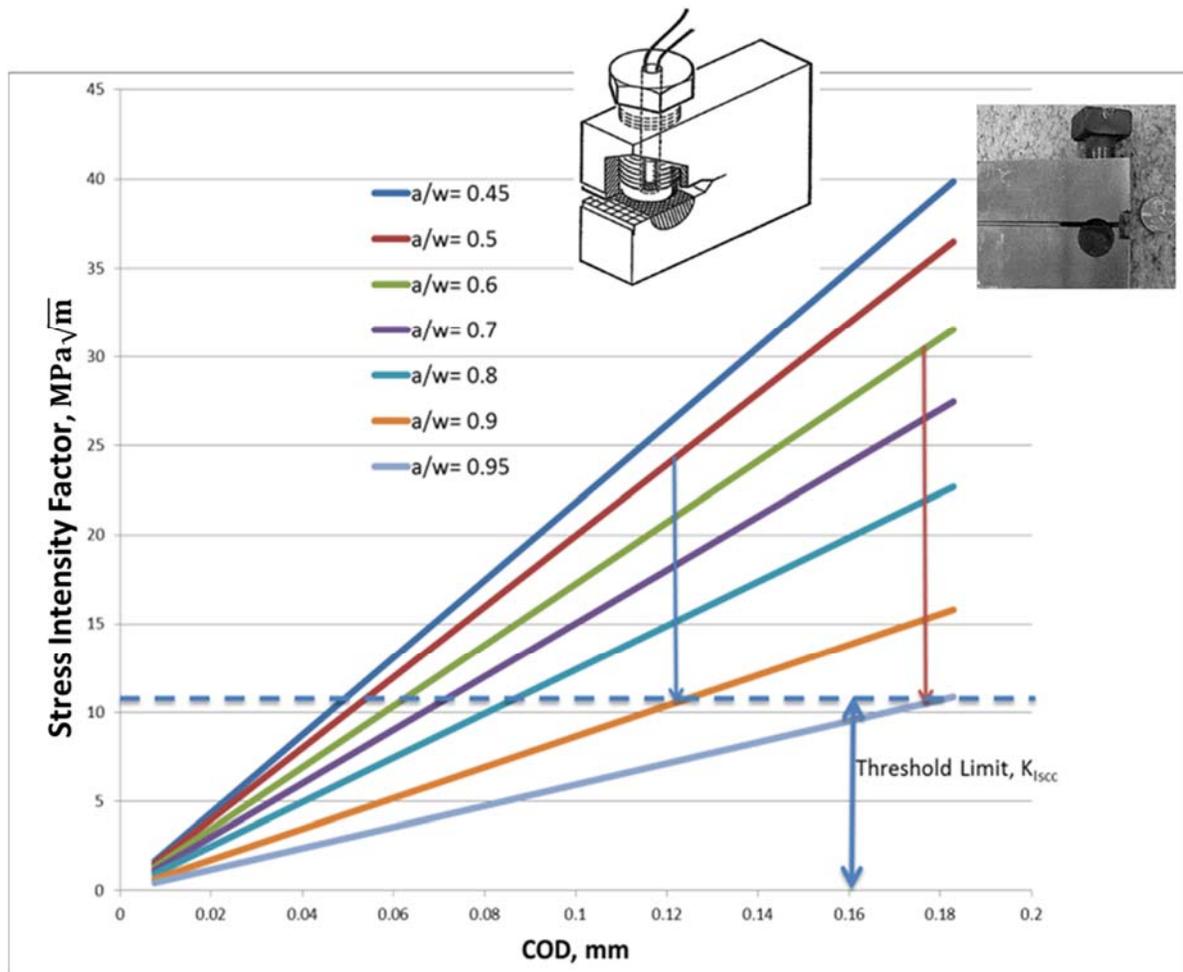
Figure 5. Expected crack growth behavior of “falling K ” constant displacement CT test

The stress intensity factor, K , is determined for the crack front (crack tip) per Equation 4 in ASTM E1681, which is dependent on crack length (a), elastic modulus (E), crack mouth opening displacement (COD), and the specimen width (W). The bolt-load CT test is conducted under “falling K ” kinetics that would allow for the examination of the relationship between K and crack growth rate (da/dt), as well as, provide data to determine a threshold value for stress corrosion cracking (K_{ISCC}), if it exists (see Figure 5). The arrows in Figure 5 illustrate the relationship between K and a/W for a COD values used in this test. As the crack grows, K drops until the CGR stops. This K level is referred to as K_{ISCC} . The CT specimens were loaded to approximately $33 \text{ MPa}\sqrt{\text{m}}$, the maximum possible per guidance in the standard to avoid plasticity effects.

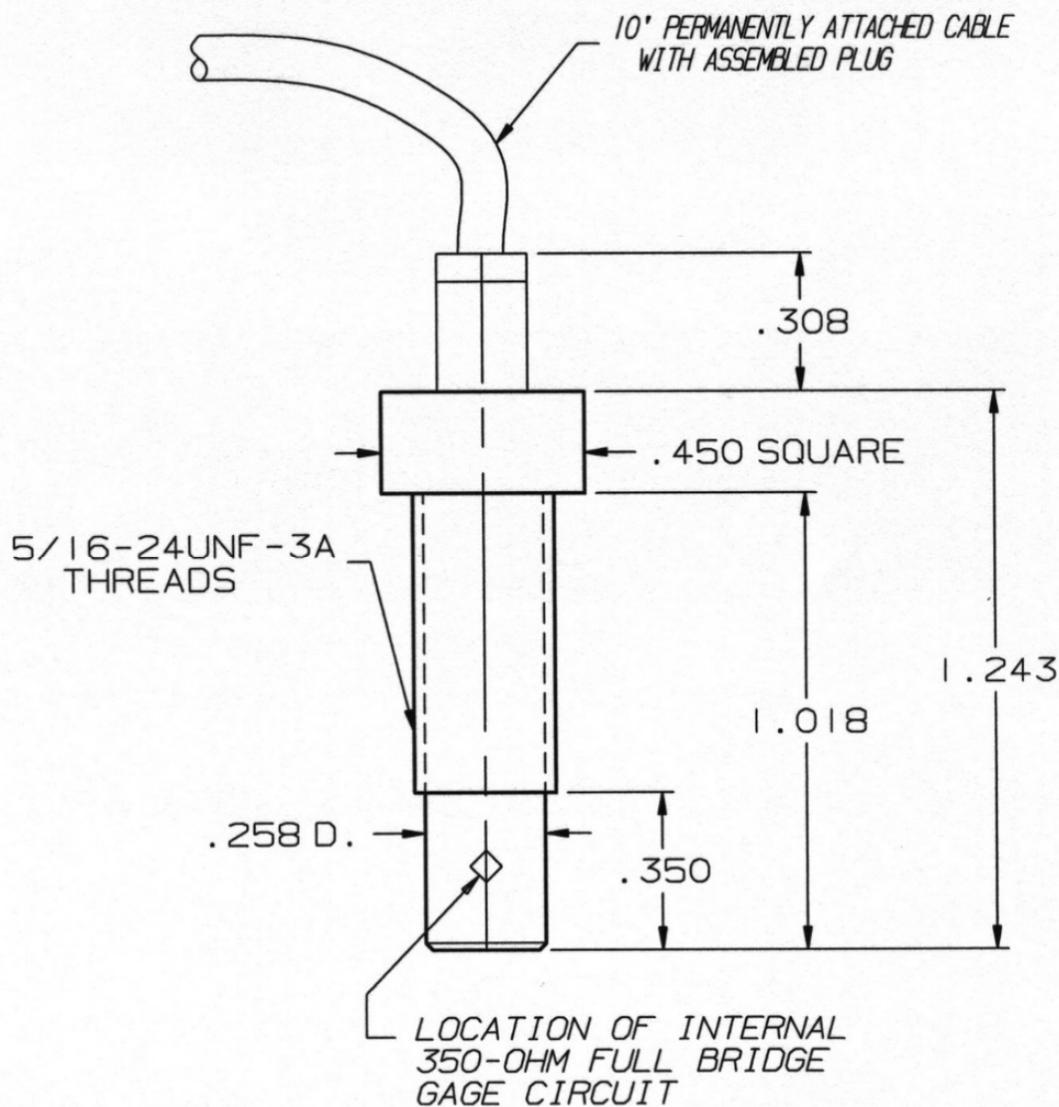
Figure 6. Instrumented bolt design

An instrumented bolt [28] with built-in load cell was selected for the bolt-load CT specimen. The design is shown in Figure 6. The feed-through on both the glass vessel (environmental cell) and the oven (see Sections 2.2 and 2.3) enabled a data acquisition system (DAS) to acquire load drop with time for a fixed displacement (COD). Figure 7 is a *typical* graph of load/temperature vs. time, which was obtained from the instrumented bolt-load CT test in Section 2.3. In Figure 7, the temperature record (green) was from a thermocouple, the “Baseline (37C)” data (yellow) were obtained from the instrumented bolt itself (threaded plug); and the “RT” (red) and the “37C” (blue) curves are the load vs. time data at room temperature and at 37 °C, respectively, for bolt-load CT specimens packed with dry salt in 75% RH environments (see test matrix in Table 3).

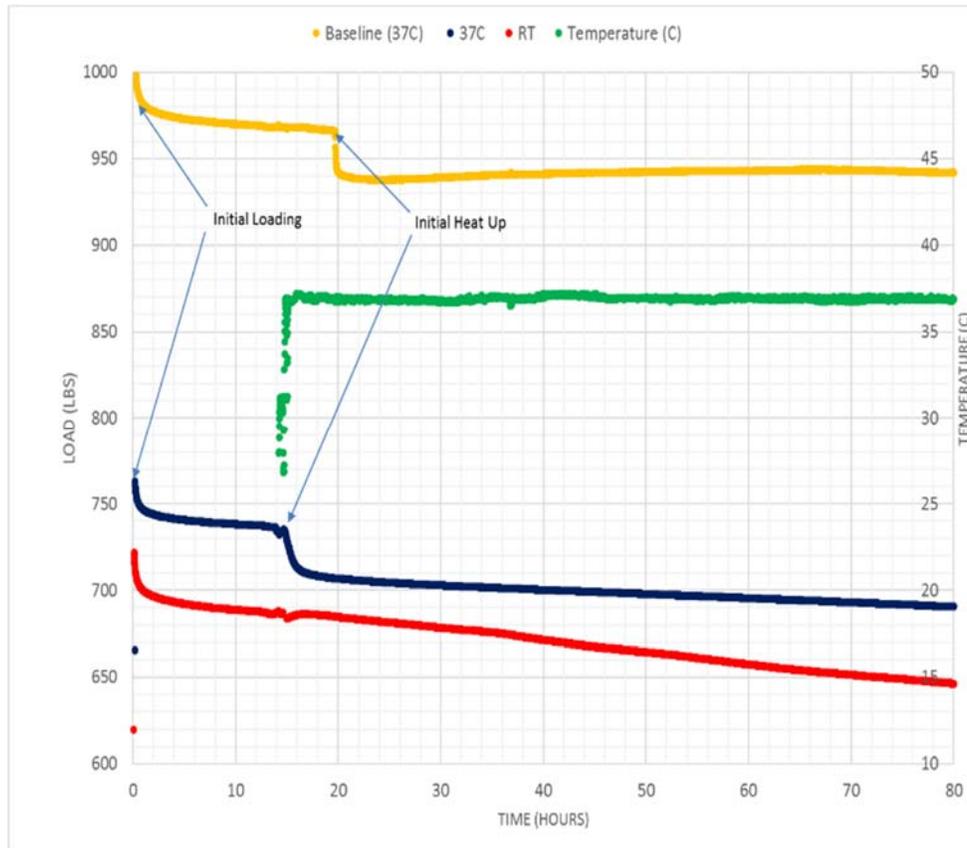
Figure 7. Typical load - time response of instrumented bolt

The CT specimen was mounted in the apparatus (Figure 20) and immersed in a chloride solution with 5 % salinity composed of artificial sea salt. This is considered as conservative because the average salinity of seawater is 3 %. Efforts were made to minimize evaporation. Multiple sets of the apparatus with CT specimen installed were placed inside an environmental control chamber, which was maintained at 50 °C and 95 % RH (see Figure 22). The strain gages in the apparatus were calibrated to compensate the temperature change in the environmental chamber. The bolt was tightened according to the desired loading on the CT specimen. Note that this is a constant displacement test, therefore, the load decreases gradually as CISCC occurs, which is similar to the load vs. time relationship presented in Figure 7 (for SRNL test).

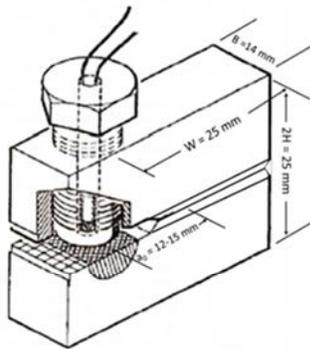
An Instrumented Bolt Measures the Load Drop With Crack Extension

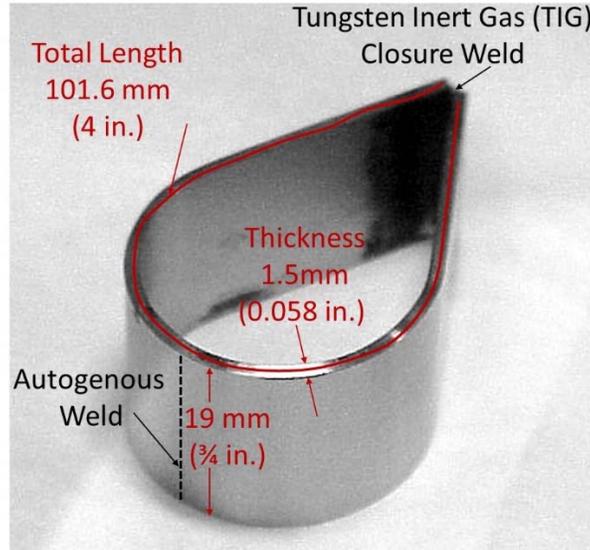
Figure 9. Teardrop coupon used to provide convenient assessment of the bolt-load CT specimen during CISCC test

To gather visual evidence of the deliquescence and corrosion of the bolt-load CT specimens without unloading and removing from the test environment, 304L stainless steel teardrop coupons (Figure 9) were inserted in glass cradles next to the bolt-load CT specimens in each vessel (Figure 10). The dry salt was also packed between the teardrop specimen and its holder, and the crevice corrosion would not occur. The teardrop specimens were originally designed for another nuclear material surveillance program at SRNL. An autogenous weld was fabricated in the teardrop coupon to provide a similar weld microstructure as was present in those containers. All the specimens were exposed to the same experimental conditions for 5 months and then unloaded for analysis.

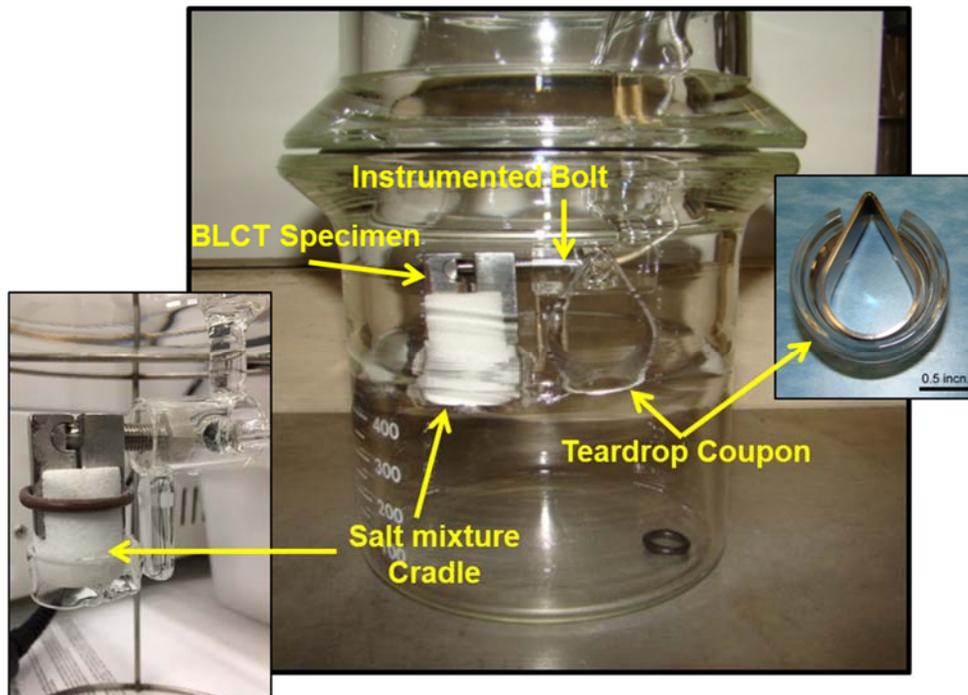
Figure 10. SCC test configuration showing the cradled instrumented bolt-load CT (BLCT) specimen and a companion teardrop coupon in a constant humidity vessel

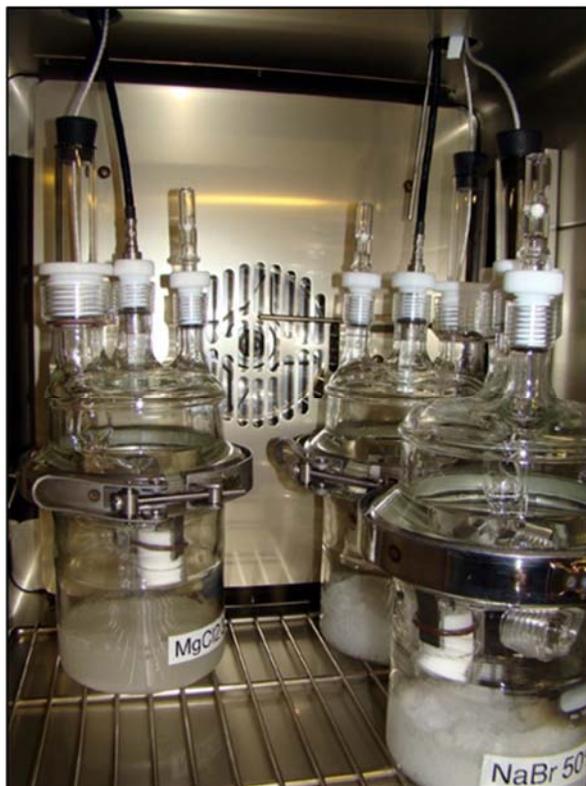
Figure 11. Experimental set up for CGR test using three different salt/dust mixtures and RH conditions at a constant oven temperature

As shown in Figure 11, three constant humidity vessels (test cells) with loaded specimens under conditions listed in Table 1 were placed inside an oven with temperature set to 50 °C. Note that absolute humidity of $\sim 30 \text{ g/m}^3$ is bounding in nature. At 50% RH and 50°C, the absolute humidity is 42 g/m^3 .

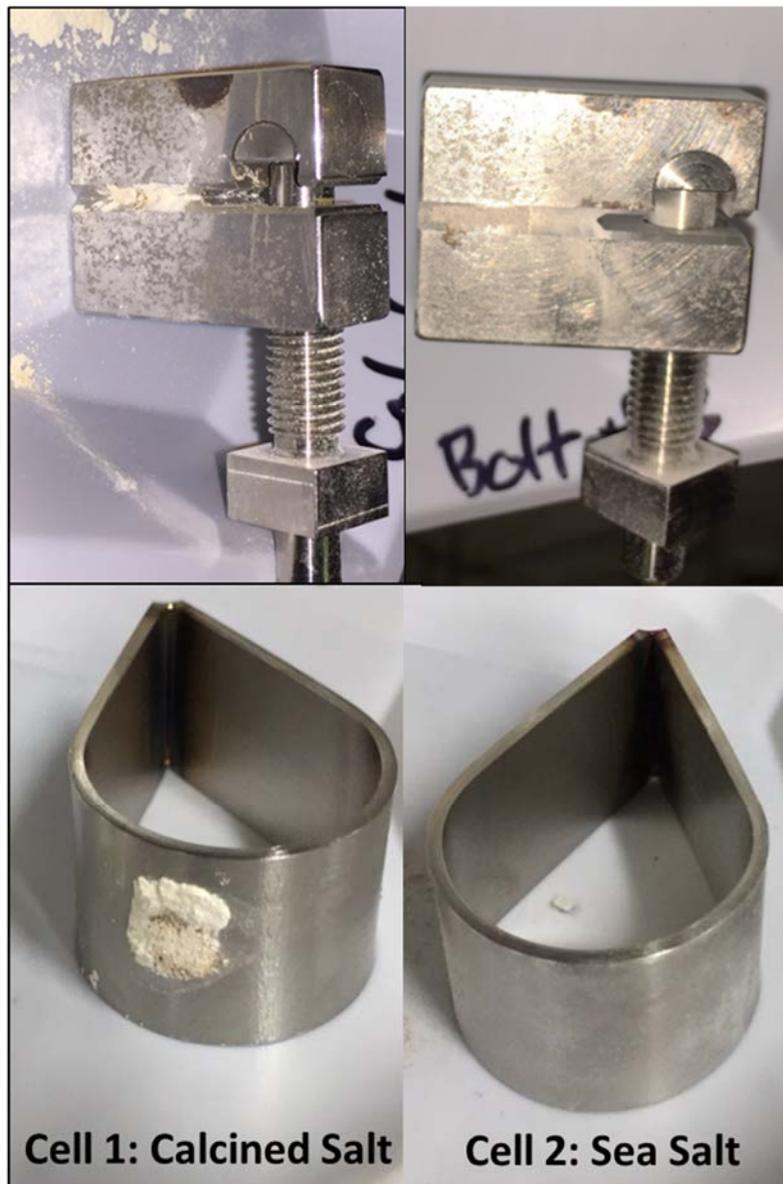
Figure 12. Specimens as removed from test cells (Cell 1: calcium-rich salt, Cell 2: sea salt)

not planar. Therefore, the associated stress intensity factor and the CGR were difficult to characterize. In the case of sea salt tests that used artificial sea salt/dust mixtures (Cells 2 and 3), the pitting corrosion or cracking was not present even when they were exposed to relative humidity that bounds possible service conditions. This is most likely due to the absence of a brine film in contact with the surface of the specimens. This observation suggests that capillary action to draw brine onto a crack face is not certain. That is, this one specimen shows that the occurrence of CISCC under deliquesce conditions with assumption that capillary forces would draw brine into a crack to wet a crack front is stochastic.

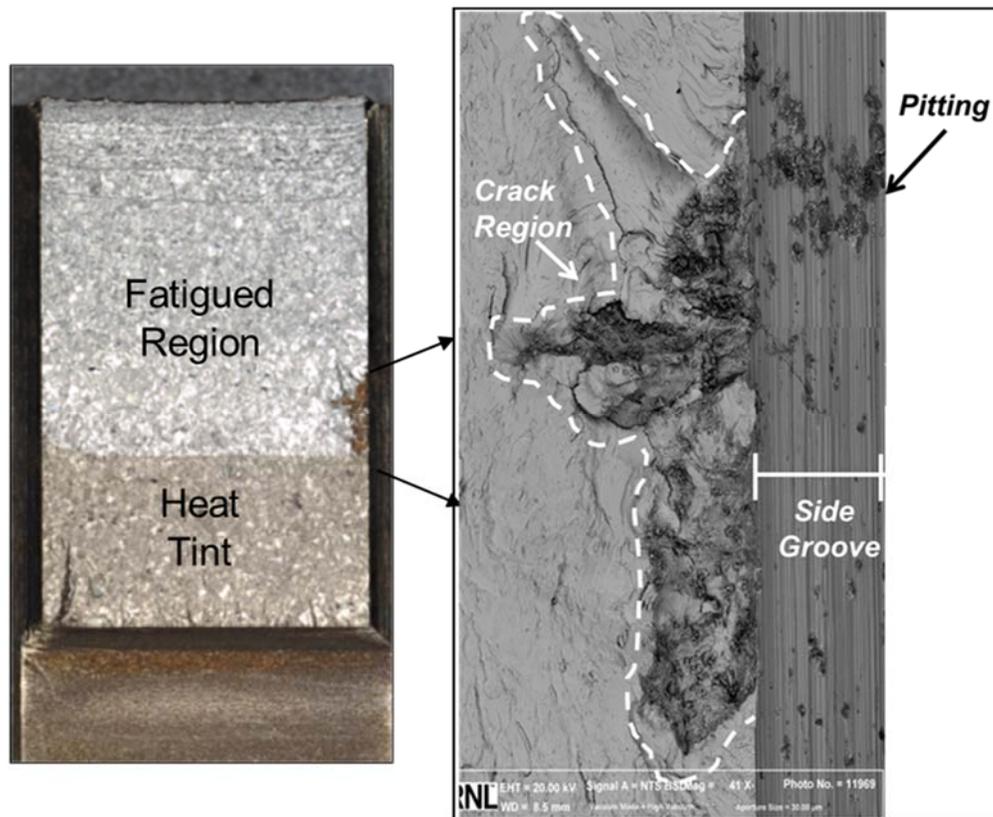
Figure 13. Optical and SEM images of the fracture surface of the bolt-load CT specimen (Specimen 1) exposed to simulated calcium-rich salt at 50 °C and 50% RH for 5 months

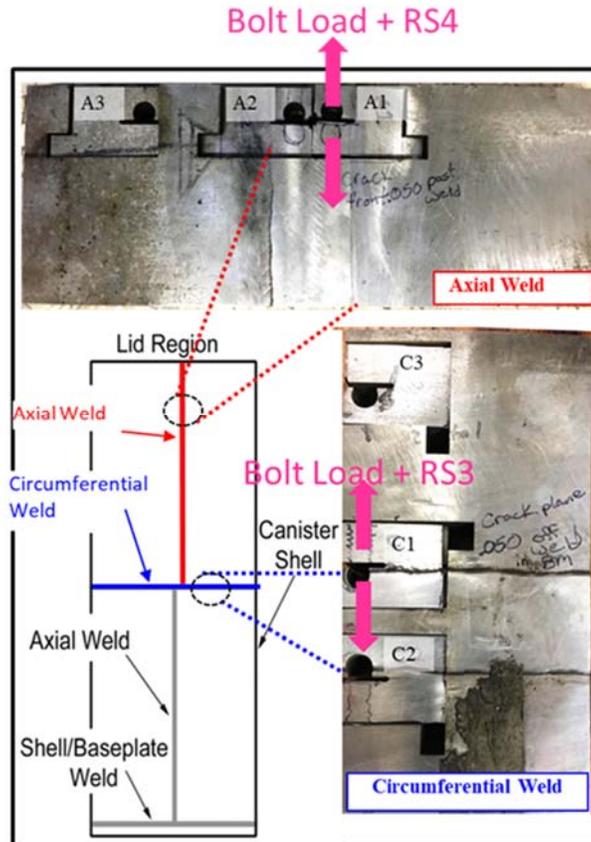
Figure 14. The Bolt-Load CT specimens as machined from two plates cut from the mockup canister

These bolt-load CT specimens were designed such that the intended crack growth direction is identical in all specimens, that is, all the expected crack extensions are parallel to the rolling direction of the plate (i.e., T-L, the weakest direction for the crack to propagate mechanically in this plate, where K_{IC} value is the lowest). During the canister fabrication, the plate is cold formed into cylindrical shape as a section of the canister, then all the sections are joined by submerged arc welding (SAW). As schematically indicated in Fig. 14, the loading experienced by the bolt-load CT is “Bolt Load + RS3” or “Bolt-Load+RS4,” where the “bolt load” is the tensile stress exerted by tightening the instrumented bolt; RS3 represents the WRS perpendicular to the circumferential weld; and RS4 is the WRS parallel to the axial weld. Note that RS3 and RS4 have been obtained experimentally [15] and numerically by finite element simulation [32] (see Fig. 15).

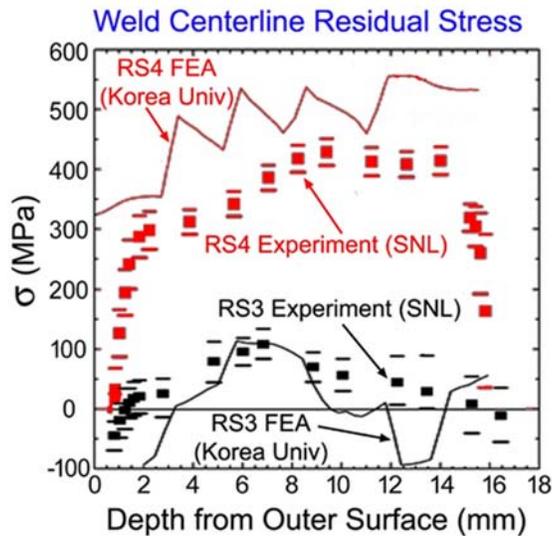
Figure 15. The WRS Components RS3 (Perpendicular to Circumferential Weld) and RS4 (Parallel to the Axial Weld) [15,32] (Courtesy of Korea University under I-NERI/USA-ROK)

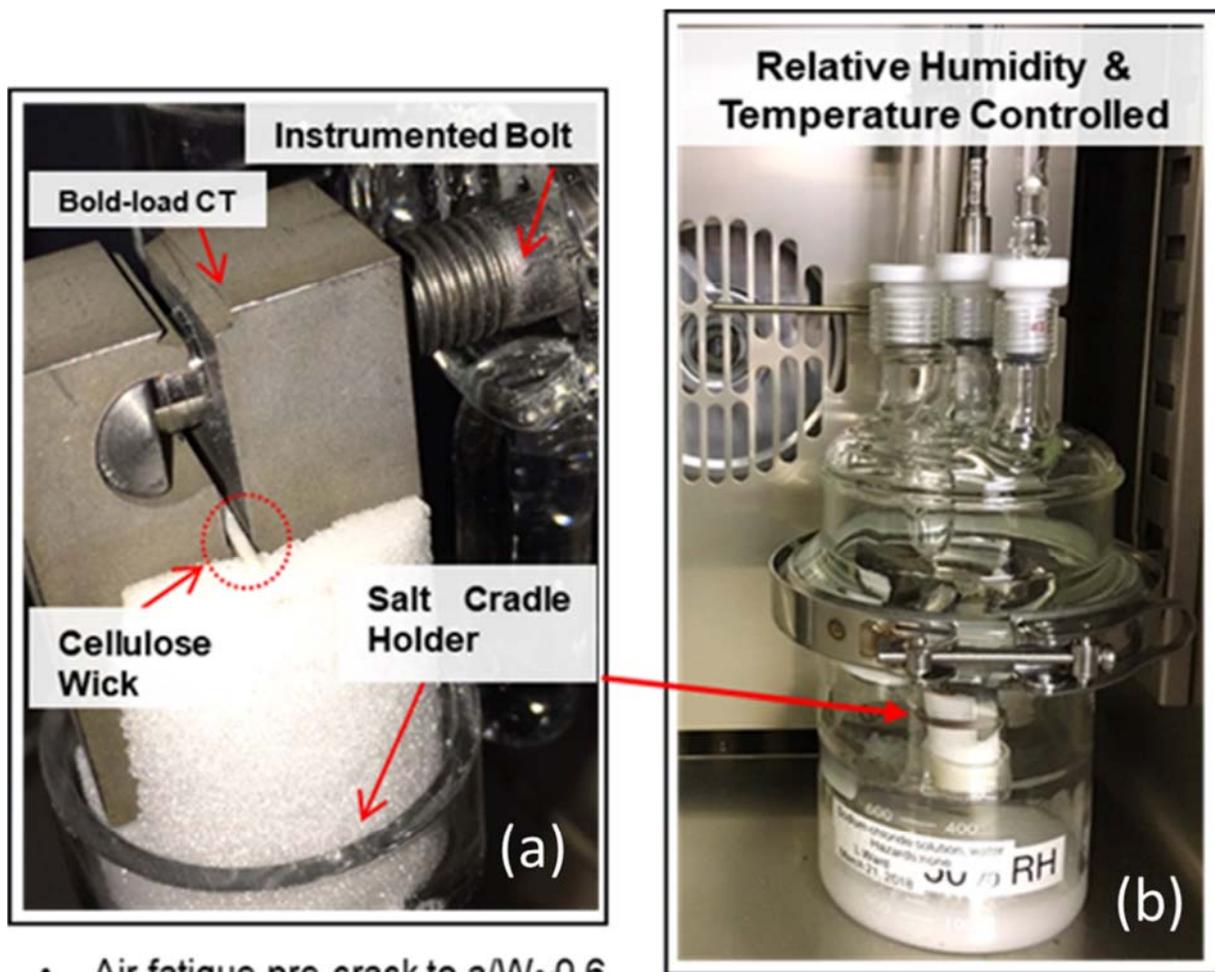
Figure 16. Typical configuration of the bolt-load CT specimen packed with dry salt (a) and then installed in a closed glass vessel with teardrop coupon under constant humidity condition (b)

The design and the pre-cracking procedure of the bolt-load CT specimens used in this experiment have been described in Section 2.1 (ASME E1681). Figure 16 shows that the dry salt used to induce CISCC was packed around the notch region of the bolt-load CT specimen. The dry salt was obtained from dehydrated artificial sea water prepared according to ASTM D1141, “*Standard Practice for the Preparation of Substitute Ocean Water.*” A chemical-free cellulose wick (Figure 17) [33] can be seen to be inserted at the end of the machined notch of the bolt-load CT specimen (see Figure 16 (a)) to ensure that the brine from the deliquescing salt is transported evenly to the crack front.

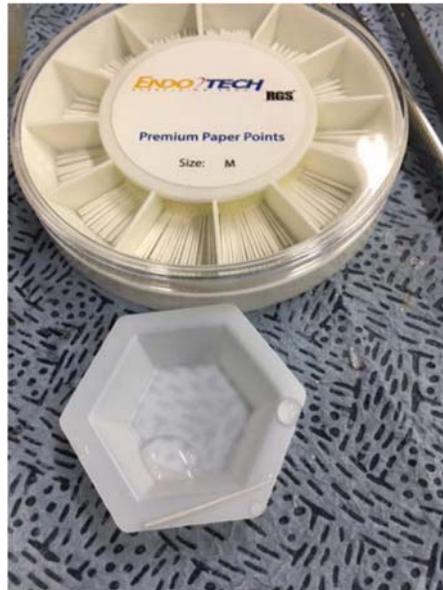
Figure 17. Cellulose wicks (in vendor package and in a test tray with water drops) used to transport deliquescing salt to crack front in bolt-load CT specimens

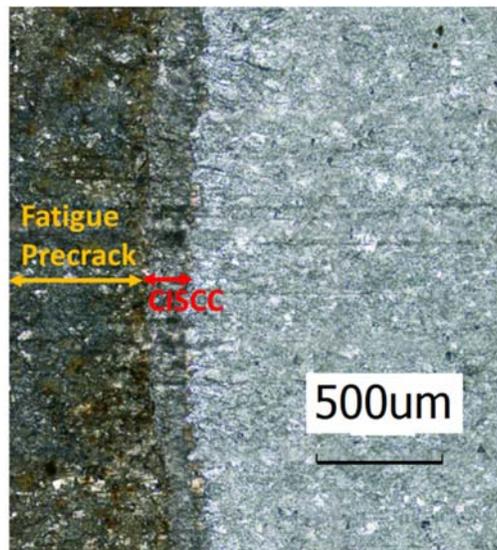
Figure 18. Typical fracture surface under CISCC (from Specimen C1 in 75% RH at 37 °C for 6 months)

Table 4 summarizes the CISCC test results for all six bolt-load CT specimens up to six-month exposure. It is noticed that higher test temperature would not always cause more crack growth (Δa) within the temperature range in this test (i.e., Specimen C1 at 37 °C vs. C2 at room temperature or 24 ±2 °C). It is also likely that these measurements were within the experimental error band. Nevertheless, it is obvious that the crack growth near the axial weld (Specimens A1 and A2) was faster than that in the circumferential weld (Specimens C2 and C1). Note that the initial mechanical load through the bolt was similar in all specimens (~33 MPa√m), but the residual stress (RS4) acting on Specimens A1 and A2 was indeed much higher than RS3 on Specimens C1 and C2, as suggested by Figure 15 (assuming that the original WRS was not altered significantly by plate cutting and by specimen fabrication using EDM). Therefore, the effective loading (WRS plus mechanical applied load) on Specimens A1 and A2 was higher than that on C1 and C2. This fact may be used to explain why A1 and A2 have greater crack growths (Δa) than C1 and C2, regardless of the test temperatures.

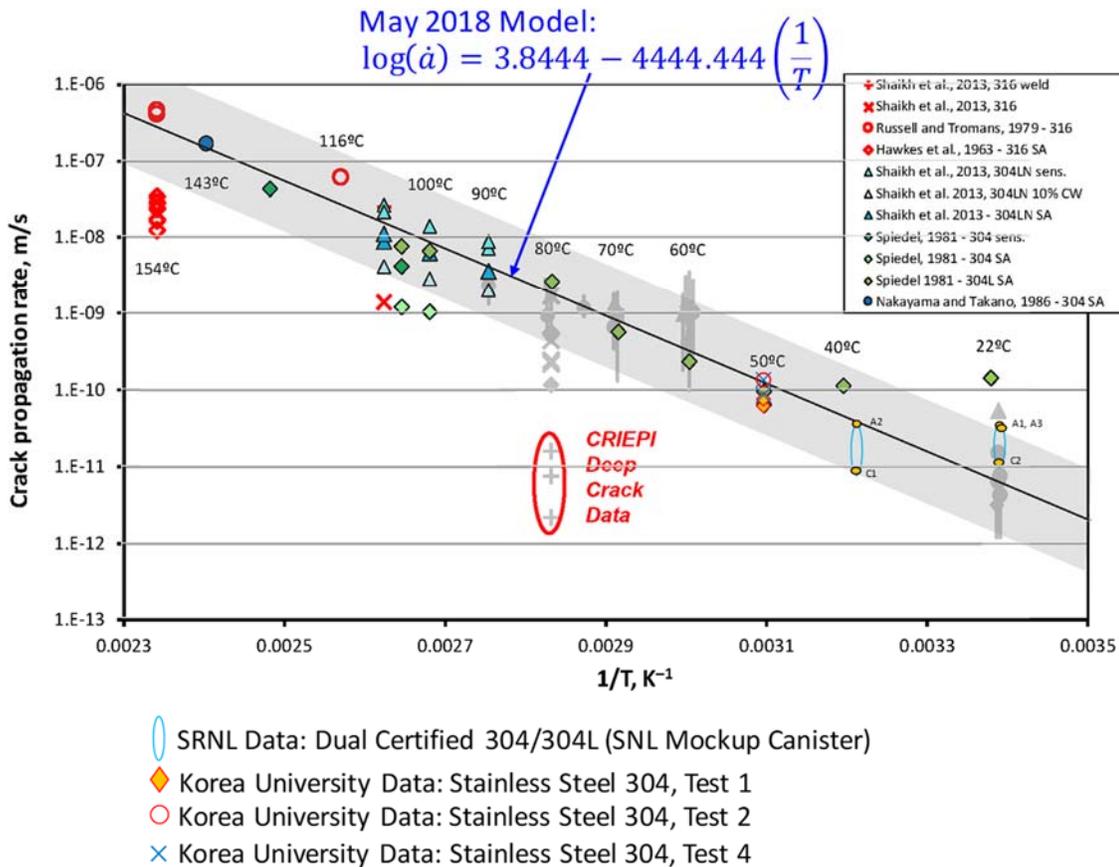
Figure 19. Chloride-induced stress corrosion crack growth rates under wide range of exposure conditions (original figure courtesy of Sandia National Laboratories [17-19])

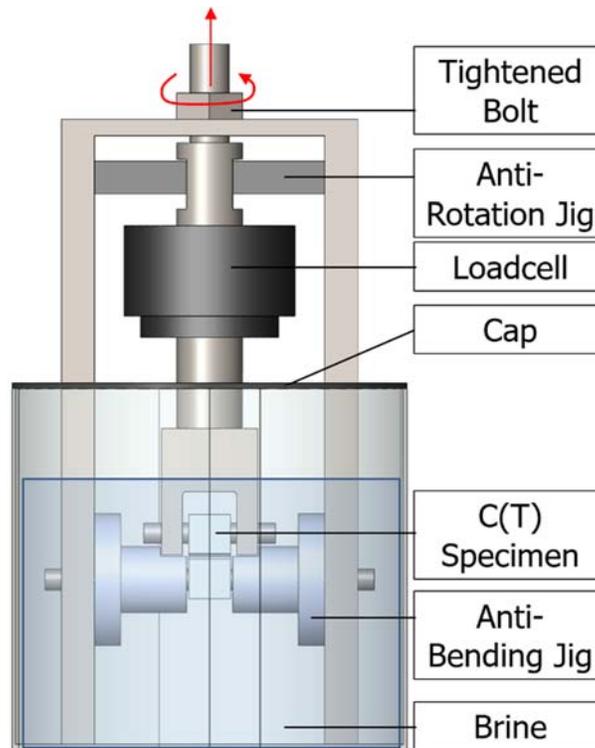
**Figure 20. Schematic diagram of the CGR test apparatus with standard CT specimen
(Courtesy of Korea University under I-NERI/USA-ROK)**

evaporation. Jigs are made to suppress the bending and rotation due to loading throughout the test. The components of the apparatus were all made from 304 stainless steel, which is the same as the material to be tested. The chemical composition of 304 stainless steel used at KU is listed in Table 5.

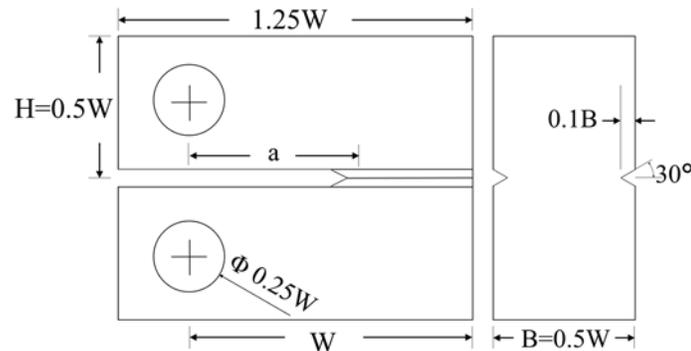
Figure 21. Standard compact tension specimen as recommended by ASTM E1820 (Courtesy of Korea University under I-NERI/USA-ROK)

The standard CT specimens were fabricated according to ASTM E1820, “*Standard Test Method for Measurement of Fracture Toughness.*” The specimen design is shown in Fig. 21, where W is 25.4 mm and thickness B is 12.7 mm (i.e., $\frac{1}{2}T$ compact tension specimen). The specimens were fatigue pre-cracked with MTS 810 servo hydraulic material testing system, then tinted at 400 °C to distinguish any crack growth due to CISCC.

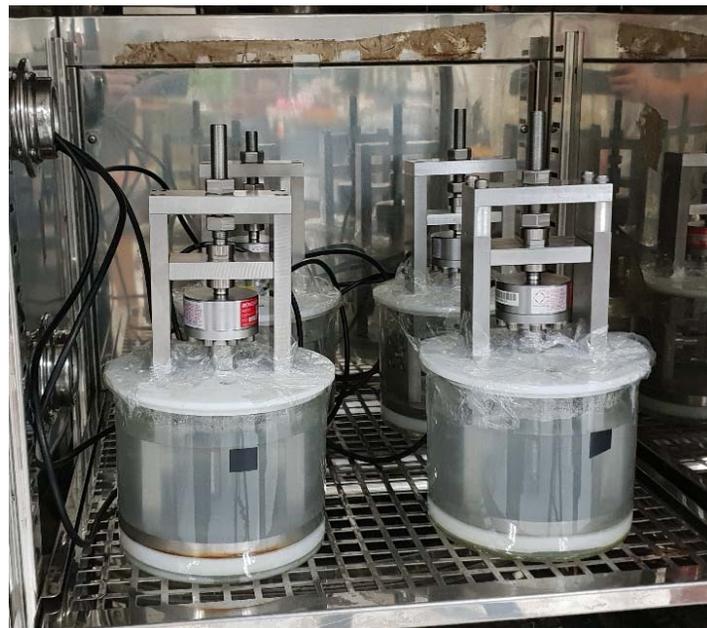
Figure 22. Korea University CISCC test conducted in an environmental control chamber (Courtesy of Korea University under I-NERI/USA-ROK)

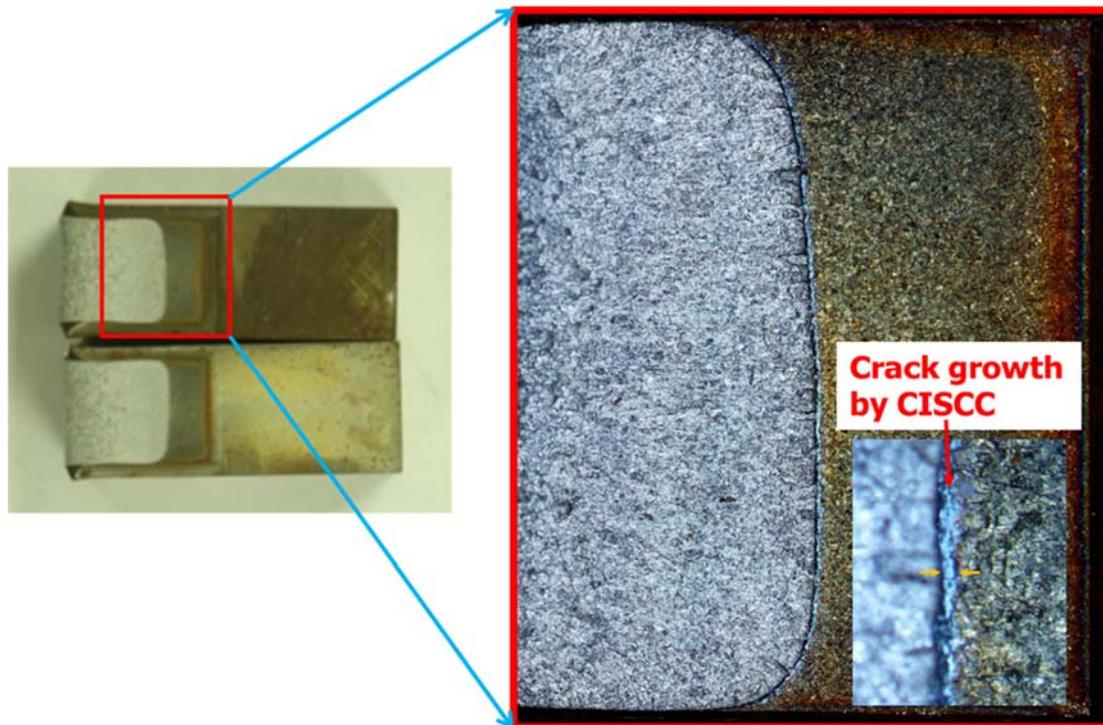
Figure 23. Typical fracture surface of CT specimen at KU with SCC indicated by arrows in the inset (Courtesy of Korea University under I-NERI/USA-ROK)

After the experiment was completed, the CT specimen was broken in halves to reveal the fracture surface. A typical fracture surface obtained by KU is shown in Figure 23 and the SCC can be identified under a microscope. The initial crack length (pre-cracked length) can be measured on the fracture surface by using the 9-point average method as recommended in ASTM E1820. The stress intensity factors are also calculated with ASTM E1820 formulation.

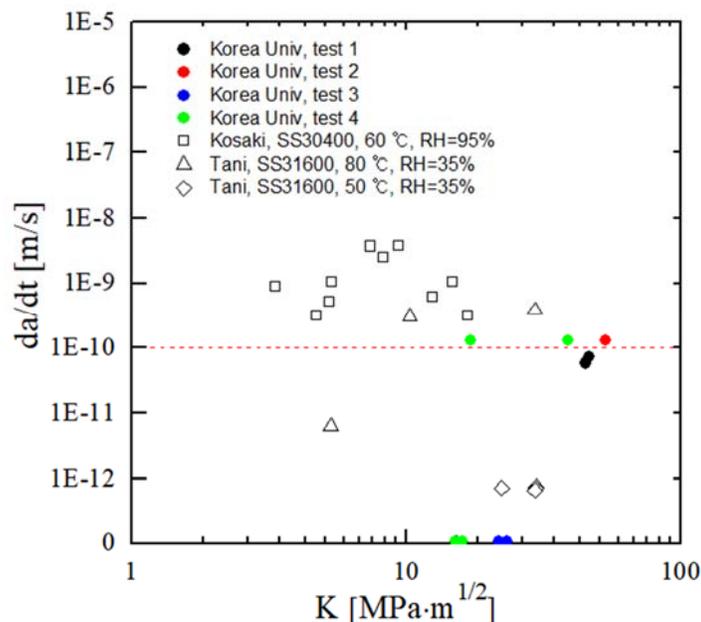
Figure 24. Dependence of crack growth rate (da/dt) on stress intensity factor (K) (Courtesy of Korea University under I-NERI/USA-ROK)

The CGR results in Table 6 are plotted in Figure 24 as a function of stress intensity factor (K). Along with other related test data obtained from CRIEPI, it seems to indicate that the CGR under CISCC conditions is insensitive to stress intensity factor (i.e., crack tip loading).

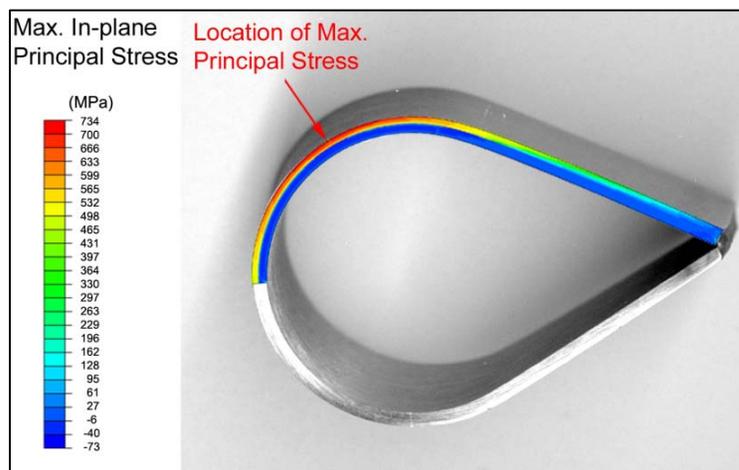
Figure 25. The location of maximum stress in the tear drop specimen [29,30]

The teardrop specimens were fabricated by bending a rectangular 304 stainless steel strip of $19.1 \times 101.6 \times 0.165$ mm ($0.75 \times 4 \times 0.065$ in.) around a 25.4 mm (1 in.) mandrel and then joining the ends by tungsten inert gas (TIG) welding. The teardrop coupon has a transverse autogenous weld at the center of curvature (apex) in the rounded section (see Figure 9), which was originally designed to simulate the weld microstructure in the weld region of a DOE storage container (e.g., [30,34]), and has been used as surveillance coupon for corrosion tests. Finite element analysis was conducted (Figure 25) [29,30] to reveal the high stress region resulting from the fabrication process in order to provide insight for SCC initiation. These teardrop coupons were adopted for the current investigation of CISCC in SNF canisters as a convenient indicator to provide a rapid assessment for the susceptibility of cracking and pitting. They were used as the companion samples with the instrumented bolt-load CT for the determination of CGR (Sections 2.2 and 2.3).

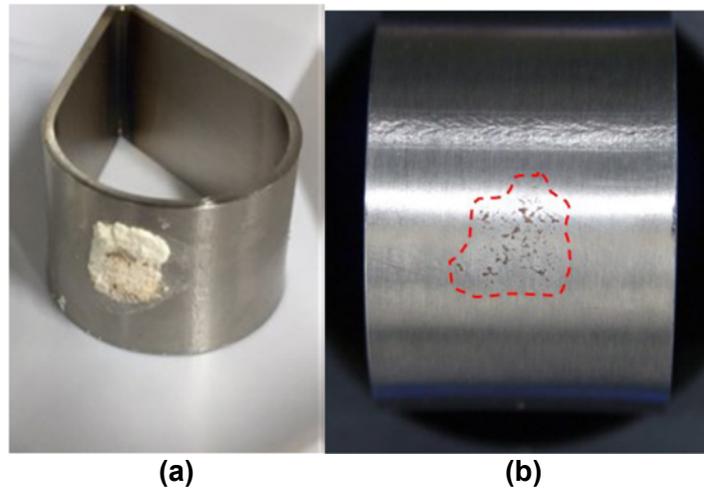
Figure 26. Adherent dust on teardrop Sample No. 1 following test (a) and the post-cleaning image with outlined corrosion region (b)

This section reports the detailed metallographic examination and analysis of the teardrop coupon, which was held in a glass cradle containing high level of CaCl_2 (0.4%) at 50 °C and 50% RH for 5 months (Test Cell No. 1 in Table 1). The exposed teardrop coupon (Sample 1) exhibited a region of adherent dust in the location where the salt/dust assemblage contacted the sample, as shown in Figure 26 (a). To remove the dust, the sample was cleaned in de-ionized water followed with an isopropanol rinse. After cleaning and drying, significant corrosion was observed as in Figure 26 (b). It was estimated that this area is about $0.25\text{-}0.28$ cm² (0.58 cm from top to bottom and 0.61 cm from left to right), on which about 6% of the area contained pits.

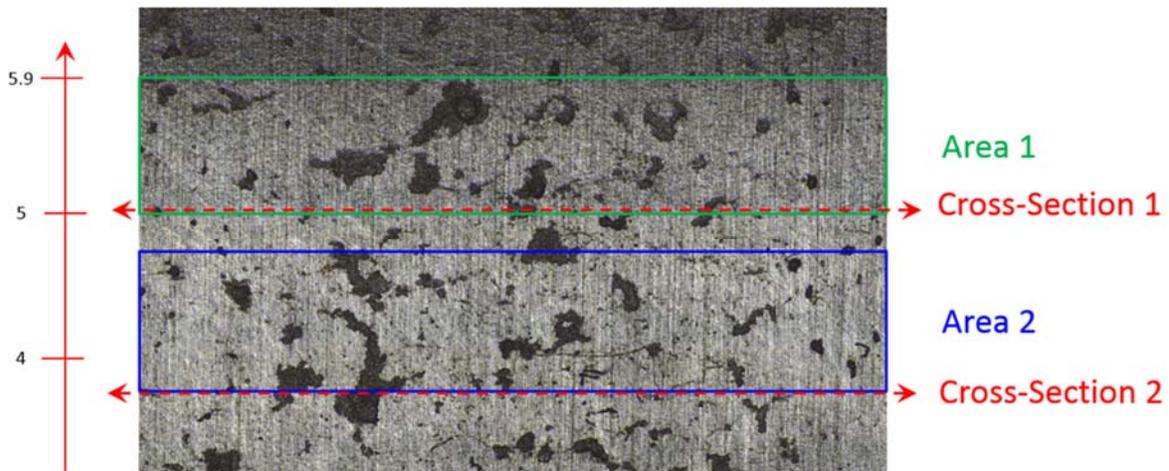
Figure 27. Image of the corrosion region on Sample 1

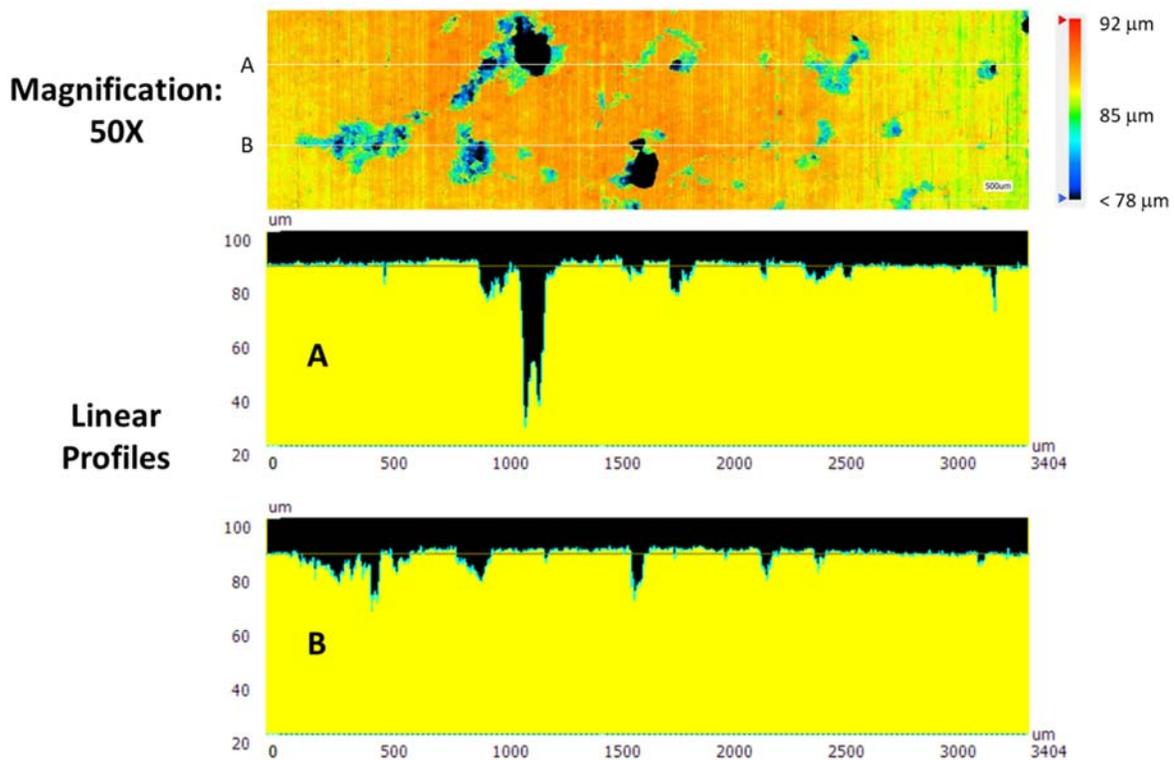
Figure 28. The LCM images of Area 1 in the corrosion area and the linear profiles of the cross-sections along Lines A and B, respectively

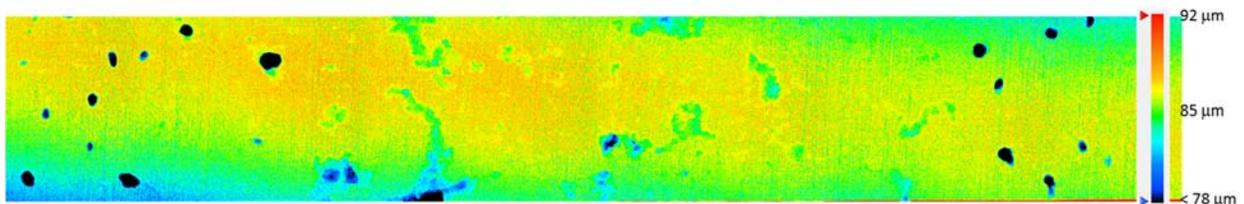
Figure 29. The LCM images of Area 2 in the corrosion area

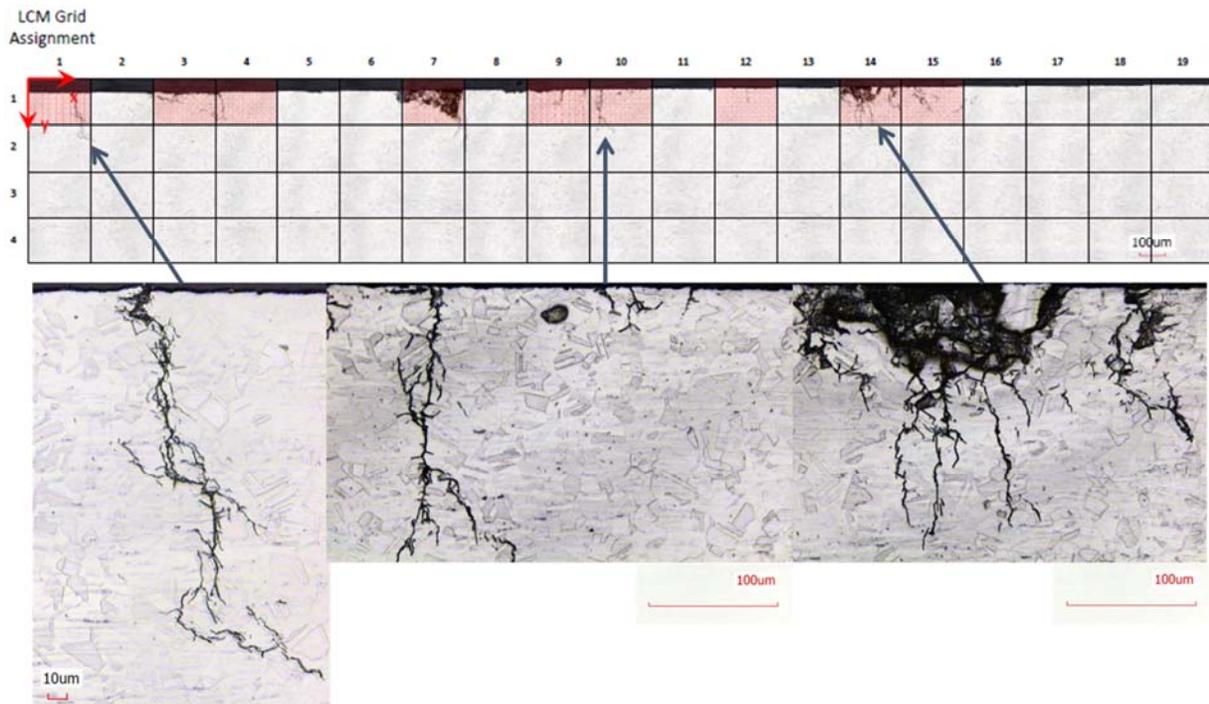
Figure 30. Images of cross-section B in Area 1 show transgranular stress corrosion cracks and pitting corrosion
