***Crack Growth Rate and Large
Plate Demonstration of Chloride-
induced Stress Corrosion
Cracking in Spent Nuclear Fuel
Storage Canisters***

***Prepared for
U.S. Department of Energy
Spent Fuel and Waste Science and Technology***

***Poh-Sang Lam
Andrew J. Duncan
Robert L. Sindelar
Savannah River National Laboratory***

September 30, 2019
Milestone No. M3SF-19SR010201052
SRNL-STI-2019-00561

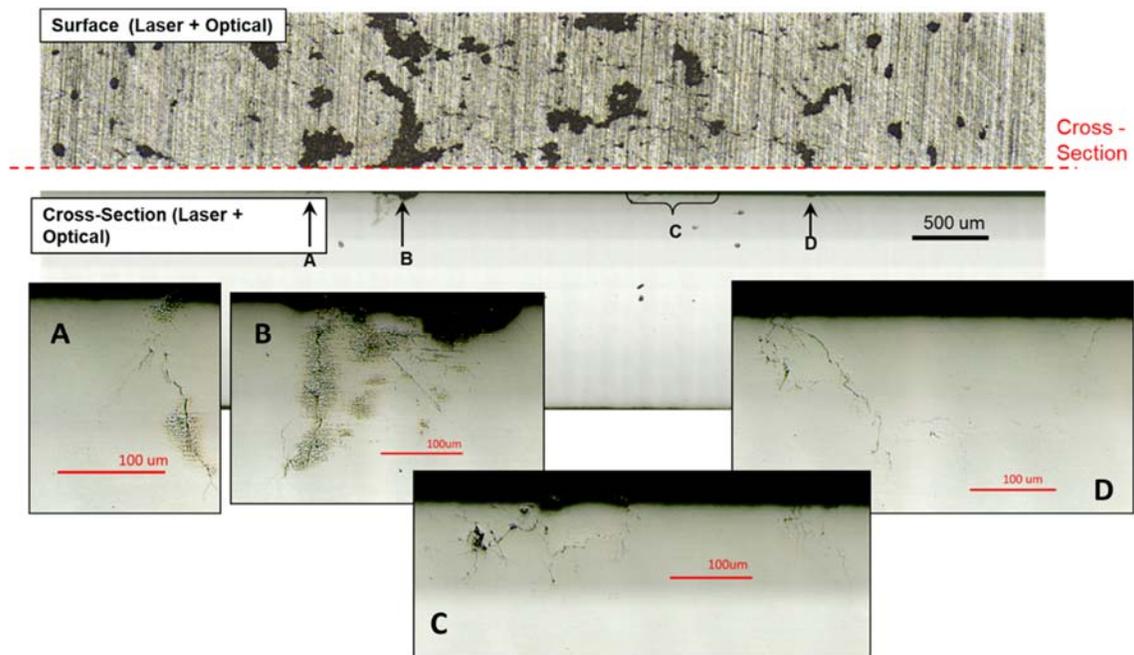
Figure 31. Images of the cross-section in Area 2 show transgranular stress corrosion cracks and pitting corrosion

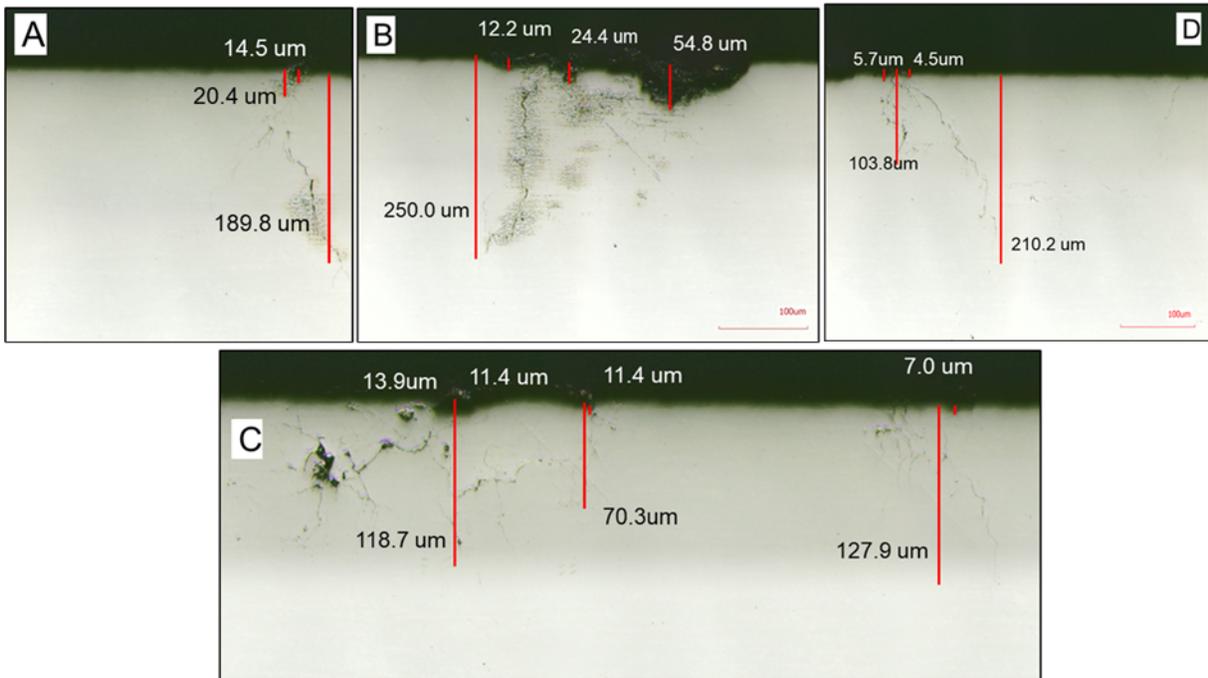
Figure 32. Characterization of pits and the associated stress corrosion cracks in sectioned teardrop coupon Sample 1

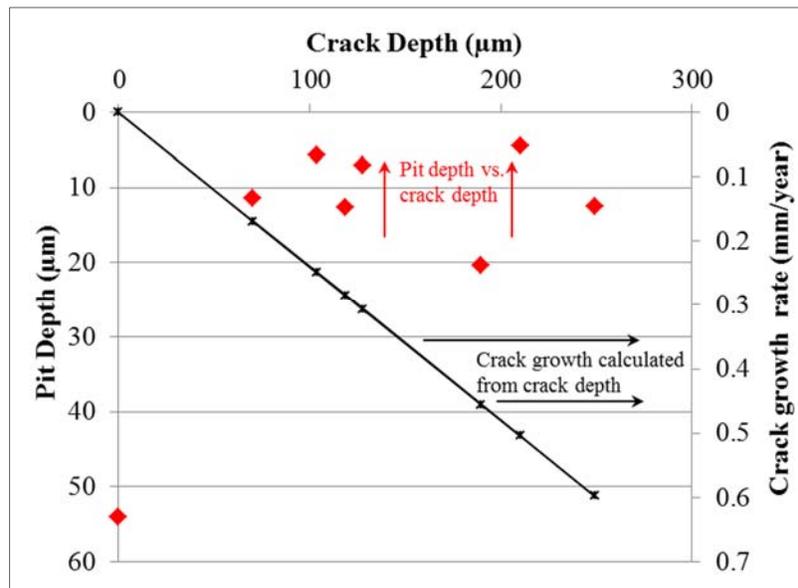
Figure 33. Relationship between pit depth and the associated crack depth (symbol ♦) as well as the corresponding crack growth rate (symbol ×) as converted from crack depth averaged by test duration (5 months)

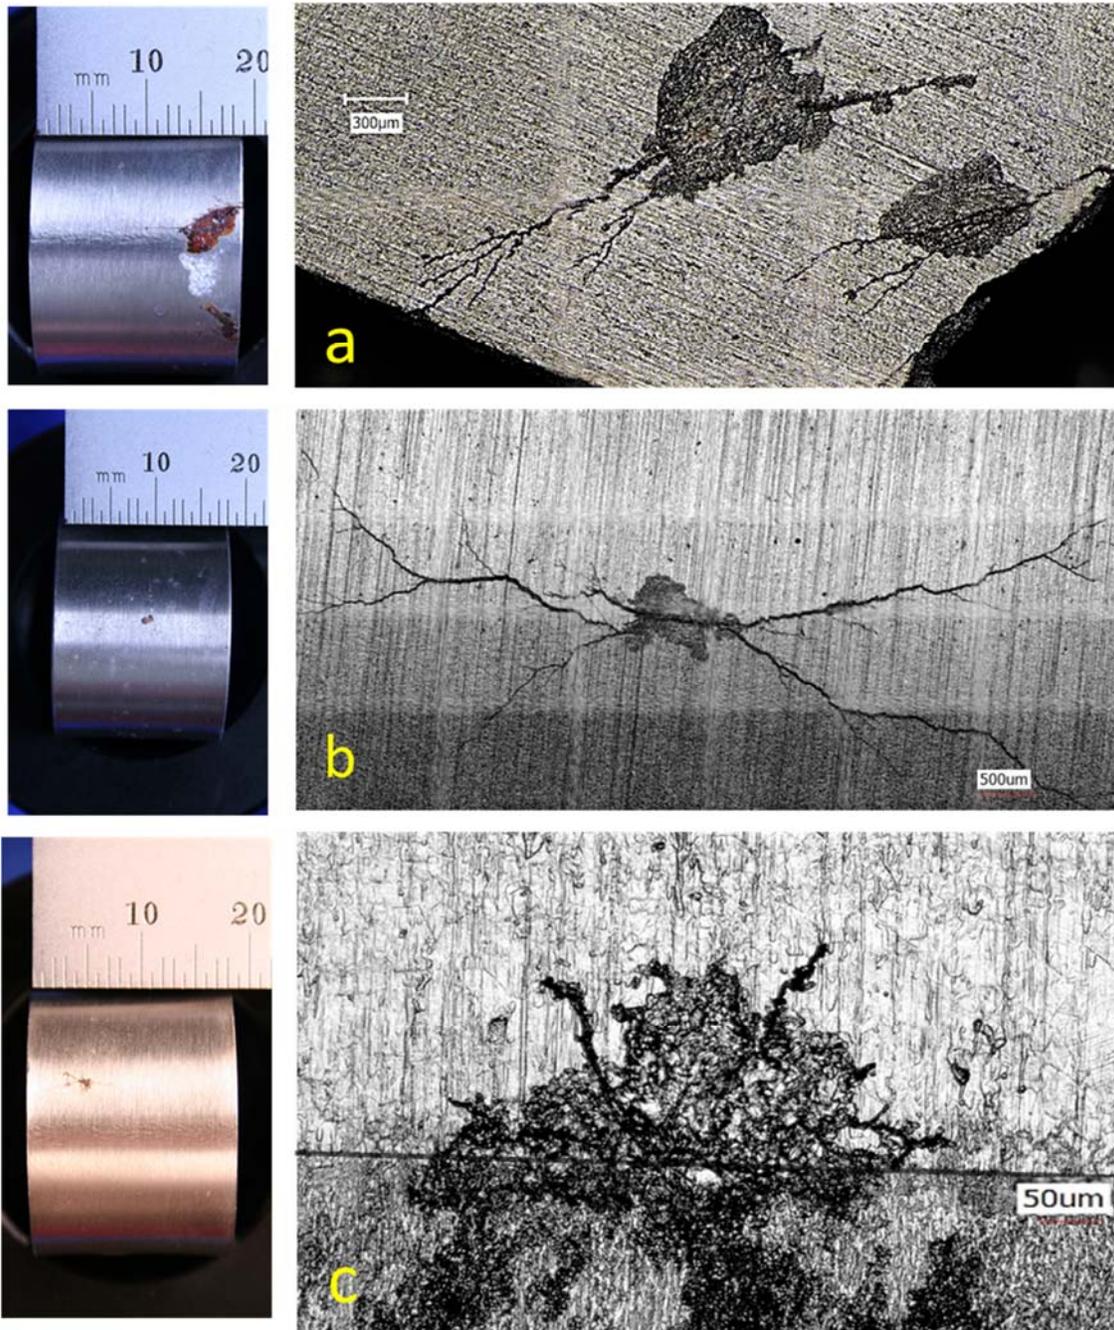
Figure 34. LCM images of cracking initiated on the surface of teardrop coupons at 50 °C and 50% RH for 100% sea salt (a), 25% sea salt + 75% CeO₂ (b), and at autogenous weld interface (shown by a dark line) in 25% sea salt + 75% artificial dust (c)

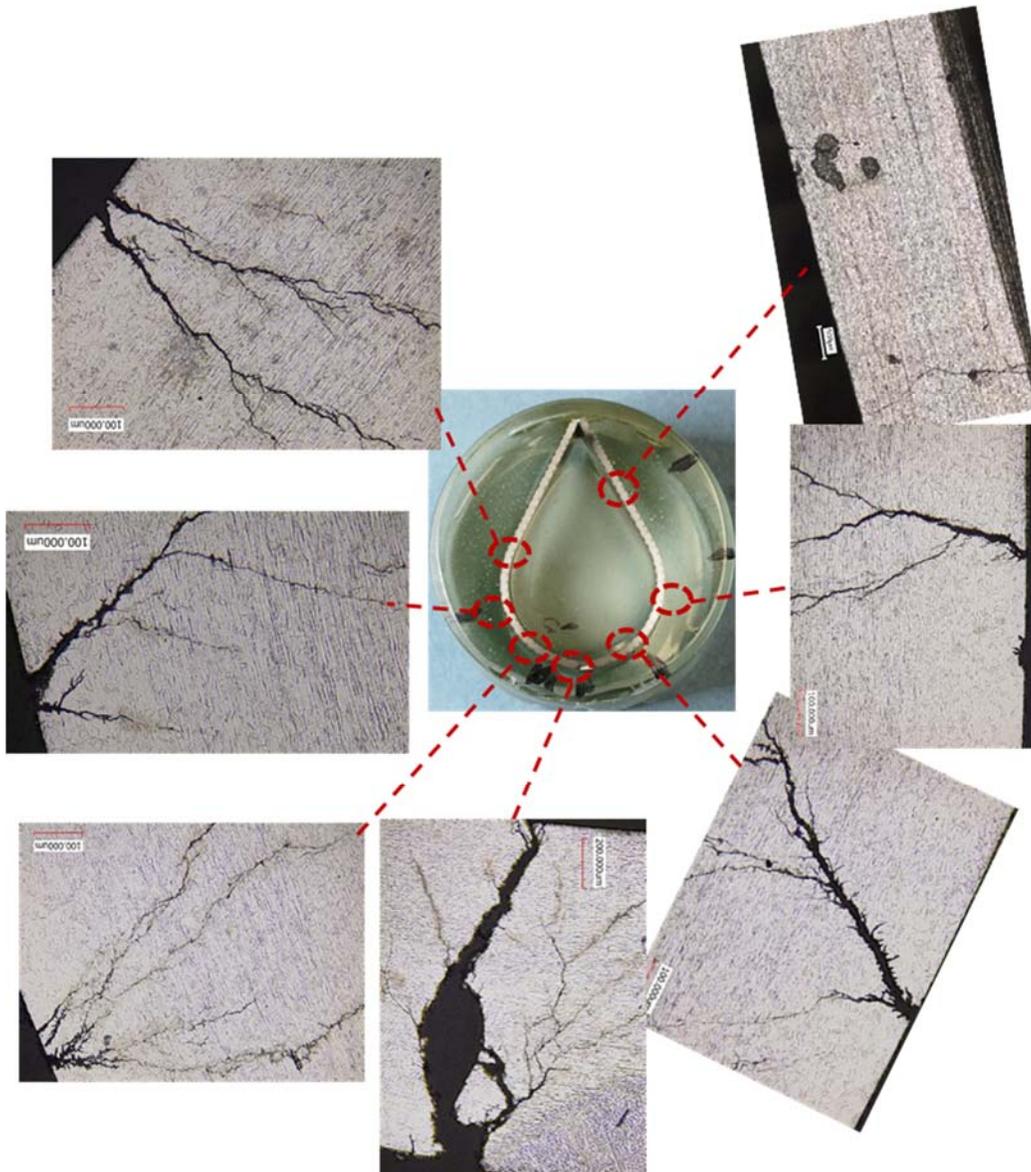
Figure 35. Composite image showing pitting/cracking at various locations in teardrop coupons exposed to dehydrated sea salt after 3-month exposure at 50 °C and 50% RH

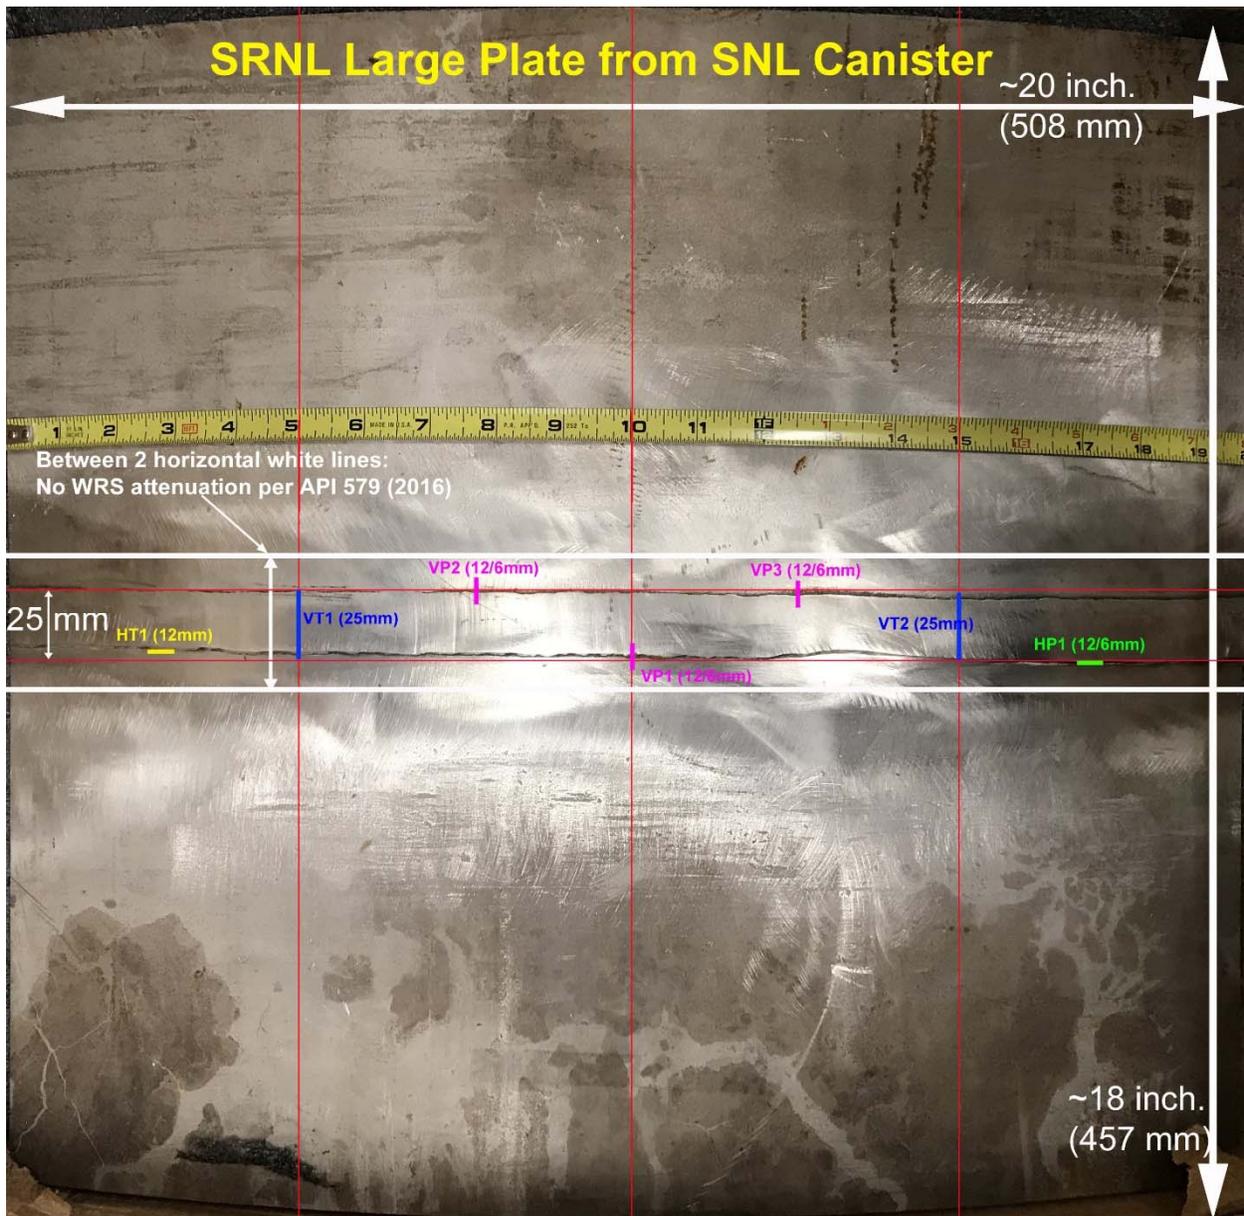
Figure 36. Large plate cut from a canister with an as-fabricated circumferential weld and the locations of starter cracks for CISCC test

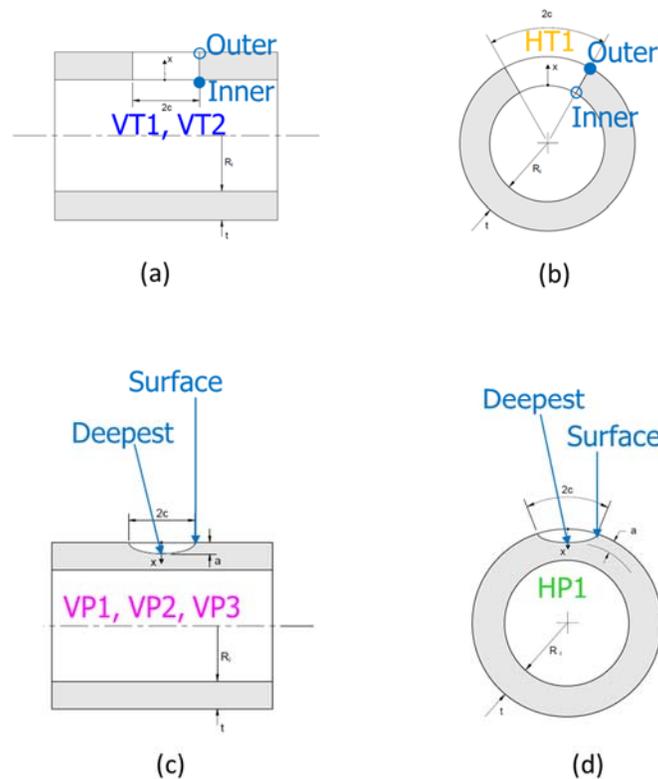
Figure 37. Large plate starter crack configurations: (a) VT1, VT2: through-wall crack across the weld; (b) HT1: through-wall crack parallel to the weld edge; (c) VP1, VP2, VP3: semi-circular part-through-wall crack perpendicular to the weld edge; (d) HP1: semi-circular part-through-wall crack parallel to the weld edge

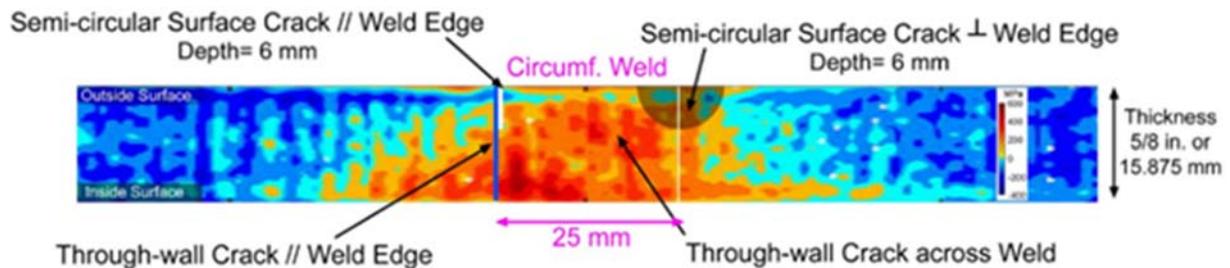
Figure 38. Large plate starter crack design as viewed from plate cross-section through the circumferential weld (superimposed over the contour map for welding residual stress parallel to the weld [15])

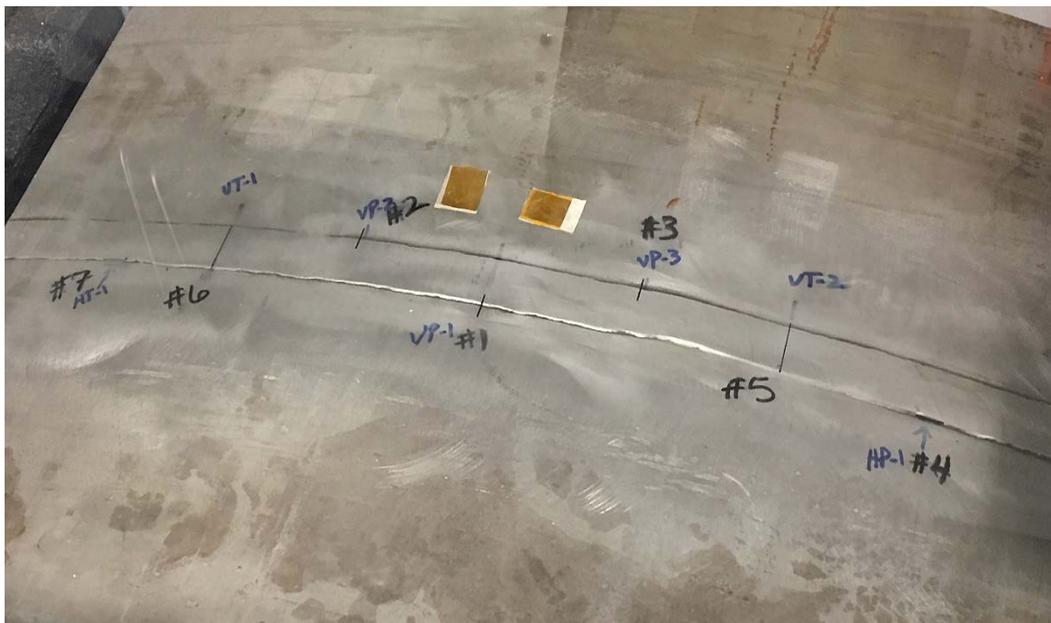
Figure 39. Large plate with EDM starter cracks after salt spray and drying

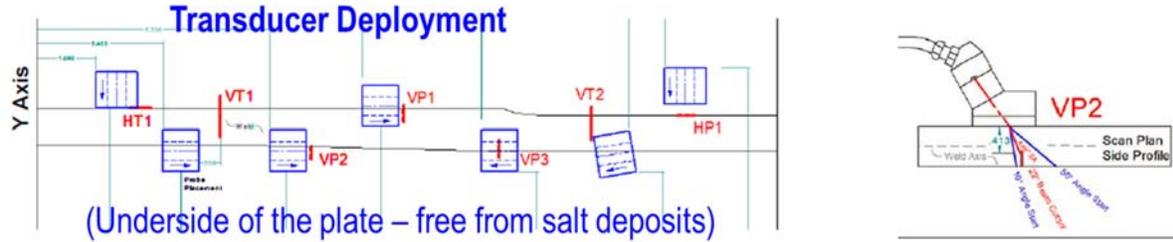
Figure 40. Phased array ultrasonic test (PAUT) for on-line monitoring of CISC in the large plate with 7 EDM starter cracks

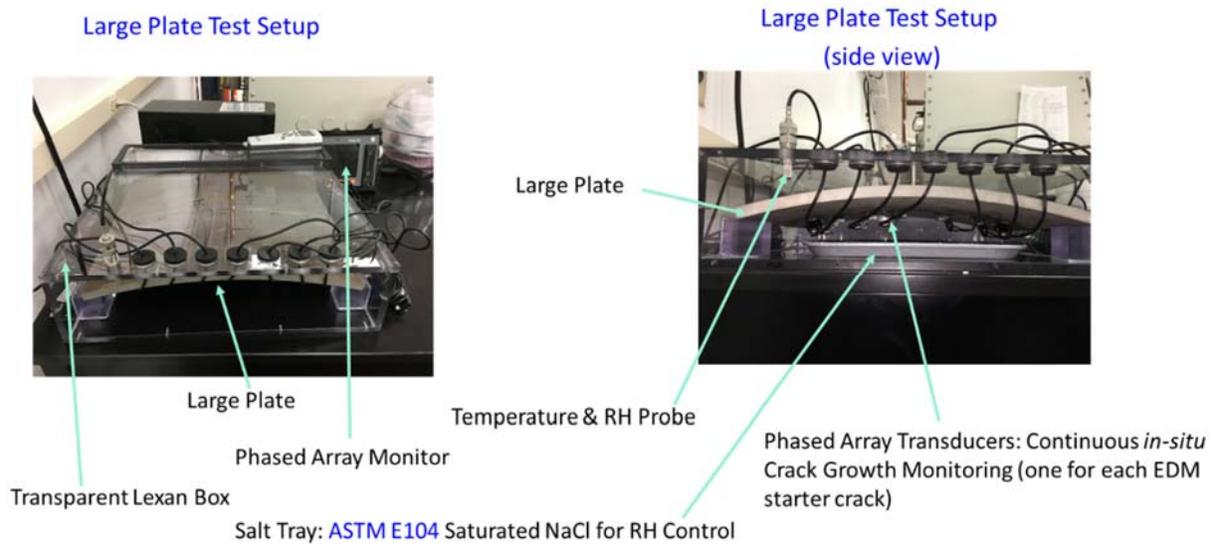
Figure 41. Experimental setup of the large plate CISC test under naturally deliquescing sea salt at room temperature and 75% RH

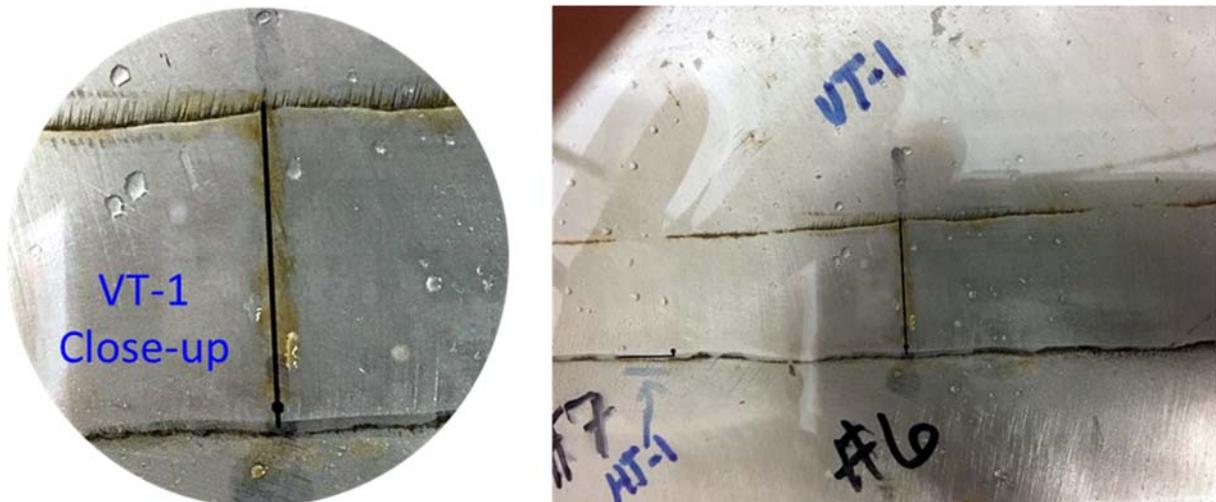
Figure 42. Deliquescence occurred in hours and forming numerous liquid droplets

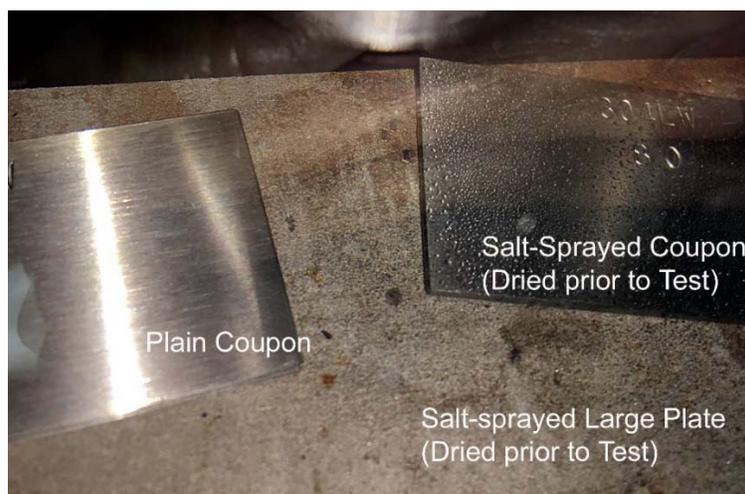
Figure 43. Stainless steel coupons used to verify deliquescence phenomenon

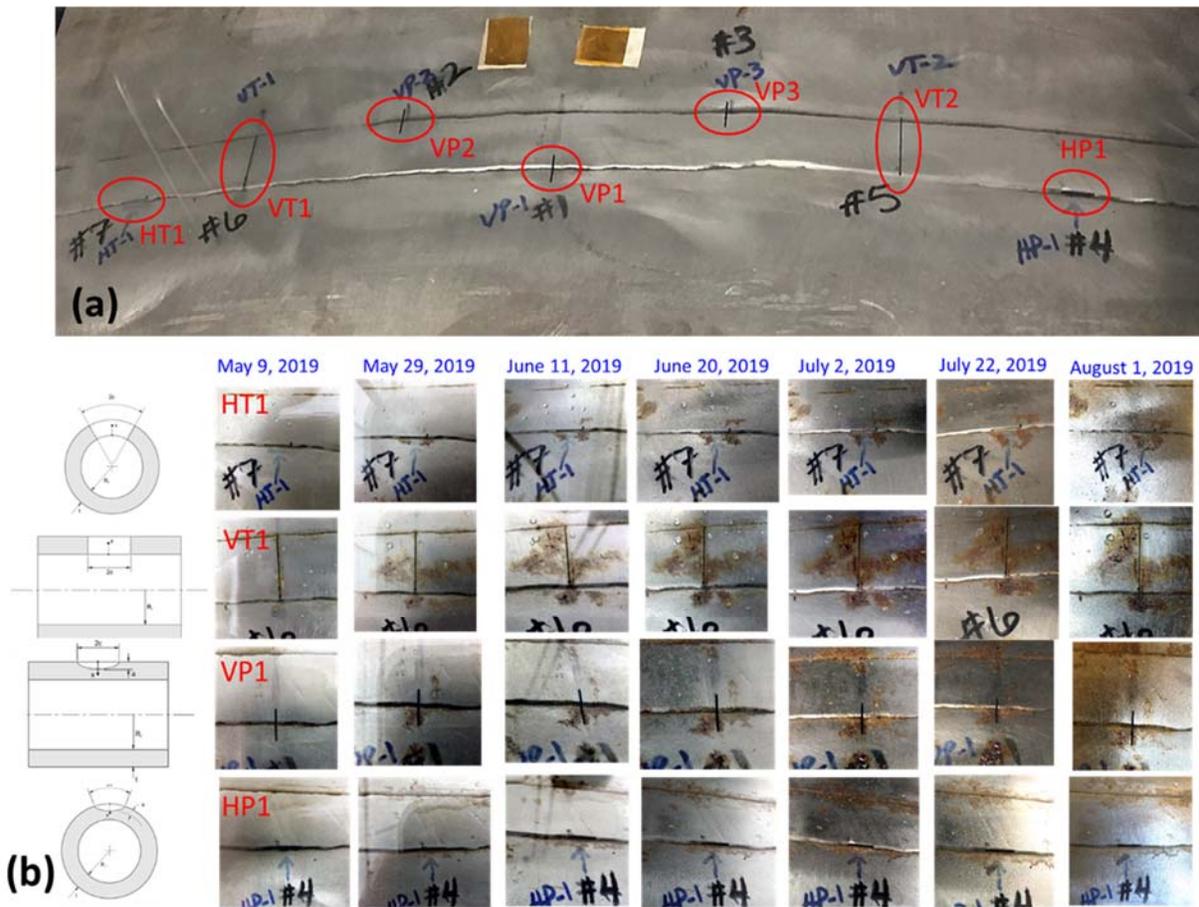
Figure 44. Layout and designations of EDM starter cracks (a) and evolution of chloride-induced corrosion near these cracks (b) during 3-month exposure at room temperature and 75% RH

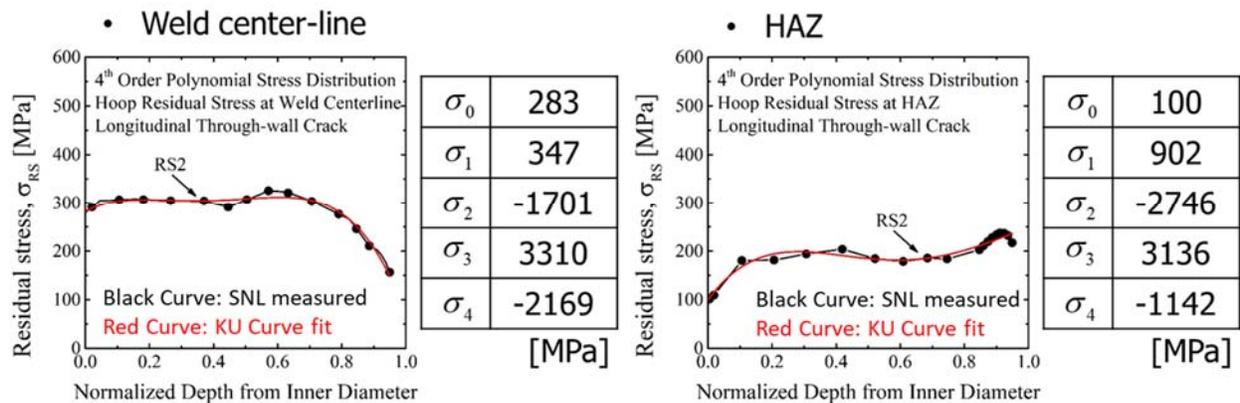
Figure 45. Curve-fitting of the welding residual stresses at weld centerline and at heat affected zone: WRS parallel to the circumferential weld: RS2; $x=0$ at the canister inner surface (Courtesy of Korea University under I-NERI/USA-ROK)

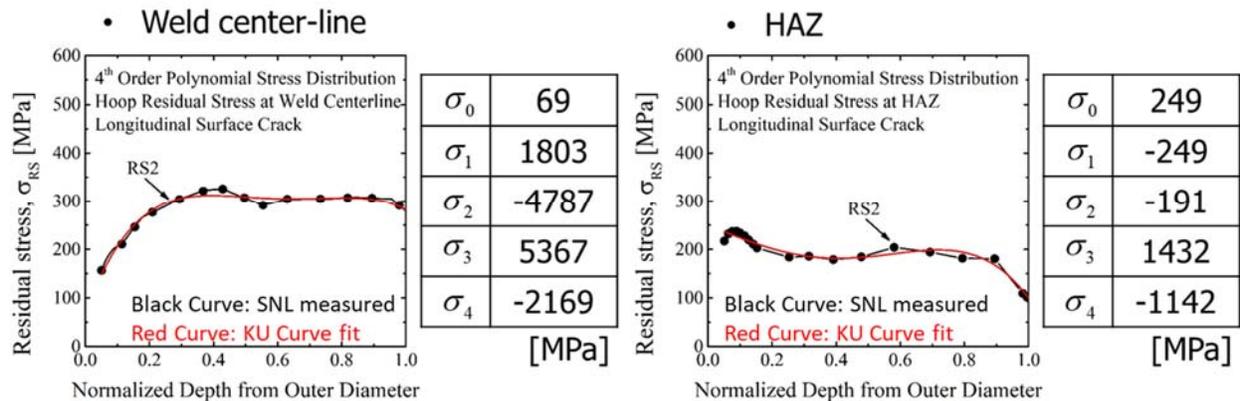
Figure 46. Curve-fitting of the welding residual stresses at weld centerline and at heat affected zone: WRS parallel to the circumferential weld: RS2; x= 0 at the canister outer surface (Courtesy of Korea University under I-NERI/USA-ROK)

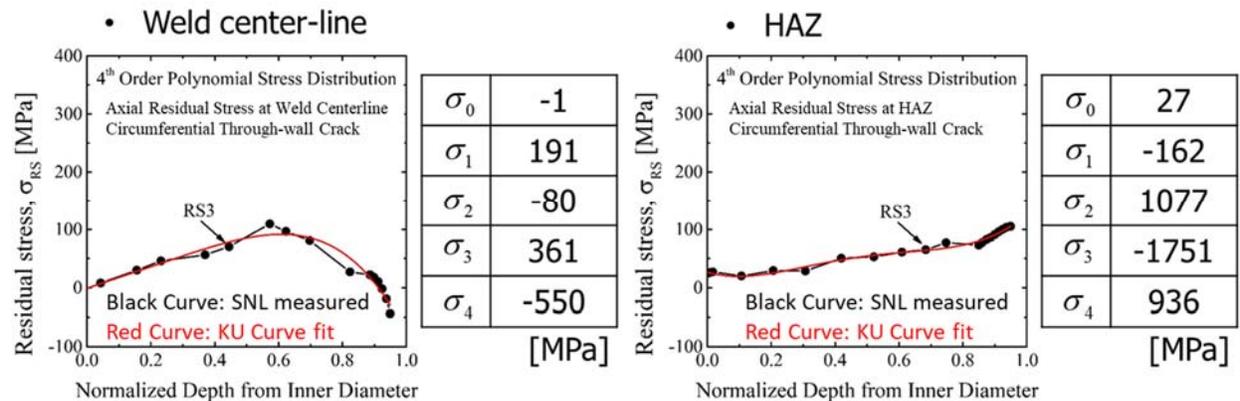
Figure 47. Curve-fitting of the welding residual stresses at weld centerline and at heat affected zone: WRS perpendicular to the circumferential weld: RS3; x= 0 at the canister inner surface (Courtesy of Korea University under I-NERI/USA-ROK)

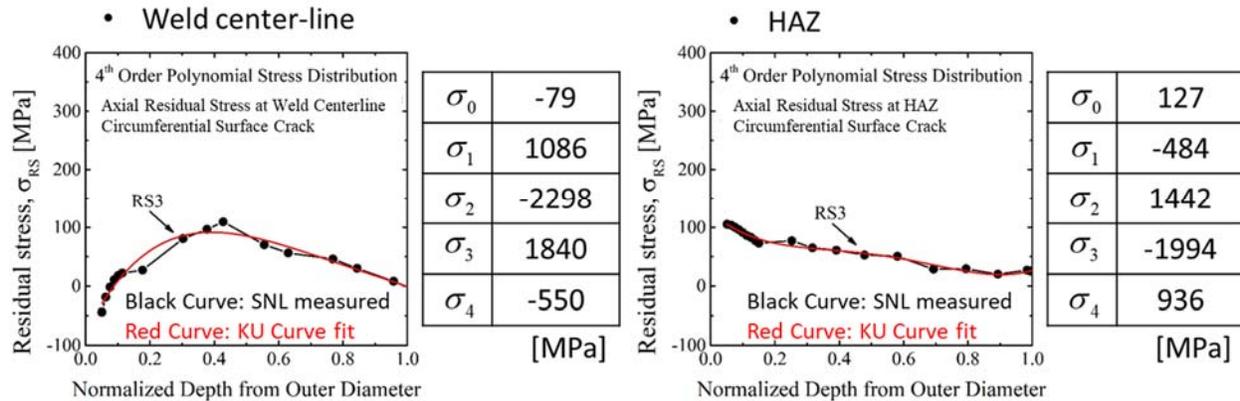
Figure 48. Curve-fitting of the welding residual stresses at weld centerline and at heat affected zone: WRS parallel to the circumferential weld: RS3; $x=0$ at the canister outer surface (Courtesy of Korea University under I-NERI/USA-ROK)

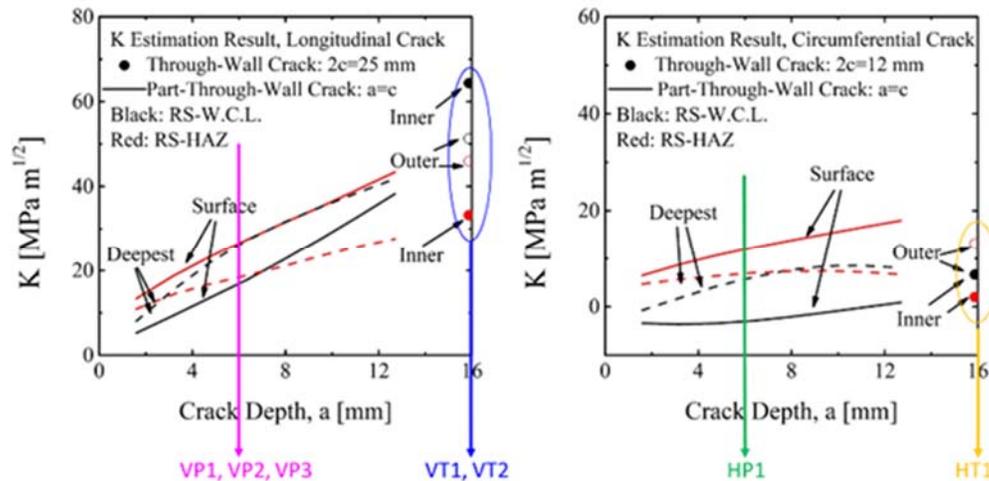
Figure 49. Stress intensity factors of the starter cracks in the residual stress fields for a circumferential weld in the mockup canister (Courtesy of Korea University under I-NERI/USA-ROK)

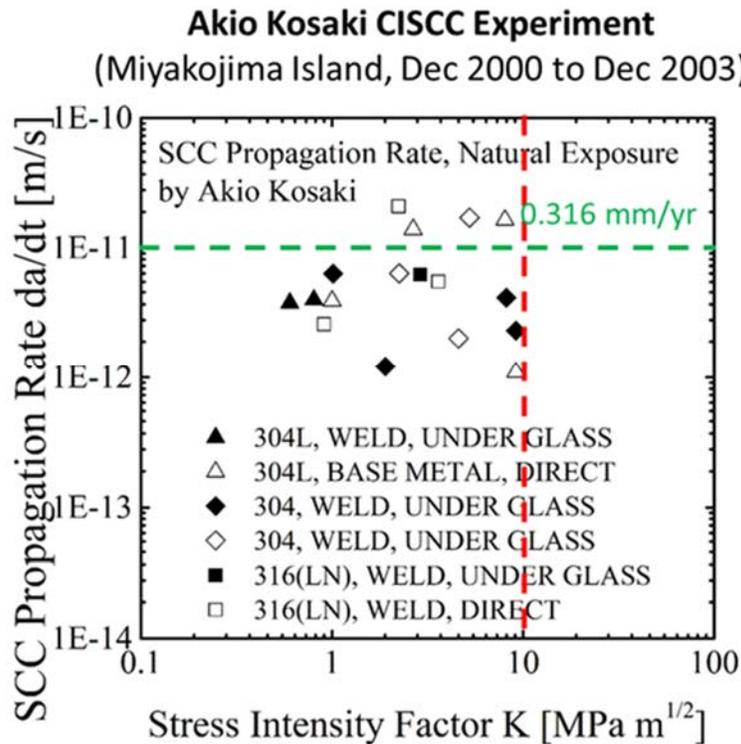
Figure 50. Summary of crack growth rate field test data obtained on Miyakojima Island [4]
(Courtesy of Korea University under I-NERI/USA-ROK)
