Savannah River Site H-Canyon Process Exhaust Tunnel Inspection Crawler Development -- 20036

ABSTRACT

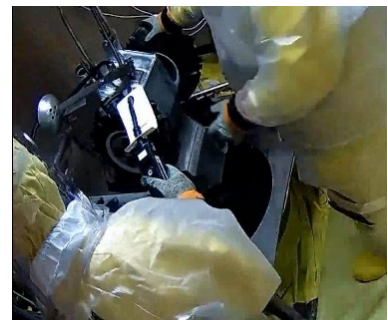
Figure 3: Crawler Insertion into Manway

During insertion into the tunnel (Figure 3), the vehicle is suspended from a rear-connected bail and passes nose down through a vertical passage (30" diameter pipe). The radial clearance is minimal. Cameras and other delicate equipment mounted to the outer shell of the 350 lb. vehicle are at risk of damage during insertion. The design approach with this crawler was to allow retraction of sensitive equipment into the body's internal cavity during lowering and then extension once the crawler was placed upright and ready for operation on the tunnel floor.

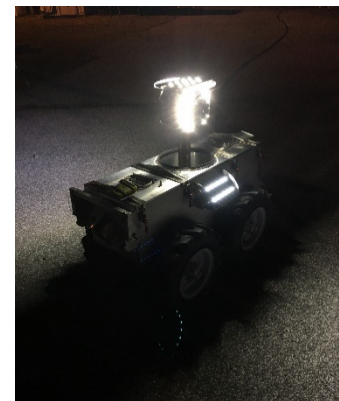
Figure 6: Lights On

The Zippermast was mounted and housed in a well that protects it from damage during insertion and removal through the manway. The well is part of a lid that fastens and seals to the top of the vehicle (Figure 6). The well has a top that retracts and "shuts" when the Zippermast reaches the down limit. However, since the Zippermast itself is rated for submerged use, there was no need to create a tight seal upon closure; the design intent was the exclusion of sand and stone. It is important to note the vehicle cavity is completely sealed from the tunnel environment and the well. Within certain limitations, the lid can be exchanged to replace or modify the inspection technology with an alternate camera setup, Light Detection and Ranging (LiDAR) or other.

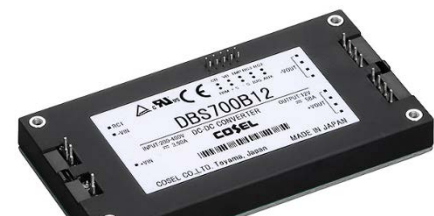
Figure 14: Cosel DC-DC Converter. Metal Plate at the Bottom is the Heat Sink

Cosel DBS700B48 and DBS700B24 are switch-mode power supplies that take an input voltage of 200-400 VDC and step it down to the preferred voltage which in this case is 48 VDC and 24 VDC needed for the onboard electronics of the crawler. Output voltage ripple is managed using large electrolytic capacitors placed in parallel with the power supply output. The capacitance required was at least 1,000 μF for 48 VDC and at least 2,200 μF . Since the internal compartment of the crawler body is sealed to the outside atmosphere to protect the electrical components, all heat generated must be transferred outside through the crawler body. Heat generating components such as the power supplies are thermally coupled to the crawler body. The housing of the power supply was designed such that the side opposite the connector pins had an integrated heat sink which was coupled to the side walls of the crawler body with thermal paste for heat transfer.

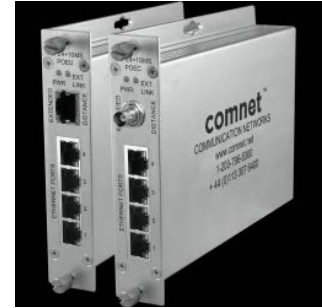
Figure 15: ComNet Ethernet-Over-Coax Converter

ComNet switches (Figure 15) were used for transmitting and receiving data between the crawler and control station. The ComNet sends/receives ethernet packets long distances over coax cable using a frequency modulation method which is reassemble at either end into regular ethernet packets for network communication. The ComNets installed on the crawler end are 802.3at power-over-ethernet (POE) compatible and power the cameras and microcontroller.

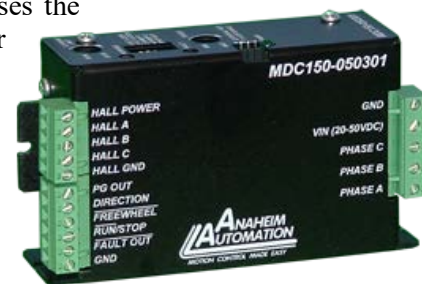
Figure 18: Anaheim Automation Brushless DC Motor Controller

Brother VF3SC30-50N400L4 Gearmotors are 400 Watt 48 VDC brushless DC motors with hall sensor outputs used to determine rotor position. Anaheim Automation MDCSL150-050301 motor controllers (Figure 18) uses the hall sensor information from the gearmotors to determine the rotor position and provide the correct high/low output sequence to the motor phase wires. If the hall sensor information is not used, this can cause the motors to turn the opposite direction upon approaching the torque rating. The RUN/STOP, DIRECTION, and FREEWHEEL input pins are used to control the gearmotors by logic level high/low provided by the microcontroller. These pins are active low. The front and rear motors of each side are controlled as a pair to achieve differential steering. A jumper pin on the circuit board of the motor controller is set to allow for external speed control with a variable input voltage of 1 – 4 VDC. A Pulse Width Modulated (PWM) signal from the microcontroller is converted to a variable 0 – 5 VDC signal using an operational amplifier circuit and applied to the external speed pin (wiper) on the side of the motor controller.

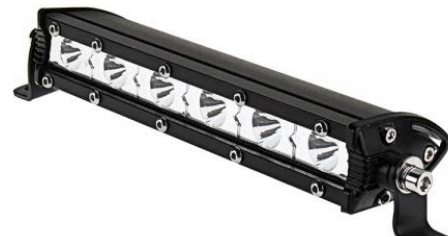
Figure 22: LED Lightbar Mounted on Sides of Crawler Body

Superbright ORBM7-18WS-FL 7-inch LED light bars (Figure 22) were mounted as side lights on the crawler body with a pair per side wired in parallel. The LEDs on the Zippermast and light bars on the sides of the crawler are powered through a logic level driven solid-state relay board. The relay board is active high, and the lights turn on when the Ethermega outputs 5 VDC from the connected digital I/O pin. A pull-down resistor is not used on the logic side of the relay board which has the benefit of visually indicating the microcontroller, when powered, is in

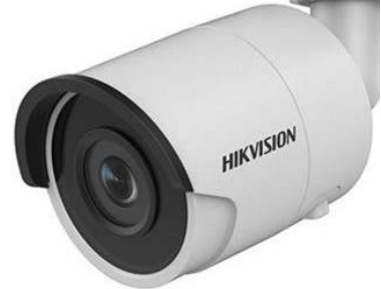
Figure 25: Driving Camera

The first camera set consists of the front and rear driving cameras (Figure 25). These cameras are 2 megapixel (MP) ultra-low light Hikvision bullet driving camera has an IR range up to 30 meters with day and night settings to automatically turn to IR when the light is too low. At all times the camera outputs a 2 MP resolution which is significantly higher than the camera on the previous crawler. This type of camera is fixed meaning that it does not have pan, tilt, and zoom (PTZ). The IP rating is at IP67, which means the camera is protected for dust and immersion in 1 meter of water for 30 minutes.

All test results of the inspection and driving cameras were successful. Initially, the field of view on the driving cameras was limited as the view angle was pointed too far down. The design/manufacture of the crawler required use of a fixed-position driving camera to provide forward viewing as well as see the front tire near the ground contact location. This would aid obstacle negotiation in addition to still allowing the forward driving view. In practice, the view angle was narrower than expected. The result was a driving camera that was disorienting as the horizon was above the view. A shim was fabricated to raise the camera to capture the horizon, this required compromise with the near-field view, but was a better overall solution.

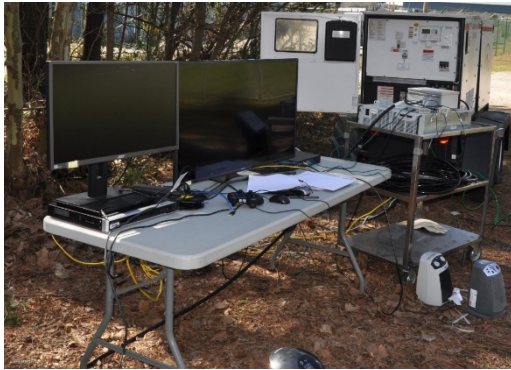
Figure 29: Control and Observation Station at 700-ft Tether Pull Site

The tether pull test (Figures 29 and 30) revealed more crawler weight was needed to have the requested 700 ft capability. The test was repeated with added weight attached to the wheels with an acceptable result. The added weight brought the crawler mass to the manway hoist limit. The extra traction allowed the reel to be unwound when it was shifted into neutral (free spin); however, it did create noticeable additional drag. In practice the reel was shifted into neutral and manually unwound to reduce drawbar load.

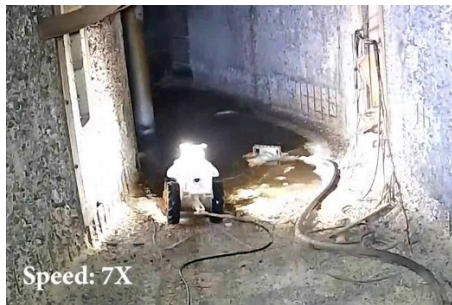
Figure 31: Moving toward a Wet Area

The crawler functioned well in the tunnel environment. The deployment and retrieval systems worked as anticipated. The extra ground clearance was key in crossing a variety of obstacles. The cameras returned excellent high definition imagery despite the winds and other challenges. The camera lift allowed first-time viewing over a large duct. The lighting while adequate, did not pan and tilt with the camera. This did slow control at first, as the camera needed to be zoomed into any objects that were too dark so the iris would adjust to the darker field of view making dark details visible. However, after getting used to the issue, this was still very workable having little impact on progress. The wet and boggy areas were sometimes challenging. See images in Figures 31-33 taken during the tunnel deployment below.
