# Influence of Glycolate Anion on Aqueous Corrosion in DWPF and Downstream Facilities – SCC Testing

SRNL-STI-2020-00020, Revision 0

## **Influence of Glycolate Anion on Aqueous Corrosion in DWPF and Downstream Facilities – SCC Testing**

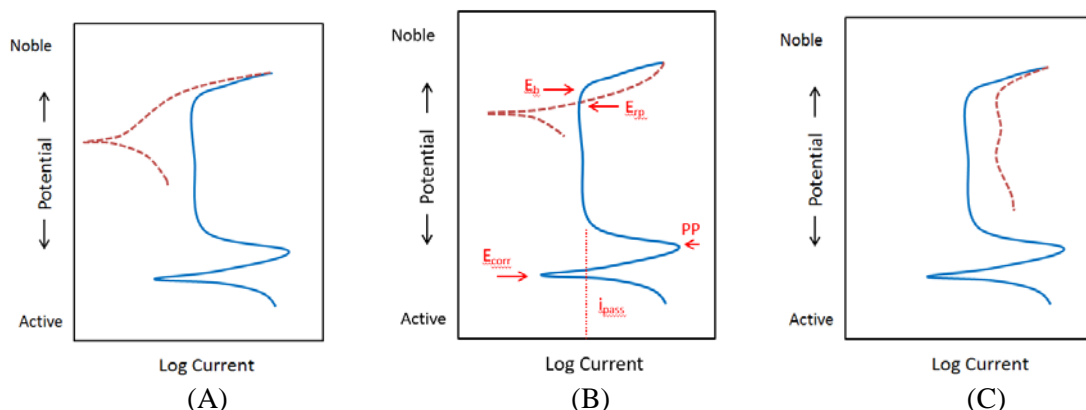
**Figure 2-1. Schematic CPP curves (blue curve is forward trace; red curve is reverse trace) showing key parameters: A) negative hysteresis; B) positive hysteresis with  $E_{rp}$ ; and C) positive hysteresis**

Schematic CPP curves are shown in Figure 2-1 highlighting the key parameters measured from the curves and the different type hystereses observed in the curves for determining localized corrosion susceptibility. An indication of pitting susceptibility is a positive hysteresis which occurs when the reverse trace (dotted line) is at larger currents than those of the forward trace (solid line) as shown in Figure 2-1C. A negative hysteresis, shown in Figure 2-1A, occurs when the reverse trace is at lower current than the forward trace and generally, indicates a material is not susceptible to pitting or crevice corrosion.

Other parameters measured from the CPP scans include a corrosion potential,  $E_{corr}$ , and a passive current density,  $i_{pass}$ . The value of  $E_{corr}$  and OCP are generally close in value and a quasi-steady state potential where the anodic and cathodic currents on the surface are balanced. For passive metals such as C276, a potential (the passivation potential, PP in Figure 2-1B) is reached where the current ( $i_{pass}$ ) is independent of potential due to the presence of a corrosion resistant oxide. The current density that can pass through the oxide is called the passive current density and is a measure of the material corrosion resistance.

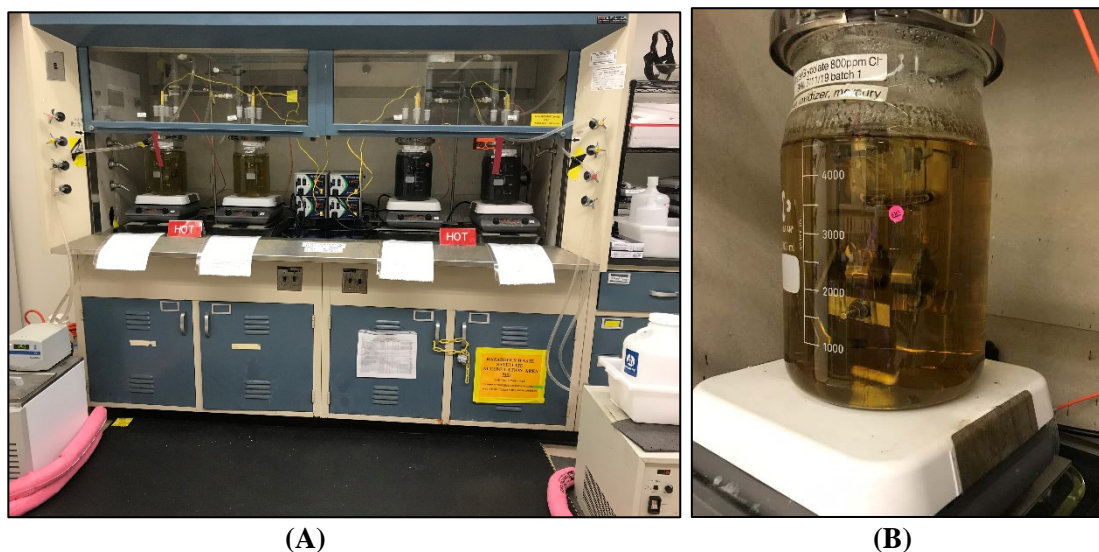
**Figure 2-2. Coupon immersion test: (A) setup of four vessels; (B) close up of hanging coupons**

Three different coupons were used in the coupon immersion test; specifically a tear-drop shaped coupon (10 cm×1.95 cm×0.15 cm) for testing C276 in a stressed condition, a flat rectangular coupon (5.1 cm×2.5 cm×0.3 cm) for determining a general corrosion rate, and a flat rectangular coupon (5.1 cm×1.95 cm×0.3 cm) with a central hole for attaching of a ceramic crevice assembly. Coupons were exposed on a borosilicate support that was hung from the container lid as shown in Figure 2-2(B). Coupons remained exposed in the solutions for the full three months. Afterwards, the coupons were rinsed with distilled water

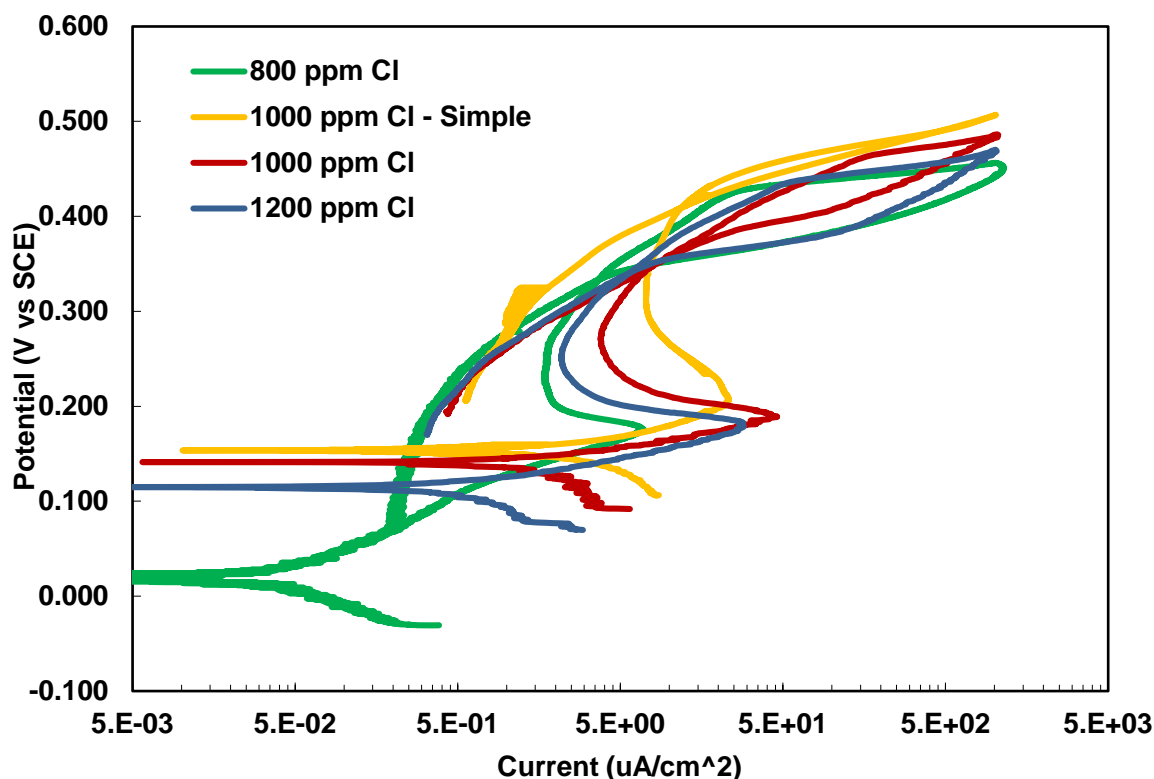
**Figure 3-1. CPP scans of C276 in glycolate-based solutions with a range of chloride concentrations (800 ppm  $\leq$  [Cl<sup>-</sup>]  $\leq$  1200 ppm) at 95 °C; [SO<sub>4</sub><sup>2-</sup>]=4200 ppm**

In glycolate-based solutions, the CPP scans for C276 were similar as shown in Figure 3-1. All the CPP scans had a passivation peak at about 0.2 V, a breakdown potential,  $E_b$ , near 0.45 V, and a repassivation peak,  $E_{rp}$  ranging between 0.35-0.39 V, slightly more electronegative than  $E_b$ . These values are summarized in Table 3-1 for each chloride concentration in the glycolate-based solutions along with  $E_{corr}$ ,  $i_{pass}$  and CR, given in mpy. A positive hysteresis loop may indicate some localized corrosion susceptibility including SCC. In the previous testing, the positive hysteresis loop was found not to be associated with pitting [3]. The test coupons were found not to have pitted during the test and only had a slightly oxidized surface, which was similar to the pre-test morphology.

As can be seen by the data in Table 3-1 and the CPP scans in Figure 3-1, the  $E_{\text{corr}}$  value for the 800 ppm Cl data is at more electronegative potentials than the remaining data that was obtained in the recent testing. These more electronegative values are believed to be a function of solution chemistry. Previously, the concentration of soluble mercury was found to influence both  $E_{\text{corr}}$  and the measured corrosion rate [2]. A higher soluble mercury concentration results in more electropositive  $E_{\text{corr}}$  and higher corrosion rates, which can be seen in the data in Table 3-1. The concentration of other oxidizing species may also influence these variables. Shifts in  $E_{\text{corr}}$  were observed in this testing for the 1000 ppm Cl test as shown in Figure 3-2 for the duplicate test performed (CPG1-1 and CPG1-2). The soluble mercury concentration for CPG1-2 might be higher than that for CPG1-1 since  $E_{\text{corr}}$  for CPG1-2 at 0.141 V is more electropositive than  $E_{\text{corr}}$  for CPG1-1 at 0.001 V.

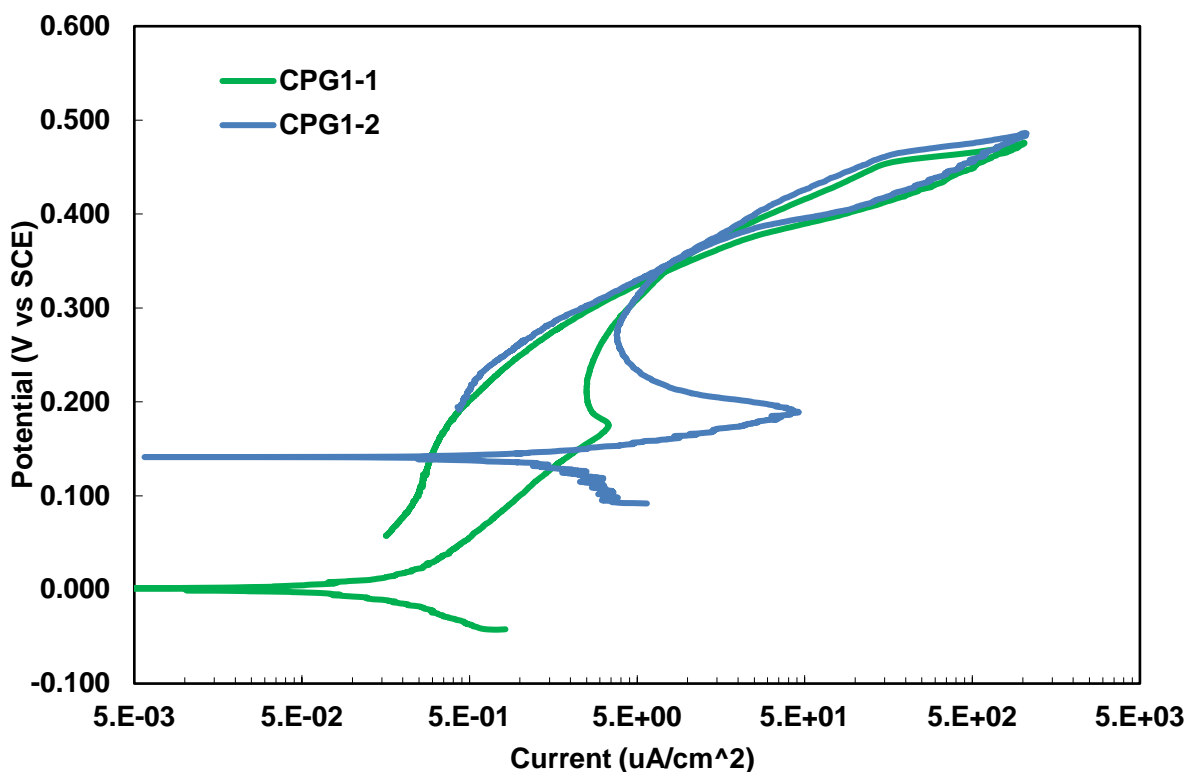
**Figure 3-2. CPP scans of C276 in glycolate-based solutions at 1000 ppm Cl and 95 °C**

Areas on the CPP scans for glycolate-based solutions that may indicate a SCC susceptibility include the presence of the passivation peak at approximately 0.2 V and the presence of the positive hysteresis loop. These areas are where large changes in current are observed for small potential changes and have changes in oxide structure occurring, providing an instability for SCC initiation. While the CPP scans indicate the electrochemical activity possible for C276, the actual exposure conditions may not drive the sample to these conditions. The coupon immersion test of simulated exposure without accelerating parameters, such as applied potentials, provides a more representative condition for SCC occurrence for the DWPF operating environment.

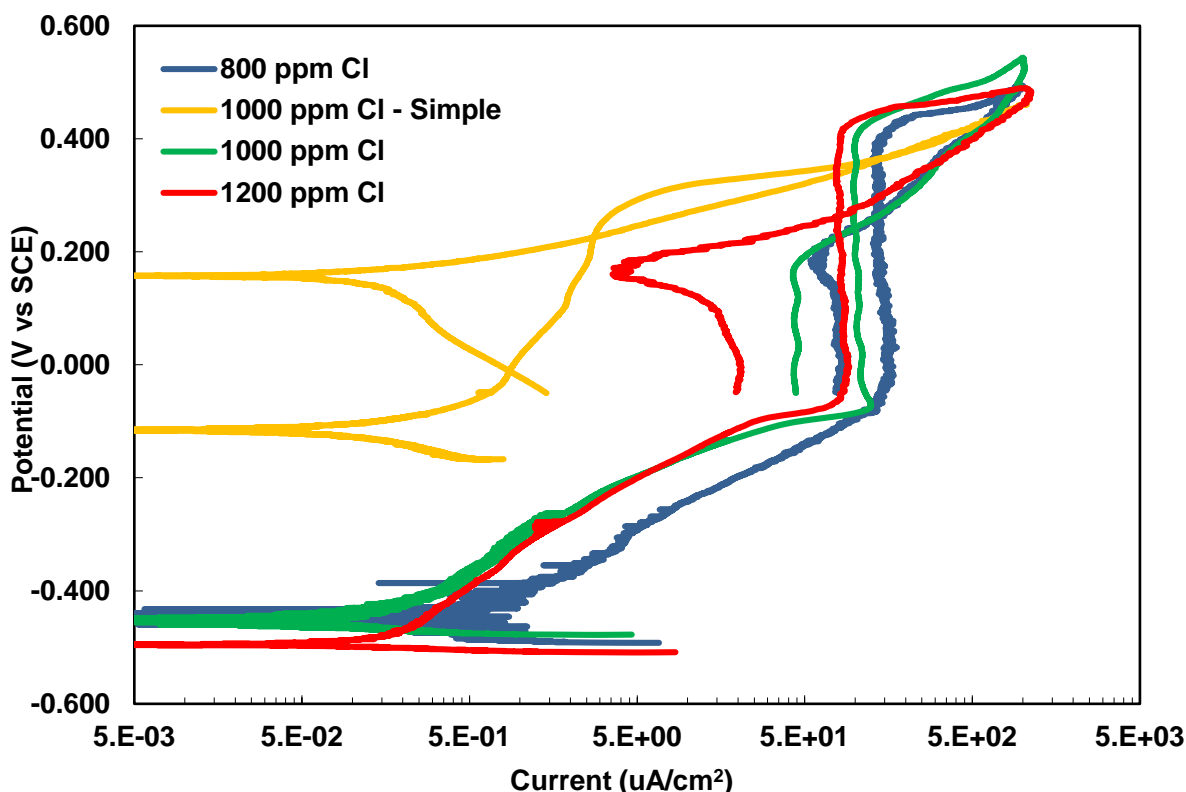
Figure 3-3. CPP scans of C276 in formate-based solutions with a range of chloride concentrations (800 ppm  $\leq$  [Cl<sup>-</sup>]  $\leq$  1200 ppm) at 95 °C; [SO<sub>4</sub><sup>2-</sup>]=4200 ppm (scans have been truncated on the reverse scan for clarity)

In the formate-based solution, the CPP scans for C276 were all similar for the complex chemistry solutions, as shown by the data presented in Figure 3-3, and were not a function of chloride concentration. The CPP scans showed a possible passivation region of similar size with a positive hysteresis. While the passivation region in glycolate-based solutions showed a distinctive passivation peak, such a peak was not definitively shown in formate-based solutions. The passivation region is defined by the potential range where current,  $i_{pass}$ , is independent of the potential. For these formate-based solutions, this passivation region occurred between -0.075 and 0.4 V with  $i_{pass}$  of 100  $\mu\text{A}/\text{cm}^2$ . Key electrochemical parameters measured from the CPP scans are given in Table 3-2 for each chloride concentration.

The CPP scan for the simple chemistry solution was characteristically different than the remaining scans since C276 displayed anodic corrosion without a passivation region (yellow/orange curve in Figure 3-3). The entire scan is also shifted to lower current values indicative of a less corrosive environment for C276. This change in corrosion behavior was not coupled with any change in general corrosion rate as shown by the data in Table 3-2. Although a positive hysteresis was observed, the size of the hysteresis was smaller as indicated by the difference between E<sub>b</sub> and E<sub>rp</sub> (0.065 V versus 0.1-0.2 V for complex chemistry solutions).

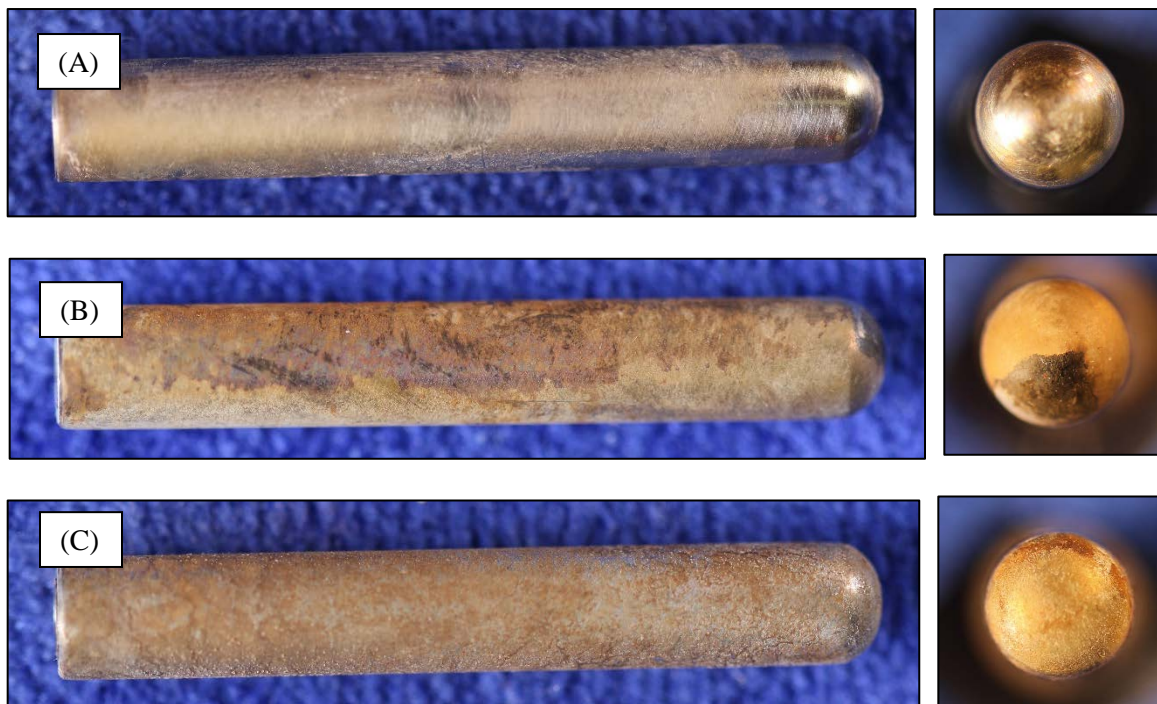
**Figure 3-4. Post-test photographs of coupons from formate-based solutions at chloride concentrations of (A) 1000 ppm simple chemistry, (B) 1000 ppm complex chemistry, and (C) 1200 ppm complex chemistry**

The test coupons from the formate-based solutions all showed some degree of change as shown in Figure 3-4. While the rust-colored deposit appears to be corrosion product, the CPP scans and the general CR of less than 0.5 mpy (Table 3-2) indicates another possibility, deposition from a surface reaction. The low CR shows that general corrosion was not aggressive, so corrosion products are not expected. The CPP scans have  $i_{\text{pass}}$  values on the order of  $100 \mu\text{A}/\text{cm}^2$ , larger than  $i_{\text{pass}}$  for a passive oxide ( $\sim 1 \mu\text{A}/\text{cm}^2$ ). The larger  $i_{\text{pass}}$  could be caused by a coating deposition from surface reactions. The bullets from the simple chemistry solution (Figure 3-4(A)) showed the least change which agrees with the measured CPP scan at lower current density than the other CPP scans in formate-based solutions. Grinding marks are still readily apparent on the bullet surface, indicating lack of significant corrosion. Test coupons blackened during testing so the potential at which this coating/corrosion products formed could not be determined.

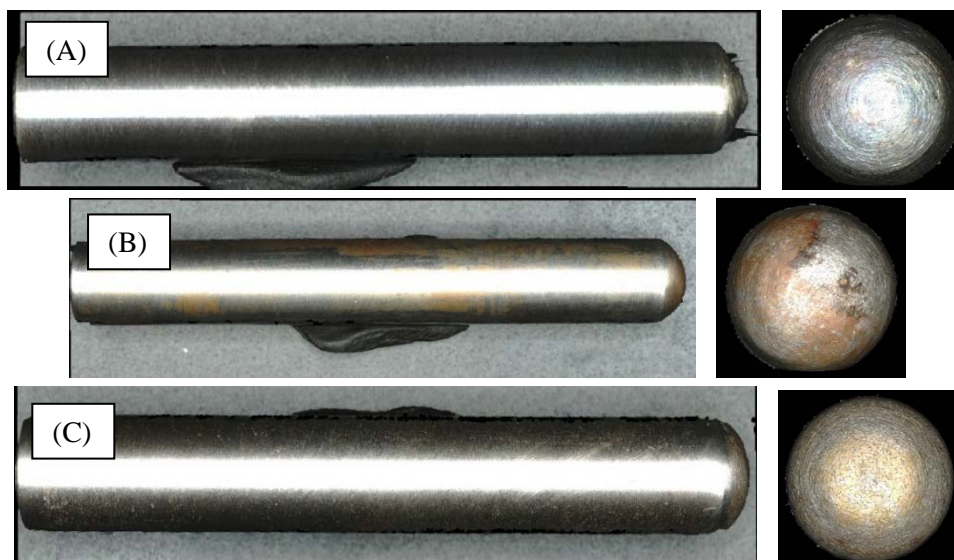
**Figure 3-5. Post-cleaning photographs of coupons from formate-based solutions at chloride concentrations of (A) 1000 ppm simple chemistry, (B) 1000 ppm complex chemistry, and (C) 1200 ppm complex chemistry**

The bullets were cleaned in 1M nitric acid for 60 seconds with most of the discoloration being removed as shown in Figure 3-5. Grinding marks are still obvious on these surfaces, but also is some degradation. The corrosion is general with some areas of more localized attack as shown especially in Figure 3-4 (B) for the 1000-ppm Cl coupon. These areas were shallow and are not representative of classic pitting. The corrosion may be a result of the destabilized oxide after going through  $E_b$  and the large polarization range in the reverse scan back to the  $E_{\text{corr}}$  value.

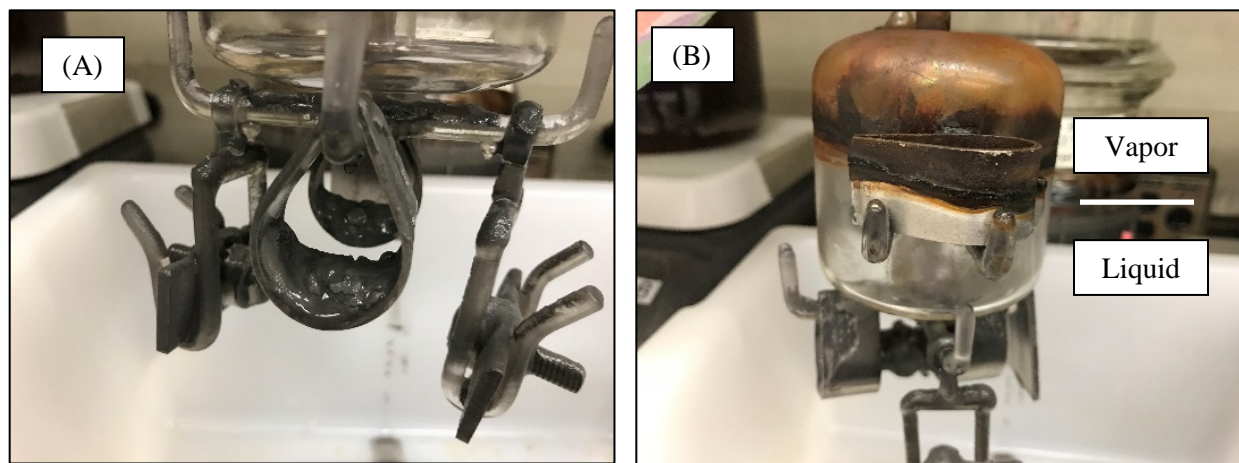
**Figure 3-6. Photographs of coupon immersion test coupons immediately after removal from a formate-based solution vessel showing (A) immersed and (B) interfacial coupons**

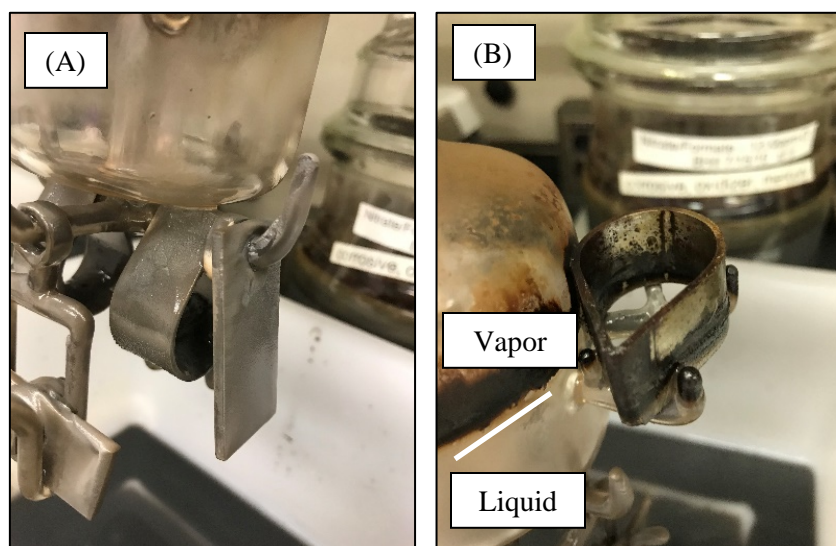
**Figure 3-7. Photographs of coupon immersion test coupons immediately after removal from a glycolate-based solution vessel showing (A) immersed and (B) interfacial coupons**

Some of the sediment formed an adherent coating on the coupon that required some rubbing to remove as shown by the photographs in Figure 3-7, which show coupons after only rinsing in water. White dotted lines in the figure show the approximate region for the vapor/liquid interface. The actual interface was variable over the three-month test period due to evaporation and slight boiling. The interface is better described as an interfacial region. The rust-colored sediment may also contain corrosion product. After removing the adherent sediment, coupons were further cleaned in 1M nitric acid. The interfacial teardrop coupons required up to four minutes soak time and additional brushing. The immersed coupons required 30-60 seconds soak time. The post-cleaning photographs are shown in Figure 3-8. Both before and after cleaning pictures of the front and back for all the coupons are shown in Appendix B.

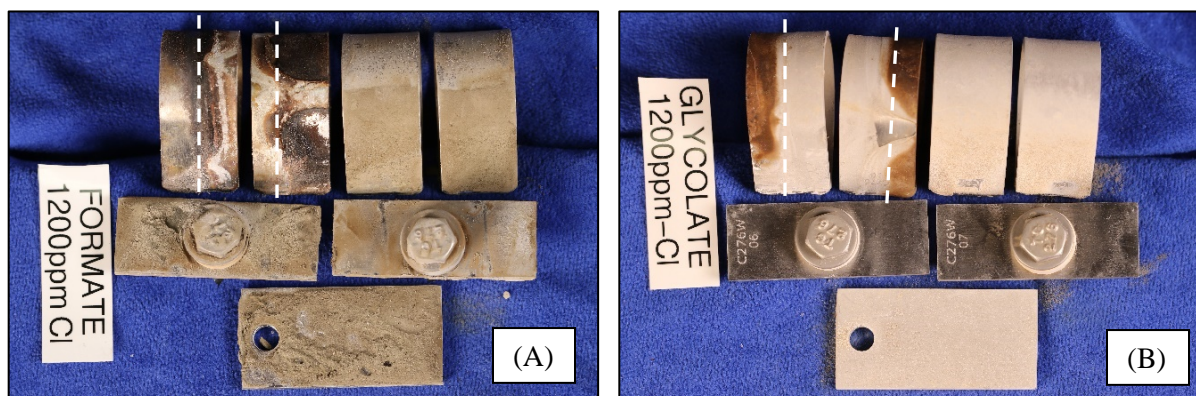
**Figure 3-8. Photographs of coupon immersion test coupons at the end of testing after rinsing to remove loose sentiment – (A) formate-based solution and (B) glycolate-based solution (white dotted line indicates vapor/liquid interfacial region with immersed portion of each teardrop facing the other interfacial teardrop)**

The immersed coupons showed no form of corrosion as can be seen by the coupon photographs taken after the nitric acid cleaning (see Figure 3-8 and Appendix B), including weld attack. In the previous coupon immersion test performed for six months, the weld was highlighted without significant localized corrosion observed [3]. These results demonstrate the corrosion resistance of C276 to these environments including SCC.

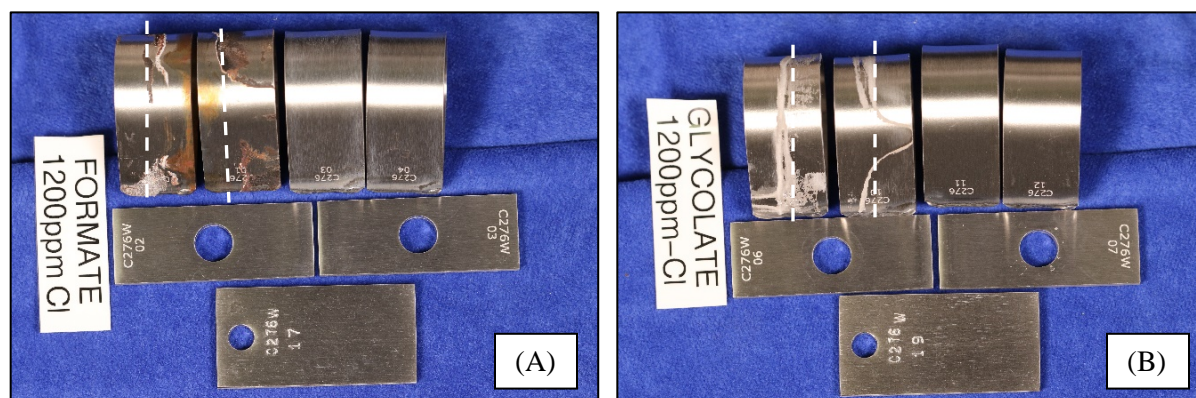
**Figure 3-9. Photographs of coupon immersion test coupons at the end of testing after rinsing and nitric acid cleaning – (A) formate-based solution and (B) glycolate-based solution**

After cleaning, the coupons were reweighed to determine any weight change. The weight changes for the immersed coupons were small (losses ranged from 0.0001 to 0.0024 g) . Some immersed coupons had residual deposits that were difficult to remove. Extensive effort was not attempted to remove adherent deposits since the coupons would be scarred and have an artificial weight loss. 12 of the 28 coupons had weight gains and residual surface oxides or deposits. Corrosion rates were calculated showing 0.01 mpy or less.

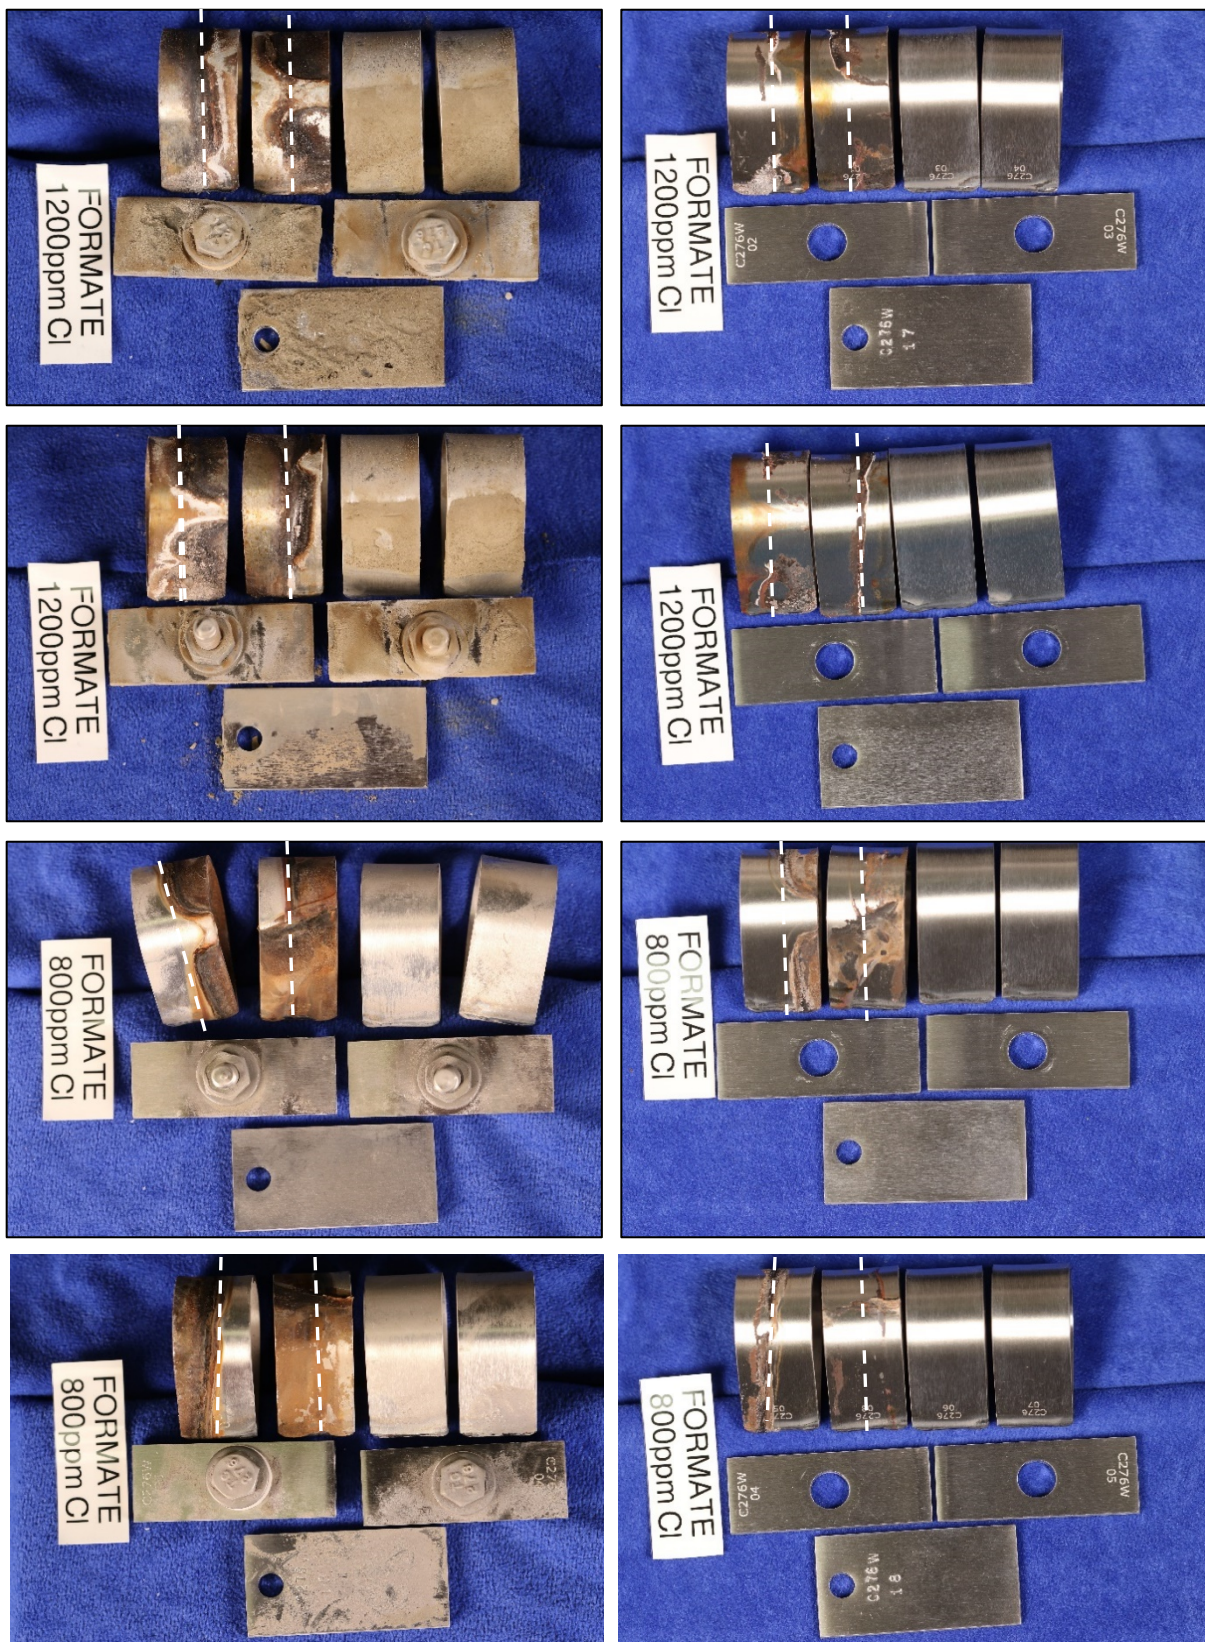
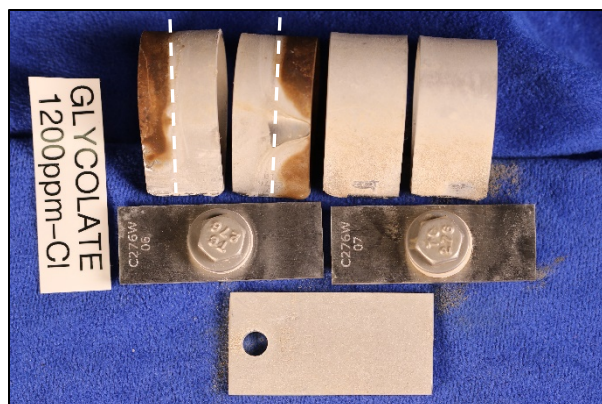
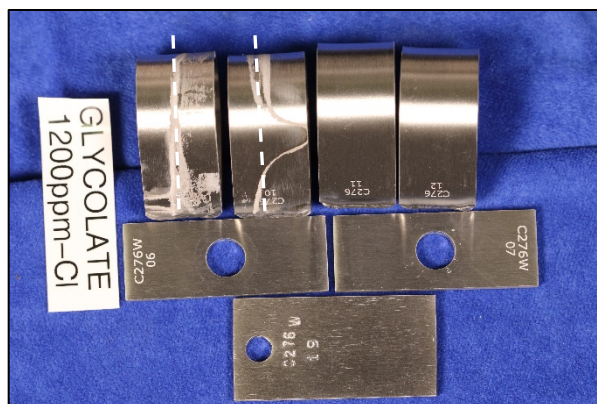
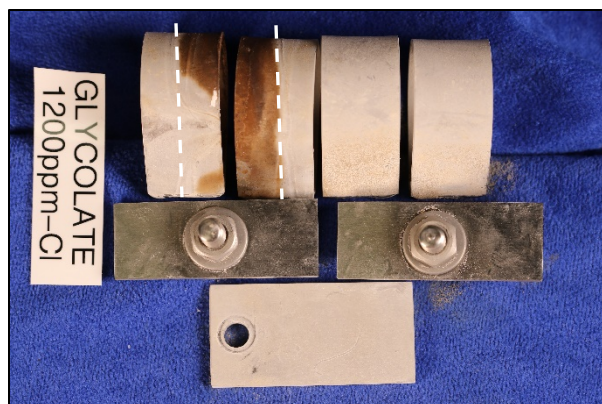
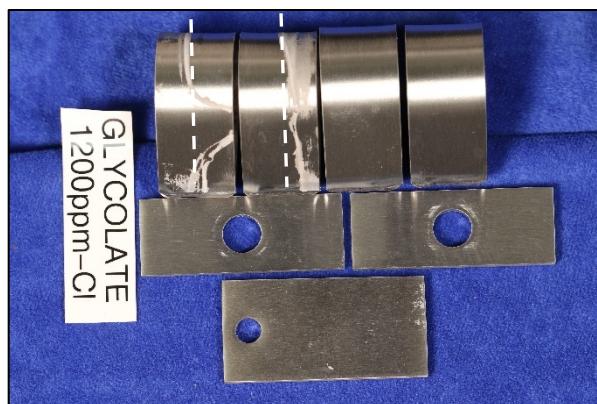
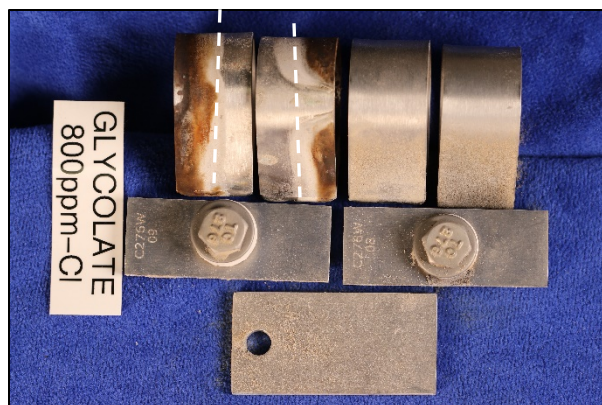
# Appendix B. Post-test Photographs of Immersion Test Coupons\*

\*White dotted lines indicate approximate location of vapor/liquid interface.
