# SDU7 Interior Liner Testing & Evaluation

SRNL-STI-2020-00209, Revision 0

**Keywords:** Saltstone, SDU, polymer,  
liner, containment

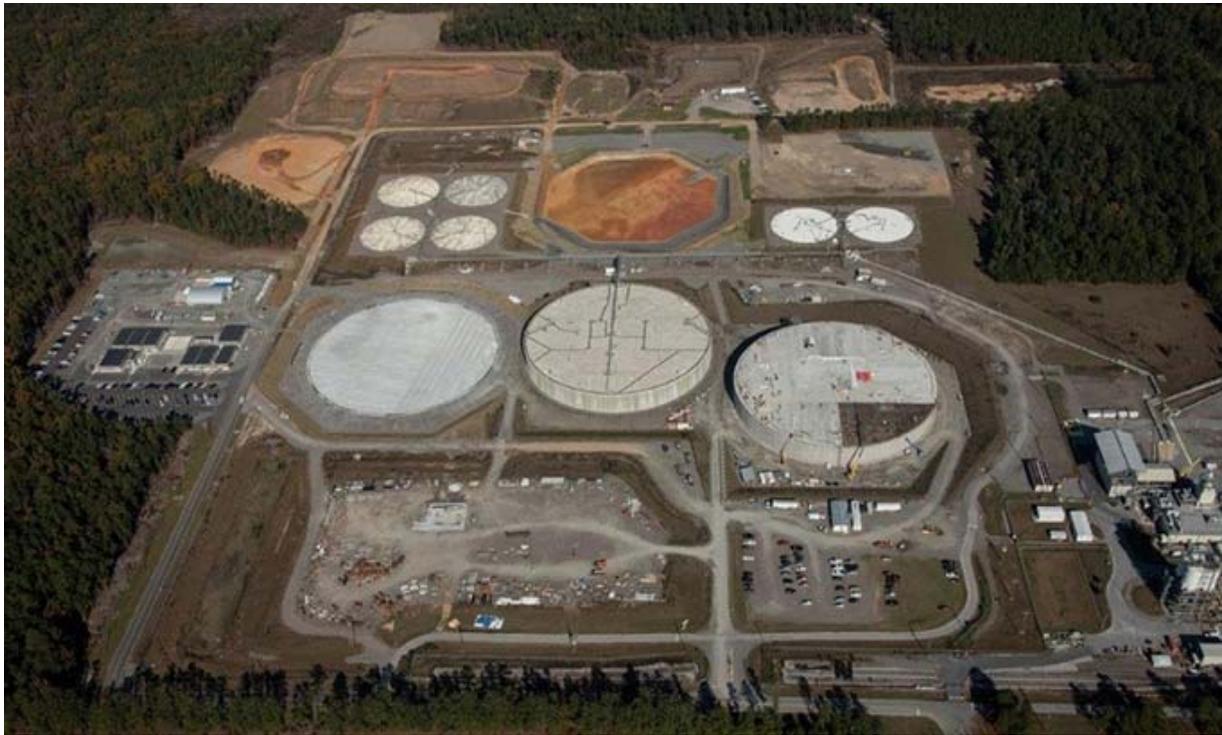
Figure 1. SDU7 (under construction at right) in Z-Area [9]

The Saltstone Disposal Unit 7 (SDU7) is a circular concrete tank approximately 375 feet in diameter by 43 feet high, contains 208 roof support columns, with a minimum capacity of 30 million gallons. The columns are 2 feet in diameter. The SDU7 design is similar to SDU6 (Figure 1), which is based on the Syracuse, NY Westcott Reservoir design.

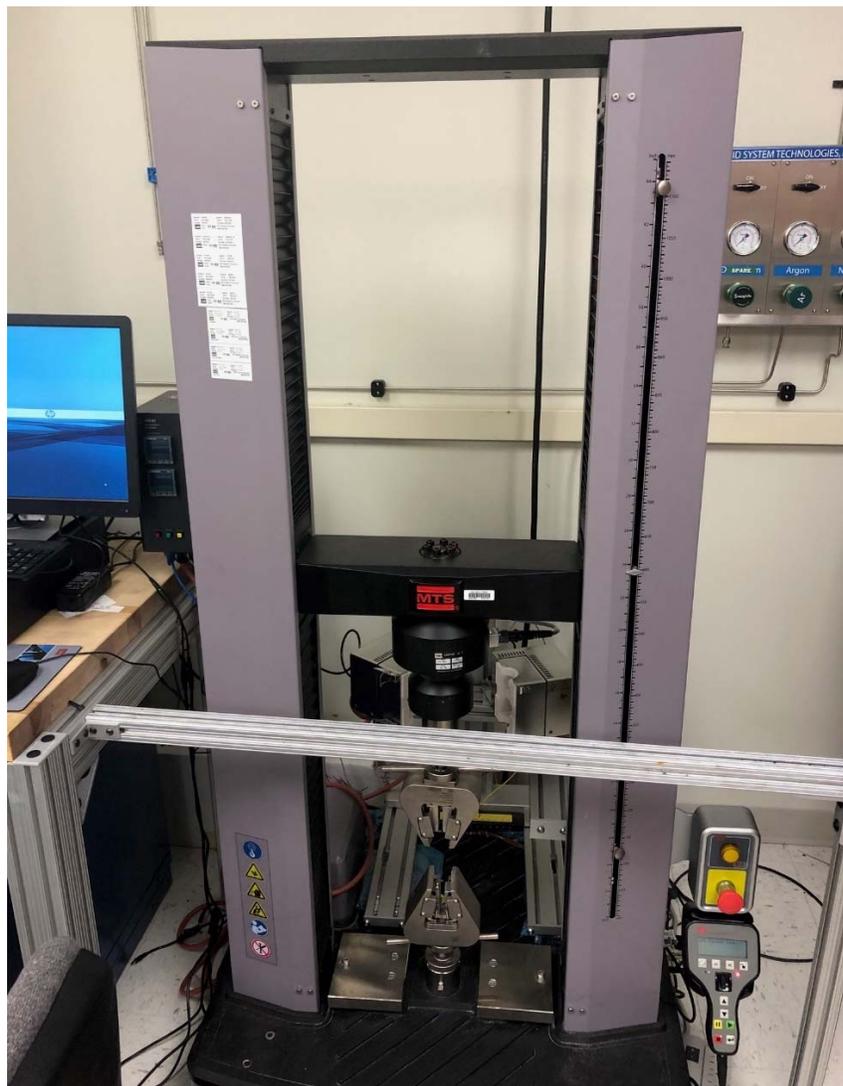
Figure 3. MTS tensile machine (Model C43-504), SRNL Hydrogen Technology Research Laboratory

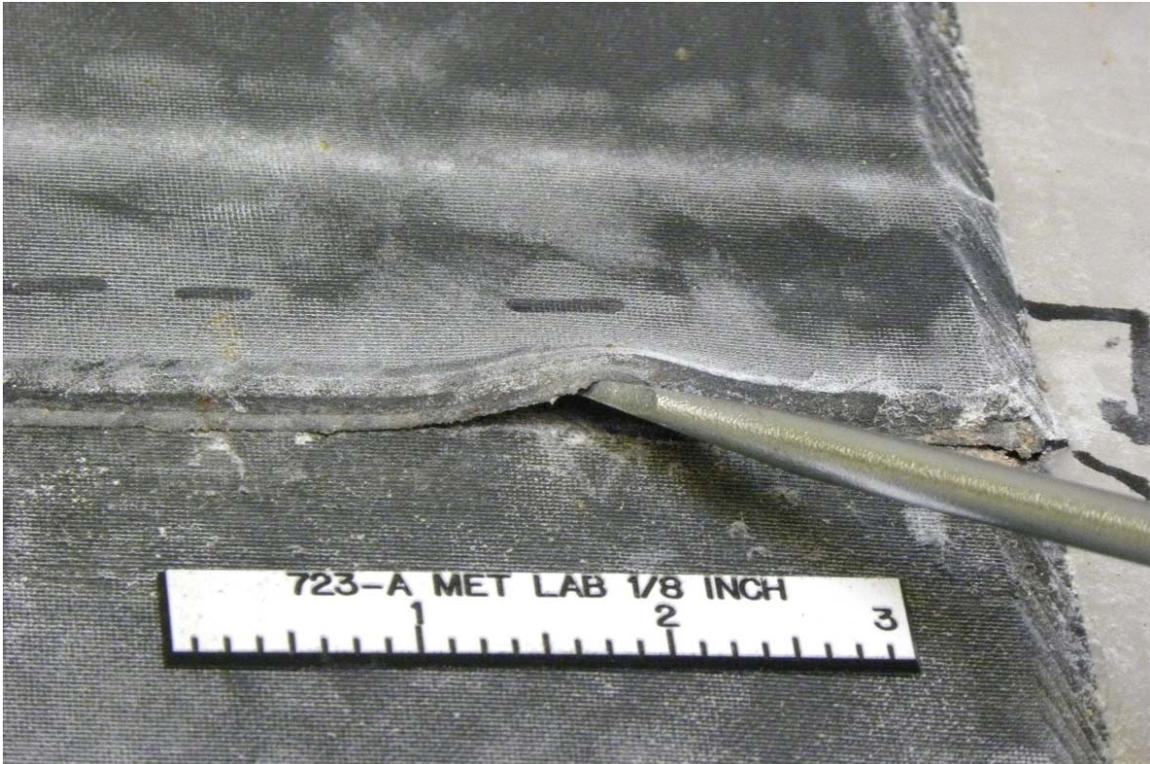
Figure 6. Seam interrogation on System C1 Paver, S2 Simulant, 1000-hour immersion (black markings denote easily debonded regions)

This is recognized to be a subjective method, as the force and angle imposed during the interrogation is not controlled or measured. However, an attempt was made to keep the probing method consistent for all samples. The main goal was to find suspect or clearly debonded areas, not to forcibly make reasonably well-bonded areas fail. The edges of the screwdriver were rounded to avoid sharp corners. The screwdriver was lightly pushed against the seam or edge joint to find areas with little to no resistance. Examples of liner edge to concrete bond and seam interrogation are shown in Figures 6 and 7.

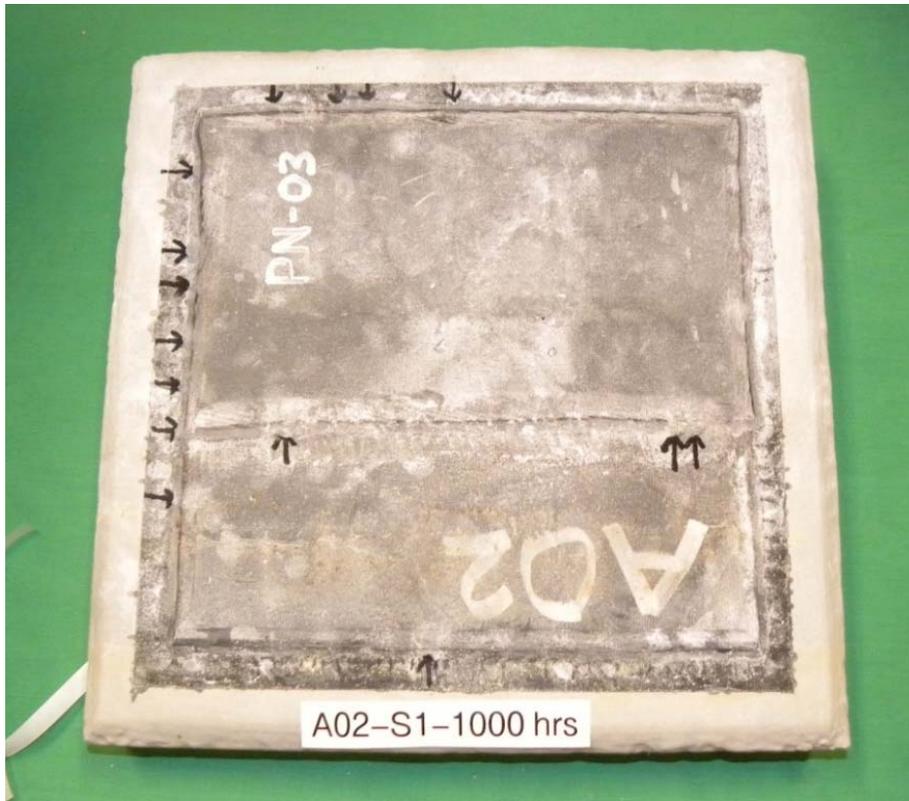
Figure 17. System A Paver, S1 simulant, 500-hour immersion

Figure 18. System A Paver, S1 Simulant, 1000-hour immersion

Figure 19. System A15 Paver, S2 simulant, 500-hour immersion

Figure 20. System A Paver, S2 Simulant, 1000-hour immersion

System A pavers (Figures 17-20) showed many small localized areas, some pavers more than others, that all seemed to be related to the tie gum or the very thin skived layer at the edge. These appear to be either due to trapped air pockets or blisters at the edge. None were noted to expel fluid when pressed. All of these areas were relatively shallow, only extending approximately 1/16”-1/8” into the skived edge and did not extend under the bulk thickness of the bonded sheet, at least not without significant effort.

In summary, System A pavers exhibited many small unbonded regions along the edges of seams and skived edges. The cause is unknown, but may be attributed to air entrapment, solvent evaporation or workmanship issues. None of the areas were observed to extend much beyond the outermost skived edge of either the seam or sheet perimeter. These regions did not seem to get progressively worse from examination at 500 and 1000 hrs in either simulant. These observations are consistent with those made by SREL personnel [23].

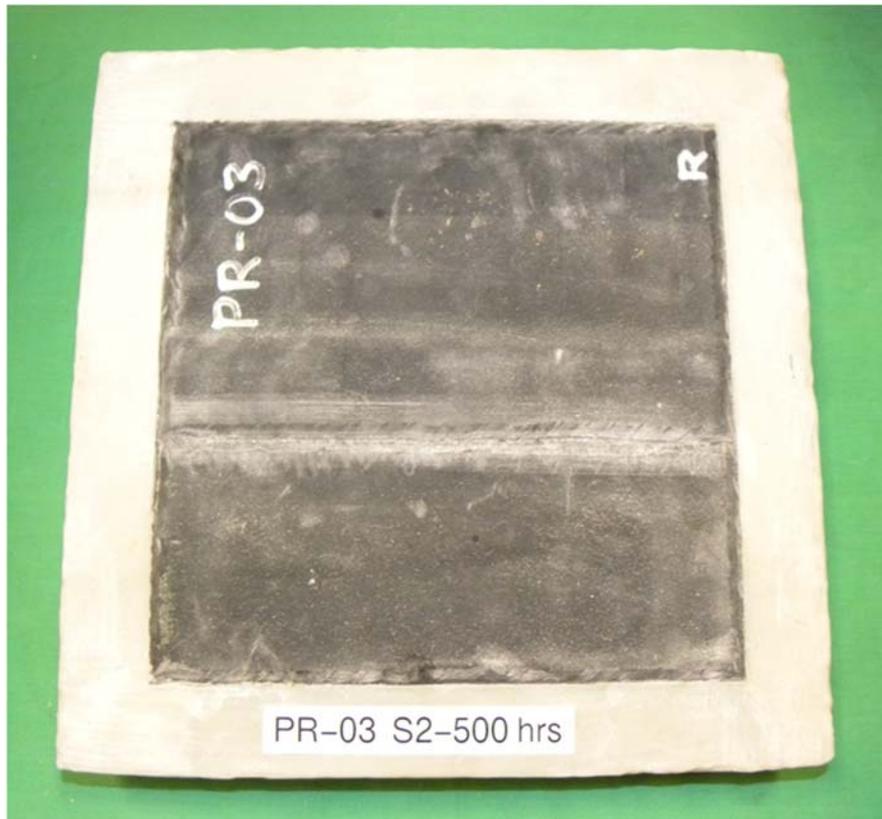
Figure 23. System B Paver, S2 simulant, 500-hour immersion (no defects or debonded areas)

System B paver PR-03 (Figure 23) was considered the only paver to be defect-free. No areas of delamination or debondment were found on that particular paver with reasonable interrogation effort. Paver PR-04 (Figure 22) showed one area with about 1” length of debonding, found by lightly tapping the screwdriver along the edge, which finds a weak spot relatively well. Areas tend to be either well-bonded or relatively easily debonded.

Only one paver (System B, REMA, PR-03) showed essentially defect-free behavior, with no significant blistering, debonding or fluid seepage observed. This observation indicates that if this adhesive is properly applied and cured, defect-free seams can be made. Other System B pavers showed minor debonded regions and/or expelled fluid. The cause of variation in paver performance with a given adhesive system is unknown.

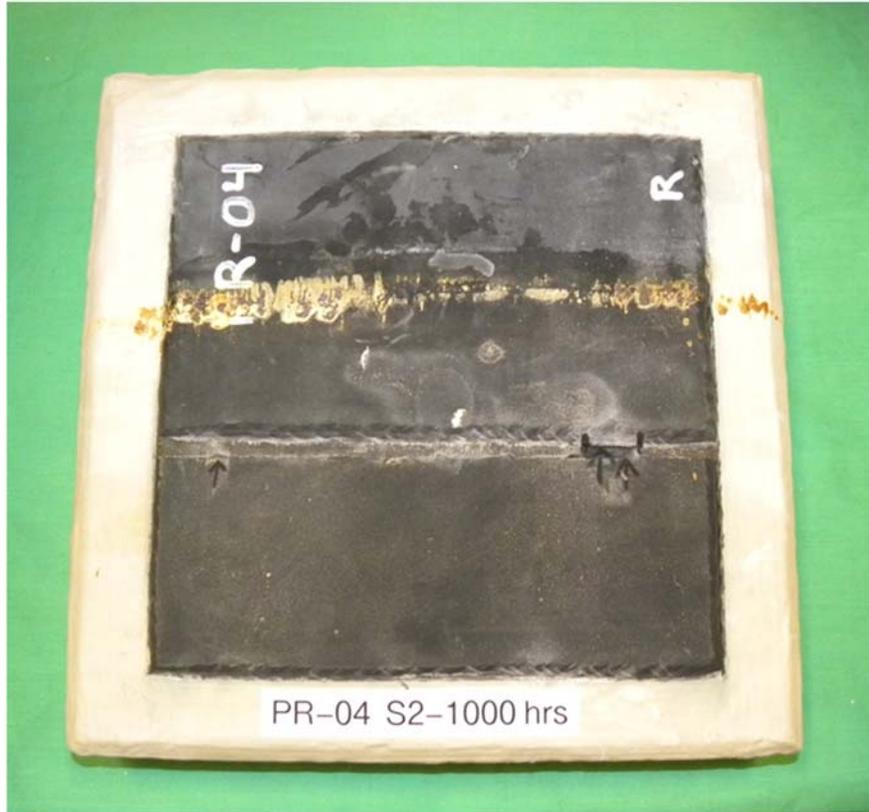
Figure 24. System B Paver, S2 Simulant, 1000-hour immersion
