Wide Area 3D Measurement System for Analysis of 3013 Inner Container Closure Weld Region

September 29 2020

SRNL-STI-2020-00418, Revision 0

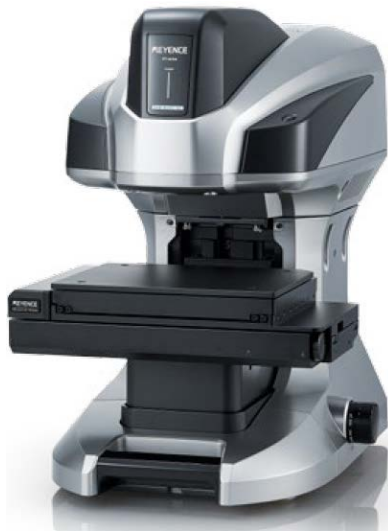
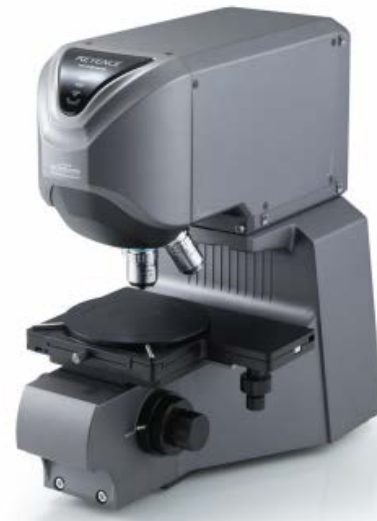
(a) **WAMS:** Fast Screening of Large Areas.

(b) **LCM:** Smaller Section Details at Higher Resolution.

Figure 4. Microscopes for examination of the ICCWR: (a) Keyence Wide Area 3D Measurement System (WAMS) model VR-5000 and (b) Keyence Laser Confocal Microscope (LCM) model VK-X110.

In FY20, A Keyence VR-5000 optical microscope with 3-dimensional (3D) wide area collection capability was employed to carry out high resolution rapid imaging of the ICCWR samples. The WAMS is a 3D surface microscope, similar to the LCM, with capabilities to collect digital optical images and height measurements. However, the WAMS uses a white LED as the measurement light source compared to the LCM, which uses a red laser as the measurement light source. Figure 4 shows pictures of the Keyence WAMS and LCM used for the examination of the ICCWR. The WAMS has the capability to measure a wide area simultaneously with high accuracy at an unprecedented speed. Although the WAMS can produce high resolutions images, the LCM has the capability to produce higher resolution images, due to its laser source, but at the expense of slower speeds as it has to scan the surface focusing into smaller areas than the WAMS at a time. Nonetheless, both systems offer capabilities that combined can be utilized to expedite the examination of the ICCWR. The WAMS can be utilized to obtain images for faster screening or identification of corrosion feature on the surface while the LCM can be utilized to obtain higher resolution images of those areas identified by the WAMS.

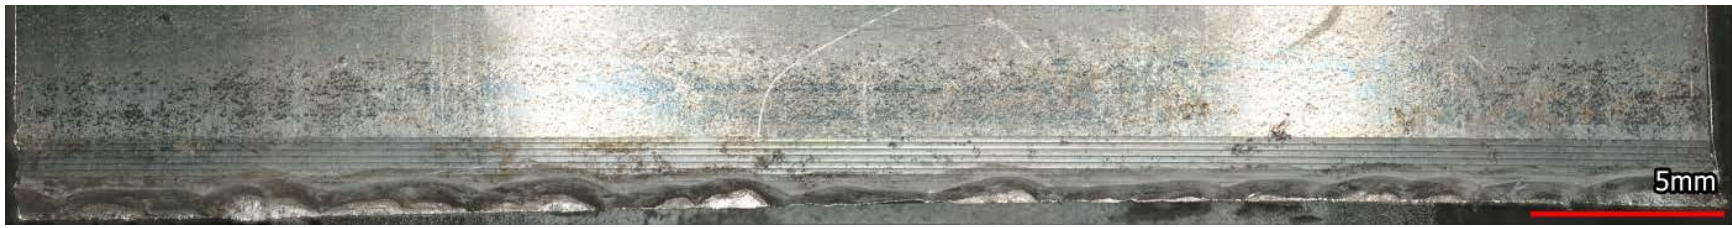
Figure A.1. High resolution image obtained with the WAMS for FY17 DE04 Sidewall Section A1.

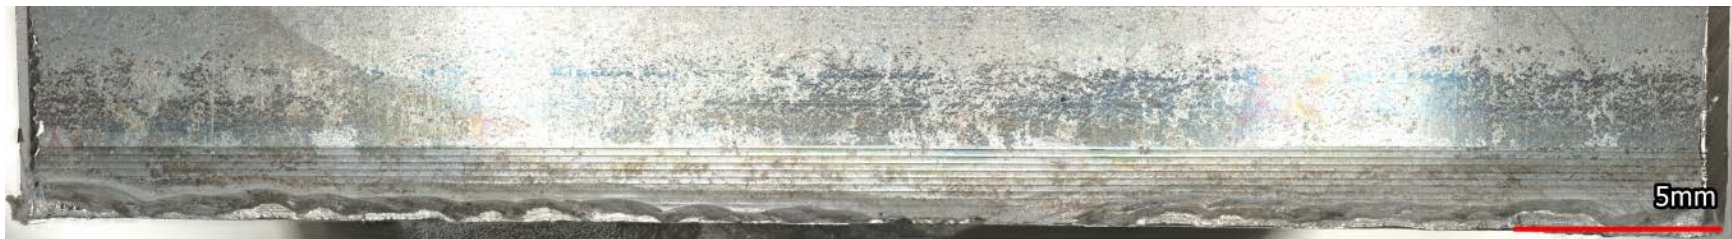
Figure A.2. High resolution image obtained with the WAMS for FY17 DE04 Sidewall Section A2.

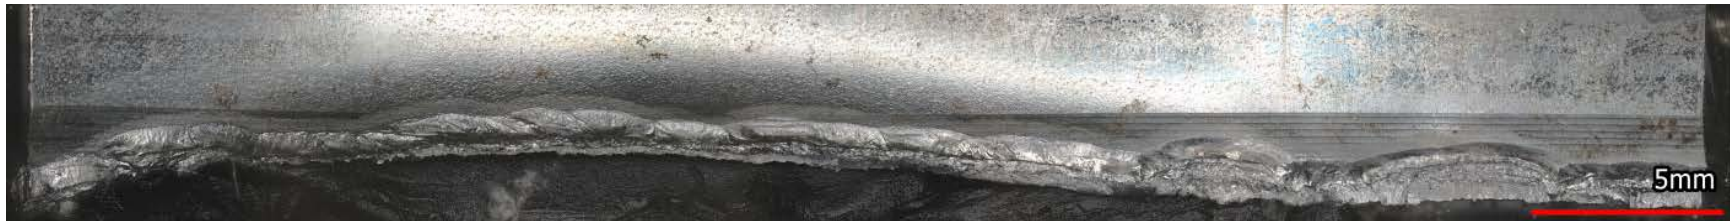
Figure A.3. High resolution image obtained with the WAMS for FY17 DE04 Sidewall Section B1.

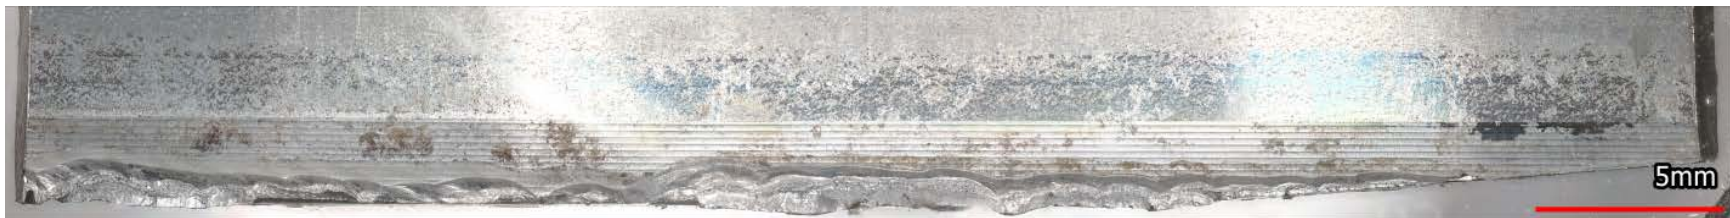
Figure A.4. High resolution image obtained with the WAMS for FY17 DE04 Sidewall Section B2.

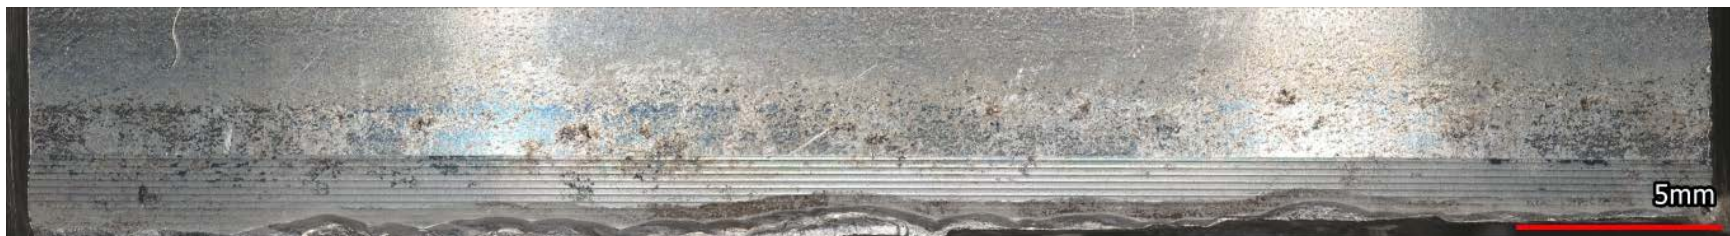
Figure A.5. High resolution image obtained with the WAMS for FY17 DE04 Sidewall Section C1.

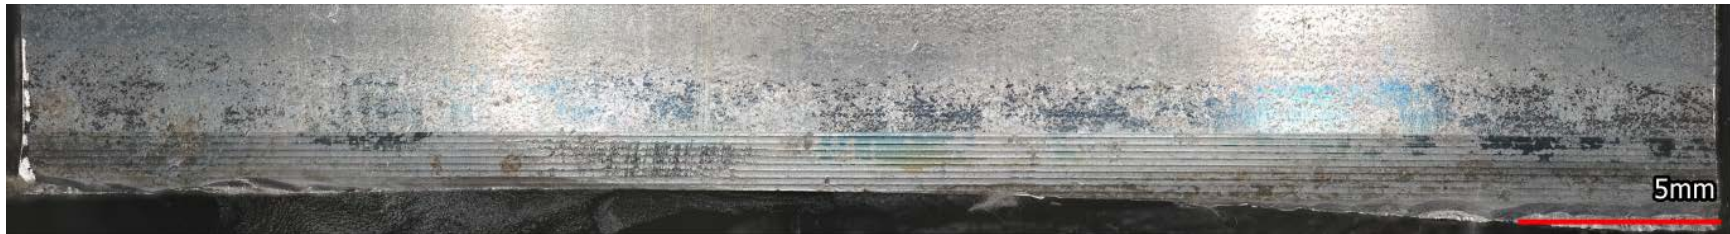
Figure A.6. High resolution image obtained with the WAMS for FY17 DE04 Sidewall Section C2.

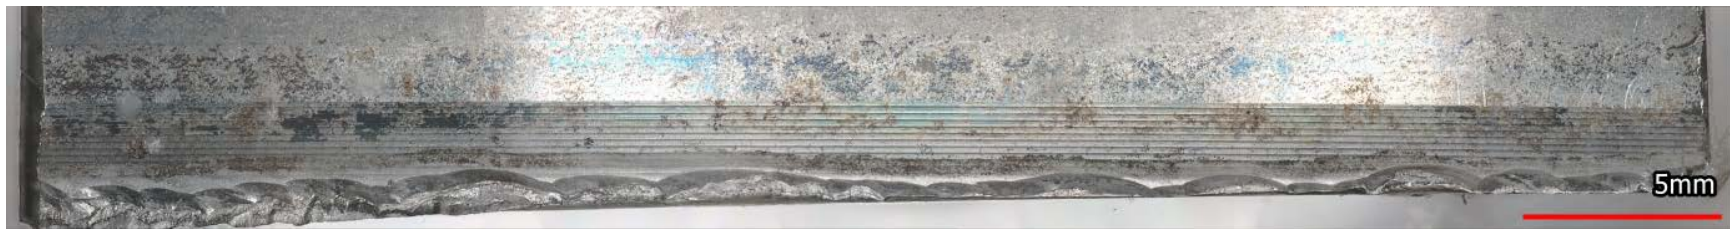
Figure A.7. High resolution image obtained with the WAMS for FY17 DE04 Sidewall Section D1.

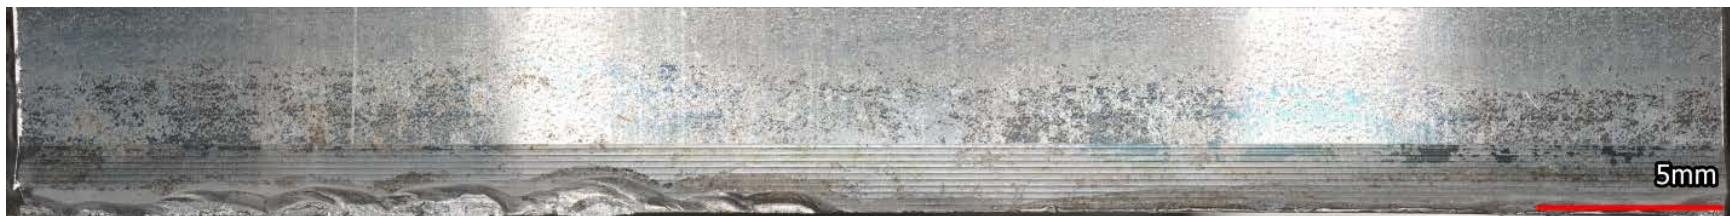
Figure A.8. High resolution image obtained with the WAMS for FY17 DE04 Sidewall Section D2.

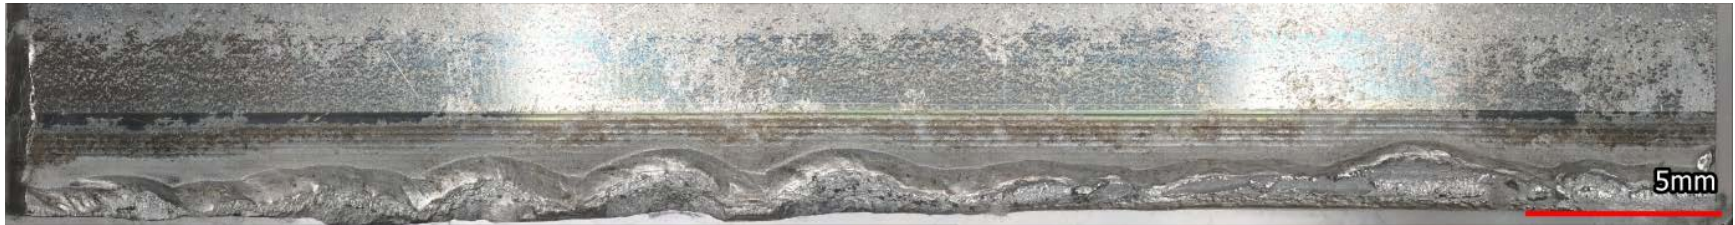
Figure B.3. High resolution image obtained with the WAMS for FY18 DE03 Sidewall Section B1.

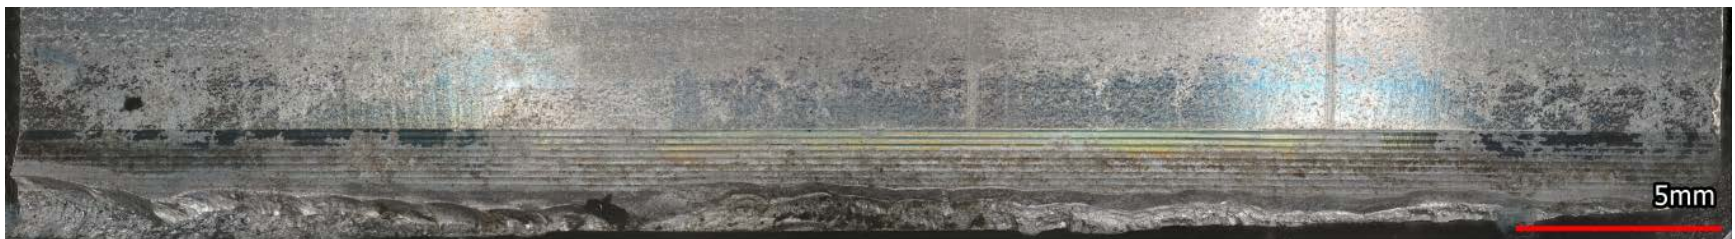
Figure B.4. High resolution image obtained with the WAMS for FY18 DE03 Sidewall Section B2.

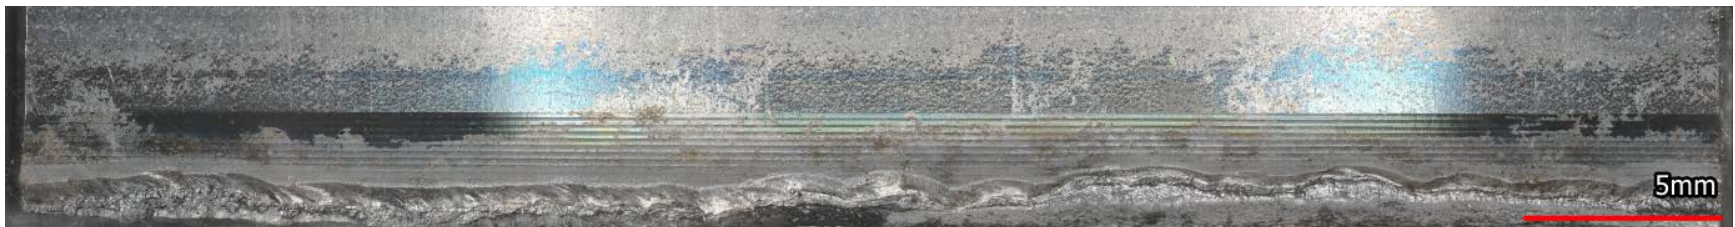
Figure B.5. High resolution image obtained with the WAMS for FY18 DE03 Sidewall Section C1.

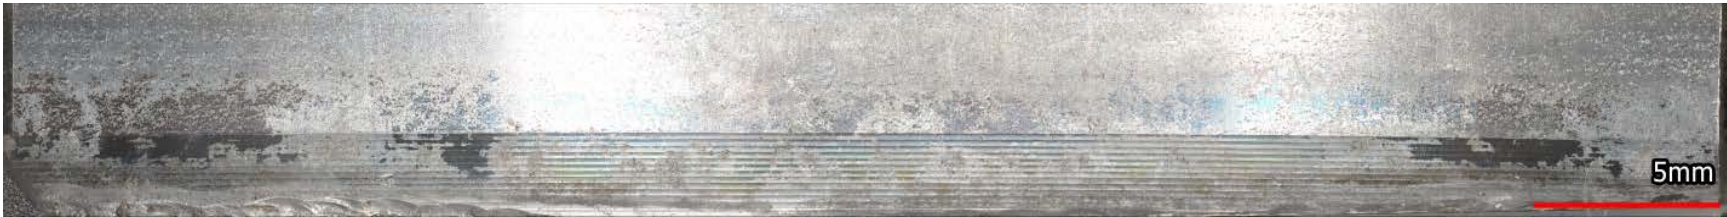
Figure B.6. High resolution image obtained with the WAMS for FY18 DE03 Sidewall Section C2.

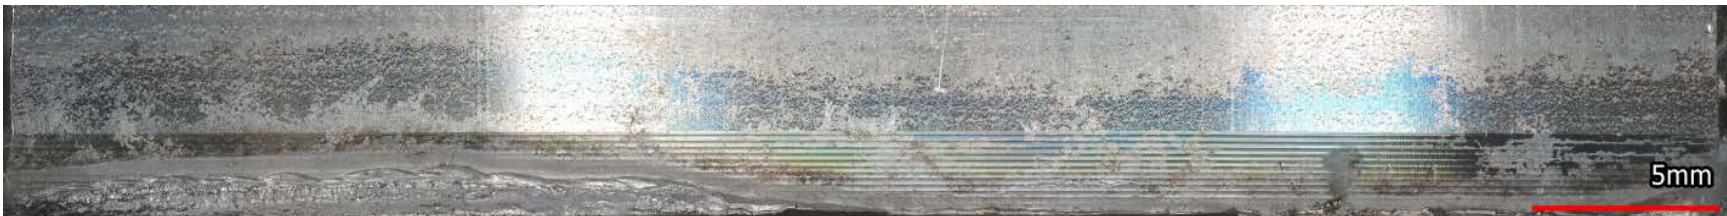
Figure B.7. High resolution image obtained with the WAMS for FY18 DE03 Sidewall Section D1.

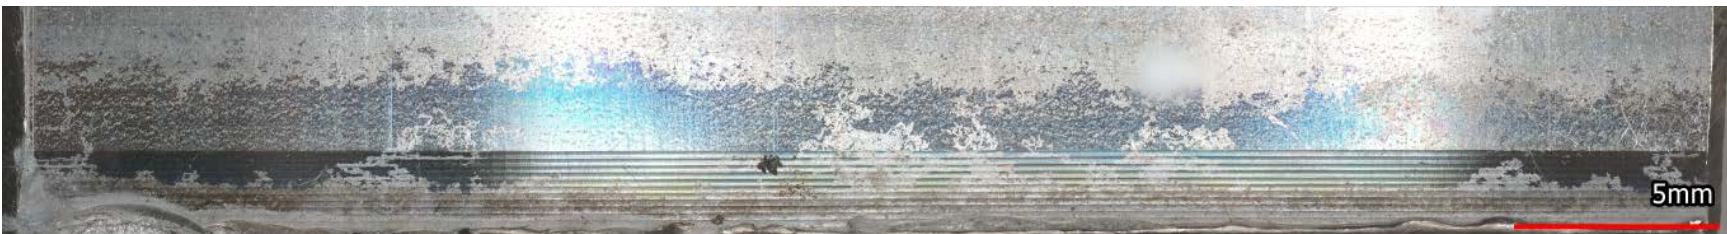
Figure B.8. High resolution image obtained with the WAMS for FY18 DE03 Sidewall Section D2.
