Dip Leg Plug Formation Evaluation and Abatement Testing in Support of the H- Canyon Accelerated Basin De-inventory

March 2021

SRNL-STI-2020-00559, Revision 0

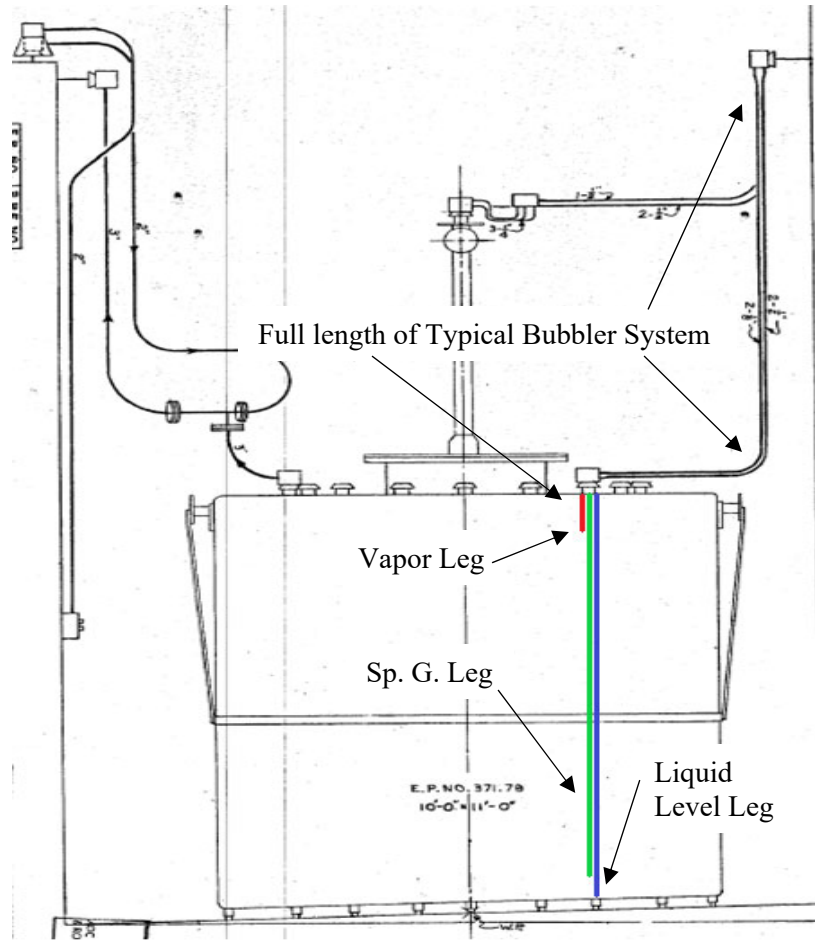
Figure 1-1. Typical Canyon Liquid Level Piping Arrangement.

For reference, a typical bubbler arrangement is shown above (Figure 1-1 and Figure 1-2). The red leg is the vapor space reference leg, the green leg is the Sp. G. reference leg, and the blue leg is the LL reference (bottom leg).

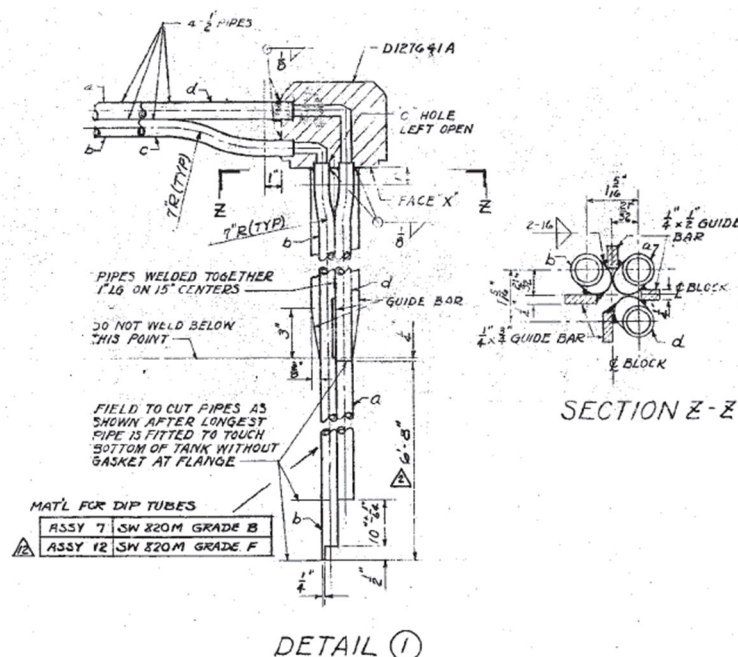
Figure 1-3. Detail of Typical Canyon Vessel Dip Leg.

The specific dip legs used in the initial testing were based on SRS drawing W230479, Revision 1, detail 1, shown below (Figure 1-3).

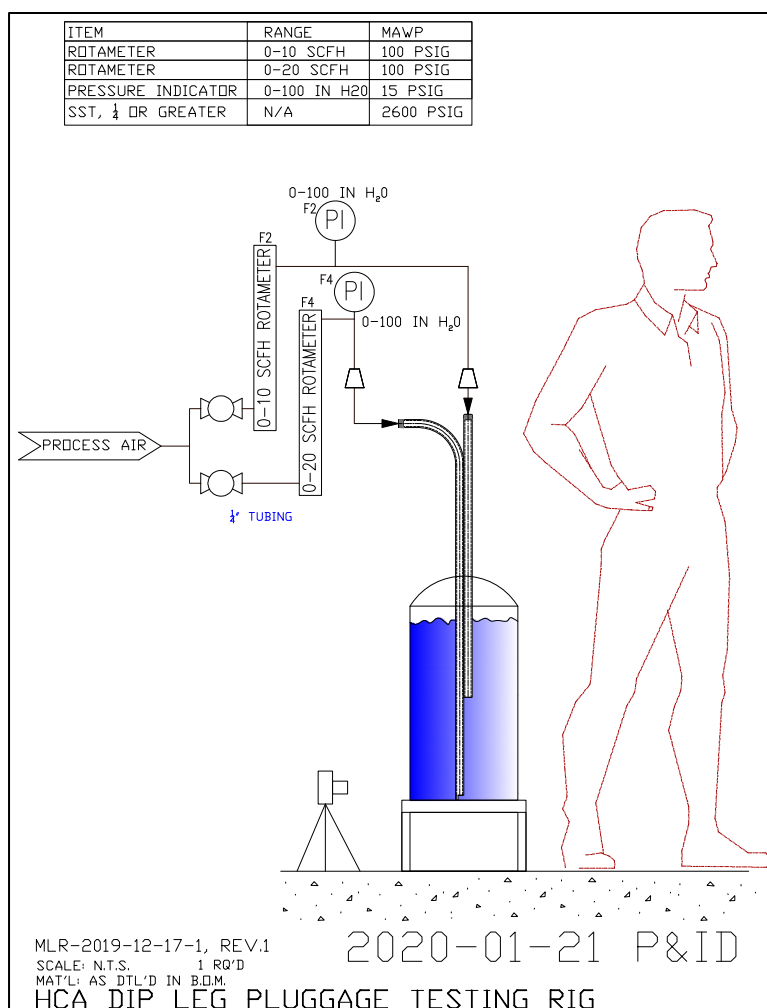
Figure 2-1. Local Instruments Piping and Instrument Diagram.

The testing (Phases 1 and 2) began with local (manually read) instruments, including differential pressure gauges (0-100 in. H₂O), and rotameters (0-10 SCFH). The differential pressure gauges used the high side for pressure input, and the low side was open to atmosphere, resulting in a gauge pressure reading. This configuration is shown below in Figure 2-1. The test rig was modified with electronic instruments after initial testing to better evaluate plugging dynamics. This included the replacement of the rotameters with mass flow controllers, the pressure gauges with pressure transducers, the local readout RTD (Resistance Temperature Detector) with thermocouples, and the addition of a computer with a Data Acquisition System (DAS) continuously reading and recording the electronic instrumentation (Phases 3 and 4). This enhanced configuration is shown in Figure 2-2. HCA directed SRNL to flow air at 7.5 SCFH (3.5 SLPM), as this was typical for the Canyon Vessels.

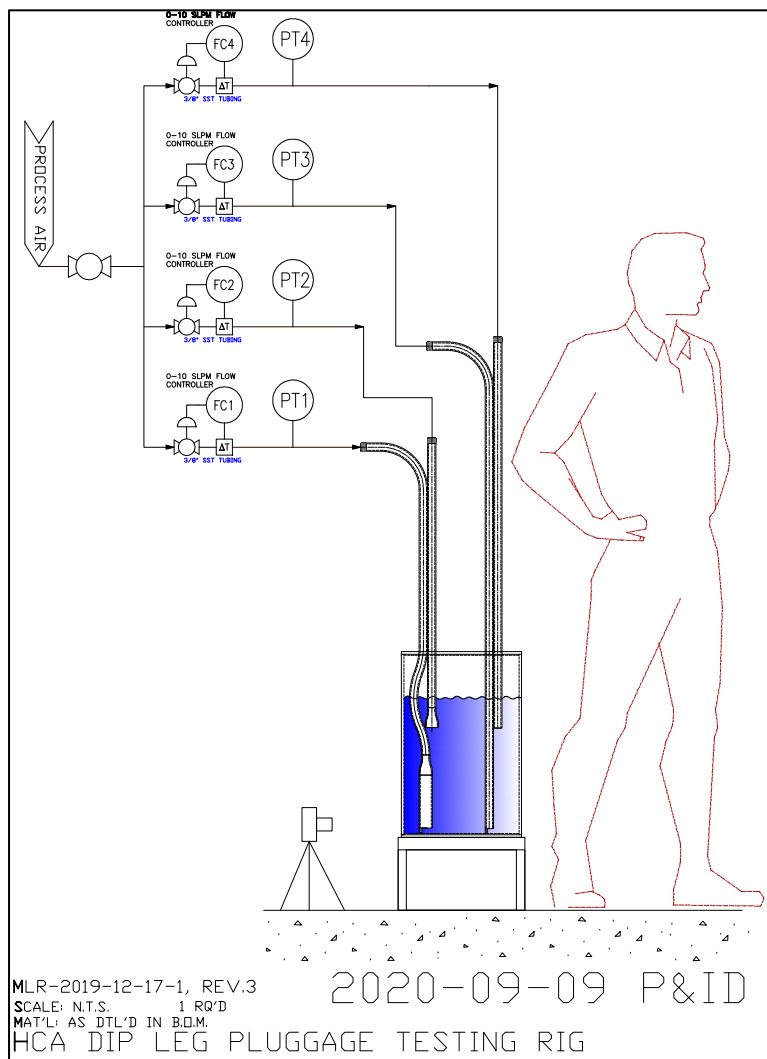
Figure 2-2. Electronic Instruments Piping and Instrument Diagram.

Once it was determined that plugging was better evaluated with continuous reading instruments, 4 Rosemount pressure transducers, 4 MKS mass flow controllers, and one thermocouple were added to the rig to replace the local instruments. This instrument list is shown below in Table 2-2.

With the addition of two newly re-designed nozzles with larger openings and the cleaned original design nozzles (see Figure 2-2), the original feed tank had to be removed and replaced with a procured acrylic tank. The tank design is provided in Appendix A. The new feed solution was mixed, installed in the new feed tank with all four (4) nozzles, and Phase 4 testing commenced (see Figure 3-14 below).

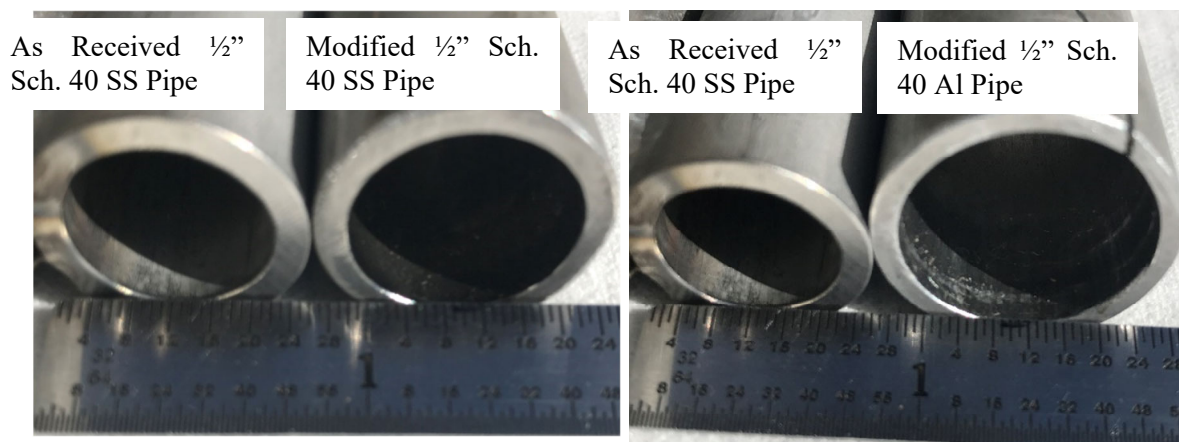
Figure 2-3. Mandrel Expansion Efforts on 1/2 in. Sch. 40 SS Pipe and Aluminum Pipe.

Before recommending any major changes, HCA Engineering requested SRNL test the existing bubbler design, which is a bundle of three small tubes welded together. In an initial attempt to increase the internal diameter of standard dip legs (1/2 in. Sch. 40 SS Pipe), several fabrication processes were attempted, all cold worked. The intent of this mechanical expansion process was to determine the amount of expansion achievable on dip leg piping using manual tools available in the field. A reducing diameter mandrel was oiled, and placed into a 1/2 in. Sch. 40 pipe, which was then placed into an arbor (left photo in Figure 2-3). The arbor was then used to press the mandrel into the workpiece. The maximum internal diameter (ID) achievable through this method was 0.69 in. ID. An attempt was made on an aluminum 1/2 in. Sch. 40 pipe, and the maximum diameter achievable before fracture was 0.84 in. internal diameter (right photo in Figure 2-3). These values are both above the nominal 1/2 in. Sch. 40 SS pipe ID of 0.622 in. These attempts were made to ascertain the feasibility of field modifications achievable on existing dip legs. The final results indicate that modifications to existing equipment are not an option.

This cold-working tube-enlargement investigation led to the decision to design a new nozzle head. The new nozzle design model is shown in Figure 2-4. It is based on a standard welded 1/2 in. x 1 in. Sch. 40 welded reducer for ease of manufacture. The LL dip leg new nozzle has the addition of 5 1/2 in. of 1 in. Sch. 40 pipe welded to the welded reducer. The Sp. G. dip leg new nozzle only has the 1/2 in. x 1 in. welded reducer. The original test rig design and the new design are shown side by side below in Figure 2-5.

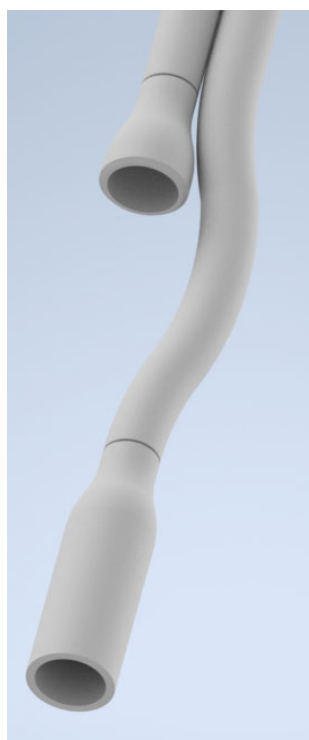
Figure 2-4. New Designed Nozzle Model.

The new nozzle design was constrained by the need to insert the full dip leg jumper (all three nozzles, vapor, Sp. G., and LL which are welded together along the seam interface) into a tank nozzle which is 3" in internal diameter. SRNL had to consider how to modify the dip leg nozzles such that the bottom two nozzles, the LL and Sp. G. dip leg nozzles, could still be installed into the 3 in. ID nozzle. This dimension was administratively controlled to 2 1/2 in. ID by HCA Engineering based on past experience. This resulted in the new nozzle design geometry shown in Figure 2-4.

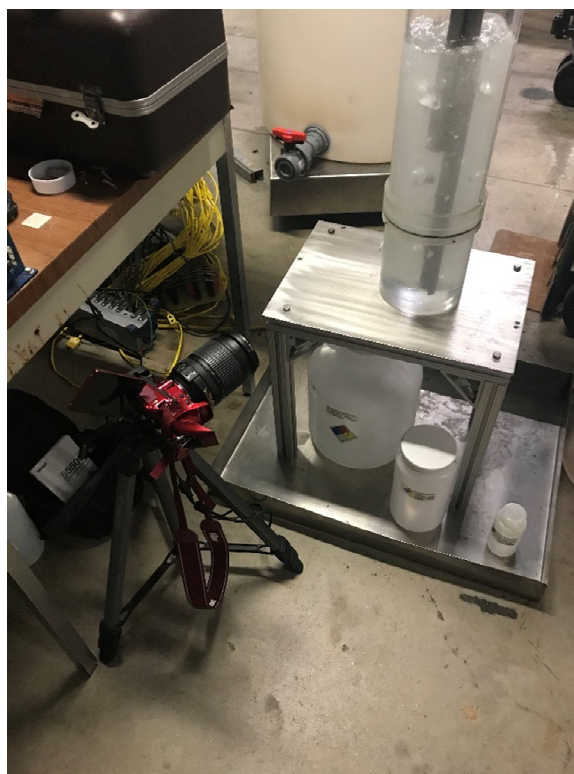
Figure 2-7. Time Lapse Photography Setup.

A time lapse setup was installed to obtain evidence of plug forming. This configuration is shown in Figure 2-7.

The original intention of the time lapse photography was to allow documentation of gradual plug formation with photos taken external to the dip legs. The belief was that plug formations would be sufficiently observable outside of the dip legs to glean information on their plug dynamics. As would be shown later, plug formations do extend beyond the exterior of the dip legs (See Figure 3-5). However, because of the varying opacity of the bubbling solution and that the plug material was found deep within the bubblers, time lapse photography proved insufficient to document the plug forming dynamics.

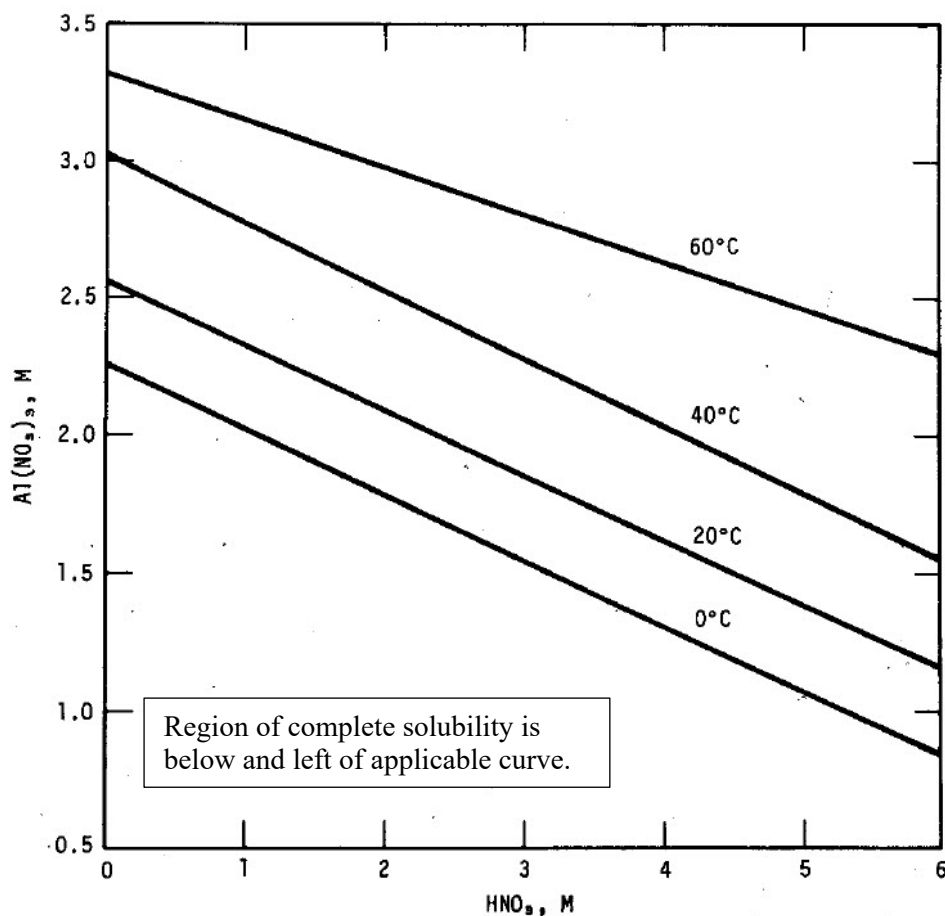
Figure 3-1. Solubility of Aluminum Nitrate in Nitric Acid Solutions².

Aluminum nitrate ($\text{Al}(\text{NO}_3)_3 \cdot 9\text{H}_2\text{O}$) forms colorless, rhombic crystals. It is deliquescent and melts in its waters of hydration at 73 °C and decomposes at 135 °C. The aqueous solution is weakly acidic because of the hydrolysis of the aluminum ion. Its solubility in water and nitric acid at different temperatures is shown in Figure 3-1².

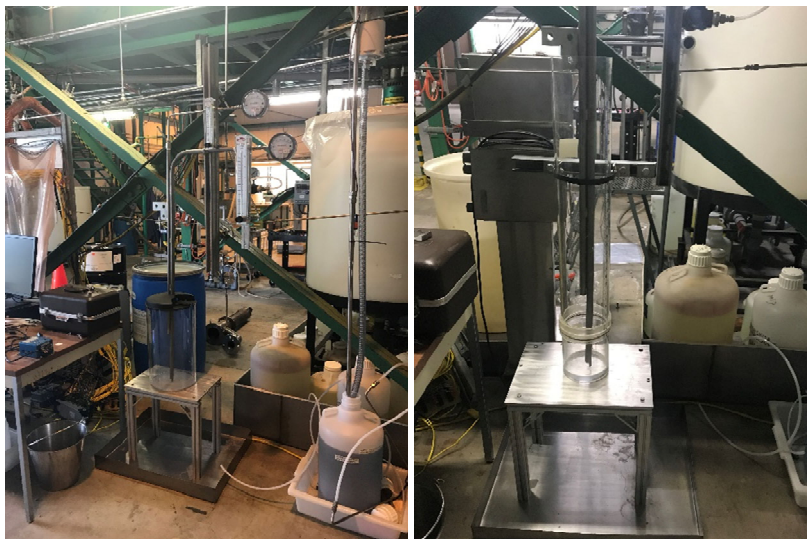
Figure 3-2. Phase 1 Test Rig.

Phase 1 testing (Figure 3-2) was an initial attempt to replicate plugging. Local instruments, including differential pressure gauges (low side open to atmosphere) and rotameters were used to measure flow, and rounds were performed periodically to maintain 7.5 SCFH. Phase 1 and all additional phases were performed at nominal room temperatures as agreed upon with the customer.

The original tank in the photo on the left was replaced with the tank shown in the photo on the right based on material incompatibility and freeboard concerns (Figure 3-2). A feed solution was prepared and added to the rig.

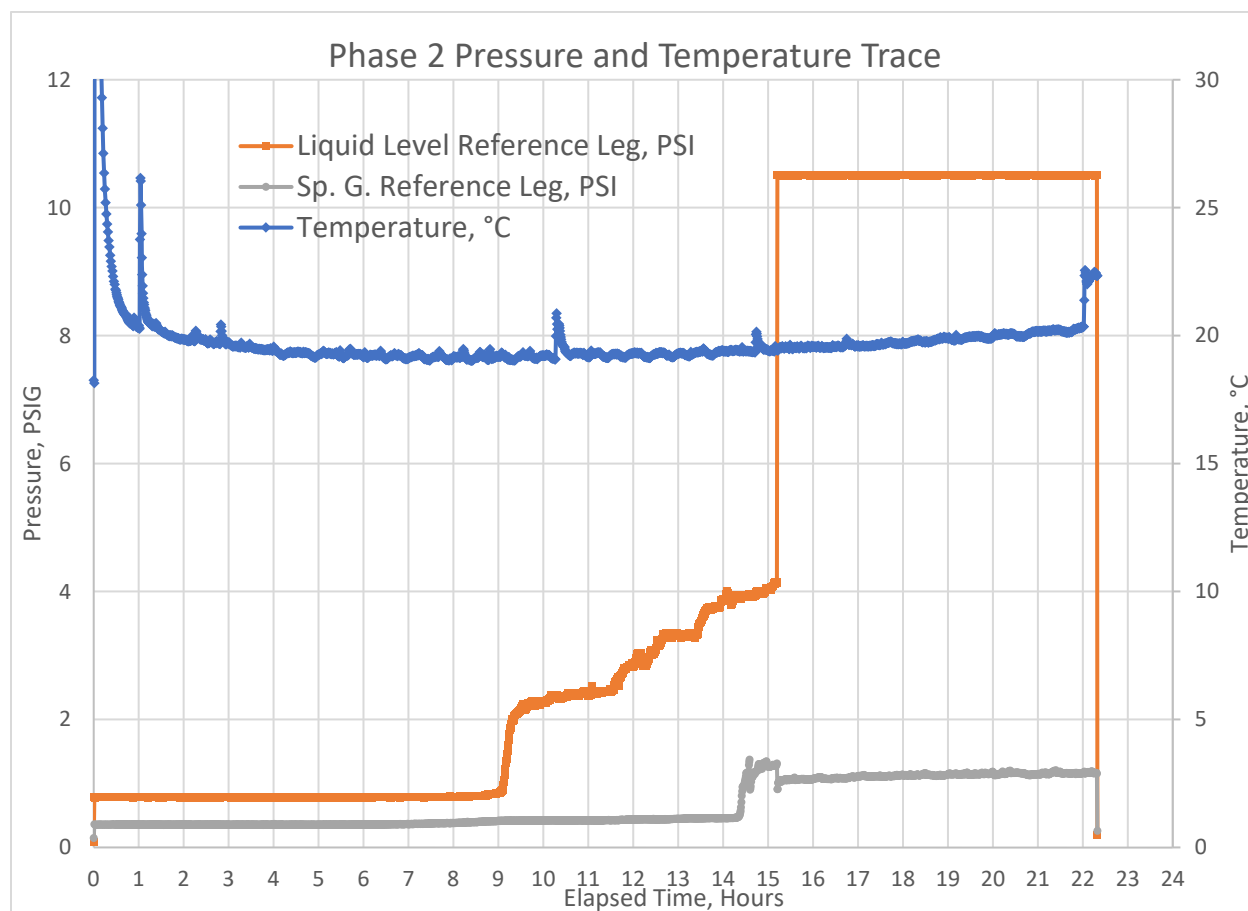
Figure 3-4. Phase 2 Pressure and Temperature Trace.

Because plug formation was occurring during both Phase 1 and 2 testing (as the pressure spikes for Phase 2 shown below in Figure 3-4), the solubility chart for Phase 2 testing (lasting less than 15 hours until full plugging) is the same Figure 3-3.

The large jump in the pressure readings for the liquid level reference leg (Figure 3-4) occurred because that leg had plugged overnight, and the corresponding flow rate had dropped to almost zero. When the flow rate was re-established to 7 SCFH, the pressure reading went above 10.5 psig as indicated. The 10.5 psig indication was the full range of the Rosemount, and so any pressures above 10.5 psig are recorded as 10.5 psig. The Sp. G. leg was beginning to re-form a plug, but testing was halted before the Sp. G. dip leg was given time to fully plug. The test was stopped when the liquid level reference leg became fully plugged.

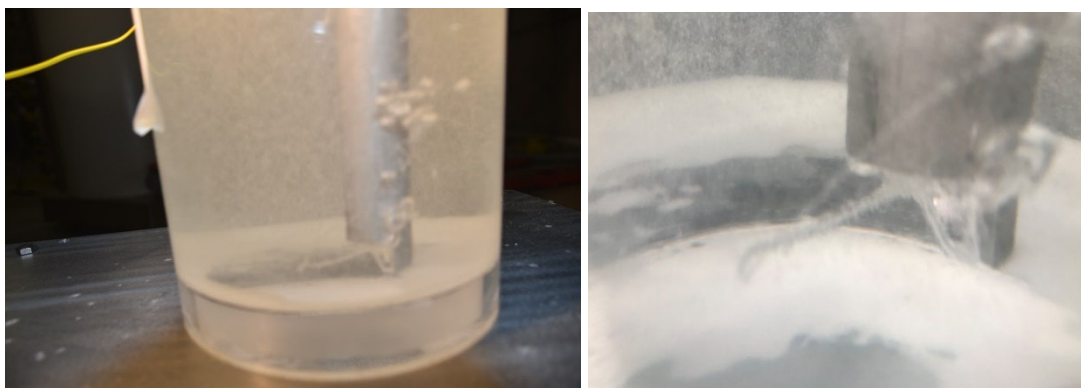
Figure 3-5. Liquid Level Reference Leg Plugging while Operating.

During the plugging, photos were taken to document the plugging dynamics. Figure 3-5 is a picture of the formed plug on the bottom of the liquid level reference leg while still operating. Air is emanating from the hollow spindles, which appear to be randomly formed “air tunneling” crystals of the aluminum nitrate. This shows the ability of aluminum nitrate crystals to bridge out into open spaces under testing conditions. The picture shows three major hollow spindles bubbling air.

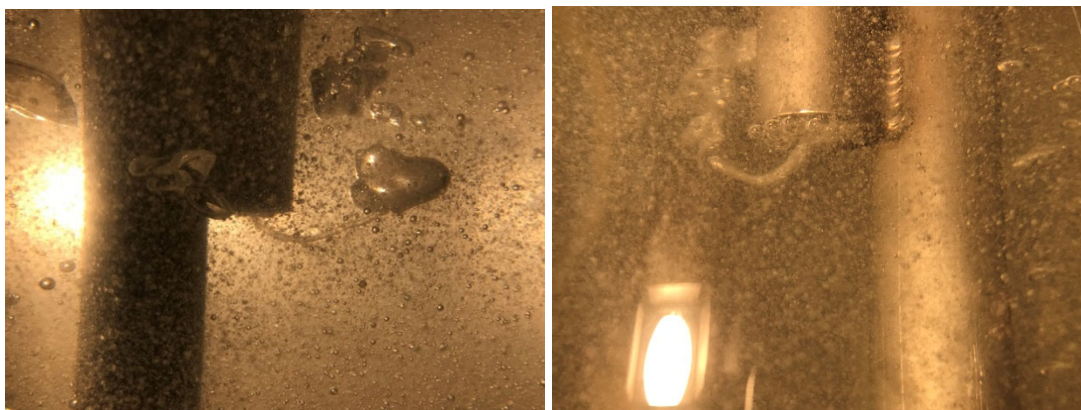
Figure 3-6. Sp. G. Reference Leg Plugging while Operating.

Plugging on the Sp. G. reference leg while operating was also documented through pictures as shown in Figure 3-6.

As the solids built up in the bottom of the dip legs, bubbling was continuously observed. The air continued to “tunnel” through areas of crystallized aluminum nitrate, creating pathways for air flow.

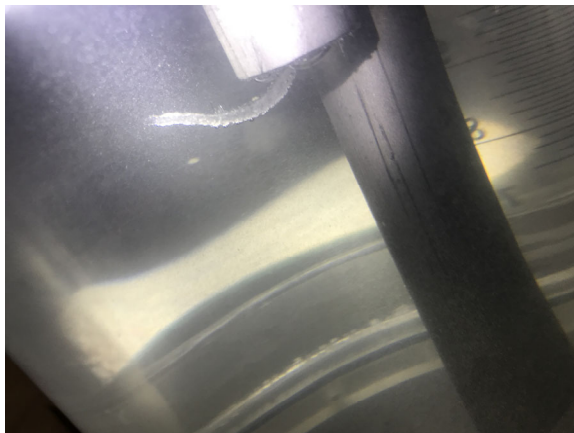
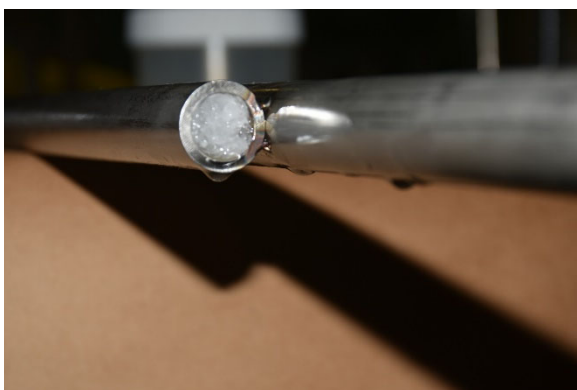
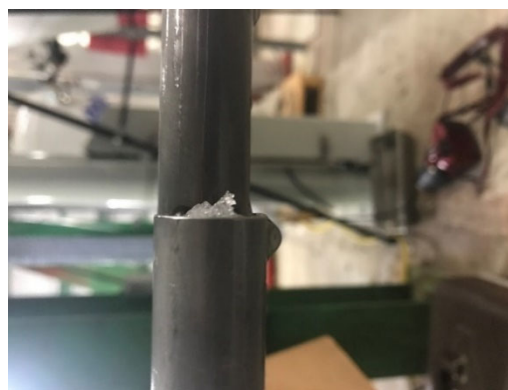
Figure 3-7. Sp. G. Reference Leg Plugging Closeups.

Unique Spindle formation of aluminum nitrate solids in Sp. G. Leg

Sp G plug just prior to mechanical removal (Spindle redissolved)

The photos indicate that the short period of time from removal from service (air flow stopped) and dip leg removal from the tank allowed sufficient time for the spindle tunnels to re-dissolve in the bulk liquid, while the main plug remained.

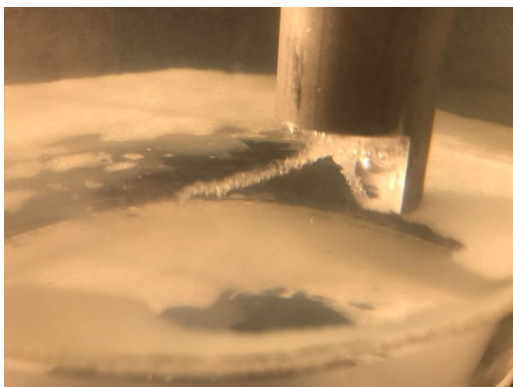
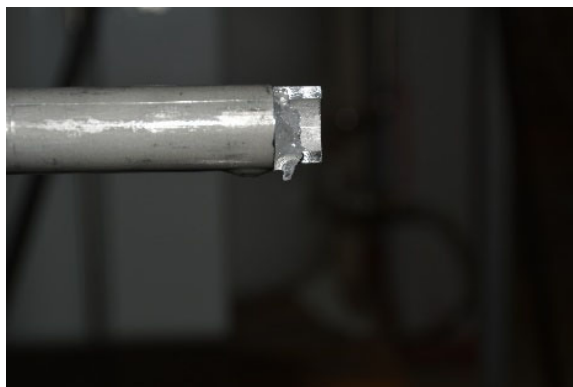
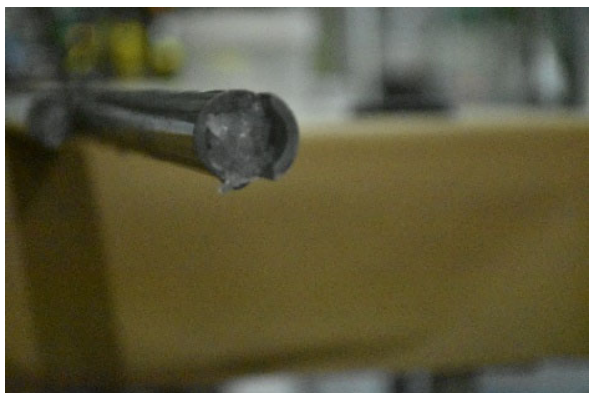
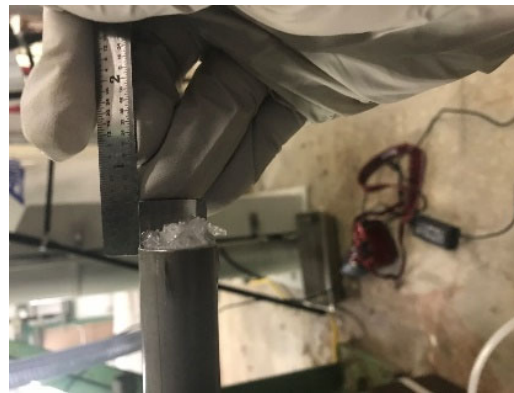
Figure 3-8. Liquid Level Reference Leg Plugging Closeups.

Spindle formation prior to leg removal (LL)

Spindle formation redissolved prior to cleaning (LL)

End view of liquid level plug prior to cleaning

Plug height with ruler for scale (LL)

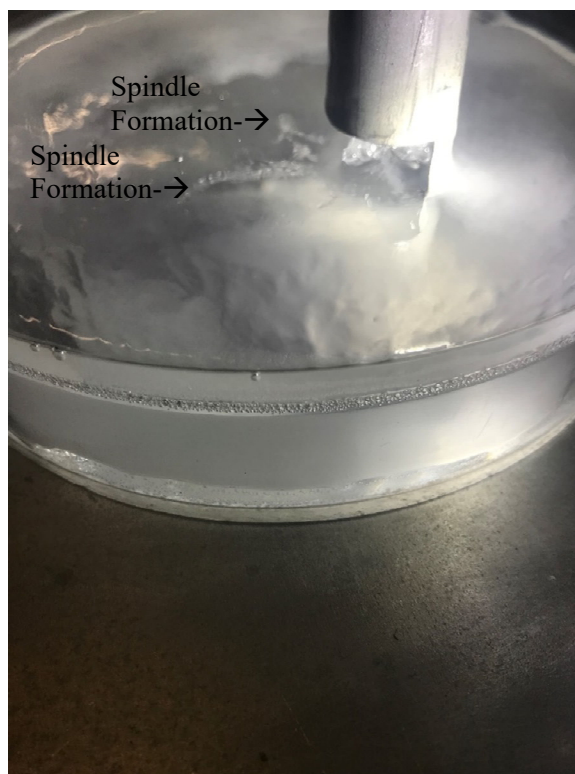
Figure 3-9. Liquid Level Reference Leg Spidering Photo.

A photo was taken of the liquid level reference leg bottom plug while the leg was in the tank after the tank was emptied (Figure 3-9). The photo shows remnants of the spidering/spindling of aluminum nitrate crystals prior to final dissolution when the leg was removed from the empty tank.

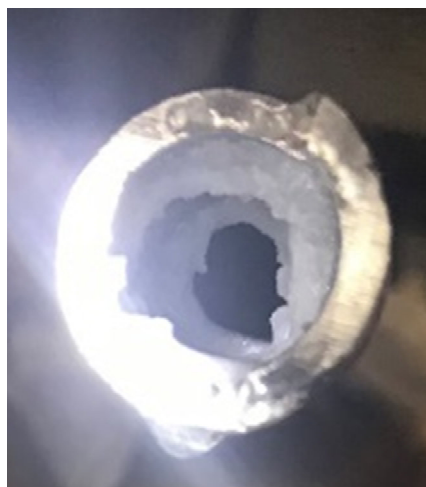
Finally, both legs showed the creation of solid aluminum nitrate up to $\frac{3}{4}$ in. thick (across full $\frac{1}{2}$ in. sch. 40 ID), with additional deposits of crystallized aluminum nitrate up to 3 inches axially from their respective exits as shown in Figure 3-10.

Figure 3-10. Spiraling Crystallization of Aluminum Nitrate in Liquid Level Reference Leg after removing the full diameter end plug.

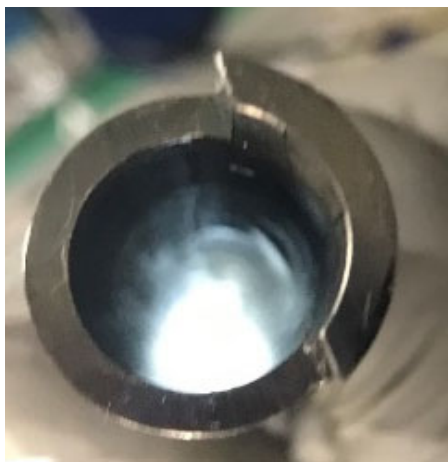
Figure 3-11. Post Cleaning Liquid Level Reference Leg.

The plug removal required significant effort. The bottom of the plug formed a hockey puck-shaped solid plug, approximately $\frac{1}{2}$ in. thick that had the consistency of rock candy. Removal efforts required some impact loading on a cold chisel. After repeating impacts, the bottom plugs broke free and revealed the spiraling shown in Figure 3-10. This spiraling required significant scraping to remove. Once the plug was removed, the dip legs were cleaned with Alcanox® and hot water. Pictures of the cleaned state are shown in Figure 3-11.

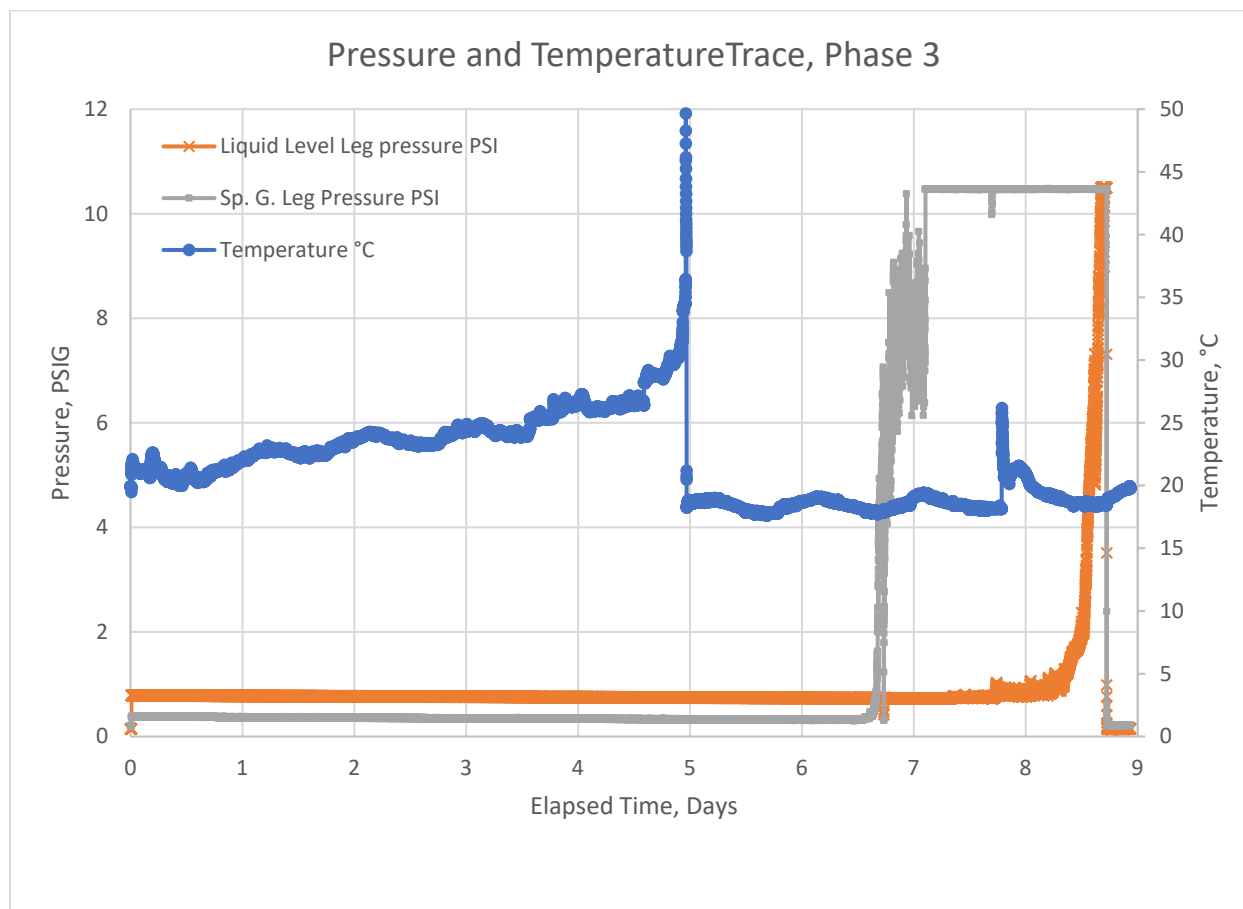
Figure 3-13. Pressure and Temperature Trace, Phase 3.

The Sp. G. leg plugged first, with the plugging occurring within 45 minutes from the first increase in pressure indication at the nozzle. The observed trend suggests that the Sp. G. leg tends to form a plug prior to the LL dip tube (see following paragraph for discussion). The liquid level dip leg (bottom leg) plugged approximately 35 hours later, with the first indications of increase in pressure 24 hours after the Sp. G. leg plugged. The liquid level plug formed more slowly, taking approximately 10 hours for an identical increase in differential pressure as demonstrated by the Sp. G. leg plugging dynamics (3/4 hours versus 10 hours to plug, see Figure 3-13). As the liquid level leg was forming a plug, there was an almost full day of slight pressure increases indicating the pending full plug to form. No pictures were taken, nor video inspections performed during Phase 3 testing. The intent of Phase 3 testing was to keep testing ongoing during the concurrent redesign of the nozzles proceeded forward, and possibly observe any new phenomenon associated with plugging.

The thermocouple readings were observed to be drifting on day 4, and indicated instrument failure; therefore, the thermocouple was replaced at the beginning of the 5th day. This is shown in the precipitous drop off in readings on day 5 (Figure 3-13).

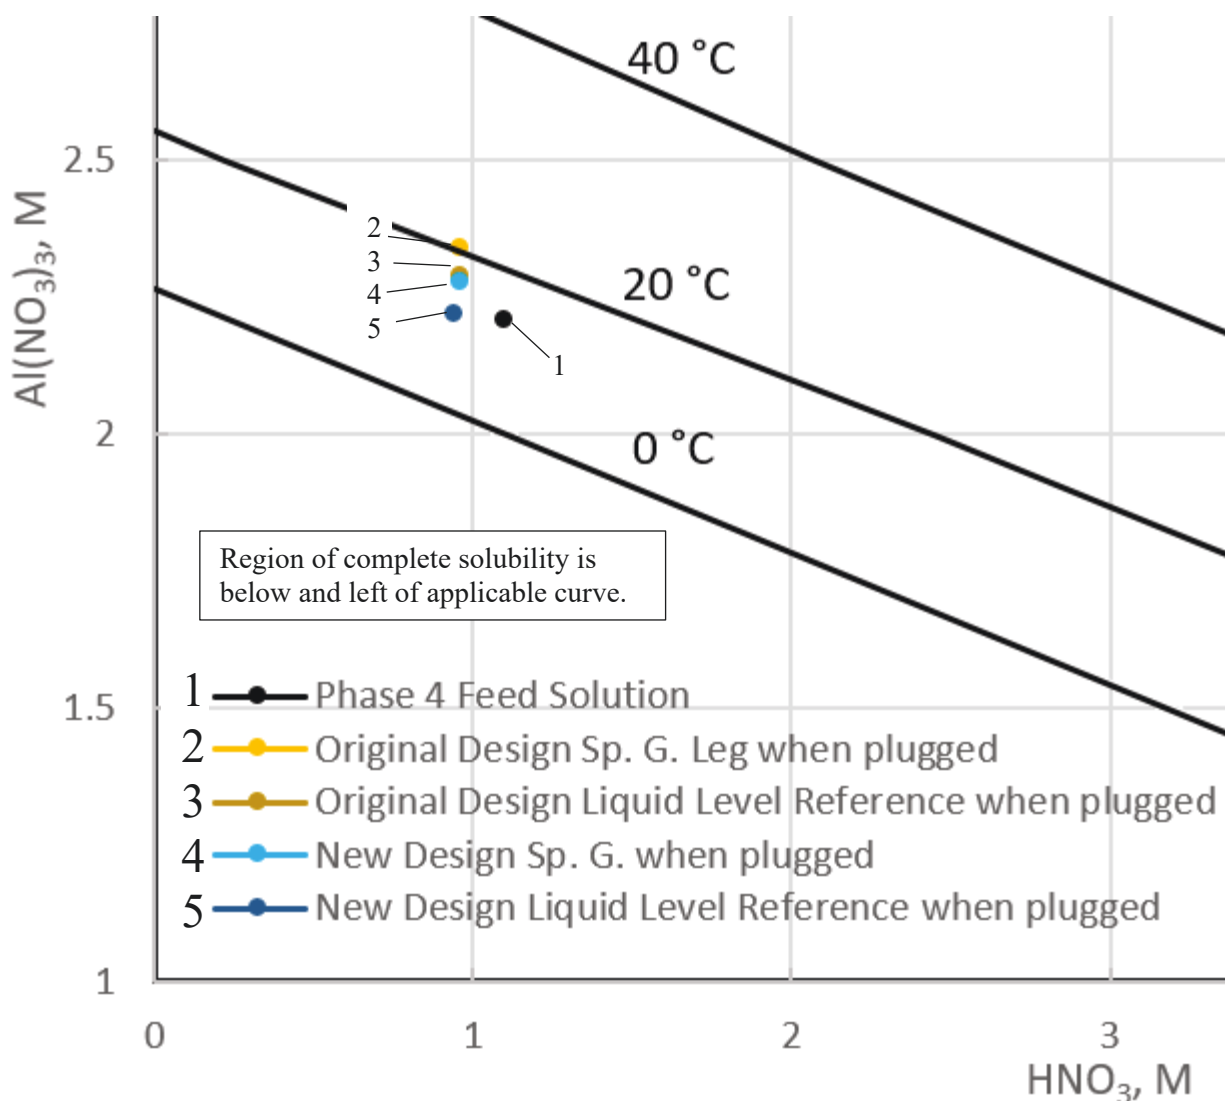
Figure 3-15 . Phase 4 Feed Solution and Final Solutions.

Feed solution and the final solutions at each of the four plugging times are shown in Figure 3-15 .

As shown, the feed was purposely prepared to be closer to the solubility limits of the solution to expedite plug forming. As each leg plugged, a sample of the solution was taken and analyzed. Because testing was performed at or below 20 °C, the solution can be seen below solubility limits, the 20°C line being clearly demarcated. The temperature of testing was below the requirements of the TTR but was agreed upon by the customer. The variations in aluminum nitrate molarity fall within analytical tolerances.

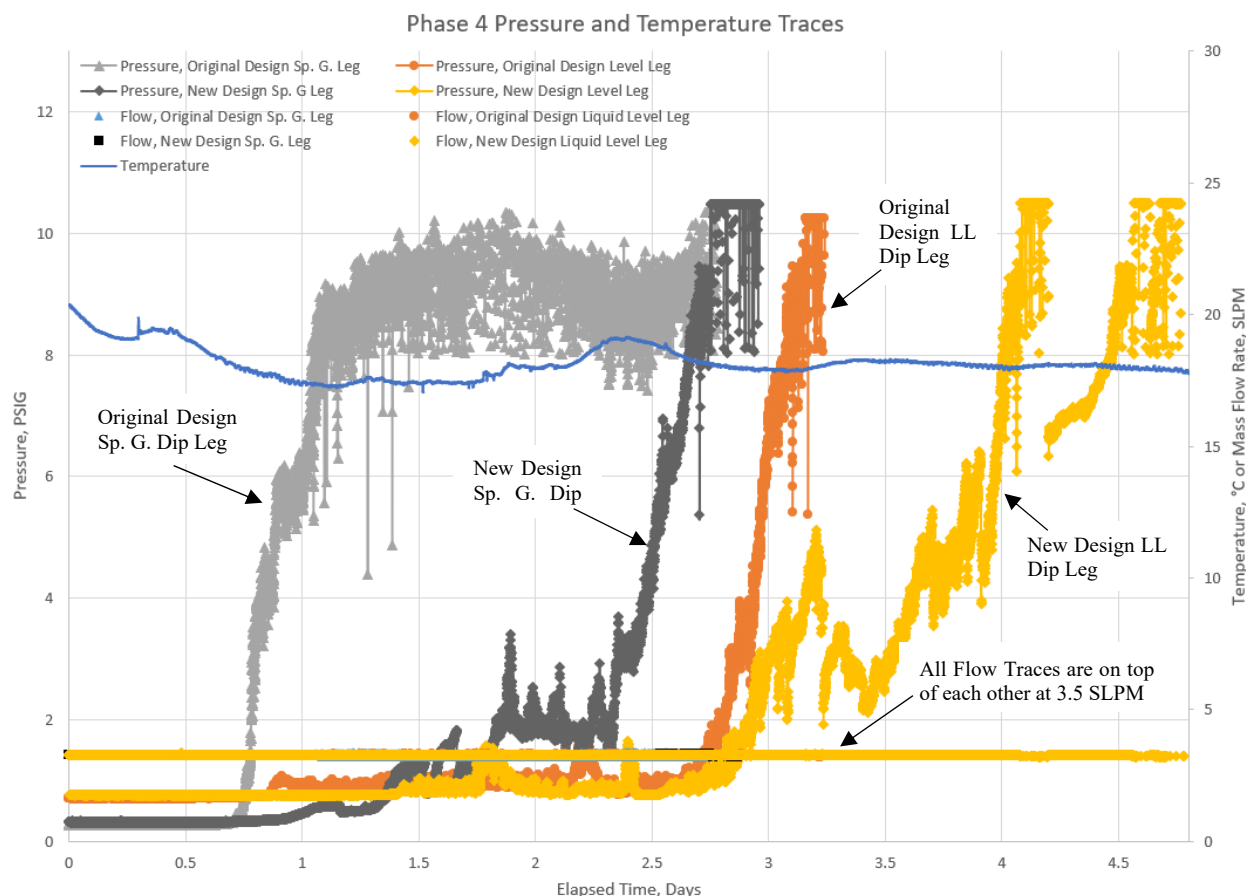
Figure 3-16. Phase 4 Pressure and Temperature Trace.

The temperature and pressure traces for Phase 4 testing are shown in Figure 3-16.

Because plugs were not dislodged significant fluctuations of pressure occurred once plugging caused a greater than 9 psig pressure. The 9 psig pressure was chosen because it was just below the full range of the pressure transducers. The period of these fluctuations was approximately 1 minute. Data were removed to eliminate fluctuation-

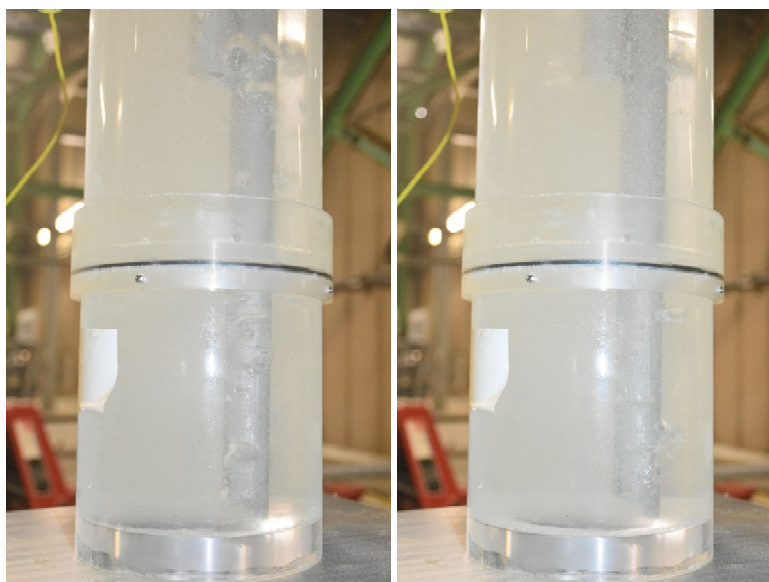
Figure 3-17. Typical Time Lapse Photography Results.

The time lapse photography proved little benefit overall to documenting the plug formation over time (See section 2.6). Two photos are shown in Figure 3-17 to demonstrate information typically obtained from the photographs. The photograph on the left was taken at 3:16 a.m. on 6/26/2020 of the Sp. G. reference leg as plugging was beginning to be indicated through pressure readings. The photo on the right is at 1:16 p.m. on the same day and was the first photo of sufficient clarity to visualize the nozzle discharge.

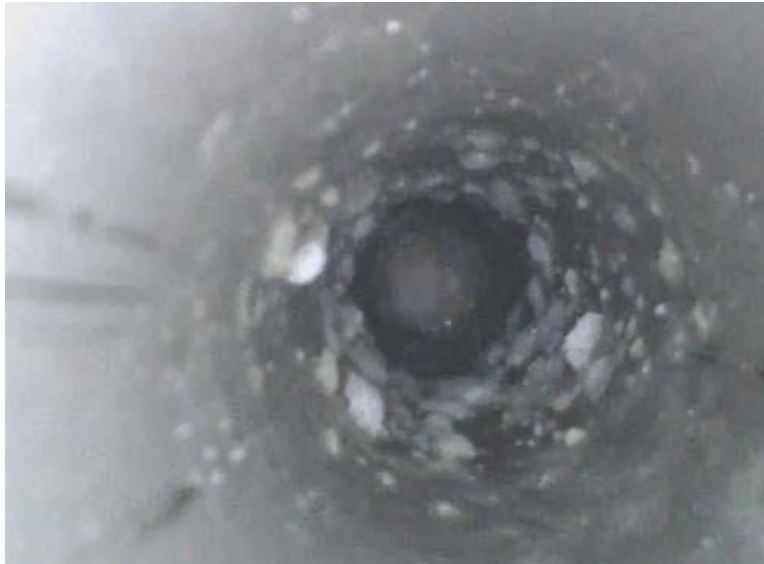
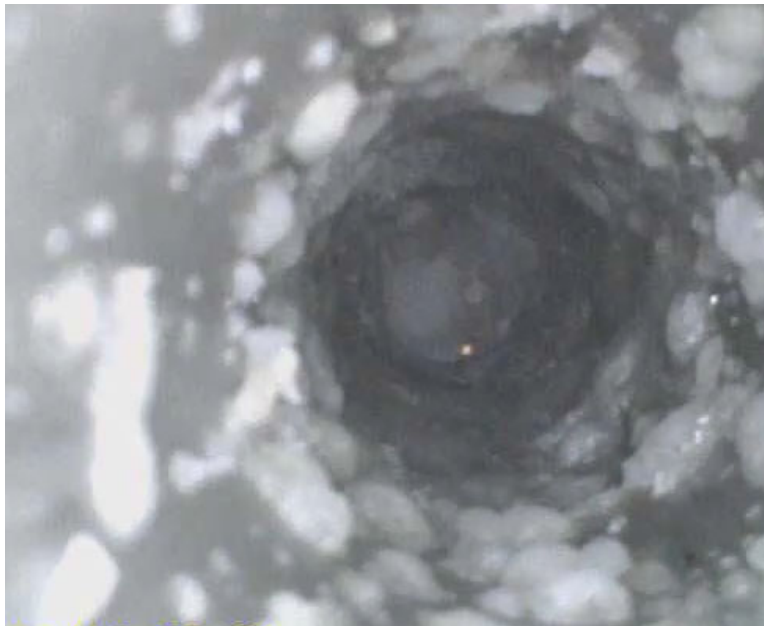
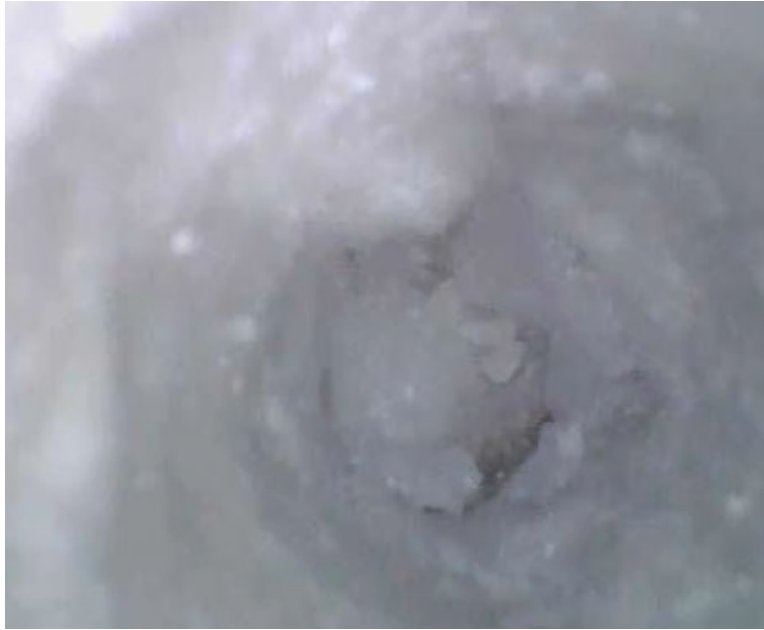
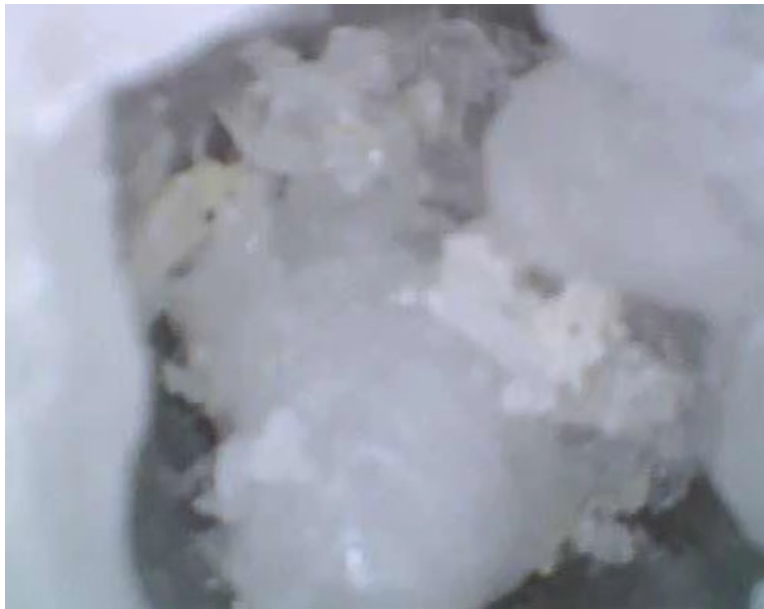
Both legs were very similar in the presentation of plug formation from the upstream side of the plugs. Several photos (Figure 3-18 through Figure 3-21) show how the crystallization process progressed. It should be noted that the liquid level for this phase of testing was approximately 4 in. above the bottom of the Sp. G. reference leg. Additionally, the testing commenced with the dip legs submersed prior to the introduction of air purging, and consequently the internal surfaces were exposed to solution prior to testing. This is atypical from plant operations, where the solution is transferred into the tank while the bubbling system is operating. The video inspection of the LL dip leg is shown in Figure 3-22. The main plug formation in the LL dip leg had re-dissolved by the time of the video inspection.

Figure 3-18. Sp. G. Reference Leg, 8 in. from Leg Discharge.

Figure 3-19. Sp. G. Reference Leg, 4 in. from Leg Discharge.

Figure 3-20. Sp. G. Reference Leg, 2 in. from Leg Discharge.

Figure 3-21. Sp. G. Reference Leg, Closeup of Backside of Plug.

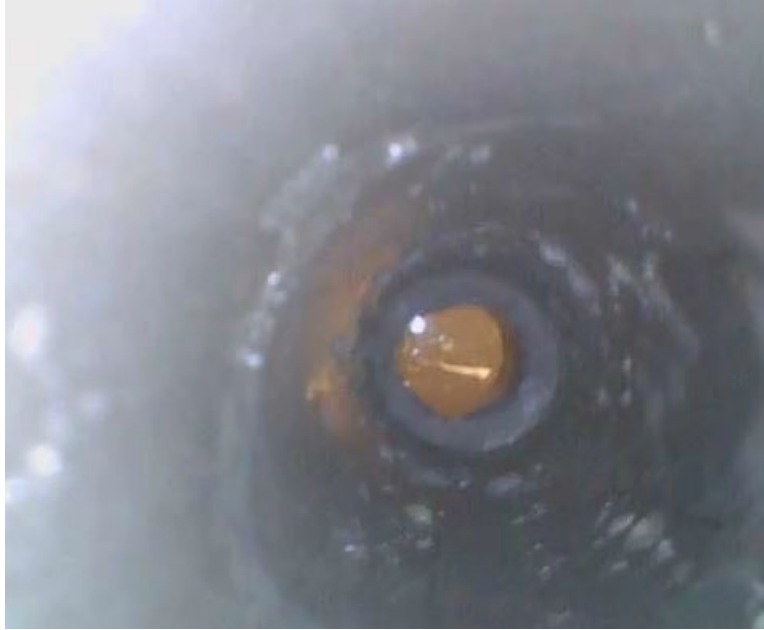
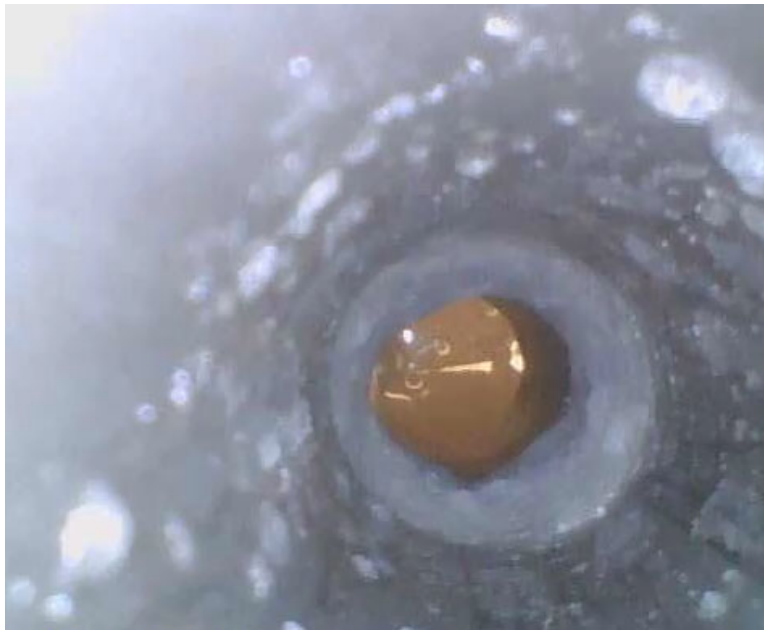
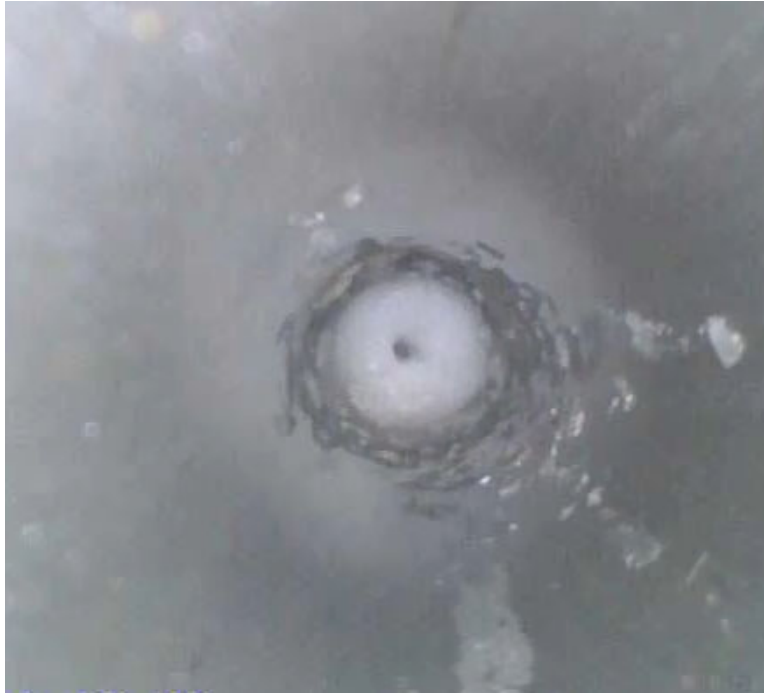
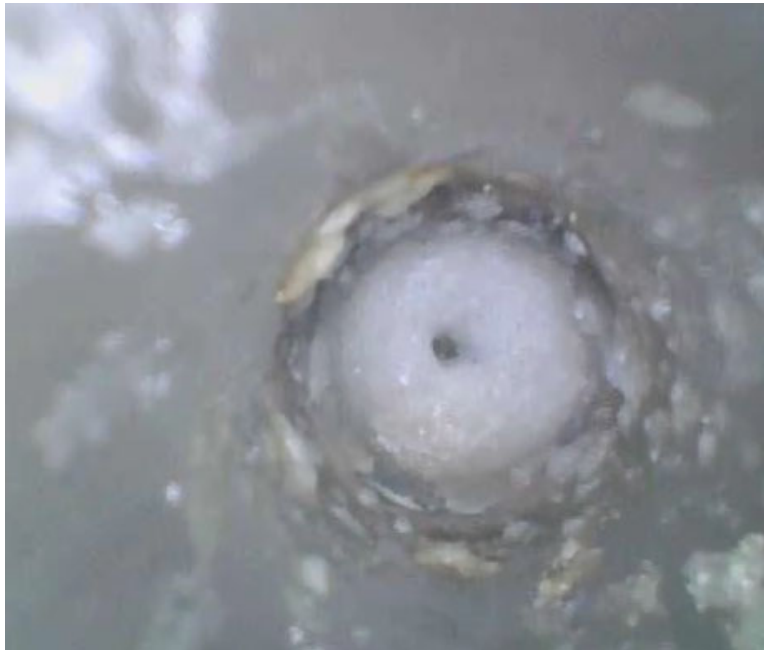
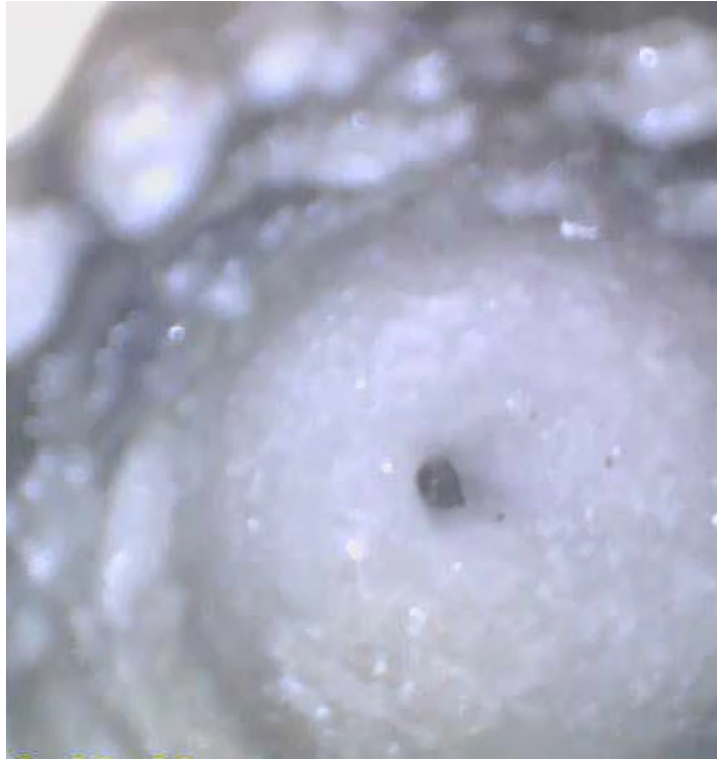
Below in Figure 3-23 through Figure 3-27 are screen shots taken from the endoscope video inspection with descriptions.

Figure 3-23. Original Design Sp. G. Reference Leg, 8 in. from Discharge.

Figure 3-24. Original Design Sp. G. Reference Leg, 2 in. from Discharge.

Figure 3-25. New Design Sp. G. Reference Leg, 8 in. from Discharge.

Figure 3-26. New Design Sp. G. Reference Leg, 3 in. from Discharge.

Figure 3-27. New Design Sp. G. Reference Leg, Closeup.
