Dip Leg Plug Formation Evaluation and Abatement Testing in Support of the H- Canyon Accelerated Basin De-inventory

March 2021

SRNL-STI-2020-00559, Revision 0

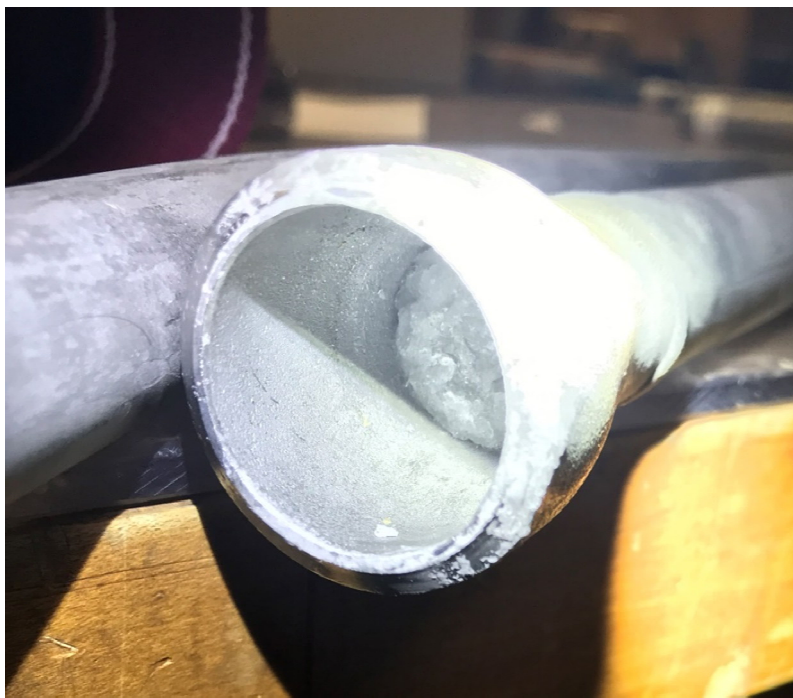
Figure 3-28. Bottom of New Design Sp. G. Reference Leg.

It is important to note that the plugging formed at the narrow section of the new Sp. G. reference leg (within $\frac{1}{2}$ in. of beginning of expansion), with the expanded section completely clear of any indications of plugging. This behavior is shown in Figure 3-28. This section was completely flooded, suggesting that a large diameter tube the full length of liquid height may be a possible solution.

As documented in reference 3, maximizing the internal diameter minimizes the tendency to bridge solids due to the larger flow area (See Figure 3-28). It should be noted that reference 3 solution was a simulant of the SRAT and SME vessels at elevated temperatures, and the mechanism of bridging may be different from the crystal formations occurring in the HCA dip legs. The canyon SSC's severely limit major design changes to the dip legs. The maximum opening through which the dip legs must be lowered by crane is 3 in. ID, and because of the nature of crane operations, this was limited to 2 ½ in. As noted in reference 3, a nested design that allowed smaller tubing to provide air to sections of larger OD nozzles provided some relief from plugging. Beginning with 2 ½ in. SCH 10 SS Pipe (2.875 in. OD) as a large diameter sheath (no additional outer piping), a design could be developed with a maximum of 1 1/2 in. SCH 40 pipe nozzles that could be located at all three locations. See Figure 5-1 below.
