Surplus Plutonium Disposition Sphincter Seal Development & Testing

D. Krementz

April 2021

SRNL-STI-2021-00008, Revision 1

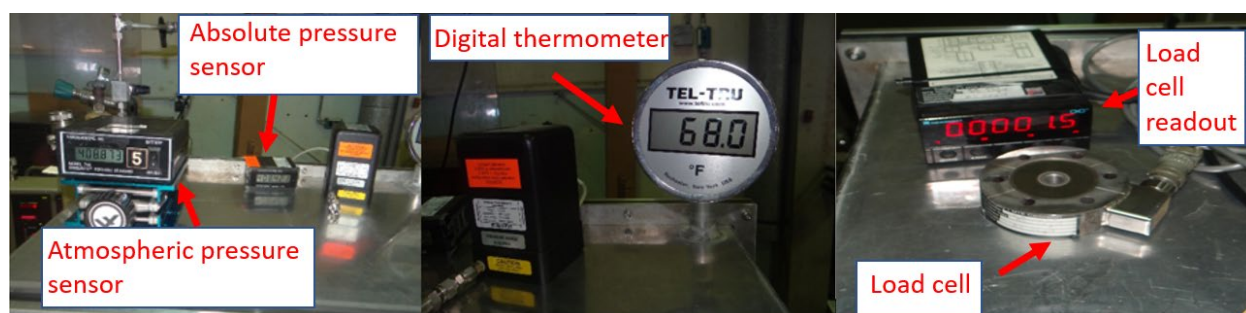
Figure 2-6. (Left): Absolute Pressure Sensors; (Middle): Digital Thermometer; (Right): Load Cell

The following sensors were used for data acquisition during testing. Each test enclosure had a digital thermometer installed on one of the ½" NPT couplings on top of the enclosure." A Paroscientific pressure sensor was used to measure the ambient atmospheric pressure and a second Paroscientific sensor was used to measure the absolute pressure inside the enclosure being tested. Load cells were also used to measure the forces required to push the cans through the sphincter seals as well as to measure the force required to replace the inner sleeve assembly. Figure 2-6 shows the primary sensors that were used.

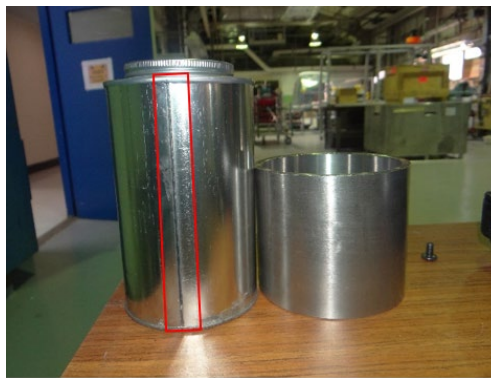
Figure 2-8. Blend Can and a Machined Shield Can

For these tests, both blend cans and shield cans were to be tested. Blend cans, including the threaded top cap, were 6.75" tall. The diameter of the cylindrical portion of the can ranged from 3.89" to 3.91". Two lips at the top and bottom of the blend can had a slightly bigger diameter than the can's base diameter. A seam on the cylindrical portion of the can protruded less than 0.01" from the adjacent outer surface and it extended from the upper lip to the bottom lip of the blend can. The seam can be seen by the red rectangle on Figure 2-8. Each blend can had 4.4 lbs. (2 kgs.) of a simulated adulterant inside of it. The shield cans had an outer diameter that was 4.50" and the height of the shield cans was 3.84". Two variations of shield cans were tested, a welded version made from pipe and a machined version made from bar stock. The machined variant of the can was made from 4.5" diameter 304 stainless bar stock. The welded variant of the shield can was made from 4" 304 stainless steel pipe with a recessed plug welded inside the pipe to form a bottom. The outer diameter (OD) surface of both shield can variants was left in an as received condition and was not modified to improve the surface finish of the commercial bar stock or/pipe. Both variations were evaluated for surface roughness, with the machined can being smoother by having an average Ra value of 67.1 μin and the welded cans having an average Ra value of 104.73 μin .

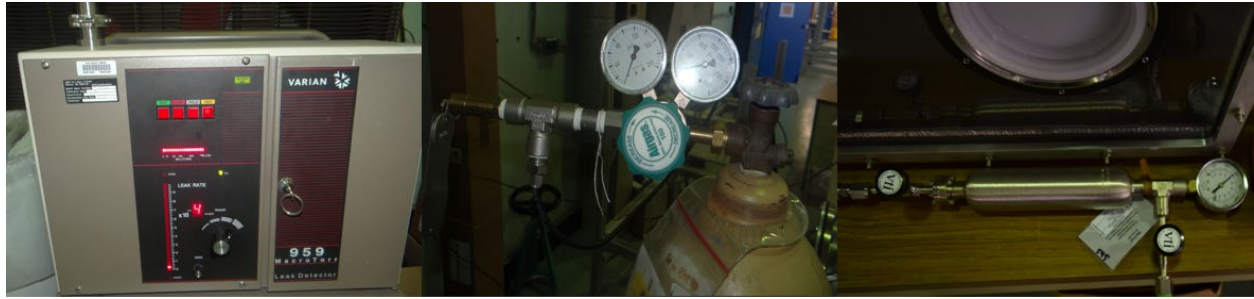
Figure 2-10. (Left): Helium MSLD; (Middle): Helium Cylinder and Pressure Regulator; (Right): Calibrated Leak Standard

The Helium leak test utilized a Mass Spectrometer Leak Detector (MSLD) that had a sensitivity of at least 1×10^{-6} atm cc/sec. A calibrated Helium leak standard of 1×10^{-6} was used to calibrate the MSLD. The MSLD was then set to detect Helium leaks of 1×10^{-4} atm cc/sec, or greater, in order to trigger the correct response. A calibrated leak standard of 1×10^{-4} atm cc/sec Helium was used during testing to confirm the MSLD was properly calibrated.

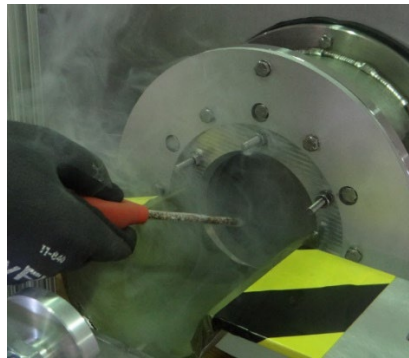
Figure 2-13. Smoke Testing

Smoke testing is a qualitative method used to locate leaks by using Draeger smoke tubes that produce a neutral buoyancy smoke. Smoke testing was done with cans installed in the sphincter seals and under a vacuum of at least -1" wc. Testing was done prior to durability testing, and then after every cycle of 1,100 cans that passed through the seal during the durability testing. This was done to determine if any sphincter seal leaks existed, and if so where they had developed. Smoke testing was performed based on the SRNL glovebox structural integrity evaluation procedure [8] and the 235-F Enclosure Integrity Program [9]. Both procedures state that smoke should be applied at 1 inch per second along the evaluation points, this equates to approximately 12 to 15 seconds of smoke application for the sphincter seals. Smoke testing will be used by the SPD Project to qualify the production sphincter seals and was the test method recommended by the glovebox experts for this type of transfer system. For these reasons, the smoke test was selected as the acceptance test for the sphincter seals. The acceptance criterion for the smoke test is no visible disturbance of smoke indicating entry into the sphincter seal, and no presence of smoke in the test enclosure after the prescribed application. For the blend can sphincter seal assembly, smoke testing was performed twice at each inspection, once with the seam oriented down (6 o'clock position) and once with the seam oriented up (12 o'clock position).

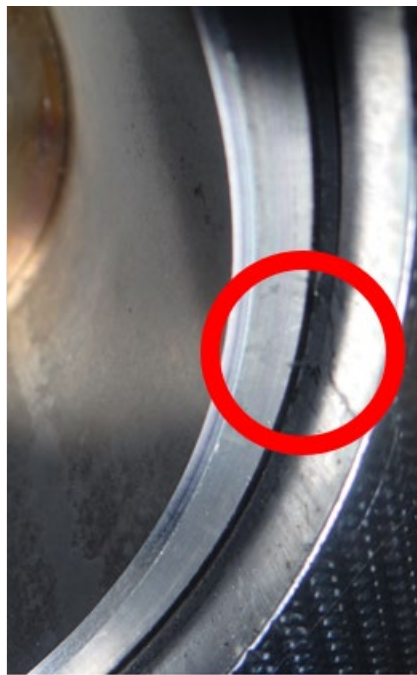
Figure 3-3. End Cap Sealing Interference

It was observed that the last seal on both assemblies caused interference with the tapered section of the end cap of the sphincter seals as depicted on Figure 3-3. The modified end cap spacer decreased the length between the taper of the end cap and the last seal. This caused the shield can to be misaligned and potentially could have created additional leak paths. Both sphincter seal end caps were modified by increasing the bore length before the tapered section on the end cap piece. It was also observed the end cap gaskets on both assemblies created interference internally and externally when torqued. It would interact with the blend can when the blend can was inserted as well as created additional disturbance when placed inside the outer sleeve. It was determined that the outer diameter and inner diameter on both end cap gaskets needed to be reduced. The threaded rods extend out of the lock cap which could present a safety hazard. Counterboring the lock cap for the nuts to be threaded against the counterbores would reduce how far the threaded rods extend past the lock cap. Cutting the threaded rods flush with the nuts after assembly and initial leak testing would also eliminate the hazard. If the modification requires the threaded rods to extend slightly past the lock cap surface, acorn nuts or rubber boots will be installed over the rod ends. Another modification that will be implemented is removal of the chamfer on the glovebox end of the outer sleeve to make a smaller path for Plutonium oxide to migrate between the inner and outer sleeve.

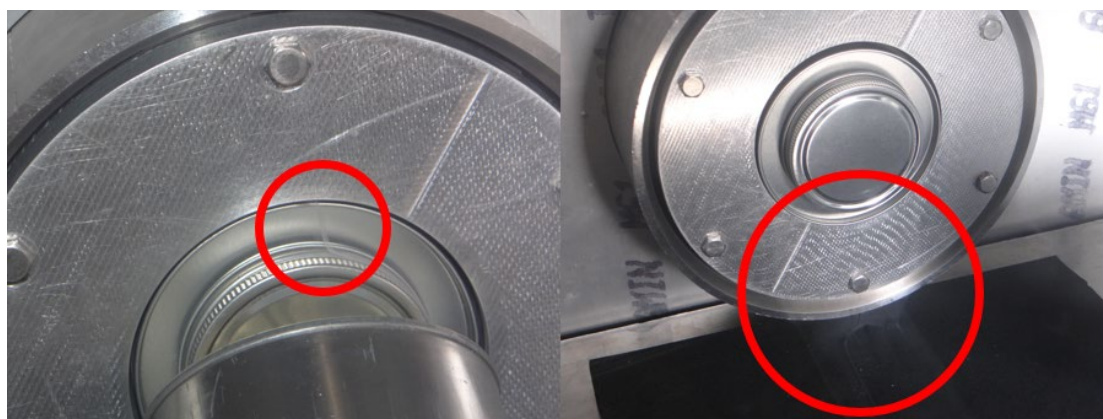
Figure 3-5. (Left): Subtle Smoke Around Seam Location (Up) with 3.14” ID Sample Set; (Right): Visible Smoke Around Seam Location (Down) with 3.30” ID Sample Set

Figure 3-5 demonstrates how a failed smoke test looks if smoke was applied significantly longer than what the smoke test procedure prescribed. The location of the seam dictated the leak path of the smoke travelling through the sphincter seal. The reduced diameter seals produced barely visible smoke when tested longer than the time limit, which can be seen on the left portion of Figure 3-5. The right portion of Figure 3-5 shows visible smoke on the 3.30” ID (default sized) seals when the seam was oriented downwards.

The 3.14” ID and 50A sample set was utilized for blend can testing. Subtle smoke was observed after 1 minute and 47 seconds when the seam was oriented up in the blend can sphincter seal. In a separate test, smoke was observed after 3 minutes and 14 seconds when the seam was oriented down. Testing was continued in this configuration because it did not require a high amount of force to push cans and provided subtle smoke if tested for more than the required time constraint of 12 to 15 seconds. Table 3-4 shows the leak rates, notes, smoke tests, temperature difference, and configurations that were tested. The numbers in parenthesis in the gage pressure column represent the absolute pressures. Towards the end of testing, it was advised that bar code stickers would be applied to the outside diameter of the shield and blend cans before

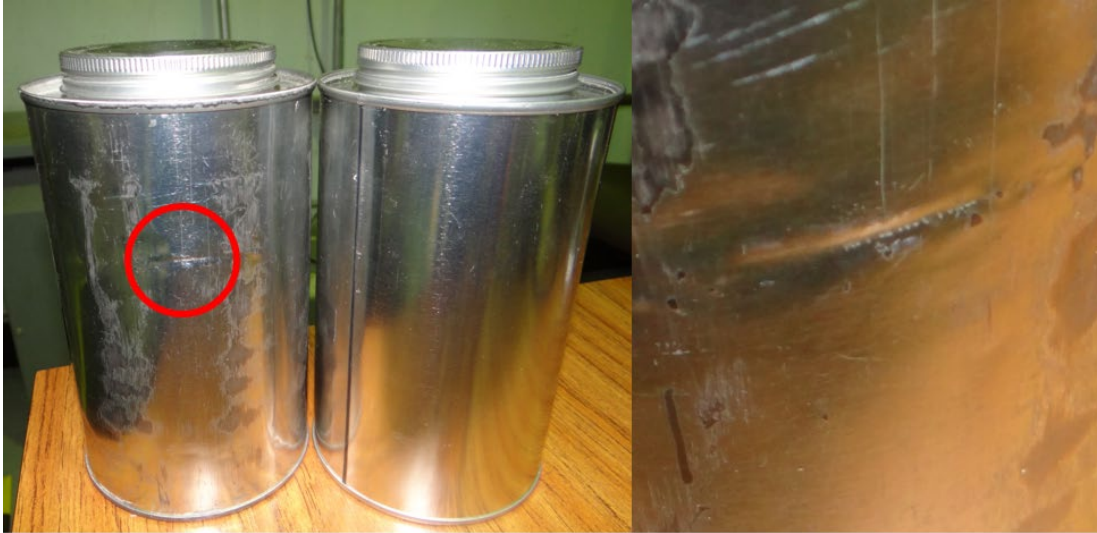
Figure 3-7. Comparison of Blend Cans

One of the blend cans that was used during testing acquired a dent during durability testing. It did not negatively affect the rate-of-rise tests and smoke tests. The dent did not create a leak path when smoke tested. Figure 3-7 compares the dented blend can that was processed 2200 times to a blend can that was not used during durability testing. The red circle on the left blend can shows the dent that occurred during testing and it was also observed that the thin lacquer coating on the dented blend can was starting to wear down. The right portion of Figure 3-7 is a close-up of the dent, which depicts a depth that was less than 0.010”.

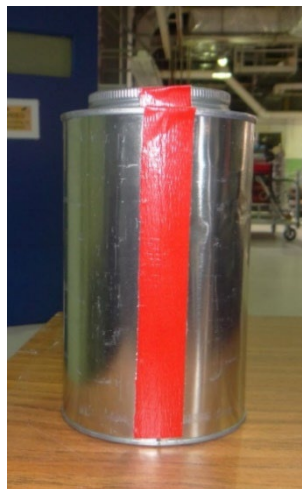
Figure 3-8. Nuclear Grade Tape on Blend Can Seam

The application of tape along the blend can seam was done to observe if it can smoothen the discontinuity of the seam and thus improve the leak rate. It should be noted that one end of the tape was folded into a tab for easy removal once inside the glovebox. Table 3-5 shows the different tapes that were applied to blend cans and the smoke test results. The clear packing tape did not create a leak path which was determined by applying smoke for 5 minutes and monitoring for leaks. The taped can passed the smoke test twice, once with the seam up and once with the seam down on two blend cans. The nuclear grade tape (Figure 3-8), performed the worst amongst the different types of tape. This was due to the textured surface of the nuclear grade tape.

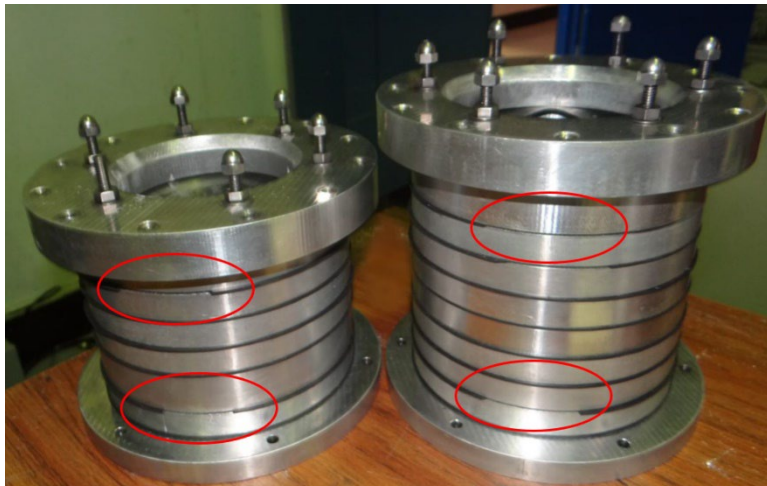
Figure 5-2. Sphincter Seal Assemblies Torque Test

First the inner seals' compression was measured while being torqued. This was done by torquing the assemblies without the inner sleeves constraining them. The recommended compression range for neoprene gaskets is between 16-30%. For the blend can sphincter seal, this range was achieved when the assembly was torqued to a range of 35 ± 3 in. lbs. and the shield can sphincter seal achieved this compression range when it was torqued to 25 ± 3 in. lbs. After achieving the desired seal compression, it was noted that the sphincter seals protruded outside the OD of the spacers. The blend can inner seals protruded past the spacer OD by up to .17" and the shield can seal protruded up to .125". Both the shield can and blend inner seals were then trimmed and the ODs were reduced in the final drawings. Figure 5-2 displays both sphincter seal assemblies torqued down without the inner sleeves. The red circles show the seals that were cut so their compression could be measured while being torqued.
