## Performance of Vapor Corrosion Inhibitors for Localized Corrosion Mitigation of Double Shell Storage Tanks at Hanford

**Pavan Shukla, Roderick Fuentes and Bruce Wiersma  
Savannah River National Laboratory (SRNL)**

*CORROSION 2021*

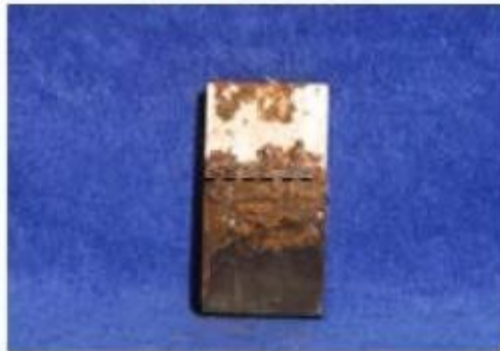
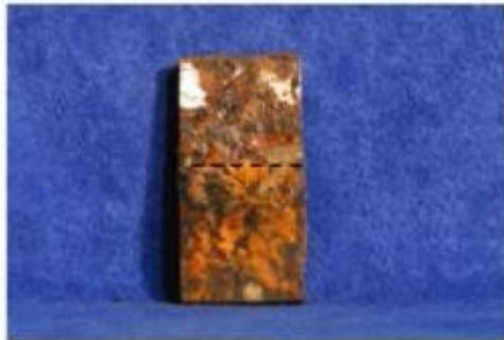
GW 50% immersion

2 months

4 months

**Sample immersed in  
groundwater (GW)  
pH=7.6**

- Testing using LDP and GW simulants
- Carbon steel samples sustained aggressive attacks for vapor and liquid air interface
- General corrosion rates were approximately 10 mpy, more aggressive in GW.
- The corrosion can aggravate at lower pHs.
  - Lower pHs can occur due to radiolysis of nitrogen to form nitric acid.

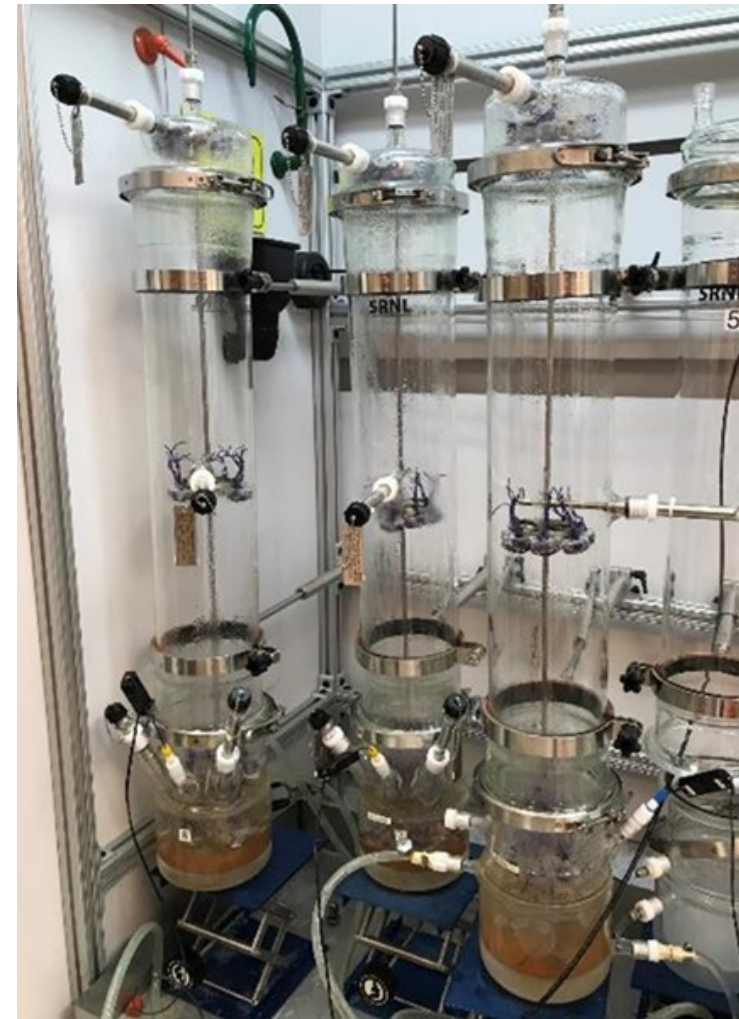
## Level 3: Top level.

- Not dipped in simulant
- Representative of region only exposed to vapor and any volatile species from the solution.

## Level 2: Intermediate level.

- Dipped in the simulant for five minutes prior to testing.
- No direct contact with solution after initial 5-minute exposure.

## Level 1: Low level.

- Dipped in the simulant prior to testing and every two weeks
- Representative of the situation when secondary liner bottom plate experienced periodic wetting/drying.

Temperature: 45 °C (GW simulant)  
Duration of testing: 6 months

Setup Image
