**Savannah River
National Laboratory®**

Hanford Double Shell Waste Tank Corrosion Studies- Final Report FY2020

SRNL-STI-2021-00142, Revision 0

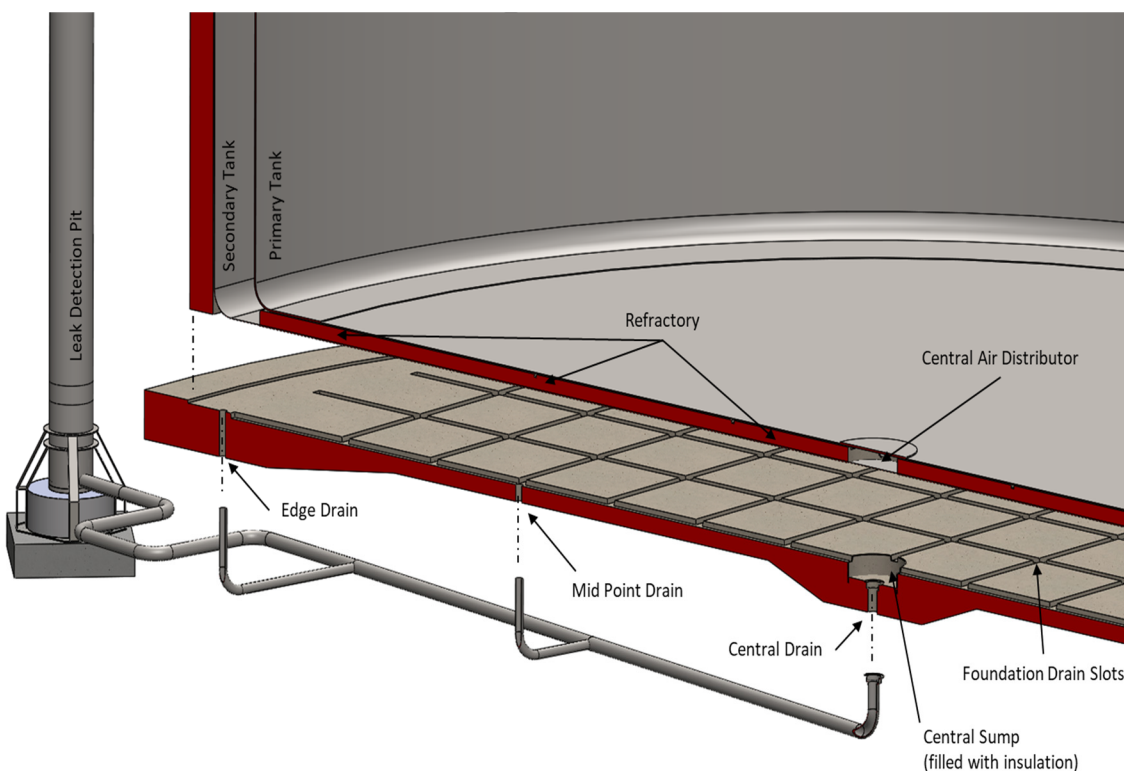
There are 27 active DSTs at the Hanford Site. Each DST consists of a primary liner (inner) surrounded by a secondary (outer) liner. The secondary liner rests on a concrete pad. A schematic diagram presented in Figure 2-1 for some DSTs (e.g., AY, AZ and SY Tank Farms), shows the concrete foundation and drain slots.

Figure 2-1 Schematic of a double shell tank depicting primary and secondary tank shells, concrete foundation, and drain slots.

Water is known to accumulate in the drain slots and may cause corrosion on the exterior of the secondary liner. Ultrasonic inspection is confined to the annular space between the primary and secondary tanks, leaving a concern that corrosion is widespread on the underside of the secondary liner bottom plate. Since the water level can vary in the drain slots based on accumulation, corrosion could be caused by direct contact with the accumulated water, or when the water level is below the underside of the tank bottom, VSC could also occur. Accumulated water is drained through the sumps into Leak Detection Pits (LDPs). The drained water was analyzed for its constituents, and two simulants were developed considering the chemical composition range of the accumulated water. The simulants were identified as LDP water and ground water (GW).

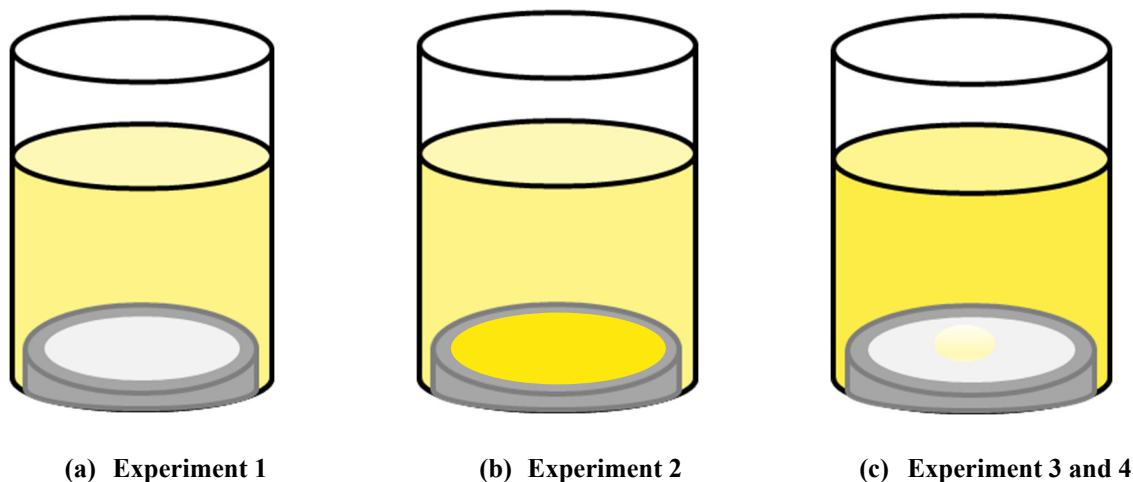
Regarding Experiments 3 and 4, an approximately 1-inch diameter glass ring was attached with silicone on the two mounted coupons. For the Experiment 3 coupon, approximately 1 g of AZ-101 evaporated salt was deposited within the glass ring. In Experiment 4, approximately 1 g of AZ-101 evaporated salt mixed with 1 g of Kaolin was deposited within the glass ring. A schematic of the four experimental setups is presented in Figure 4-1. The glass ring was kept in place after making the deposits so the deposits can stay in place for the duration of the test.

Figure 4-1. Schematic of the underdeposit corrosion tests: (a) Experiment 1, (b) Experiment 2, and (c) Experiments 3 and 4

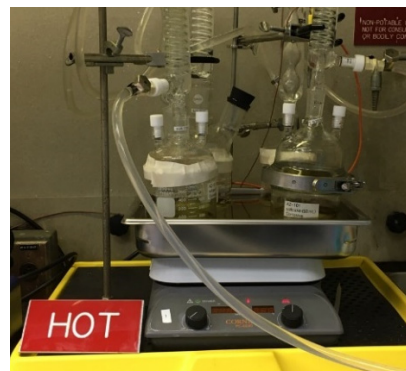
The coupons along with the simulants were placed in glass beakers. The glass beakers were covered with lids. The beakers were placed in a mineral oil-bath and its temperature was maintained such that the test solutions in each beaker was close to 70 °C. Miscellaneous images of the pre-setup and setup steps are shown in Figure 4-2. An image showing all four experiments in the mineral oil bath is also included in Figure 4-2.

(i) All four experiment setups maintained at 70 °C using the mineral oil bath

Figure 4-2. Images of experimental setup steps of underdeposit/crevice corrosion

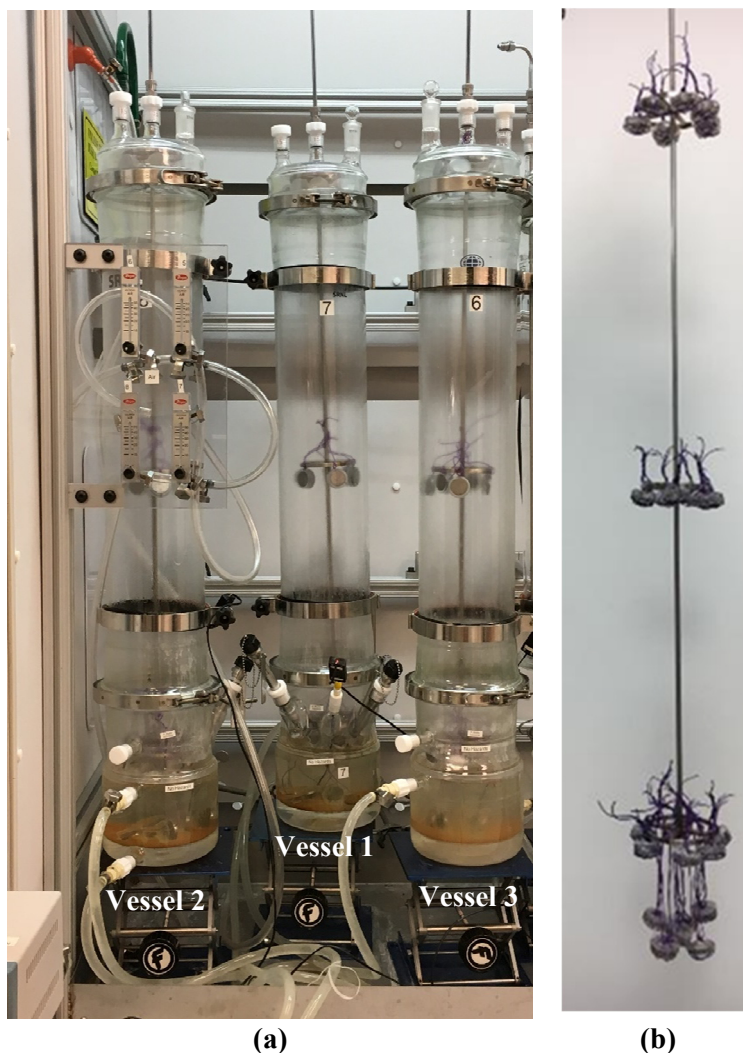
Level 3: Top or high level. This set of coupons was not exposed to the solution prior to testing. The coupons were suspended approximately 36 inches above the simulant. This level is representative of the secondary liner bottom plate region that is only exposed to the humidified air and any volatile species from the solution.

Figure 4-4 Images of the (a) experimental configuration, and (b) steel rod to suspend the coupons inside the vessel containing electrolyte.

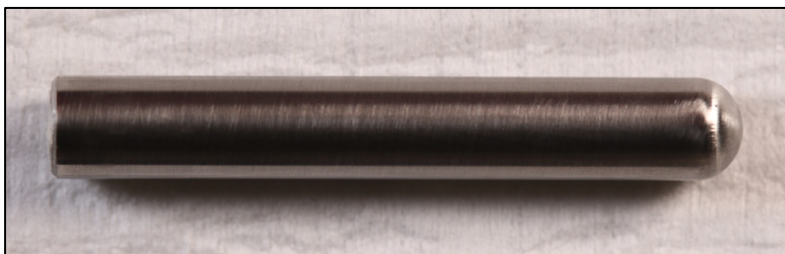
The electrochemical testing including long-term OCP measurements were performed by using electrodes in a “bullet” shape with dimensions: 0.188 inch in diameter and 1.25 inches long (Metal Samples Company part number EL-400). In Figure 4-5, an image of the sample after being polished and rinsed is shown. Before testing, a drill was used to rotate the sample and grind it to a uniform 600 grit finish. Afterwards, the sample was rinsed with distilled water and then acetone. The bullets were visually examined for any defects and to ensure that the sample had a uniform surface preparation. The sample was then attached to a stainless steel rod protected by a glass holder. A polytetrafluoroethylene (PTFE) fixture was used to prevent liquid contact with the stainless-steel rod and ensure electrical isolation.

Figure 4-5. Side view image of the “bullet” shaped coupon

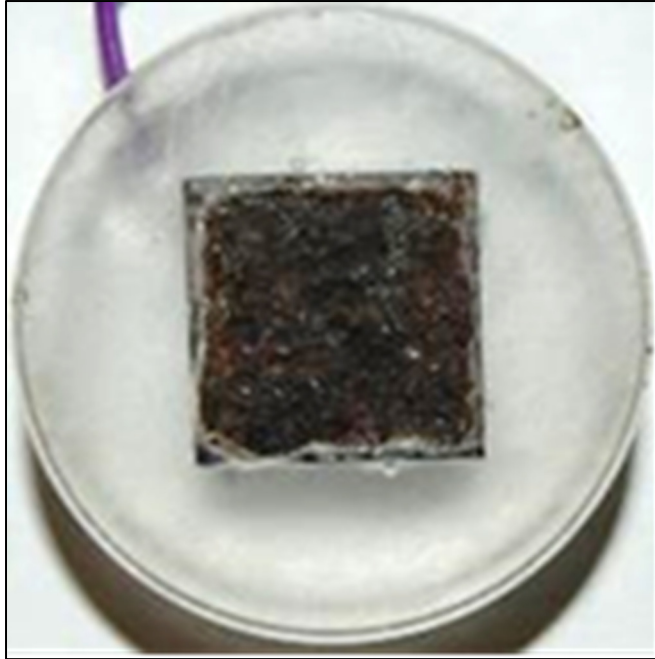
Long-term potential drift testing also involved using coupons with mill-scale and corrosion products. These coupons were fabricated by cutting 1.5 cm × 1.5 cm of AAR TC-128 metal plate with mill-scale plus corrosion products. The plate was cut using an Electrical Discharge Machine (EDM). The samples were connected to a wire for electrical connection using silver epoxy, then mounted with a two-part clear epoxy solution (EpoKwick from Buehler) so that one face of the coupon was exposed. Figure 4-6 shows an image of the mill-scale coupons used in the testing.

Figure 4-6. Image of a coupon with mill-scale used to study evolution of OCP

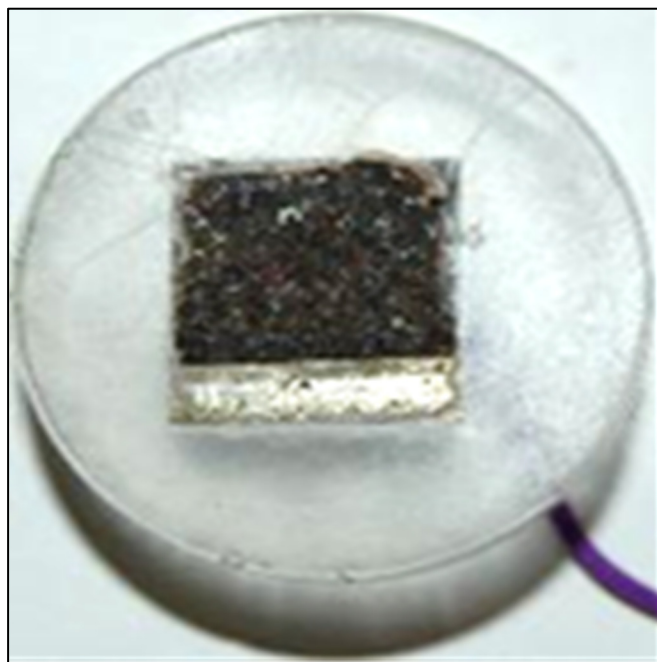
Long-term potential drift testing also involved using coupons with surfaces only partially covered with mill-scale plus corrosion products: these coupons were modified versions of the coupons with mill-scale plus corrosion products surfaces. After fabricating the mill-scale plus corrosion product coupons, approximately one fourth of the coupons' surfaces were machined to remove the mill-scale and corrosion product layers. An image of such coupon is presented in Figure 4-7; these are identified as partial mill-scale coupons.

Figure 4-7. Image of a partial mill-scale coupon used to study evolution of OCP

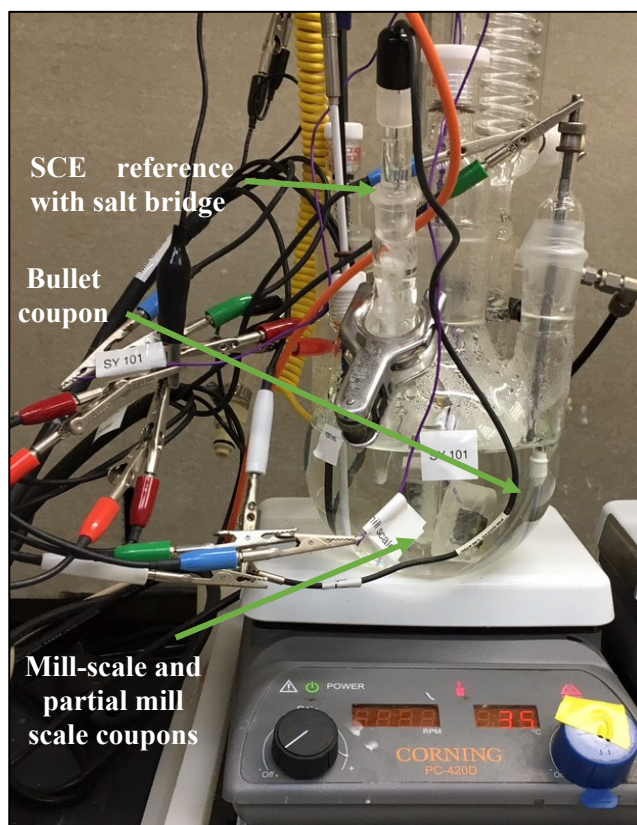
For long-term OCP drift testing, a multiplexer (Gamry) was used to obtain OCP values for each of the six coupons. Three corrosion cells were used, each with three working electrodes. OCP was measured every 10 seconds within the first week (i.e., 1-2 days) of starting the experiment and then every hour for approximately 4 months.

Figure 4-8. Image of the experimental setup used for the OCP drift experiments.

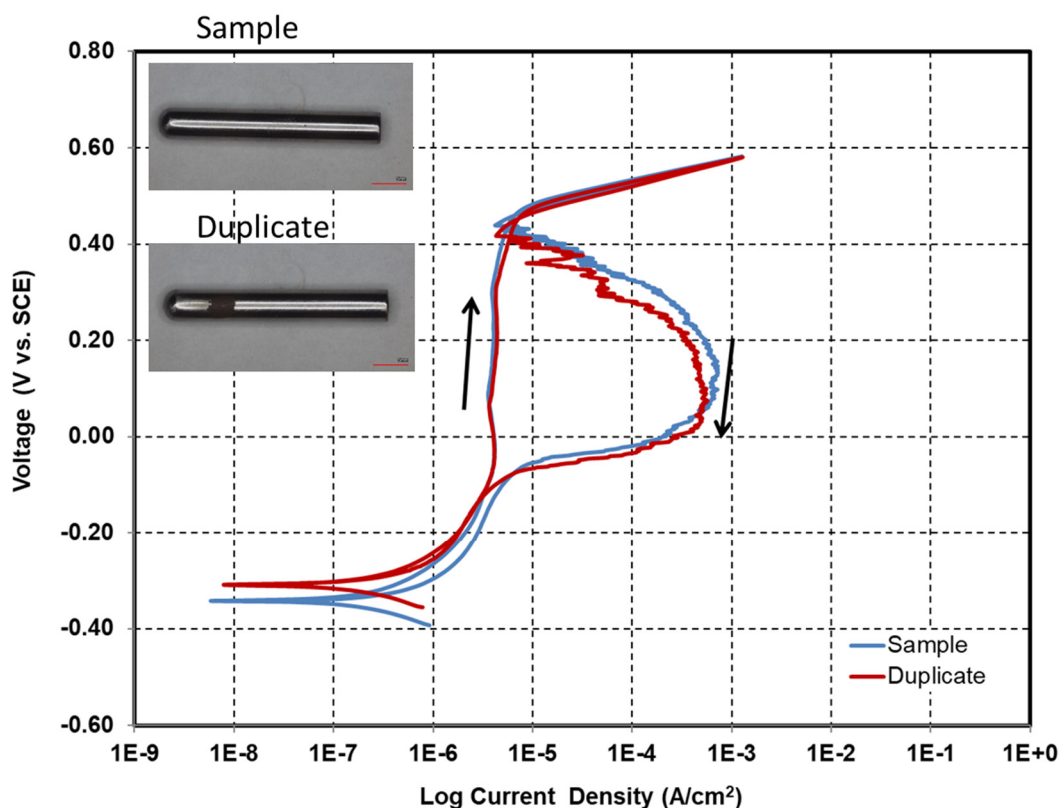
Figure 5-1. CPP results of Test 6 from High Hydroxide statistically selected chemistries matrix and, pictures of sample and duplicate bullet coupon after test [5]]

The coupons images in Figure 5-1 exhibited small pits on the shank and with a larger cluster of pits on the nose, with the duplicate displaying a large cluster of pits on the shank. The location of the pits and corroded area did not affect the CPP results, as they are similar. A recommendation was made by the TIEP corrosion sub-group to perform a potentiodynamic-potentiostatic test. The potential was scanned from the OCP in the positive direction until it reached 200 mV_{SCE}. The potentiostatic test was conducted at this potential for several hours to allow for pit initiation and growth. Figure 5-2 presents the CPP result for this test. The potentiodynamic test in Figure 5-2 (a) is similar to the CPP forward scan in Figure 5-1 up to 200 mV_{SCE}. Then, while holding the potential at 200 mV_{SCE}, a dramatic increase was observed after 25 hours with the current density reaching a maximum of 1.43 mA/cm² as seen in Figure 5-2 (b). A decrease to approximately 0.8 mA/cm² occurred after and the current remained around this value for 10 hours. Following this 10-hour period of increased current density, the current density remained low, but fluctuated slightly between 20-80 uA/cm².

The conditions for the un-reported test, which was conducted in 2018, were described in previous reports [5] as Test 6 for the High Hydroxide Matrix. No nitrite was present in the solution. The Pitting Factor (PF) for this solution was 1.95, and since the minimum required PF was 1.2, it was anticipated that a cyclic potentiodynamic polarization (CPP) curve would produce a "pass" result. However, the CPP result was a mixed hysteresis "fail" with the appearance of small pits. To further assess this case, a potentiostatic test was performed. The potential was scanned from the OCP to a potential of 200 mV vs. saturated calomel electrode (SCE). The potential was held at this value for several hours so that pit propagation on the electrode surface could be assessed. After 25 hours a dramatic increase in the current density was observed, achieving a maximum of 1.43 mA/cm² before it settled at approximately 0.8 mA/cm² for 10 hours. After that time, the current decreased dramatically to a value between 20-80 μ A/cm². This change in current is indicative of a decrease in the corrosion rate. The surface attack on the coupon was more typical of general corrosion than pitting corrosion. For the second test, 0.2 M nitrite was added to the solution, corresponding to an increase in the PF from 1.95 to 2.02. The CPP test in this solution resulted in negative hysteresis with no pits, corresponding to a pass. This means that the addition of nitrite of just 0.2 M for this dilute chemistry mitigated pitting corrosion. This test, in conjunction with other data from the test matrix, was instrumental in establishing the minimum limit for nitrite concentration as 0.2 M.

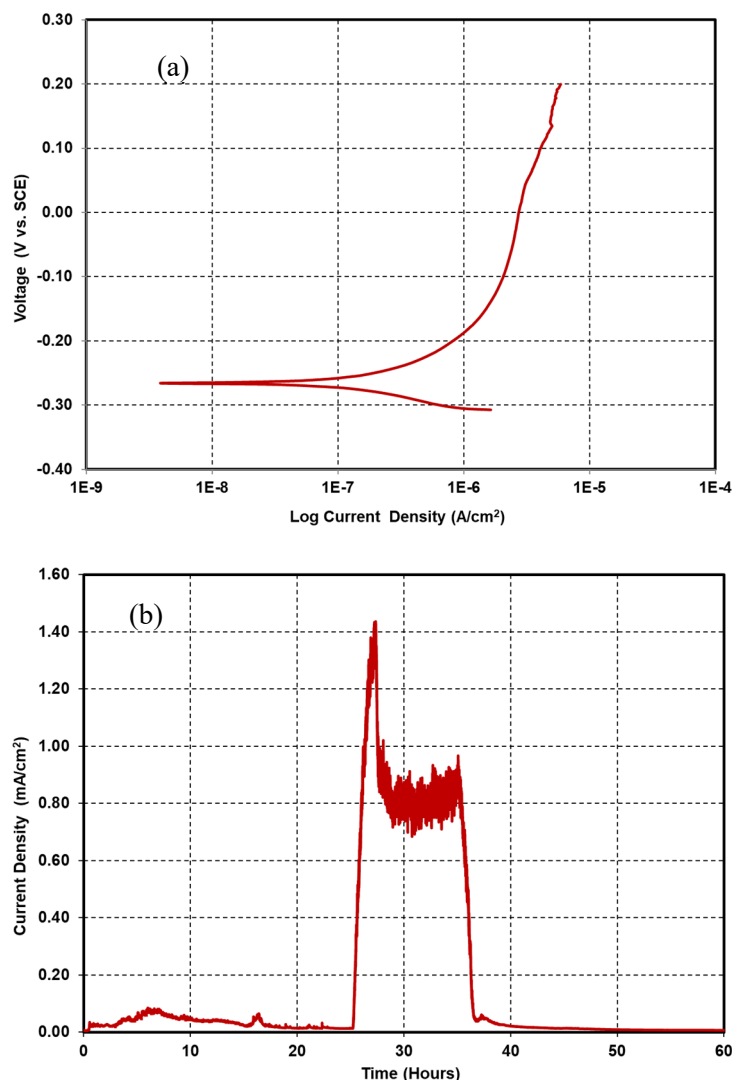
Figure 5-2. (A) Potentiodynamic, and (B) Potentiostatic hold for 60 hours of Test 6 from the high hydroxide statistically selected chemistries matrix

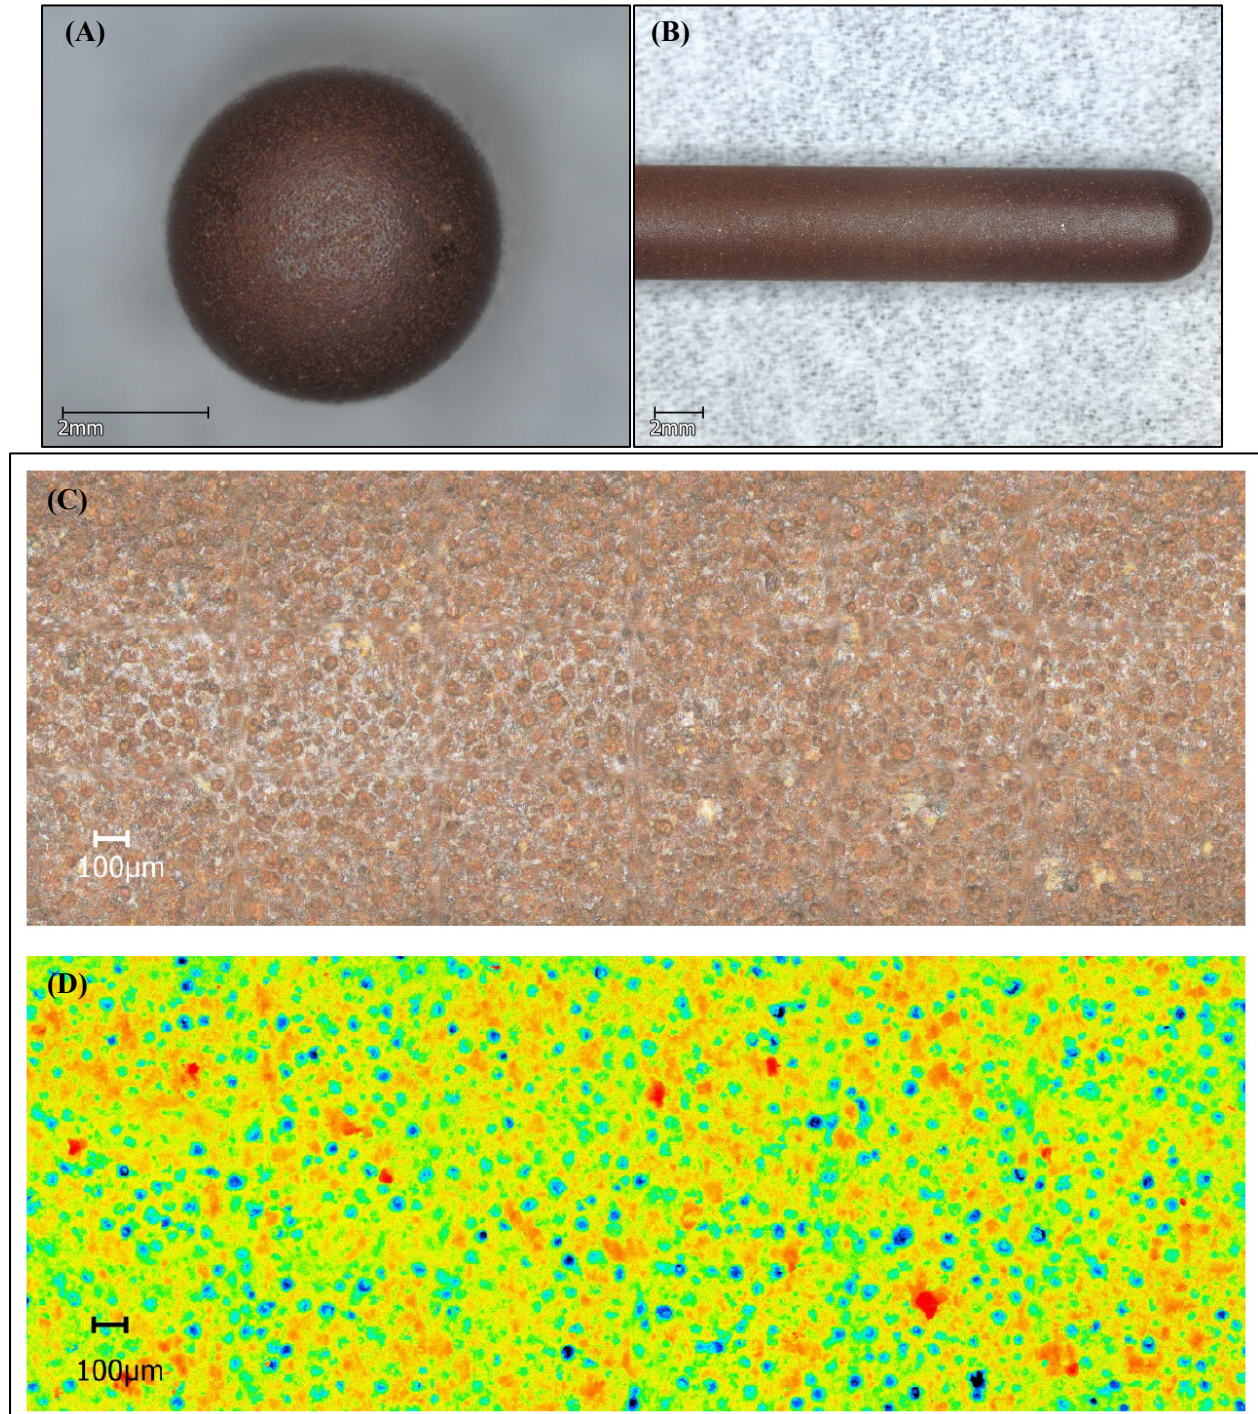
Images of the sample after the test are shown in Figure 5-3. The sample corroded uniformly with shallow pits observed in the Laser Confocal Microscope (LCM) images (C and D). It appears that there are tiny pits ($\sim 60\ \mu\text{m}$ in diameter) uniformly distributed on the surface with a maximum depth of $\sim 40\ \mu\text{m}$. The height profile with color gradation shows the relative pit depths, with blue being the deepest and yellow approximating the surface.

Figure 5-3. Images of nose (A) and shank (B) of bullet coupon. LCM image (C) and height profile of coupon (D).

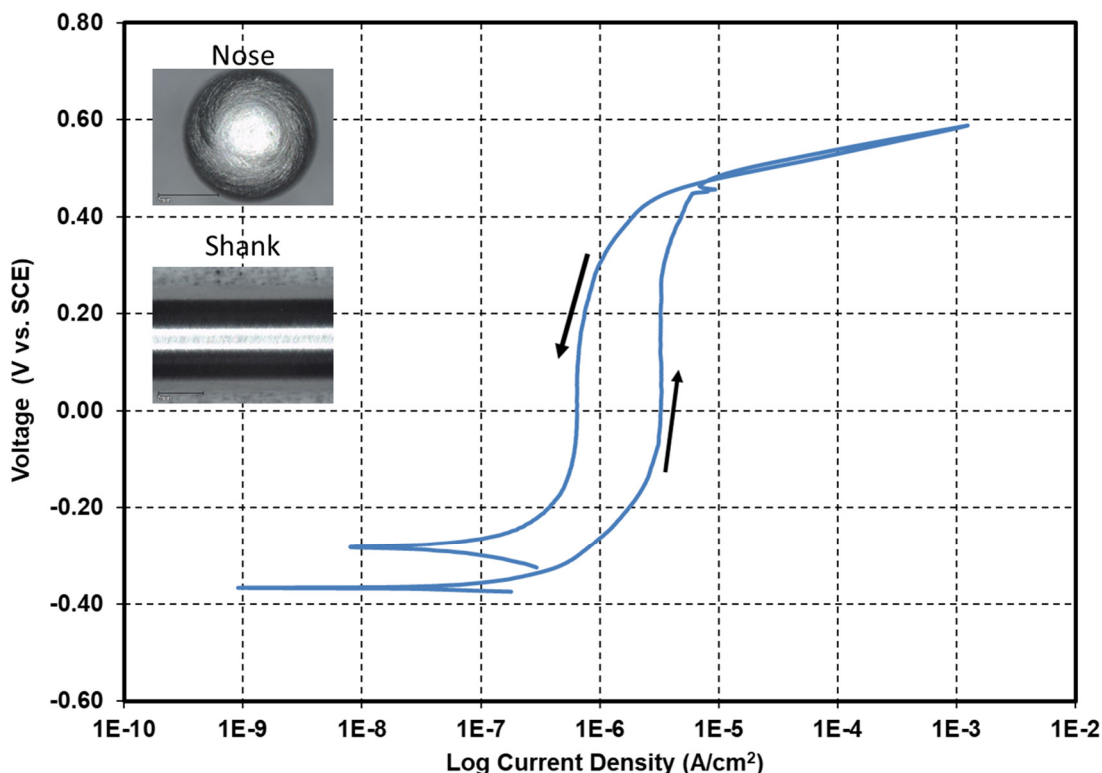
A CPP test was performed in the same solution, except that a small amount of nitrite was added (i.e., 0.2 M). Figure 5-4 shows the CPP result indicating category 1 or negative hysteresis. Thus, the presence of 0.2 M nitrite was sufficient to mitigate the pitting attack. The obtained result, in conjunction with other tests in the matrix, was used to help establish the limits for minimum nitrite concentration to be 0.2 M.

Figure 5-4. CPP results of Test 6 from High Hydroxide statistically selected chemistries matrix with 0.2 M addition of nitrite and, pictures of nose and shank of the bullet coupon after test.

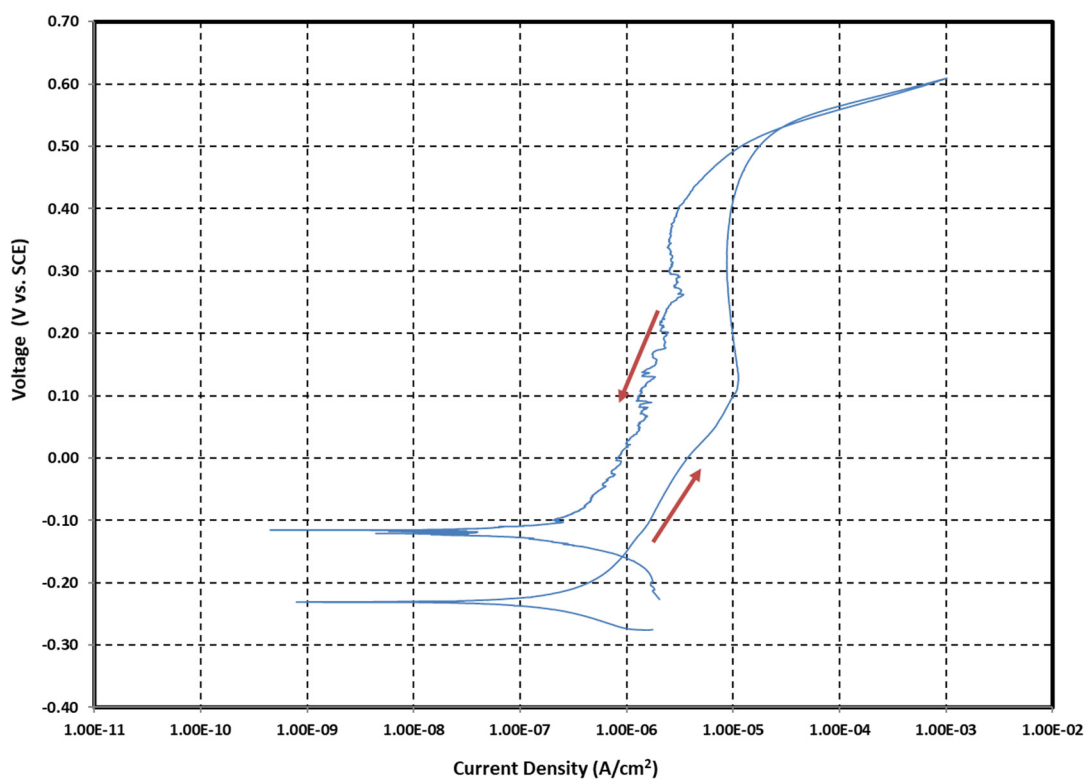
A CPP test for a bullet coupon in AZ-101 simulant is presented in Figure 5-5. As seen in the figure, the data indicate that the pitting corrosion of the coupons without deposits is not likely.

Figure 5-5. CPP curve of a bullet coupon in AZ-101 Simulant without deposits

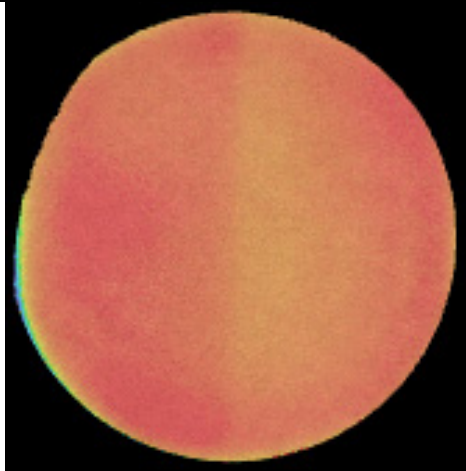
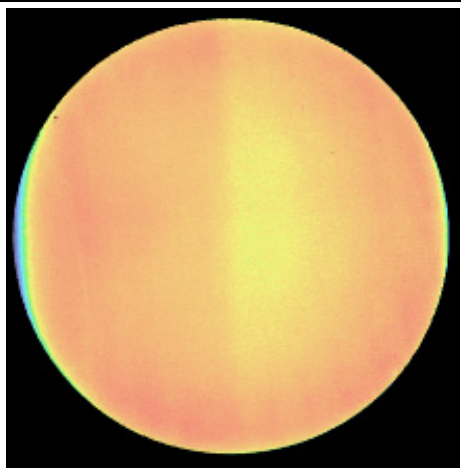
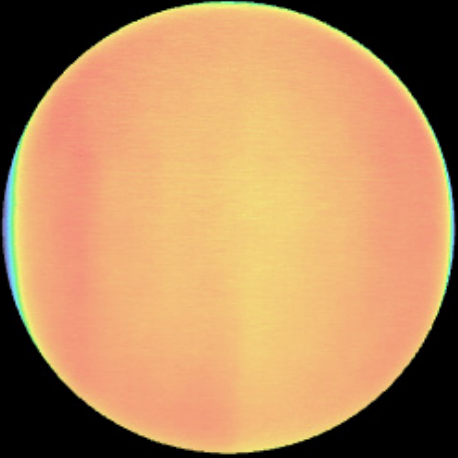
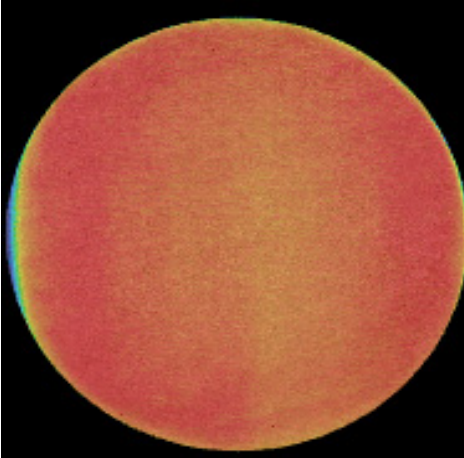
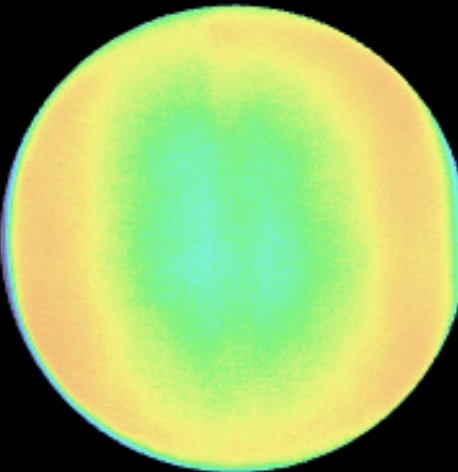
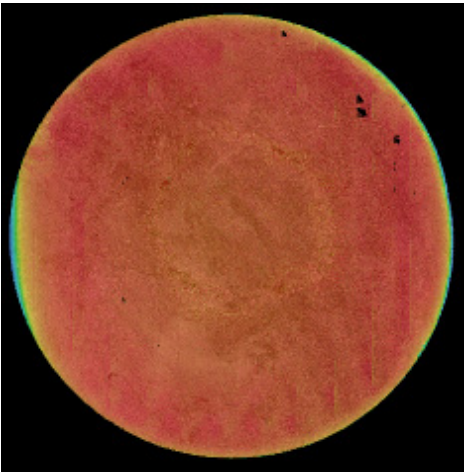
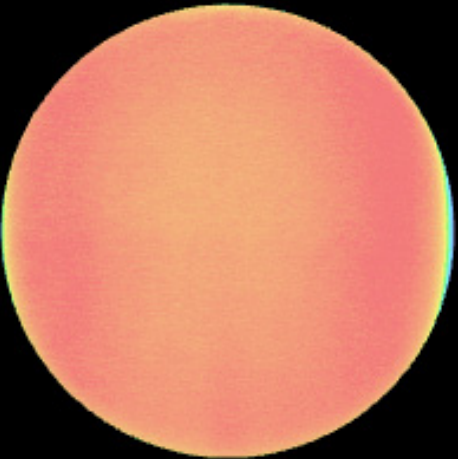
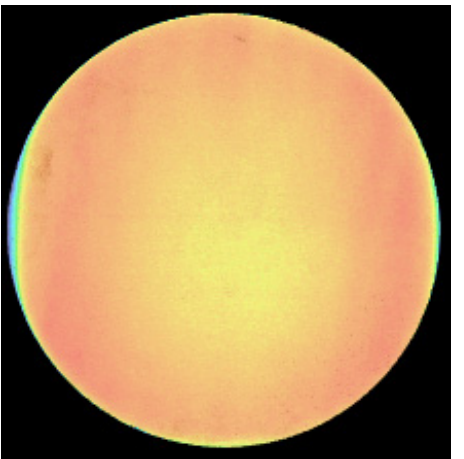
The coupon mass data from the four experiments after four months of exposure is listed in Table 5-4. The Experiment 1 coupon mass loss was 0.2 mg, which corresponded to the corrosion rate of 0.4 $\mu\text{m}/\text{yr}$ (0.016 mpy). This low corrosion rate indicated that corrosion of the coupon was negligible. The Experiment 2 coupon lost 1 mg, which translated into corrosion rate of 2 $\mu\text{m}/\text{yr}$ (0.08 mpy). This is still a very-low corrosion rate and is not indicative of significant underdeposit corrosion. The Experiment 3 coupon lost 5 mg; a closer examination of the coupon surface indicated that the corrosion occurred directly underneath the glass ring and silicone material, and no corrosion was observed below the saltcake deposits. The Experiment 4 coupon gained 9 mg; indicating absence of corrosion under the saltcake plus kaolin deposits.

Table 5-5. Profiled images of the underdeposit corrosion coupons before and after exposure

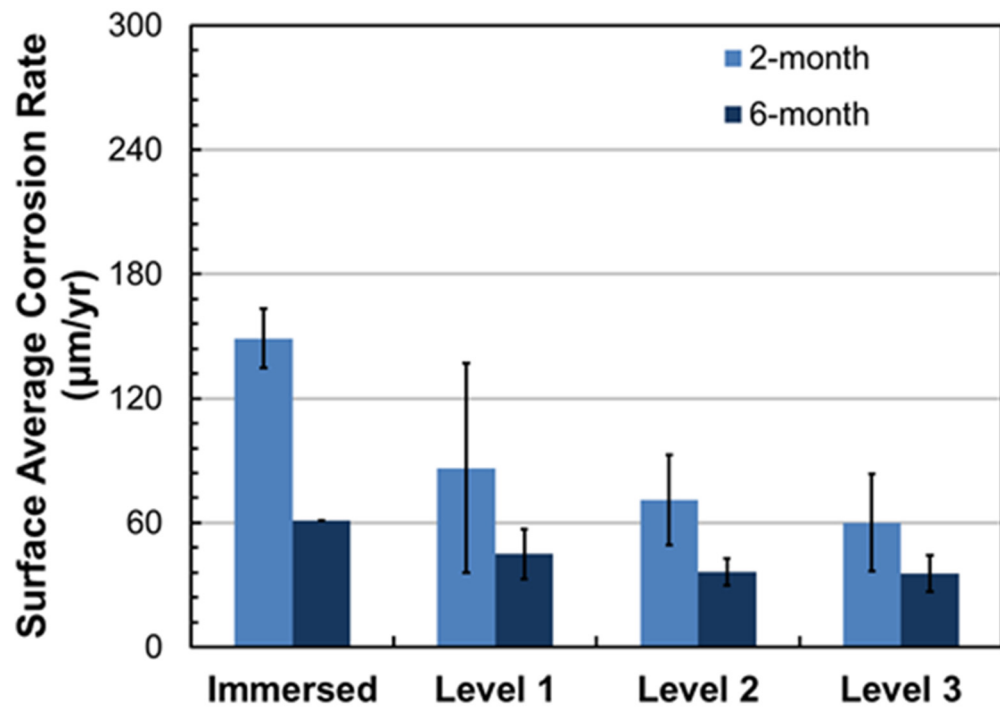
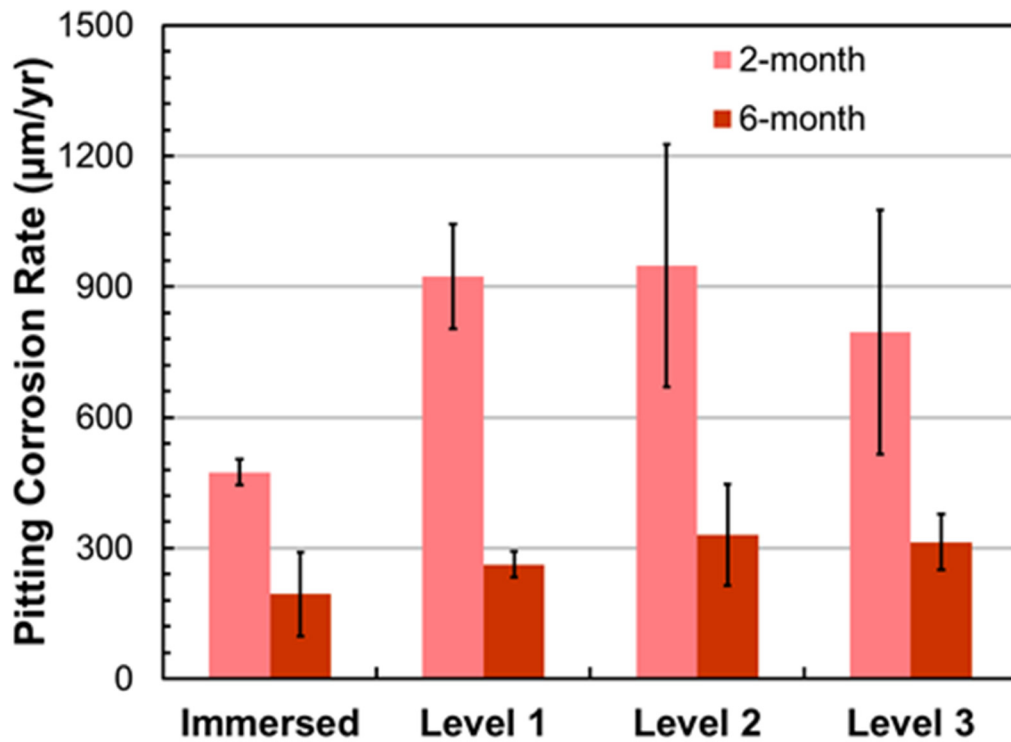
A statistical analysis was conducted to determine significance of the decrease in corrosion rate due to addition of 100% recommended dosages of VCI-A and VCI-B, and 50% of the recommended dosage of VCI-B. The statistical method used was Student's t-test, which is based on the hypothesis that there is no statistically significant difference between the corrosion rates used in the t-test—that is, that they are essentially identical to each other in terms of the coupon corrosion rates. The statistical result calculated by the test, P value, is the probability that the hypothesis is true. The higher the P-value, the greater the chance that the two sets of corrosion rates for the 2- and 6-month coupons are statistically similar. If the P-value is equal to or less than 0.05, it indicates that there is a less than 5% chance that the two sets of coupons have similar corrosion rates—that is, it means, with 95% confidence, that there is a statistically significant difference between the two 2- and 6-month coupons.

Figure 5-6. Average of (a) surface average, and (b) pitting corrosion rates for coupons in Vessel 1 (GW, and then GW +100% VCI-A). The black line in each bar represents the standard deviation.

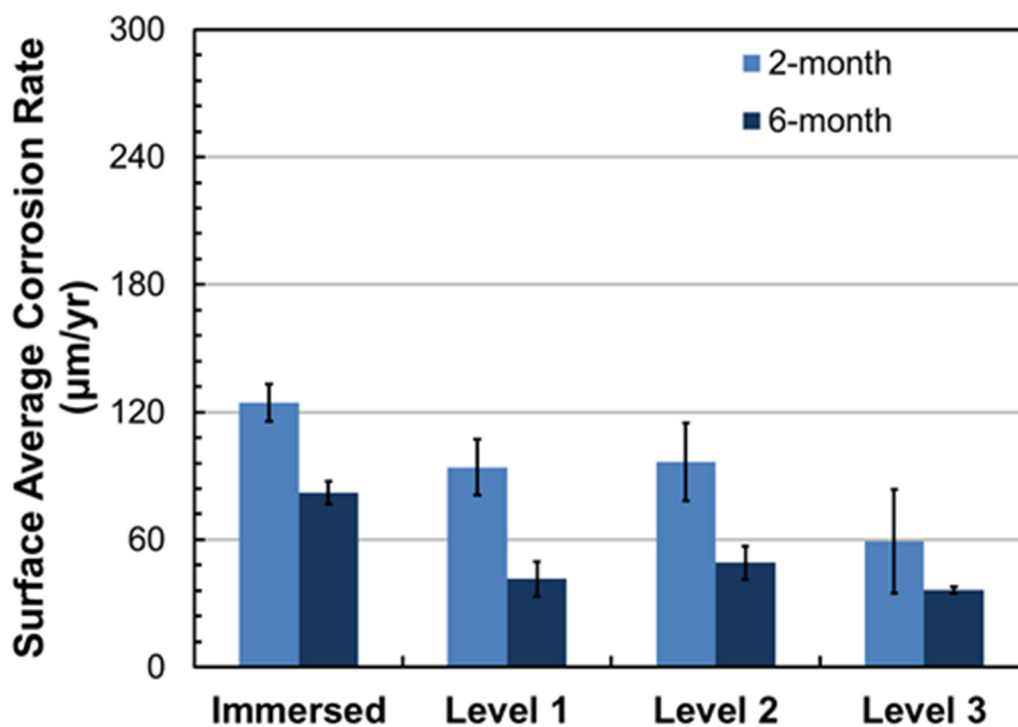
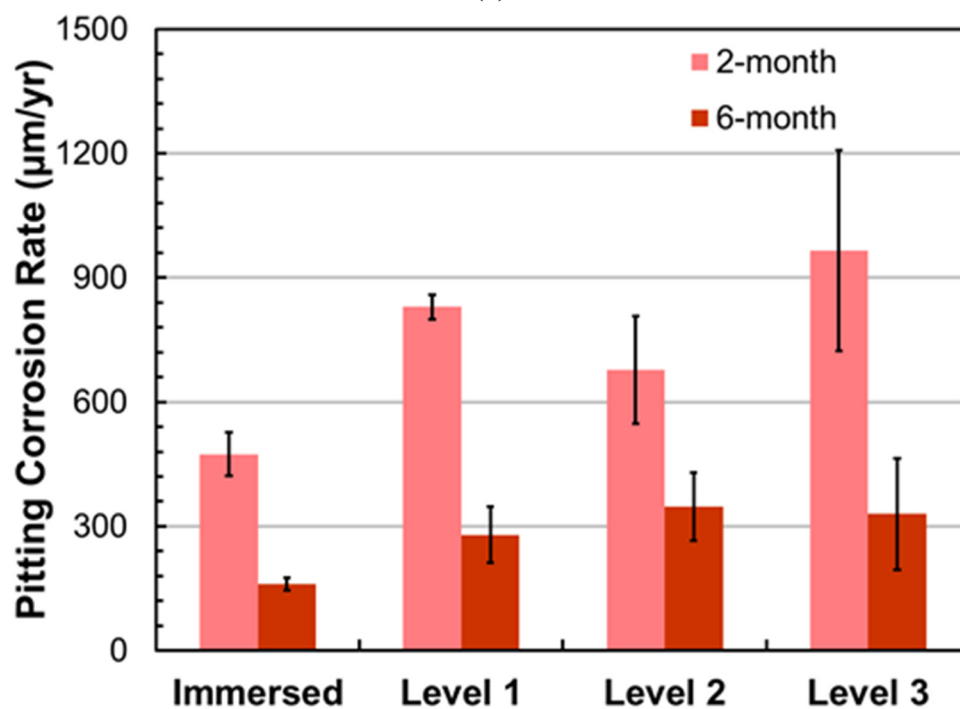
Figure 5-7. Average of (a) surface average, and (b) pitting corrosion rates for coupons in Vessel 2. The black line in each bar represents the standard deviation.

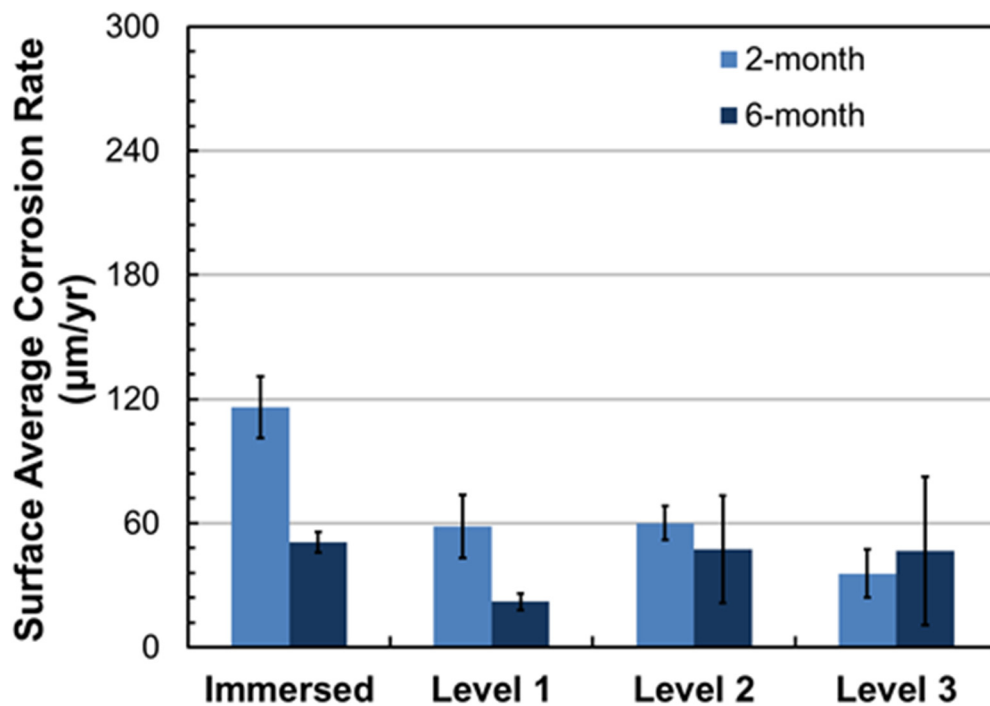
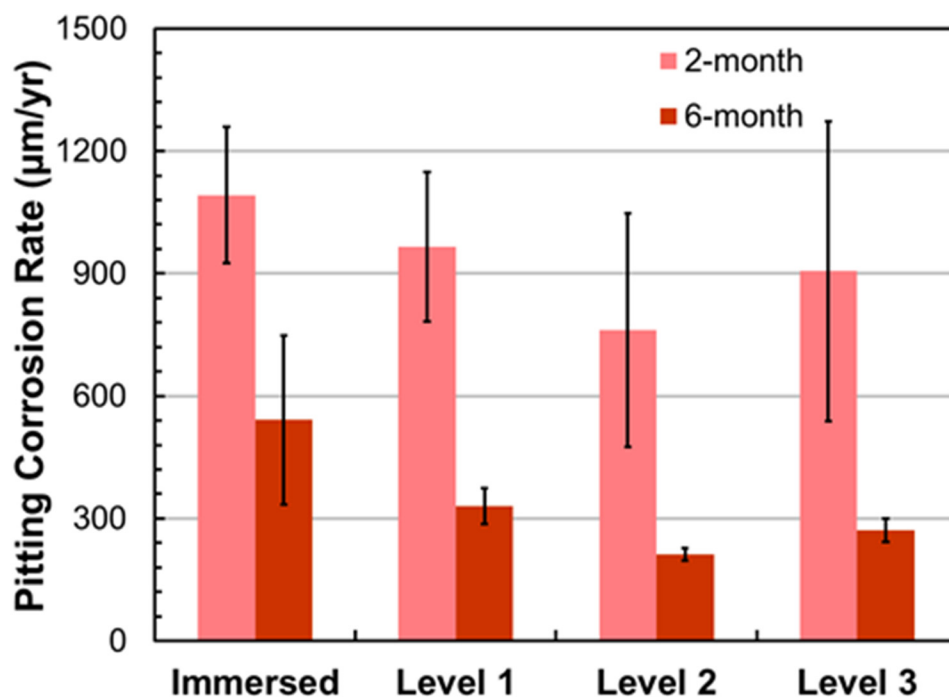
Figure 5-8. Average of (a) surface average, and (b) pitting corrosion rates for coupons in Vessel 3. The black line in each bar represents the standard deviation.

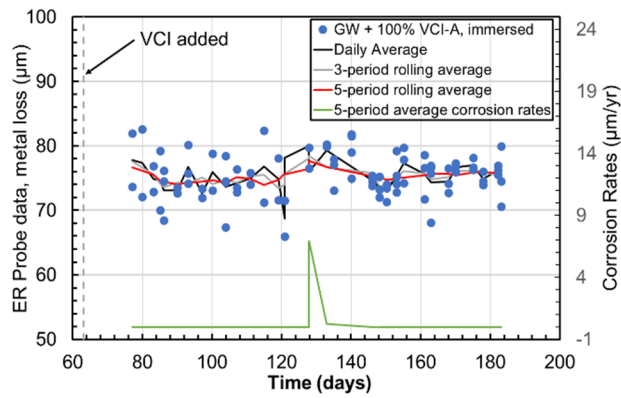
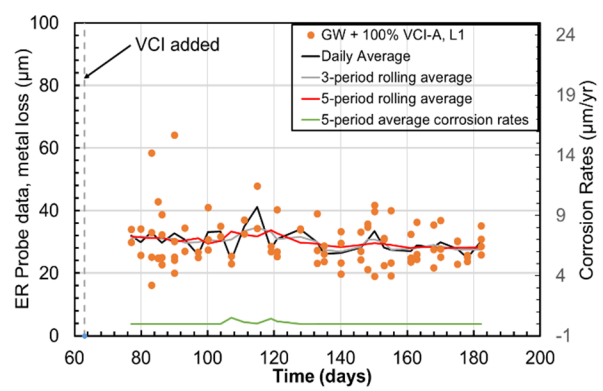
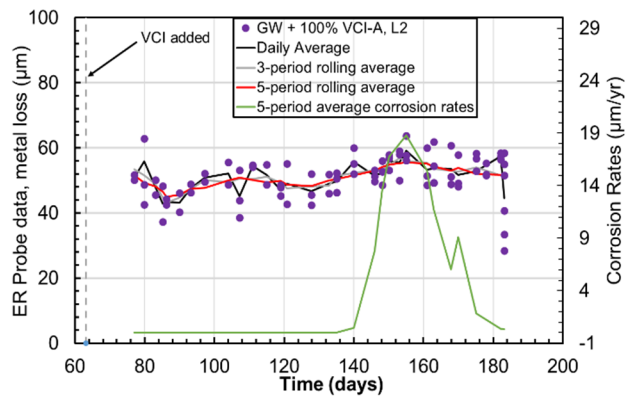
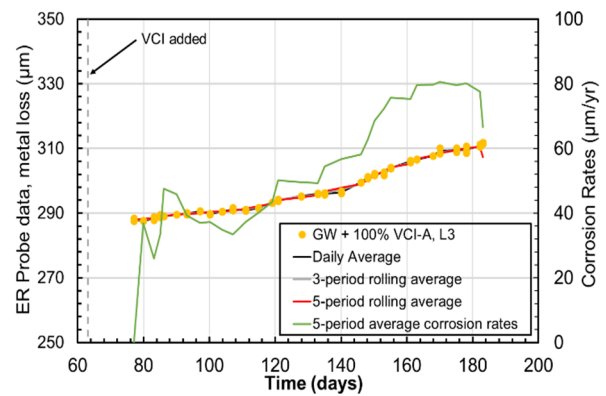
For Vessel 1, the ER probe data collected using the Model A datalogger during the VCI treatment is presented in Figure 5-10(a), Figure 5-10 (b), Figure 5-10 (c), and Figure 5-10 (d) for immersed, Level 1, Level 2, and Level 3 probes, respectively; the data in each of the four figures also include corrosion rates estimated using the 5-period rolling average of the ER probes' data. The 2-month and 6-month (for VCI treatment only) ER-probe-derived corrosion rates are listed in Table 5-11. A parallel treatment was applied to Vessels 2 and 3 ER probe data, and the coupons' and ER probes' corrosion rates are listed in Table 5-11. Vessel 2 ER probes' processed data and corresponding 5-period-rolling-average-derived corrosion rates are presented in Figure 5-11(a), Figure 5-11 (b), Figure 5-11 (c), and Figure 5-11 (d) for immersed, Level 1, Level 2, and Level 3 probes, respectively. Similarly, Vessel 3 ER probes' processed data and corresponding 5-period-rolling-average-derived corrosion rates are presented in Figure 5-12(a) and Figure 5-12 (b) for Level 2 and Level 3 probes, respectively.

Figure 5-10. Vessel 1 ER probe data and corresponding corrosion rates

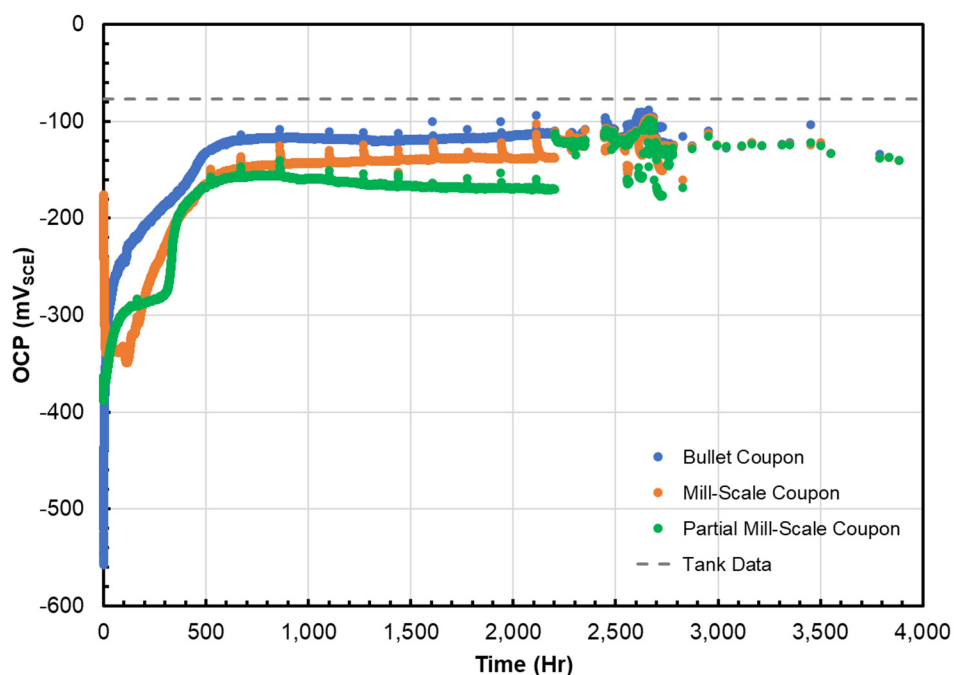
Figure 5-13. OCP data for the bullet (600-grit polished surface), mill-scale, and partial mill-scale coupons in AY-101 simulant. The tank data represents the average open circuit potential over 0.5 years. Note that the initial tank potential for the first 3 months was -80 mV vs. SCE.

Figure 5-13 to Figure 5-17 also contain the average actual tank data, which are represented by gray dashed line in each figure. The caption for the figure also includes the actual tank data that were obtained for the first three months. The tank data are listed in Table 5-14. The initial and the last OCPs are listed in Table 5-13. The tank and simulant OCP data were analyzed, and analysis results are presented in Table 5-15.

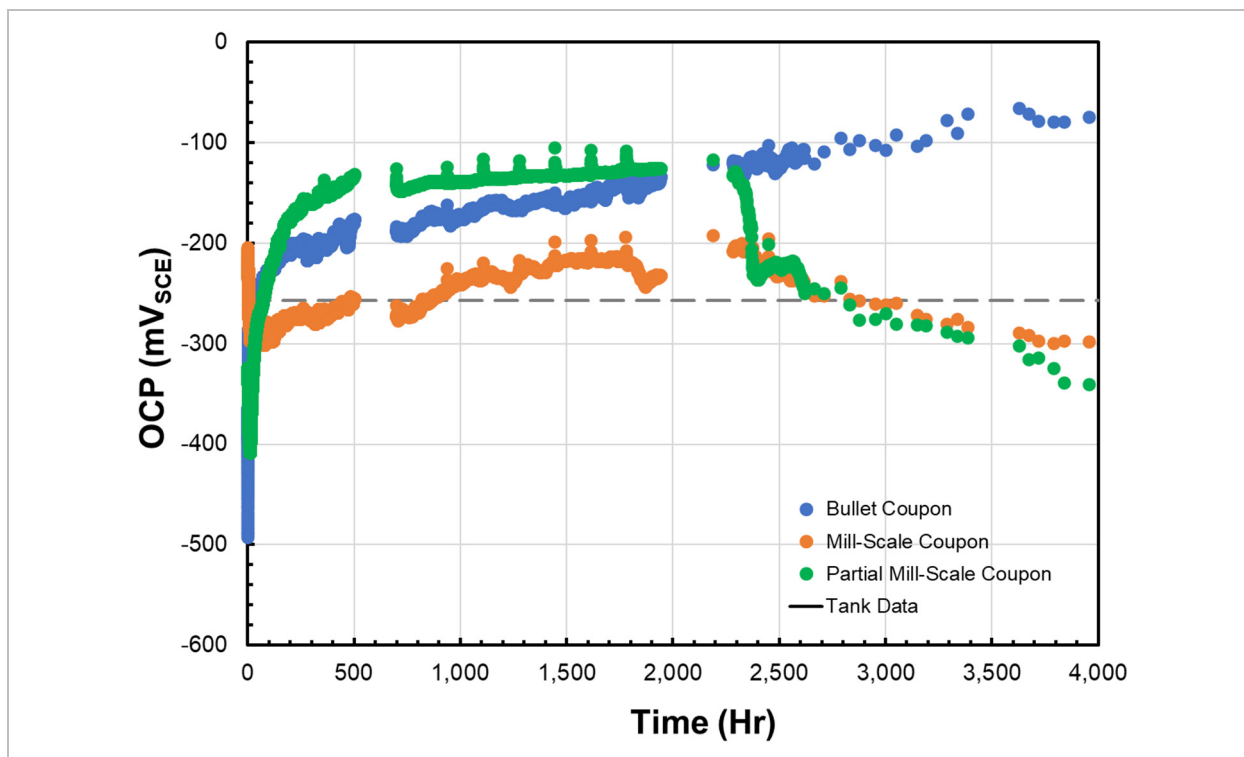
Figure 5-14. OCP data for the bullet (600-grit polished surface), mill-scale, and partial mill-scale coupons in SY-101 simulant. The tank data represents the average open circuit potential over 5.5 years. Note that the initial tank potential for the first 3 months was -257 mV vs. SCE.

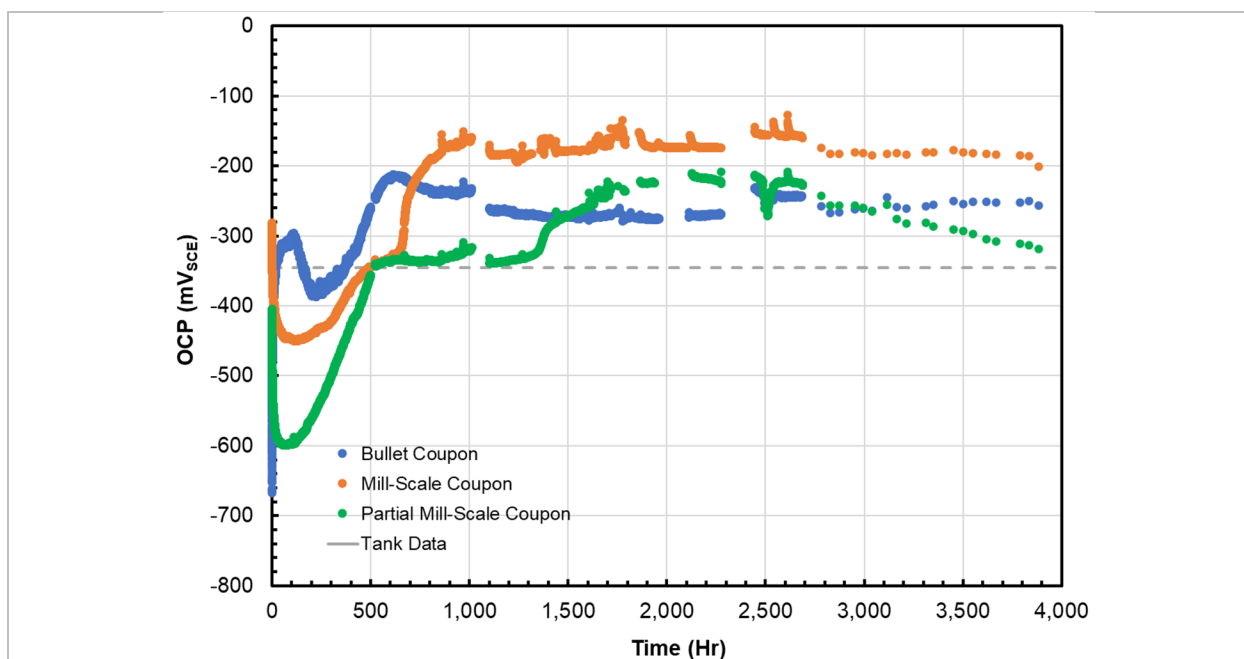
Figure 5-15. OCP data for the bullet (600-grit polished surface), mill-scale, and partial mill-scale coupons in AW-105 Base. The tank data represents the average open circuit potential over 6.5 years. Note that the initial tank potential for the first 3 months was -257 mV vs. SCE.
