**Savannah River
National Laboratory®**

Hanford Double Shell Waste Tank Corrosion Studies- Final Report FY2020

SRNL-STI-2021-00142, Revision 0

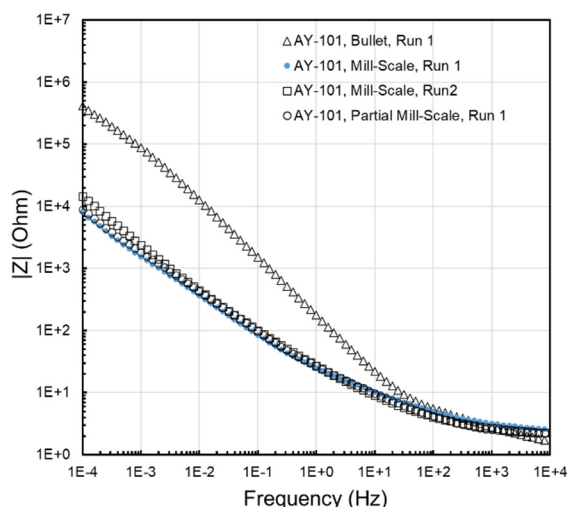
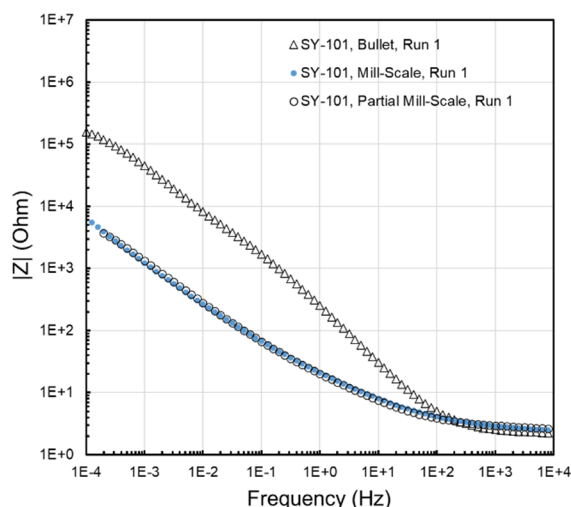
EIS measurements were conducted in the frequency range of 10^4 to 10^{-4} Hz, immediately after completing the OCP measurements. EIS data for the coupons in the AY-101 and SY-101 simulants are presented in Figure 5-18.

Figure 5-18: EIS data for bullet, mill-scale, and partial mill-scale coupons in AY-101 and SY-101.

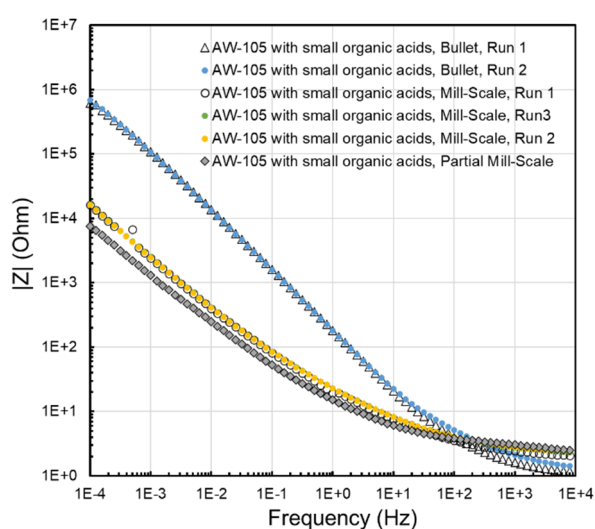
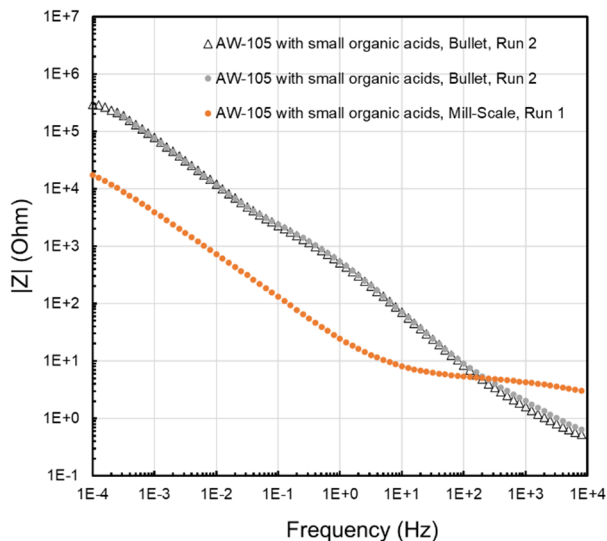
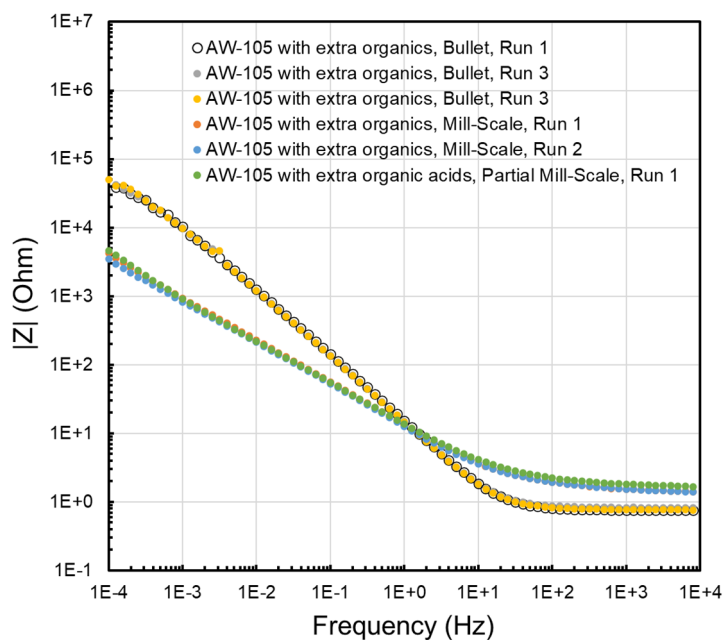
EIS data for the bullet, mill-scale, and partial mill-scale coupons in AW-105 Base and AW-105 Representative are presented in Figure 5-19(a) and Figure 5-19(b), respectively. EIS data for the bullet and mill-scale coupons in AW-105 Elevated TOC are presented in Figure 5-19(c).

Figure 5-19. EIS data for bullet, mill-scale, and partial mill-scale coupons in the three variants of AW-105 simulants.

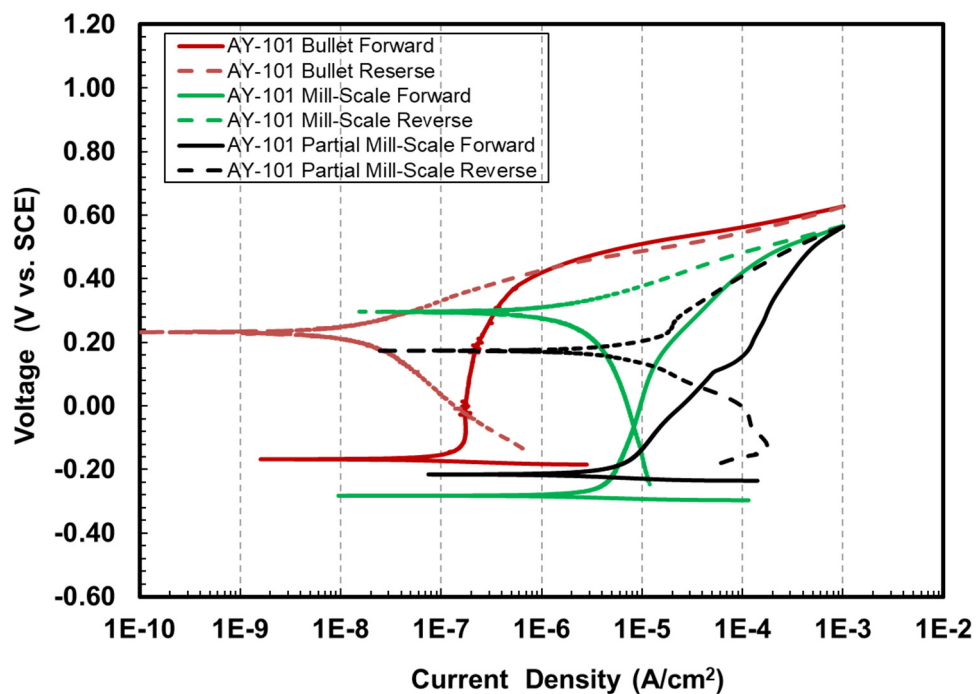
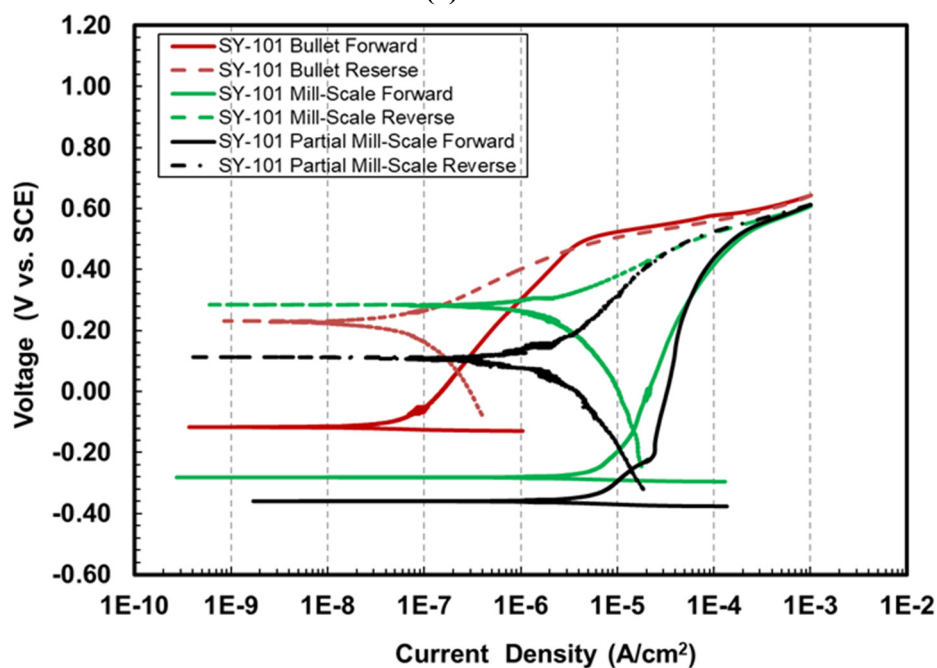
Figure 5-20. CPP data for the bullet, mill-scale, and partial mill-scale coupons after OCP holds in (a) AY-101 and (b) SY-101 simulants

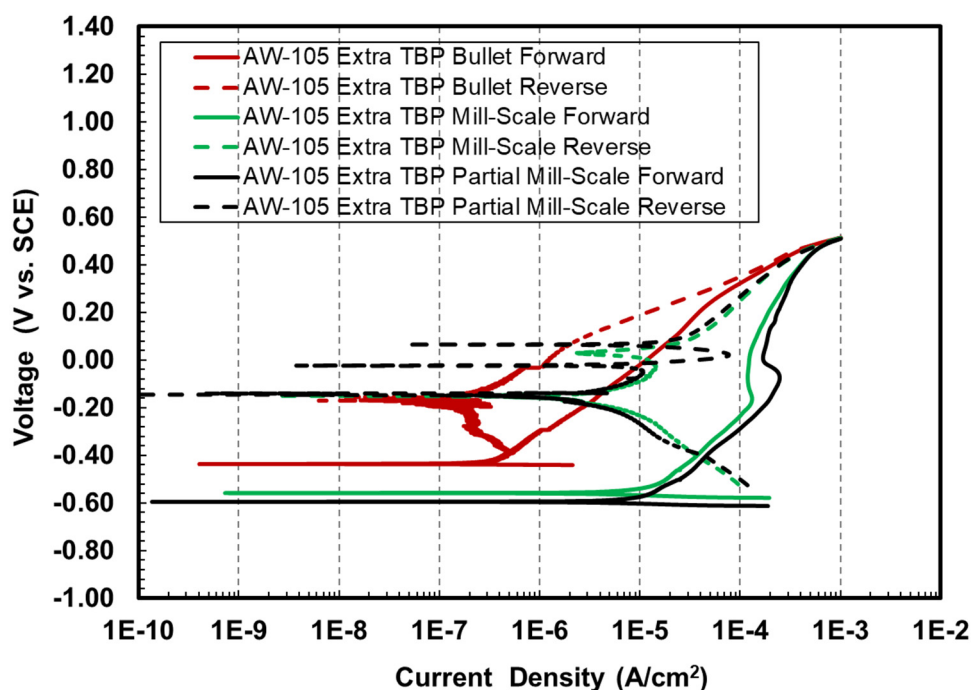
The CPP data for the bullet, mill-scale, and partial mill-scale coupons in AW-105 Elevated TOC are presented in Figure 5-22. The three coupons' CPP responses exhibit negative hysteresis, i.e., pitting corrosion of the electrode material is unlikely in the simulant chemistry. The passive current density of the bullet coupon is in the range of 10^{-4} to 10^{-3} mA/cm². Compared to the mill-scale and partial mill-scale coupons, the passive current density of the bullet coupon is about one-two orders of magnitude lower. The two plausible explanations, as mentioned previously, could be the cause of higher passive current density in the mill-scale and partial mill-scale coupons compared to the bullet coupon.

Figure 5-22. CPP data for AW-105 Elevated TOC
