**Savannah River
National Laboratory®**

Corrosion of Steel During Long-Term Exposure to Evolving Cementitious Environments

SRNL-STI-2021-00187, Revision 0

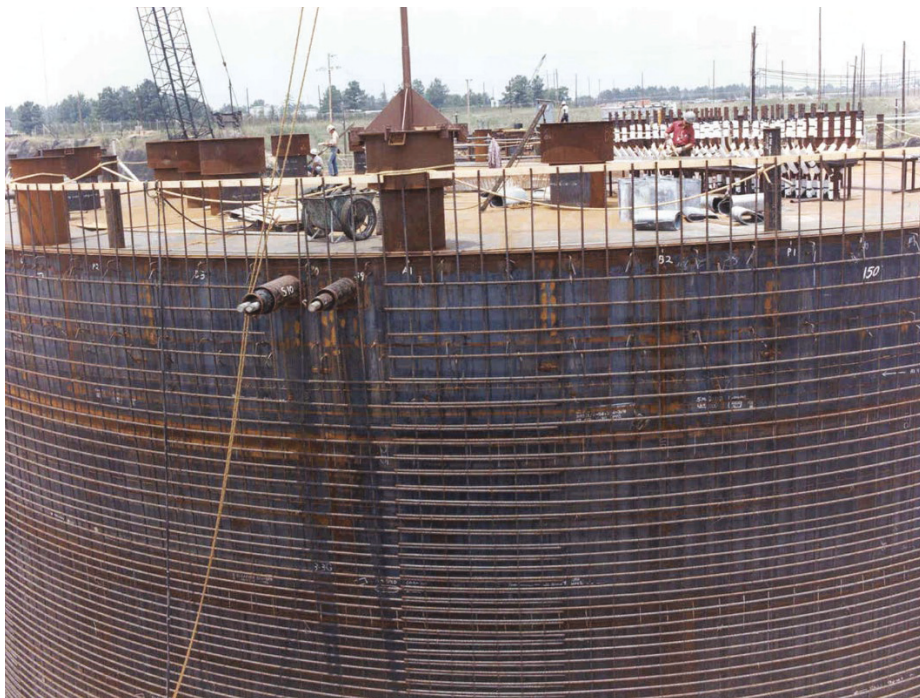
Figure 2-4. Rebar for a Type IIIA Waste Tank [2]

The rebar material was either ASTM A615 Grade 40 or Grade 60 [12]. Type III tanks built before 1972 utilized Grade 40, while the Type IIIA tanks utilized Grade 60. Figure 2-4 shows the rebar utilized for a Type III/IIIA waste tank. The secondary wall and the transfer lines that go into the tank are also visible. The difference between the two tank configurations is the

minimum required tensile strength (40 vs. 60 ksi). According to ASTM A510 [13], there are several grades of carbon steel that would meet the chemical and mechanical property criteria cited in ASTM A615 [14]. The decision on which grade of carbon steel was used for rebar would have depended upon availability. Based on previous corrosion tests with different grades of carbon steel, no significant difference would be anticipated in their corrosion behavior. Drawings of the concrete vault indicated that the rebar size was typically between 1.12 to 1.41 inches in diameter and spaced between 4 to 16 inches apart [20].

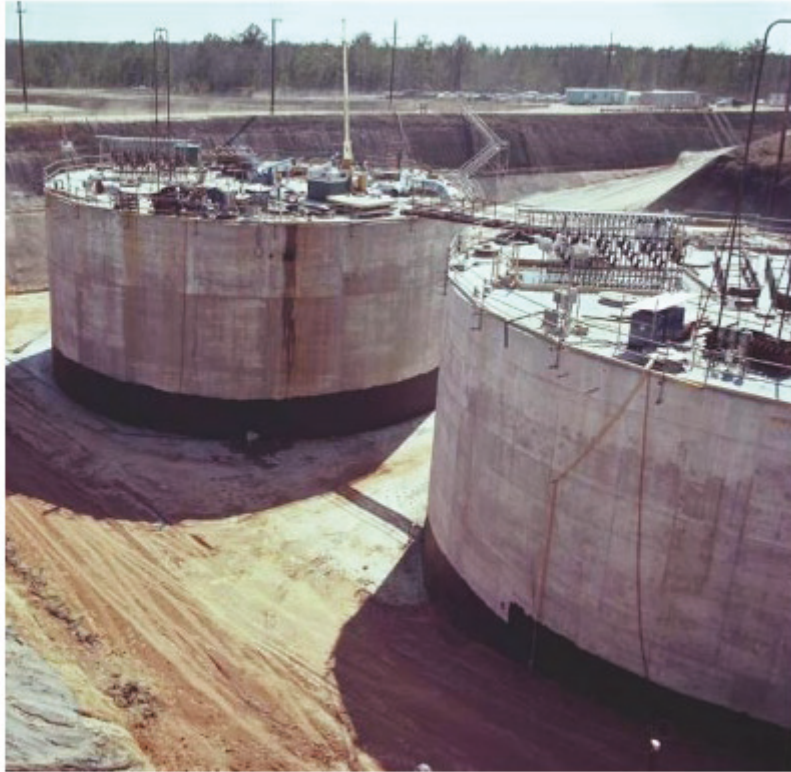
Figure 2-8. Concrete Vault for Type III Waste Tanks [2]
