An Assessment of the Materials of Construction for the Transfer Lines and Unit Operations Equipment Associated with the Recycle Diversion Process

B. J. Wiersma

June 2021

SRNL-STI-2021-00252, Revision 0

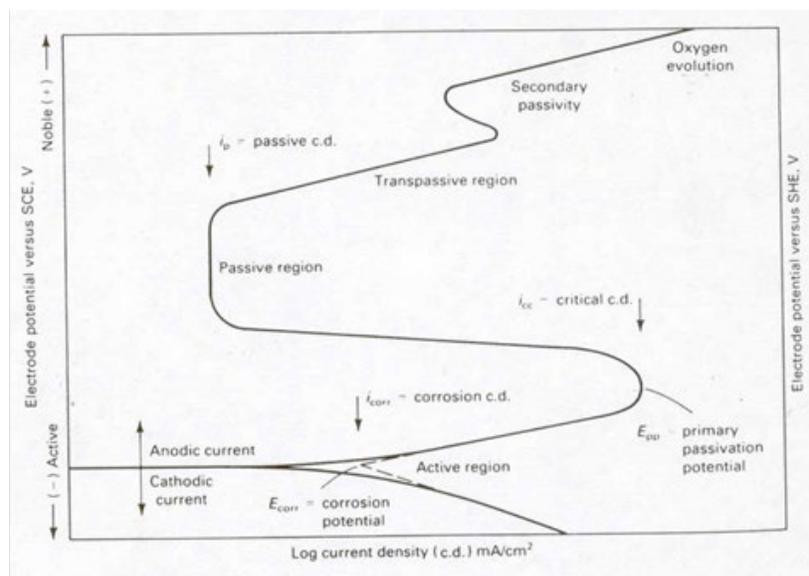
Figure 2-1 Potential vs. Current Diagram Illustrating Corrosion Behavior

Corrosion is the destructive result of a chemical reaction between a metal or metal alloy and its environment [9]. Corrosion is the primary means by which most metals deteriorate on contact with water, acids, bases, salts, oils, and other solid and liquid chemicals [15]. Commonly, corrosion processes involve transfer of electronic charge between a metal and an aqueous environment. The metal dissolution process, or anodic reaction, involves dissolution of a metal species and release of a metal cation into the solution and the liberation of electrons in the metal. To maintain electroneutrality, the electrons in the metal are consumed by a cathodic reaction at the liquid-metal interface, which occurs at the same rate as the anodic reaction. Reduction of dissolved oxygen in the aqueous environment is an example of a cathodic reaction. If there is a deficiency of electrons at the metal surface, the interface between the metal and the solution becomes positively charged or anodically polarized. As the surface becomes more anodically polarized, the rate of corrosion increases (see Figure 2-1).

In many engineering materials (e.g., aluminum, stainless steel alloys, etc.), the corrosion rate suddenly decreases above some critical potential, E_{pp} (see Figure 2-1). This corrosion resistance above E_{pp} is defined as passivity. Passivity is caused by formation of a thin, protective, hydrated oxide, corrosion-product surface film that acts as a barrier to metal dissolution. In many cases, the passive film exists naturally in aerated environments. Frequently alloying elements, such as chromium are added to a metal to increase the resistance of the passive film. Passive materials, however, are vulnerable to degradation as well. Because the passive film is thin and frequently brittle, mechanical or chemical breakdown may occur at local sites and result in localized corrosion of the underlying metal. These localized mechanisms are stochastic, depend on the local environments that evolve, and frequently occur at accelerated rates. Due to their random nature, the failure of a system by one of these mechanisms may be sudden and catastrophic. The breakdown of passivity is also illustrated in Figure 2-1. The increase in current shown in the transpassive region of the plot may be an indication of pit initiation and growth. Examples of localized corrosion include pitting corrosion, intergranular corrosion, de-alloying, and crevice corrosion. Localized corrosion may also act in concert with other factors such as stress and accelerate degradation. An example of this synergistic process is stress corrosion cracking (SCC).

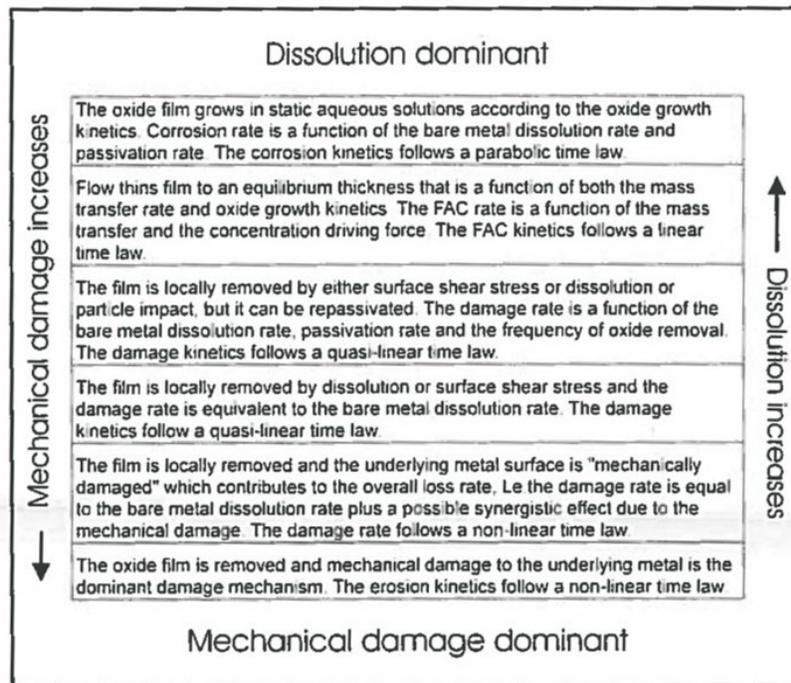
Figure 2-2 Spectrum of Corrosion and Erosion-Corrosion Behavior [15].

The spectrum of erosion-corrosion damage is shown in Figure 2-2. In stagnant conditions, corrosion dominates the damage mechanism and the rate decreases parabolically with time due to the formation and growth of the passive film. At low fluid velocities, flow assisted corrosion (FAC) is a function of the mass transfer rate of aggressive species and the protective film on the surface dissolves and corrosion continues at a roughly linear rate. Above a critical velocity, known as the breakaway velocity, the passive film is continuously damaged and removed. Thus, the overall degradation rate becomes a function of both the mechanical damage to the film and corrosion. At high fluid velocity, the metal removal process is controlled by cavitation erosion or by droplet impacts. The oxide is continuously removed and as a result, high metal losses occur due purely to erosion. The erosion process is time dependent and experiences an incubation period related to the time it takes for the surface to be embrittled.

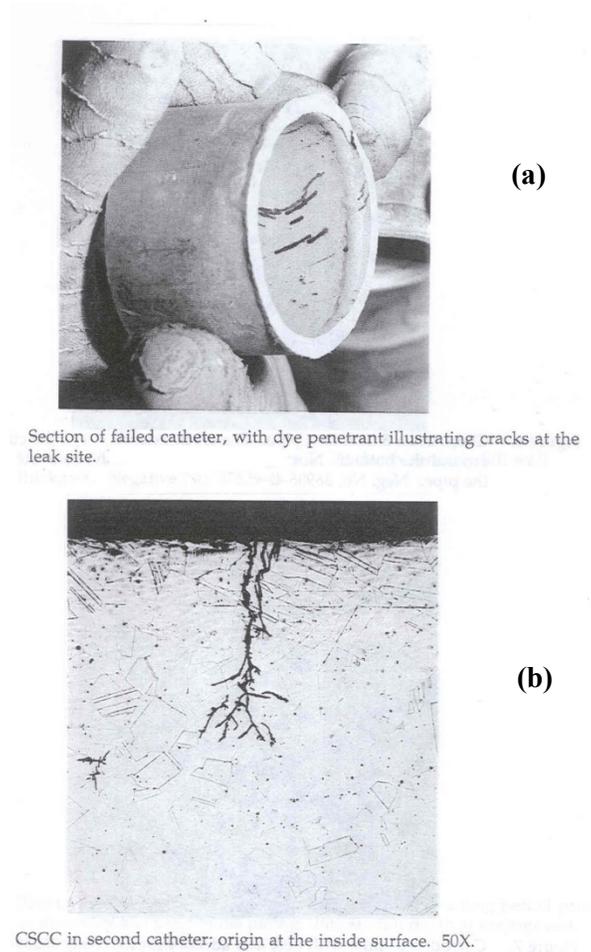
Figure 3-1. Section of core pipe from clean-out-port #3: (a) Dye penetrant test showing cracks on the interior of the pipe, (b) Micrograph showing transgranular chloride SCC [35].

Instances of transgranular SCC have been observed in the waste tank farm. In each case natural water was involved and the chloride ion was observed to be the species that initiated the attack. Stress corrosion cracking of a stainless steel core transfer line was also observed [35] near a clean-out port in the concentrate transfer system (CTS) loop for Tanks 29-32 in the early 1980's (See Figure 3-1). The piping had been placed according to the revision of Specification 4482 applicable at that time. The failures at the clean-out port probably occurred sometime between hydro-testing

of the system and placing the line in radioactive service. Natural well water, with no added corrosion inhibitors, was utilized for the hydro-test and is the likely source of the chloride ions. Although the well water is typically low in chlorides (less than 5 ppm), evaporation may have increased the chloride concentration. Concurrent with this failure, it was discovered that an underground steam line near the clean-out port had leaked for an extended period. During the repair of the steam line, the degree and extent of heated soil in the area was observed to be unusual. The steam leakage was postulated as a heat source which would produce the elevated temperatures necessary to enhance stress corrosion cracking. A time/temperature combination is also required for cracks to initiate and propagate. It was observed that both the extended period of steam leakage and the extended period before the line was placed in service were likely contributors to the failure. It was therefore recommended that the repair time for leaks in buried steam lines be minimized and that new pipelines should not be held out of service for extended periods of time [35].

Due to this failure, it was also recommended that the time for which the transfer lines are exposed to stagnant well water at elevated temperatures be minimized. Administrative controls, such as the Corrosion Control Program Description Document, are in place to minimize the potential for well water to be left in the lines for extended periods of time [36]. In fact, placing the lines in service with the waste supernate, which contains inhibitors such as nitrite and hydroxide, will protect the stainless steel.

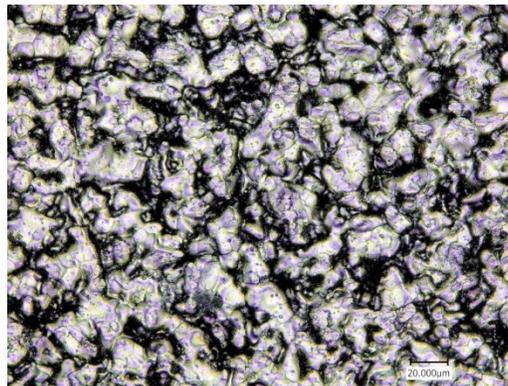
Figure 3-2. Sintered 316L material at 1000X magnification [52].

The fabrication of the sintered metal filter media results in a crevice-like structure having numerous small contact points (see Figure 3-2). There was a concern that the localized corrosion resistance of the CFF may be reduced as the pH of the solution is cycled between the well inhibited high pH waste feed chemistry to that ultimately of the planned cleaning acid chemistry. This would be further exacerbated when aggressive anions, such as chloride and sulfate, are present. Conditions like these can result during the proposed acid cleaning cycle or during extended outages if proper layup procedures are not followed. Corrosion of small contact points could result in the opening of the filter's effective pore size or potentially impact the structural integrity of the filter, which may increase the filter tube replacement frequency.

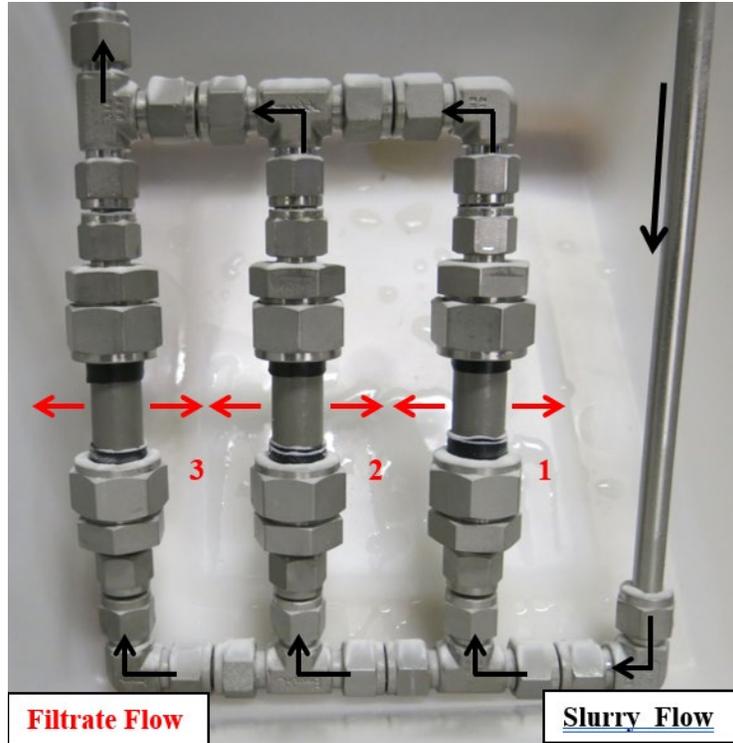
Figure 3-3. Set-up for CFF flow through tests [52].

Both axial flow through the filter and perpendicular flow through the porous media was achieved. The axial velocity was 2-3 ft/s, while the transmembrane pressure was on the order of 30 to 45 psig. The test was conducted for 1 month. During that time the pH of the simulant ranged from 7 to 9 and precipitation of oxalate occurred. The oxalic acid cleaning cycle was also simulated.

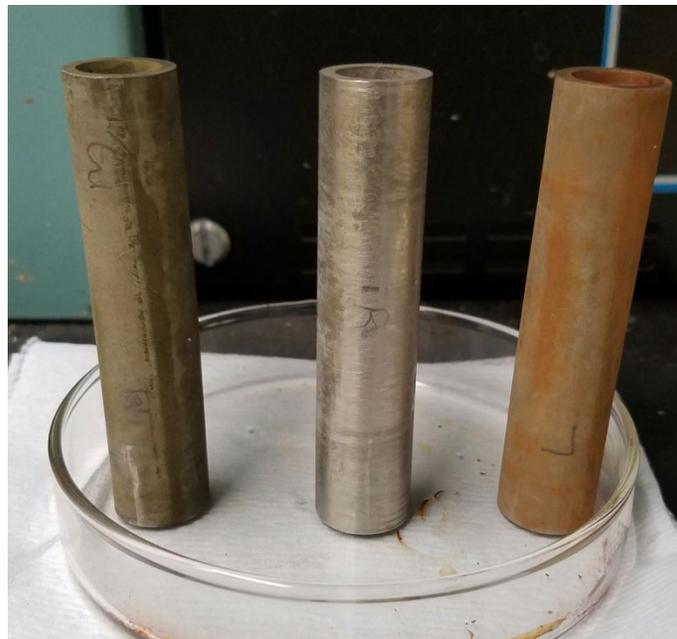
Figure 3-4. Post-test CFF filter media samples after cleaning [52].

Following the tests, the filter media sections were removed and examined for evidence of corrosion. Figure 3-4 shows the CFF samples after they had been removed from the system and cleaned. Results of the filter characterizations, water permeability, gas permeability and bubble point, following the filter flow through test were inconclusive. Two of the three filter tubes showed no significant increase in pore size or permeability as compared to the three as-received untested tubes. Although the chemistry tested was high in chloride and sulfate concentration and maintained at a relatively low pH (<10) for one month, evidence of significant localized corrosive attack, pitting or crevice corrosion, was not observed within the resolution of the various filter characterization test methods. This conclusion was also verified by the filter flow rates tests, which indicated no significant change in flow rate had occurred during the flow-through test. The third exposed filter tube, on the other hand, demonstrated a significant increase in pore size, exhibiting an increase of approximately 2 times in pore size as compared to all the other tube samples. Although brown colored deposits were observed on all surfaces of this filter, no plausible explanation could be postulated that would explain a corrosion mechanism that would have affected the entire wall thickness. Testing showed the range of pore size was much broader for this one sample demonstrating a broader effect. Based on the electrochemical testing, it seems unlikely that the increase in pore size resulted from a localized corrosive attack. Further testing of this tube would be required to determine the cause and extent of the increased pore size.

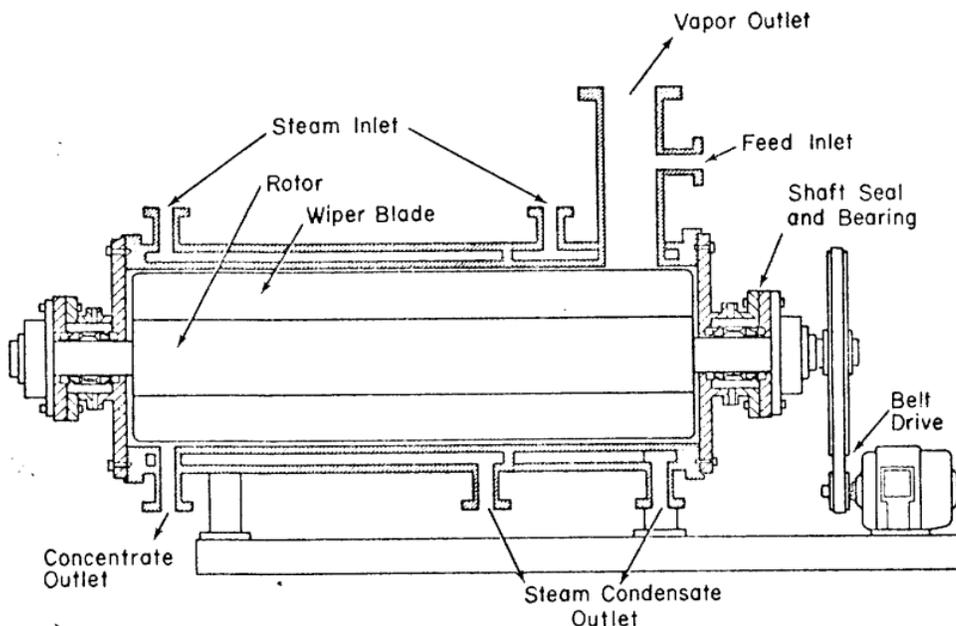
Figure 3-5. Schematic of Horizontal WFE [13].

The horizontal WFE was operated for 2093 hours, of which 1741 hours were intermittent operation and 352 hours were continuous. Operation was interrupted occasionally to change various experimental parameters (e.g., steam pressure, feed rate, solution chemistry, etc.). The unit was disassembled for inspection. No bearing or mechanical seal failures were observed (i.e., abrasive wear was not an issue). However, three areas of concern were raised:

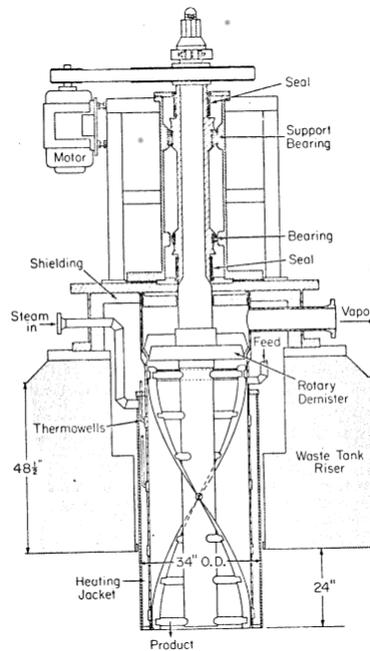
Figure 3-6. Schematic of Vertical WFE.

The vertical WFE was operated for 1111 hours with two problem areas identified.

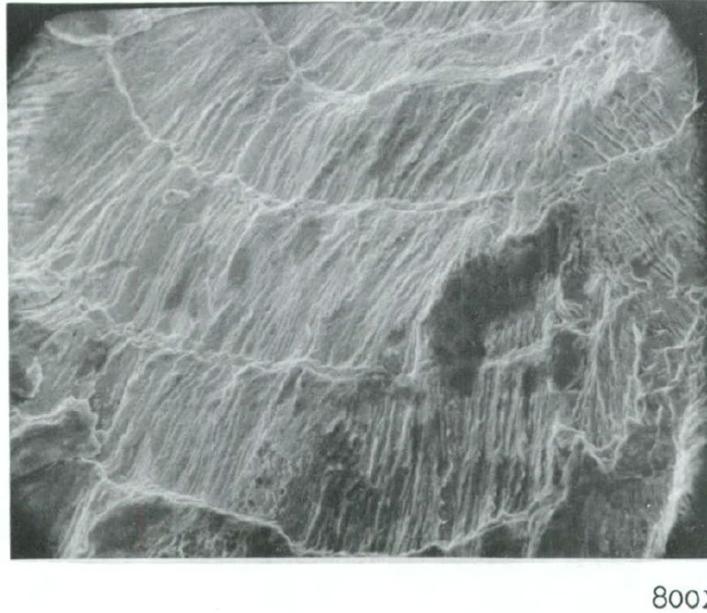
Figure 3-7 Large fatigue striations with finer secondary striations perpendicular to the primary striations [14].

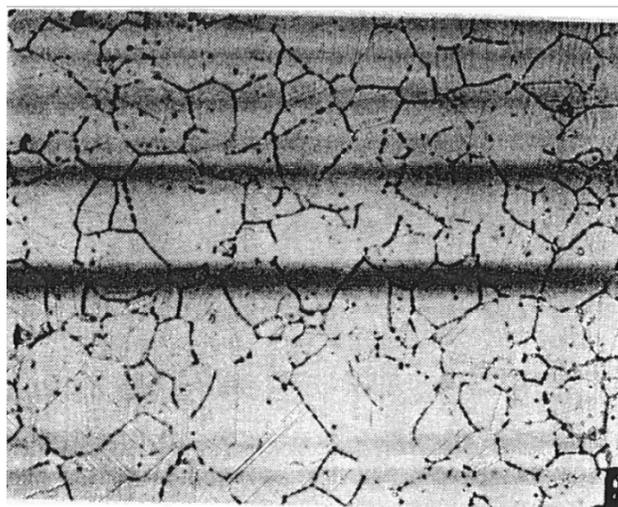
Figure 3-8. Optical micrograph of sensitized 304L stainless steel microstructure (500 X magnification) [56].

Corrosion tests were performed with 304L stainless steel plate in a simulated USF environment. The metallurgical conditions of the weld heat affected zone were reproduced by heating the coupons in air for 4 hours at 650 °C. This produced a sensitized microstructure (see Figure 3-8) that exhibited chromium carbide precipitates at the grain boundary. The coupons were partially immersed in the test solutions to show the effects from exposure to both vapor and liquid. The test solutions were selected to address the high-acid range of mixtures expected in the WFE. The solution compositions are shown in Table 3-9. The solution temperature was approximately 115 °C and the tests were conducted for 230 hours.

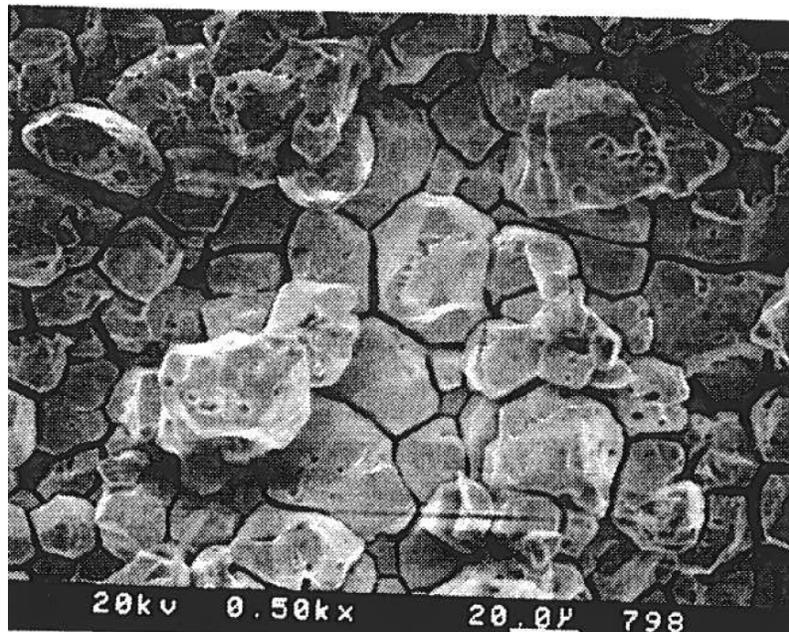
Figure 3-9. SEM image of surface of specimen after vapor phase exposure, showing IGA (500X magnification) [56].

Figure 3-9 and Figure 3-10 are scanning electron microscope (SEM) images that illustrate the extensive intergranular attack (IGA) that occurred during the test. Most of the grains at the surfaces had dropped away in both vapor and liquid exposed metal surfaces. The depth of intergranular attack was measured from the SEM image shown in Figure 3-10. The rates of attack in both the liquid and vapor space for each solution are shown in Table 3-10. The corrosion rates were similar for the liquid and vapor space and ranged from 80 to 140 mils/yr. Assuming a nominal wall thickness of 0.28 inches for the 6-inch diameter pipe, failure due to IGA would occur within 6 years. This service life assumes continuous usage, which is likely conservative. Another consideration that was mentioned was that the evaporator bottoms would tend to accumulate constituents of the stainless steel (e.g., iron, chromium, and nickel). The concentration of these species could reach unacceptable levels for downstream processes. No further documentation on testing for this WFE was located. However, the process and equipment were never placed in service.

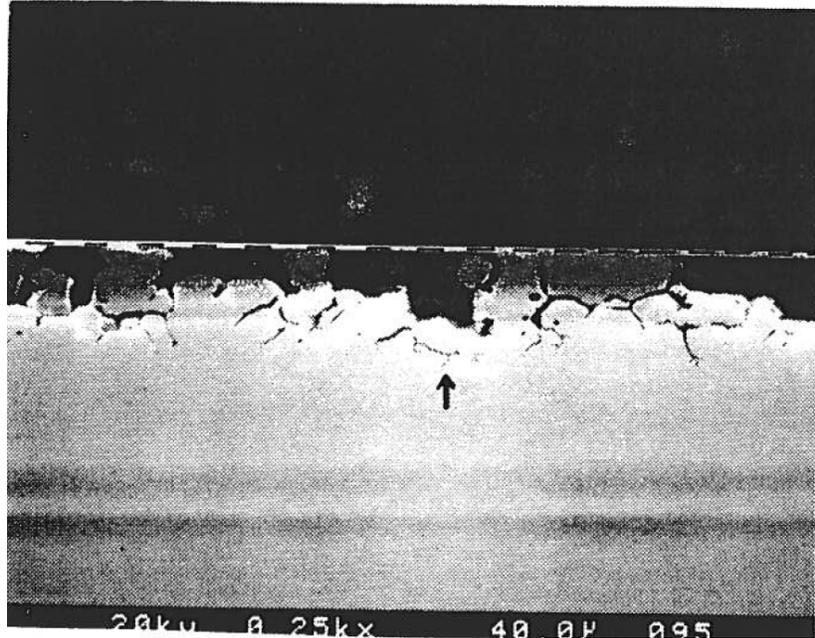
Figure 3-10. SEM image of cross-sectioned specimen showing IGA depth of attack in the liquid exposed metal. The dashed line indicates the level of the original surface and the arrow points to the deepest IGA penetration (250x magnification) [56].

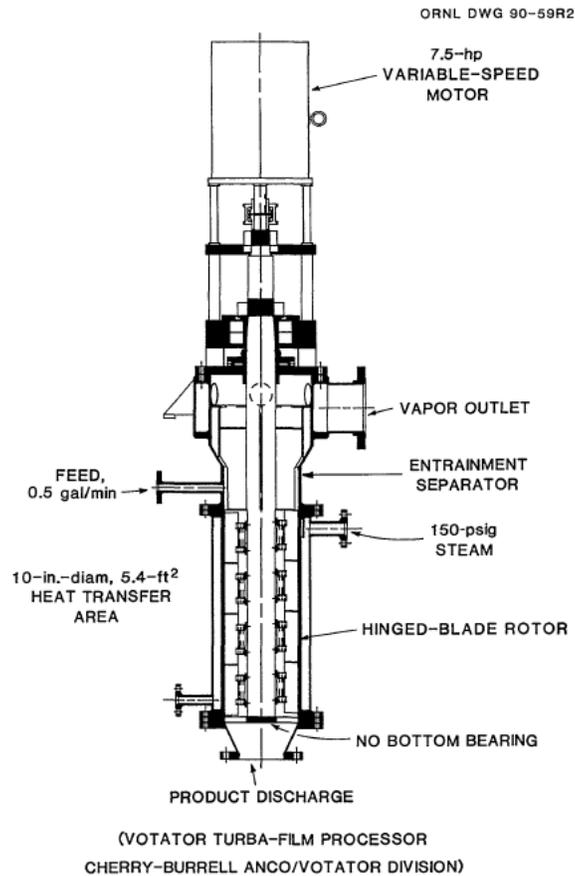
Figure 3-11. WFE for Pilot-Scale Tests at ORNL [10].

The evaporator facility consisted of a 500-gallon mixing tank; an insulated 500-gallon preheat/feed tank; the WFE, which had a 5.4 ft² heat transfer surface area (see Figure 3-11); a product collection station; a heat exchanger to condense the distillate; a 250 gallon distillate receiver tank; cooling

water dichlorination unit; assorted piping and fluid transport media. The heating jacket of the evaporator was heated with 150 psig steam to 180 °C steam. The mixing tank could be heated with 50 psig steam to 147 °C. In addition to evaluating process variables, the equipment was inspected for corrosion problems and the effects of the waste on the evaporator heat transfer surface due to erosion-corrosion and scaling [10].

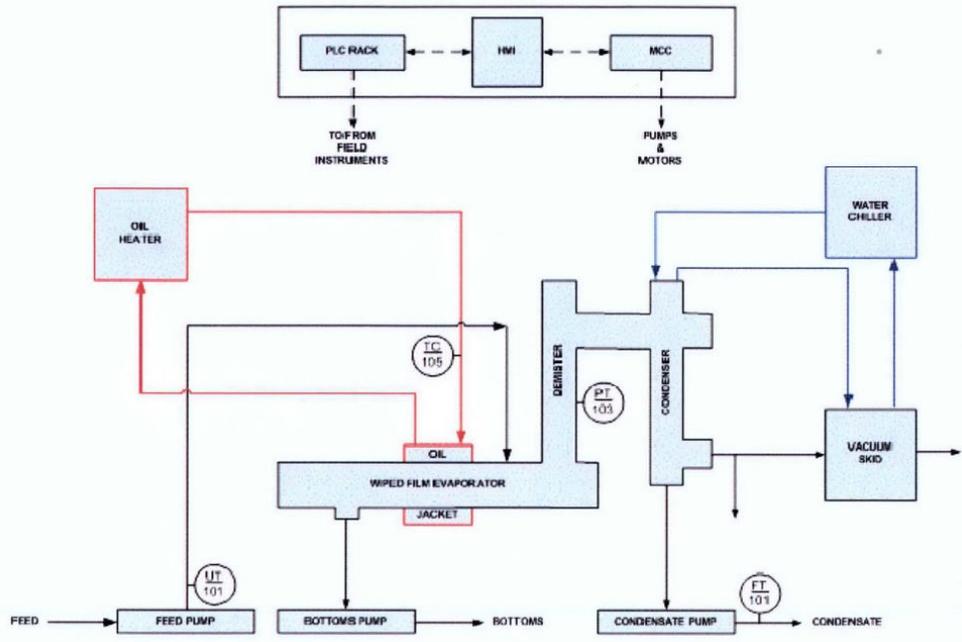
Figure 3-12. CEES Pilot Scale WFE System [59].

The WFE system that was tested is shown in Figure 3-12. This WFE augments traditional water removal through the usage of a high vacuum. The vacuum reduces the boiling point of water to approximately 50 to 60 °C. The system included a Rototherm evaporator assembly with a condenser with a 1 ft² heated surface (see Figure 3-13); a diesel generator; a water chiller; a vacuum system; cavity pumps; a feed preheater; and various piping, valves and instruments. The MOC for

the heat transfer surface was 316 stainless steel. However, the piping and valves for the feed bottoms and condensate were constructed of carbon steel.

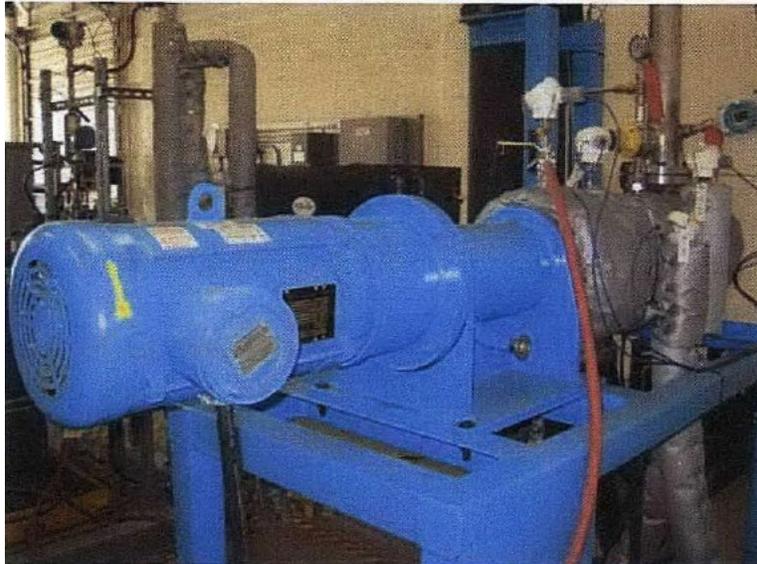
Figure 3-13. Pilot Scale Rotatherm WFE [59].

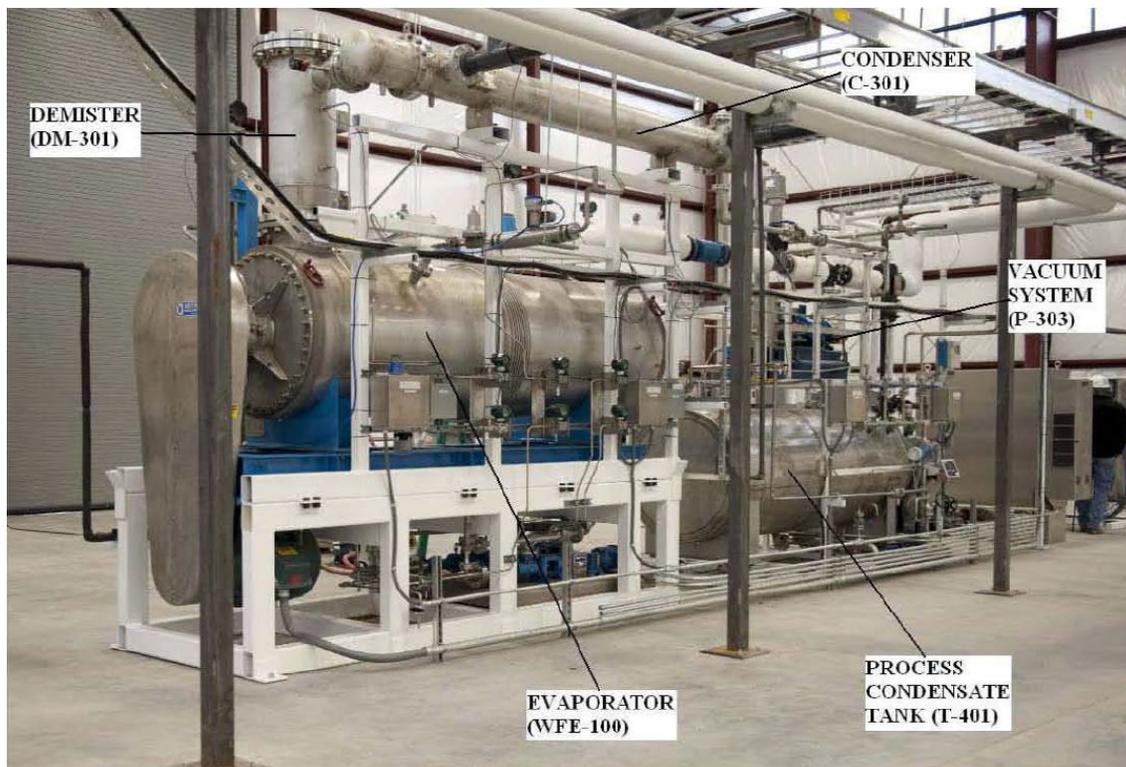
Figure 3-14. Full-Scale Rotatherm WFE [60].

A full-scale demonstration of the modular WFE was performed in 2011 [59]. A photograph of the WFE is shown in Figure 3-14. The AN-105 simulant was utilized for the demonstration. The heat transfer surface area of the evaporator was 50 ft². The heating medium was 28 psig steam (~260 °F), and the vacuum system was operated such that the exit temperature was approximately 120 °F. The flow rate was varied between 8 and 10 gpm. The tests were conducted over a five-day period. A post-test inspection did not reveal significant degradation of any of the WFE components. However, longer-term testing would be necessary to demonstrate that the MOCs are adequate.

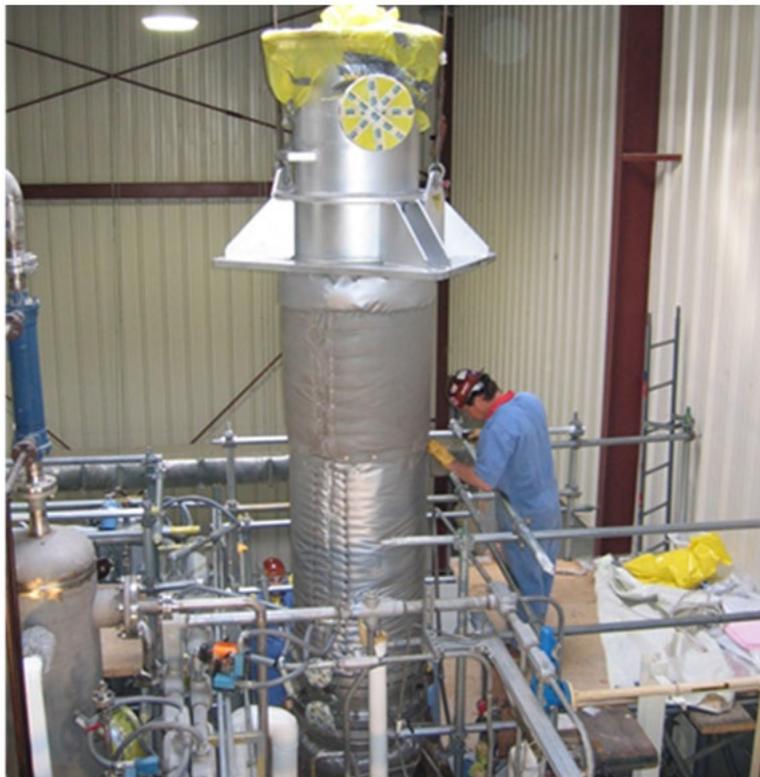
Figure 3-15. Hanford ETF Thin Film Dryer.

A thin film dryer (TFD), also known as a WFE, manufactured by BUSS-SMS of Germany and distributed in the U.S. by the LCI corporation, is used as part of waste processing operations at the Effluent Treatment Facility (ETF) in the 200E Area of the Hanford Site [63]. It has been operational since 1995. The TFD is shown in Figure 3-15. The TFD is composed of a rotor and six flights of blades made from 316L housed inside a 365°F (185°C) steam heated drum (see schematic of LCI TFD in Figure 3-16). The internal surface of the drum is lined with Inconel Alloy 625. The flights of blades spin within 0.5 mm of the wall of the drum at a fixed speed of 252 RPM, which is equivalent to a blade tip speed of 26 ft/sec. During normal operation, feedwater (an aqueous brine) is injected into the top of the dryer. The water portion of the brine evaporates as it runs down the walls leaving solid material (dried salts) which is removed by the rotating blades. Two feedwater chemistries were used in the TFD. Table 3-15 shows the groundwater chemistry used during approximately 70% of operation. Table 3-16 shows the process condensate chemistry used during the balance of operation. As can be seen from the chemistry of the solutions, the pH ranges from 5 to 10.5 [64].

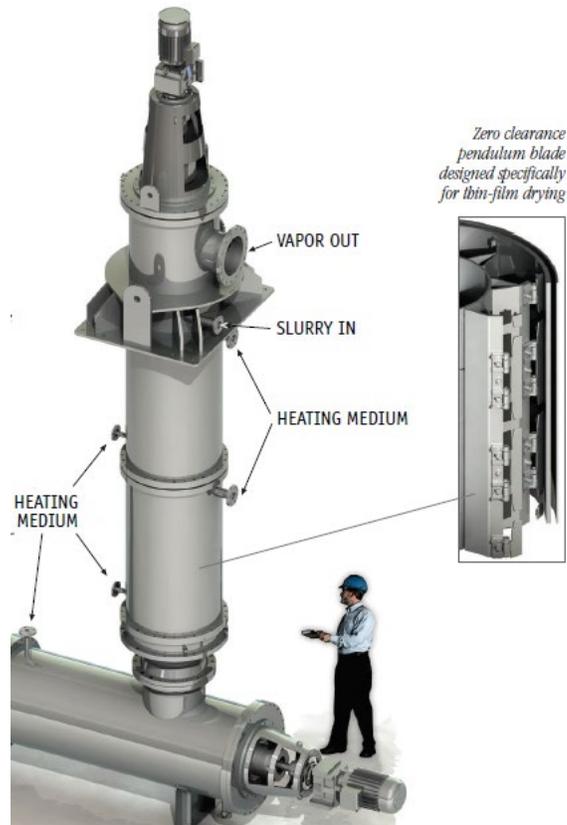
Figure 3-16 Schematic of an LCI TFD taken from Product Literature 2021.

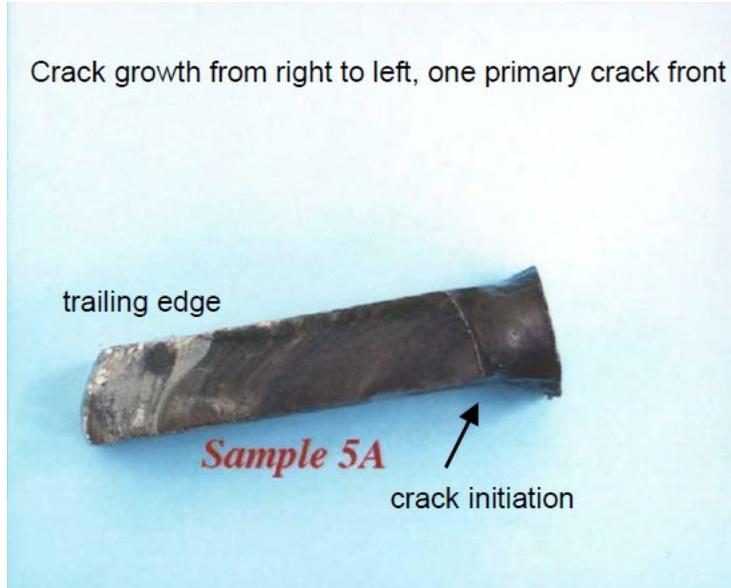
Figure 3-17 Macroscopic view of failed blade tip [64].

The failure analysis was based on visual and photographic inspections of several of the failed blades in conjunction with background information on the operation of the TFD. Nine samples of the failed blades were sectioned from the TFD and viewed macroscopically and microscopically. Figure 3-17 shows a macroscopic view of a failed blade section. Figure 3-18 and Figure 3-19 show micrographs of the fracture surface that illustrate the failure mechanisms.

Based on the visual inspection of the samples, the SEM work and a review of the operating conditions of the TFD, blade failures likely occurred due to chloride stress corrosion cracking, corrosion fatigue, cyclic fatigue, or some combination of these mechanisms. Some evidence of all three failure modes was discovered during the failure analysis process. More evidence was found to support chloride stress corrosion cracking and/or corrosion fatigue than was found for cyclic fatigue. No evidence of intergranular stress corrosion cracking was discovered during the analysis. This mode of failure was therefore eliminated as a possibility. No mention of erosion-corrosion of the blades was indicated in the report, despite the presence of solids although, it should be recognized that glass frit was not present in the waste.

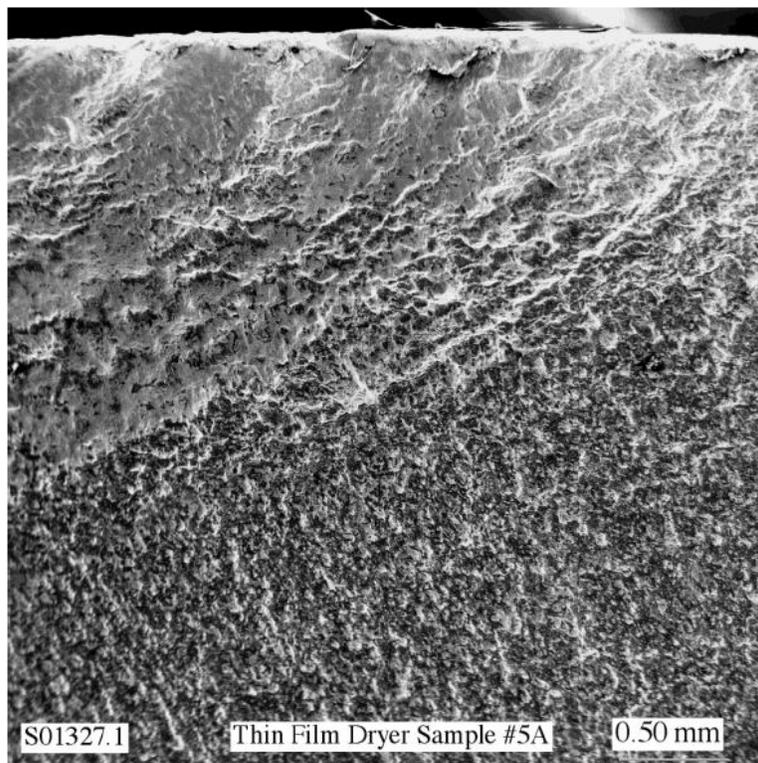
Figure 3-18. Failure by Chloride SCC or Corrosion Fatigue (see upper left) [64].

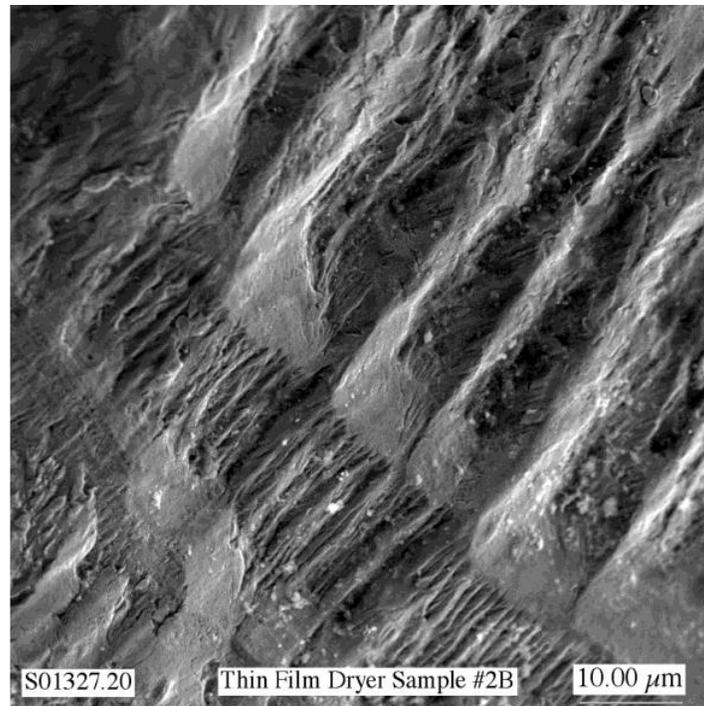
Figure 3-19 Failure by Fatigue [64].

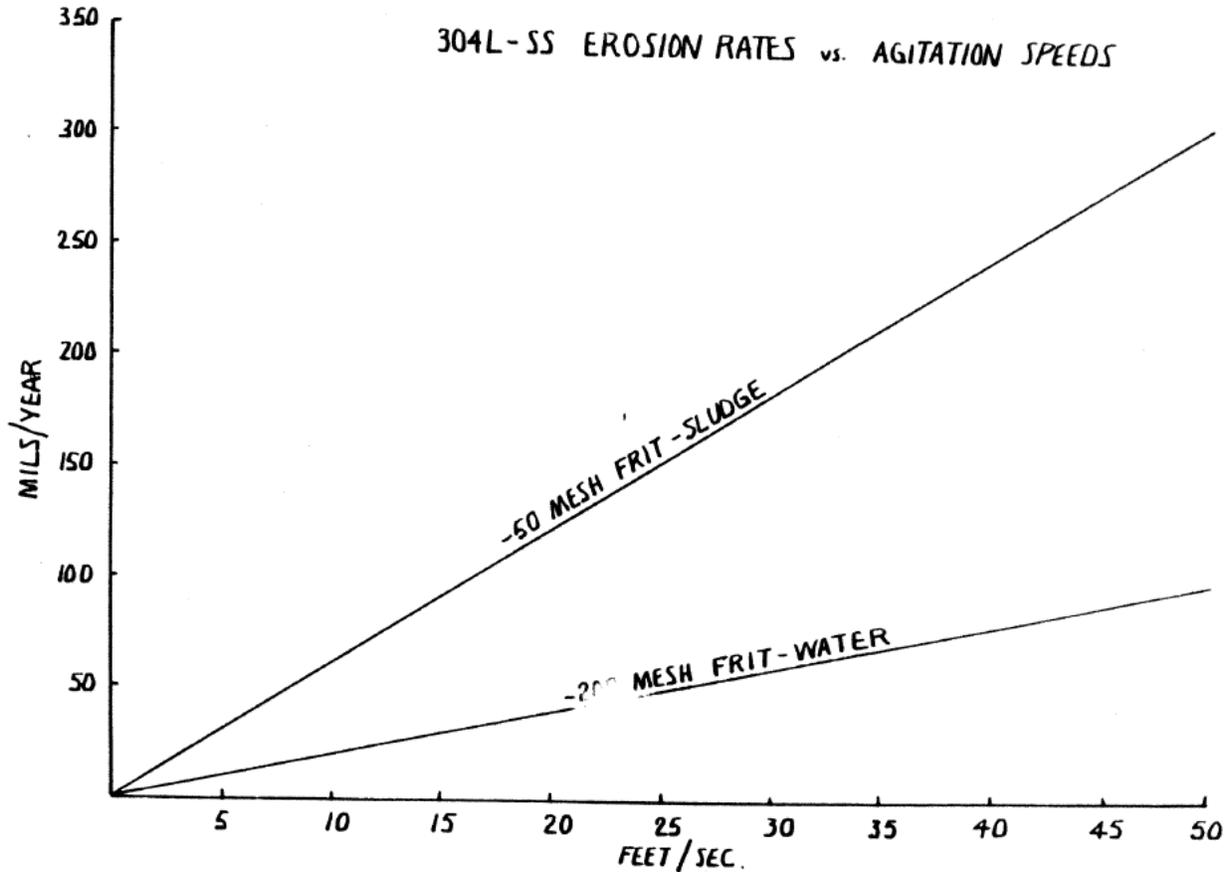
Figure 3-21. Erosion Test Apparatus Results [11]

Evidence of erosion caused by slurries that contained glass frit surfaced in early 1981 at an SRS pilot-plant testing facility [11]. Sludge/frit slurries were used in the melter slurry feed system. Examination of the centrifugal pump used in the feed system revealed substantial erosion wear on components. An erosion test apparatus (ETA) was constructed to investigate the performance of agitator blades in the sludge/frit slurries. Tests were performed in 50 mesh frit/sludge slurry and 200 mesh frit/water slurry. Figure 3-21 shows the relationship between the erosion-corrosion rates and the tip velocity for 304L stainless steel. The results show that erosion-corrosion rates at high velocities for the coarser 50 mesh frit were greater than that for the finer mesh frit. For example, at 10 ft/s, an erosion-corrosion rate of 20 mils/yr is predicted for 200 mesh (74 microns) frit service and 60 mils/yr is predicted for 50 mesh (297 microns) frit service. Care should be used in applying these results to the WFE. The test conditions were not well documented. If this test was for the SME/SRAT, they would have been performed under acidic conditions versus the alkaline conditions of the WFE. Solids concentration was also not reported. These values would represent bounding conditions because the test environment was at lower pH, higher temperature, and higher frit concentration than would be observed in the RD flowsheet.

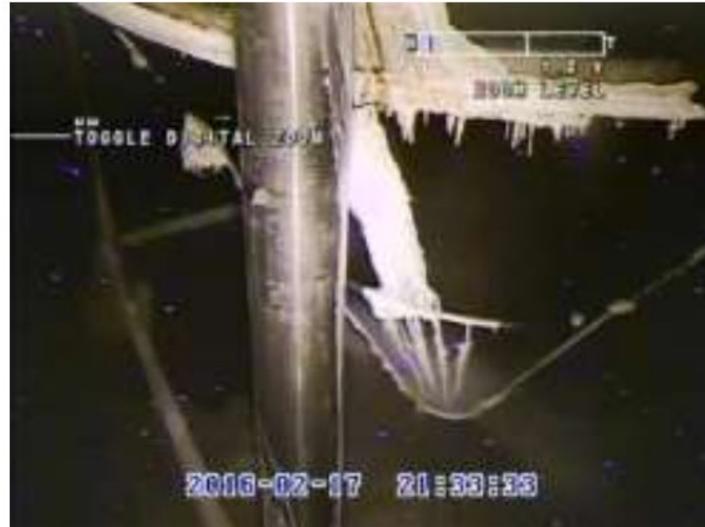
Figure 3-22. Leakage from 3H Evaporator Shell [23].

The pattern of degradation indicated by the UT exam, the proximity of the steam lance to the bottom spherical head, and the presence of undissolved solids suggested that slurry abrasive wear was the failure mechanism. Additionally, the angle of incidence between the steam lance spray and the bottom spherical head (approximately 45 °) was near the optimal value (approximately 30 °) for ductile materials such as G3. An evaluation utilizing an erosion rate model was performed to assess the likelihood that this was the failure mechanism [23]. The erosion rate given the parameters and assumptions in the model was proportional to the abrasive velocity cubed. The calculated fluid power based on the abrasive velocity of the steam lance would have easily produced the amount of erosion observed on the bottom spherical head. The presence of hard solid particles (e.g., undissolved solids) are also necessary to erode the surface. The hardness of the particles must exceed that of the eroded material, which in this case was the Hastelloy G3 (a Brinnell Hardness of 140). The model estimated that the observed erosion would be consistent with a stream that consisted of 0.5 wt.% of the solids that exceeded this hardness, coupled with an abrasive velocity that was approximately 15% of the lance steam exit velocity. These conditions could easily exist at the bottom spherical head.

This failure demonstrated that undissolved solids at a sufficient velocity and at a low incident angle could produce erosion of a ductile material, such as a stainless steel or nickel based alloy. It is recommended that during the design of the WFE, these parameters be considered when evaluating the blade and heat transfer surface for the possibility of erosion. The model used for the 3H evaporator erosion situation is recommended as a starting place, but other models may be available.

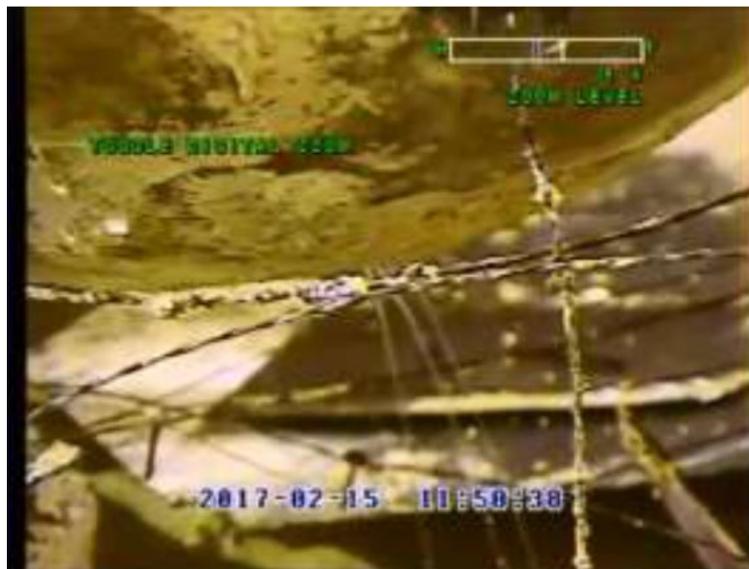
Figure 3-23. Leakage from the Bottom Spherical Head of the 3H Evaporator [23].
