Large Plate Experiment of Chloride-induced Stress Corrosion Cracking in Spent Nuclear Fuel Storage Canisters

Spent Fuel and Waste Disposition

***Andrew J. Duncan
Lisa N. Ward
Emmanuel E. Perez
Thanh-Tam T. Truong
Robert L. Sindelar
Savannah River National Laboratory***

August 31, 2021
Milestone No. M3SF-21SR010207082
SRNL-STI-2021-00412

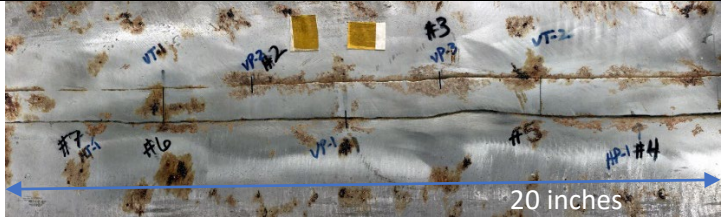
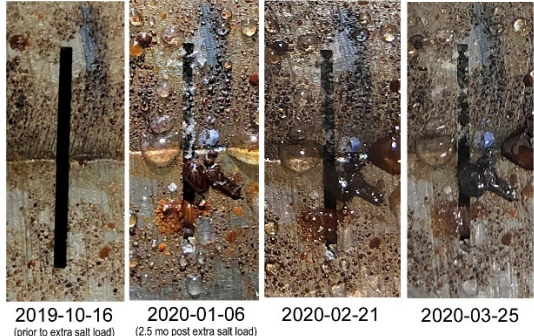
Experiment Metric	Notes	Image
Visual Test Results	<p>Clear evidence of rusting and staining.</p> <p>The rusting appearance remained essentially unchanged after first month throughout the 2-year exposure period</p>

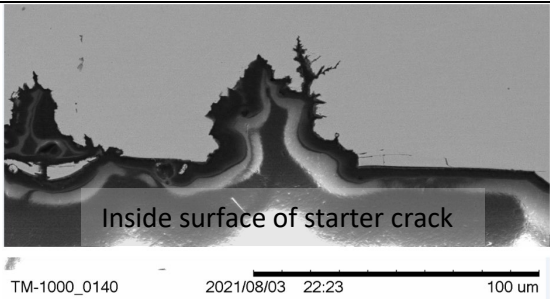
<p>Inside surface of starter crack</p><p>TM-1000_0140 2021/08/03 22:23 100 μm</p></div> <div>

Experiment Metric	Notes	Image
Maximum Observed Crack Growth Rate	<p>CGR = 0.022 mm/year (0.044 mm maximum SCC crack depth observed after 2-year exposure, and assuming no initiation time)</p> <p>The maximum pit depth observed was 300 μm from inside surface of EDM defect into the section thickness of the plate. The images are at 0.06” (1.5 mm) beneath the top surface of the plate.</p>	<div>

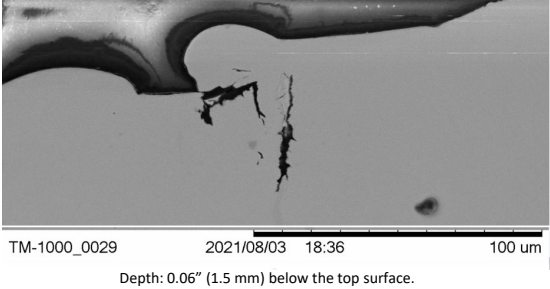
<p>TM-1000_0029 2021/08/03 18:36 100 μm</p><p>Depth: 0.06” (1.5 mm) below the top surface.</p></div>

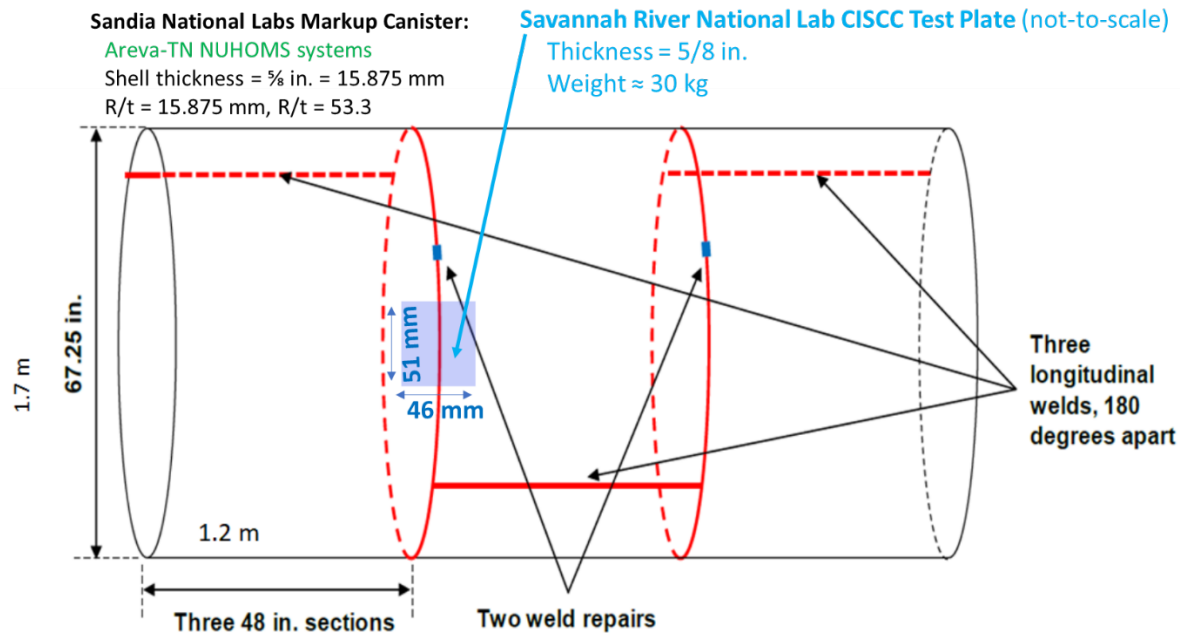
Figure 1. A sketch of the full size mockup canister showing the fabrication welds and the representative location where the SRNL large plate was harvested

As shown in Figure 1, the Savannah River large plate was sectioned through a region of the canister that contains a circumferential weld and has a planar dimension of 51×46 cm (20×18 inch.) with a nominal thickness of 16 mm ($\frac{5}{8}$ inch.) and its weight is approximately 30 kg. The SRNL large plate exposure to temperature and controlled humidity conditions was initiated May 8, 2019 and completed May 12, 2021.

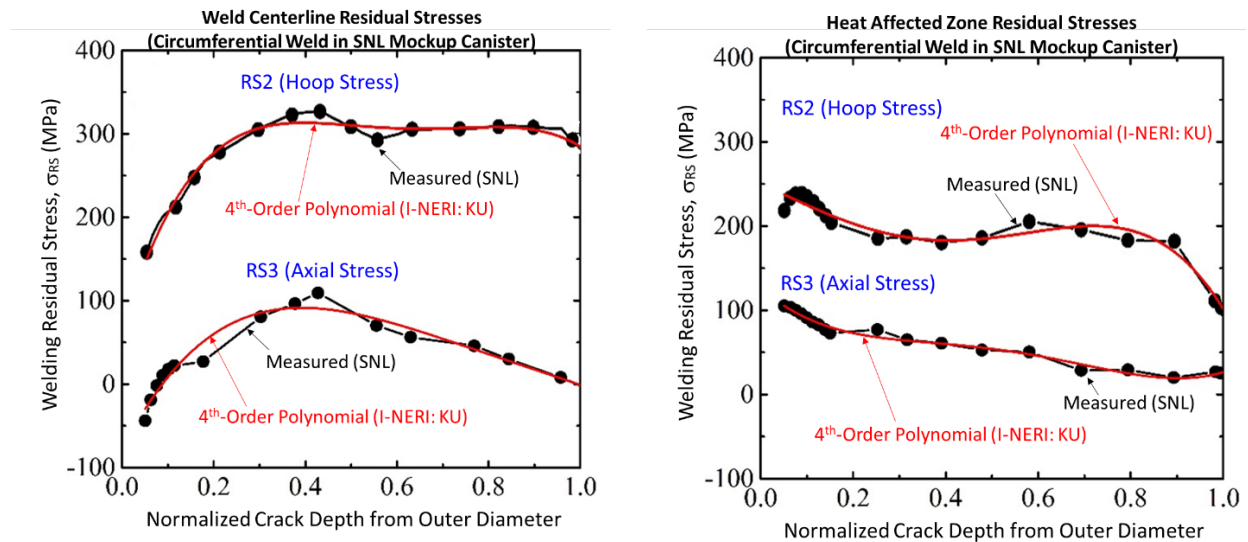
Figure 2. Welding residual stresses associated with the canister circumferential weld. The Weld Centerline and the Heat Affected Zone Residual Stresses were measured at the approximate center of the weld, and at 4 mm from the weld toe (fusion line) into the base material, respectively [1]

To facilitate structural integrity assessment as required in the AMP for SNF canisters, the WRS distributions have been determined experimentally at SNL [1]. For a circumferential weld that is associated with the current Savannah River large plate test, the SNL WRS results are summarized in Figure 2, in which the black curves represent the average of the experimental (measured) values [1], and the red curves are the 4th-order polynomial curve fitting that is needed to facilitate stress intensity factor (SIF) calculations with API 579 [2, 3] (or other similar national or international consensus codes for the industry). The 4th-order polynomial fit reported here was obtained by Korea University under DOE I-NERI/USA-ROK program [12]. These residual stresses were also determined using the finite element method [13] by simulating the actual welding procedure documented in a previous report [1] and are in good agreement with the experimental results. The designations of these welding residual stresses are shown in Figure 3, where RS2 is the WRS component parallel to the weld and tends to open an axial crack, and RS3 is the WRS perpendicular to the weld and is responsible for opening a circumferential crack.

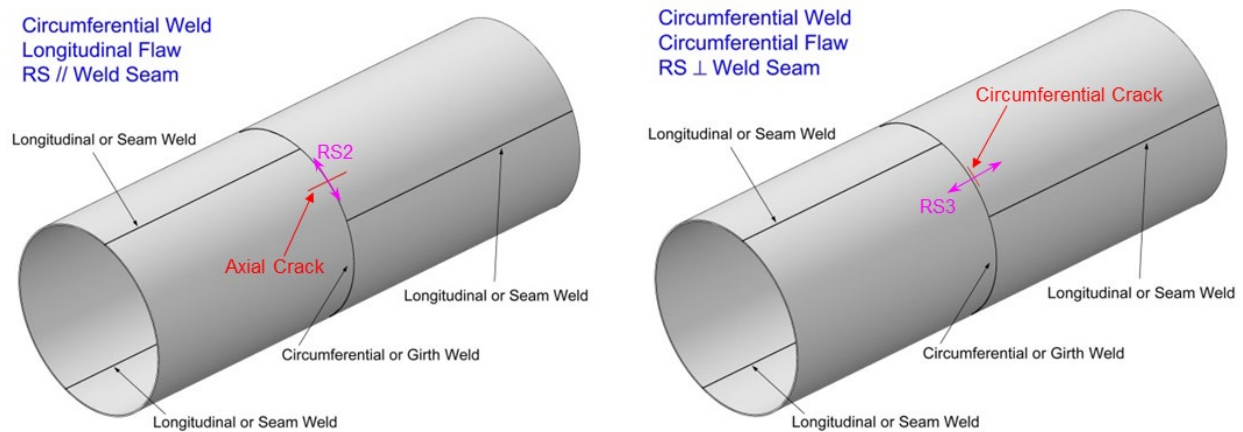
Figure 3. Designations of residual stresses (RS2 and RS3) for a circumferential weld in a canister

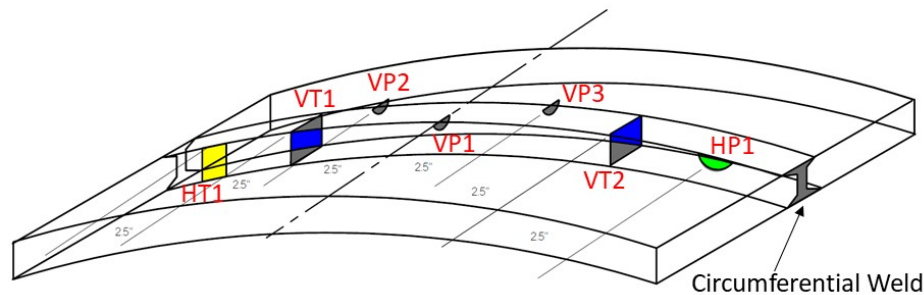
Figure 4: Starter crack layout and orientation in the large plate

Starter Crack Description (total 7 EDM cracks):

VT1, VT2: Through-wall crack across the weld.

Crack length= **25 mm**

HT1: Through-wall crack parallel to the weld edge.

Crack length= **12 mm**.

VP1, VP2, VP3: Semi-circular Part-through-wall crack perpendicular to the weld edge.

Crack length= **12 mm** and crack depth = **6 mm**

HP1: Semi-circular Part-through-wall crack parallel to the weld edge.

There are seven starter cracks built in the SRNL large plate (Figures 4). The designations and descriptions of these EDM starter cracks are:

The starter crack layout and orientation is schematically shown in Figure 4. Each type of the EDM crack configuration is shown in Figure 5. When these cracks are overlaid over the contour map of the residual stress parallel to the circumferential weld [1], the WRS loading of these cracks can be seen in Figure 6. The starter crack tips are located in the weld/HAZ region. Note that the stress contour in Figure 6 only applied to the starter cracks that are perpendicular to the weld (i.e., VT1, VT2, VP1, VP2, and VP3).

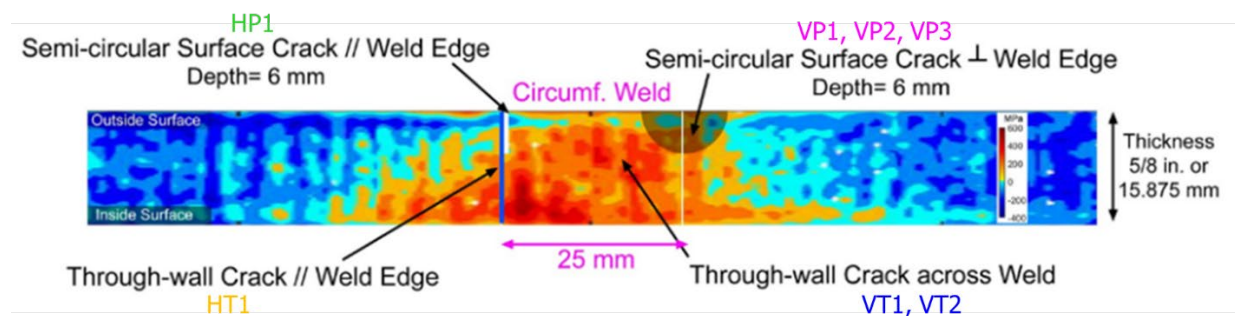
Figure 6. Large plate starter crack design as viewed from plate cross-section through the circumferential weld (superimposed over the contour map for welding residual stress parallel to the weld [1])

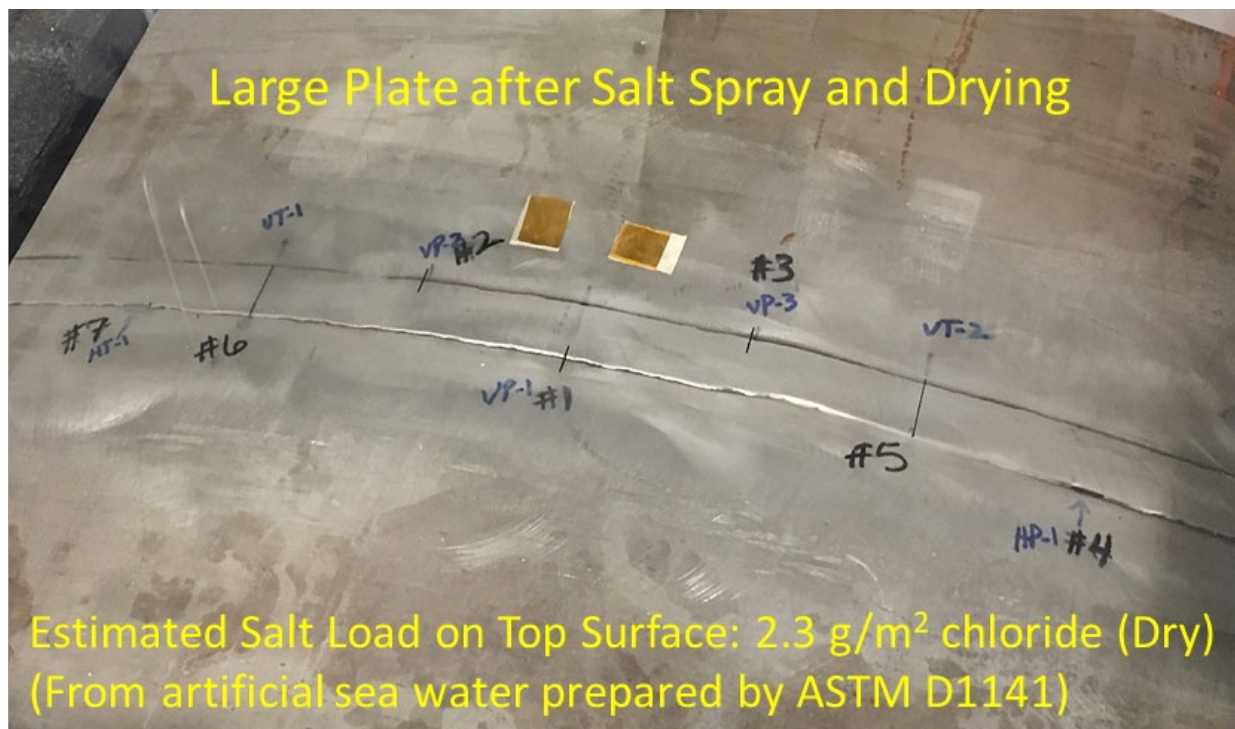
Figure 7. Large plate with EDM starter cracks after salt spray and drying

Artificial sea salt was prepared by following the procedure recommended by ASTM D1141, then deposited on the outer surface of the plate in the welded region with an air brush. The estimated salt load on the plate top surface was 2.3 g/m^2 chloride (dry). The salt coating procedure, as outlined in ASTM G41, “Standard Practice for Determining Cracking Susceptibility of Metals Exposed under Stress to a Hot Salt Environment,” was used to create an evenly distributed salt layer over the plate surface. Figure 7 shows the large plate after salt spray and drying, ready for placing inside the test cell.

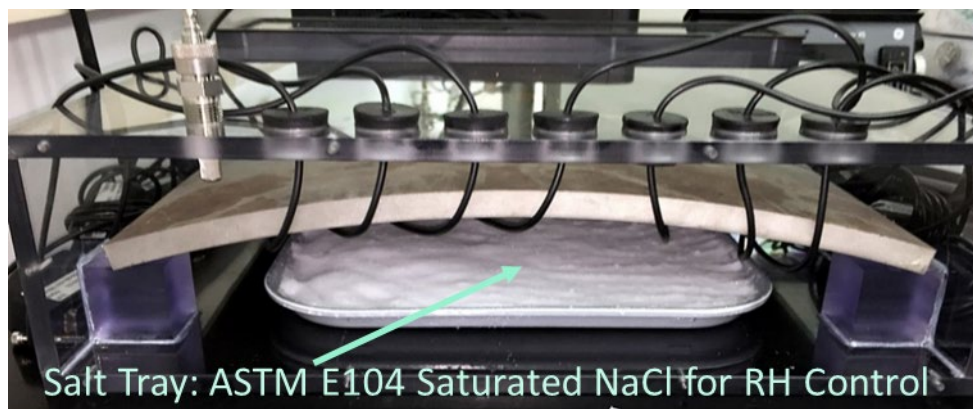
Figure 9. The NaCl salt tray under the large plate for maintaining a constant relative humidity in the test cell

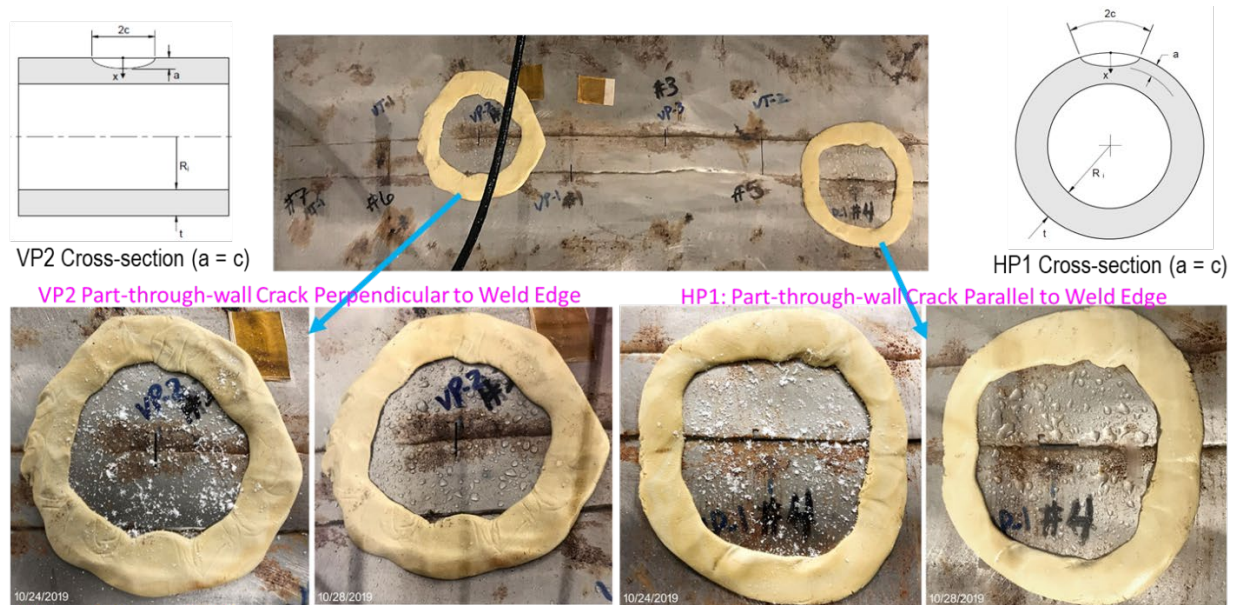
Figure 11. Additional salt applied to selected starter cracks (VP2 and HP1)

Because no cracking was observed after 5 months of exposure with the initial salt load of 2.3 grams Cl^-/m^2 on the plate surface, two starter cracks (VP2 and HP1) were selected to receive additional salt load, where VP2 is a semicircular surface crack perpendicular to the weld, and HP1 is a semicircular surface crack parallel to the weld edge. The original crack lengths are both 12 mm on the plate surface. As seen in Figure 11, these two cracks were isolated with putty material (yellow) from the other starter cracks and the extra salt was applied to the enclosed areas on October 24, 2019). The deliquesced salt brine droplets can be seen in Figure 11.

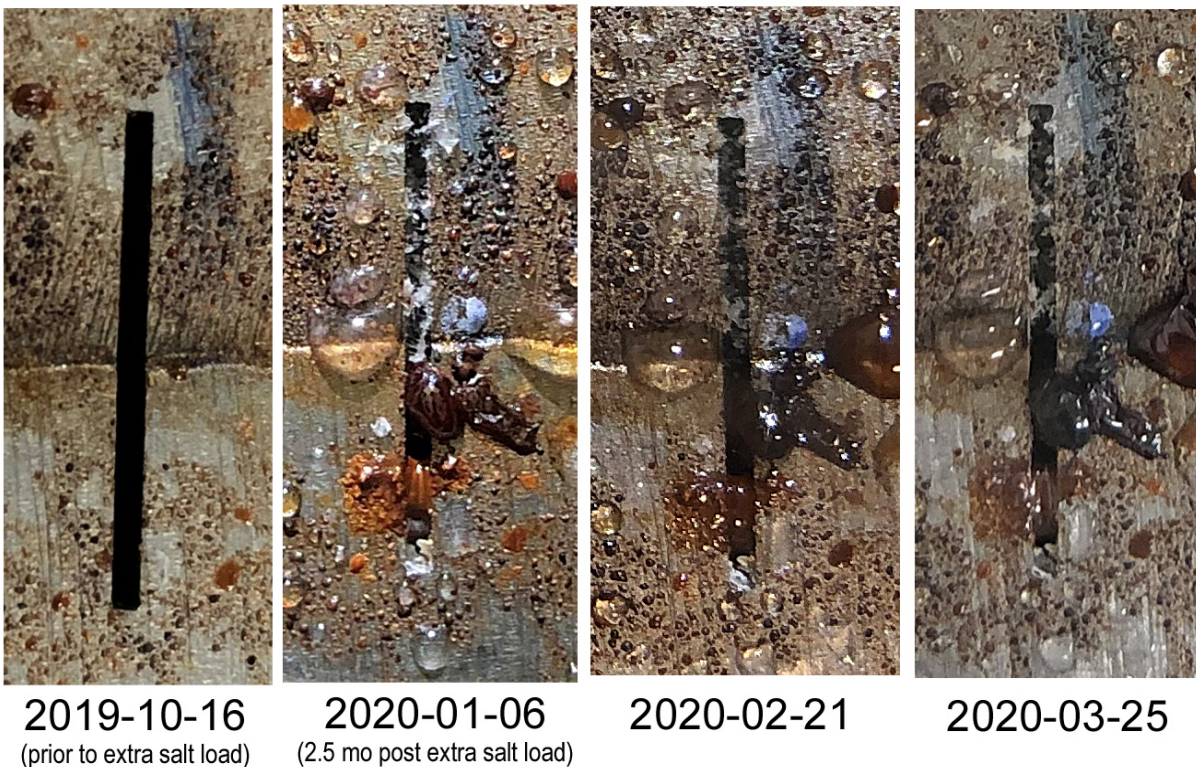
Figure 12. Closeup view of corrosion evolution of a semicircular surface crack VP2 after additional salt was applied (original crack length is 12 mm and is perpendicular to the weld)

Figure 12 shows the corrosion activities of VP2 from October 16, 2019 (about a week before the extra salt was applied) through March 25, 2020. Most of the corrosion products appear to be highly concentrated with iron. A very small spot with light-colored, crack-like morphology seemed to form at the lower crack tip across the crack opening, but it turned out to be a small salt cake or crystal that has been broken up.

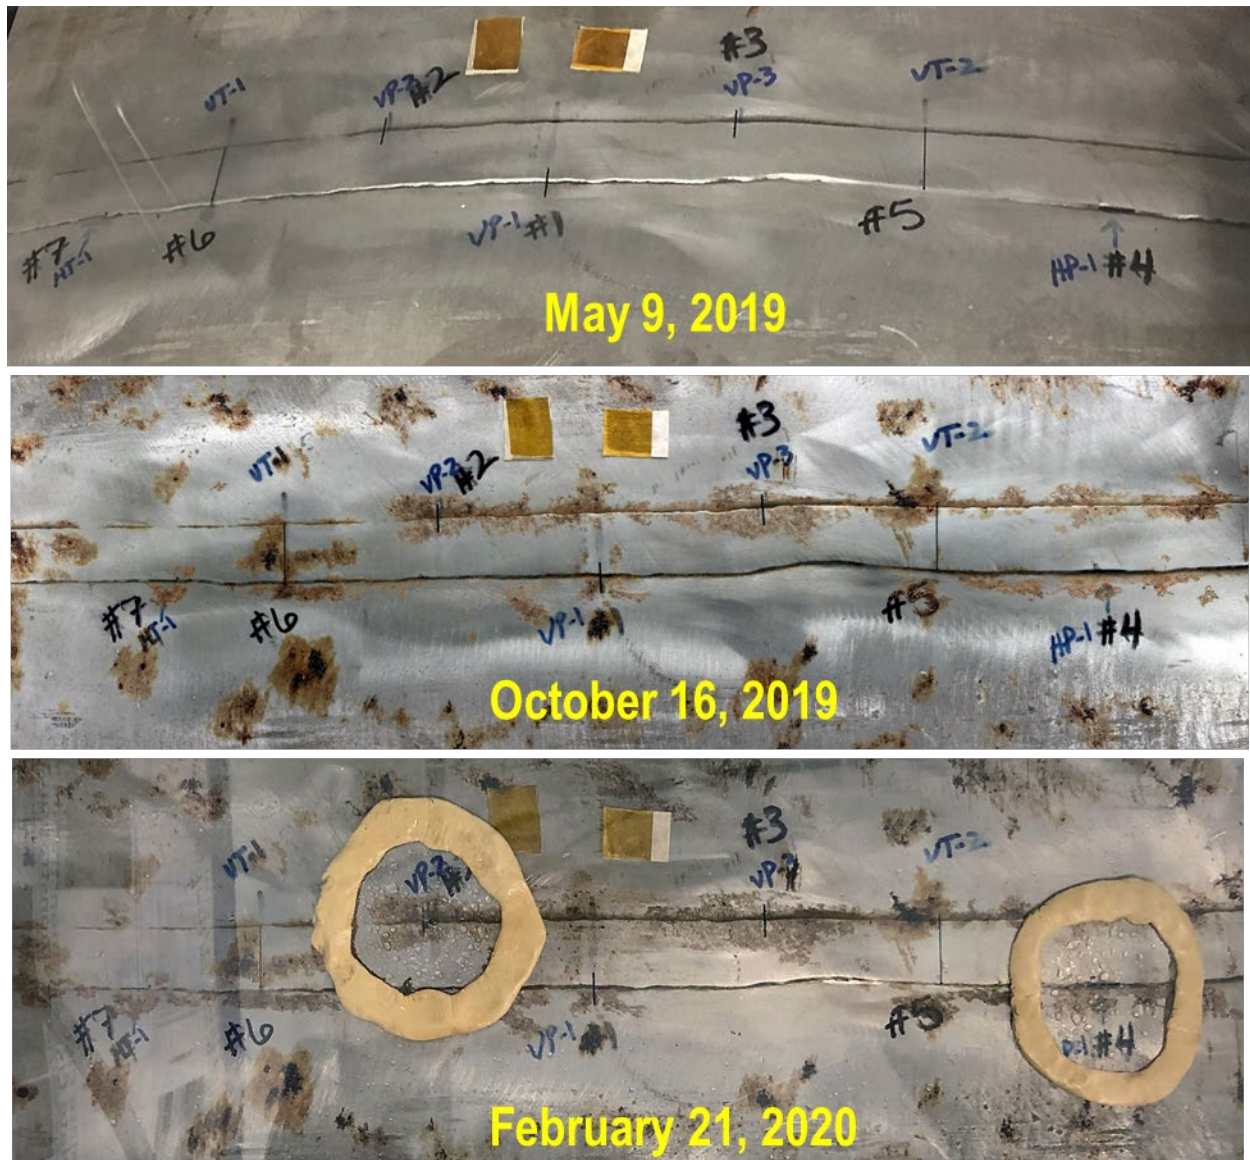
Figure 13. Evolution of general corrosion on the large plate in weld region

A comparison of general corrosion in the weld region across the width of the entire large plate from May 9, 2019 (test initiation date) through February 21, 2020 is shown in Figure 13. The corrosion pattern appears to be stabilized quickly (sometime between May and October 2019). Even with extra salt applied to the two starter cracks on October 2019, it seems that the appearance of general corrosion was not affected (Figure 13). Of course, in the very close vicinities around those two starter cracks with extra salt load, the general corrosion remains relatively active (see VP2 in Figure 12).

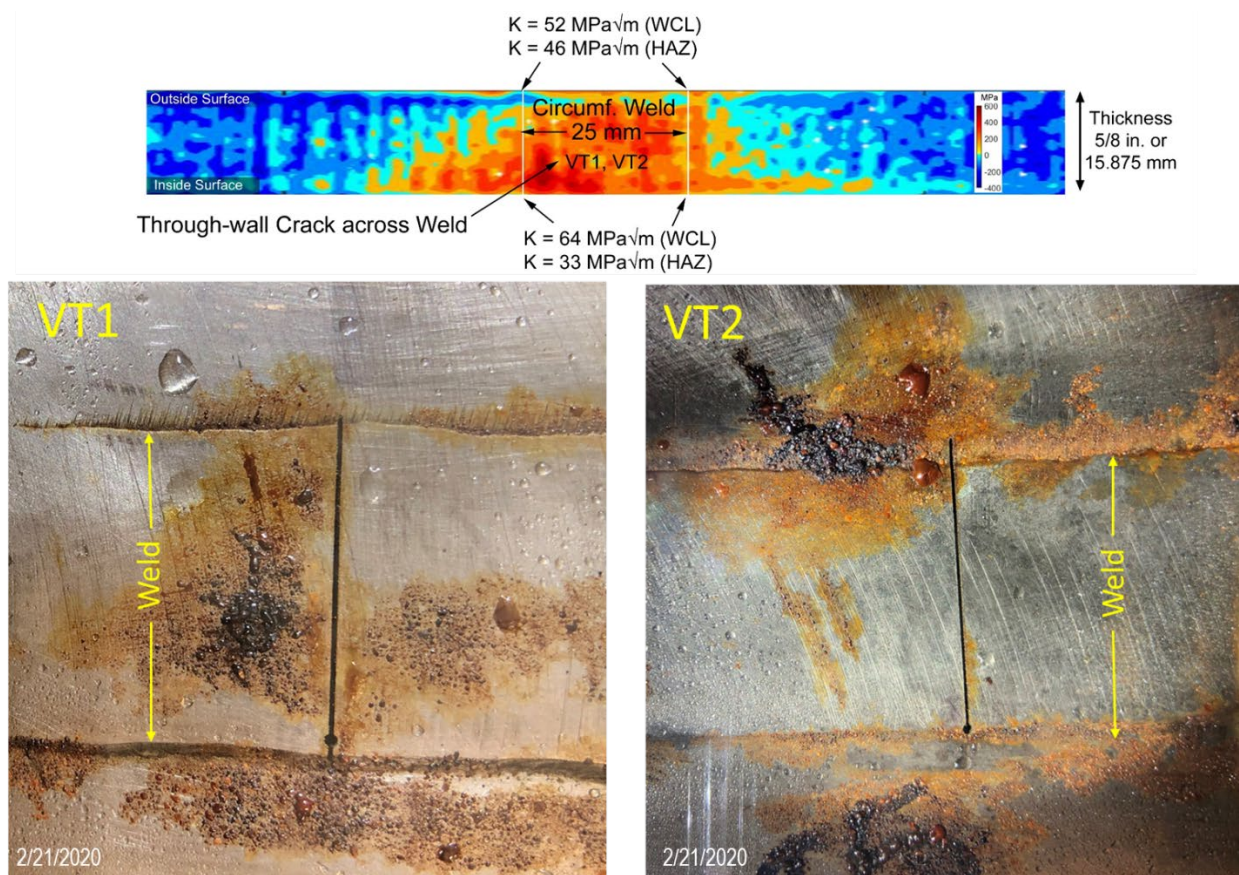
Figure 14. Stress intensity factor solutions for the starter crack VT1 or VT2 and the images of these cracks after 9.5 months of exposure (VT1 and VT2 are through-wall cracks across the weld)

**Table 4. Stress Intensity factors for starter cracks VT1 or VT2
(Axial through-wall crack: Half crack length $c = 12.5$ mm)**

Welding Residual Stress	Crack Tip Location	Stress Intensity Factor (MPa \sqrt{m})
Weld Centerline	Outside Surface	51.6
	Inside Surface	64.3
Heat Affected Zone	Outside Surface	46.1
	Inside Surface	33.3

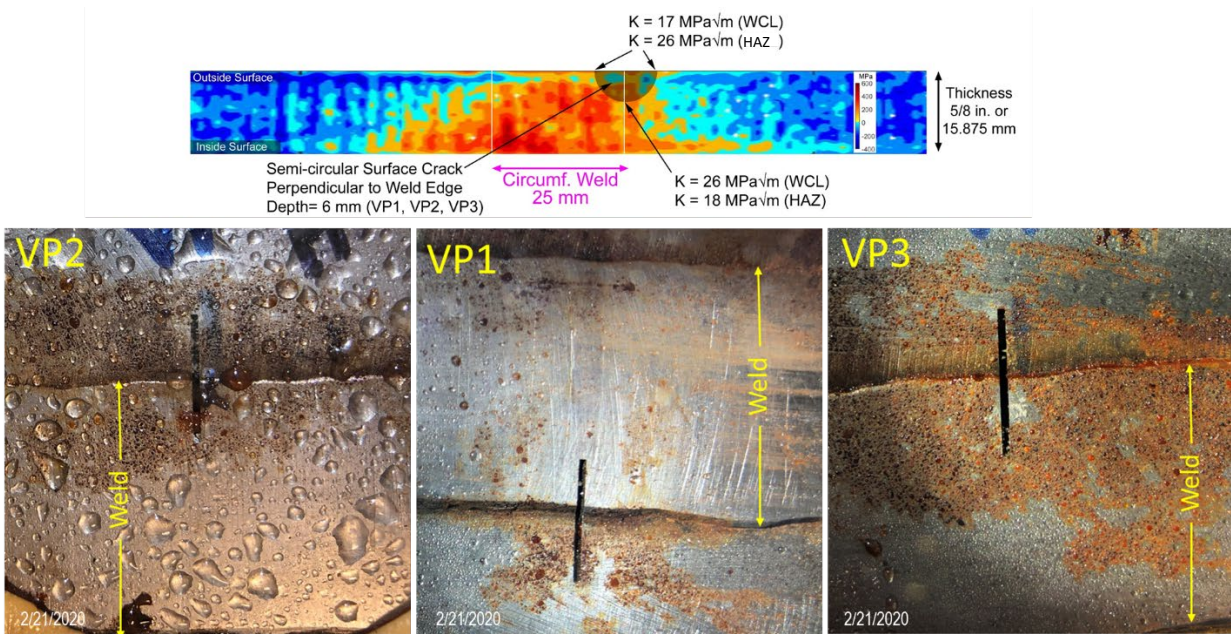
Figure 15. Stress intensity factor solutions for the starter crack VP1, VP2, or VP3 and the images of these cracks after 9.5 months of exposure (VP1, VP2, and VP3 are semicircular part-through-wall surface cracks perpendicular to the weld)

Welding Residual Stress	Crack Tip Location	Stress Intensity Factor (MPa \sqrt{m})
Weld Centerline	Deepest Point	26.0
	Surface Point	16.9
Heat Affected Zone	Deepest Point	18.3
	Surface Point	26.4

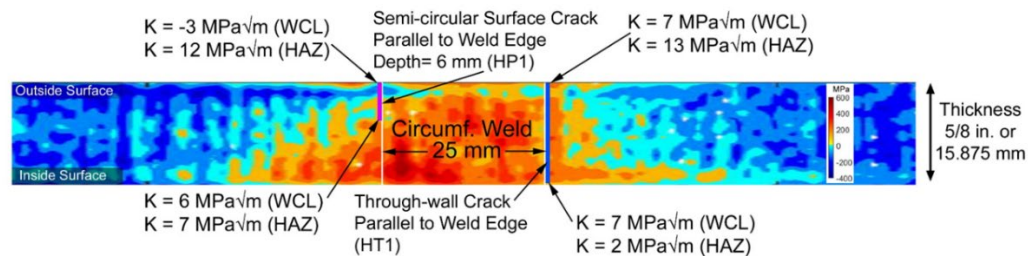
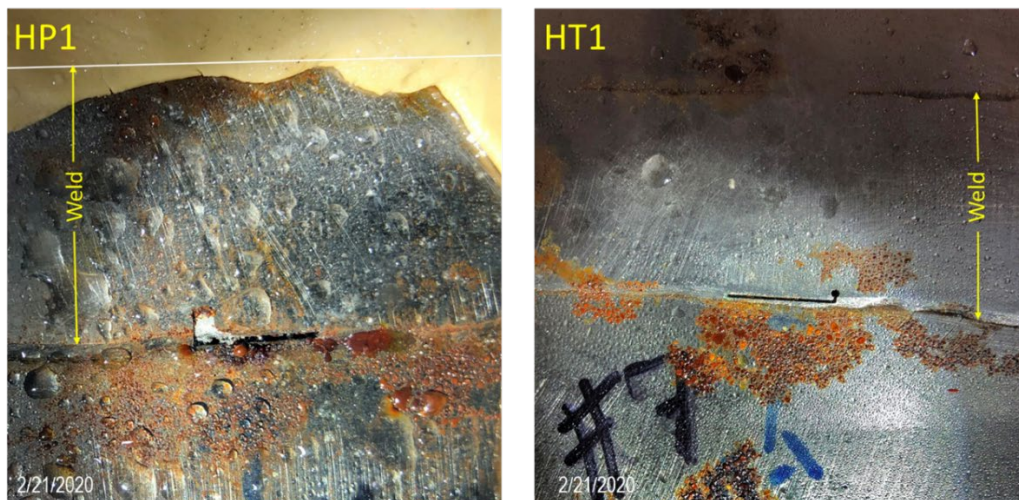
Figure 16. Stress intensity factor solutions for the starter cracks HP1 and HT1, and the images of these cracks after 9.5 months of exposure (HP1 is a semi-circular part-through-wall surface cracks parallel to the weld; and HT1 is a through-wall crack parallel to the weld)

Welding Residual Stress	Crack Tip Location	Stress Intensity Factor (MPa√m)
Weld Centerline	Outside Surface	6.5
	Inside Surface	6.7
Heat Affected Zone	Outside Surface	13.3
	Inside Surface	1.9

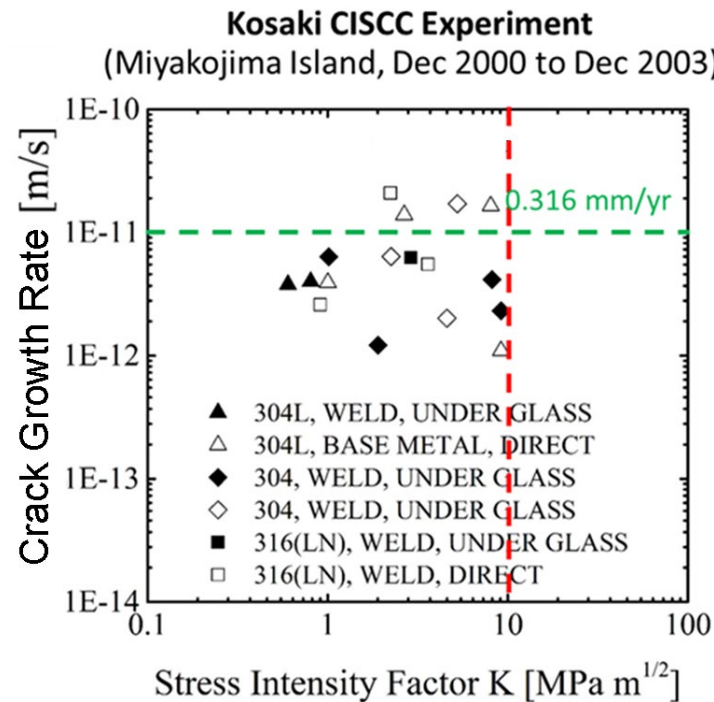
Figure 17. Crack growth rates from natural exposure on Miyakojima [15, 16]
(Courtesy of Korea University under I-NERI/USA-ROK)

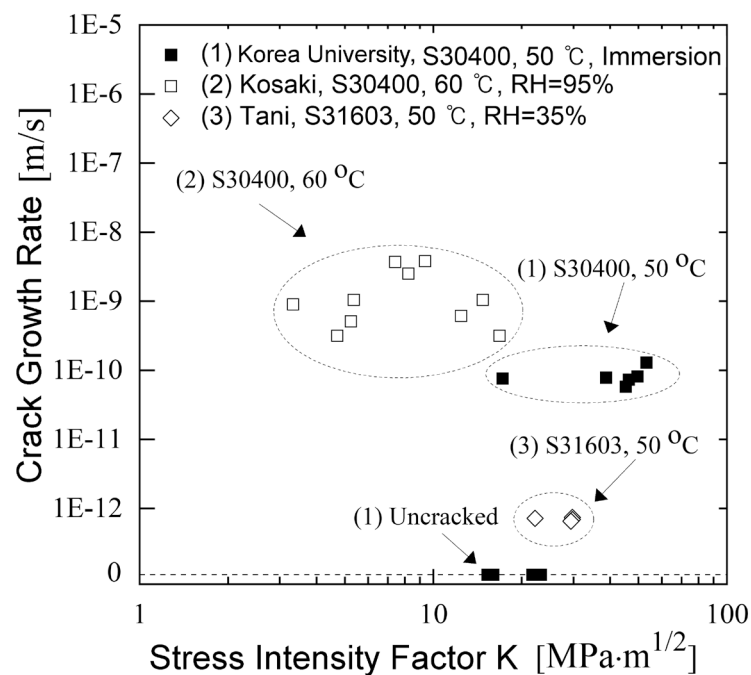
Figure 18. Crack growth rates from laboratory tests for stainless steels at 50 and 60°C under various CISCC conditions [19]

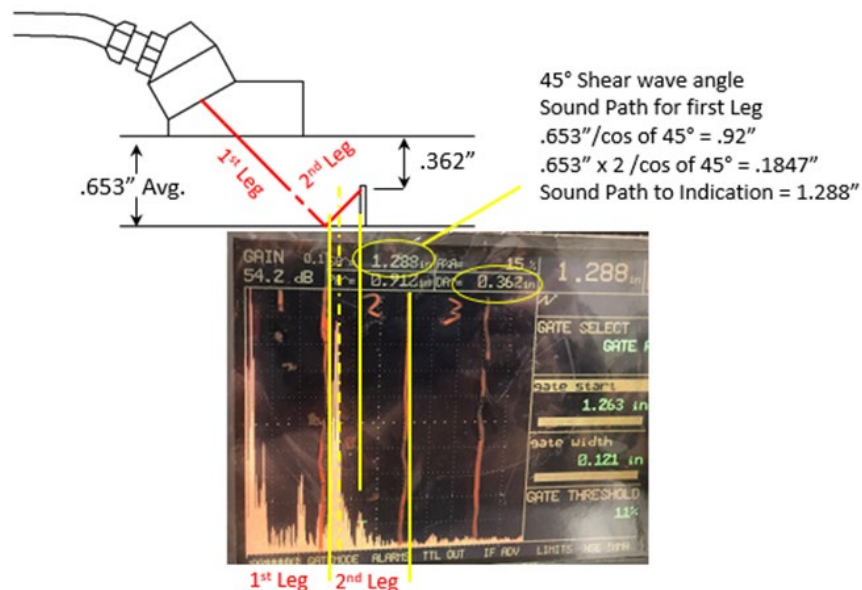
Figure 19. Ultrasonic Shearwave Examination of SRNL Large Plate Seed Crack VP-2 EDM Notch to detect stress corrosion cracking

Next, ultrasonic shearwave examination of the volume around the starter cracks was conducted. Figure 19 is a depiction of the scan plan as well as the indication in the second leg of the ultrasonic shearwave beam. The larger beam is a collective reflection of the beam spread at the bottom (corner trap) of the notch. The signal within the 1st leg being the diffracted tip from the top of the notch. The indication found in the EDM notch did not exceed the distance amplitude curve. Numerous factors can account for this either due to proximity of the indication to the corner trap, directional variations, or size. This indication however was declared by the UT inspector due to responses (reflections) from varying scanning positions which correlated to relatively the same depth. Measurements of the remaining ligament of the plate under VP-2 were 0.398 inches prior to the experiment and, 0.362 inches after. However, no crack extension was observed in the destructive examination at the notch tip.

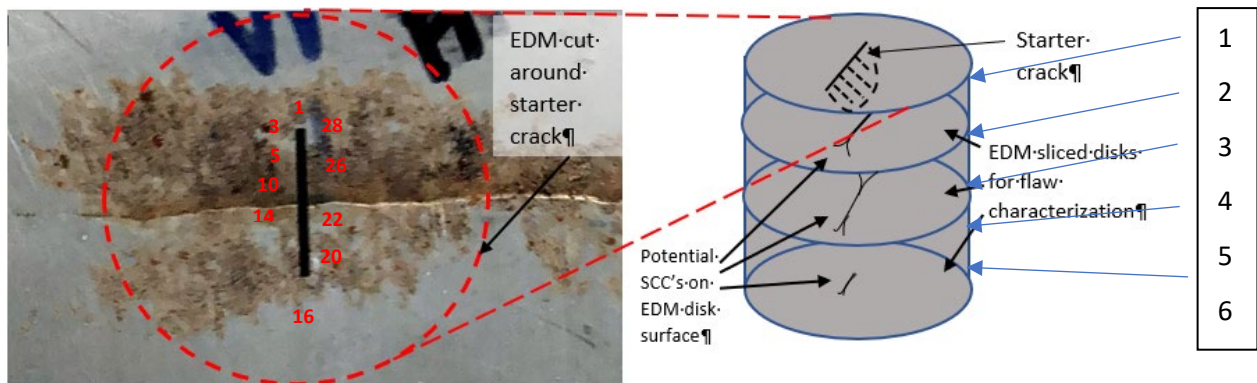
Figure 20. Schematic of serial sectioning of materials containing a starter crack VP-2 along the depth of the stress corrosion crack. Images from areas 1-13 and 24-28 are in the base metal. The other areas (14-23) are in the weld metal

Figures 21 - 31 contain images of crack like indications and pits on the inside surface of starter crack VP-2 at a depth of 0.06" below the outside surface of the plate. Areas labelled 1-28 span counter-clockwise (from top view) around perimeter of the starter crack as shown on image in Figure 20. Crack lengths ranging from 5 to 44 μm and pits up to 300 μm were observed.

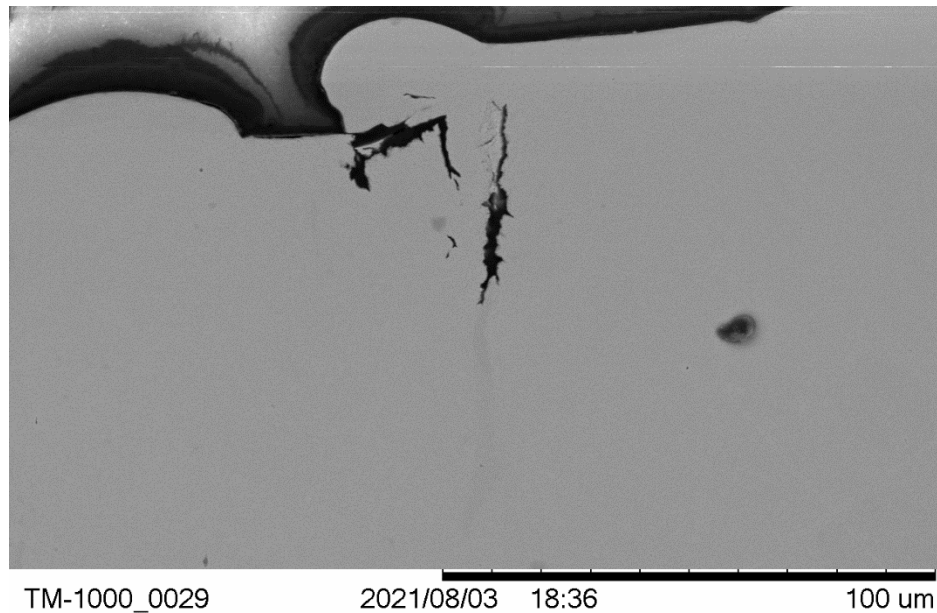
Figure 21 Secondary Electron Micrograph of Crack observed in Sample 1, Area 1. This image shows the 44 μm long stress corrosion crack, the maximum observed (base metal)

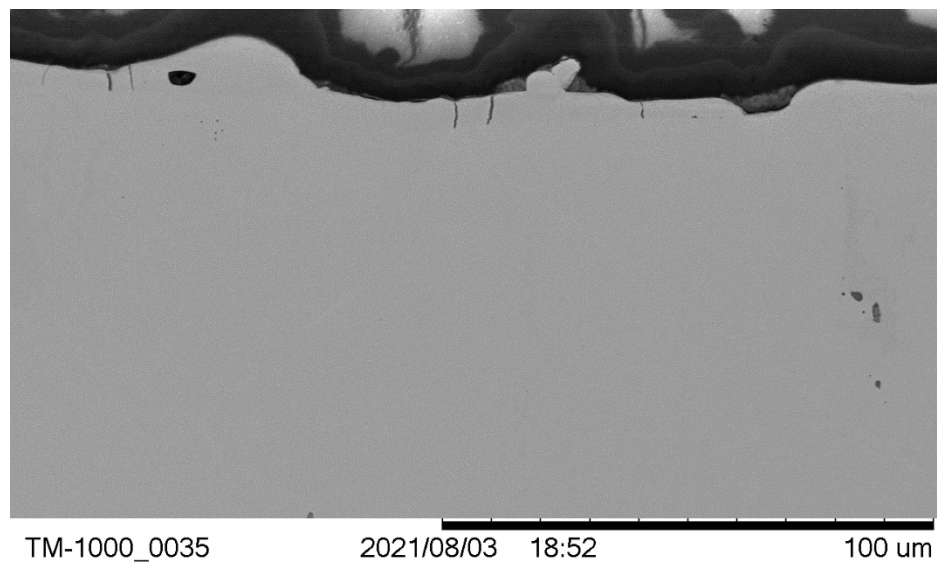
Figure 22 Secondary Electron Micrograph of Cracks observed in Sample 1, Area 3

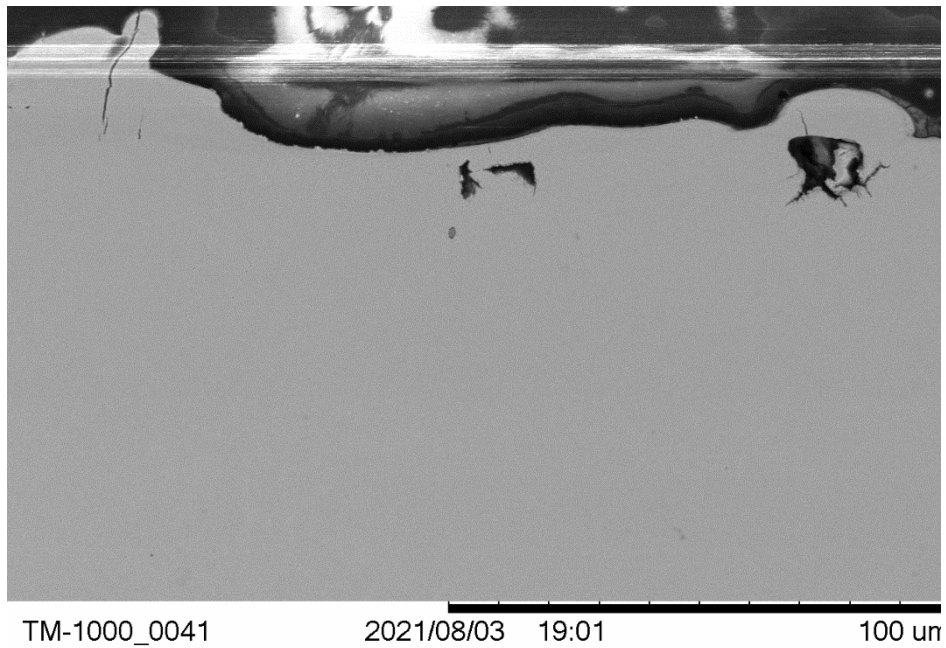
Figure 23: Secondary Electron Micrograph of Cracks observed in Sample 1, Area 10

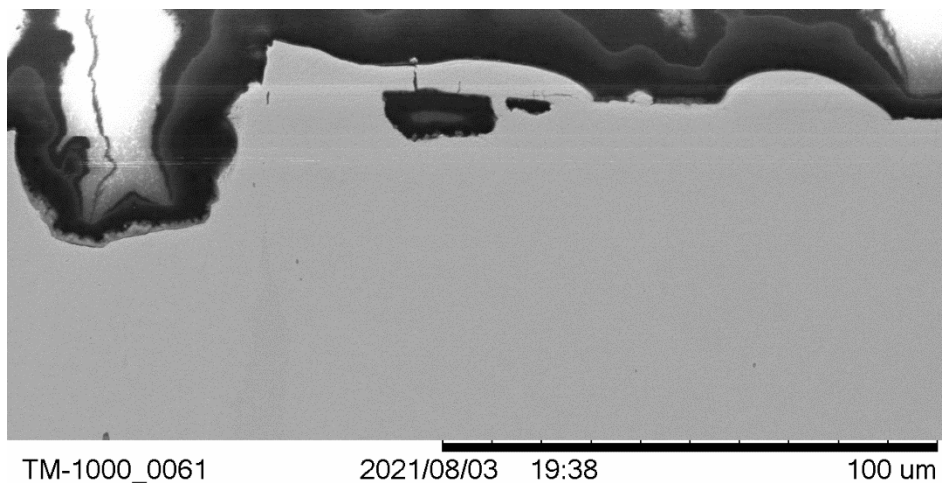
Figure 24: Secondary Electron Micrograph of Pits and Cracks observed in Sample 1, Area 5. Note that the Secondary Electron Micrograph images show artifact image features away from the sample surface that appear as cracks. These are not artifacts are not stress corrosion cracks in the stainless steel

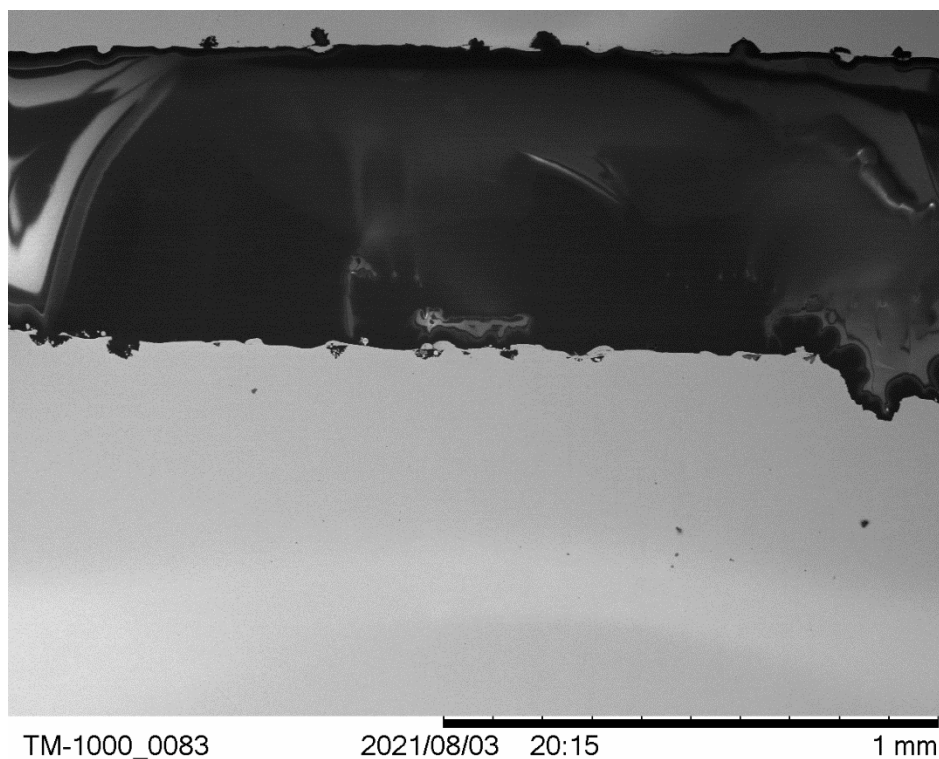
Figure 25: Secondary Electron Micrograph of Pits observed in Sample 1, Area 14

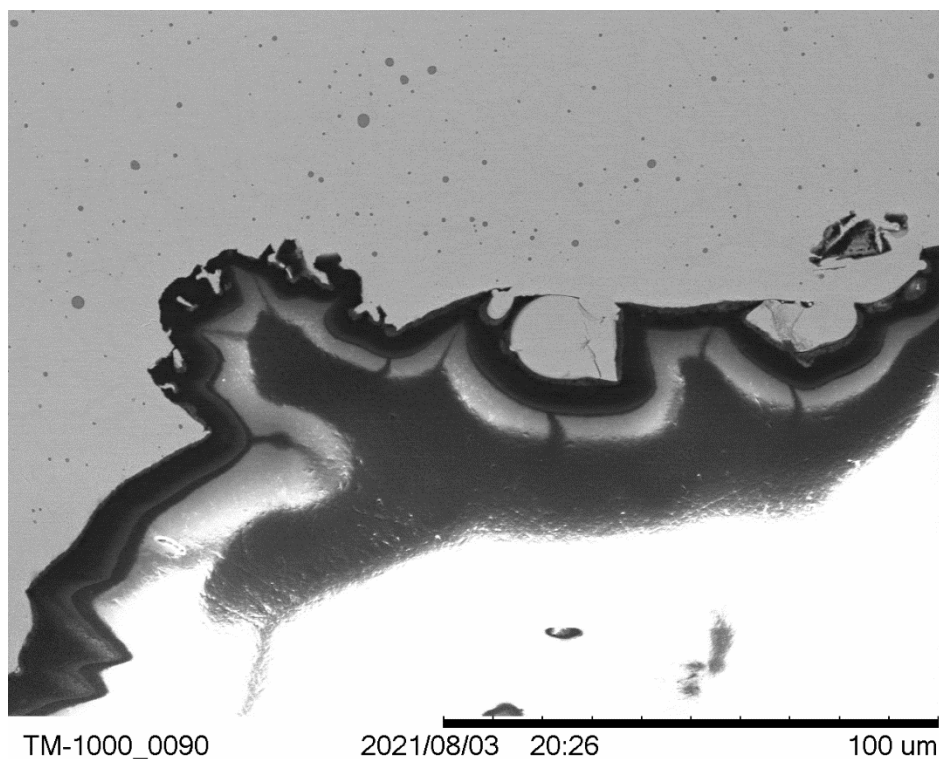
Figure 26: Secondary Electron Micrograph of Pits observed in Sample 1, Area 16

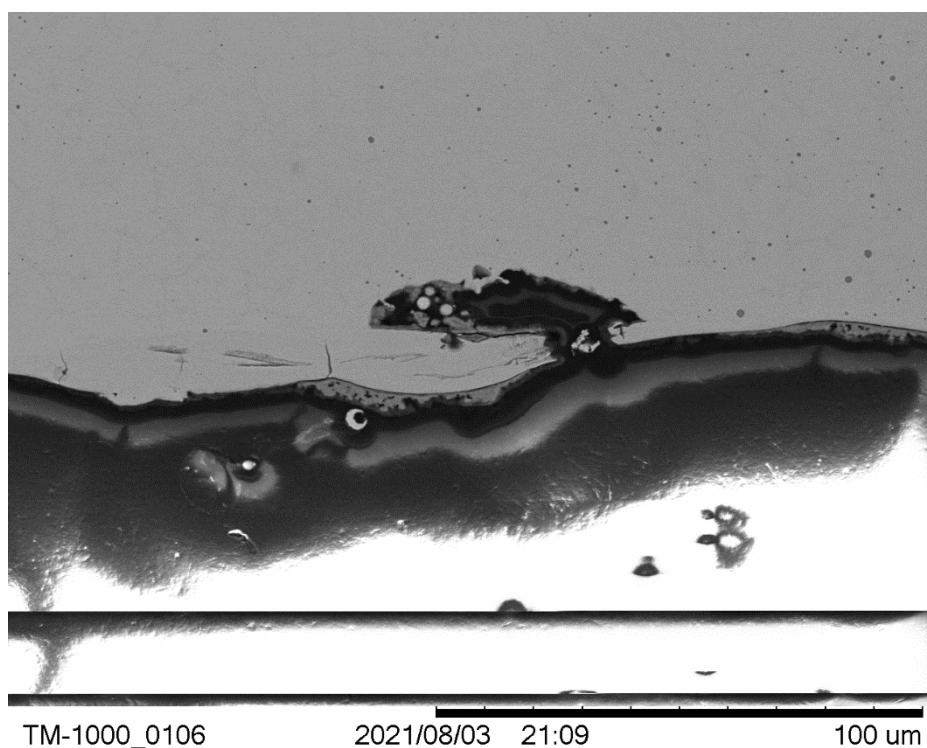
Figure 27: Secondary Electron Micrograph of Pits observed in Sample 1, Area 20

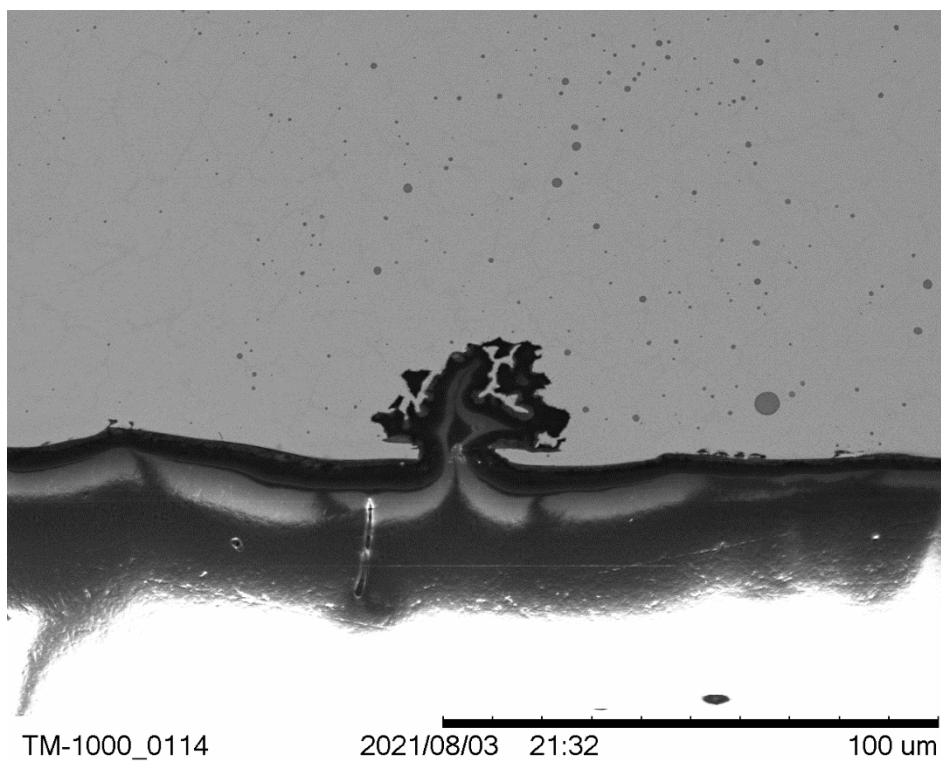
Figure 28: Secondary Electron Micrograph of Pits observed in Sample 1, Area 22

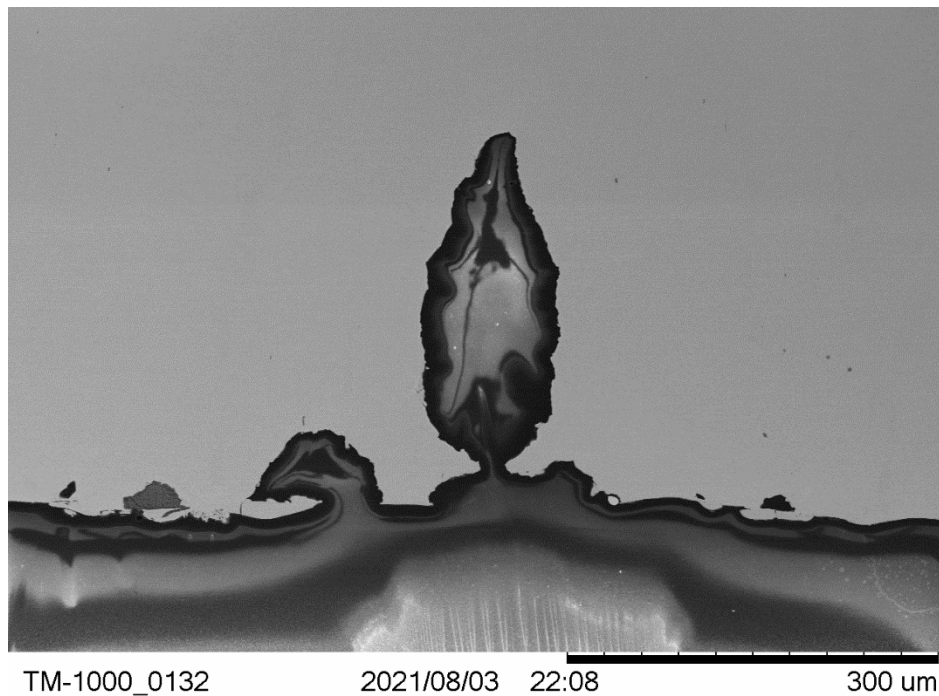
Figure 29: Secondary Electron Micrograph of Pits observed in Sample 1, Area 26 This image shows the 300 μm deep pit, the maximum observed (base metal)

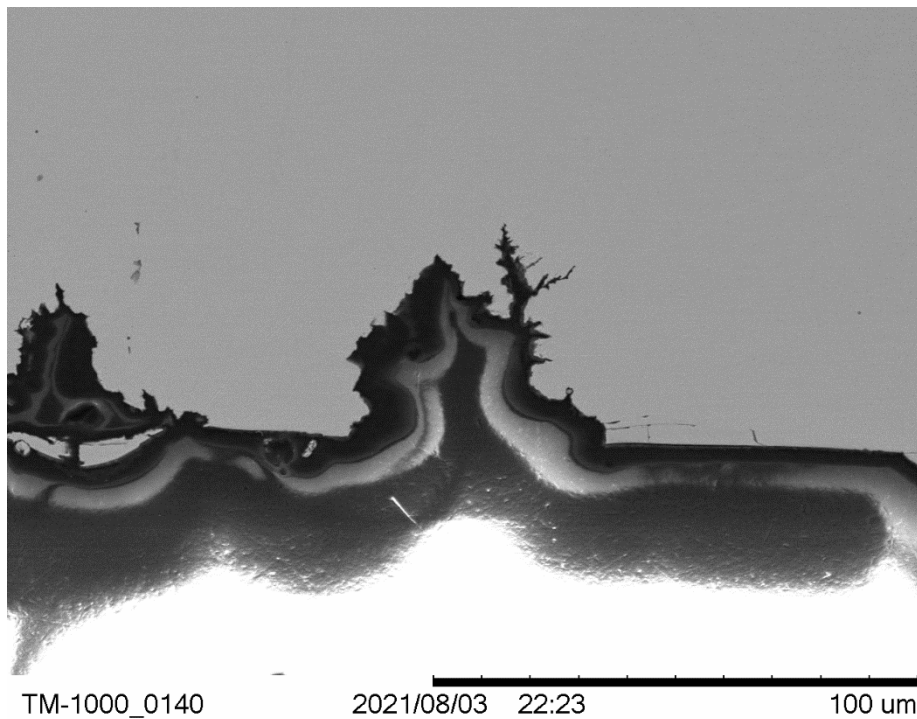
Figure 30: Secondary Electron Micrograph of Pits observed in Sample 1, Area 28

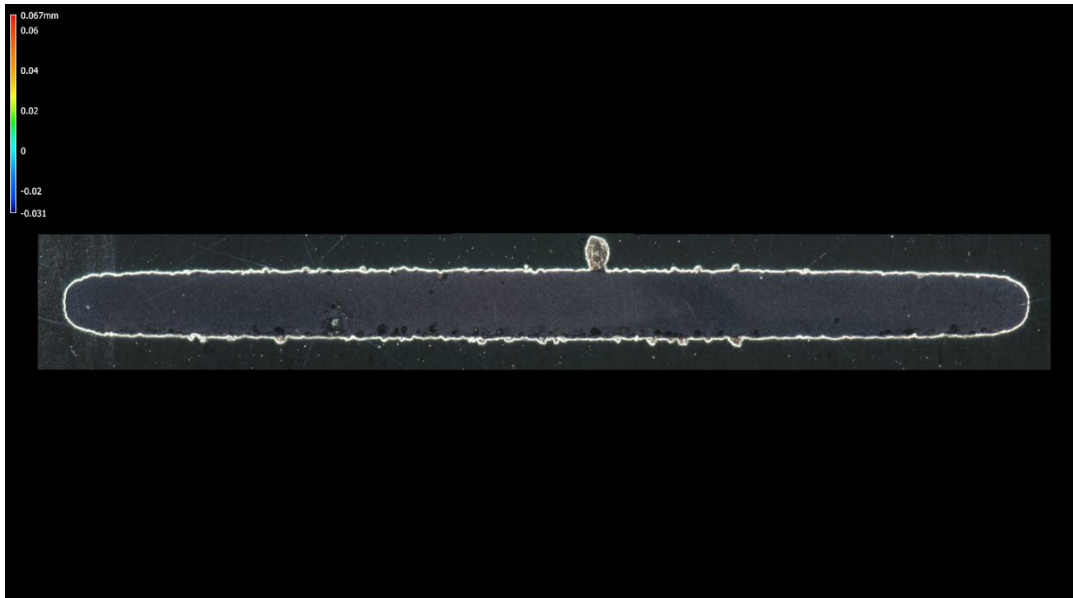
Figure 31: Optical Micrograph (using LCM) of Starter Crack, Sample 2. Chloride-induced pitting around the starter crack, in both base and weld metal is observed
