Large Plate Experiment of Chloride-induced Stress Corrosion Cracking in Spent Nuclear Fuel Storage Canisters

Spent Fuel and Waste Disposition

***Andrew J. Duncan
Lisa N. Ward
Emmanuel E. Perez
Thanh-Tam T. Truong
Robert L. Sindelar
Savannah River National Laboratory***

August 31, 2021
Milestone No. M3SF-21SR010207082
SRNL-STI-2021-00412

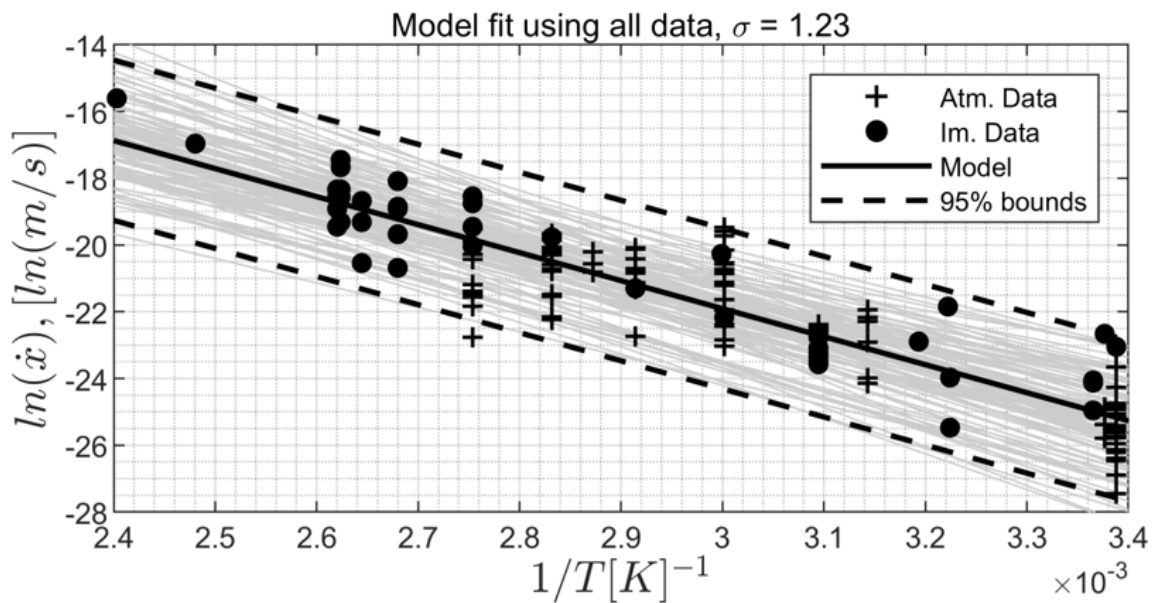
Figure 32: Crack Growth Rate as a function of Temperature [21]

The SNL model [21] is shown below. The adjusted Crack growth rates for 295 K range between 36 $\mu\text{m}/\text{year}$ and 5.3 mm/year . This model is similar to that used in the ASME code case [22] for canister in-service inspection.

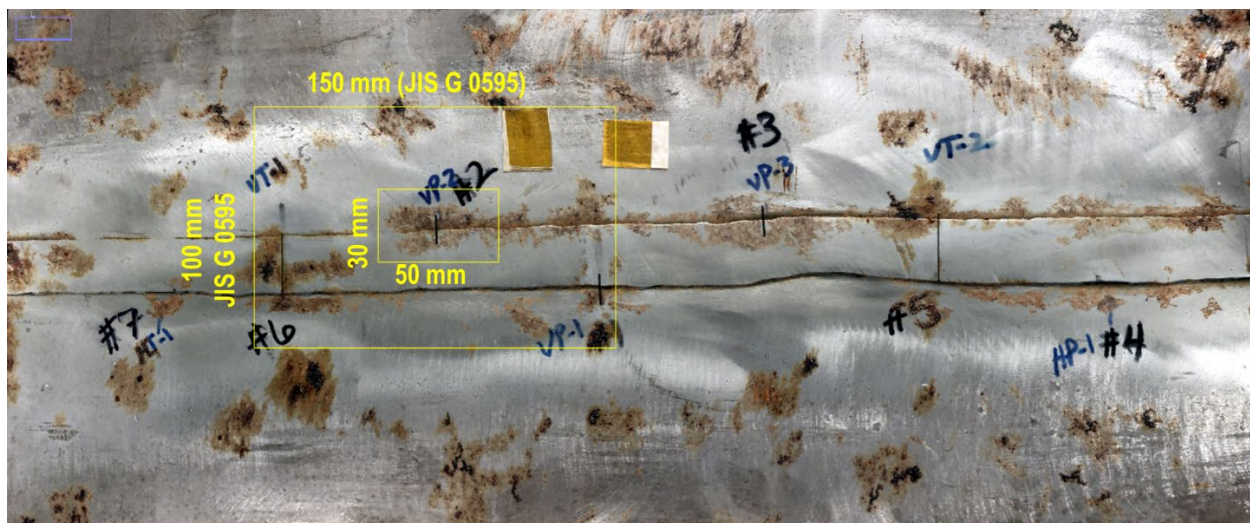
Figure 33. Rust coverage assessment for SRNL large plate: The yellow boxes represent JIS G 0595 region (100X150 mm), and a modified region (30X50 mm) currently used to evaluate starter crack VP2 and its vicinity, respectively

This section describes degradation assessment to characterize large plate using JIS G 0595 method as suggested in ASME Section XI Code Case N-860. The weld area of the large plate is shown in Figure 25, which was taken on October 16, 2019. It was found that no significant changes of corrosion appearance since then, even after extra salt load was applied to two of the starter cracks (Fig. 12). As shown in Figure 25, a strict application of JIS G 0595 with a sampling size of 100×150 mm is not practical. Therefore, the rust coverage was performed over a 30×50 mm area (about 1/3 of the linear dimensions as required by JIS N 0595) around the seed crack VP2. Note that the design crack length of VP2 on the plate surface is 12 mm.

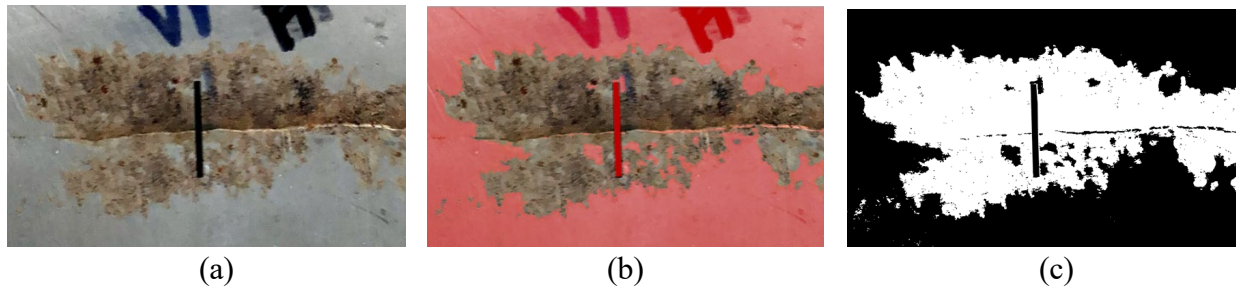
Figure 34. Image analysis to evaluate the rust coverage: sampled region (a), masking un-corroded area in red (b), and calculation of the white pixel counts in the rusted areas (c)

The estimation for the rust coverage can be described in three steps: (1) Image processing was performed over the 30×50 mm sampling region around starter crack (Figure 26a); (2) Masking the un-corroded area in red over the sampling region (Figure 26b); and (3) Calculating the total pixel counts in the white area where the rust is identified (Figure 26c).
