Hanford Double Shell Waste Tank Corrosion Studies- Final Report FY2021

SRNL-STI-2022-00195, Revision 0

For fiscal year (FY) 2021, the Savannah River National Laboratory (SRNL) focused on two experimental tasks related to Hanford Double Shell Tank (DST) chemistry and integrity. The first task focused on understanding risk of corrosion due to formation of either continuous layers or discrete patches of deposits on the tanks' inner sidewalls and bottoms. The second task studied vapor space corrosion (VSC) inhibition of the secondary liner using vapor corrosion inhibitors (VCIs) at dosages less than the manufacturer recommended and a control test in which no VCIs were added. Conclusions for activities and experimental tasks that were performed for FY21 supporting Hanford DSTs are presented below in subsections.

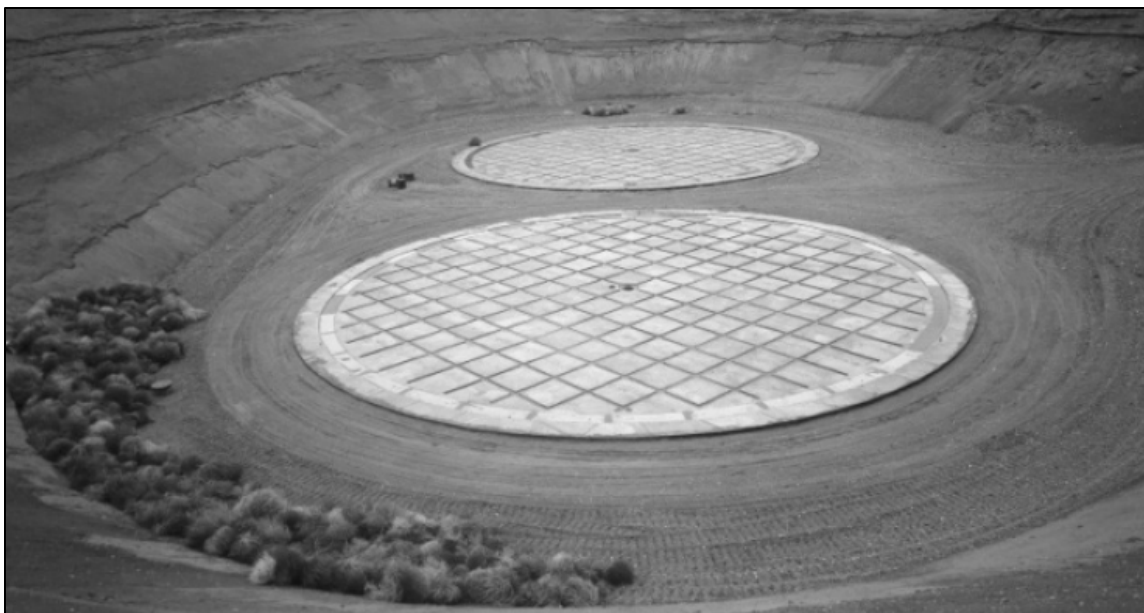
Figure 3-4 Concrete foundation for tanks AZ-101 (foreground) and AZ-102 (background) showing the cast drain slots.

Each DST consists of a primary liner (inner) surrounded by a secondary (outer) liner. The secondary liner rests on a concrete foundation that contains slots to direct any leakage to drain slots, which empty to a leak detection pit (LDP) [2], as shown in the schematic in Figure 3-3. Figure 3-4 shows the drain slots that were cast into the foundation of Tanks AZ-101 and AZ-102.

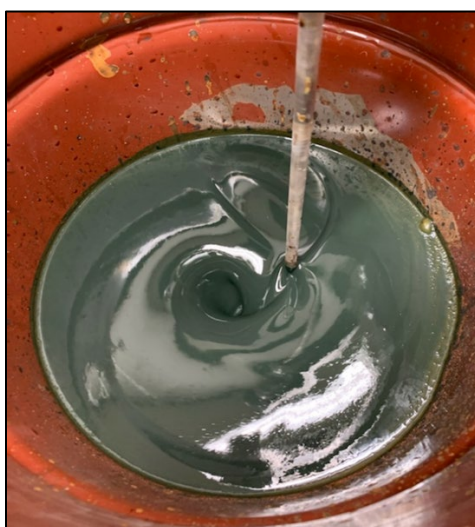
Figure 5-1 Precipitate solids after the addition of the sodium carbonate.

- While measuring the pH of the solution, add 8 M sodium hydroxide to precipitate the metal hydroxides/oxides. The pH should be greater than 10.
- Add 0.6 M sodium carbonate (approximately 400 ml) to convert the more soluble hydroxides (e.g., calcium and magnesium) to carbonates. The final pH at this step will be approximately 12. The solids are greenish-black as shown in -Figure 5-1.

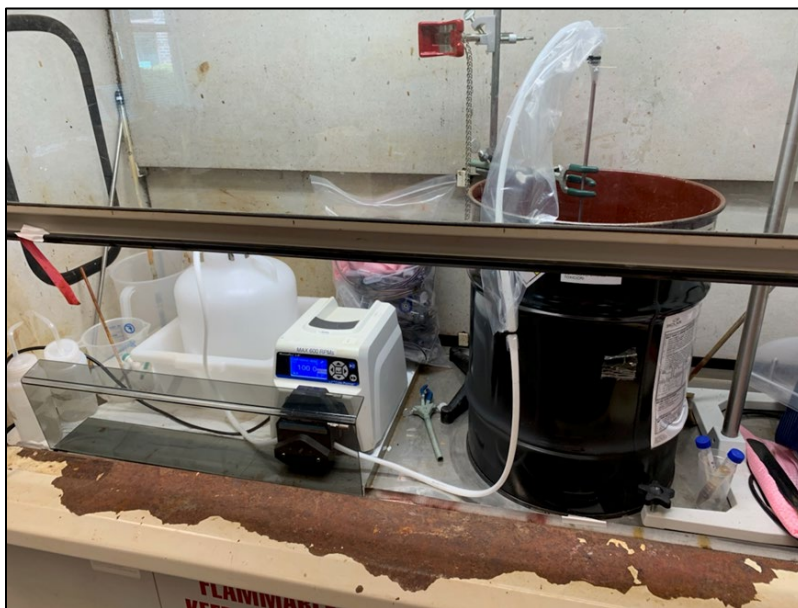
Figure 5-3 Set-up for washing with inhibited water.

6. Wash the insoluble solids with inhibited water (0.01 M NaOH and 0.01 M NaNO_2) to remove excess soluble sodium, nitrate, and carbonate ions. This process is accomplished by a) decanting the liquid layer above the settled solids, b) adding back inhibited water and mixing for approximately 30 minutes, c) allowing the solids to settle and then d) repeating steps a) through c) until the nitrate concentration is approximately 1000 mg/l. Figure 5-3 shows the pump and mixer set-up for the washing the solids.

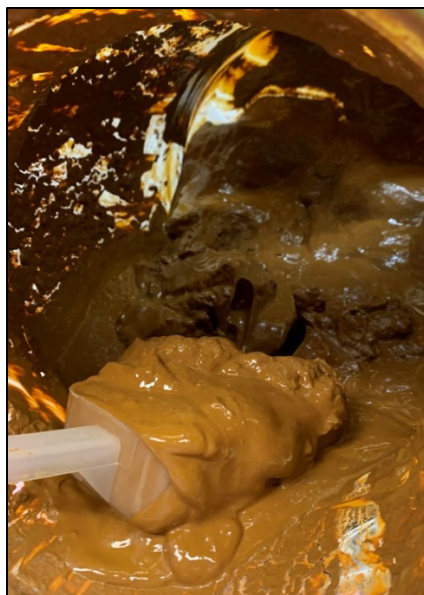
Figure 5-5 Final sludge slurry product.

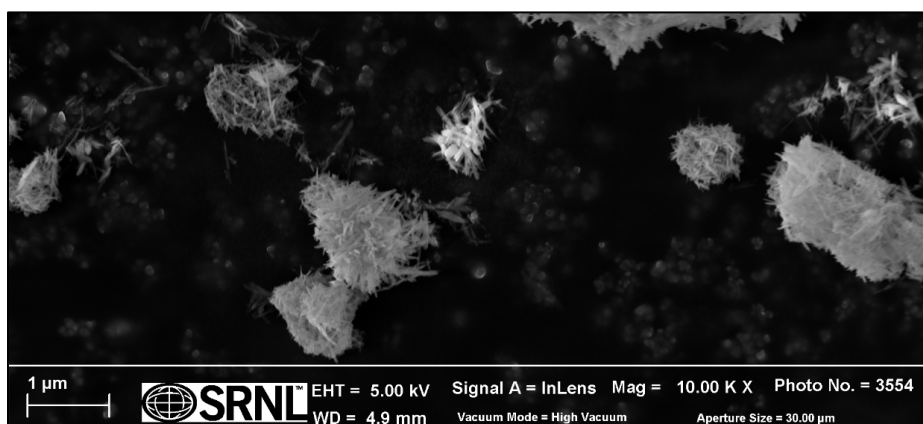
Figure 5-6 SEM micrograph of sludge particles.

An SEM micrograph of the undissolved solid particles is shown in Figure 5-6. The final sludge slurry was also characterized for particle size, wt.% solids, and sludge slurry density. These values were compared to the same values that were measured for the 2000 AZ-101 core sample and the 2003 SRNL simulant that was produced. The particle size distribution for each sludge slurry is shown in Figure 5-7. The distributions are presented two ways: a) percentage in a channel (i.e., for a given diameter, the percentage of the total number or volume that are at that diameter.) and b) the cumulative distribution of particle size diameter. The 50th percentile diameter for each was compared and is shown Table 5-6. In addition, the wt.% insoluble solids and the sludge slurry density are also shown in the table. The 50th percentile for the 2021 sludge simulant was approximately 8.3 μm , whereas the 50th percentile for the actual 2000 sludge was approximately 3.3 μm . The distributions indicate that there were several large solids particles ($\sim 100 \mu\text{m}$) present in the 2021 sludge, whereas there were no particles sizes greater than 30 μm measured for the 2000 sludge. It is possible that some particle agglomeration occurred with the 2021 sludge. Particle agglomeration seems even more likely with the 2003 SRNL simulant. In this case the 50th percentile particles size was nearly 25 μm , and large particles near 250 μm were measured.

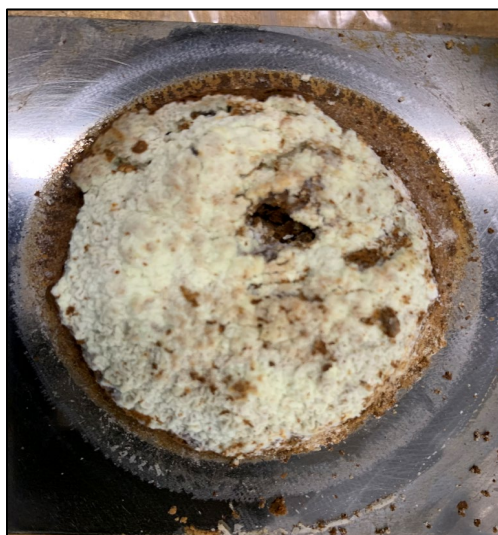
Figure 5-9 Adherent insoluble solid baked on a carbon steel coupon

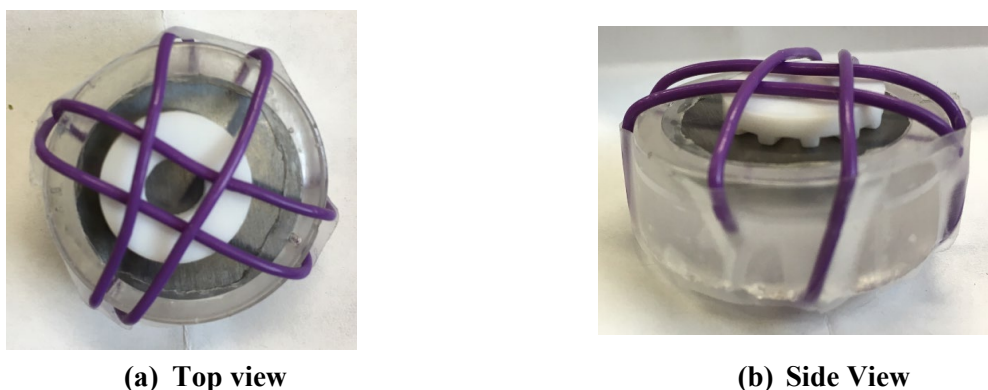
Figure 5-14. (a) Top, and (b) Side views of the partially covered “base” coupon. The coupon’s surface is partially covered with a crevice former, which is held in place using purple wire and tape

coupon was weighed so that the weight change at the end of the tests could be recorded. A crevice former was tightly attached to each coupon surface using tape and wire (see configuration in Figure 5-14). The crevice former partially covered the coupon surface, which created conditions for crevice corrosion. A “modified” version of the coupon included platinum wire that was connected by a wire, as well as a connection of another wire behind the coupon. The modified coupon assembly is presented in Figure 5-15. The wires were electrically connected by applying a layer of silver epoxy to each. The coupons were then mounted in a slightly larger mount than the “base” coupon. This configuration will be known in the text as “modified”.

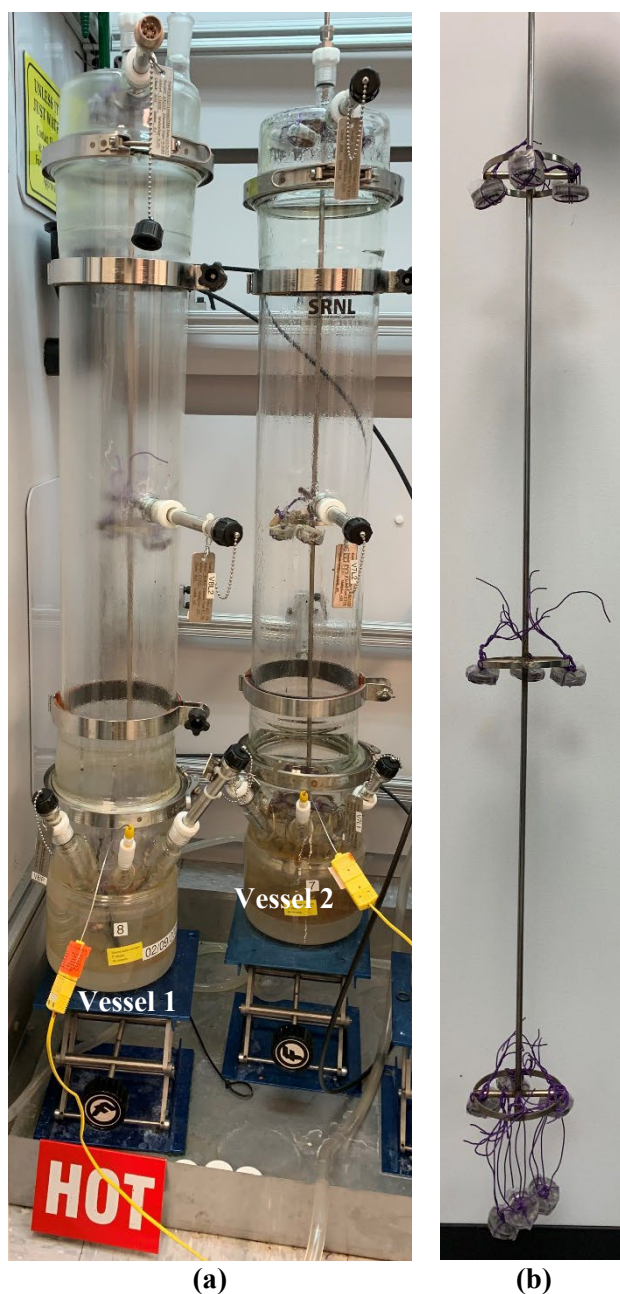
Figure 5-16 Images of the (a) experimental configuration, and (b) steel rod to suspend the coupons

Level 3: Top or high level. This set of coupons was not exposed to the solution prior to testing. The coupons were suspended approximately 36 inches above the simulant. This level is representative of the secondary liner bottom plate region that is only exposed to the humidified air and any volatile species from the solution.

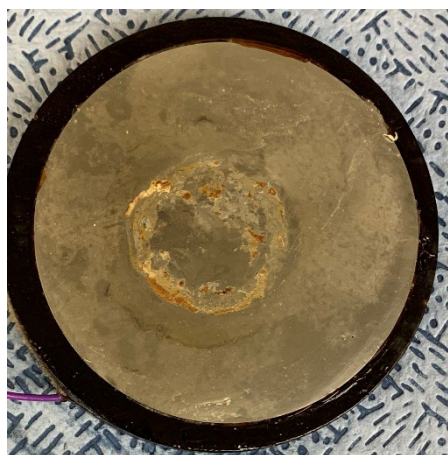
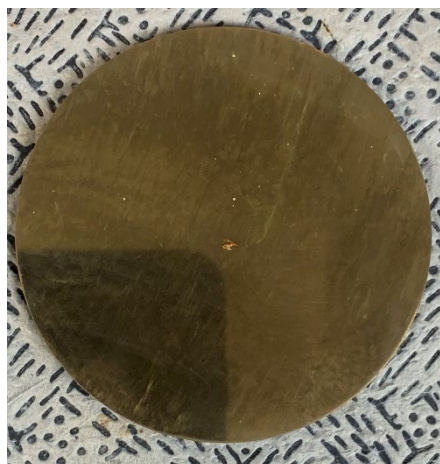
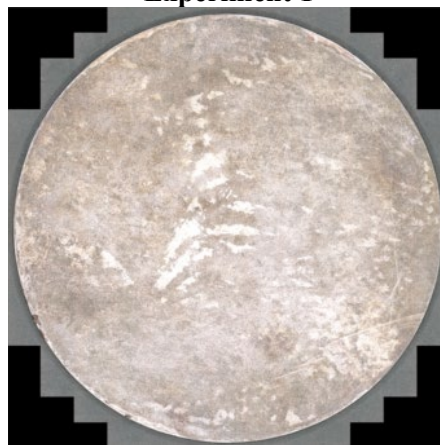
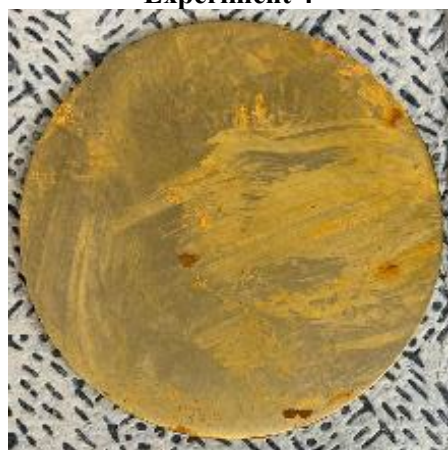
Figure 6-12 shows post-test images of each of the coupons. From a macroscopic viewpoint, there appeared to be little attack of the metal surface.
