***Summary of Chloride-induced  
Stress Corrosion Cracking  
Experiments with a Spent Fuel  
Storage Canister Large Plate***

***Daniel Foley  
Emmanuel E. Perez  
Andrew J. Duncan  
Lisa N. Ward  
Thanh-Tam T. Truong  
Robert L. Sindelar  
Savannah River National Laboratory***

***June 3, 2022***  
Milestone No. M4SF-22SR010207082  
SRNL-STI-2022-00260

# Large Plate Experiment of Chloride-induced Stress Corrosion Cracking in Spent Nuclear Fuel Storage Canisters

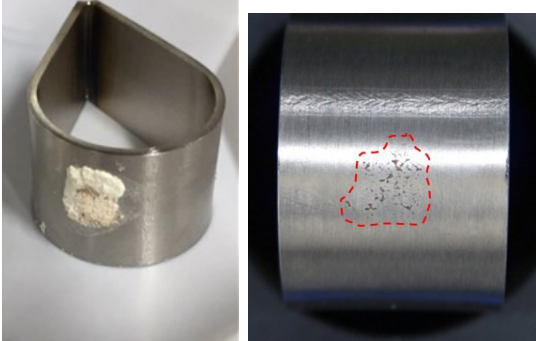
Teardrop specimen

Plate Test Specimen	Dual-certified 304/304L plate, approximately 51×46 cm with thickness 16 mm and weight about 30 kg containing a circumferential weldment. Seven (7) electrical discharge machined defects throughwall and part-throughwall, perpendicular and parallel to the weldment in the residual stress region of the weldment

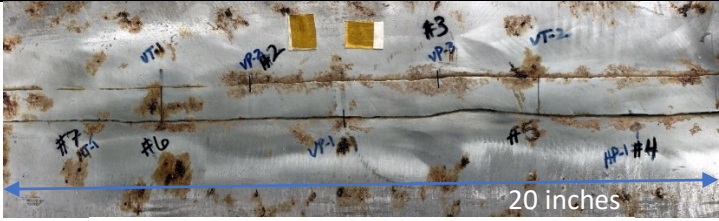
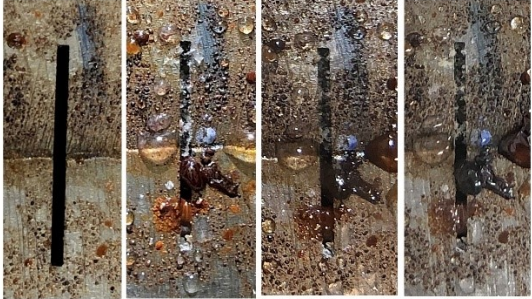
Experiment Metric	Notes	Thumbnail Picture
Initial Visual Test Results	<p>Clear evidence of rusting and staining.</p> <p>The rusting appearance remained essentially unchanged after first month throughout the 2-year exposure period</p> <p>Examination via JIS G 0595 results in a rating between RN-2 and RN-3</p>

<p>2019-10-16 (prior to extra salt load)    2020-01-06 (2.5 mo post extra salt load)    2020-02-21    2020-03-25</p>

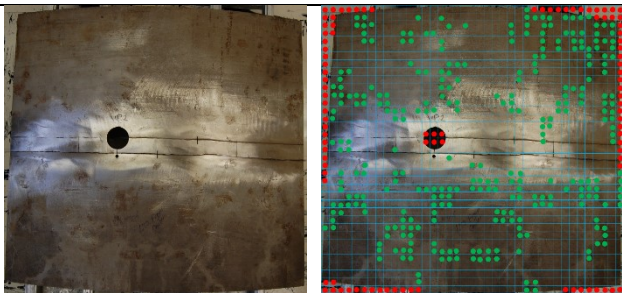
Experiment Metric	Notes	Thumbnail Picture
Post Cleaning Visual Test Results	Grid counting analysis of the cleaned plate resulted in 22% of the plate surface showing indicators of corrosion

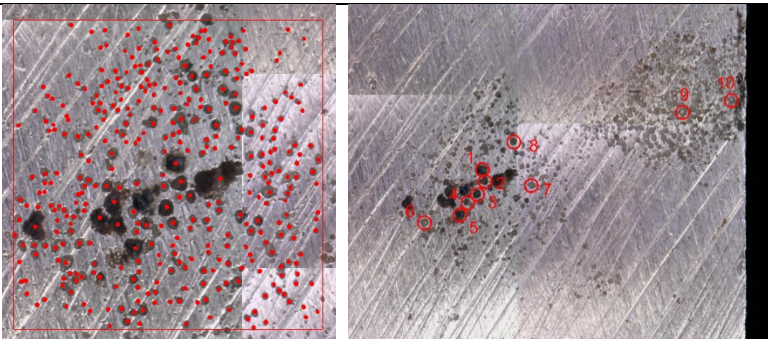
Penetrant Test Results	No evidence of SCC at weld toe region (crevice) or at surface out from 7 EDM defects	
Ultrasonic Test Results	Inconclusive with no definitive call of SCC from any of the 7 EDM defects	
Corrosion Pit Analysis Results	<p>Corrosion pit densities in selected areas of interest ranged from <math>1.19 \times 10^6</math> - <math>3.87 \times 10^7</math>.</p> <p>Cross sectional area analysis of the ten largest pits in each selected area of interest found average largest pit sizes ranging from <math>0.0773 - 0.2069 \text{ mm}^2</math>. The largest measure pit size was <math>0.3135 \text{ mm}^2</math>.</p>

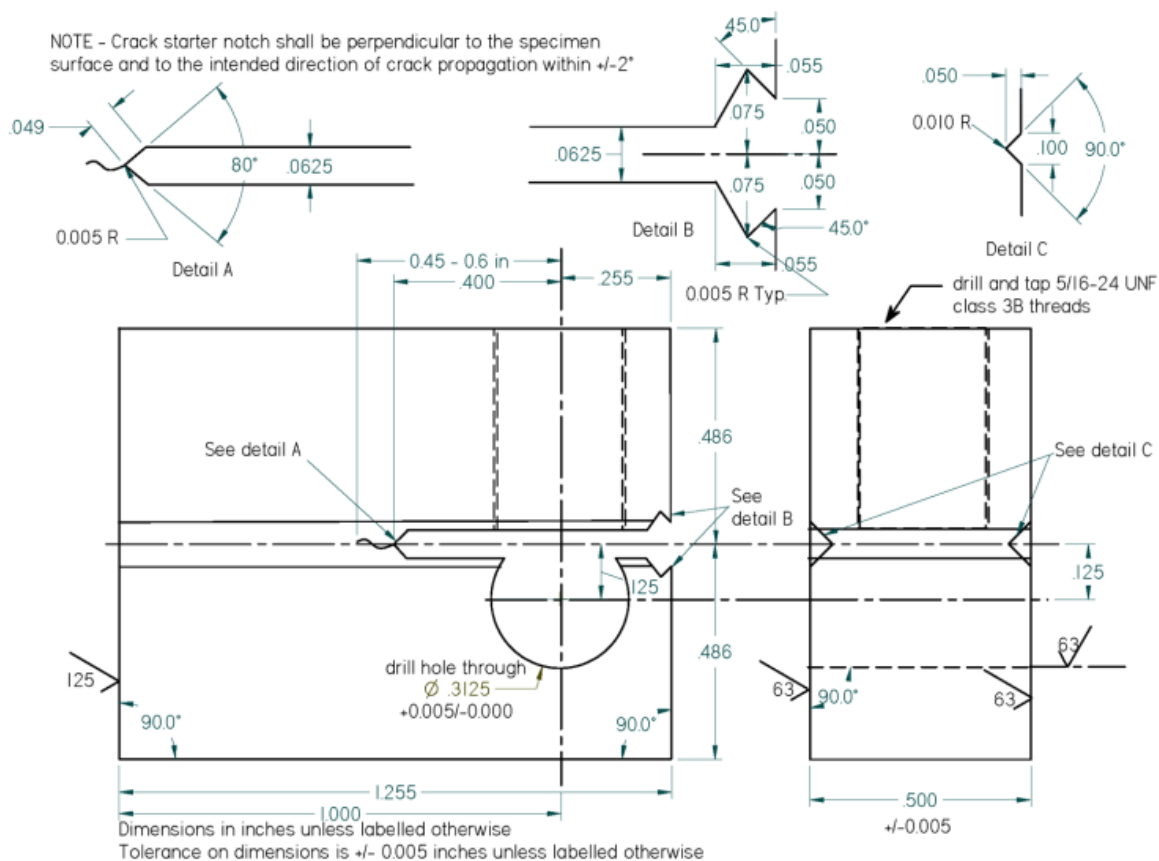
**Figure 1: ASTM E1681 bolt loaded compact tension specimen design with 10% side groove on each side of specimen.**

Bolt-load compact tension specimens were fabricated from both archival 304 stainless steel plates and from plate sections harvested from the dual certified 304/304L stainless steel full-size mockup canister. The specimen design was based on that described in ASTM E1681 as shown in Figure 1.

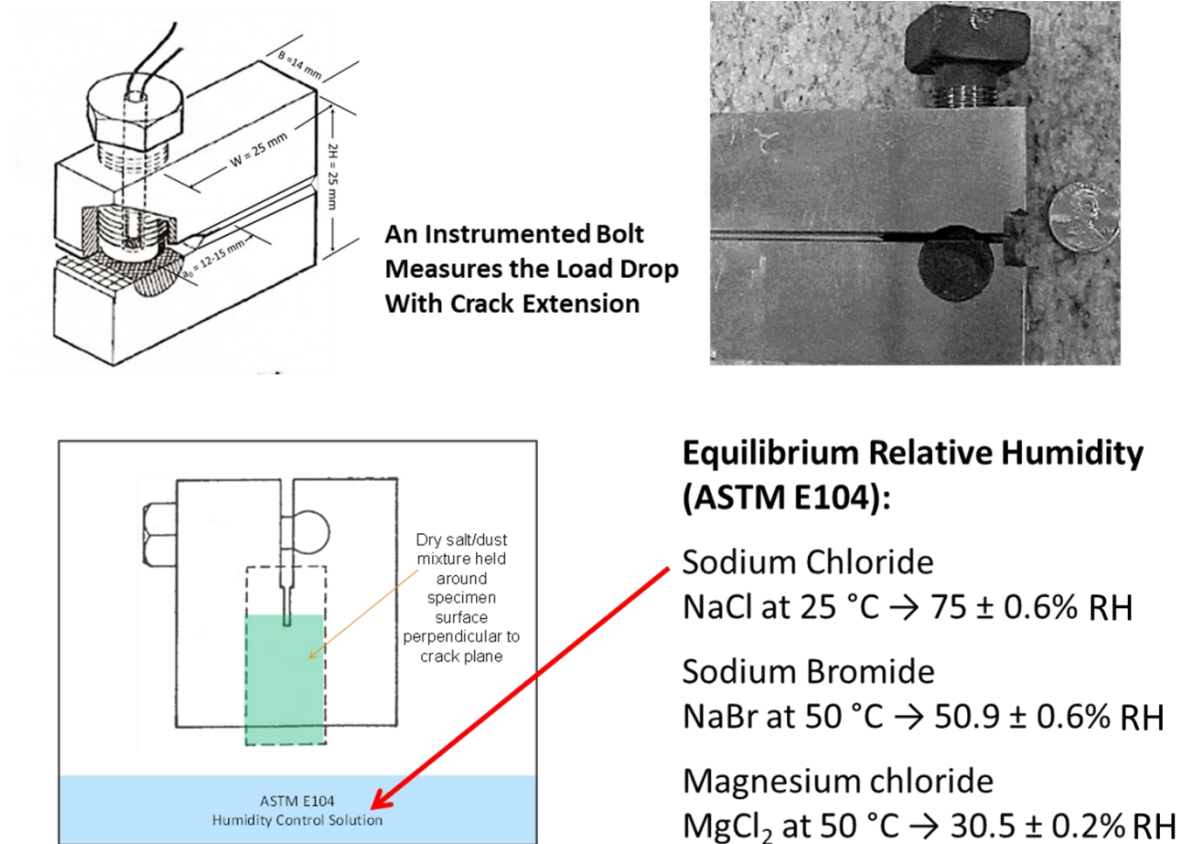
**Figure 2: Typical arrangement of the bolt-load CT specimen in the constant humidity vessel.**

A constant RH atmosphere was achieved using ASTM E104 “*Standard Practice for Maintaining Constant Relative Humidity by Means of Aqueous Solutions*” and the artificial sea salt was prepared in accordance with ASTM D1141, “*Standard Practice for the Preparation of Substitute Ocean Water*.” The salt/dust composition for Test Cell 1 is based on previous corrosion studies [5] [11] and is intended to be an artificially aggressive condition due to the high level of  $\text{CaCl}_2$  while the compositions for Test Cells 2 and 3 were selected to be more relevant to canister service conditions. The dry salt assemblage was held to the specimen in the form of a cradle while both the specimen and the dried salt assemblage were suspended over an ASTM E104 humidity control solution inside a glass vessel which acted as an environmental chamber. A schematic configuration of the experiment setup is provided in Figure 2.

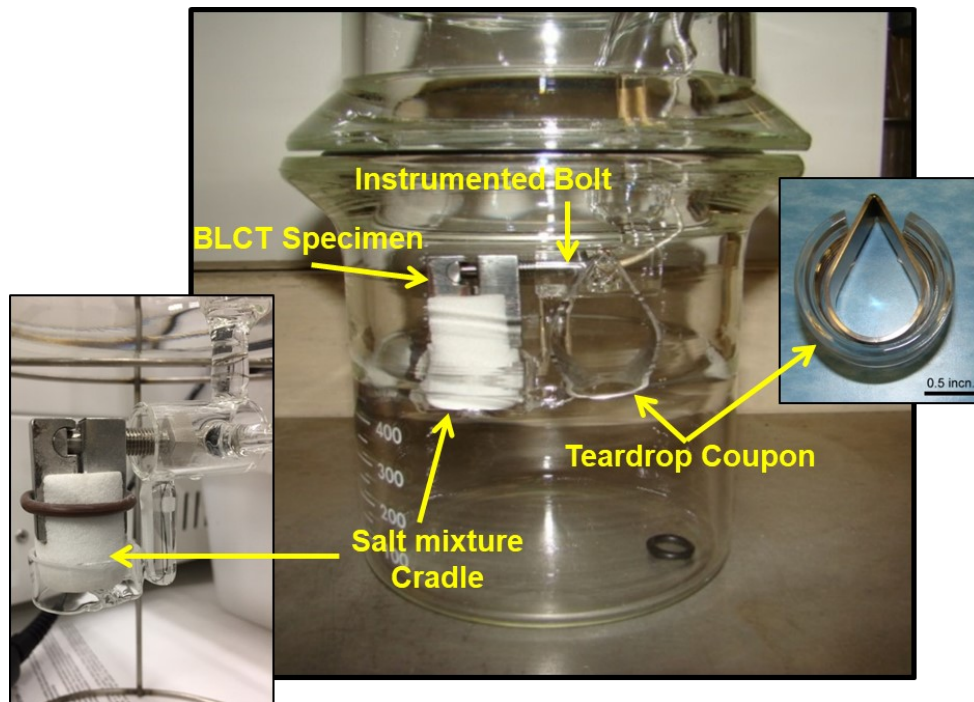
**Figure 3: SCC test configuration showing the cradled instrumented bolt-load CT (BLCT) specimen and a companion teardrop coupon in a constant humidity vessel.**

To gather visual evidence of deliquescence and corrosion without unloading and removing the bolt-load CT specimens from the test environment a 304L stainless steel teardrop coupon was loaded into a glass cradle inside the environment chamber as a companion specimen. Dry salt was packed between the teardrop coupon and its cradle to ensure that crevice corrosion would not occur. An example of the complete loading arrangement is provided in Figure 3.

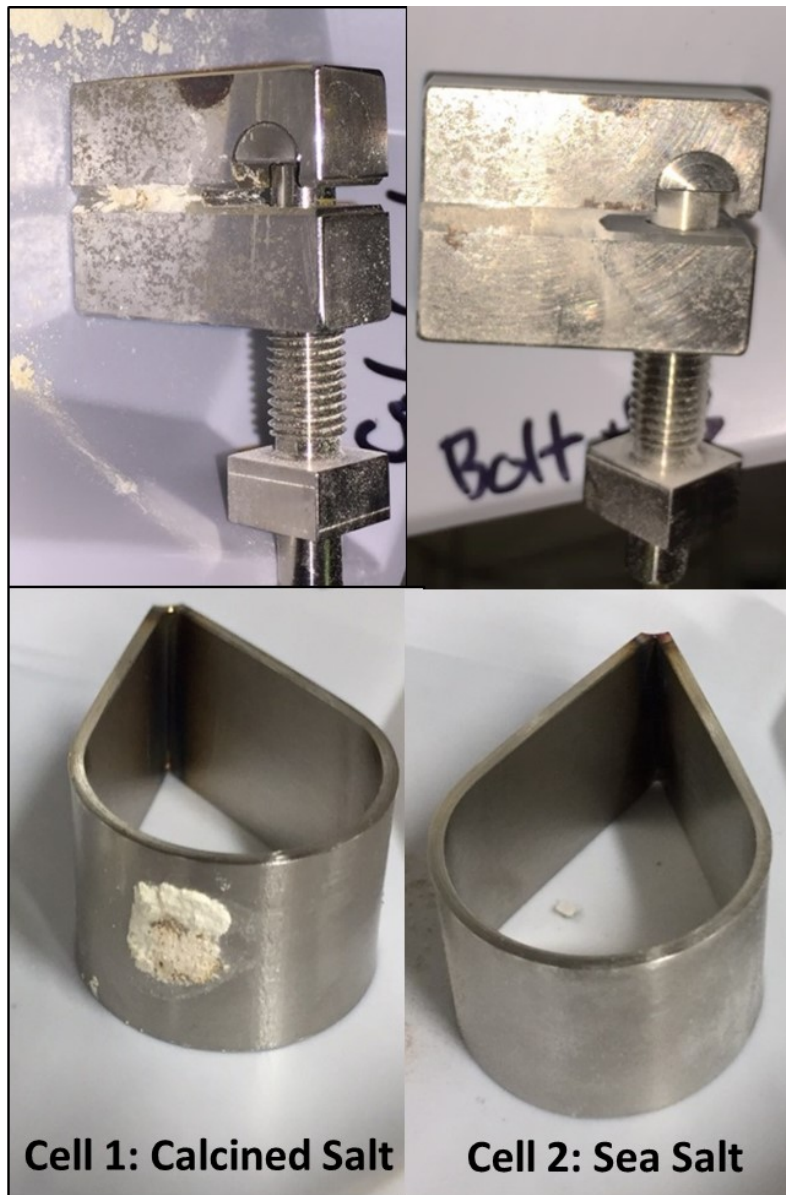
Figure 4: Specimens as removed from test cells (Cell 1: calcium rich salt, Cell 2: sea salt)

Examination of the bolt load CT specimen taken from Test Cell 1 reveals that at  $50^{\circ}\text{C}$  and 50% RH, the simulated dried salt residue will deliquesce and induce pitting corrosion and cracking in 304 stainless steel as depicted in Figure 5. Unfortunately, the nature of the cracking in this region was not planar and therefore the associated stress intensity factor and CGR are difficult to characterize. In the cases of the artificial sea salt/dust mixtures in Test Cells 2 and 3, pitting corrosion and cracking were not present. This is likely due to the absence of a brine film in contact with the surface of the specimens, indicating that capillary action to draw brine onto the crack face is not certain.

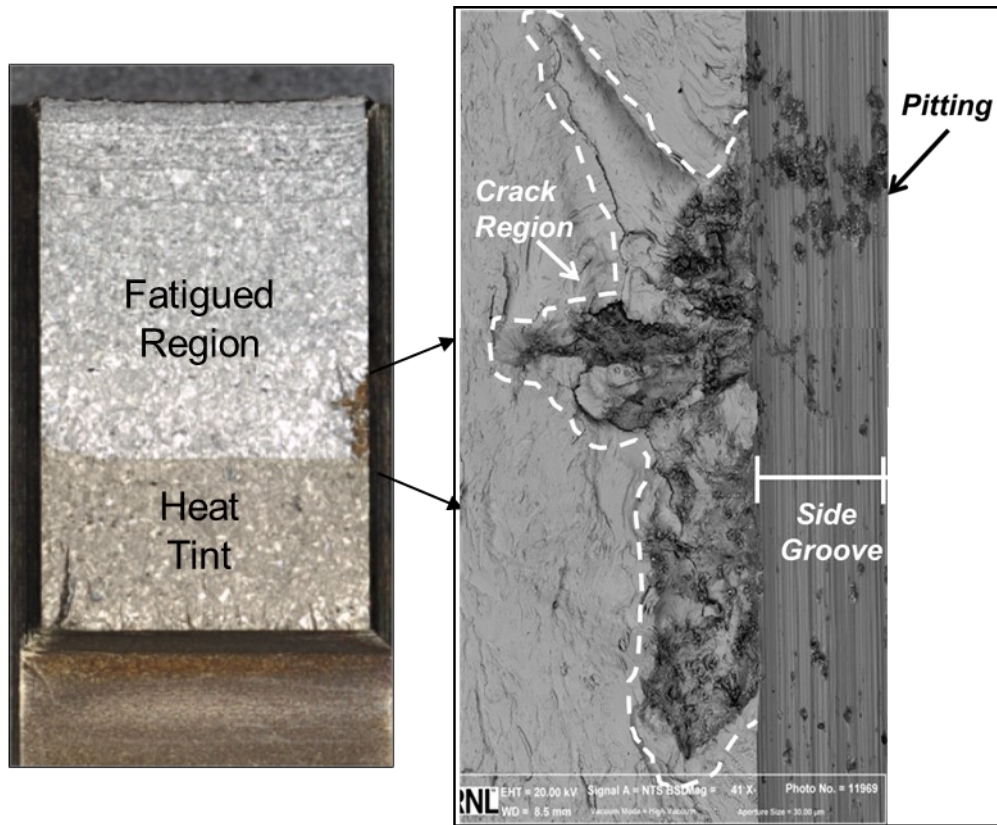
**Figure 5: Optical and SEM images of the fracture surface of the bolt-load CT specimen (Specimen 1) exposed to simulated calcium-rich salt at 50 °C and 50% RH for 5 months**

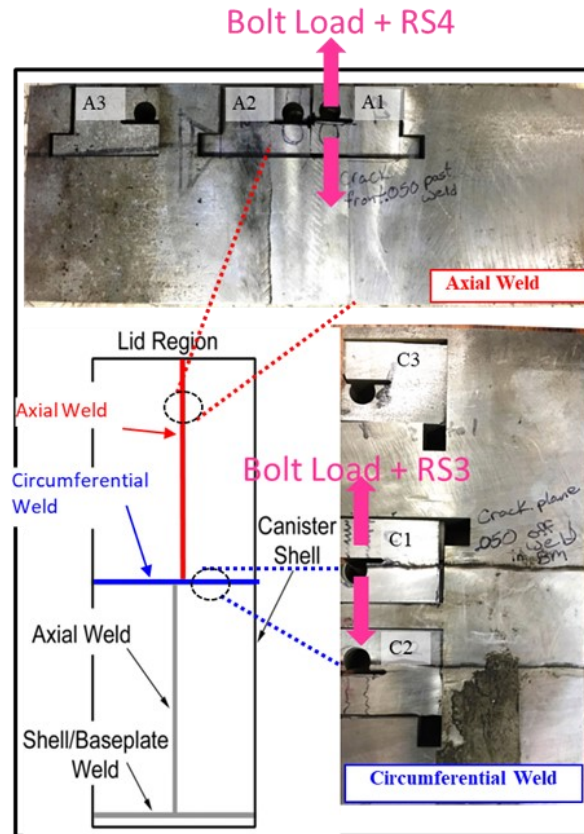
**Figure 6: The Bolt-Load CT specimens as machined from two plates cut from the mockup canister**

The samples used for this experiment were machined from two small plates cut from the SNL full sized mockup canister. One of the plates contains an axial (longitudinal) weld and the other has a circumferential (girth) weld. Figure 6 shows a schematic of the collection points for the two plates and depicts how the bolt-load CT specimens were machined from the plates.

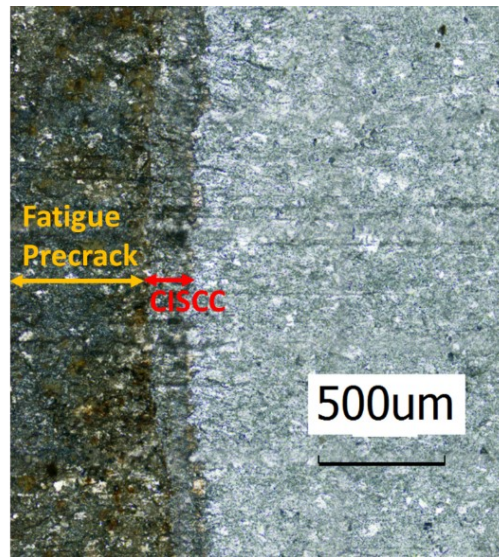
Figure 7: Typical fracture surface under CISCC from specimen C1

The base metal bolt-load CT specimens, A3 and C3, (see Fig. 14 and Table 3) were removed from the test apparatus at the end of two months; while specimens A1, A2, C1, and C2, which are associated with the HAZ, remained in the test setup for six months. All specimens after testing were cleaned by following ASTM G1, “*Standard Practice for Preparing, Cleaning, and Evaluating Corrosion Test Specimens*.” Final crack lengths were established first by heat tinting the specimens at 350°C for 30 minutes to mark the final crack front, then break open the specimen in halves by fatigue. The crack lengths were measured with an optical microscope in compliance with ASTM E1681 at the transition from heat tint and un-oxidized fatigue surface. Figure 7 is a typical fractured surface (from Specimen C1 after exposure for six months). It shows the regions of fatigue pre-cracking, CISCC ( $\Delta a$ ), and the final fracture by fatigue.

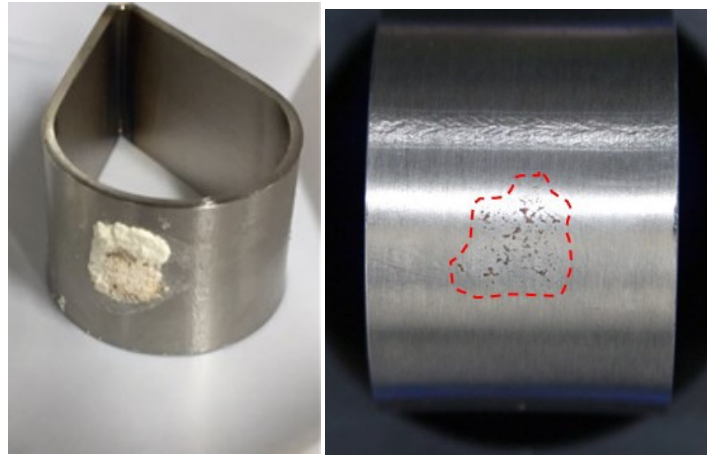
**Figure 8: Adherent dust on teardrop Sample No. 1 following test (a) and the post cleaning image with outlined corrosion region (b)**

In the experiments discussed in Sections 2.2 and 2.3 teardrop coupons were included in the glass vessel as companion specimens to the bolt-load CT specimens. These teardrop coupons were intended to act as convenient indicators of susceptibility to cracking and pitting. After being removed from the testing vessel, each of these teardrop specimens was examined to determine the extent of corrosion. Only one teardrop coupon, exposed to high level of  $\text{CaCl}_2$  (0.4%) at 50 °C and 50% RH for 5 months (Test Cell No. 1 in Table 1), exhibited signs of significant corrosion as shown in Figure 8.

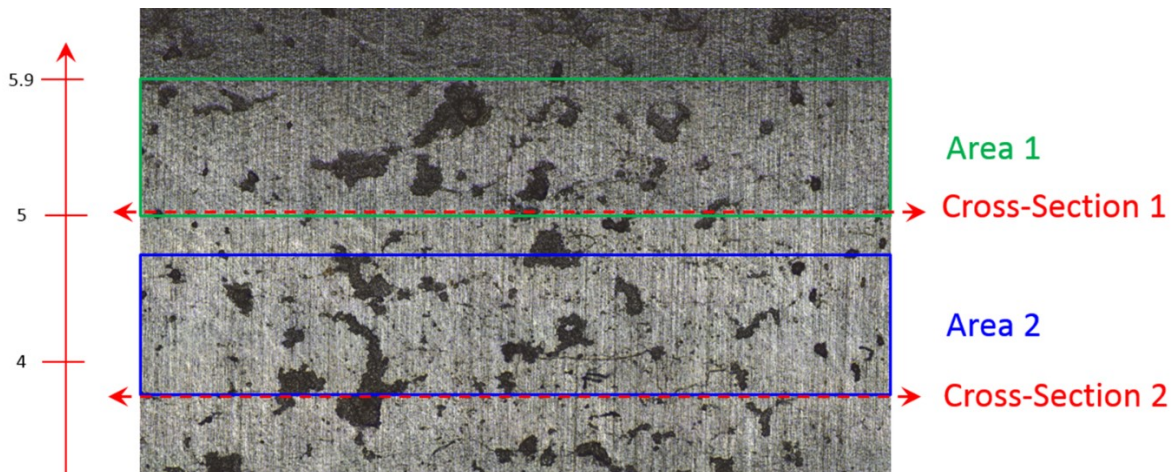
**Figure 9: Image of the corrosion region on Sample 1**

The specimen was subjected to metallographic examination and analysis to further investigate pitting and cracking. First, the corroded region was imaged using laser confocal microscopy (LCM) to identify areas of interest. In particular, the LCM images of Area 1 and Area 2 in Figure 9 provided depth information for the corrosion pitting observed along lines A and B in Figure 10.

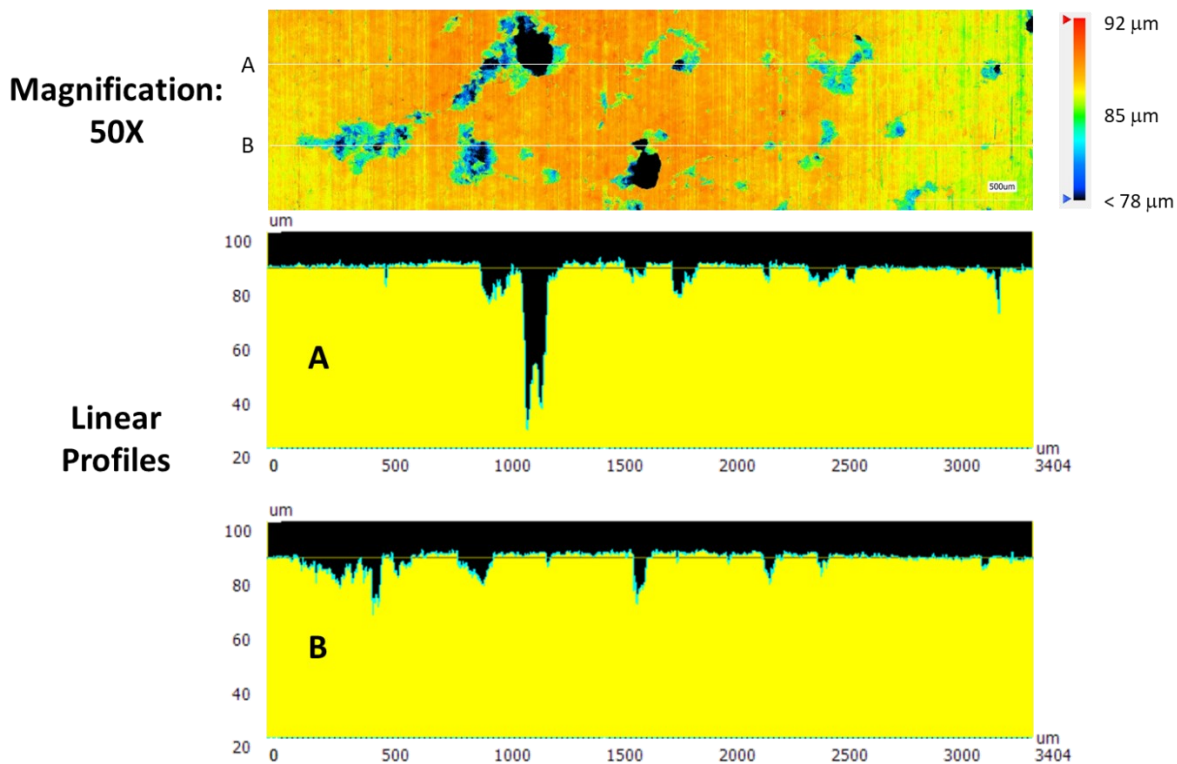
**Figure 10: The LCM images of Area 1 in the corrosion area and the linear profiles of the cross-sections along Lines A and B, respectively**

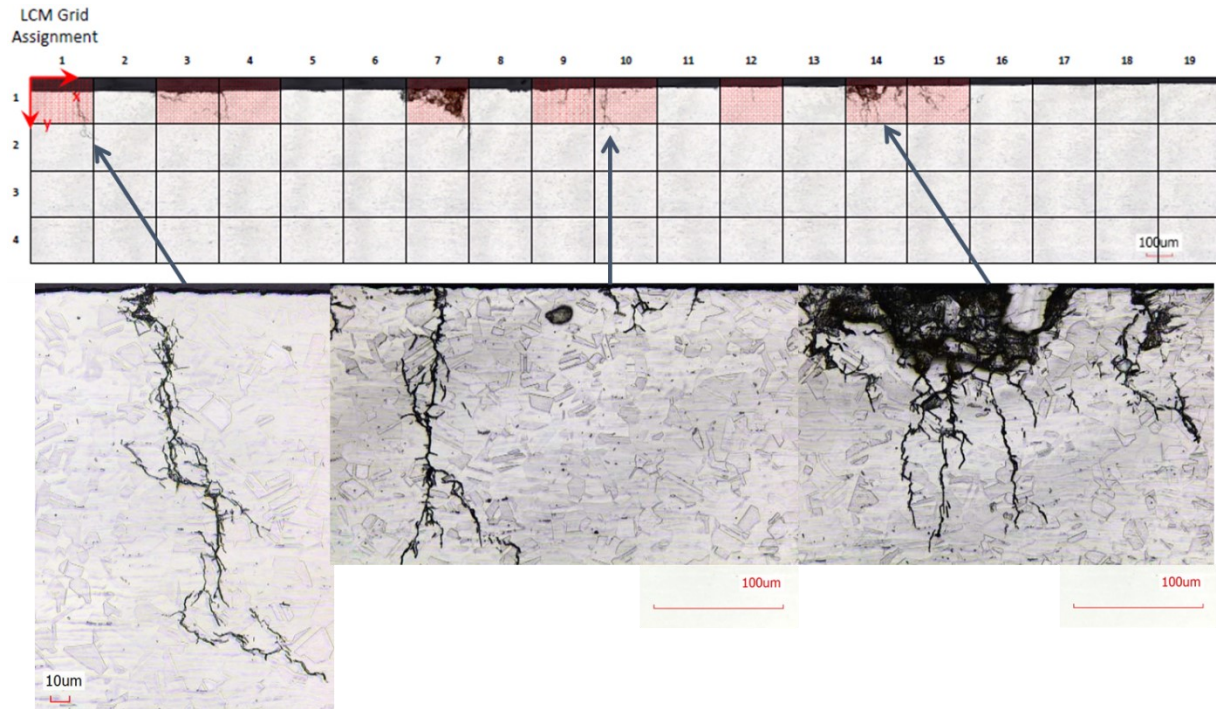
Figure 11: Images of cross-section B in Area 1 show transgranular stress corrosion cracks and pitting corrosion

Cross-section B from Area 1 was mounted, polished, and electrolytically etched with oxalic acid (10%) and imaged at 50X magnification to observe cracking morphology. Images from the cross section, shown in Figure 11, indicate that cracking is primarily transgranular. The longest crack observed in Figure 11, depicted on the lower left of the image, was measured to be approximately  $200\mu\text{m}$  which corresponds to an average crack growth rate of 0.48 mm/year based on an exposure time of 5 months. Additionally, the cracks depicted in Figure 11 and Figure 12 demonstrate that cracks below the teardrop coupon surface are interconnected and the smallest pits (in terms of diameter and pit depth) appear to develop networks of “long” cracks.

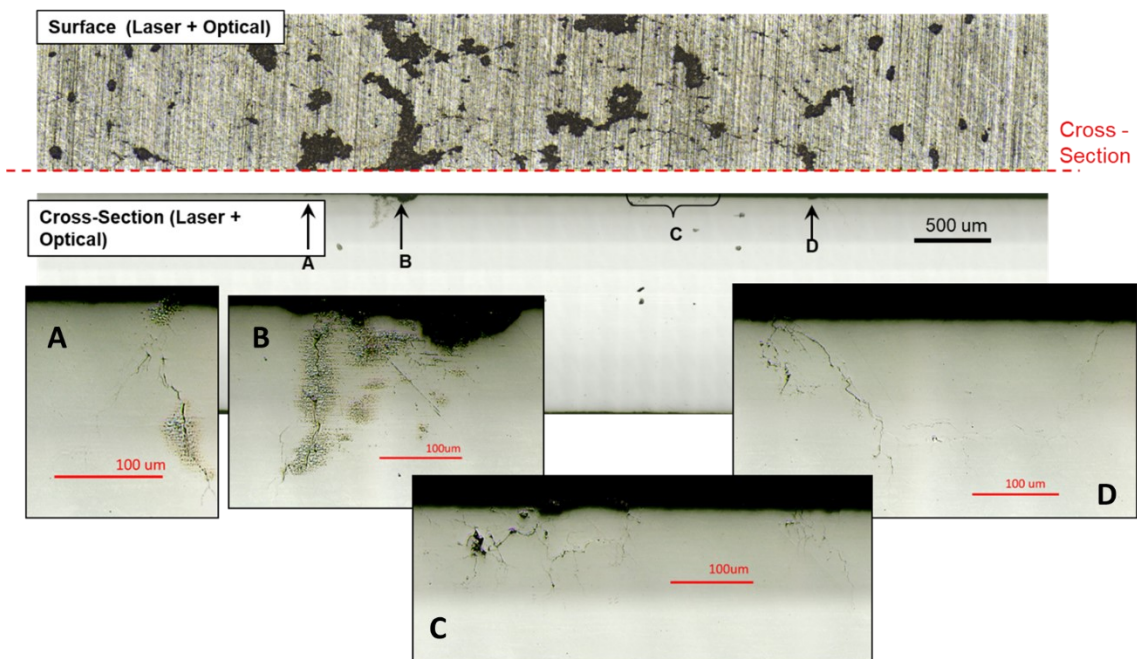
Figure 12: Images of the cross-section in Area 2 show transgranular stress corrosion cracks and pitting corrosion

Additional characterization of regions A, B, C, and D in the cross-section of Area 2 (Figure 12) were conducted. The pit depths and the associated SCC depth (lengths) were measured and indicated in Figure 13.

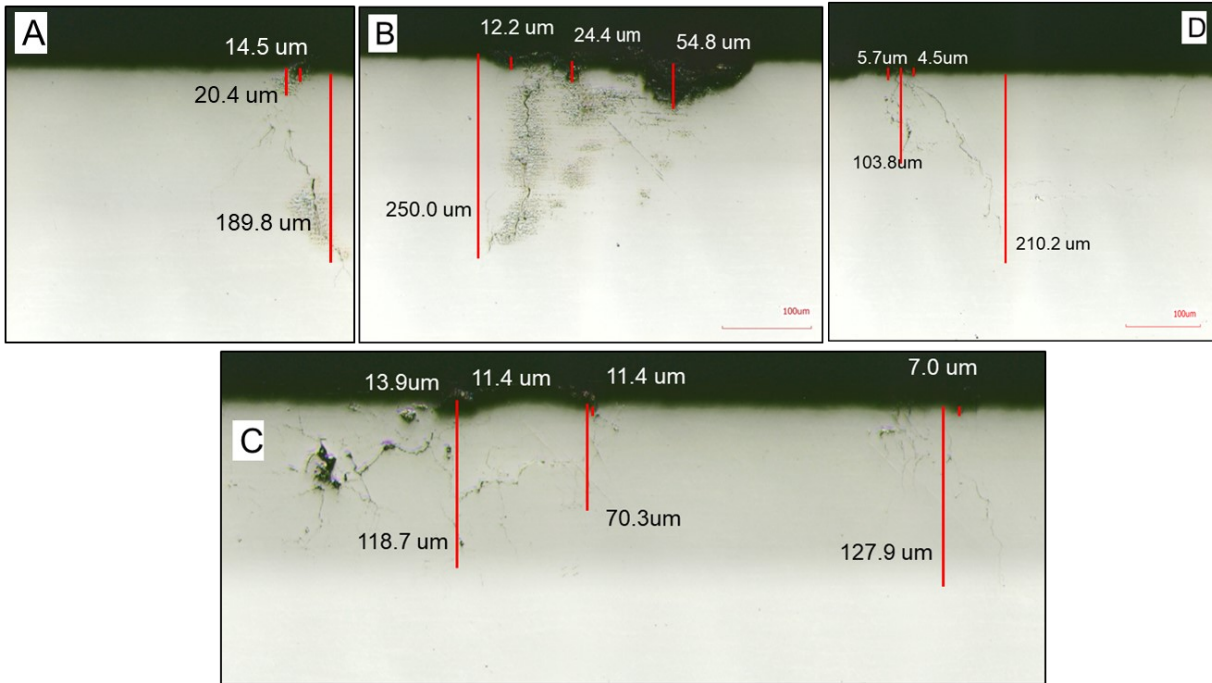
**Figure 13: Characterization of pits and the associated stress corrosion cracks in sectioned teardrop coupon Sample 1**

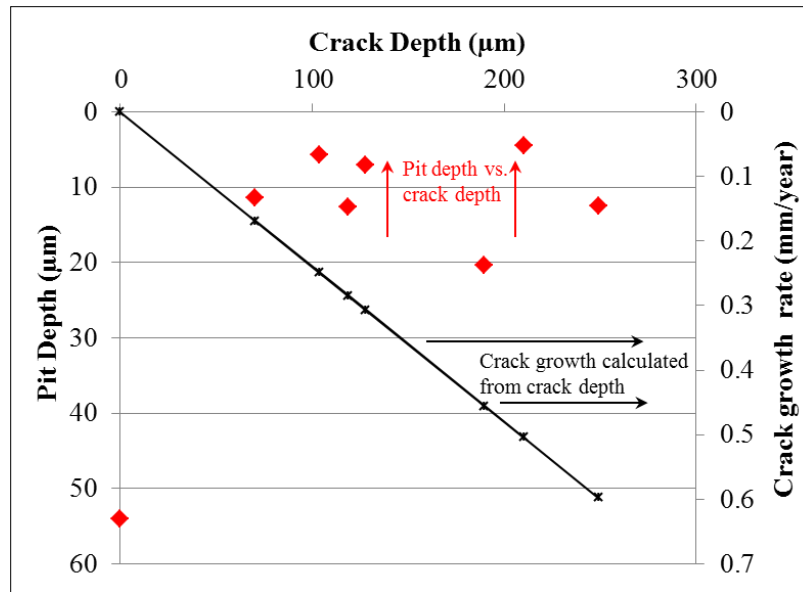
**Figure 14: Relationship between pit depth and the associated crack depth (symbol ♦) as well as the corresponding crack growth rate (symbol ×) as converted from crack depth averaged by test duration (5 months)**

Plotting the results of crack length compared to pit depth reveals that there is no observable relationship between the two.

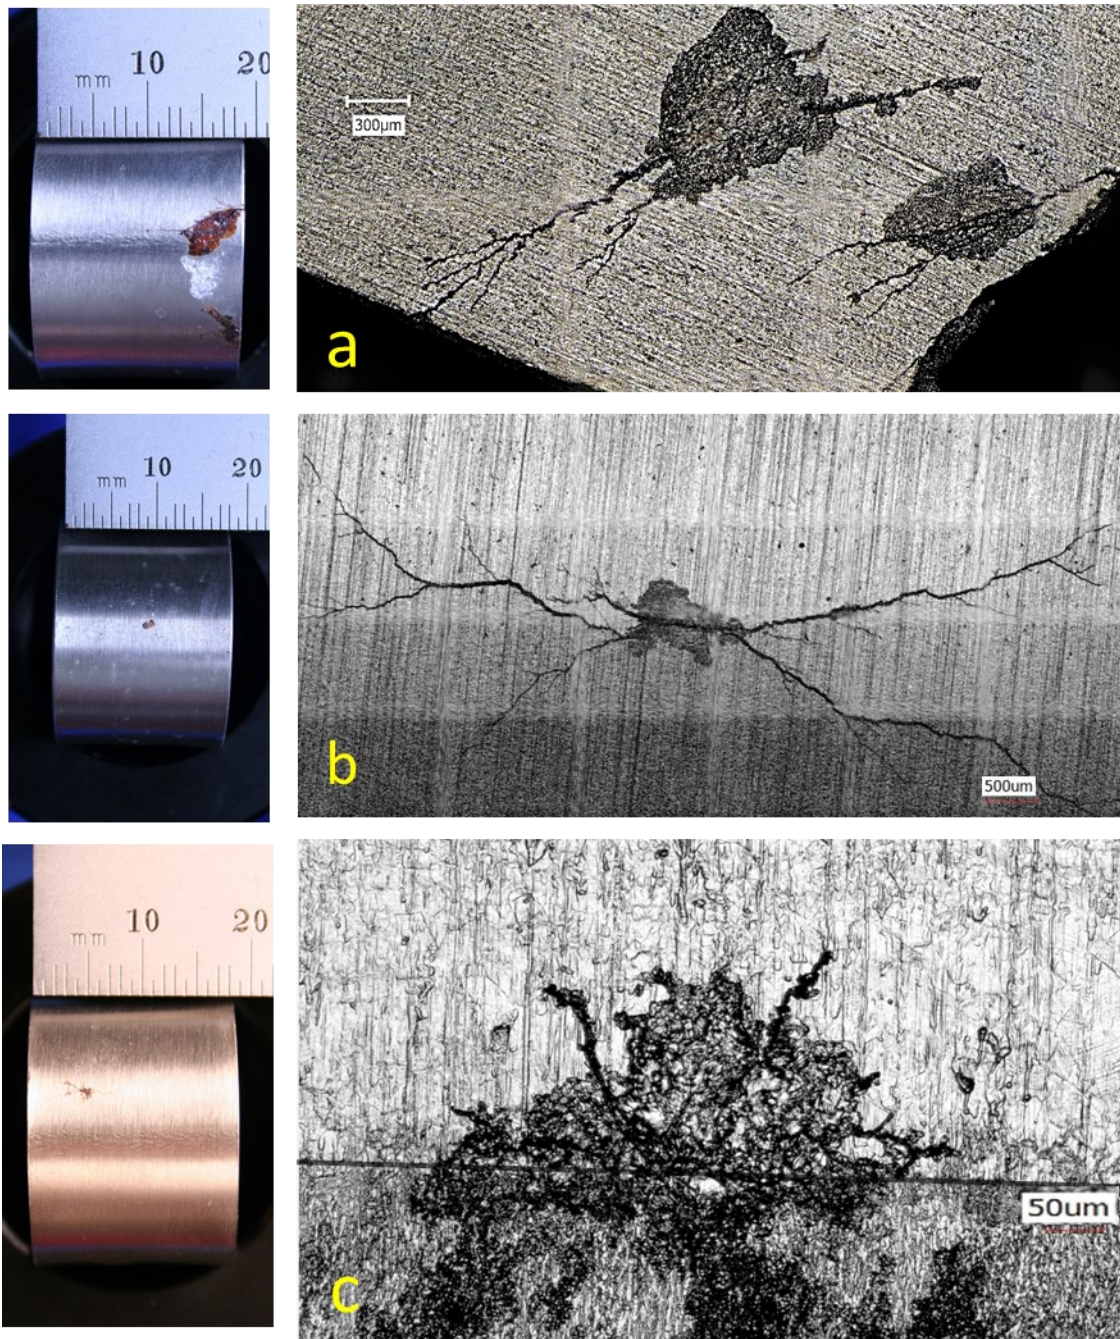
Figure 15: LCM images of cracking initiated on the surface of teardrop coupons at 50 °C and 50% RH for 100% sea salt (a), 25% sea salt + 75% CeO<sub>2</sub> (b), and at autogenous weld interface (shown by a dark line) in 25% sea salt + 75% artificial dust (c)

Since no corrosion was observed on the teardrop coupons associated with Test Cells 2 and 3 a set of follow up tests was conducted on teardrop coupons with sea salt at 50°C and 50% RH for 3 months. The results of these follow up tests indicate that an aggressive environment was achieved and cracking did occur during the 3 month test. Figure 15 shows results from these tests and illustrate the presence of CISCC in the teardrop coupons. Specimens are shown in Figure 15 (a), (b), and (c) for 100% sea salt, 25% sea salt/75% CeO<sub>2</sub>, and 25% sea salt/75% artificial dust conditions, respectively. Once again a strong correlation between pit size and crack length could not be established.

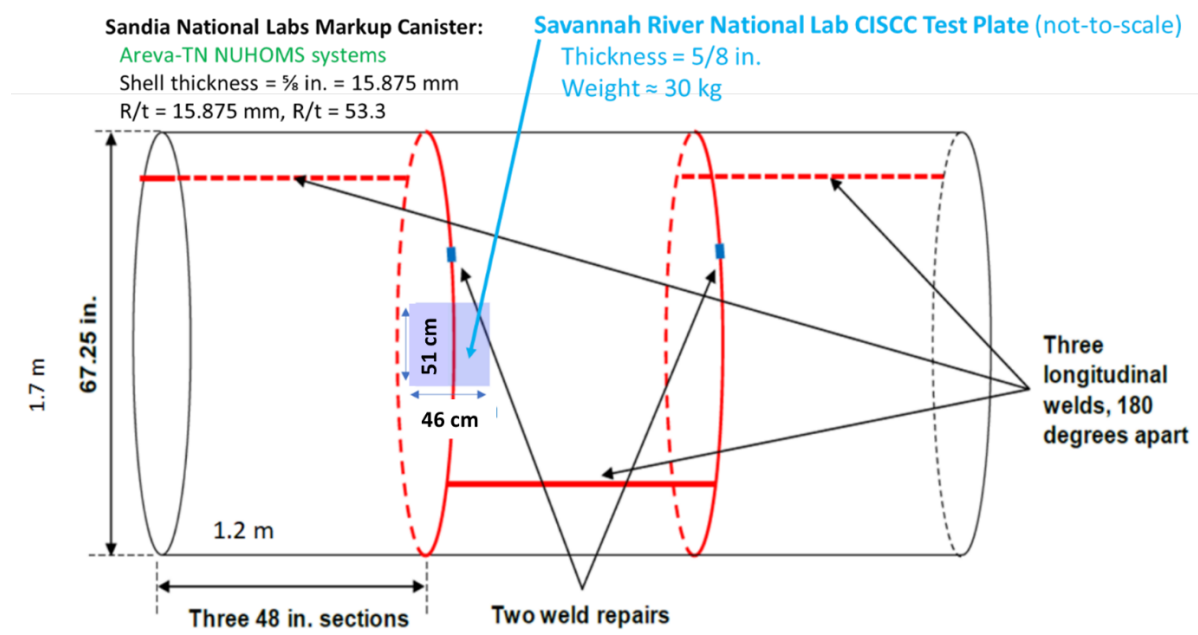
**Figure 16: A sketch of the full size mockup canister showing the fabrication welds and the representative location where the SRNL large plate was harvested.**

Where the previous efforts described in this report were intended to gather data on the threshold stress intensity factor, the large plate demonstration conducted at SRNL is intended to demonstrate corrosion and cracking behavior at the structural level. The large plate used here consisted of a 51x46x1.6 cm section cut from the same full sized mockup canister as the bolt-load CT specimens described in Section 2 which contained a circumferential weld (Figure 16 provides a diagram of where the plate was cut from). The size of the plate was carefully determined from finite element calculations to minimize redistribution or relieving of WRS during cutting of the plate.

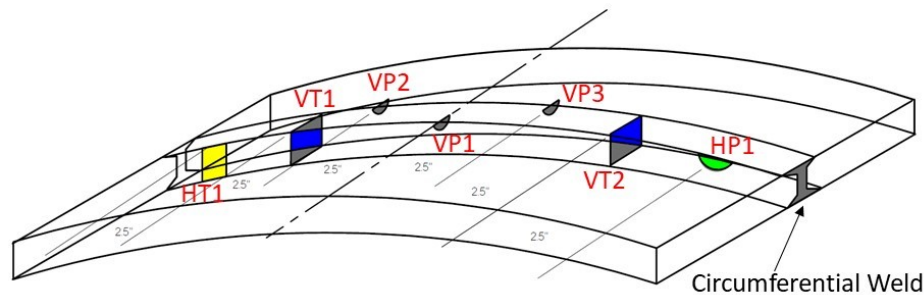
## **Starter Crack Description** (total 7 EDM cracks):

**Figure 17: Starter crack layout and orientation in the large plate.**

The orientation and layout of each crack is schematically shown in Figure 17 while the EDM crack configurations are shown in Figure 18.

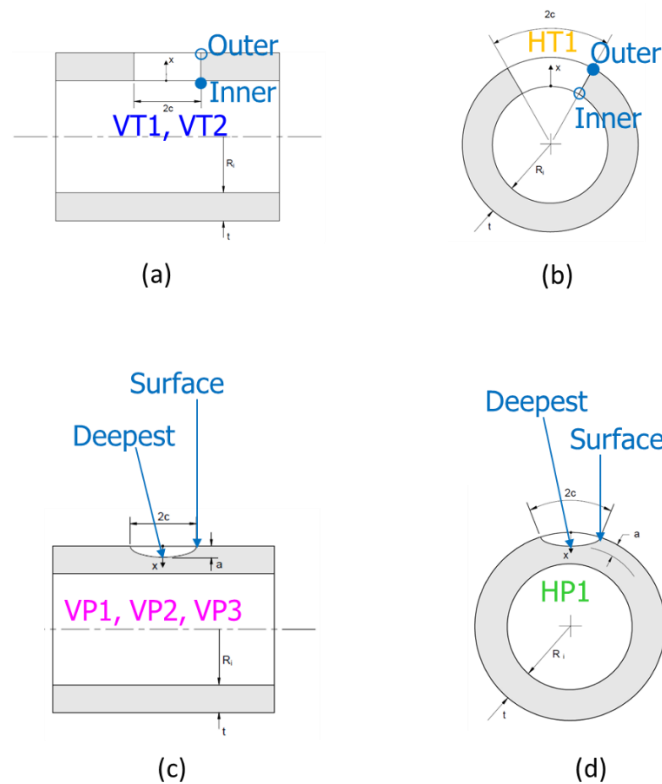
**Figure 18: Large plate starter crack configurations: Type (a) VT1, VT2: through-wall crack across the weld; Type (b) HT1: through-wall crack parallel to the weld edge; Type (c) VP1, VP2, VP3: semicircular ( $a = c$ ) part-through-wall crack perpendicular to the weld edge; and Type (d) HP1: semi-circular ( $a = c$ ) part-through-wall crack parallel to the weld edge**

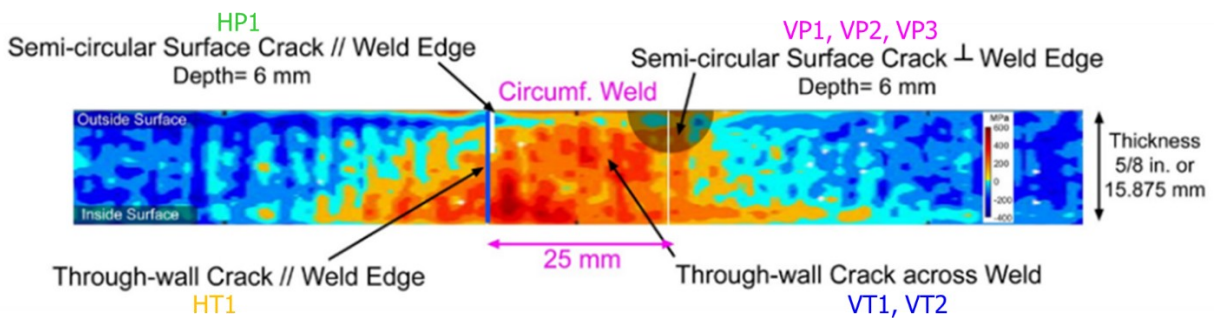
**Figure 19: Large plate starter crack design as viewed from plate cross-section through the circumferential weld (superimposed over the contour map for welding residual stress parallel to the weld [13])**

When the starter cracks are overlaid over the contour map of residual stress parallel to the circumferential weld [13], the WRS loading of the cracks can be seen as shown in Figure 19

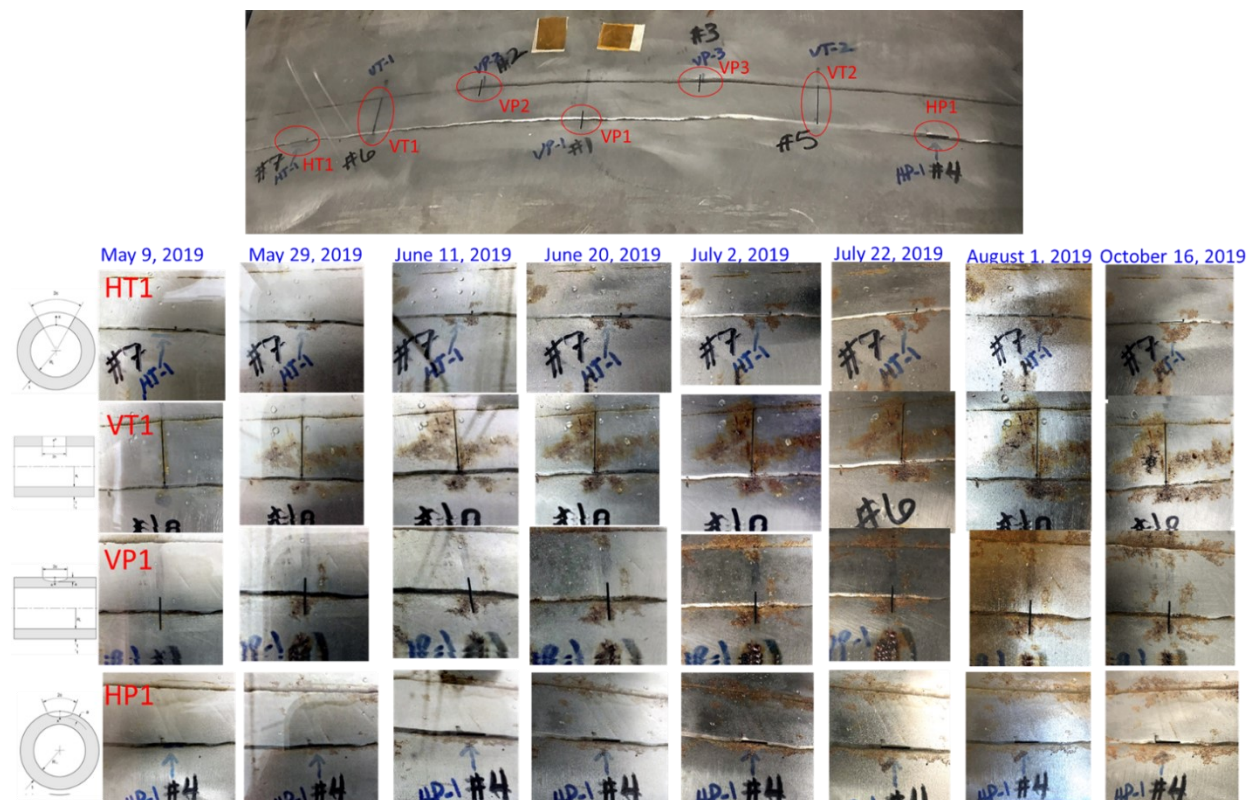
**Figure 20: Evolution of chloride-induced corrosion near starter cracks during 5 months of exposure at room temperature about 22C and 73% RH**

During the first five months of exposure periodical examination of the plate was performed and imaging of the seven starter cracks was acquired (see Figure 20).

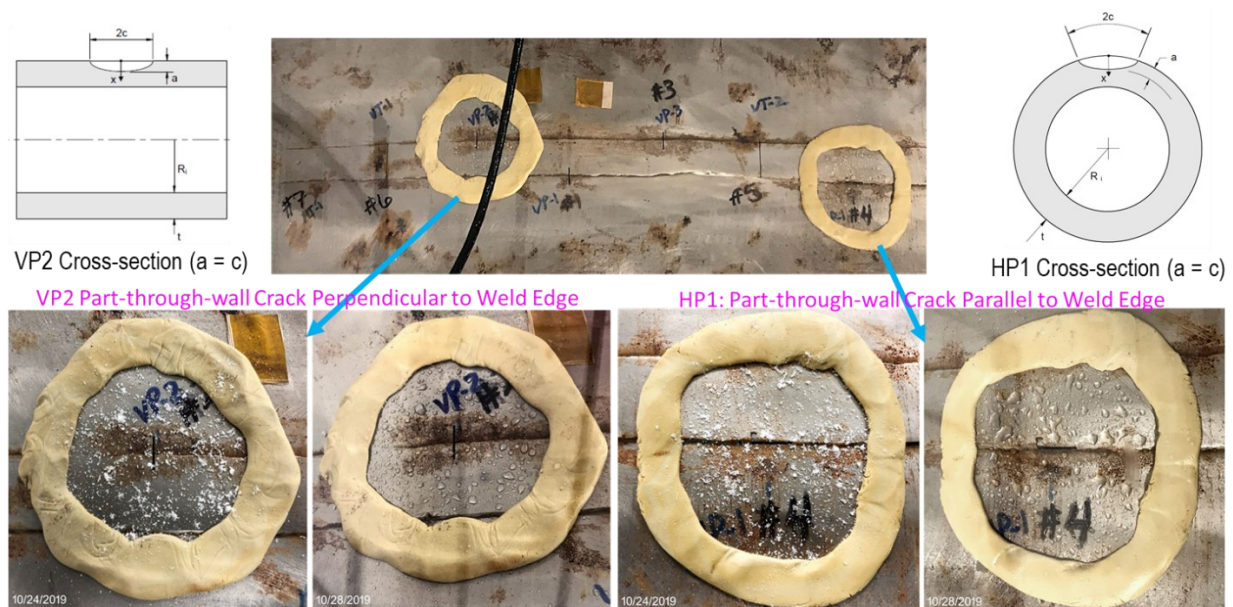
**Figure 21: Additional salt applied to selected starter cracks (VP2 and HP1).**

Since cracking was not observed during the first five months of the experiment an additional salt load was added to two of the starter cracks (VP2 and HP1) to create a more aggressive corrosion environment. To achieve this, dry salt was placed on the regions surrounding the selected cracks. To prevent the water droplets that formed from the additional salt load from running off the surface of the plate a ring of plumbers putty was placed around the cracks as shown in Figure 21.

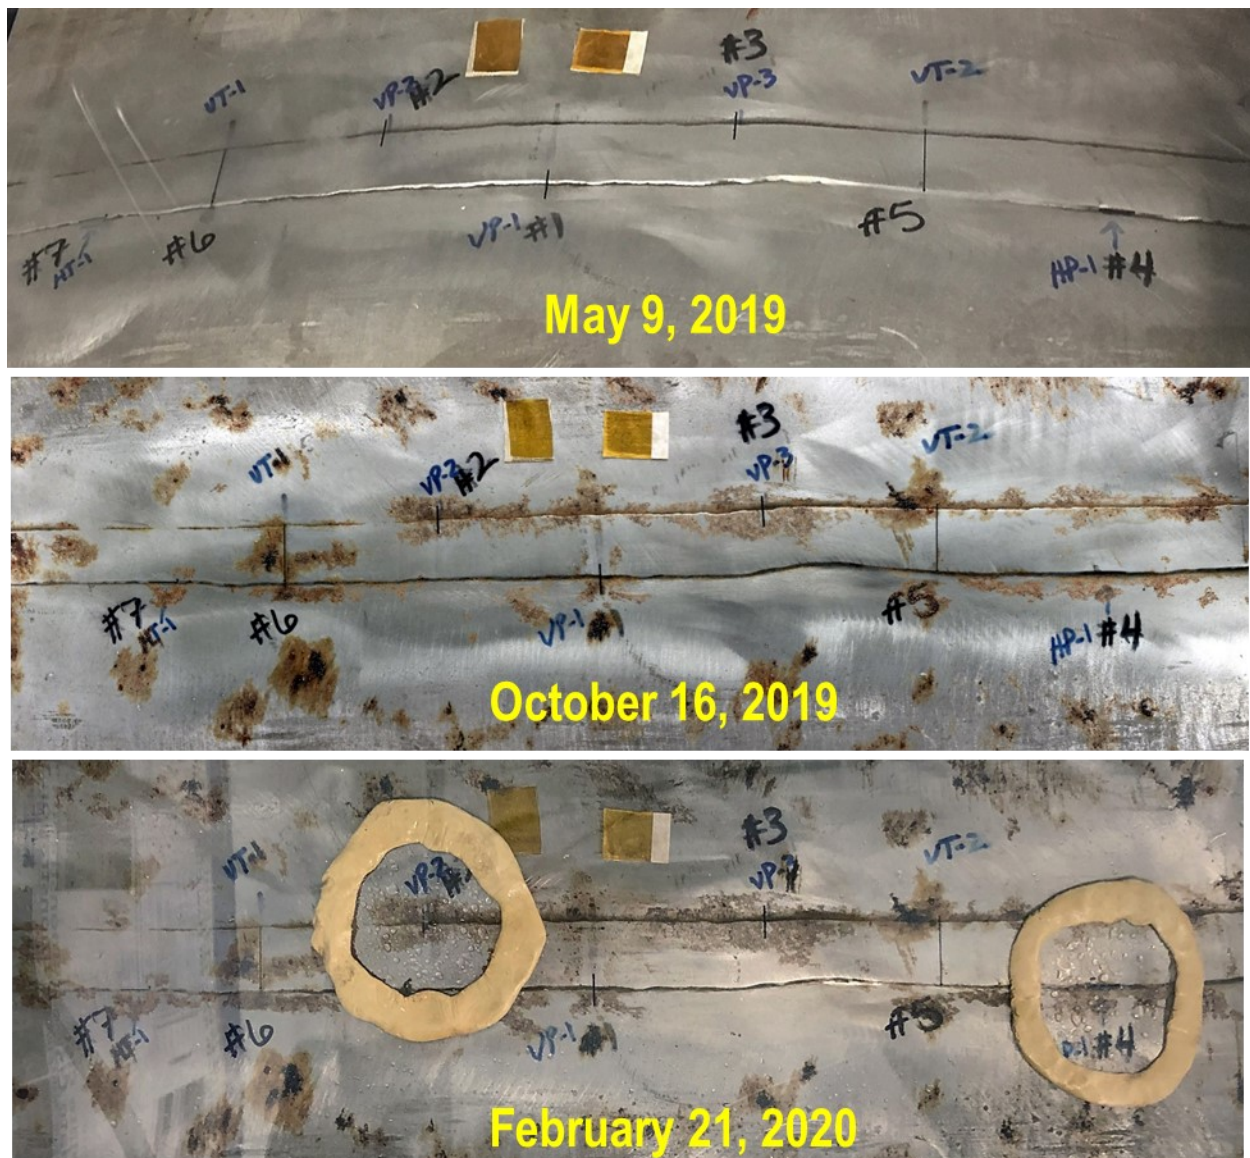
Figure 22: Evolution of general corrosion on the large plate in weld region

A comparison of general corrosion in the weld region between May 9, 2019 and February 21, 2020 found that the corrosion pattern appears to quickly stabilize. Even the areas with extra applied salt loading show little difference in general corrosion accumulation during this time period. Figure 22 shows images depicting the corrosion buildup on the plate from May 9, 2019 to February 21, 2020

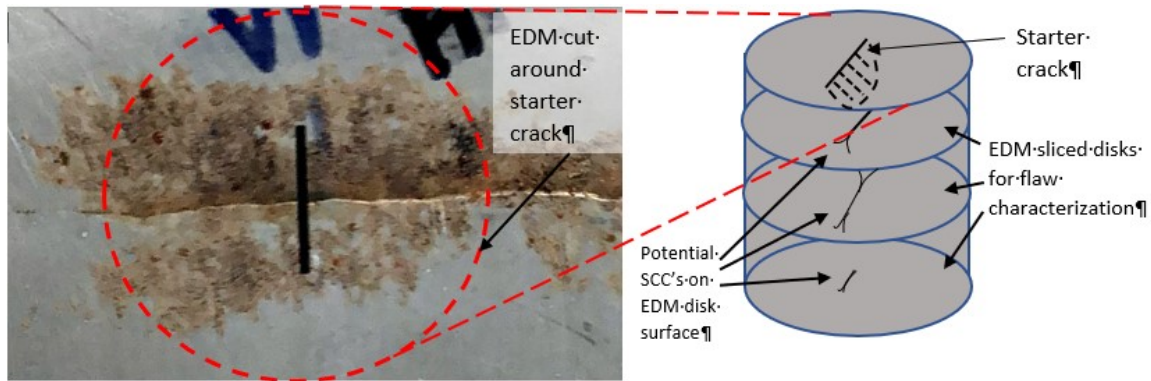
Figure 23: Schematic of serial sectioning of materials containing a starter crack along the depth of the stress corrosion crack.

After the NDE results were observed, a circular plug containing starter crack VP2 was sectioned from the large plate by EDM for metallographic analysis. Serial sectioning was performed by EDM to create thin slices at regular intervals along the depth of the flaw. Figure 23 contains a schematic of the sectioning performed and Table 5 provides information about the position of each sample relative to the top surface of the plate.
