***Summary of Chloride-induced  
Stress Corrosion Cracking  
Experiments with a Spent Fuel  
Storage Canister Large Plate***

***Daniel Foley  
Emmanuel E. Perez  
Andrew J. Duncan  
Lisa N. Ward  
Thanh-Tam T. Truong  
Robert L. Sindelar  
Savannah River National Laboratory***

***June 3, 2022***  
Milestone No. M4SF-22SR010207082  
SRNL-STI-2022-00260

# Large Plate Experiment of Chloride-induced Stress Corrosion Cracking in Spent Nuclear Fuel Storage Canisters

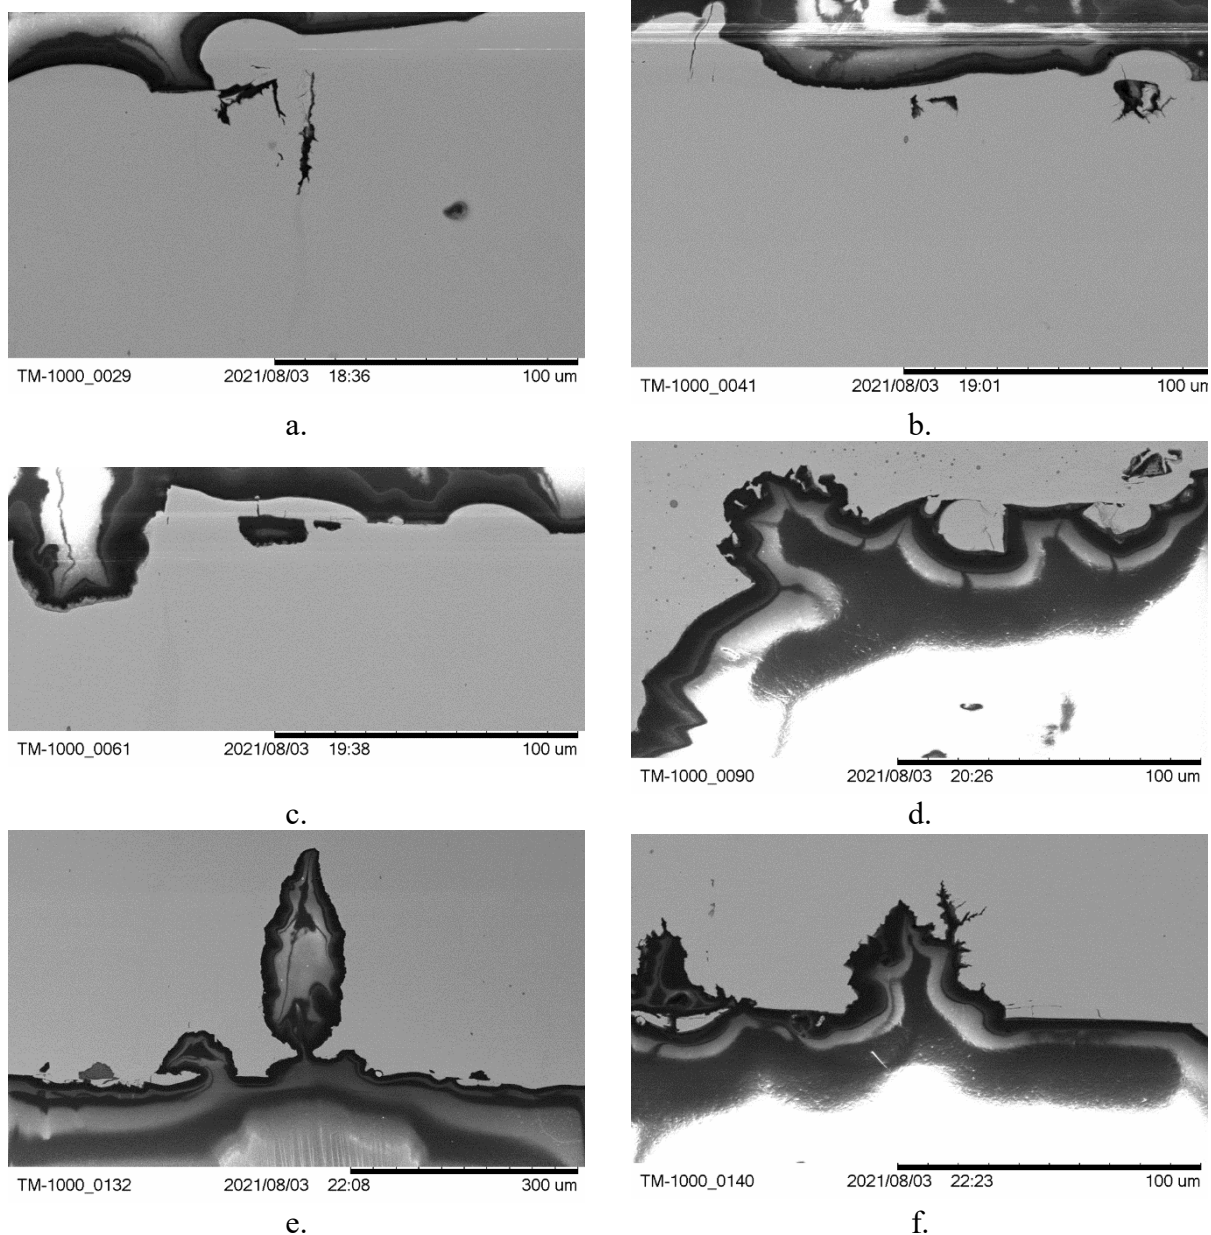
**Figure 24: Secondary electron micrographs of pits and cracks from a. Sample 1, Area 1 b. Sample 1, Area 10 c. Sample 1, Area 5 d. Sample 1, Area 16 e. Sample 1, Area 26 f. Sample 1, Area 28**

The sample slices were mounted to metallographic mounting epoxy with the bottom of the specimen facing up and polished for imaging. Secondary electron micrographs were taken on areas labelled 1-28 surrounding the starter crack as depicted in Figure 23. Multiple cracks and pits were observed on the inside surface of the starter crack as shown in Figure 24 images a-f.

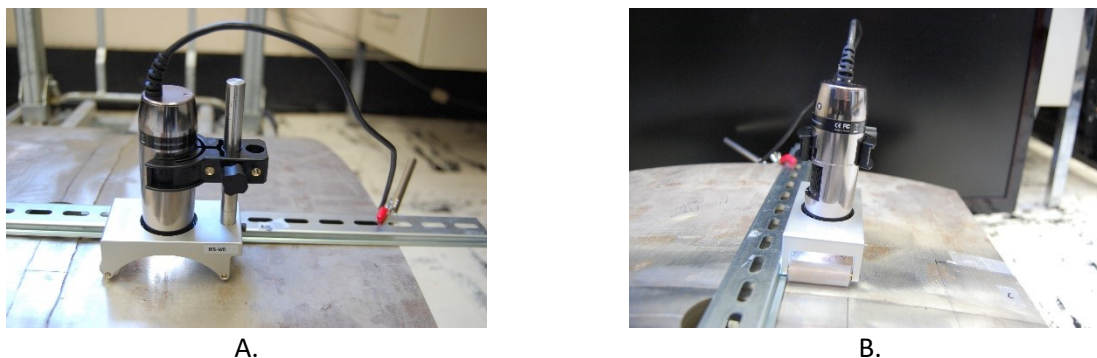
**Figure 25: A. The Dino-Lite microscope mounted on the wheel-rack stand with the metal guide mounted to the plate B. the placement of the wheel rack stand against the metal guide**

microscope mounted was placed on the surface of the plate such that the rollers were in contact with the edge of the metal guide as depicted in Figure 25.

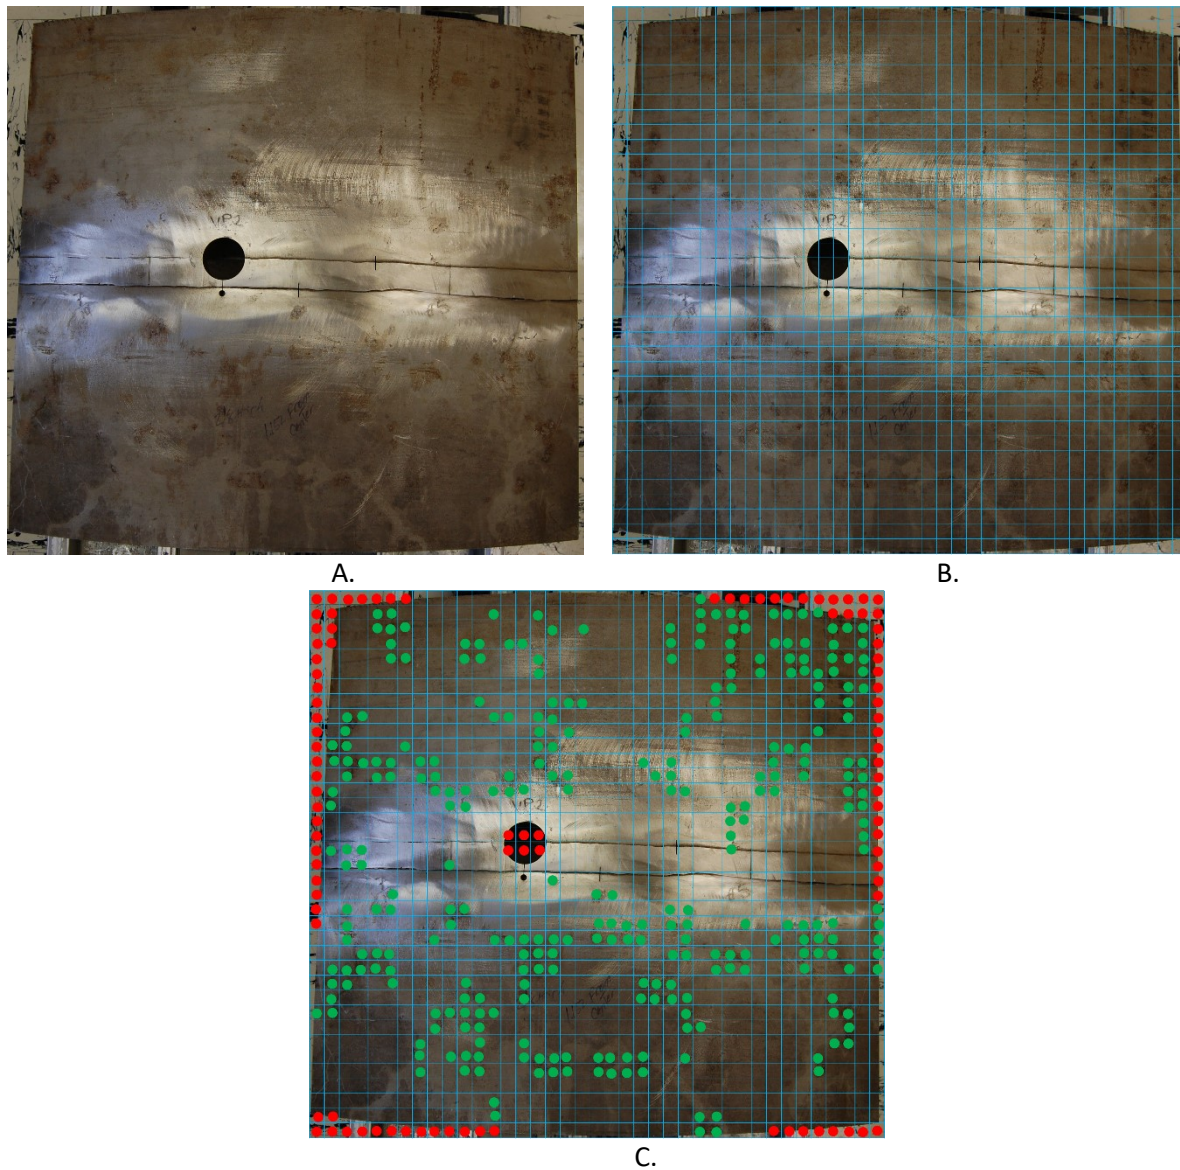
**Figure 26: A. Image of plate from Nikon D-40. B. Image of plate with superimposed grid. C. Grid counting analysis of the plate. Red dots correspond to cells that are disregarded, green dots are cells showing visible signs of corrosion.**

An approximation of the surface area affected by corrosion was determined by superimposing a regular grid over the photo of the plate collected using the Nikon D40 camera. Any cells in the grid where less than half of the surface area of the cell was occupied by the plate were excluded from analysis. With the unoccupied cells removed the remaining cells were examined for visual indicators of corrosion such as surface discoloration, buildup of corrosion products on the surface, or the appearance of corrosion pits on the surface. Figure 26 provides a visualization of this analysis.

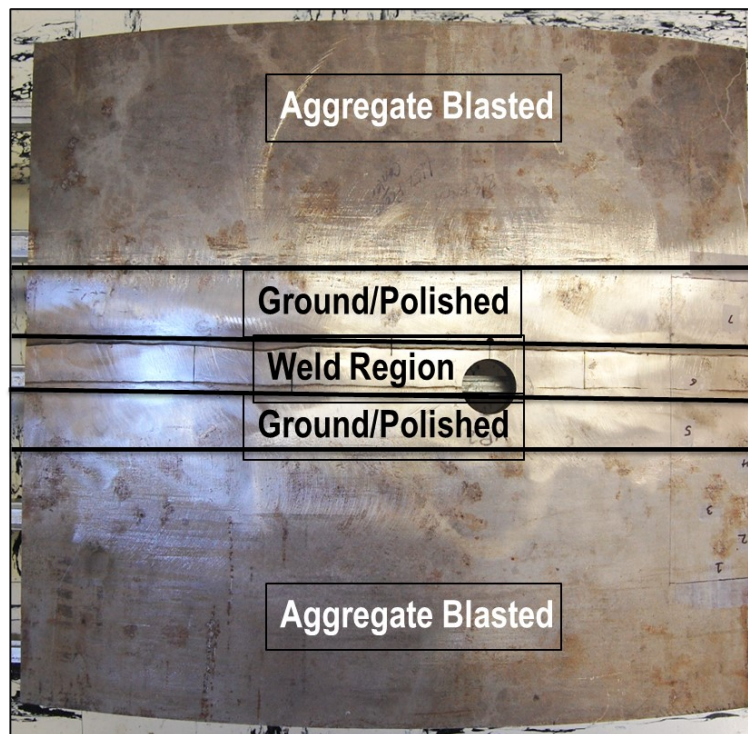
**Figure 27: Breakdown of the unique surface types identified by visual analysis**

Beyond the presence of corrosion on the surface, the preliminary visual analysis also reveals critical details about the character of the plate surface. Specifically, the plate can be broken down into three distinct surface types as depicted in Figure 27.

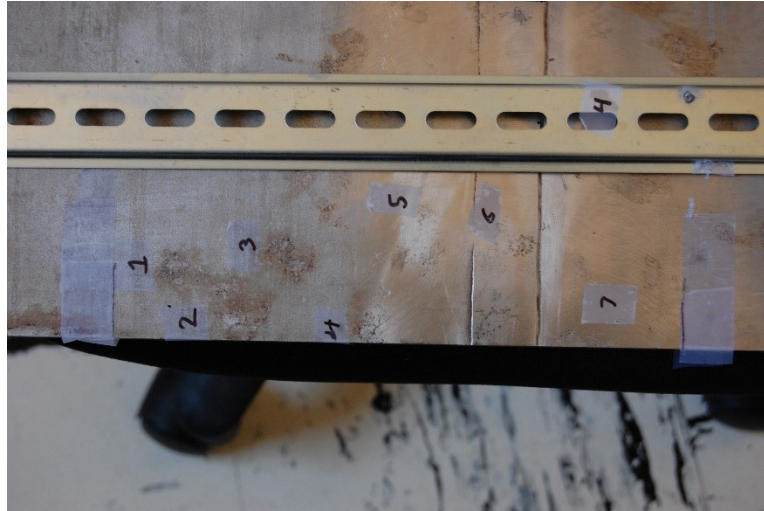
**Figure 28: Region of interest delimited by the metal guide on top, the plate edge on bottom and tape on the left and right. Numbers on tape have been placed on the plate to indicate the seven areas of interest identified for analysis.**

occurring in all the distinct regions of the plate surface. The region of interest and the seven areas of interest are depicted in Figure 28.

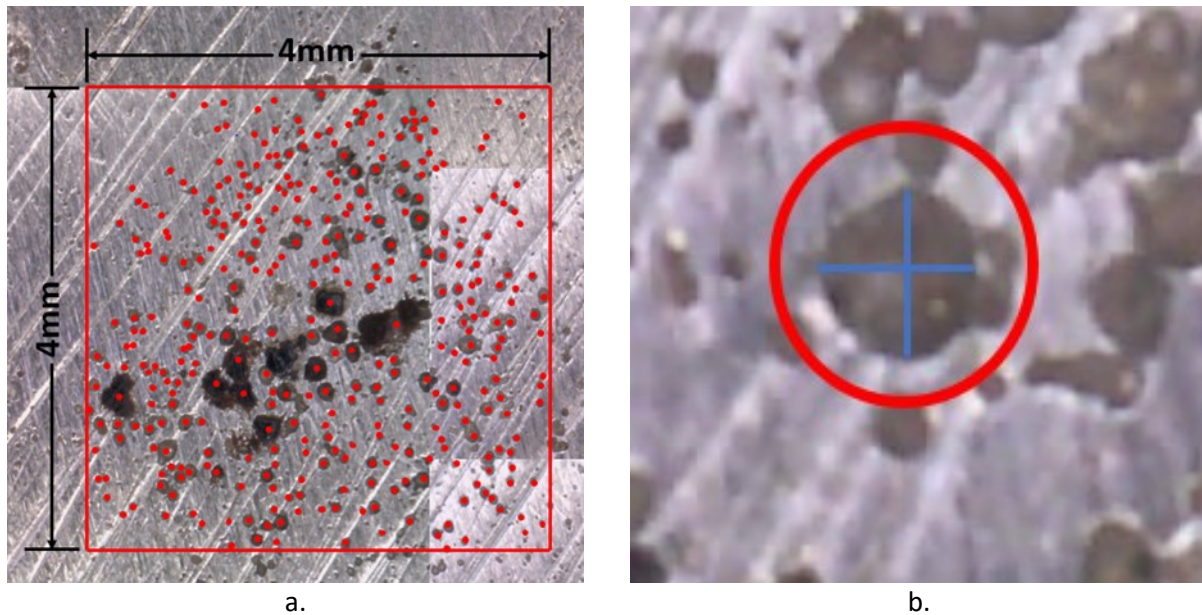
**Figure 29: A. Pit counting within a region of interest. Red dots correspond to identified pits, the red square denotes the counting region. B. Measuring approximate major and minor axis (depicted as blue lines). Red circle highlights the pit in question**

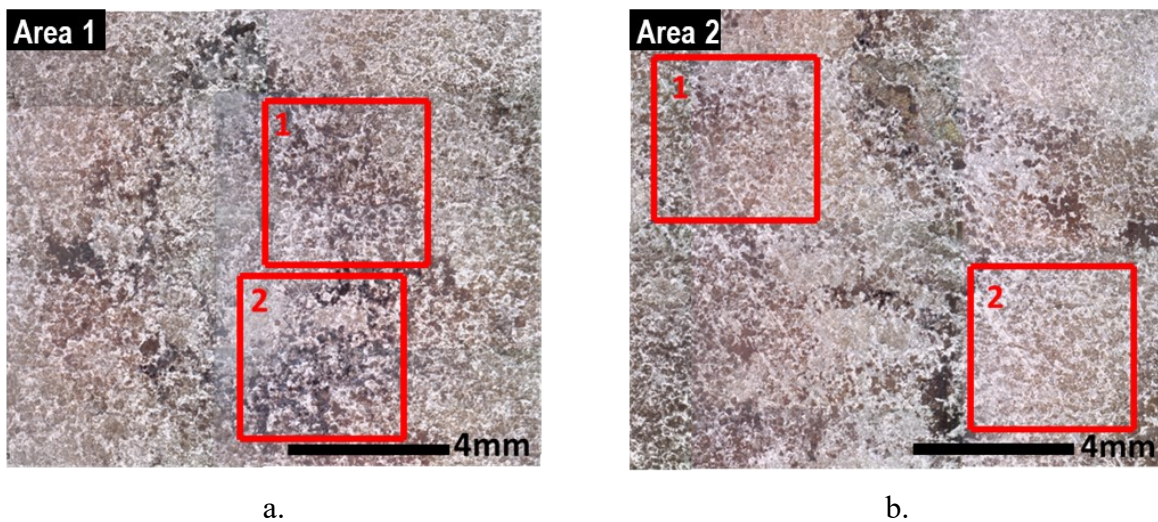
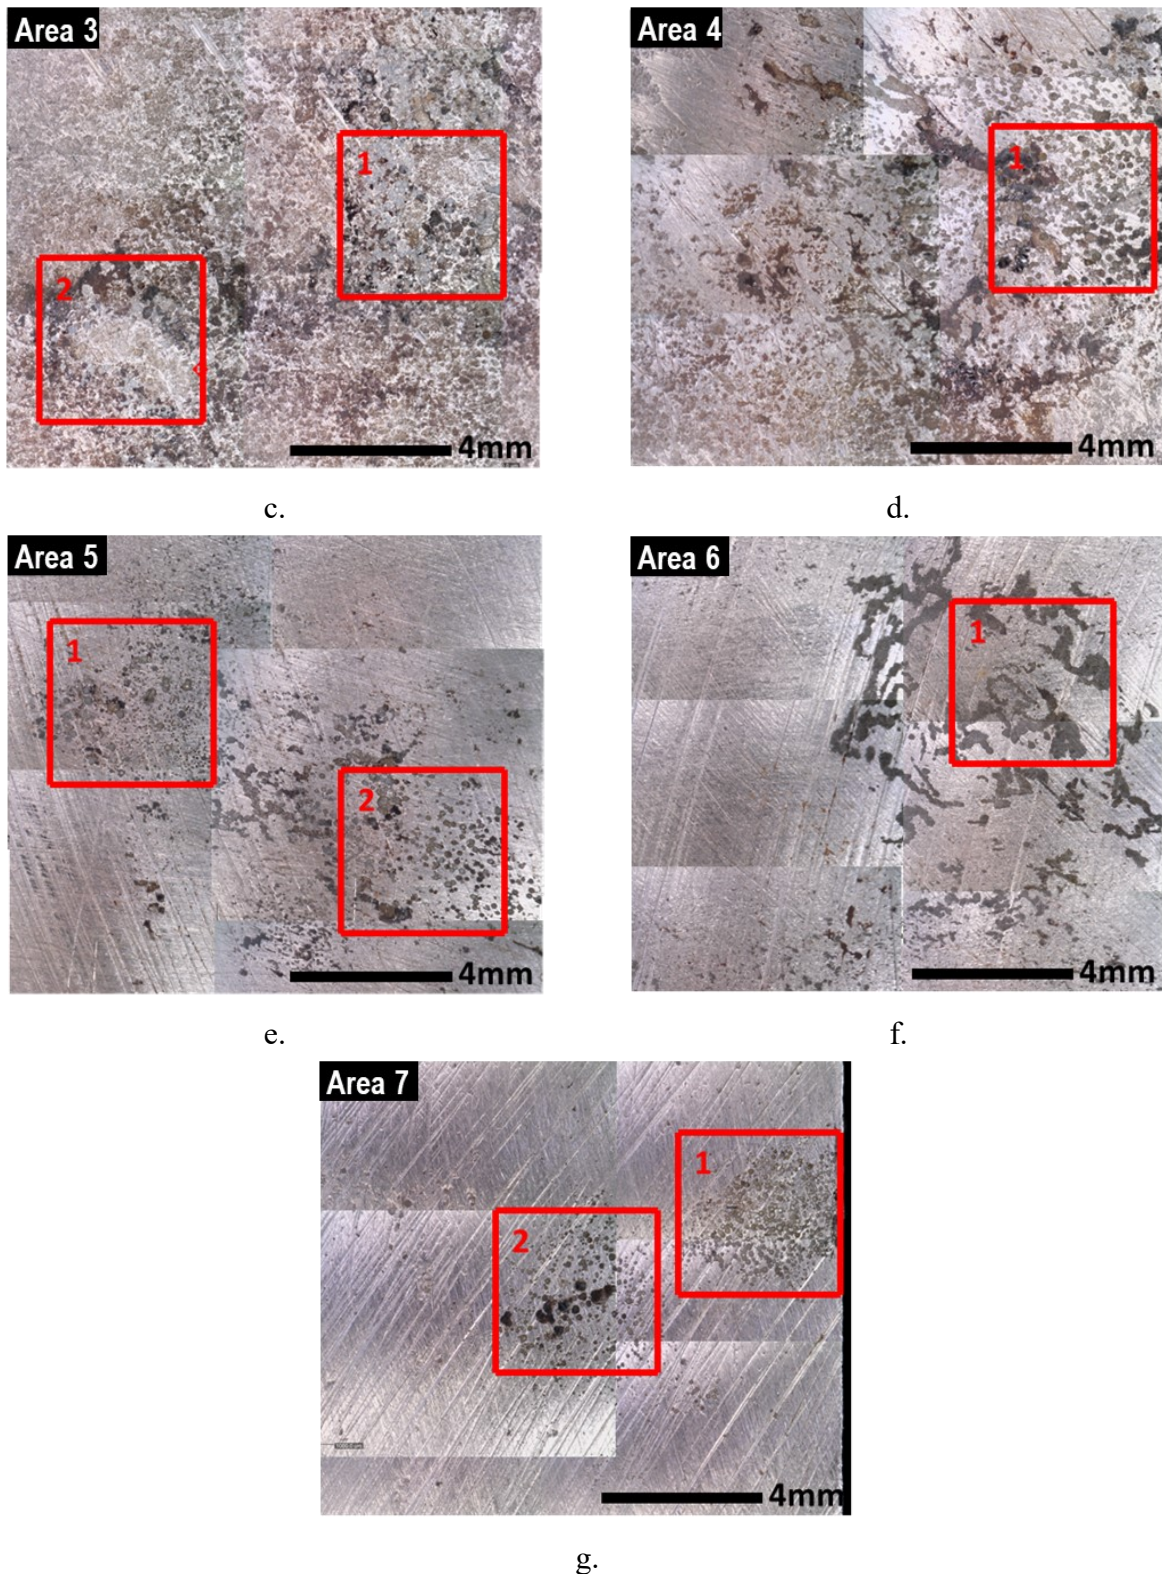
Figure 30: Pit density analysis selections for A. area of interest 4 B. area of interest 6 and C. area of interest 7. The red box denotes the area where counting was performed. Two
