FY2022 Status Report: Model 9975 O-Ring **Fixture Long-Term Leak Performance**

September 2022 SRNL-STI-2022-00437, Revision 0

Keywords: 9975

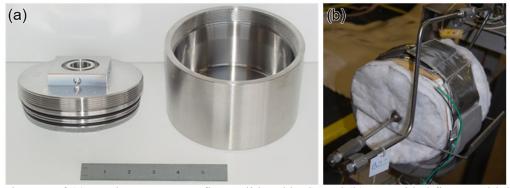
Figure 1. Pictures of (a) mock-up PCV test fixture lid and body and (b) assembled fixture with heater and insulation.

Test fixtures were assembled with either Parker Seals V0835-75 (Viton® GLT) O-rings or Parker Seals VM835-75 (Viton® GLT-S) O-rings in a mock-up PCV. The assembly and setup have been described in detail in previous reports [10-11]. The two-piece lid of the mock-up PCV was machined to be identical to the actual PCV lid used in the 9975 shipping package. The body of the mock-up PCV is 3.5 inches tall with a thread hole machined in the bottom to provide a port for evacuating and filling the vessel with gas. A PCV test fixture with the O-rings installed in the lid is shown in Figure 1a. The mock-up PCV fixtures were assembled per the requirements described in the SARP [1]. The fixture is heated with a flexible heater and capped with insulation at the exposed ends. The assembled fixture is shown in Figure 1b. The assembled fixture was leak tested initially to confirm leak-tightness before conditioning at 200, 250, 270, 300, 350, 400, or 450 °F.

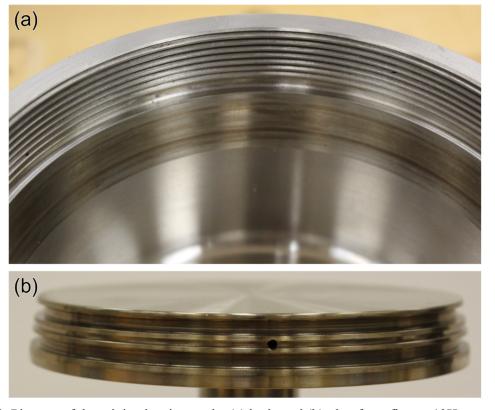
Figure A-2. Pictures of the minimal stains on the (a) body and (b) plug from fixture 13H.

Additional observations of fixture 13H include the O-rings were adherent to the plug and the fixture body. The O-rings have flat and rounded surfaces on opposite sides (Figure 2). The O-rings were black and there were minimal stains on the plug and fixture body (Figure A-2). No defects were visually observed on the O-rings. In contrast to fixture 43 (failed after 13.4 years at 200 °F), there was no visible grease around the threads of the plug or on the O-rings, nor any stains on the O-rings. Furthermore, fixture 13H was not rectangular like fixture 43 with compression set above 90% after 4 weeks. It is not known at this time the cause of leak test failure for fixture 13H. The other GLT-S O-rings aging at 200 °F remain in test after passing the leak test at 12.5 years.
