Hanford Double Shell Waste Tank Corrosion Studies- Final Report FY2022

July 2023

SRNL-STI-2023-00048, Revision 0

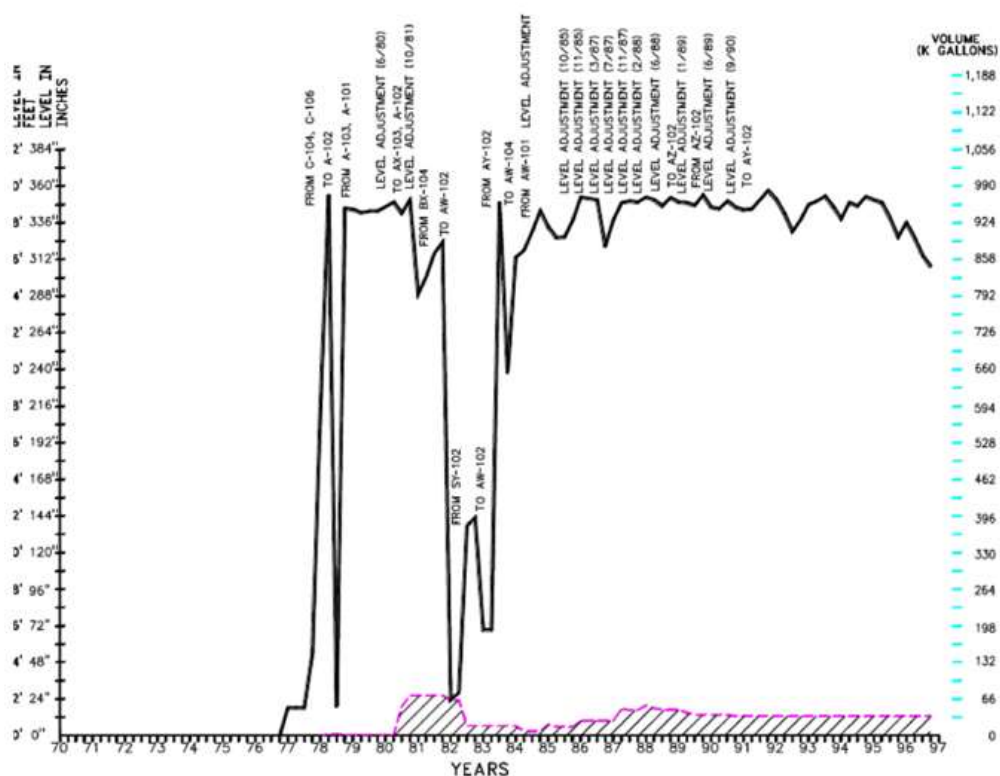
Figure 2-1: Tank AZ-101 Waste Level History from 1976 to 1988.

AZ-101 was constructed between 1970-74 and was placed into service in 1976 [4]. The tank level history is depicted in Figure 2-1. The service history for the tank may be divided into three historical intervals [4]. Between 1976-1983, the tank received waste from four sources: Evaporator Feed, Double Shell Slurry Feed, Complexed Waste and Non-Complexed Waste. A small amount of solids precipitated on the tank bottom during this period. After the waste was decanted to DST AW-102, between 1983-1989, the tank received Neutralized Current Acid Waste (Purex) from DST AY-102 and AW-101. Figure 2-2 shows that the waste temperatures approached the boiling point (~215 °F). The air circulators were used to suspend the solids, however, there was solids build-up due to settling of aluminum phases. Since that time there has been only one transfer into or out of the tank (i.e., Tank AN-106 sent a waste transfer in 2009). The temperature has been steady at approximately 145 °F. The air circulators have not been operated during this time so that the solids layer, which is 1-2 feet deep, has been undisturbed.

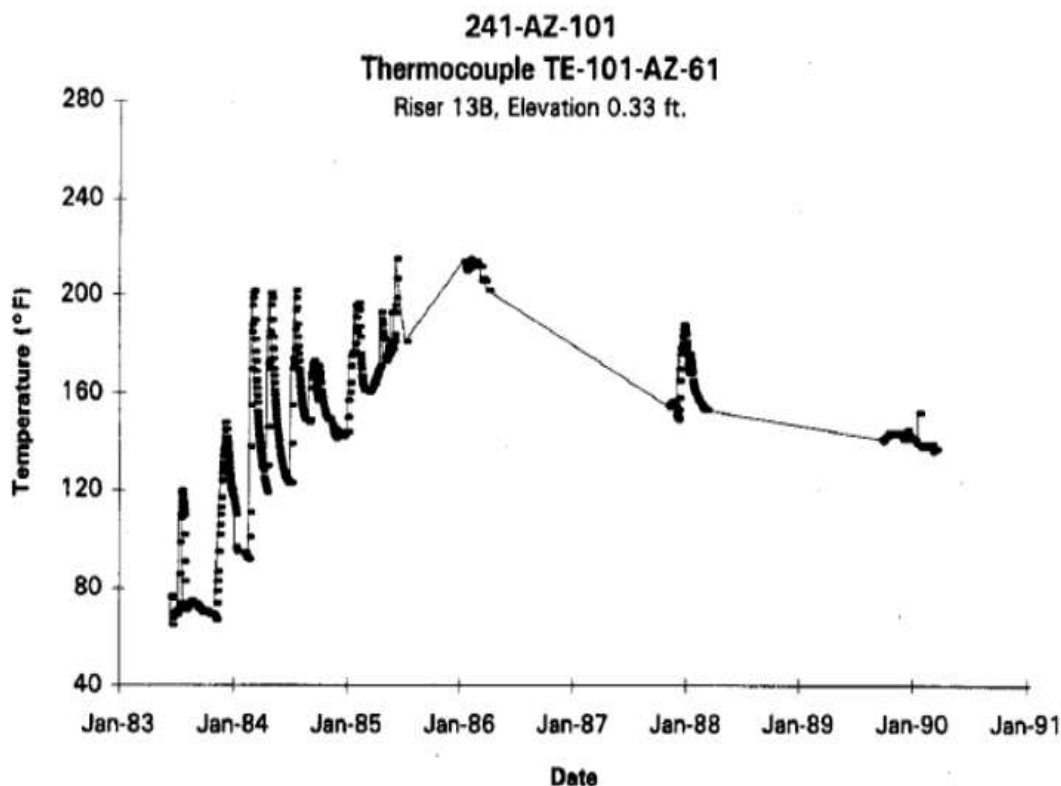
Figure 2-2: Tank AZ-101 Temperature History from 1983 to 1990.

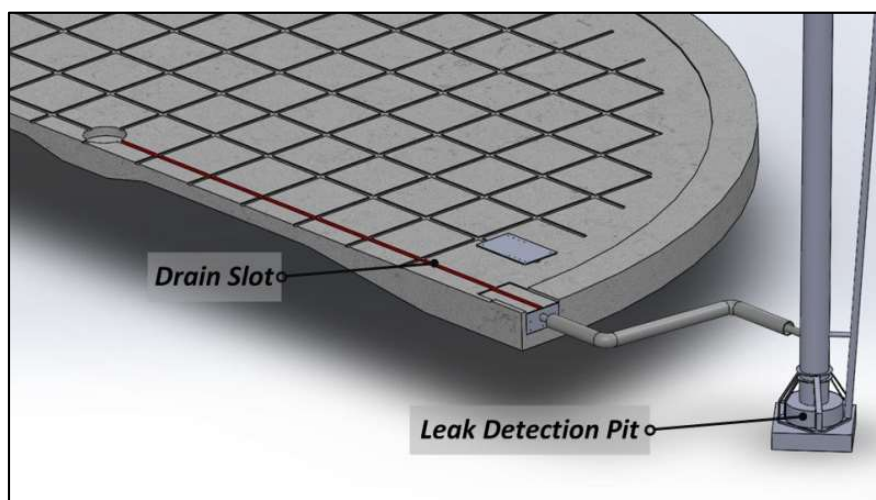
Figure 2-3: Schematic of drain slots connected to the leak detection pit (LDP).

Each DST consists of a primary liner (inner) surrounded by a secondary (outer) liner. The secondary liner rests on a concrete foundation that contains drainage slots that will direct any leakage to a leak detection pit (LDP) [5], as shown in the schematic in Figure 2-3. Figure 2-4 shows the drainage slots that were cast into the foundation of Tanks AZ-101 and AZ-102.

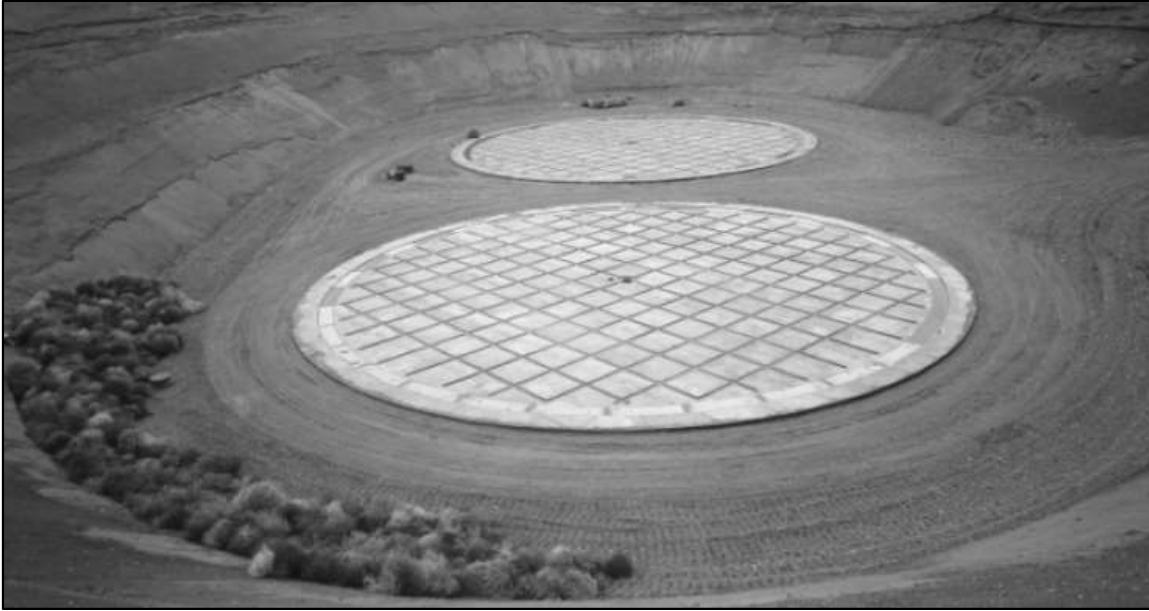
Figure 2-4: Concrete foundation for tanks AZ-101 (foreground) and AZ-102 (background) showing the cast drainage slots.

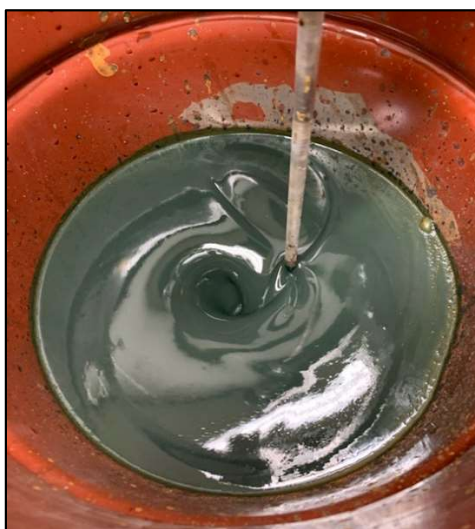
Figure 4-1: Precipitate solids after the addition of the sodium carbonate.

- While measuring the pH of the solution, 8 M sodium hydroxide was added to precipitate the metal hydroxides/oxides. The pH was greater than 10.
- 0.6 M sodium carbonate solution (approximately 400 ml) was added to convert the more soluble hydroxides (e.g., calcium and magnesium) to carbonates. The final pH at this step was approximately 12. The solids were greenish-black as shown in Figure 4-1:.

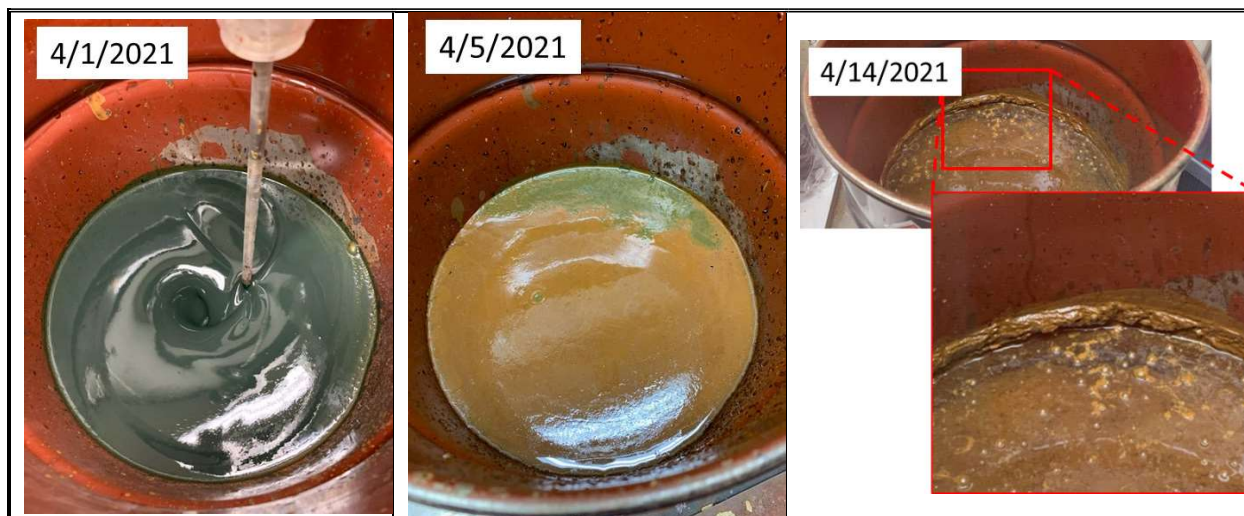
Figure 4-2: Change in precipitate solids during settling.

- The solids were allowed to settle for approximately 2 weeks. During this process the sludge changed color from blackish-green to reddish orange (See Figure 4-2:), which was indicative of the transition from $\text{Fe}(\text{OH})_3$ to Fe_2O_3 .

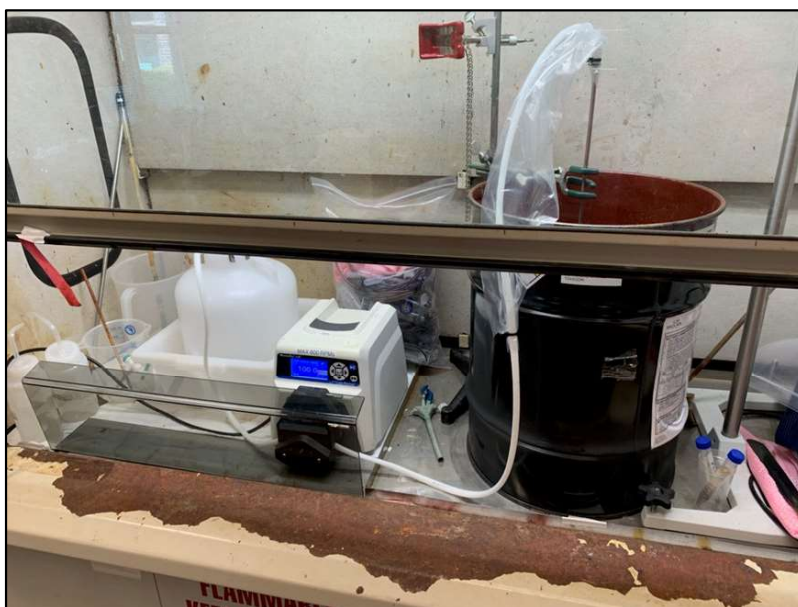
Figure 4-3: Set-up for washing with inhibited water.

- The insoluble solids were washed with inhibited water (0.01 M NaOH and 0.01 M NaNO_2) to remove excess soluble sodium, nitrate, and carbonate ions. This process was accomplished by a) the liquid layer above the settled solids was decanted, b) inhibited water was added back and mixed for approximately 30 minutes, c) the solids were allowed to settle and then d) steps a) through c) were repeated until the nitrate concentration was approximately 1000 mg/l. Figure 4-3: shows the pump and mixer set-up for the washing the solids.

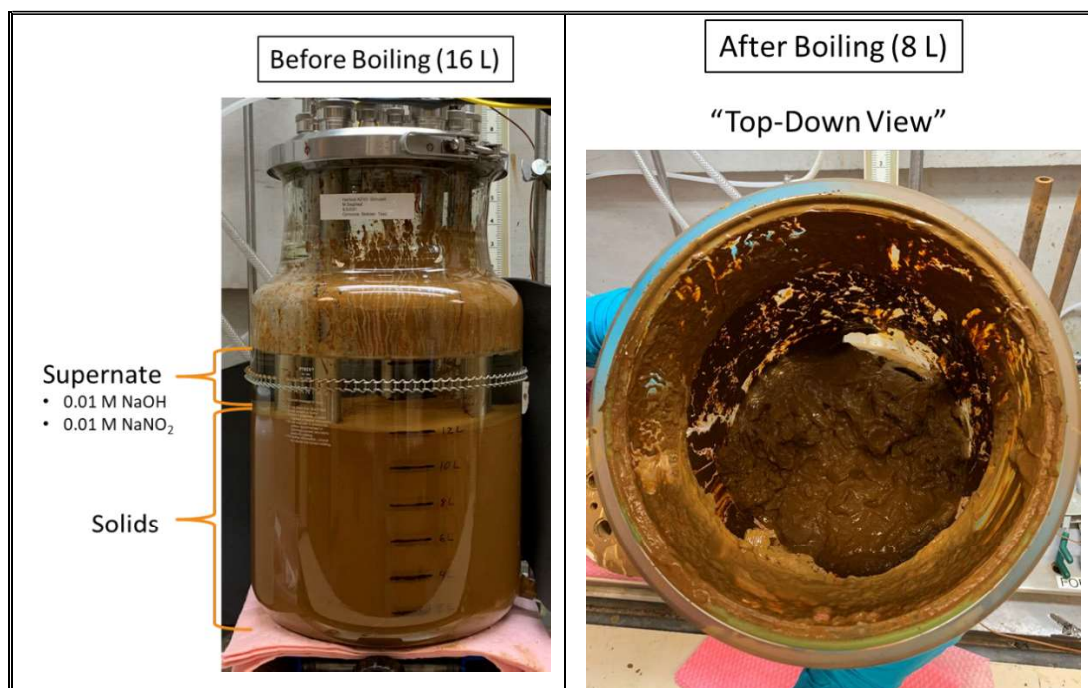
Figure 4-4: Sludge slurry as it is evaporated.

9. The sludge slurry was placed in a heated vessel with a condenser. The slurry was boiled at 102-103 °C for 6 to 7 hours to raise the total insoluble solids concentration to greater than 20%. Figure 4-4: shows the sludge slurry before and after the concentration step. A close-up of the sludge slurry simulant is shown in Figure 4-5:. Approximately 8 liters of sludge was prepared for these tests. The process took approximately 45 days.

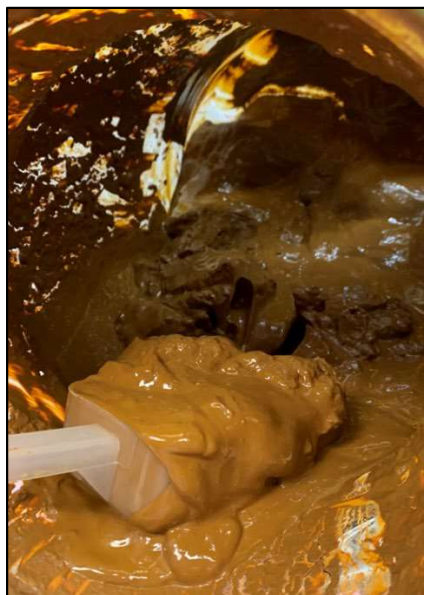
Figure 4-5: Final sludge slurry product.

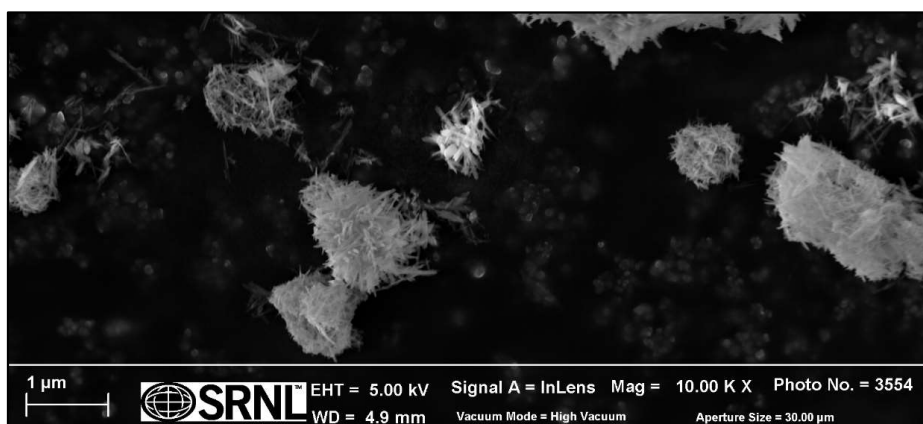
Figure 4-6: SEM micrograph of sludge particles.

An SEM micrograph of the undissolved solid particles is shown in Figure 4-6:. The final sludge slurry was also characterized for particle size, wt.% solids, and sludge slurry density. These values were compared to the same values that were measured for the 2000 AZ-101 core sample and the 2003 SRNL simulant that was produced. The particle size distribution for each sludge slurry is shown in Figure 4-7:. The distributions are presented two ways: a) percentage in a channel (i.e., for a given diameter, the percentage of the total number or volume that are at that diameter.) and b) the cumulative distribution of particle size diameter. The 50th percentile diameter for each was compared and is shown Table 4-6. In addition, the wt.% insoluble solids and the sludge slurry density are also shown in the table. The 50th percentile for the 2021 sludge simulant was approximately 8.3 μm , whereas the 50th percentile for the actual 2000 sludge was approximately 3.3 μm . The distributions indicate that there were several large solids particles ($\sim 100\text{ }\mu\text{m}$) present in the 2021 sludge, whereas there were no particles sizes greater than 30 μm measured for the 2000 sludge. It is possible that some particle agglomeration occurred with the 2021 sludge. Particle agglomeration seems even more likely with the 2003 SRNL simulant. In this case the 50th percentile particles size was nearly 25 μm , and large particles near 250 μm were measured.

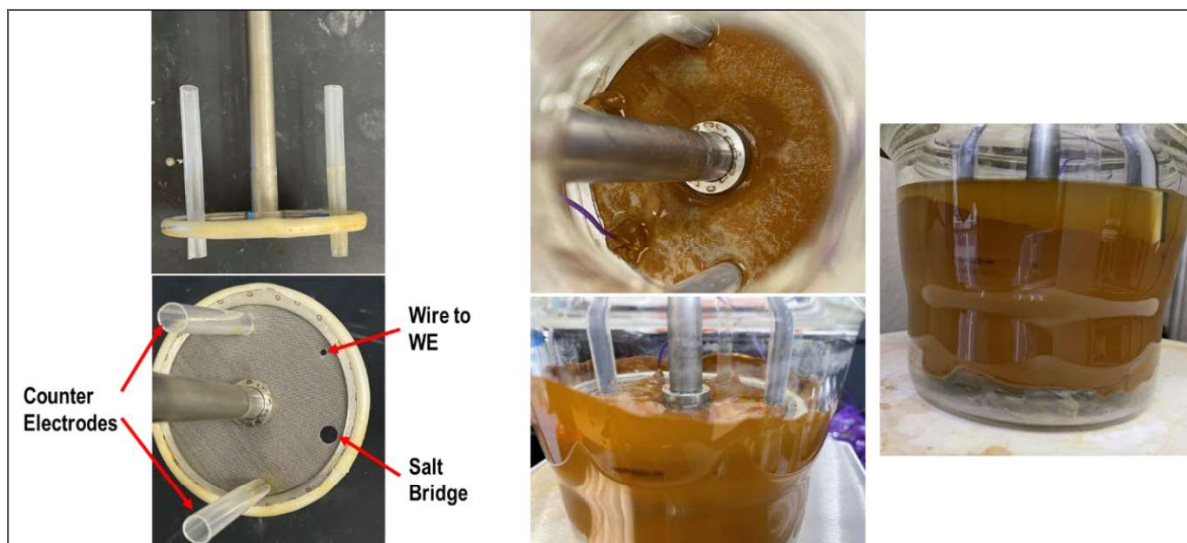
Figure 4-8: Images of Stainless-Steel Mesh Plunger and Compressed Sludge Configuration

with the interstitial liquid and is confined to a defined volume. Images of the plunger and compressed sludge configuration are shown in Figure 4-8. A cross-sectional diagram of the cell configuration is also shown in Figure 4-9.

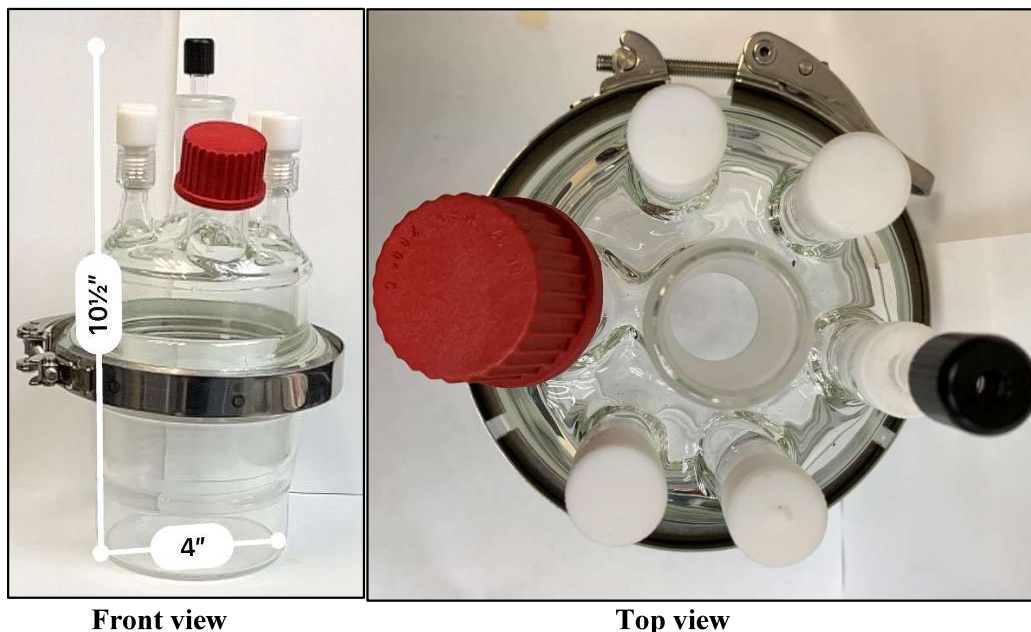
Figure 4-10: Glass vessel used for underdeposit testing: Front view with dimensions at the left; Top view at the right showing the seven different ports on the lid.

Three vessels were fabricated by the SRNL glass shop for the long-term exposure tests. Figure 4-10 presents front and top view images of one of the vessels. The vessels were approximately 10.5" high and approximately 4" in diameter. Ports were formed on the lid in order to insert electrodes for the electrochemical tests, a thermocouple, a condenser, and for solution addition.

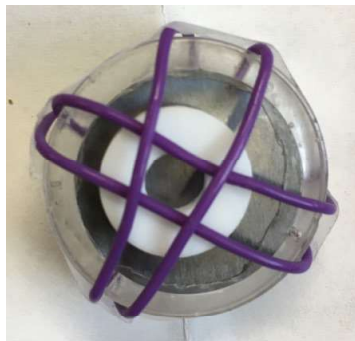
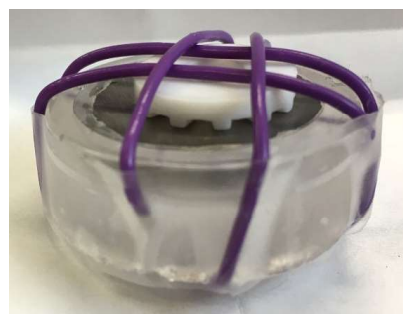
grit finish. The coupons were mounted in a mold prepared with a two-part clear epoxy solution (EpoKwick[®] from Buehler) so that one face of the coupon was exposed to the test electrolyte. Prior to mounting, each coupon was weighed so that the weight change at the end of the tests could be recorded. A crevice former was tightly attached to each coupon surface using tape and wire (see configuration in Figure 4-12). The crevice former partially covered the coupon surface, which created conditions for crevice corrosion.

(a) Top view

(b) Side View

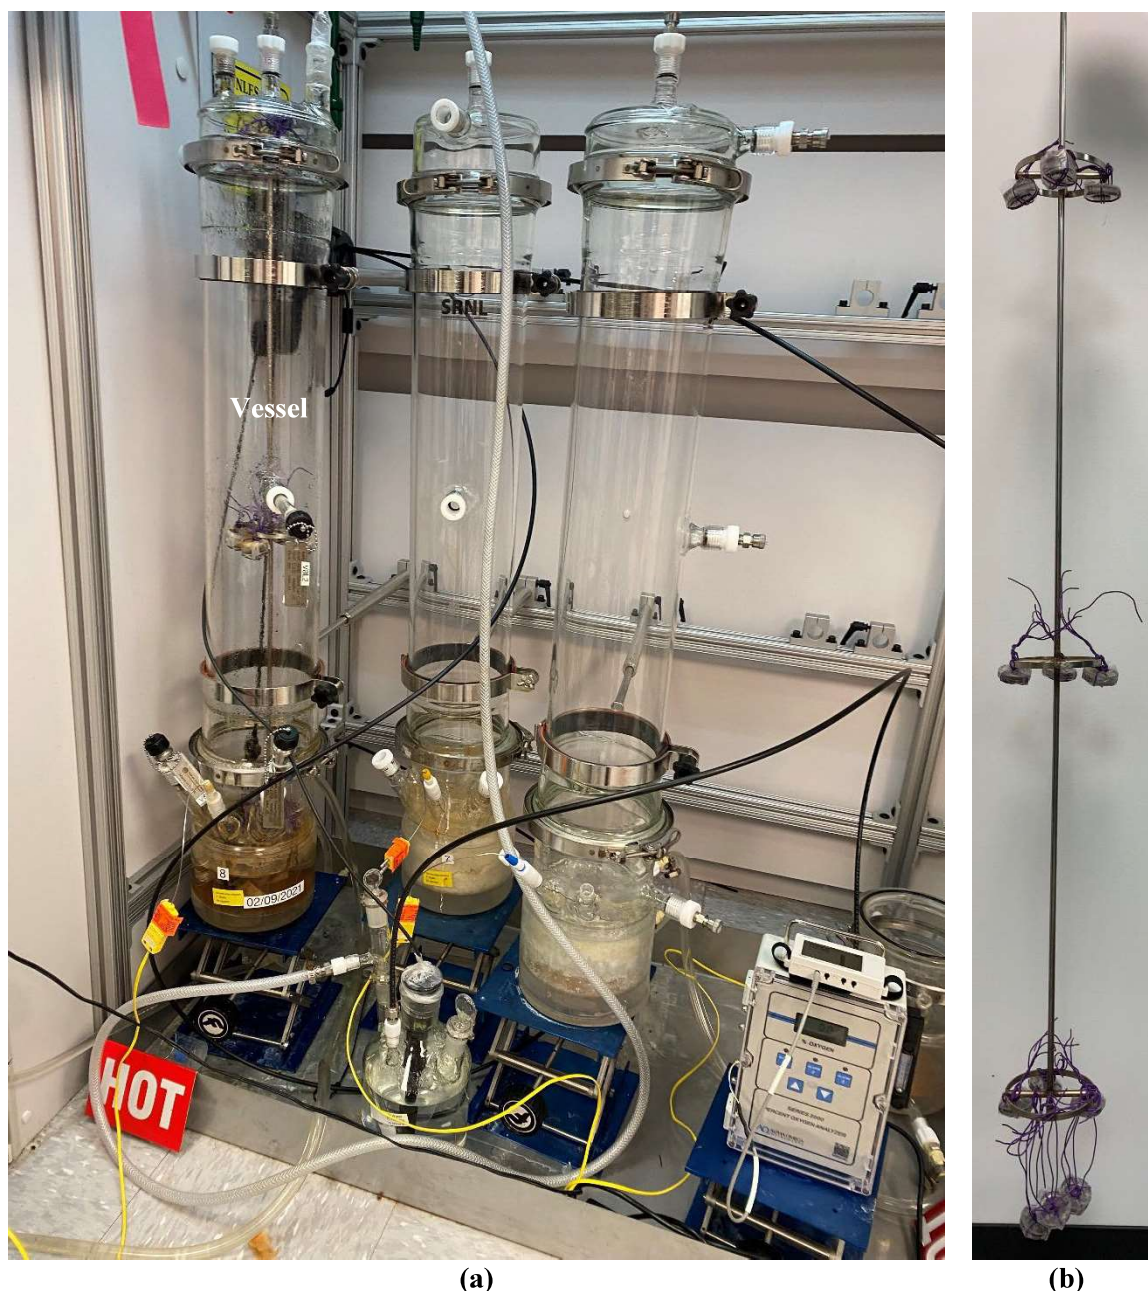
Figure 4-13: Images of the (a) experimental configuration, and (b) steel rod to suspend the coupons

Initially, the coupons at each level were exposed to the GW simulant only for 78 days, without any nitrogen. The GW simulant was then purged with nitrogen starting on the 78th day of the experiment; the purging continued for the next 120 days. In addition, simultaneous to the start of nitrogen purging, another set of polished coupons at each level were loaded in the experimental vessel; three coupons each at Levels 1, 2, and 3, and four coupons immersed in GW. This step investigated the influence of the nitrogen purge alone on carbon steel corrosion. Leaving a few of the coupons that had been exposed for 78 days investigated the effect of nitrogen on mitigating corrosion that had already initiated. Furthermore, when nitrogen was added to the vessel, a port on the top lid of the vessel was fitted with a tube that passed through a water trap; this allowed flow of the nitrogen through the vessel. The dissolved oxygen concentrations were measured in the GW simulant and water trap. In addition, the oxygen concentration was also measured in the outflow gas that passed through the water trap.

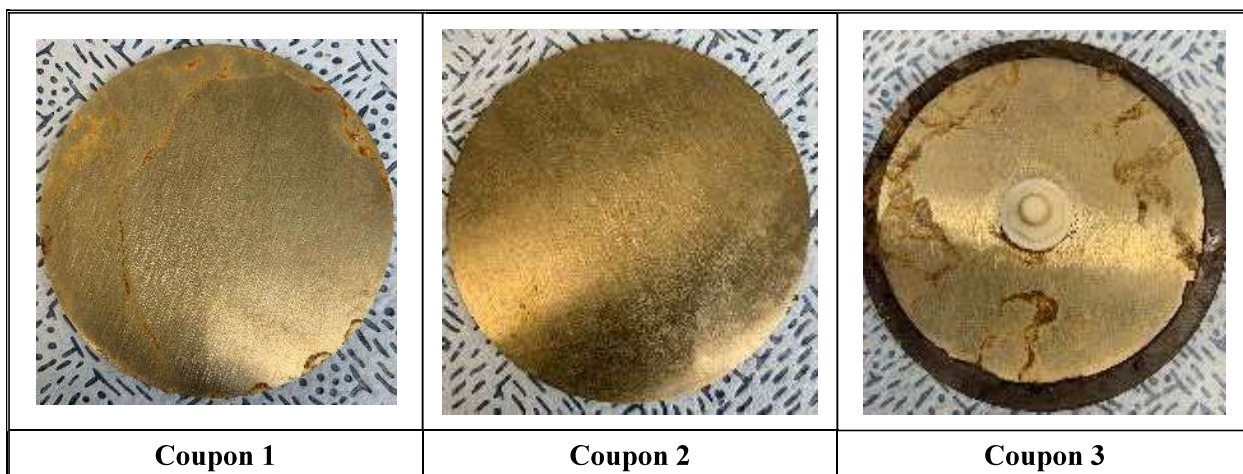
Figure 5-1: Post-test images of the long-term underdeposit coupons

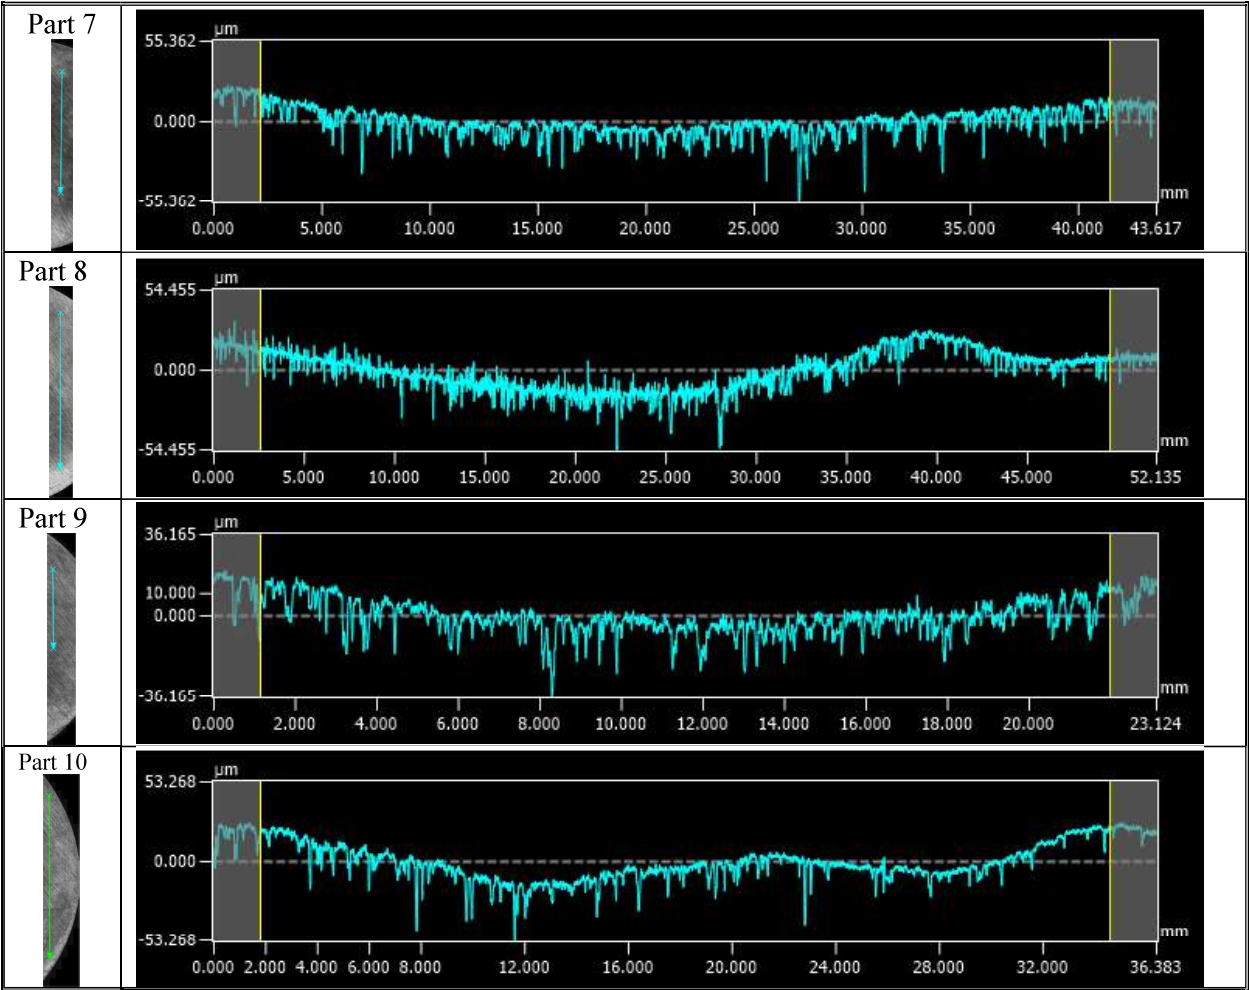
Figure 5-3: Camera and profiled images of Coupon 2 parts.

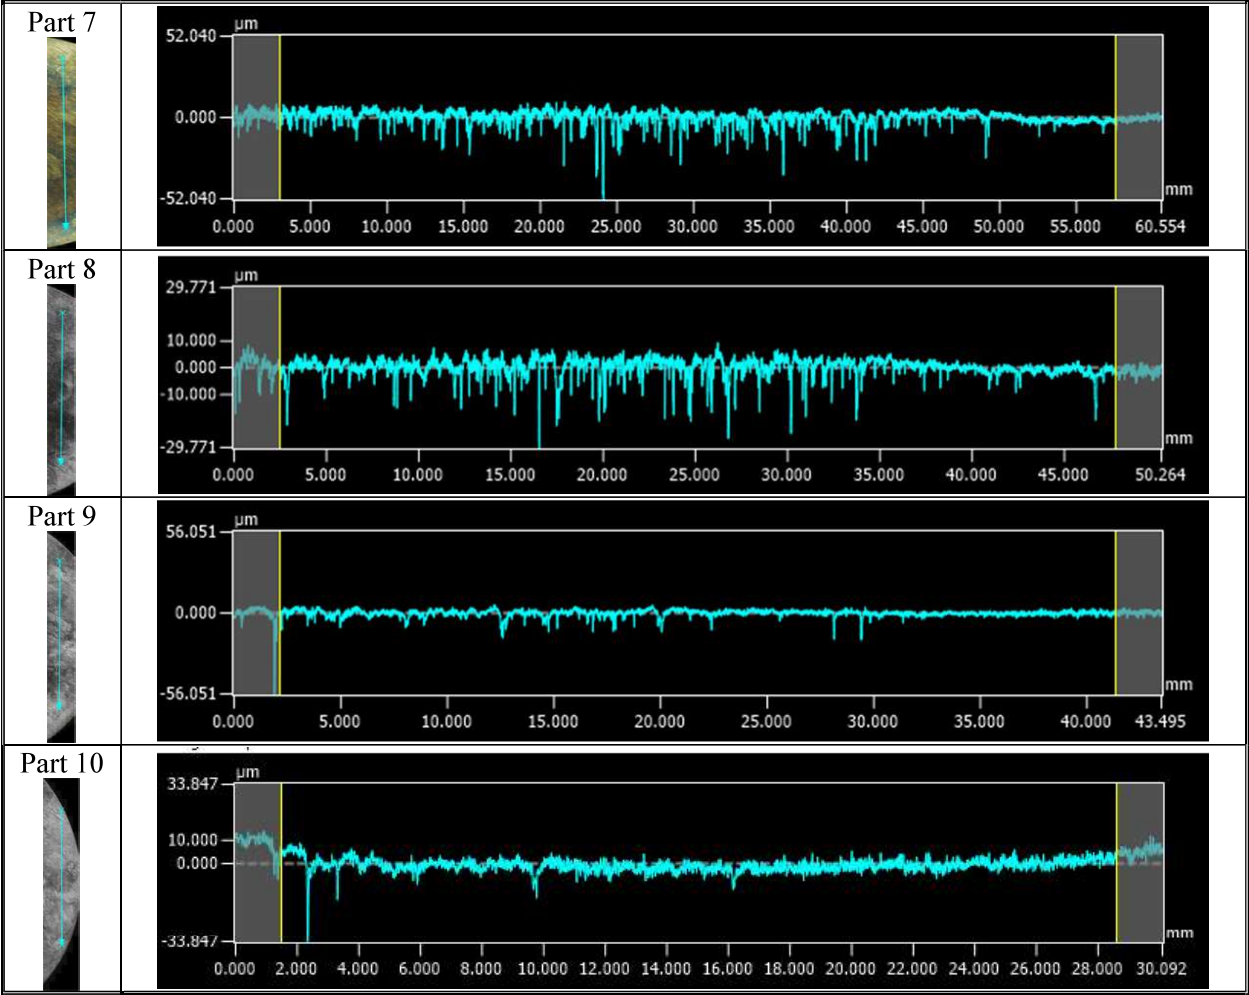
Figure 5-4: Camera and profiled images of Coupon 3 parts.

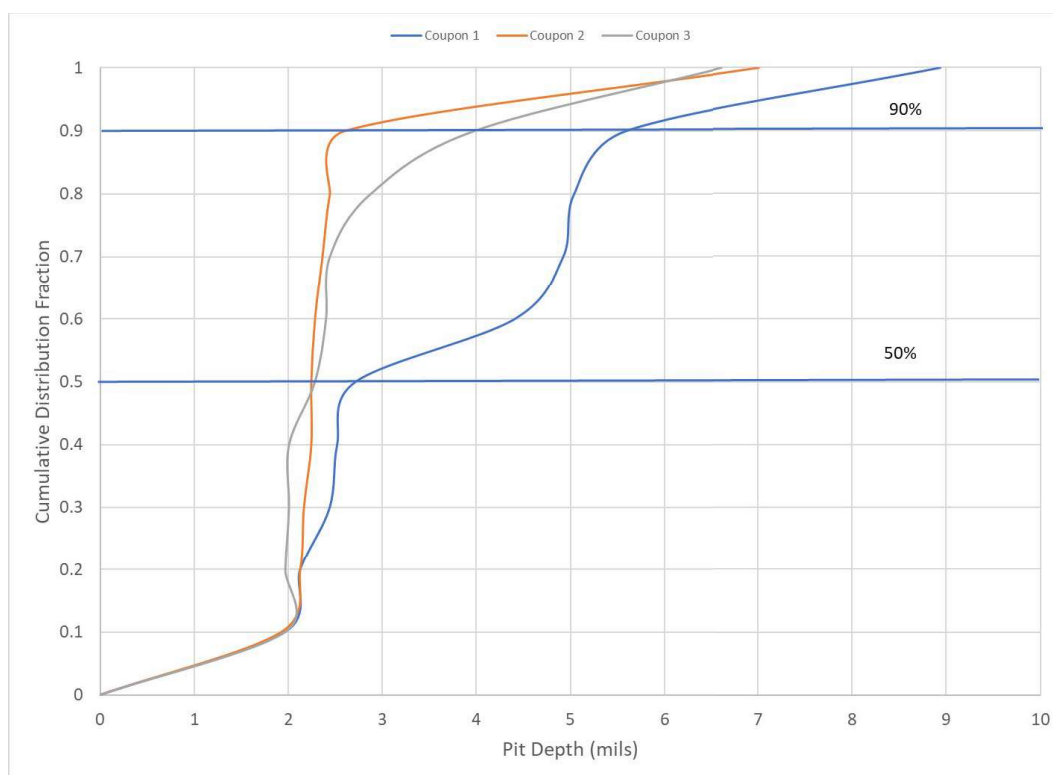
Figure 5-5. Cumulative Distributions for Maximum Pit Depths (mils) for Coupons 1, 2, and 3.

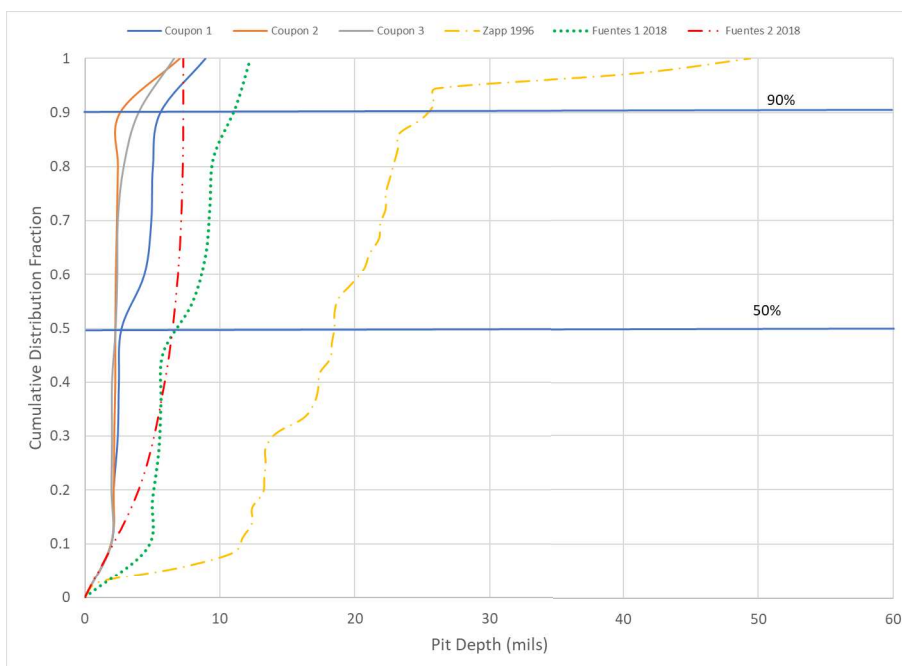
Figure 5-6. Cumulative Distributions for Maximum Pit Depths (mils) for Coupons 1, 2, and 3 and Three Historical Tests.

These observations indicate that these micropits differ from stable, propagating pits. One possibility is that these micropit features initiated early on during the test beneath a solid particle, but stable pit growth was not sustained for the entirety of the test. A possible explanation for this observation is that inhibited interstitial liquid from the wet sludge penetrated through the solids and resulted in repassivation of these small pits beneath the solids.

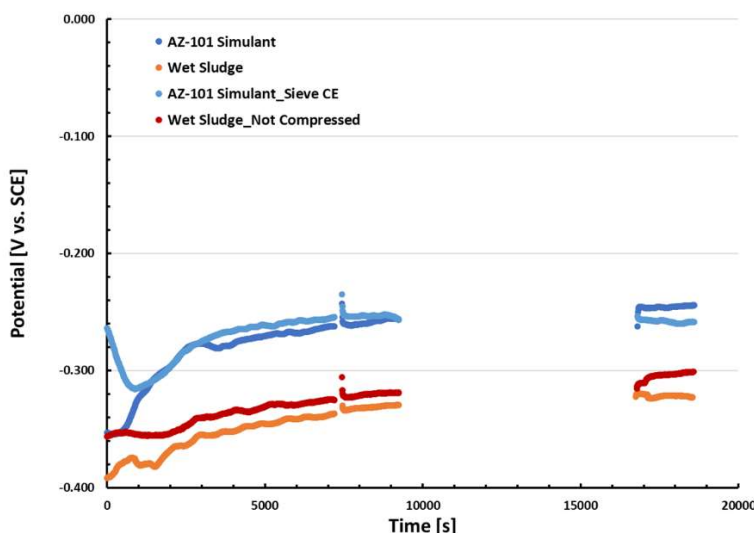
Figure 5-7: OCP evolution with time during short-term electrochemical tests.

The influence of wet sludge on potential measurements was also evaluated by comparing the OCP values for the interstitial liquid and the wet sludge. The presence of the wet sludge resulted in an active shift in the negative direction of approximately 40 – 70 mV in the potential of the carbon steel coupon as compared to the interstitial liquid. It was also noted that compression of the sludge resulted in a 10 – 20 mV negative shift in the OCP compared to that of the uncompressed sludge. The shift to more active potentials may be indicative of the initiation of localized or general corrosion beneath the solids.

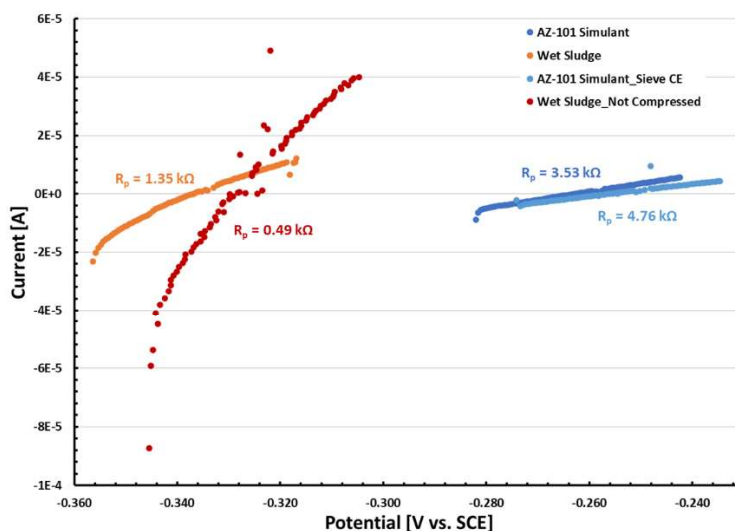
Figure 5-8: LPR data for short-term electrochemical tests

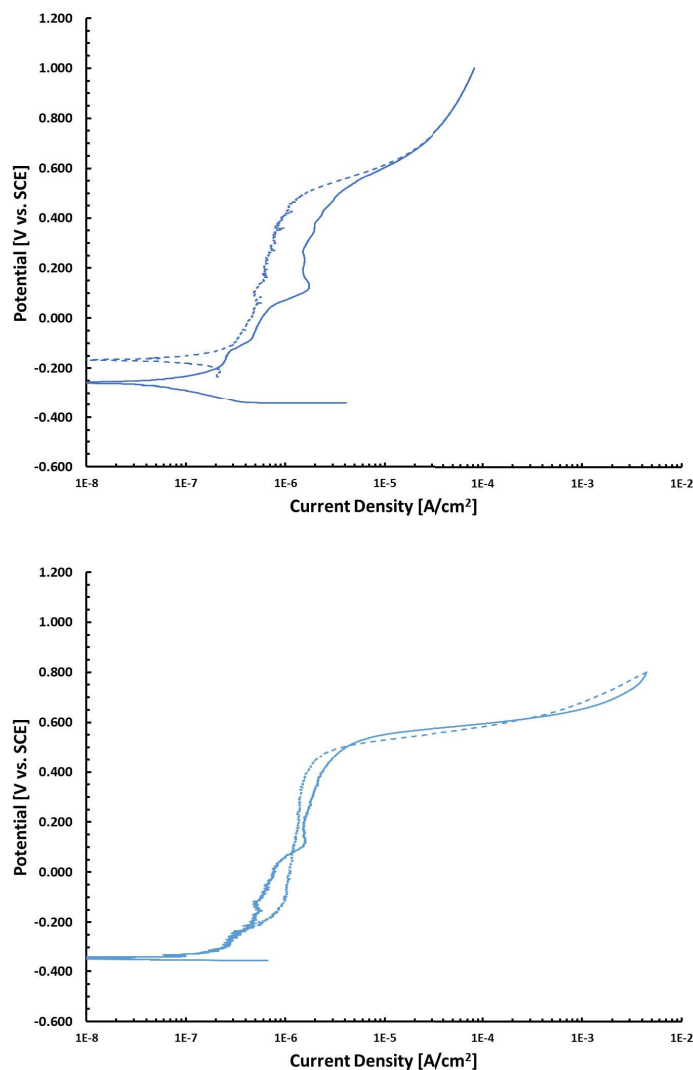
Figure 5-10: CPP curves for AZ-101 Interstitial Liquid Simulant with graphite counter electrodes (top) and plunger counter electrode (bottom). Solid line indicates forward scan and dashed line indicates reverse scan.

Polarization curves from CPP scans were used to evaluate the localized corrosion behavior of the varying conditions. Figure 5-10 shows the comparison of the two conditions tested in interstitial liquid only: using graphite counter electrodes and using the wire mesh counter electrode. The scan using the graphite electrodes (top) shows the issue encountered when using these as a counter electrode. Despite polarizing the electrode to 1 V, the current density limit of 1 mA/cm² could not be obtained. This was attributed to the relatively small cathodic area the electrodes afforded compared to the large area of the 3-inch diameter coupon. The wire mesh of the plunger offered substantially more surface area, and the current limit was able to be obtained at a reasonable potential value. The current during the forward scan of the CPP curve for this test displays some instability indicating that the characteristics of the oxide film are being disturbed. The current on the reverse scan is initially less than that of the forward scan. However, the current on the return scan crosses over the forward scan current at approximately +100 mV and exceeds the forward scan current for the remainder of the test. According to the protocol utilized by SRNL, WRPS, and the CSG to evaluate CPP curves, the result would be classified as a Category 3 or mixed response. This result may indicate the initiation of pits on the forward scan, but later cessation of growth due to repassivation. On the other hand, this may reflect the influence of other ionic species present that are being oxidized or reduced and ultimately influencing the total current that is measured. This possibility cannot be ruled out either given the characteristics of the CPP curve. Another test such as the modified G192, which may elicit more pit growth than the CPP test, may have made a distinction between these two possibilities [30].

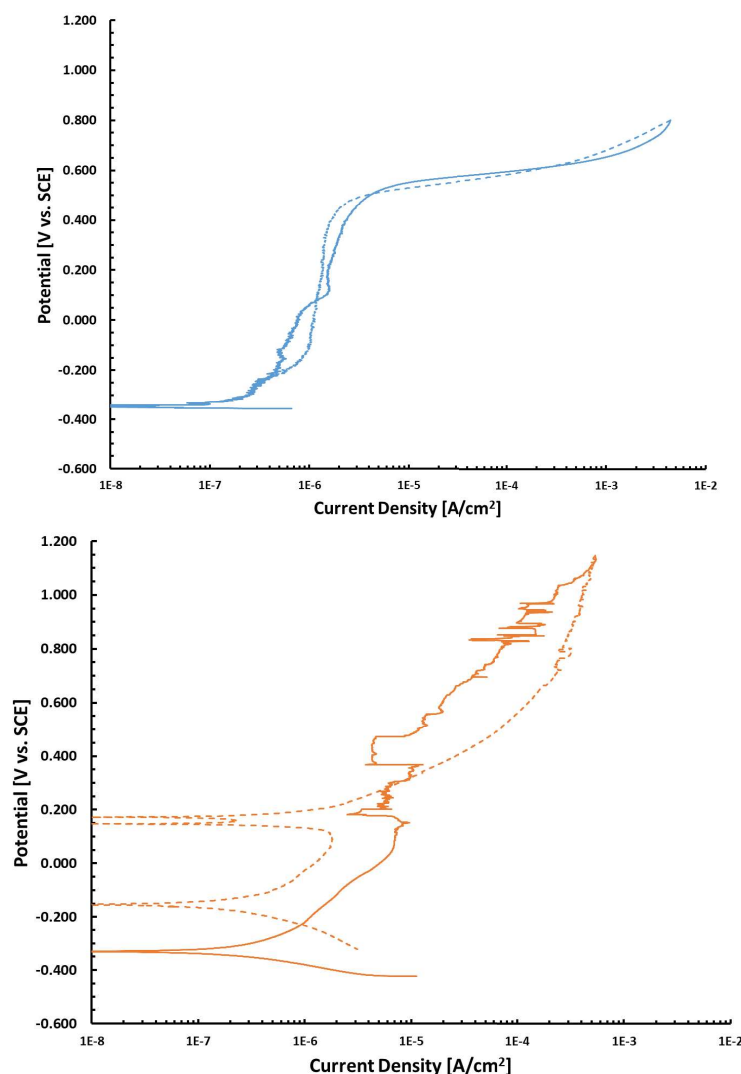
Figure 5-11: Comparison of polarization curves for exposure to AZ-101 Interstitial Liquid only (top) and compressed AZ-101 Sludge (bottom). Solid line indicates forward scan and dashed line indicates reverse scan.

Figure 5-11 shows the comparison of the CPP curves for the interstitial liquid only and that of the condition of compressed wet sludge. The CPP curve for the compressed sludge condition exhibited pronounced instability in the forward scan and had positive hysteresis at the initial stage of the return scan (i.e., category 2), indicating pitting, crevice corrosion, or some other type of localized corrosion mechanism. The polarization curve for the compressed sludge condition also indicated repassivation of this localized attack at 290 mV vs. SCE. With this repassivation potential being more than 600 mV higher than the corrosion potential, it is unlikely that this accelerated attack would occur at open circuit given the time interval evaluated. It was also apparent from these tests that the compressed sludge yielded a lower corrosion potential, higher corrosion rate, and a higher passive current density than the interstitial liquid.

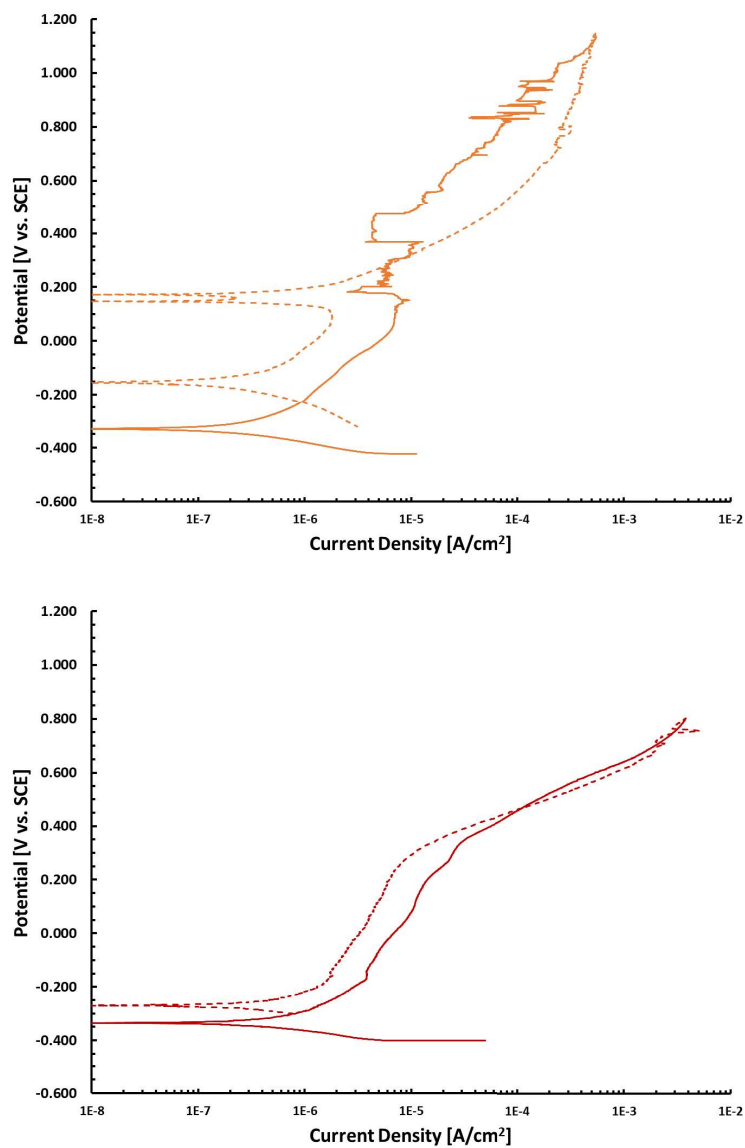
Figure 5-12: Comparison of polarization curves for exposure to compressed (top) and loose (bottom) AZ-101 Sludge. Solid line indicates forward scan and dashed line indicates reverse scan.

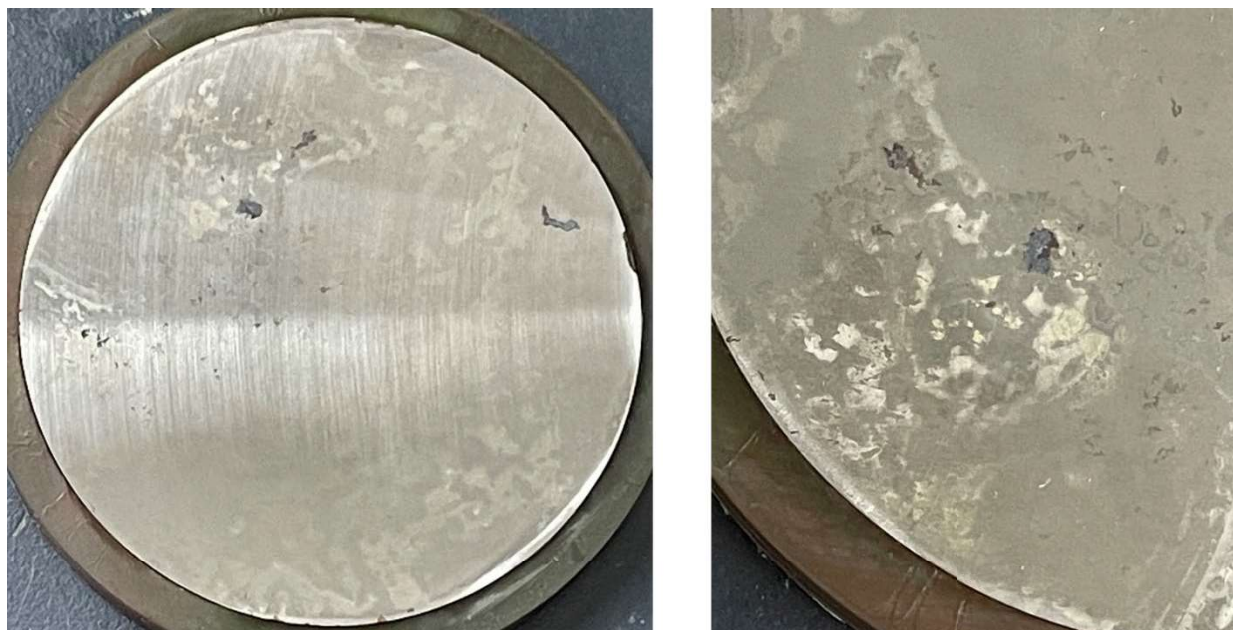
Figure 5-13: Images of coupon following exposure to compressed sludge during the short-term electrochemical test sequence.

Because of the possible indications of localized corrosion observed during the CPP scan, the coupon used for the compressed sludge condition was analyzed for the nature and extent of localized corrosion that occurred. Images of the coupon surface are shown in Figure 5-13.

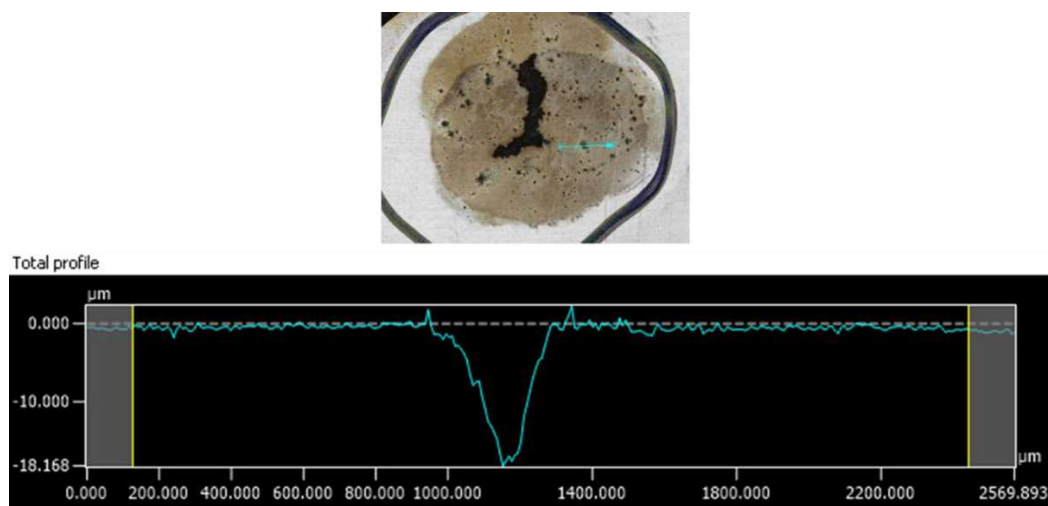
Figure 5-15: Optical image (top) and depth profile (bottom) of a single micropit beneath loosely adherent deposits during test exposed to compressed sludge.

A second micropit profile is shown in Figure 5-15. The depth profile conducted for this area covers only a single micropit to better characterize the pit itself. In this case, the pit penetrated to a depth of approximately 18 μm (0.7 mils) and has a diameter of roughly 400 μm (15.7 mils). The diameter to depth ratio is approximately 22, which is also typical of broad and shallow attack on carbon steel.

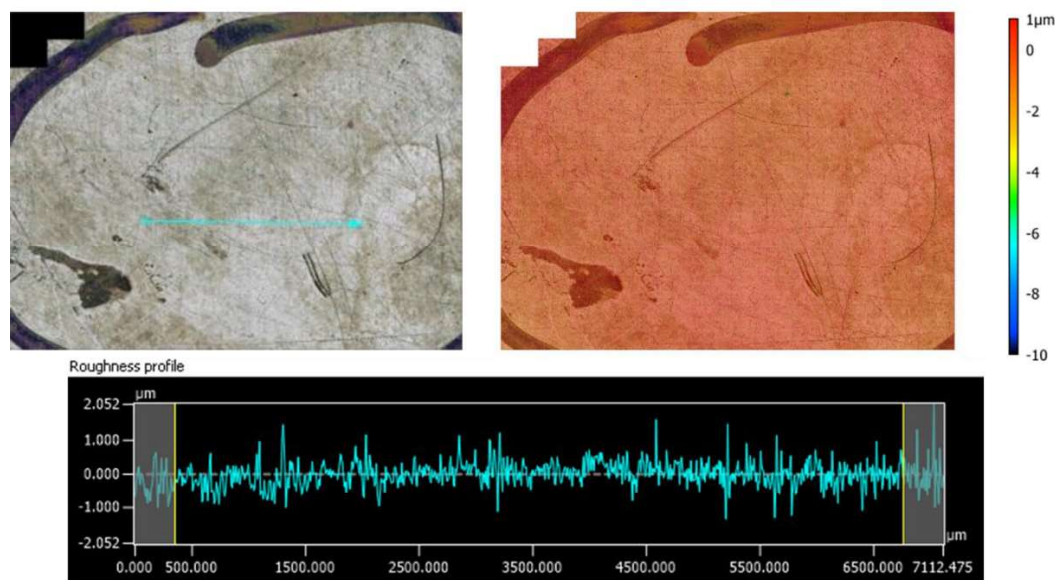
Figure 5-16: LCM profile map (top) and depth profile (bottom) of area away from loosely adherent deposits during test exposed to compressed sludge.

any detectable localized corrosion, as seen in Figure 5-16. On the profile map (top right), no green, blue, or black areas are present, indicating that no localized or general attack in excess of $2\text{ }\mu\text{m}$ was present. Examination of the depth profile (bottom) reinforced that no corrosion features were present across the line scan conducted. The only feature that can be observed is the periodic oscillations in depth (approximately $\pm 1\text{ }\mu\text{m}$) that are associated with the grinding of the sample surface to 600-grit.
