Hanford Double Shell Waste Tank Corrosion Studies- Final Report FY2022

July 2023

SRNL-STI-2023-00048, Revision 0

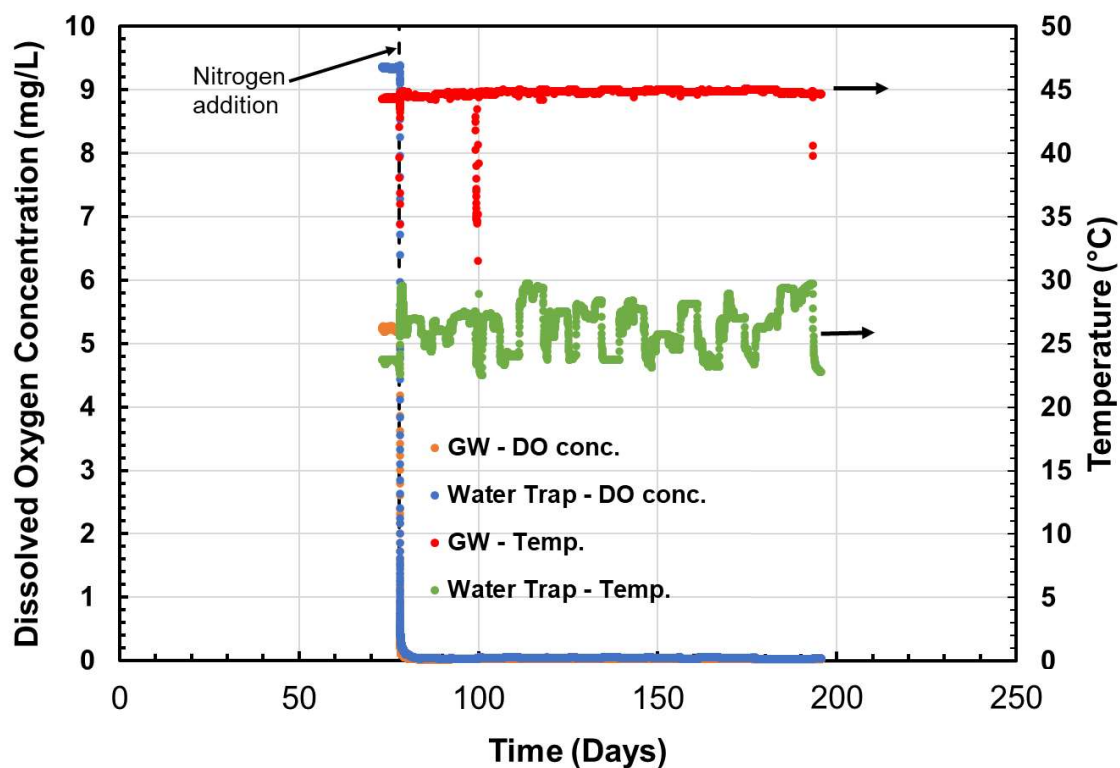
Figure 5-17: Liquid phase dissolved oxygen concentrations and temperatures versus time.

The dissolved oxygen (DO) concentration data, just before adding nitrogen and after the addition in the experimental vessel and in water trap, are presented in Figure 5-17. The DO values are close to 9 ppm before the addition of nitrogen, and close to zero after the addition. The time lag between the start of the nitrogen addition and DO values reaching zero was negligible. As seen in Figure 5-17, the GW simulant temperature remained close to $45\text{ }^{\circ}\text{C}$ throughout the experimental duration. The gas phase oxygen concentration data is presented in Figure 5-18. As seen in the figure, the gas phase oxygen concentration quickly reached zero after addition of nitrogen.

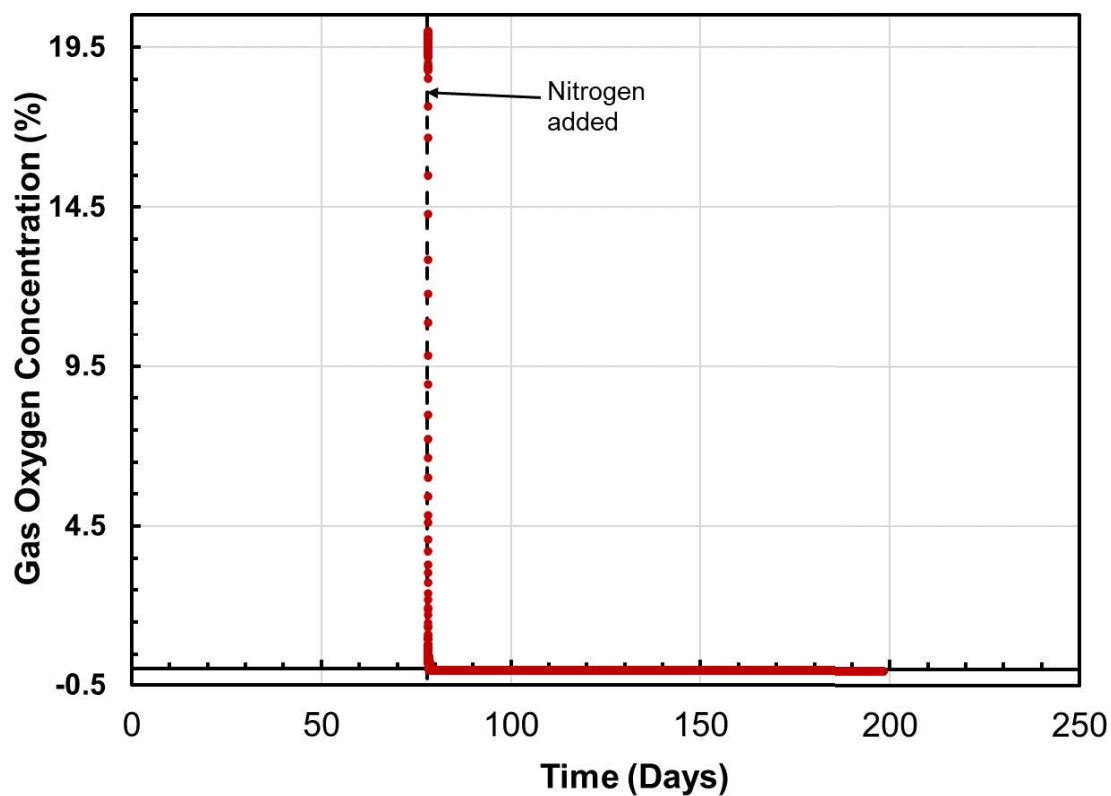
Figure 5-18: Gas phase dissolved oxygen concentrations versus time.

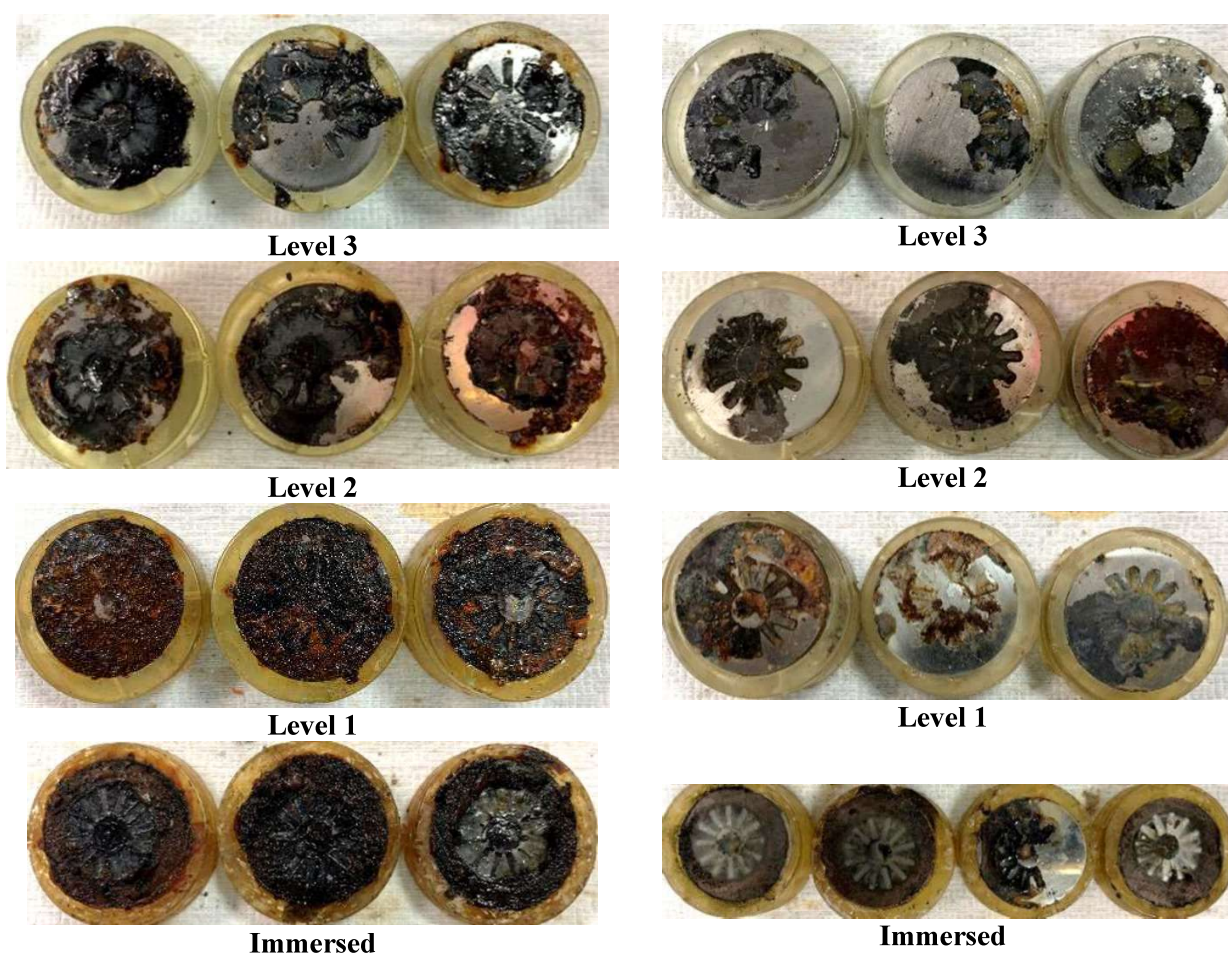
(a) Exposed to GW only for 78 days and
GW + N₂ for 120 days

Figure 5-19: Images of the coupons exposed to (a) GW only for 78 days and GW +N₂ for 120 days, and (b) GW + N₂ for 120 days.

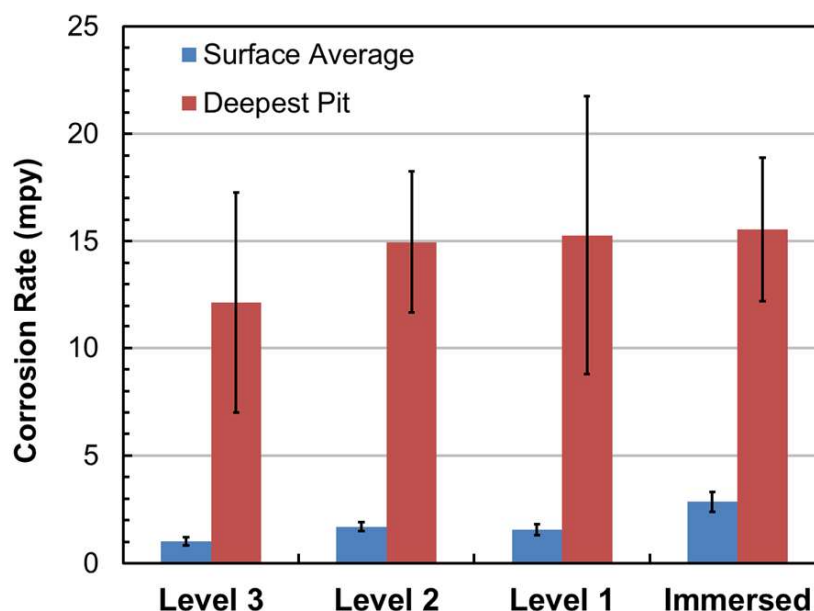
Figure 5-21: Surface average and deepest pit corrosion rates of the coupons sequentially exposed to GW for 78 days and GW + N₂ for 120 days. The standard deviations of the corrosion rates are represented by a solid black line in each bar.

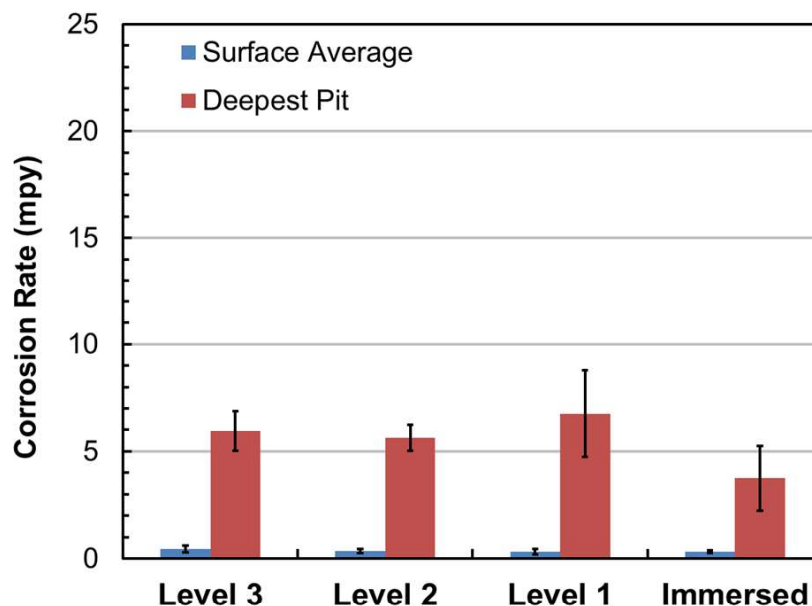
Figure 5-22: Surface average and deepest pit corrosion rates of the coupons exposed to GW + N₂ for 120 days. The standard deviations of the corrosion rates are represented by a solid black line in each bar.

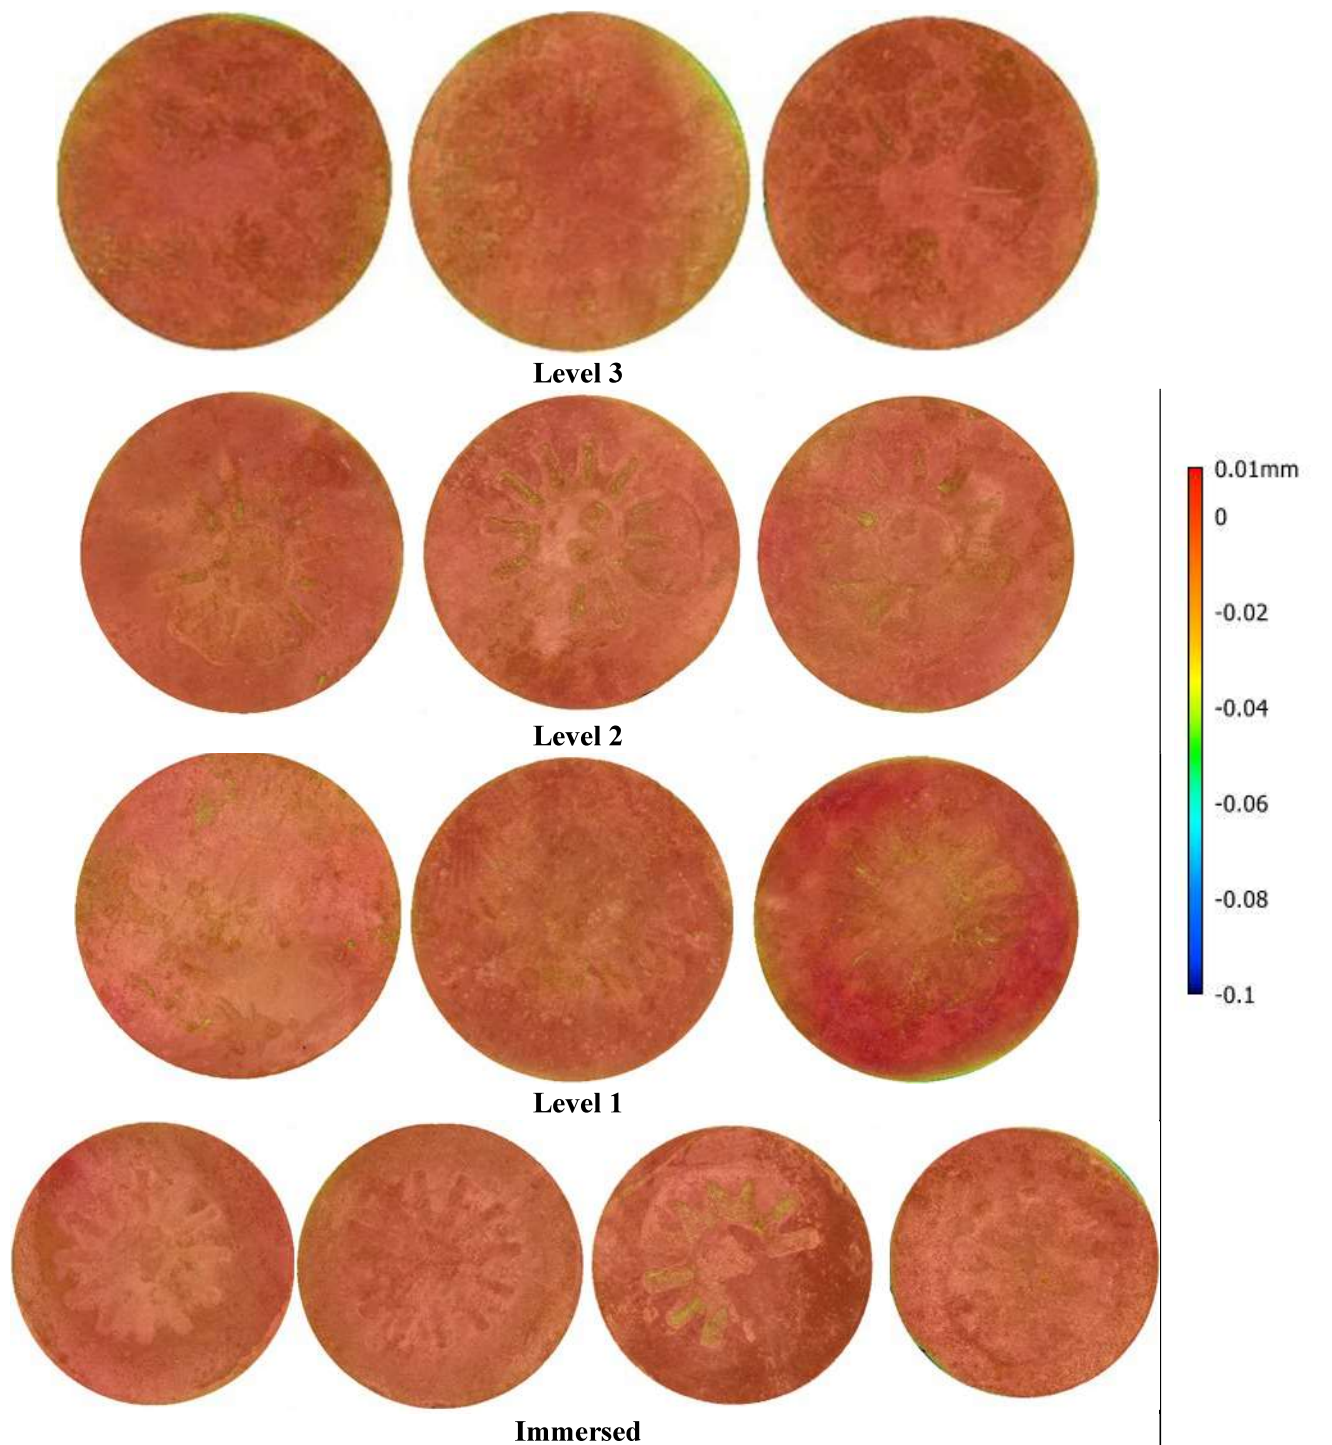
Figure 5-24: Profiled images of the coupons sequentially exposed to GW +N₂ for 120 days.
