# **Dissolution of a Can Carrier Pin in Concentrated Nitric Acid Solutions**

**B. J. Wiersma and L. Dyers**

May 2023

SRNL-STI-2023-00107, Rev.0

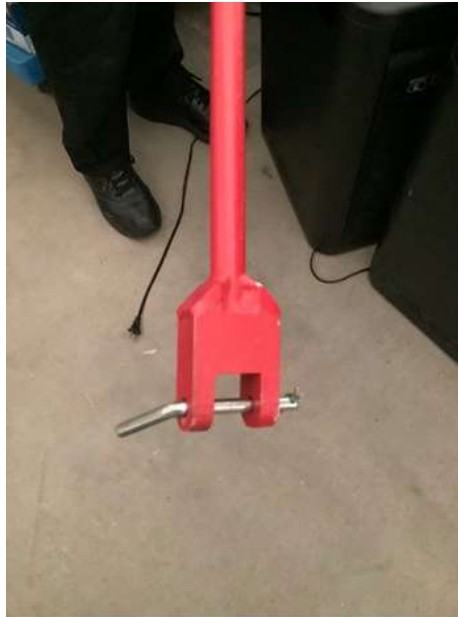
**Figure 1-1. Charging Device with Zinc Coated Carbon Steel Pin.**

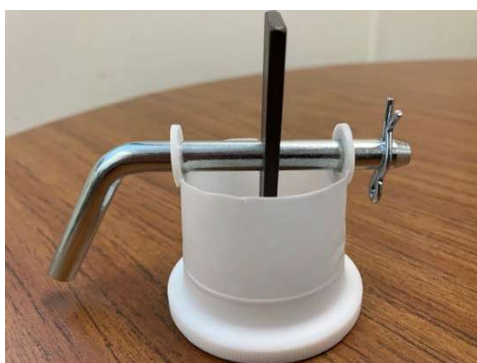
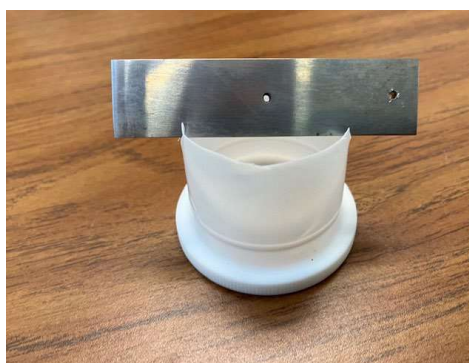
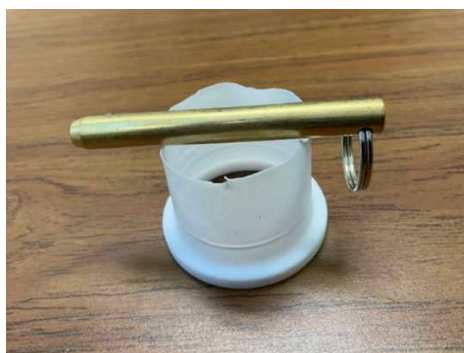
The test configuration or pin assembly for the scoping tests mirrored some of the conditions in the dissolver, but not completely. Table 2-3 and Figure 2-2 describe and illustrate the pin assembly for the scoping tests. The zinc plated carbon steel pin (i.e., configuration 1) was set-up in a configuration that was like that in the dissolver. The 410 stainless-steel [13] coupon is the same material that was used to fashion the can carrier

**Figure 2-2. Materials Configuration for Initial Scoping Tests (a) Zinc Plated Carbon Steel Pin, (b) ASTM A537 Carbon Steel Coupon, and (c) 360 Brass Pin.**

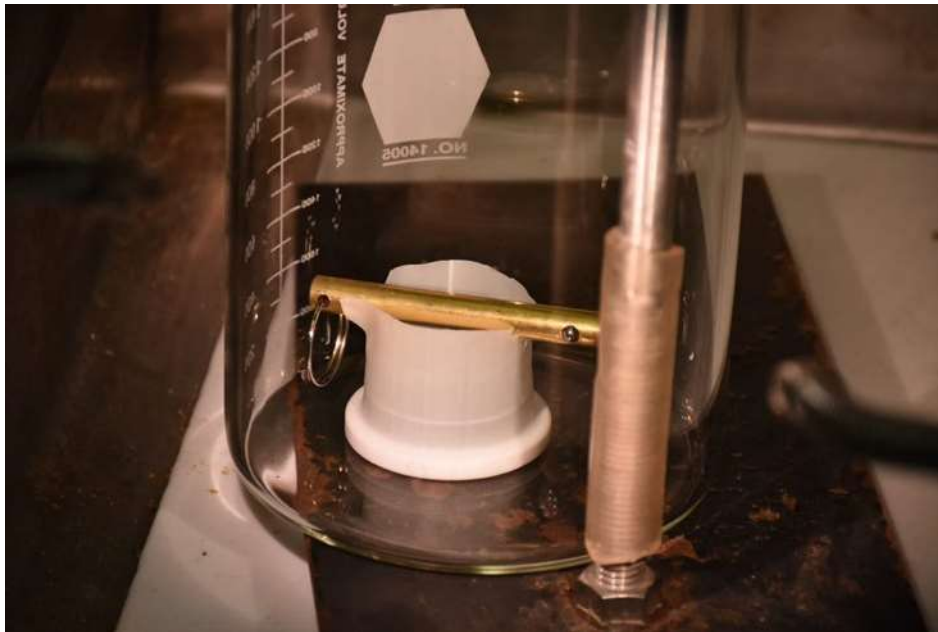
**Figure 2-5 Test Configuration with 360 Brass Pin**

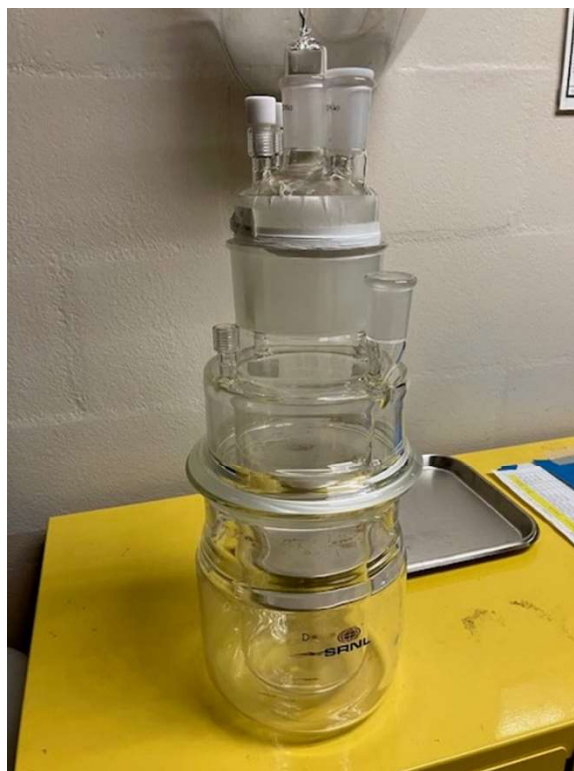
The representative tests were conducted in the vessel-in-vessel apparatus shown in Figure 2-7. The pin assembly and test solution were placed in the inner vessel. The pin was suspended in the test solution by an all-thread rod that was screwed into Teflon Holder 2 (See Figure 2-6 and Figure 2-8). The all-thread rod was supported by a ring stand. A pressure gauge dial was utilized in the system to detect movement of the pin assembly. This movement would be coincident with changes in the weight of the pin assembly due to pin dissolution. Cooling water was circulated through the jacket surrounding the inner vessel to maintain the bulk temperature of the test solution. The thermocouple located in the jacket is considered to be representative of the bulk solution temperature. The chiller utilized to circulate the water is shown in Figure 2-9. Two thermocouples were utilized. One thermocouple was placed in the jacket area and was utilized to monitor the cooling water temperature. The second thermocouple was placed adjacent to the pin assembly (See Figure 2-6) to monitor local temperature. A temperature read-out was connected to the thermocouples so that the temperatures could be recorded.

**Figure 2-7. Test Vessel for Representative Tests**

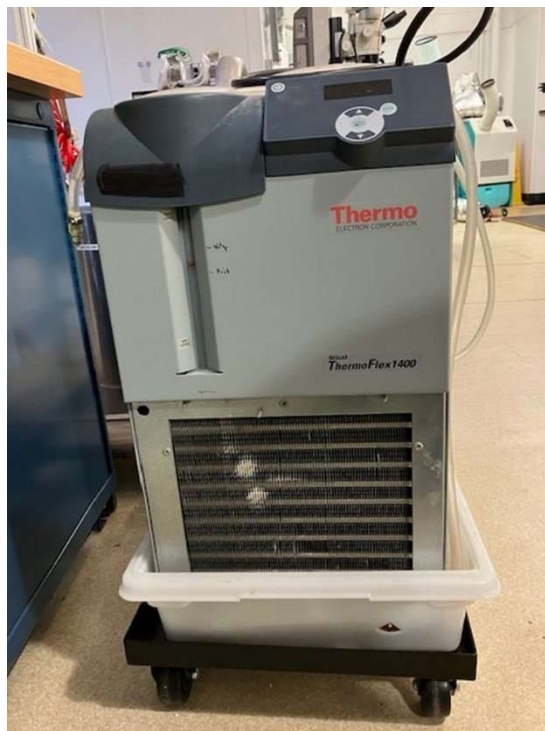
**Figure 2-9. Chiller Utilized for Representative Tests**

The tests were initiated by starting the chiller and circulating water through the jacket at either 15 or 25 °C. Once the bulk temperature was established, approximately 1 liter of the test solution was added to the vessel. This solution was then allowed to equilibrate with the water in the jacket until the solution was within 1 degree of the temperature of the water in the jacket. The pin assembly was then lowered into the solution to begin the test.

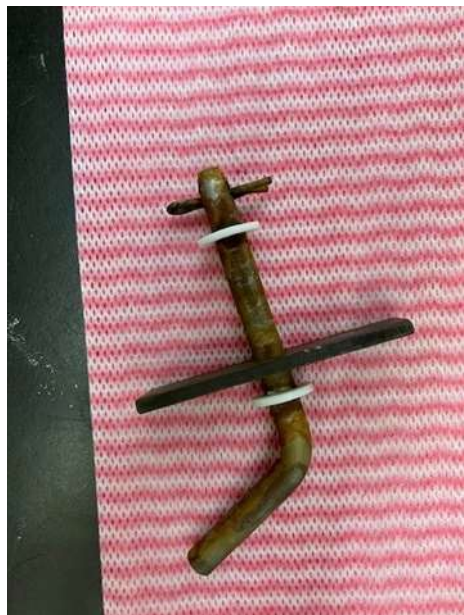
At the completion of the test, visual observations and photographs of the pin were made (see Figure 3-2). In general, the shiny zinc electro-plated layer had disappeared, and the pin had areas that were either dull gray or orangish brown in appearance. Areas near the Teflon washer appeared to be more discolored (orangish-brown) than most of the pin, indicating perhaps more attack in this region although it was clearly limited. No galvanic or crevice corrosion was observed on the pin adjacent to the 410 SS coupon. The 410 SS coupon was also unattacked.

**Figure 3-2. Post-Test Condition of Zinc Plated Carbon Steel Pin.**

The lack of NO<sub>x</sub> generation, the mottled appearance of the sample, the solution color change, and the absence of a significant temperature increase suggested that there was an additional barrier to the zinc and steel surfaces and that passivation of the carbon steel had occurred. The drawing for the pin states that the pin was plated or rather electroplated in a zinc bath. A note on the drawing also states that the pin has good strength and “some corrosion resistance”. A review of ASTM standard B633 indicates that the zinc electroplated surface may receive a “supplementary treatment” after the plating process [14]. These treatments include chromate conversion coatings, passivation coatings, and phosphate coatings. Phosphate coatings are black and were therefore most likely not utilized. Chromate and passivation coatings may be colorless per the ASTM practice.

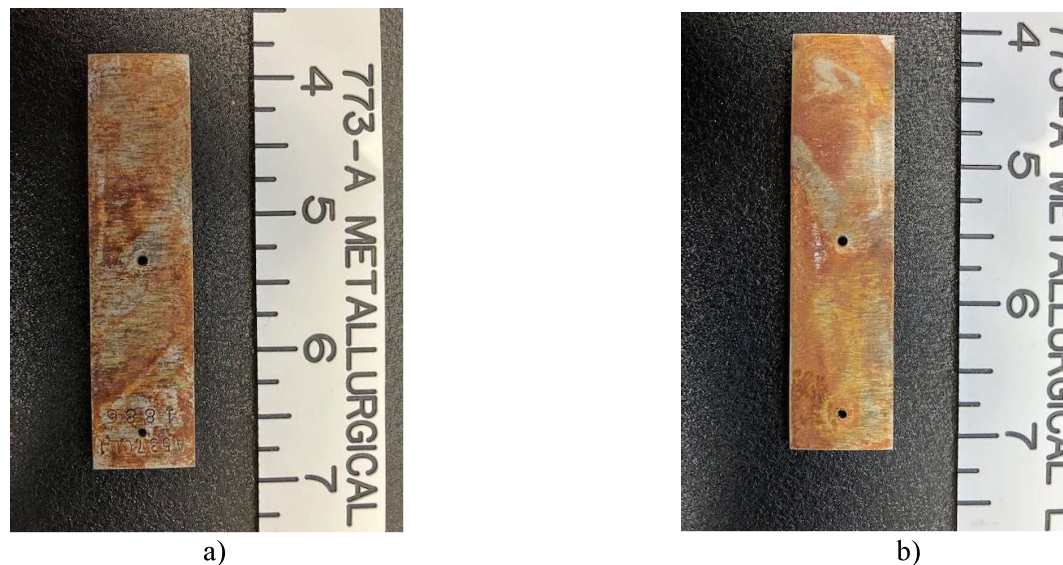
The test in Solution 6 was conducted for 5 hours. As with the test in Solution 3, the solution remained clear, there was no discernable local temperature change, and no evolution of a brown gas. The coupon

surface gradually changed from a bright, silver color, to a dull gray and to ultimately orangish-brown as before. The initial polishing marks and engraved number on the coupon were still present after the test, which suggested limited attack. Qualitatively it appears that the addition of KF and  $\text{Gd}(\text{NO}_3)_3$  had no effect on the rate of corrosion of the carbon steel at these low concentrations. The orangish-brown color also suggested that the passive ferric nitrate compound had formed on the surface.

**Figure 3-6. Post-test Condition of Carbon Steel Coupon Tested in Solution 6: (a) front and (b) back.**

The coupons were weighed after the test so that the corrosion rate for each may be calculated. Given the weight change of the coupon during the test, the test time, the surface area of the coupon and the density of the steel, the corrosion rate may be calculated [15]. The corrosion rate for the coupon immersed in Solution 3 was 0.228 in/yr, while the corrosion rate for the coupon immersed in Solution 6 was 0.258 in/yr. Although the corrosion rate was slightly higher for the coupon in the solution with the KF and  $\text{Gd}(\text{NO}_3)_3$ , the difference may not be statistically significant given that only a single test was performed. The literature indicated that for 6 M nitric acid the corrosion rate is approximately 13 in/yr, while at 13 M nitric acid the corrosion rate decreases to 0.02 in/yr due to passivation. The corrosion rates measured in these tests are consistent with the literature observation and show the influence of passivation.

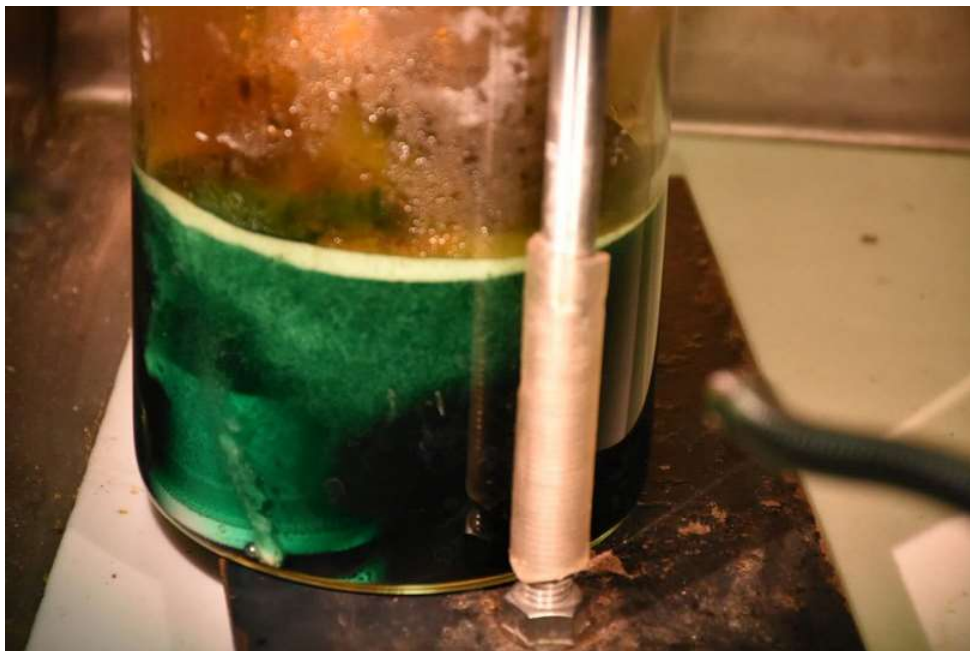
After 21 minutes, a piece of the pin that had extended over the edge of the Teflon platform fell to the bottom of the vessel next to the stainless-steel ball (see Figure 3-9). Dissolution of the pin and piece was rapid as evidenced by the violent bubbling and the formation of a thick layer of brown gas above the dark green solution. The local temperature of the solution reached its maximum value of 50.2 °C. Shortly after this picture was taken, the carbon steel ring fell to the bottom of the vessel. Violent bubbling continued for another six minutes until the pin had completely dissolved. The absence of bubbles and foam at the surface was the indication that the pin had completely dissolved (see Figure 3-10). Notably the carbon steel ring did not dissolve significantly, once again displaying passivity at the concentrated nitric acid conditions.

**Figure 3-9. 360 Brass in 10.3 M Nitric Acid; Piece of Pin Dissolving Next to Ball.**

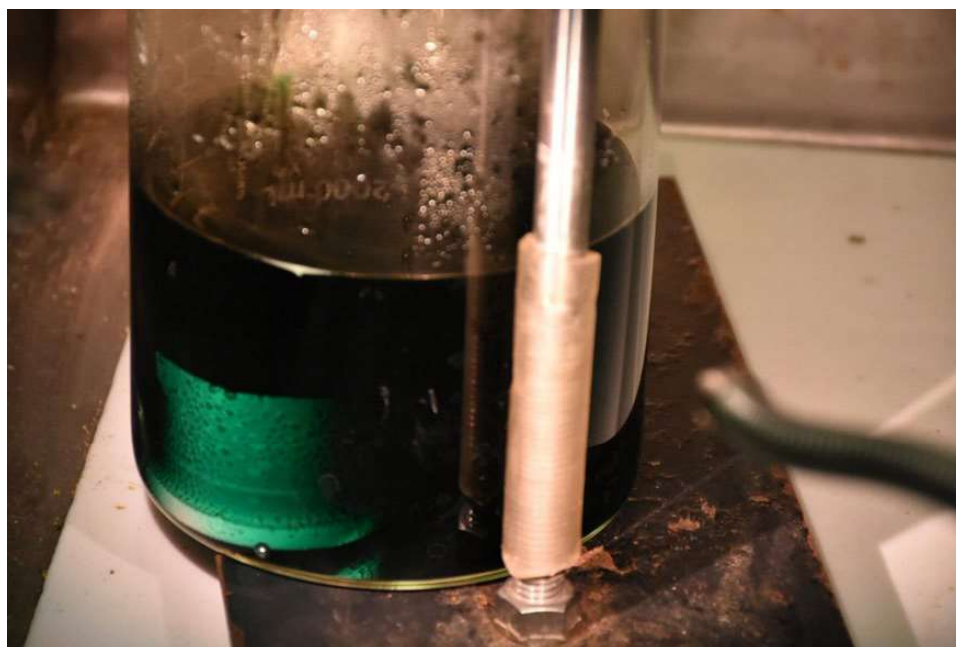
**Figure 3-10. 360 Brass in 10.3 M Nitric Acid; Test Complete as Indicated by no Bubbling.**

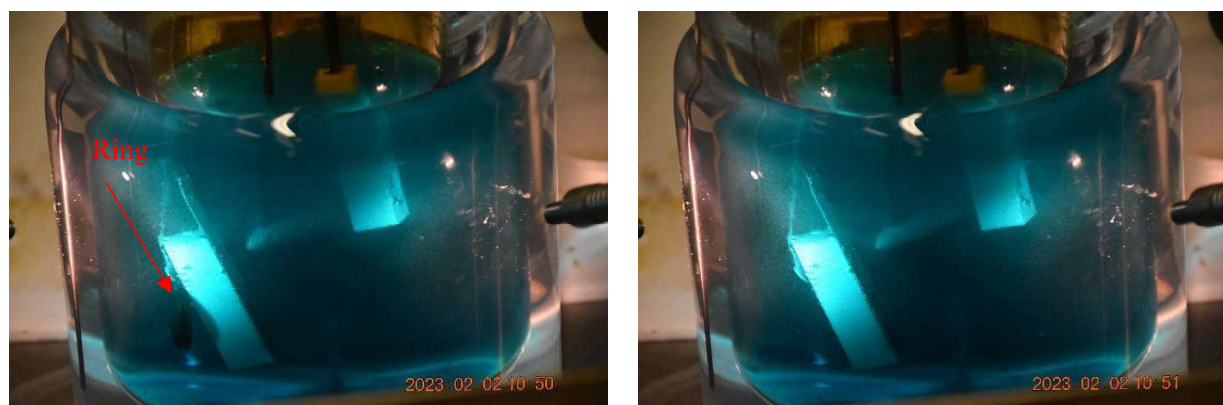
The next piece of the assembly to fall to the bottom of the vessel was the carbon steel ring (See Figure 3-14). This piece also failed due to a combination of galvanic and crevice corrosion, which preferentially “sawed” through the end of the brass pin (Brass 1 in Figure 2-6). Thus, not only did the ring fall to the bottom of the vessel but a piece of the brass also fell to the bottom of the vessel. In addition to brass dissolution, the carbon steel ring also corroded. As was observed in the scoping tests, the degree of corrosion increased as the concentration of nitric acid decreased. This phenomenon is also explained by passivation.

**Figure 3-14 360 Brass in 8.5 M Nitric Acid at 15 °C; Carbon Steel Ring Falling to Bottom of Vessel.**

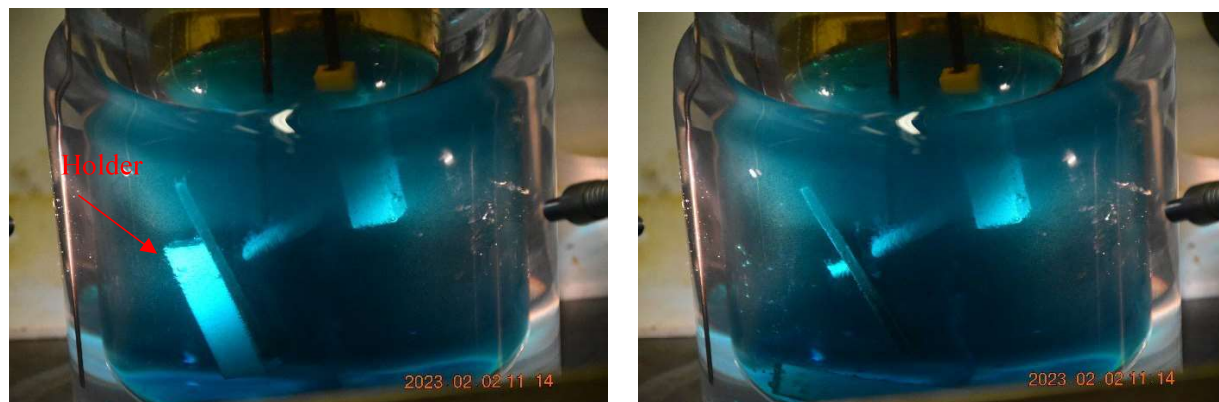
Teflon Holder 1 (see Figure 2-6) was the next piece of the assembly to fall to the bottom of the vessel (See Figure 3-15). The crevice created by the contact between the holder and the pin accelerated corrosion of the brass. Teflon is chemically inert in this environment and did not degrade. Eventually, the diameter of the pin decreased such that the holder slid off the pin and fell to the bottom of the vessel.

**Figure 3-15. 360 Brass in 8.5 M Nitric Acid at 15 °C; Teflon Holder Falling to Bottom of Vessel.**

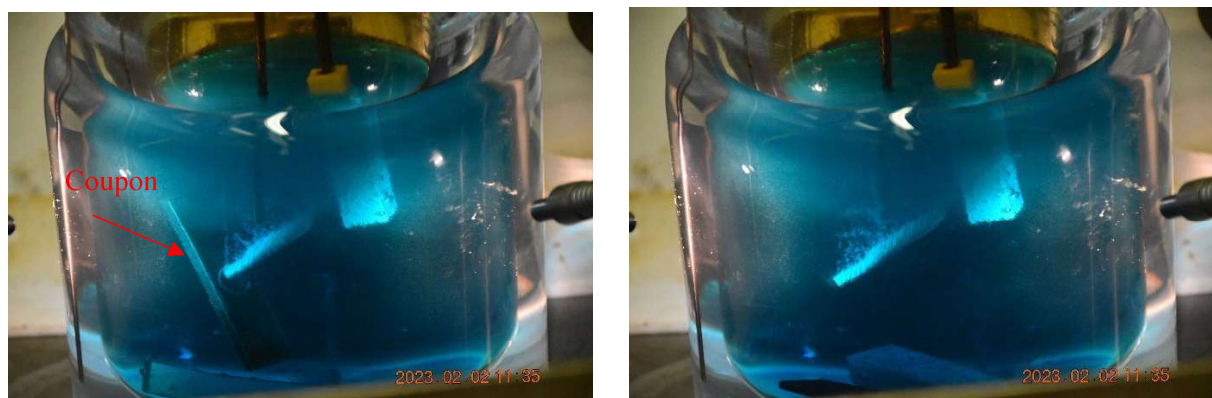
The 410 stainless-steel coupon also fell to the bottom of the vessel due to the combination of crevice and galvanic corrosion of the brass. Figure 3-16 shows that severe necking of the pin had occurred where the coupon was located. Likely, the presence of the carbon steel ring and Teflon Holder 1 prevented the coupon from sliding off the pin earlier. The coupon represents the handle of the FCA can carrier.

**Figure 3-16. 360 Brass in 8.5 M Nitric Acid at 15 °C; 410 SS Coupon Falling to Bottom of Vessel.**

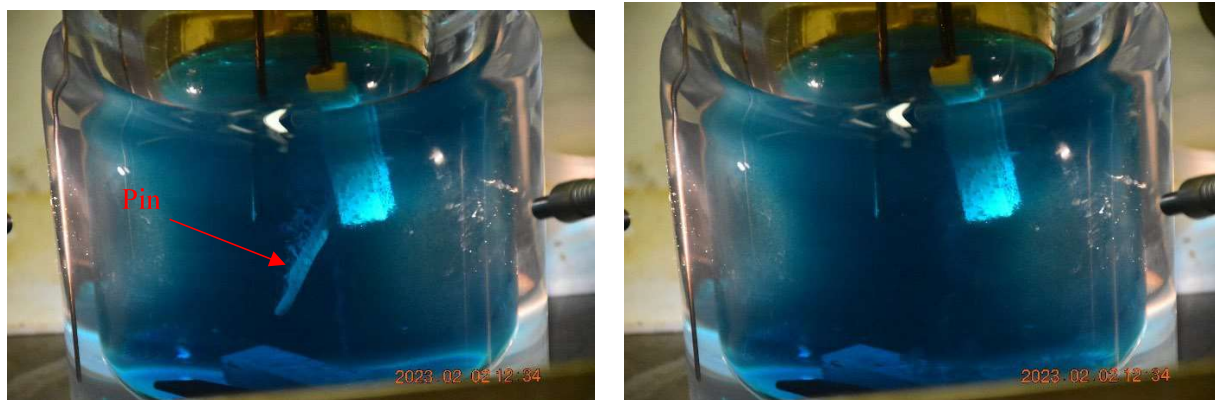
The final piece of the assembly to fall to the bottom of the vessel was the pin itself. Figure 3-17 shows that the pin begins to tilt downward in almost a vertical orientation. Crevice corrosion between Teflon Holder 2 and the pin preferentially corrodes the brass until it slides out of the holder and falls to the bottom of the vessel.

**Figure 3-17. 360 Brass in 8.5 M Nitric Acid at 15 °C; Brass Pin Falling to Bottom of Vessel.**

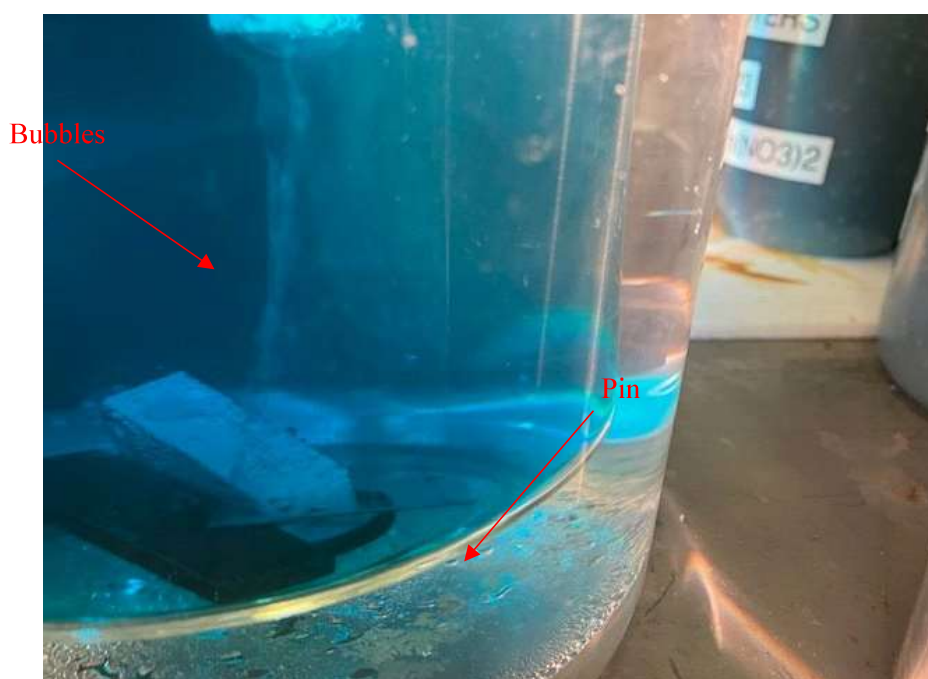
The dissolution of the pin proceeds uniformly over the surface of the pin at a rate that is dependent upon the concentration and bulk temperature of the solution. Figure 3-18 shows the uniform dissolution of the pin as it rests on the bottom of the vessel. The disappearance of the bubbles coincided with the complete dissolution of the pin.

**Figure 3-18. 360 Brass in 8.5 M Nitric Acid at 15 °C; Brass Pin Dissolving on Bottom of Vessel.**
