**FIRST INTERIM STATUS REPORT: MODEL 9975 LIFE EXTENSION
PACKAGE TESTING**

Savannah River National Laboratory
Materials Science & Technology

Publication Date: January 2010

Revision Log**Document No.** SRNL-TR-2009-00439**Rev. No.** 1**Document Title** First Interim Status Report – Model 9975 Life Extension
Package Testing (U)

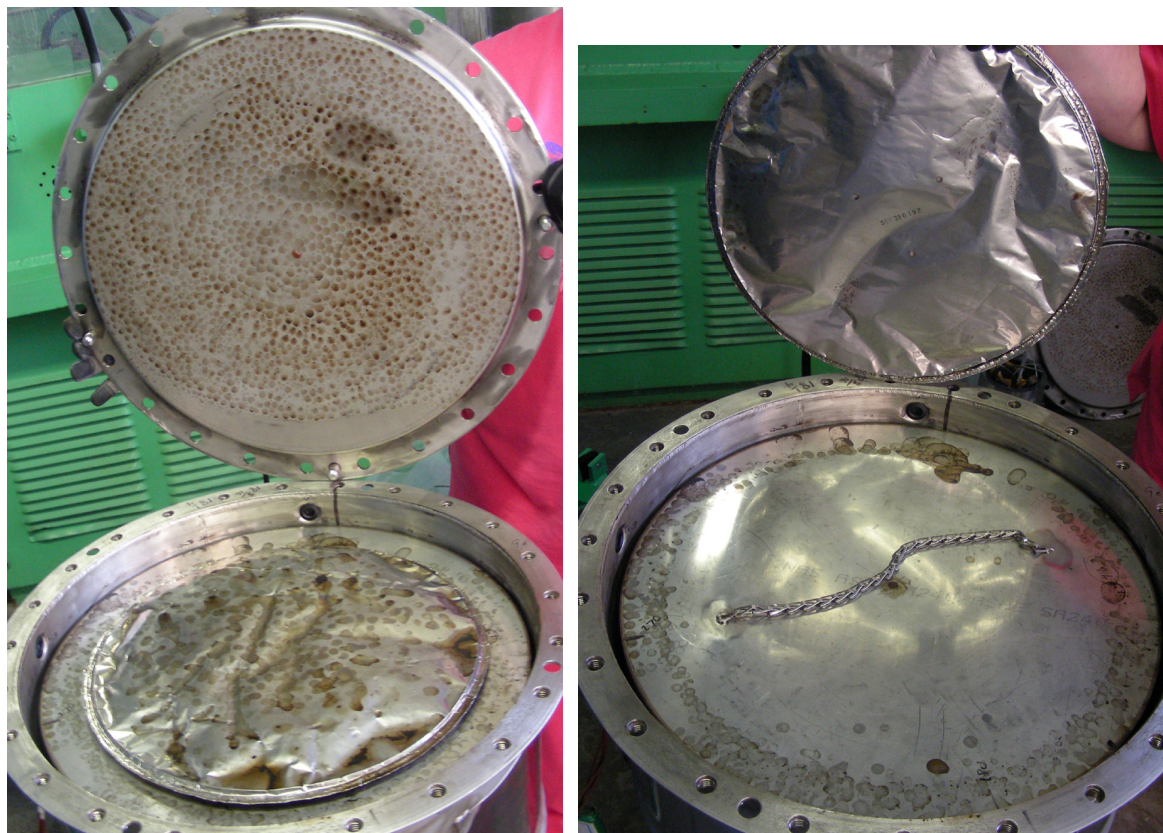
Figure 2. Stain on LE2 lid and other upper components from initial condensation activity.

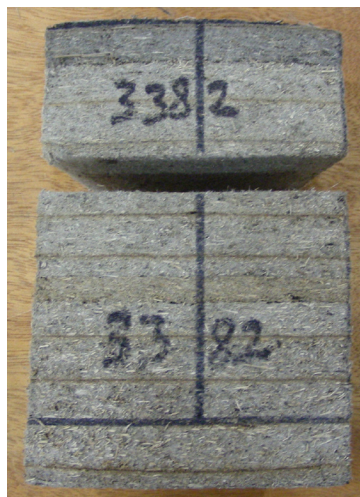
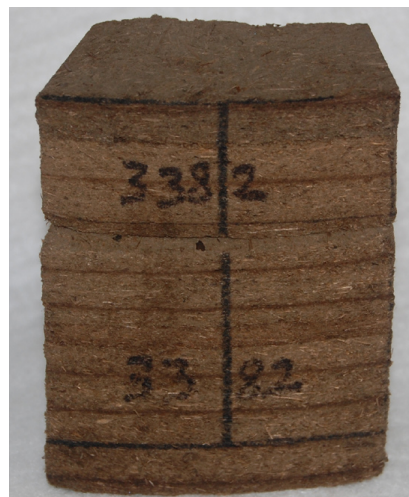
(a) baseline

(b) after 6 wks 90°F 95% RH

(c) after 63wks 142°F, 80%RH

Figure 10. Sequence of photographs of small removable fiberboard sections from test LE1.

Photographs of the removable sections help to track fiberboard changes over time. Sequences of photographs for each package are shown in Figures 10-12. In test LE1, the appearance of the removable sections remains relatively uniform, although they darken somewhat over time. A strong odor was noted from the removable sections after 14 weeks at 142°F ambient, and continued

during subsequent inspections. The peak moisture content measured on the side of the removable sections ranged from 18 to 31 %WME at 142°F ambient. The bottom surface of the lower removable section was observed to have 100 %WME at week 63. At no time was mold observed on the LE1 fiberboard. The removable sections for LE1 would have been at a temperature close to the external environment (142°F).

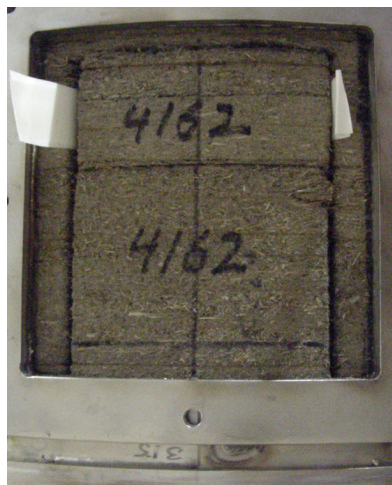
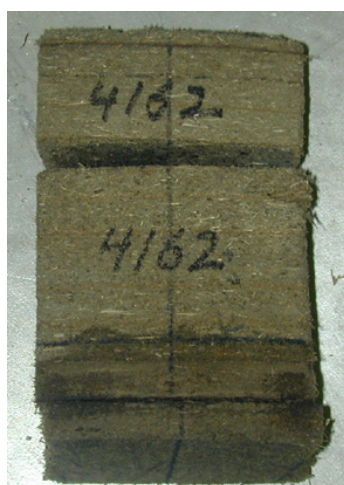
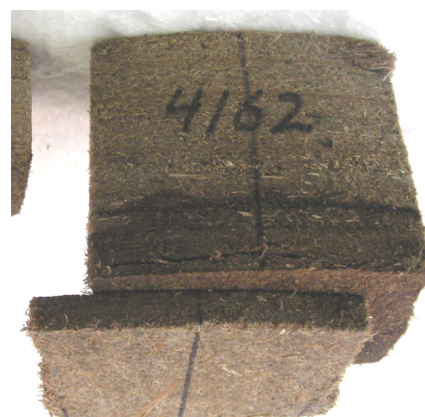
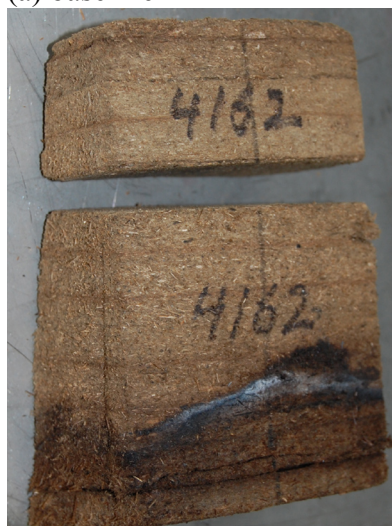
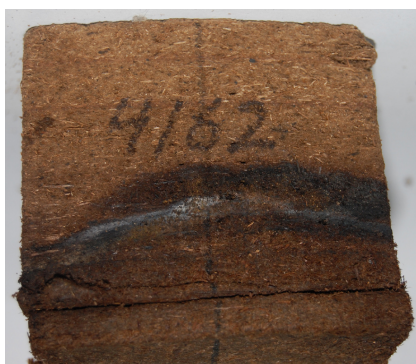
Figure 11. Sequence of photographs of small removable fiberboard sections from test LE2.

With tests LE2 and LE3, the bottom layers of the removable sections (as well as the rest of the lower fiberboard assembly) darkened significantly as they accumulated excess moisture. Some mold also grew in this region. In LE2, the bottom layers were observed to be saturated during the first inspection (after 3 weeks at temperature, 8 weeks total exposure), and a strong odor of decaying vegetation was noted after 19 weeks in test. Mold did not appear on the test 2 removable sections until 63 weeks exposure. A steep moisture gradient existed at the bottom of LE2; the saturated layers had a moisture content of 100 %WME, while approximately ½ inch above this region the moisture content was typically 17 %WME or less.

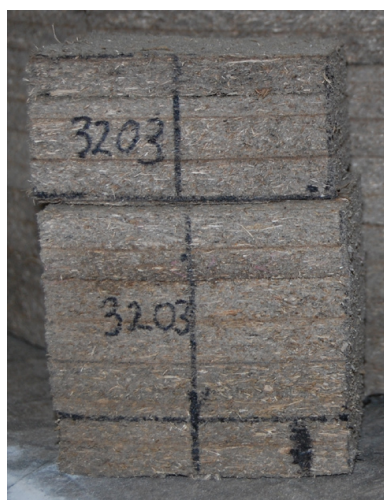
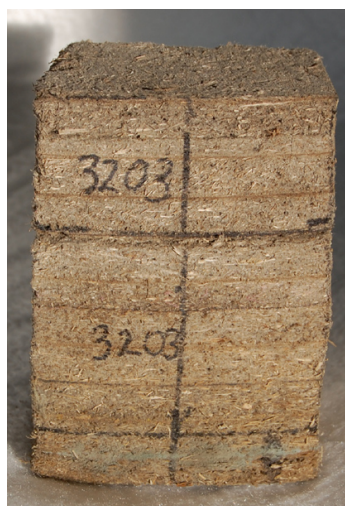
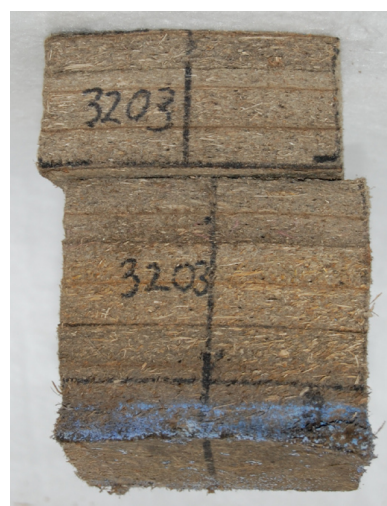
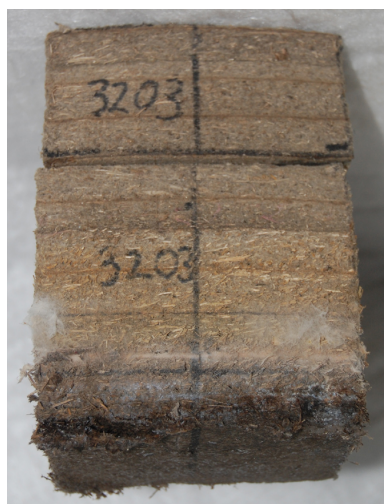
Figure 12. Sequence of photographs of small removable fiberboard sections from test LE3.

In LE3, mold was observed after 5 weeks exposure. At this time, the moisture content of the LE3 removable sections ranged from 67 %WME in the bottom layer to 12 %WME in the top layer. The moisture content of the bottom layer increased to 100 %WME at 15 weeks exposure. The mold continued to grow during subsequent exposure. During examination after 45 weeks exposure, the moisture content of the lower removable section at the maximum height of mold growth was 20 %WME. The temperature of the removable sections within the conditioning environment is unknown for test packages LE2 and LE3.

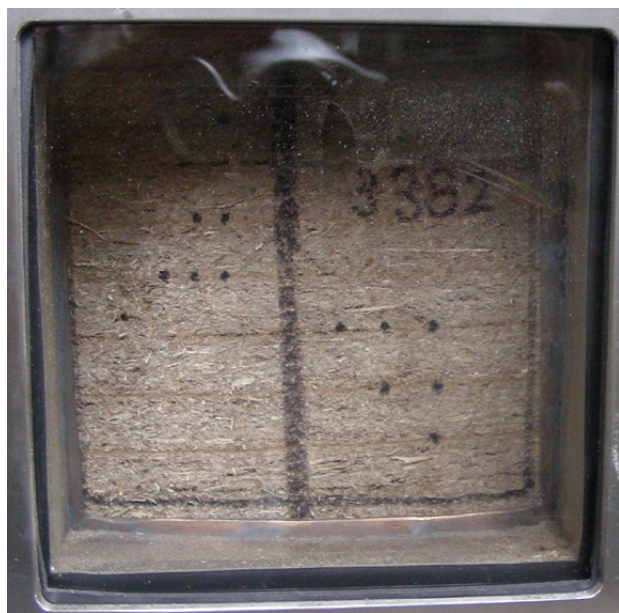
Figure 13. View of the side of test LE1 through the view port at time 0 (a) and after 53 weeks (b)

The drums for tests LE1 and LE2 were modified to include a view port on the side. A pattern was marked on the lower fiberboard assemblies to be viewed through the view port, and identify the extent to which the fiberboard moved. Typical photographs of this pattern through the view port are shown in Figures 13 and 14. In all cases, the overall fiberboard height was reduced, as indicated by the pattern shifting downward. Measurements were made from photographs taken at each inspection interval to estimate the amount of fiberboard movement. These measurements are summarized in Figures 15 and 16.

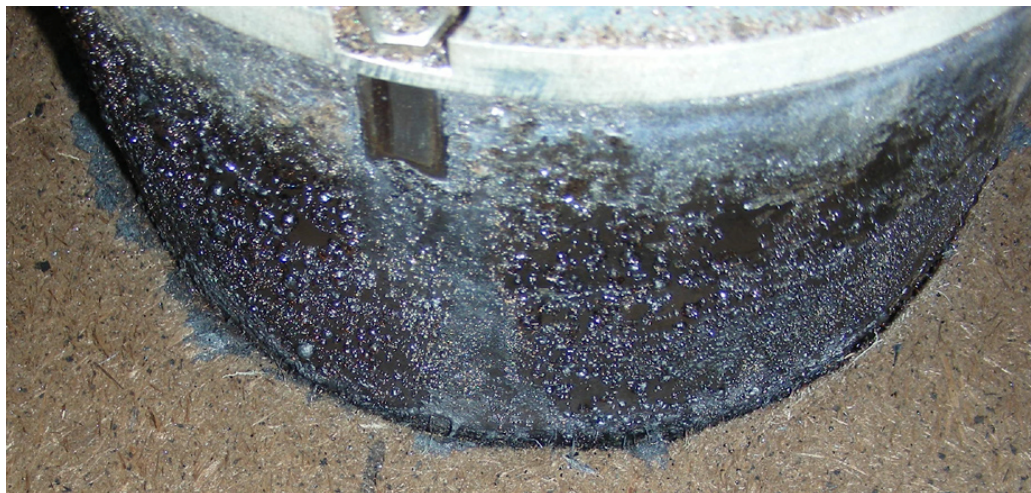
Figure 17. Corrosion product on the LE2 shield, after 19 weeks in test.

The corrosion of the lead shields is also of interest. In LE2, the corrosion product was observed during the first inspection, after 19 weeks in test, and was dark gray / black and nodular (Figure 17). Significant corrosion product was slower to develop on the LE1 shield, but was similar in appearance (Figure 18). In contrast, the corrosion product on LE3 remained white, but did develop occasional nodules (Figure 19). Of these three cases, the corrosion product on LE3 is the closest in appearance to that typically seen on 9975 packages (smooth white surface). Chemical analysis of corrosion product collected from LE2 showed that it was generally consistent with the lead carbonate seen on other packages.

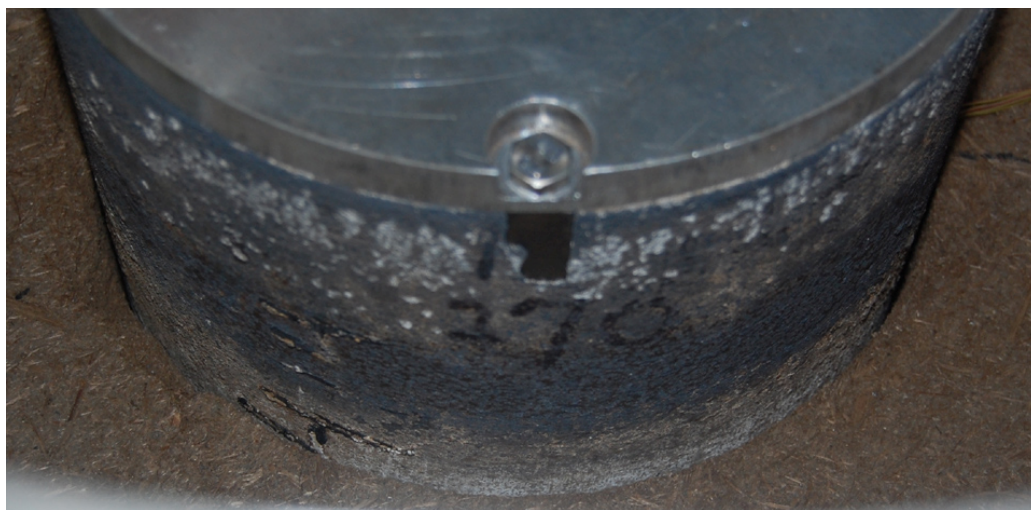
Figure 18. Corrosion product on the LE1 shield, after 63 weeks in test.

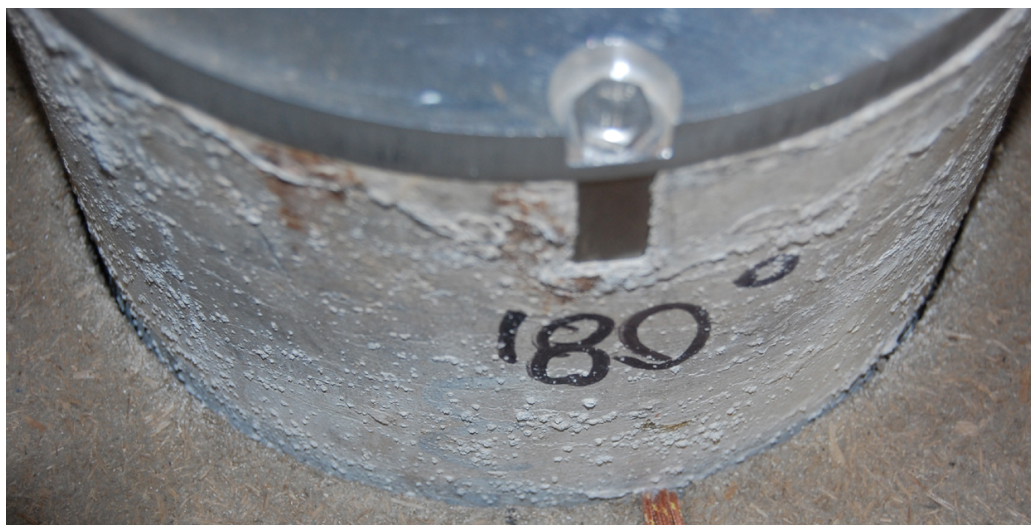
Figure 19. Corrosion product on the LE3 shield, after 45 weeks in test.
