**FIFTH INTERIM STATUS REPORT: MODEL 9975 PCV O-RING FIXTURE
LONG-TERM LEAK PERFORMANCE**

Savannah River National Laboratory
Materials Science & Technology

Publication Date: April 2011

Revision Log**Document No.** SRNL-TR-2010-00136**Rev. No.** 1**Document Title** Fifth Interim Status Report: Model 9975 PCV O-Ring Fixture Long-Term Leak Performance (U)

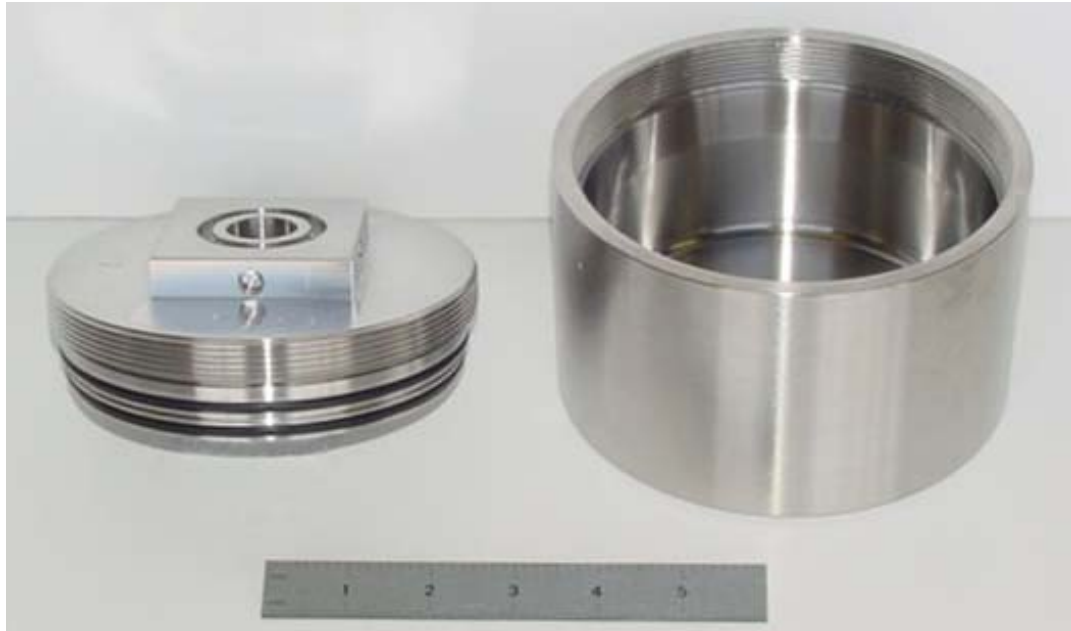
Figure 1. Mock-up PCV test fixture lid and body.

The two-piece lid of the mock-up PCV, consisting of the cone seal nut and cone seal plug, was machined to be identical to the actual PCV lid. The body of the mock-up PCV was shortened to 3.5 inches from the original design of 18.6 inches and a threaded hole was machined in the bottom to provide a port for evacuating and filling the vessel with gas and for in-situ leak testing of the O-rings. A PCV test fixture with the O-rings installed in the lid is shown in Figure 1.

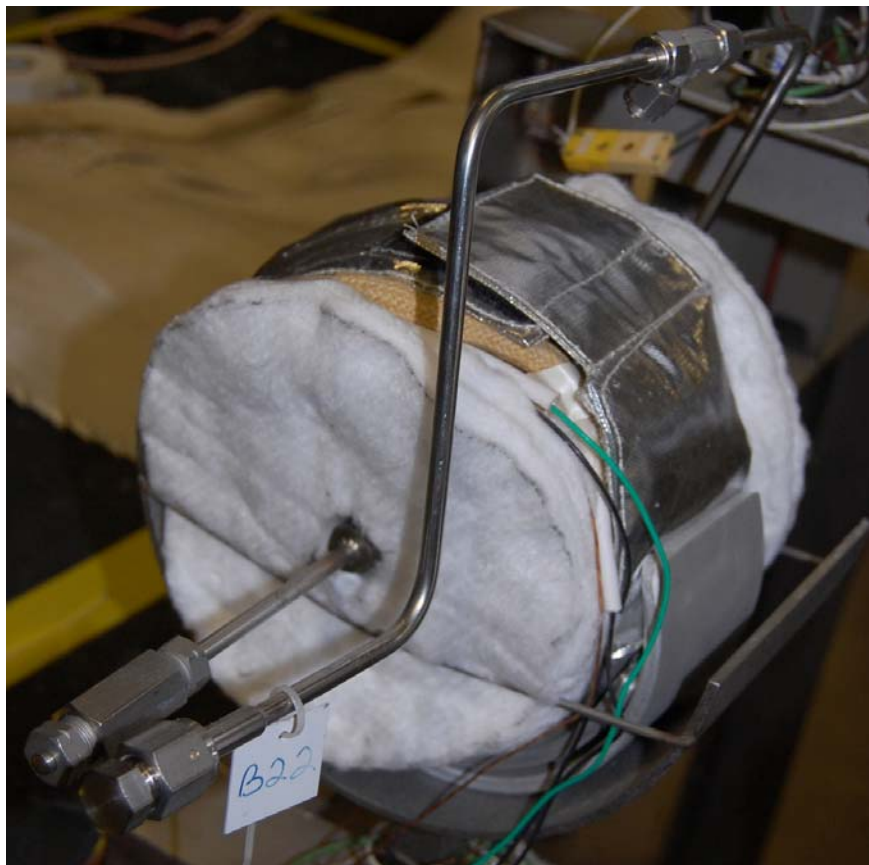
Figure 2. Assembled mock-up PCV.

The vessels are heated with a flexible, wound-wire heater wrapped around the vessel circumference. Ceramic fiberboard and fiber batting are used to insulate the exposed ends of the fixtures. Stainless steel tubing is attached to the port on the top of the fixture lid via a high-pressure fitting and to the hole machined into the bottom of the PCV body. A thermal fuse was added to each heater to prevent excessive temperature excursions. The heaters are controlled by a desktop computer running LabView™ software, with feedback via a type-K thermocouple attached to the PCV body. The final assembled fixture is shown in Figure 2.

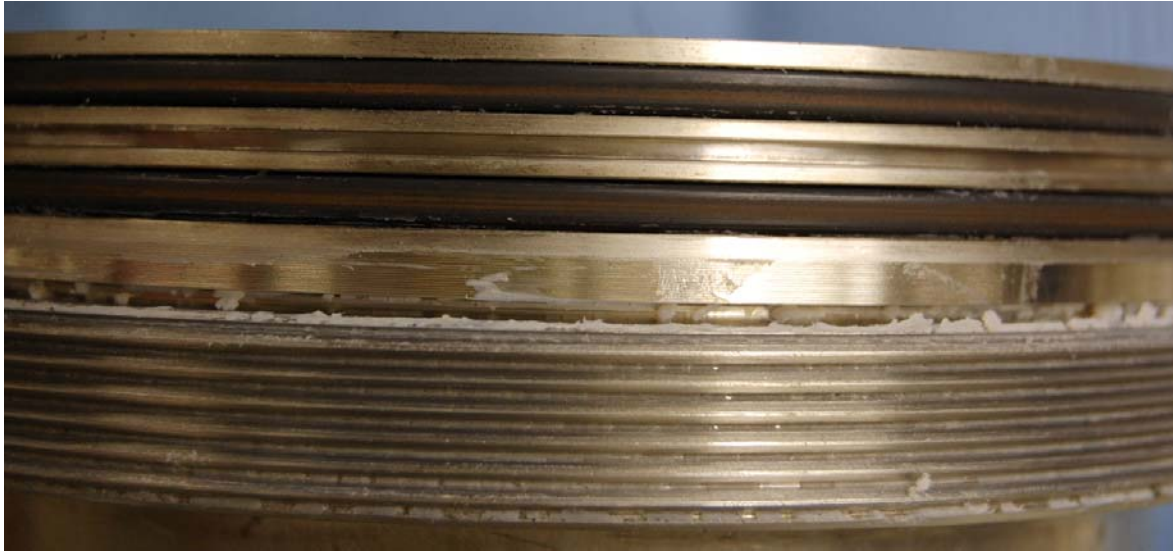
Figure 3. Excess grease on the closure nut from fixture 31. Note also the brown band on each O-ring indicative of oxidized grease (not the same grease used on the closure nut).

- The body and/or plug retained black deposits from the O-rings to varying degrees in each fixture (Figure 4).
- A brown ring was observed around most of the O-ring ID and OD surfaces for fixture 31, especially the outer O-ring (Figure 3). This is indicative of oxidized grease.
- Both O-rings from fixture 32 had material missing and/or cracks. The inner O-ring had a linear indication ~1 inch long on the ID surface. It has the appearance of a shallow crack, but might reflect the loss of material that stuck to the fixture. The outer O-ring had much more distinct linear regions of material loss along the ID surface, with several small radial cracks as well. These were clustered in several locations (Figure 5).

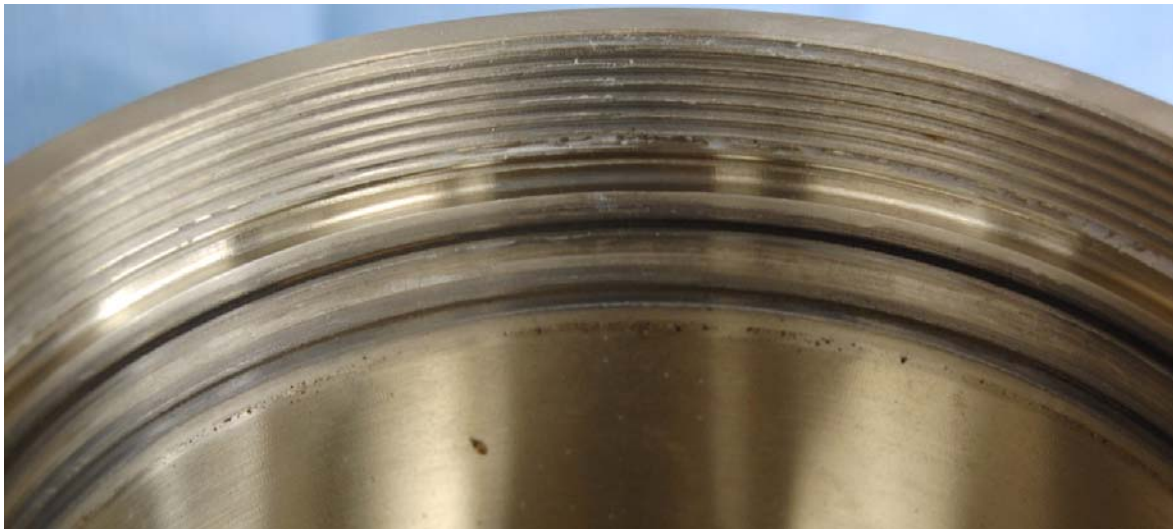
Figure 4. Black deposits left on the body of fixture 31 from the O-rings.

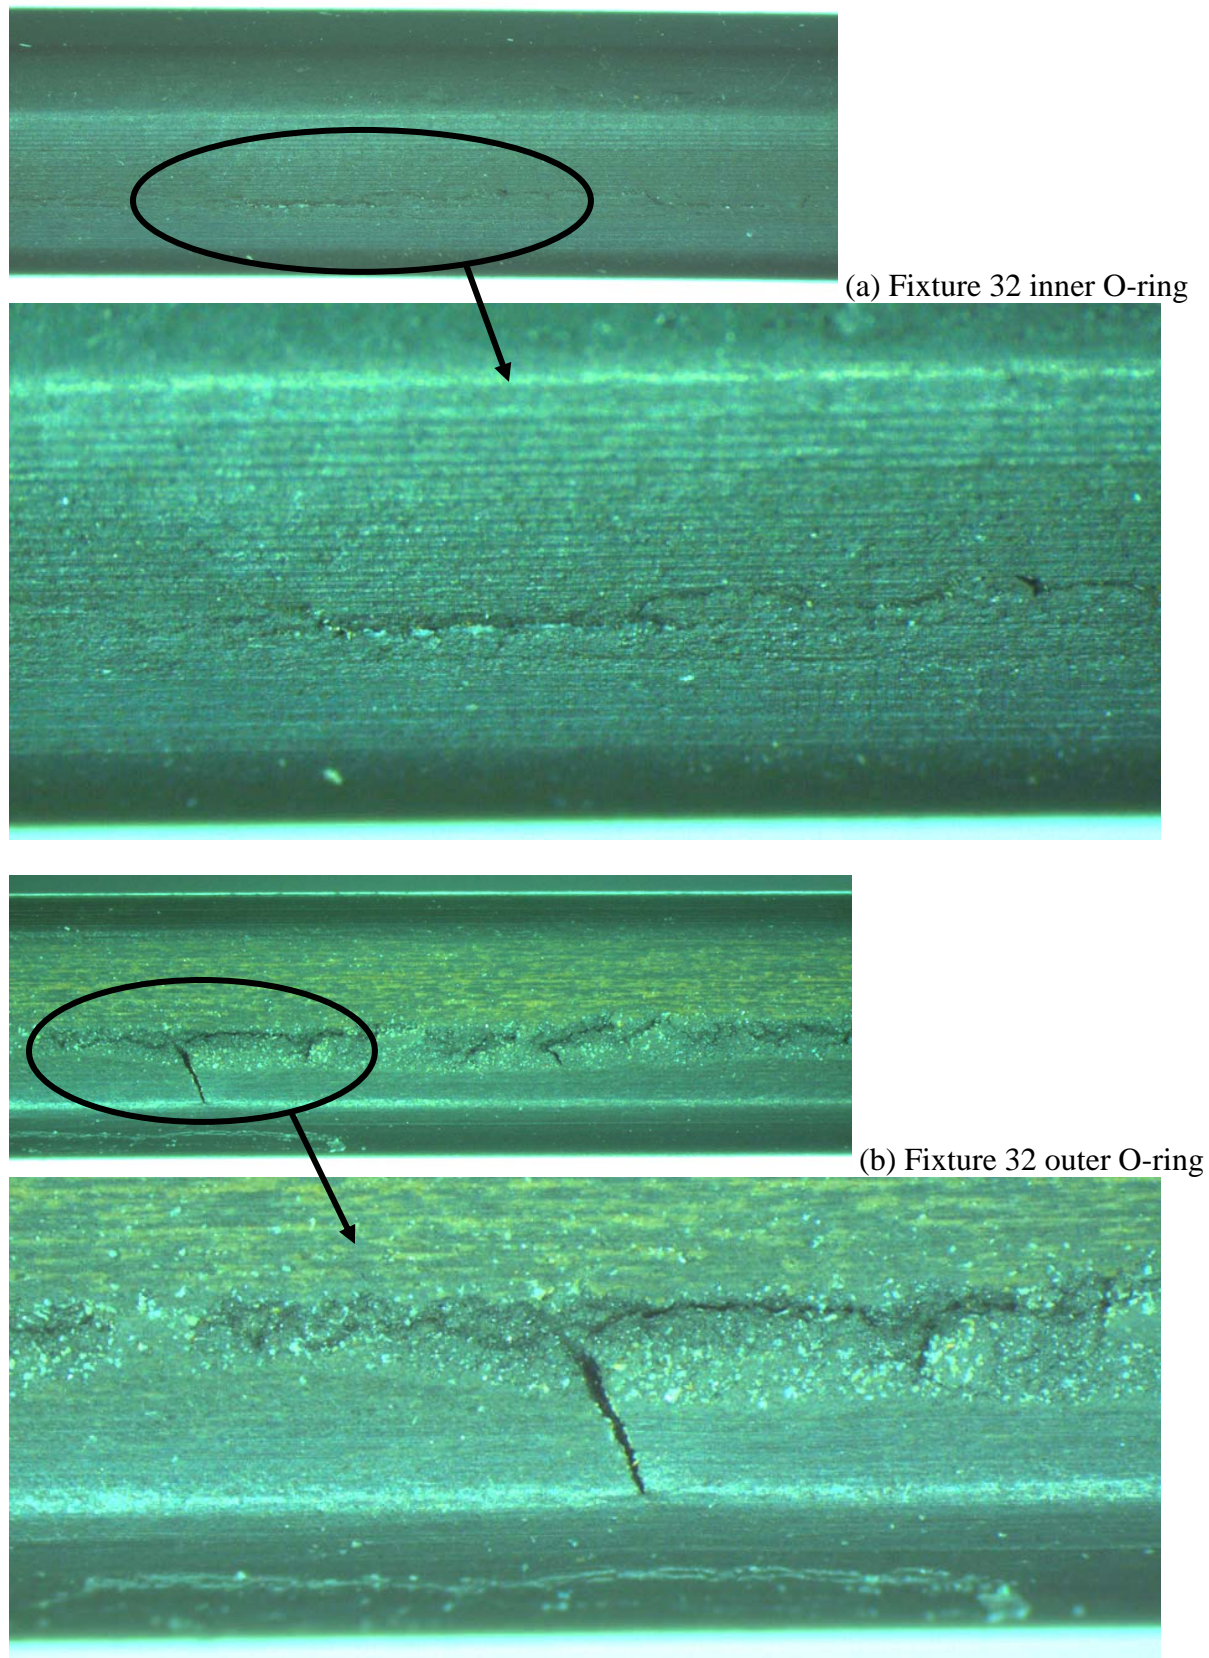
Figure 5. Fixture 32 O-ring ID surfaces showing material loss and/or cracking.

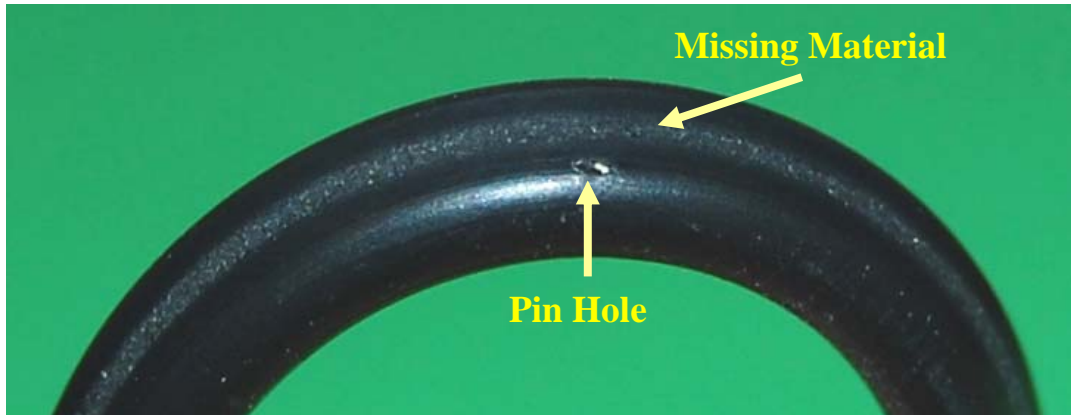
Figure 6. Figure 38H outer O-ring ID surfaces showing material loss and/or cracking and pin hole.

- Fixture 38H: Metal very clean, no residue. O-rings difficult to remove from plug. Outer O-ring- Missing material, and/or cracks on mold line, one pin-hole, but not through wall (Figure 6).

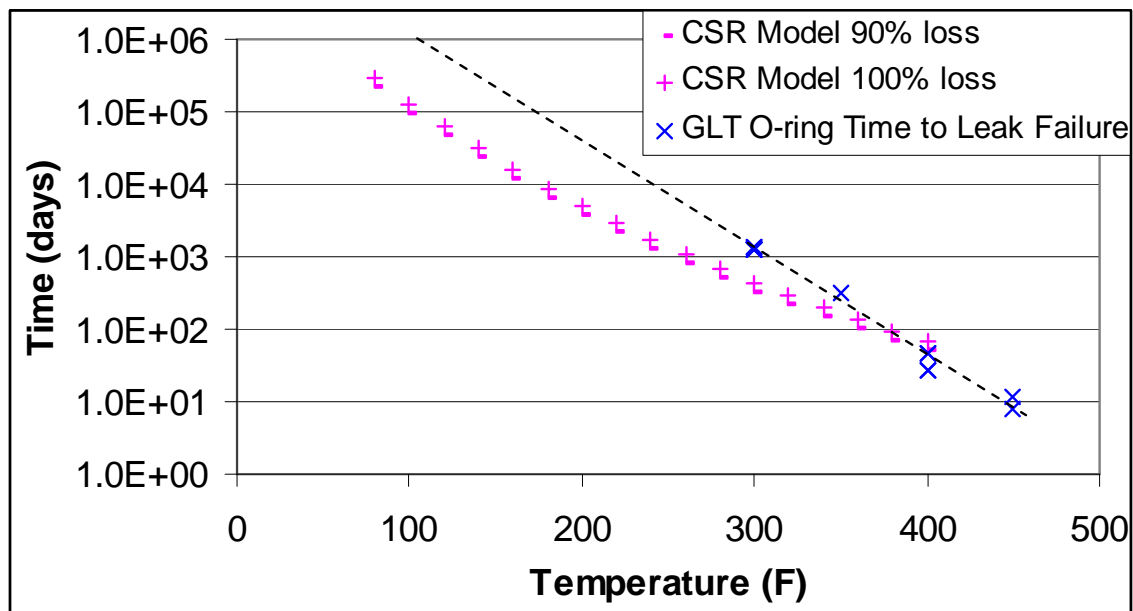
Figure 7 Leakage-based service life data for GLT O-rings (from fixtures with room temperature leak rate failures) compared to life predictions from GLT O-ring compression stress relaxation (CSR) data.

A separate task [2, 13] is underway to correlate the compression stress relaxation (CSR) of O-rings with aging temperature. While CSR does not provide a direct correlation to leak tightness, it is hoped that the time for the compressive force to relax to a specific value (such as 90% or 100% loss of initial force) may provide a degree of correlation with the service life based on leak-tightness. Lifetime estimates for GLT O-rings based on CSR data have been presented in Reference 14. With several room temperature leak failures of aged O-ring fixtures, an initial comparison is now possible to demonstrate whether CSR data correlates with leak data. This comparison is shown in Figure 7 for GLT O-rings. Lifetime estimates based on the two parameters are similar at higher temperatures (~350 – 400 °F). Figure 7 also suggests that the CSR data provide a conservative life prediction at lower temperatures with regards to the actual time to leak failure of the O-rings. This observation should be viewed with caution, however, since the lower temperature portion of both curves is based on extrapolation beyond the available data. Insufficient data currently exist to draw a similar comparison for GLT-S O-rings.
