**US ARMY CORPS OF ENGINEERS – ENGINEERING RESEARCH AND DEVELOPMENT
CENTER – PETROGRAPHIC ANALYSIS OF SECTION 3 PERSONNEL TUNNEL
CONCRETE**

Petrographic Analysis of H-Canyon Section 3 Personnel Tunnel Concrete

June 2017

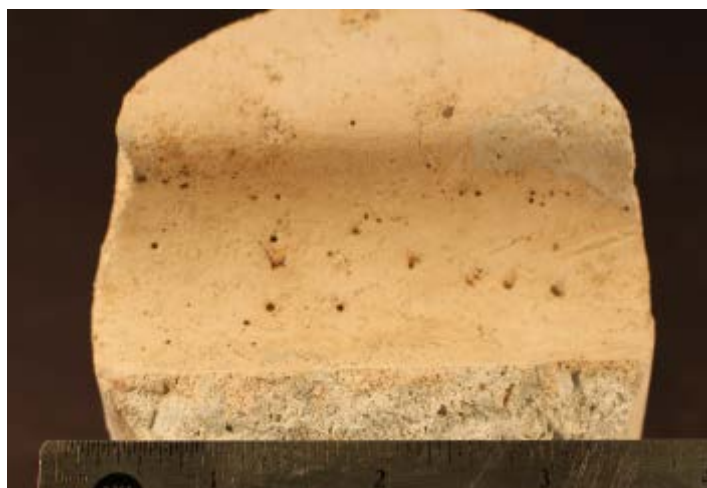
The core was extracted from the south wall of the personnel tunnel. It was seven inches in length and three and three-fourths inches in diameter (Figure 1). Cracking was not observed on the surface, nor throughout the exterior of the core. The surface of the core had been in contact with a sheet pile panel rib that caused a cylindrical impression (Figure 2).

Figure 2. As received core sample 170051-1 showing impression and discoloration of cement where the concrete was in contact sheet pile material.

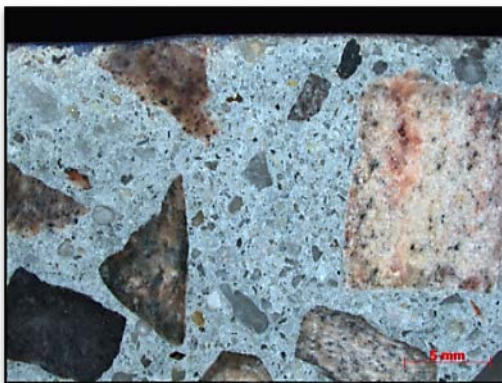
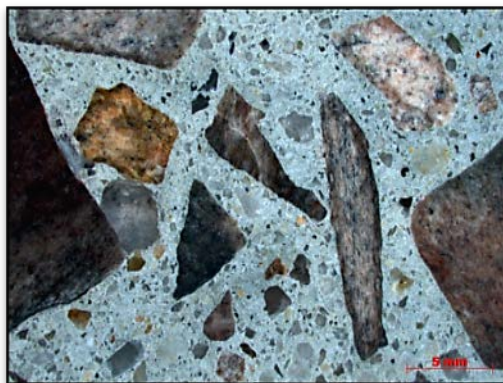
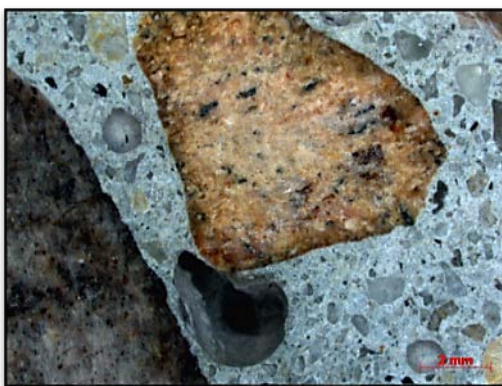
Low and high magnification photomicrographs of the typical microstructure observed in concrete specimen 170051-2 are presented in Figure 6. The coarse aggregate is uniformly distributed and appears to make up 40

percent of the volume. The coarse aggregate is interpreted to be a metamorphic siliceous creek rock gravel and ranges from one to two inches in size. They are sub-angular to angular with a small portion being elongate. The fine aggregate made up approximately 40 percent of the volume and was sub-angular to sub-rounded in shape. It is interpreted to be crushed quartz sand amongst other siliceous minerals. The paste content was light grey (N7). This color and its code were determined by implementing the Munsell Rock Color Book. There were few signs of cracking or infilling, thus it is suspected to not have suffered ASR-related deterioration. Internal cracks within the coarse aggregate are rare and are interpreted to represent pre-existing damage.

Figure 6. Low and high magnification photomicrographs of 170051-2 (a) Surface edge of core with coarse aggregate (b) Coarse aggregate (c) High magnification of the core showing large void near aggregate (d) High magnification of fine aggregate and paste

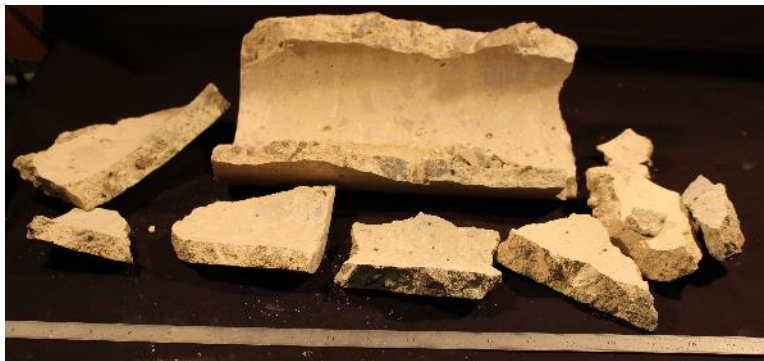
The as received over-core was from the north wall of the personnel tunnel. The sample broke during shipping and was not intact (Figure 11). As such, distinguishing between original and transport-related damage was difficult.

Figure 11. As received core sample 170051-5

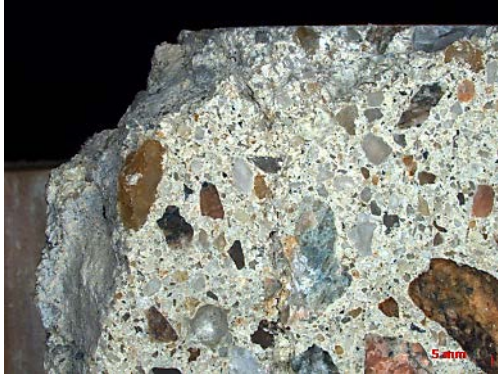
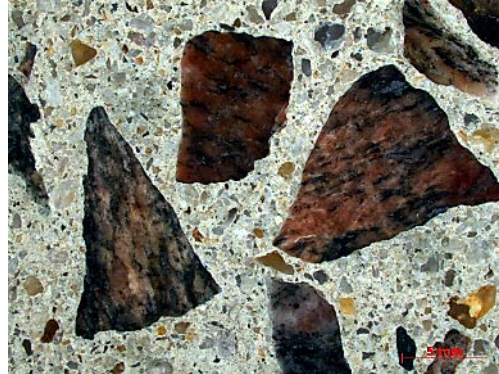
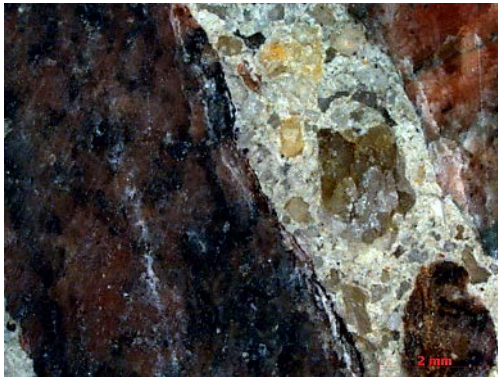
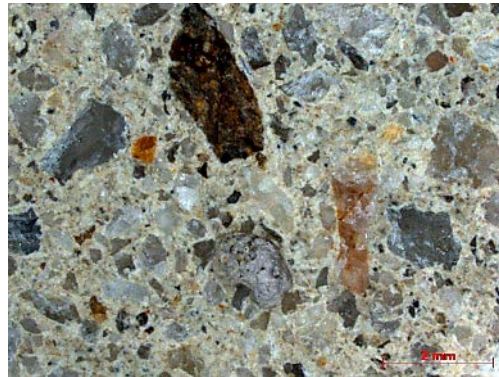
Low and high magnification photomicrographs of the typical microstructure observed in concrete specimen 170051-5 are presented in Figure 12. The coarse aggregate is uniformly distributed and appears to make up 40 percent of the volume. The coarse aggregate is interpreted to be a metamorphic siliceous creek rock gravel and ranges from one to two inches in

size. They are sub-angular to angular with a small portion being elongate. The fine aggregate made up approximately 40 percent of the volume and was sub-angular to sub-rounded in shape. It is interpreted to be crushed quartz sand amongst other siliceous minerals. The paste content was pale yellowish brown (10YR 6/2). This color and its code were determined by implementing the Munsell Rock Color Book. Due to the state in which the core was received, making conclusions based off cracks seen within the core is not advised. Internal cracks within the coarse aggregate are rare and are interpreted to represent pre-existing damage.

Figure 12. Low and high magnification photomicrographs of 170051-4 (a) Edge of core with coarse and fine aggregate (b) Coarse aggregate (c) High magnification of a crack following the edge of a coarse aggregate (d) High magnification of fine aggregate and paste.

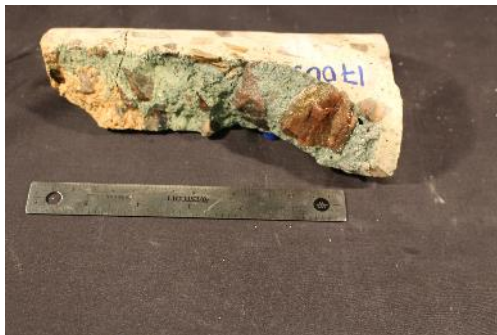
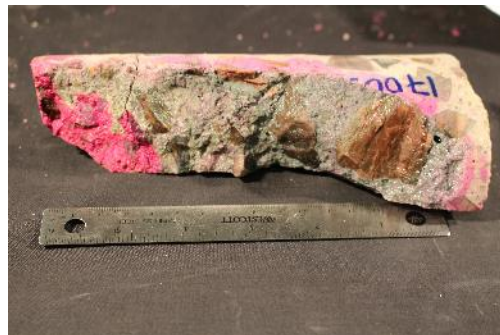
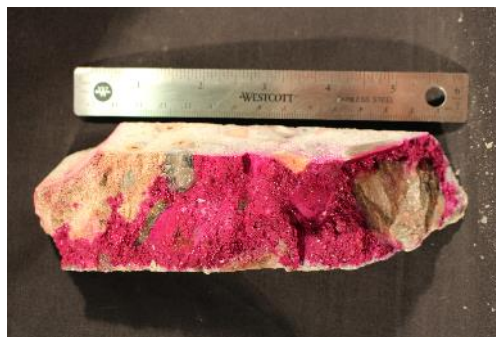
The application of sodium cobaltinitrite and rhodamine B to the surface of the concrete are indicator methods to identify the presence of ASR. Due to the absence of staining by both sprays, it was concluded that ASR processes have not taken place (Figure 29a and b, Figure 30a and b).

Phenolphthalein, a pH indicator, was applied to core 170051-1 that was observed to have two distinct regions of paste according to color (Figure 29c) and the only exposed exterior surface in the as-received cores. The test indicated that the moderate orange pink area has a pH of less than or equal to 10, suggesting carbonation of the concrete at a higher rate than is expected. This carbonation seems linked with the sheet pile panel it was in contact with. It was also applied to 170051-3 (Figure 30c) and no carbonation was observed.

Figure 29. Various chemical sprays applied to core sample 170051-1 (a) sodium cobaltinitrite showing no reaction (b) rhodamine B highlighting carbonated cement with a bright pink stain (c) Phenolphthalein indicating the top portion of the sample having a pH of less than 8.6
