Ongoing Investigation of the Effect that Drugstore Beetles have on Celotex Assemblies Found within Radioactive Material Packagings

Bradley M. Loftin¹, James M. Shuler²

¹Savannah River National Laboratory, ²U. S. Department of Energy, Packaging Certification Program

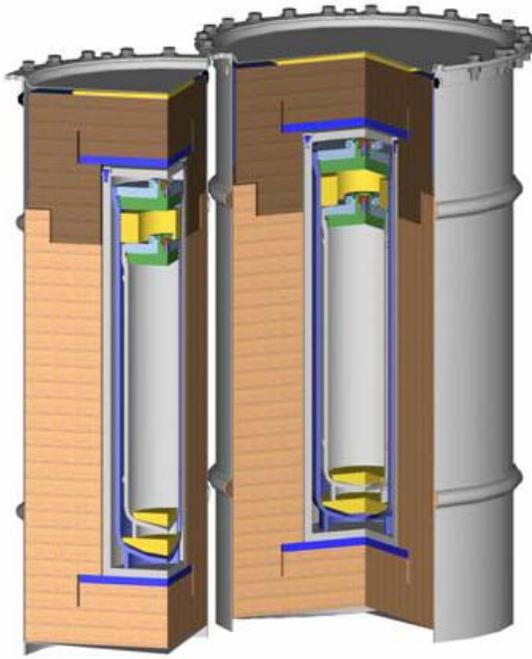
Model 9975 Shipping Package

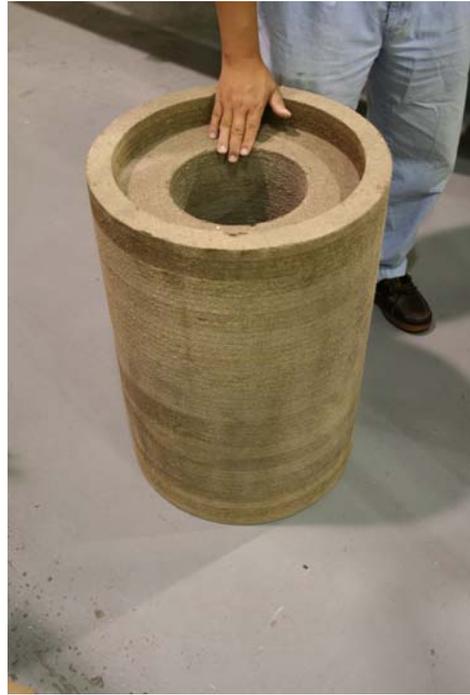
9975 Lower Celotex™ Assembly

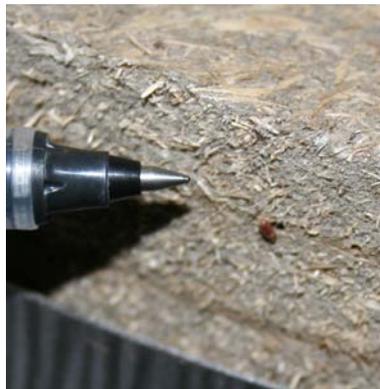
Drugstore Beetle on Celotex™ Assembly
(ink pen at left for reference)

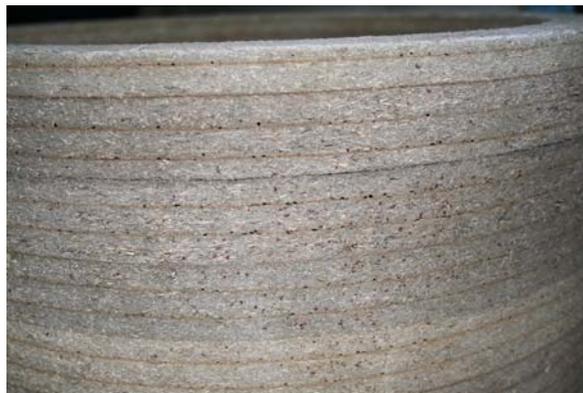
There were numerous beetle bore holes seen on the sides of the upper Celotex™ subassembly and on the internal face of the lower Celotex™ subassembly. It was discovered that there was a concentration of bore holes at the glue layers bonding the layers of Celotex™. The lower Celotex™ assembly contained numerous bore holes on the external of the assembly and there was a large amount of frass (beetle excrement) left inside the package. There was no evidence of any live beetles within the package or the Celotex™.

Drugstore Beetle Bore Holes in Celotex™ Lower Subassembly

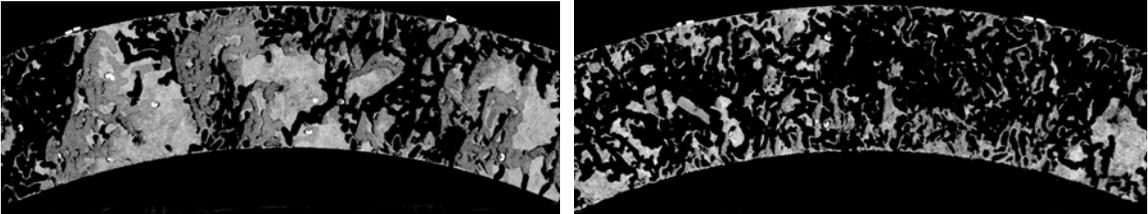
A small slice, approximately 6 inches long, was cut out of the lower Celotex™ subassembly from package 02662 and a CT scan was performed on it. The results of the CT scan showed that the beetles are selectively consuming the glue layers between the Celotex™ layers. The images below show damage at two glue boundary layers between the Celotex™ layers.

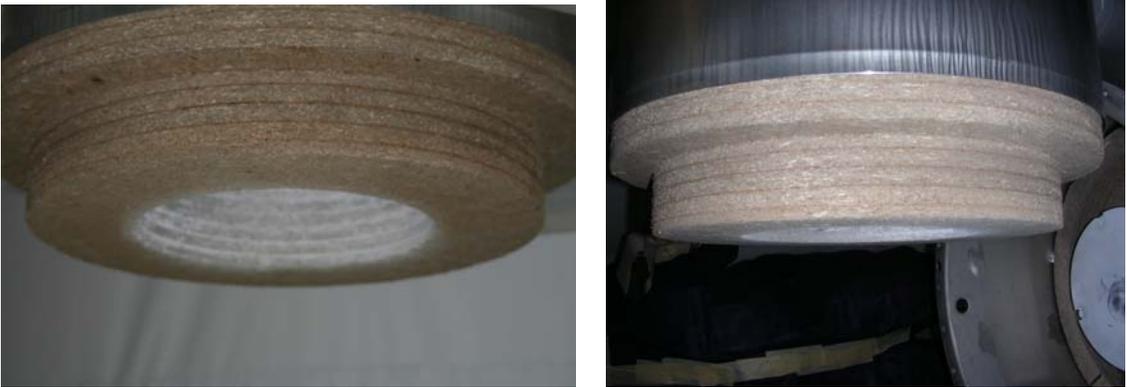
—This package is being used to “grow” the beetle population. There were quite a few beetle bore holes in the Celotex™ and glue layers bonding the layers of Celotex™ in the region around the interface between the two Celotex™ subassemblies. Three or four live beetles were seen crawling inside of the package at the initial opening. This package was opened again on May 21, 2008 for a second examination. Differences in the amount of damage to the Celotex™ within the package were minimal, however there was a significant growth of the beetle population as approximately two dozen live beetles were seen crawling inside of the package and many dead beetles were found on top of the upper and lower Celotex™ subassemblies.

02711 Upper Celotex™ Assembly 12/07

02711 Upper Celotex™ Assembly 05/08

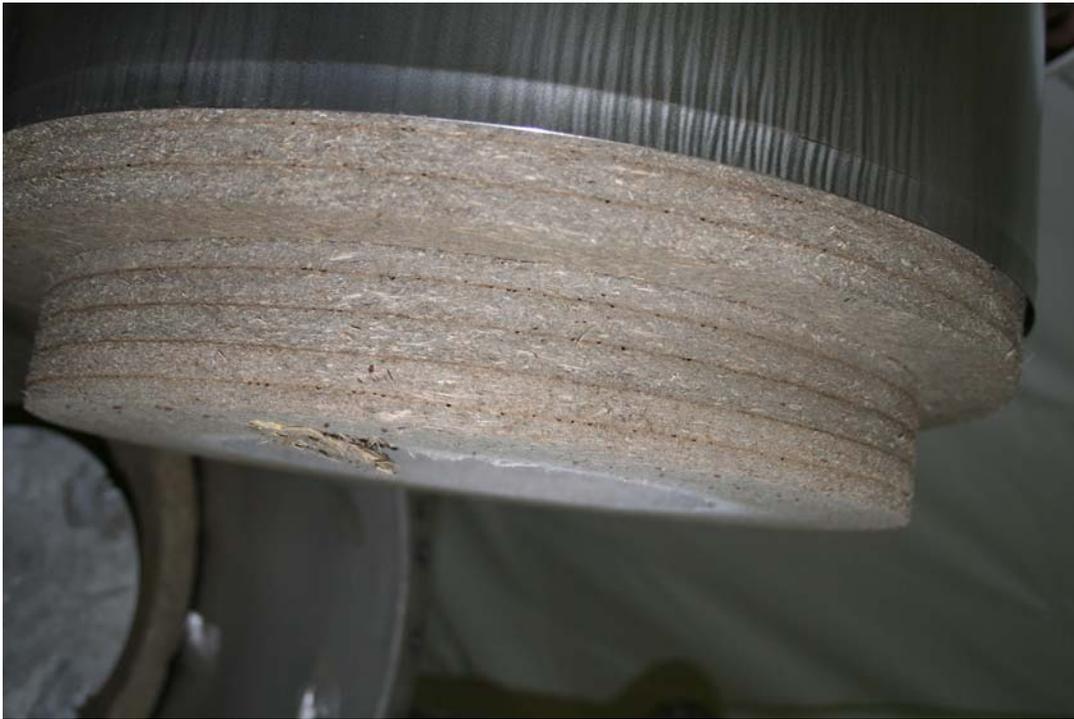
9975 02711 was opened again on June 1, 2009. The package has remained in a controlled environment for the duration of the testing and had not been disturbed nor opened since May 2008. The Celotex™ did not have any more discernible damage and there was not a significant increase in the number of holes in the glue boundaries. It was anticipated, after seeing the increase in the beetle population in the previous opening, that the beetle population would be even greater and that the beetles would have consumed even more of the Celotex™ subassemblies. However, the beetle population seemed to have decreased since the last opening. The beetles may have just been dormant due to a lack of light. It was noted that once the package was opened for about five minutes, a few live beetles were seen crawling within the package.

02711 Upper Celotex™ Assembly 06/09

It is now recommended that the drugstore beetles in 9975 02711 be eradicated as required by the initial permit to bring the beetles into the state of South Carolina. This should be done by initially freezing the package, then removing the lead shield and containment vessels. Freezing the package should eliminate all of the beetles, but as an additional measure, the package without the lead should be able to be placed into a CT scan and valid data gathered. Once the package has been through the CT scan, it can be frozen again without the lead and containment vessels to ensure that all of the beetles have been killed. Then it is recommended that the Celotex™ be destructively tested to determine if there was a loss or change in the properties important to the safety of the package.

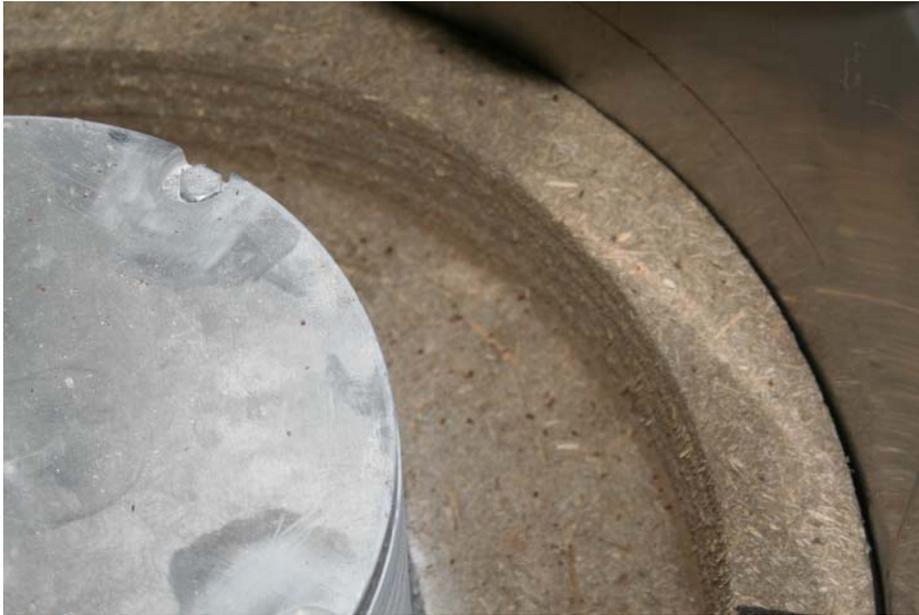
The Celotex™ Assembly had similar damage and did not look to be any worse than before. A piece of Celotex™ was attached to the top of the upper assembly, but it was not evident which part of the package the piece came from. There was not any significant accumulation of frass on top of the upper assembly. There was no additional accumulation of lead carbonate and the amount of dead beetles did not appear to increase significantly since the last opening.

02711 Lower Celotex™ Subassembly 06/09

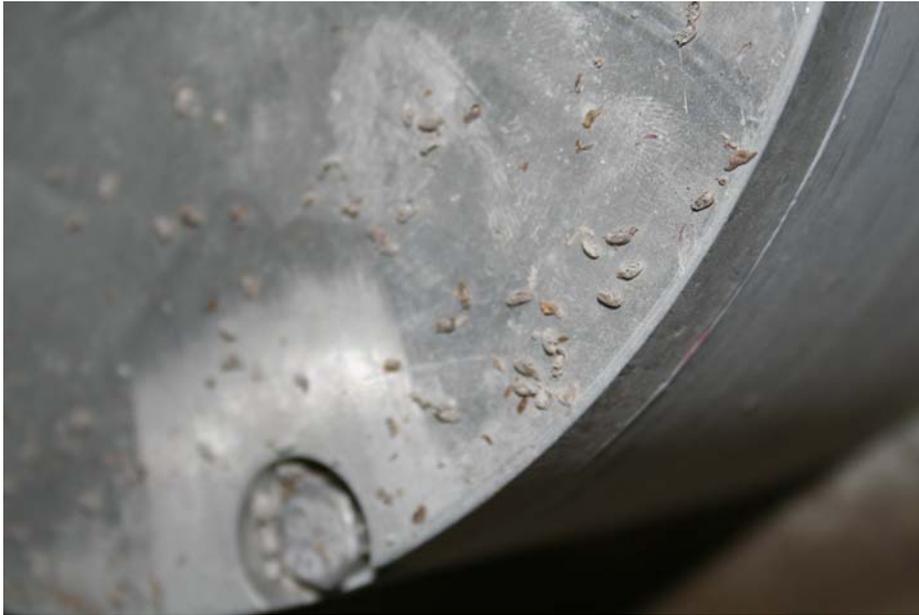
Dead Drugstore Beetles on top of the Lead Shield (9975 02711 06/08)
