INVESTIGATION OF THE POTENTIAL FOR CAUSTIC STRESS CORROSION CRACKING OF A537 CARBON STEEL NUCLEAR WASTE TANKS

Savannah River National Laboratory
Materials Science & Technology Directorate

Publication Date: October 2009

DOCUMENT: SRNS-STI-2009-00564 Rev.1
TITLE: Investigation of the Potential for Caustic Stress Corrosion
Cracking of A537 Carbon Steel Nuclear Waste Tanks

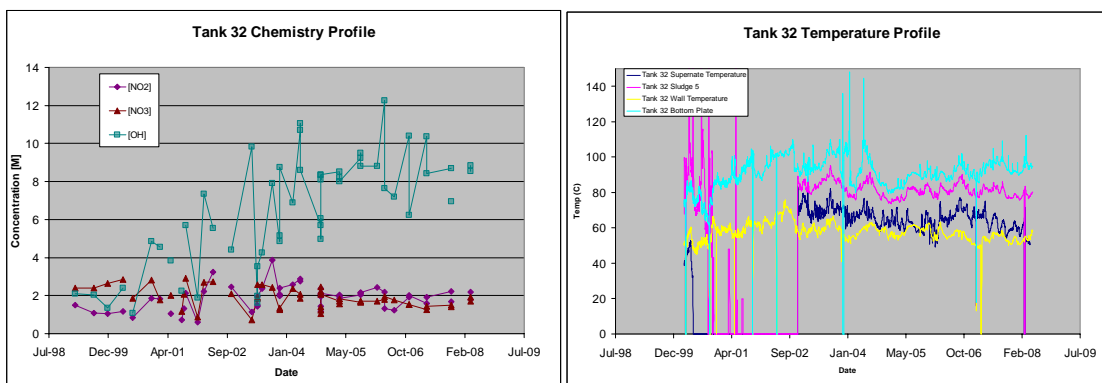
Figure 1 Chemistry and temperature profiles for Tank 32 [1].

The chemistry and temperature histories of Tanks 30 and 32 in the past ten years can be seen in Figures 1 and 2 (reproduced from Ref. [1]). The most critical location can be identified at Tank 32 Bottom Plate (see Fig. 1, curve in cyan), where a high temperature above 120 °C occurred for an extended period of time. Note that Tank 30 experienced a much higher temperature surge (Fig.2, yellow curve), but that temperature dissipated quickly because there is no sludge in Tank 30 to provide latent heat as in the case of Tank 30.

The test condition was chosen to bound the chemistry and temperature histories since 2002 for Tanks 32 and 30, respectively, as shown in Figures 1 and 2. The test solution was made from 12 M hydroxide [OH^-], 1 M nitrate [NO_3^-], 1 M nitrite [NO_2^-], and 1 M (for the U-bend test) or 0.3 M (for the large plate test) aluminate [AlO_2^-] by dissolving salts of NaOH, NaNO_3 , NaNO_2 , and $2(\text{NaAlO}_2) \cdot 3\text{H}_2\text{O}$ at above-room temperature. After the solution was transferred to the immersion test vessels, the temperature was raised to the target 125 °C in three 1.6-liter Teflon beakers for the U-bend test and a 6-gallon Hastelloy (C-276) test tank for the large plate test.

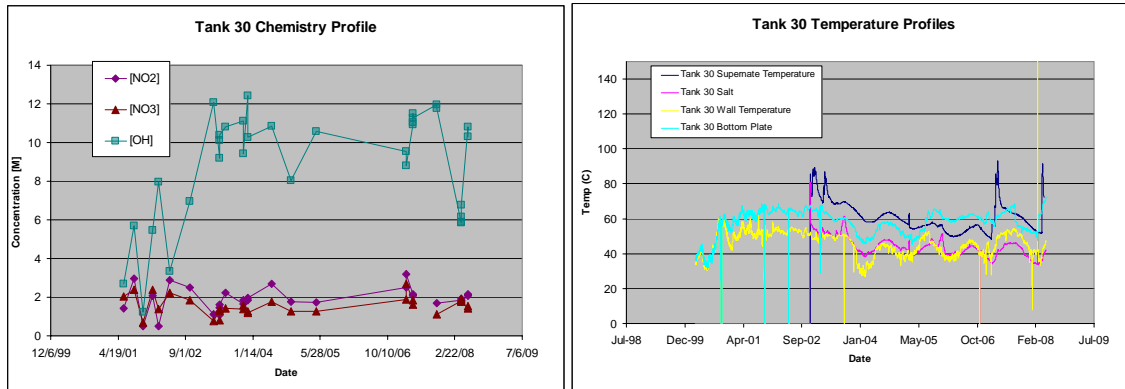
Figure 2 Chemistry and temperature profiles for Tank 30 [1].

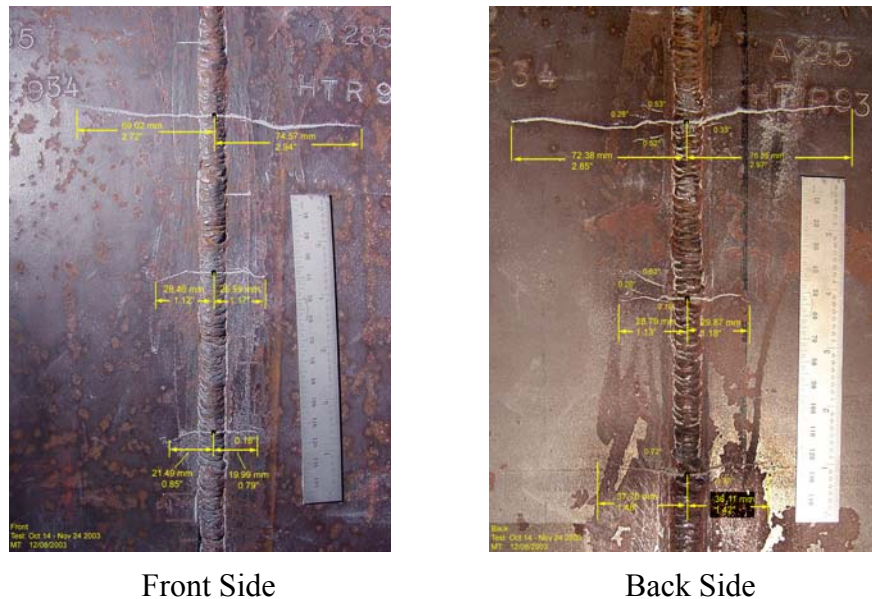
Figure 3 Nitrate stress corrosion cracking of the as-welded A285 plate for Types I and II waste tanks (reported in 2002) [5].

In an earlier study[†] [5] sponsored by Westinghouse Savannah River Company High Level Waste Division [6] and by the U. S. Department of Energy Office of Science [7], the nitrate stress corrosion cracking in A285 carbon steel for Types I and II waste tanks was shown to be effectively eliminated by relieving the welding residual stress through heat treatment. Figure 3 shows the stress corrosion cracks growing from the initial, machined seed cracks in an as-welded, non-heat treated A285 plate, which was submerged in a 5 M sodium nitrate solution at 90 °C. Meanwhile, no cracking could be found even by ultrasonic testing in the companion test plate which had been heat treated. The stress corrosion cracking was initiated from the seed cracks as early as two weeks following immersion in the aggressive solution (no inhibitors were present).

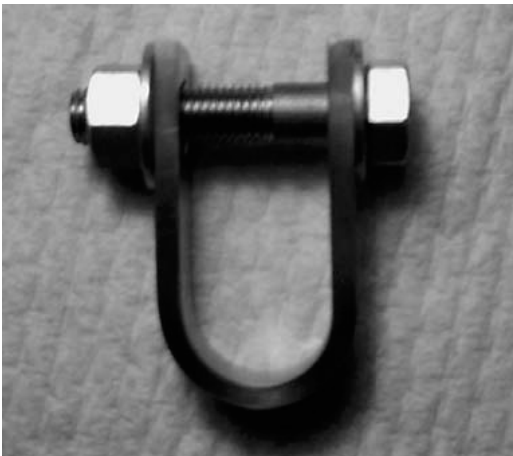
Figure 4 U-bend specimen (Ref. [10,13]).

Two types of specimens were used: 1) small scale U-bends (Fig. 4) with a before-bent dimensions of 5-in. long, 1 in. wide, and $\frac{1}{8}$ in. thick; and 2) large plate (12×12×1 in., formed by welding two 6×12×1 in. sections together) with machined seed cracks (Fig. 5). Each specimen contained a weld. Heat treatment to relieve the welding residual stress was applied to half of the specimens. Both sets of the specimens (as-welded and heat-treated) were submerged side by side in the same caustic solution at 125 °C.

Prior to submerging in the test solution, each pair of the specimen legs was bent approximately parallel. To maintain the shape without relaxing the elastic tensile strain, the legs were tightened by nuts and a screw which are properly insulated with Teflon washers and sleeve to avoid the galvanic effects between two different materials (Fig. 4).

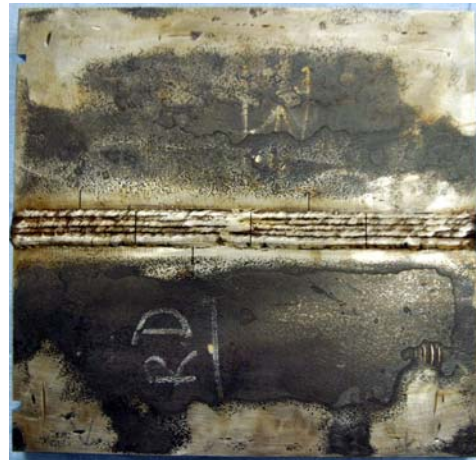
Figure 5 Large-plate specimen (Ref. [4]).

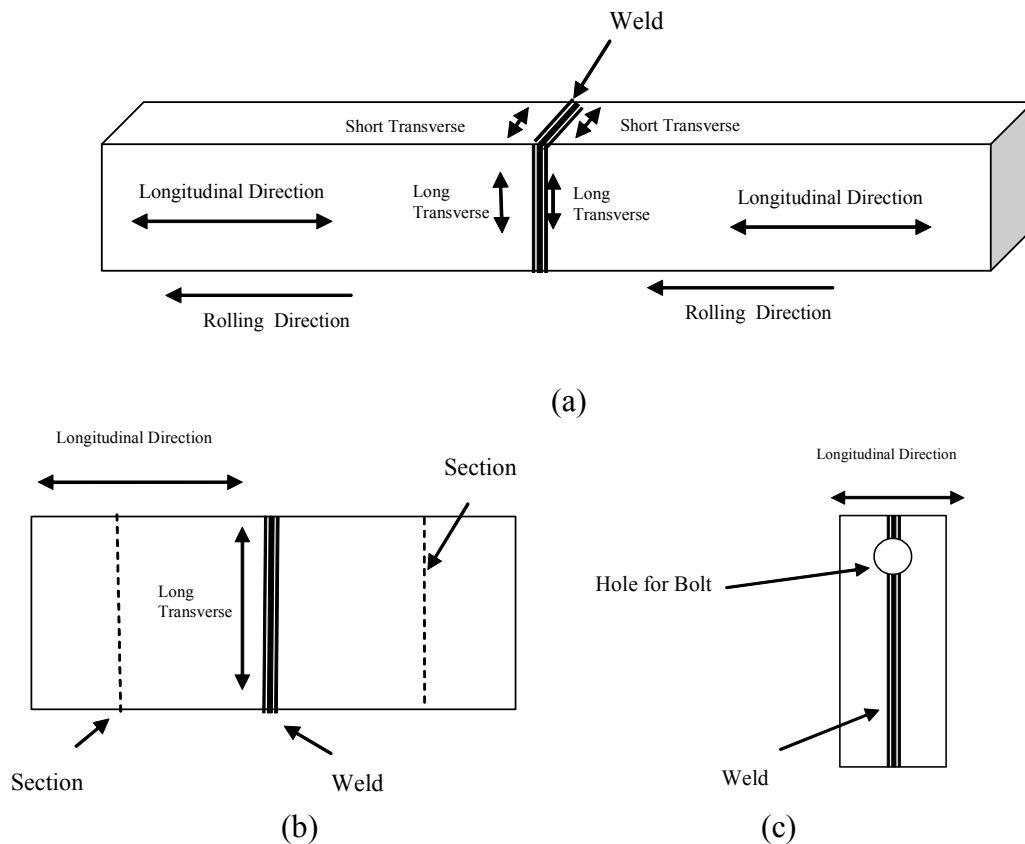
Figure 6 (a) Schematic of the two welded plates from mill sheet, (b) schematic of the weld and the orientation for the U-bend specimen, (c) side view of the final U-bend specimen after bent around a mandrel [11,15].

The testing used a total of eight U-bend specimens (Figs. 4 and 6), four of which were as-welded (fabricated and assembled per ASTM G 30) and the other four were heat treated (Section 2.3.1) prior to assembling. These eight specimens were submerged in three commercially available Teflon beakers filled with the pre-mixed caustic solution (Section 2. 1). These specimens were deployed in three beakers in the following manner to reduce the potential of experimental errors caused by any changes of solution concentrations and the fluctuation of the heater temperatures:

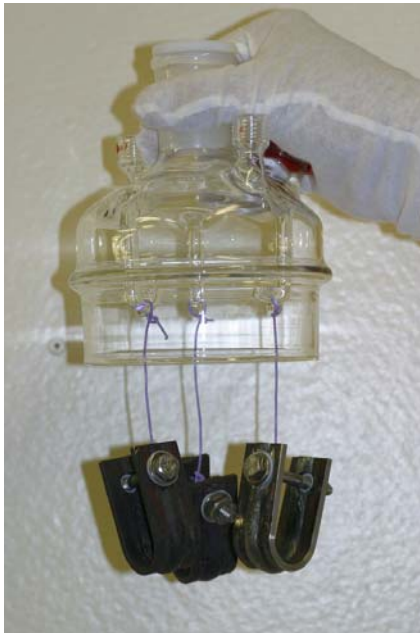
Figure 7 U-bend specimens are suspended from the hooks inside the glass cap to the beaker.

Figure 7 shows these specimens suspended with Teflon wires from the hooks that were built as part of the glass cap of the Teflon beaker. The glass cap has opening ports to accommodate the condenser and two thermocouples (Fig. 8). In addition, an extra port is available as needed, so a thermometer, for example, can be inserted to directly measure the solution temperature independent of the digital temperature controller readings. Each Teflon beaker was heated with an electric mantle to maintain the test temperature at 125 °C. A glass condenser (Graham type, see Fig. 9) was fabricated for each of the beakers to recover the water vapor and to maintain constant salt concentrations in the test solution.

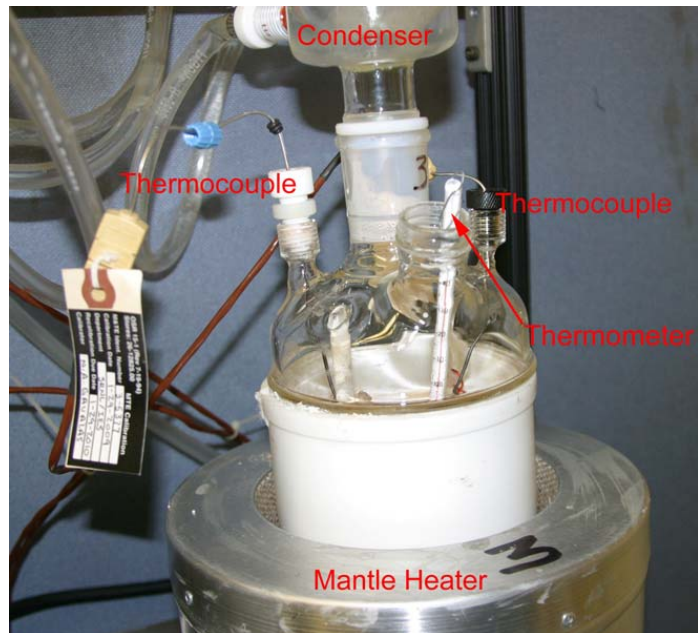
Figure 8 The assembly of the test beaker.

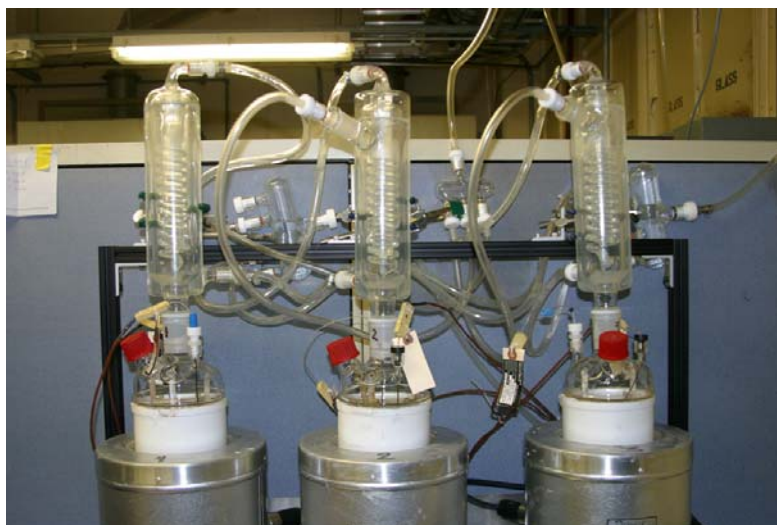
Figure 9 Graham Condensers on top of the test beakers.

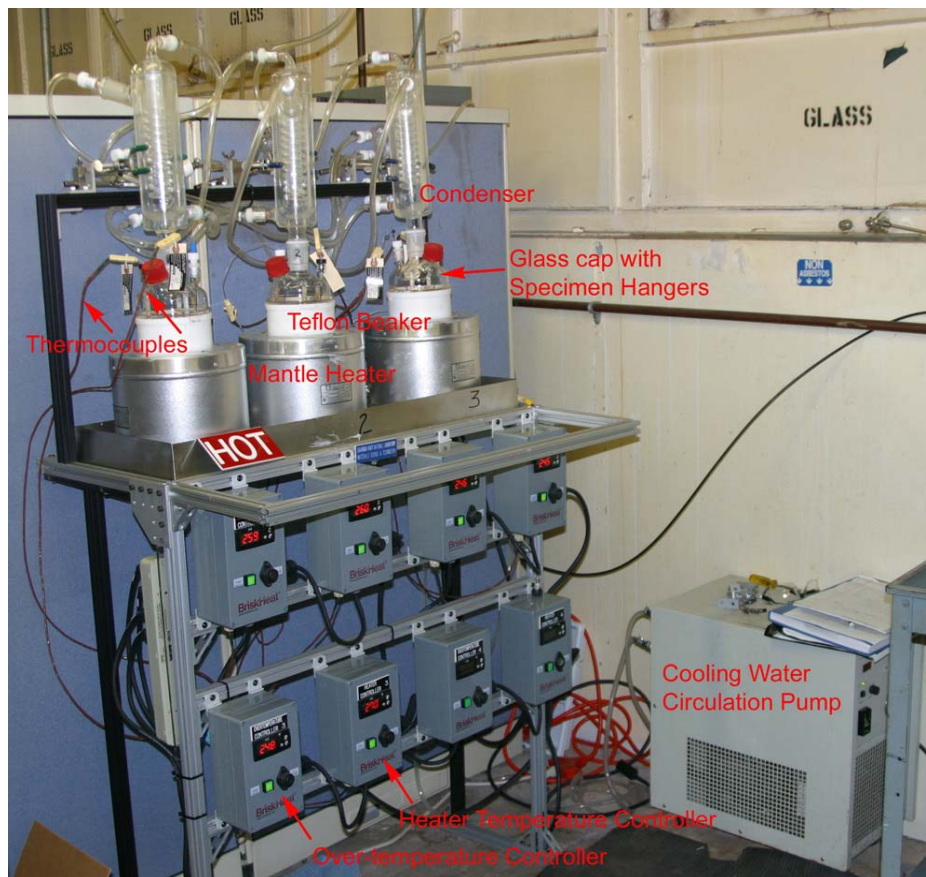
Figure 10 U-bend test station

The overall laboratory setup can be seen in Figure 10. The duration of the testing was 21 days. The U-bend specimens were examined periodically for cracking during the test period.

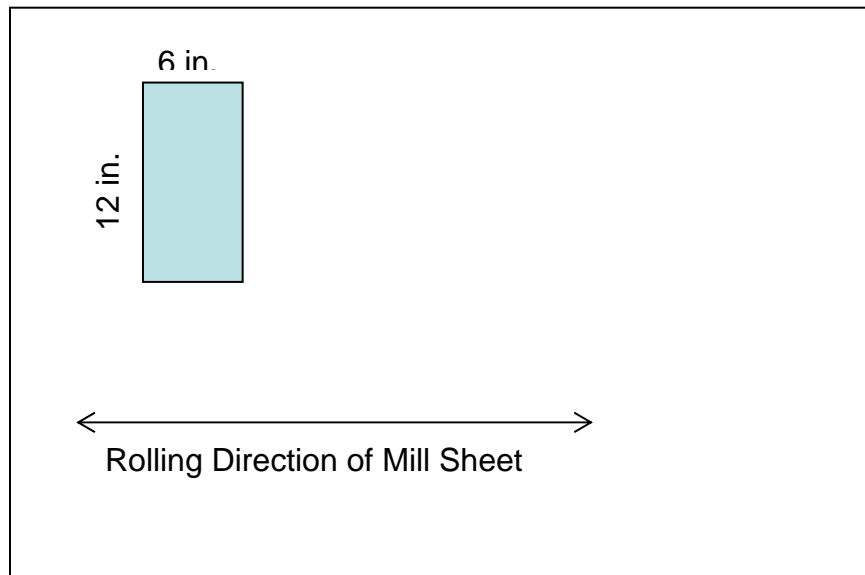
Figure 11 The 6 in. × 12 in. plate is cut from an A537 mill sheet – the 6-inch side is parallel to the rolling direction of the mill sheet.

The plate specimens were fabricated in a manner similar to those used in the previous nitrate SCC testing for Type I and II waste tanks (welded A285 carbon steel plates in 5 M sodium nitrate solution at 90 °C [5-7]). To be consistent with the U-bend specimens, the weld orientation was chosen to be perpendicular to the rolling direction of the steel mill sheet. Therefore, two 6 in. × 12 in. plates were cut from an one-inch thick A537 sheet as schematically shown in Figure 11 and then butt-welded to form a 12 in. × 12 in. specimen plate. Such an arrangement ensures that the weld is in the desired orientation.

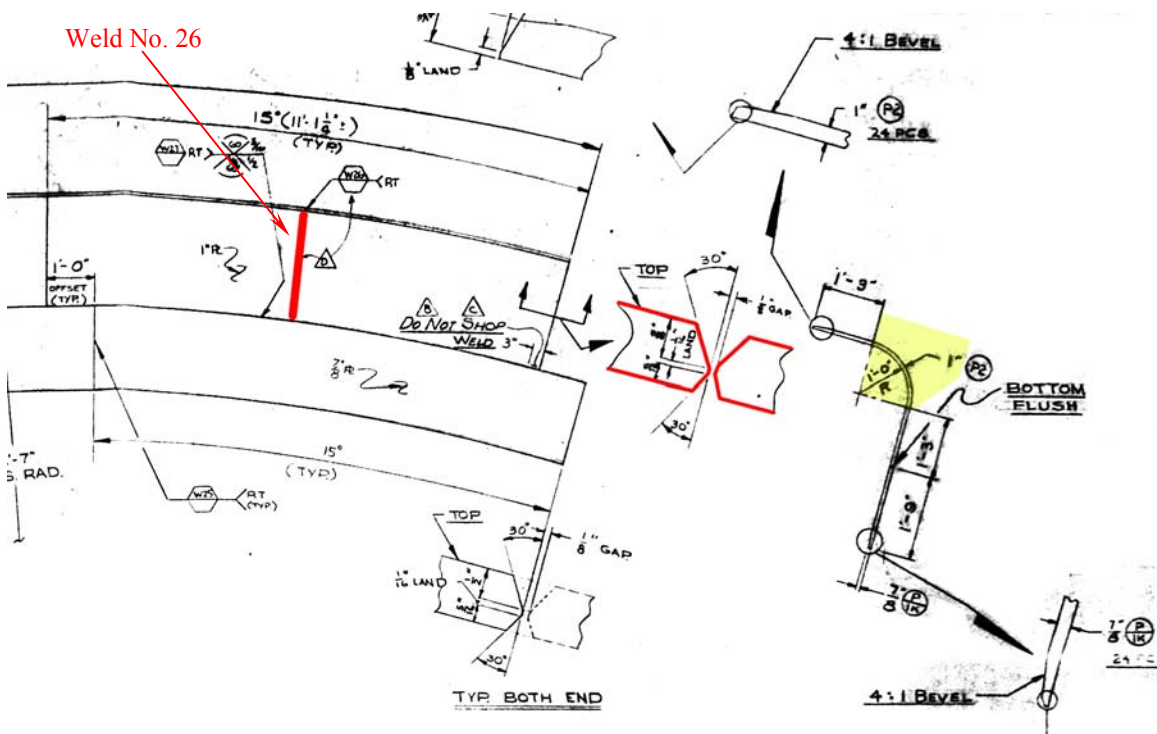
Figure 12 Vertical seam weld No. 26 in the bottom knuckle area (thickness: 1 inch).

The thickness of the large plate specimen is one (1) inch, which was chosen based on the thickness of the plate at the location where the highest service temperature was found in Tank 32, near the bottom knuckle [1]. Within that bottom plate, the most susceptible area for CSCC to occur is the vertical seam, Weld No. 26, which is marked in red in Figure 12 (as part of the Blue Print File 211620 [17]). The original welding document from Nooter Corporation (in 1964, see Appendix 4) specified that the SMAW was used in butt-joining the tank wall with a double K-notch. The Oxxweld 65 (brand name for ER70S-2 wire, see Appendix 5) was used for the initial weld between the closest point along the double-K notch; and the filler metal, coated E-7018 (Appendix 6), was used to complete the weld on one side of the tank wall (as many passes as necessary). This process was repeated for the other side of the tank wall. The same welding procedure and parameters were adopted to fabricate the plate specimens for the CSCC experiment. However, there were slight differences in the actual welding of the two plates, for example, the length of each pass and the number of passes. Appendices 7 and 8 document the actual welding processes and parameters for the as-welded plate and for the heat-treated plate, respectively.

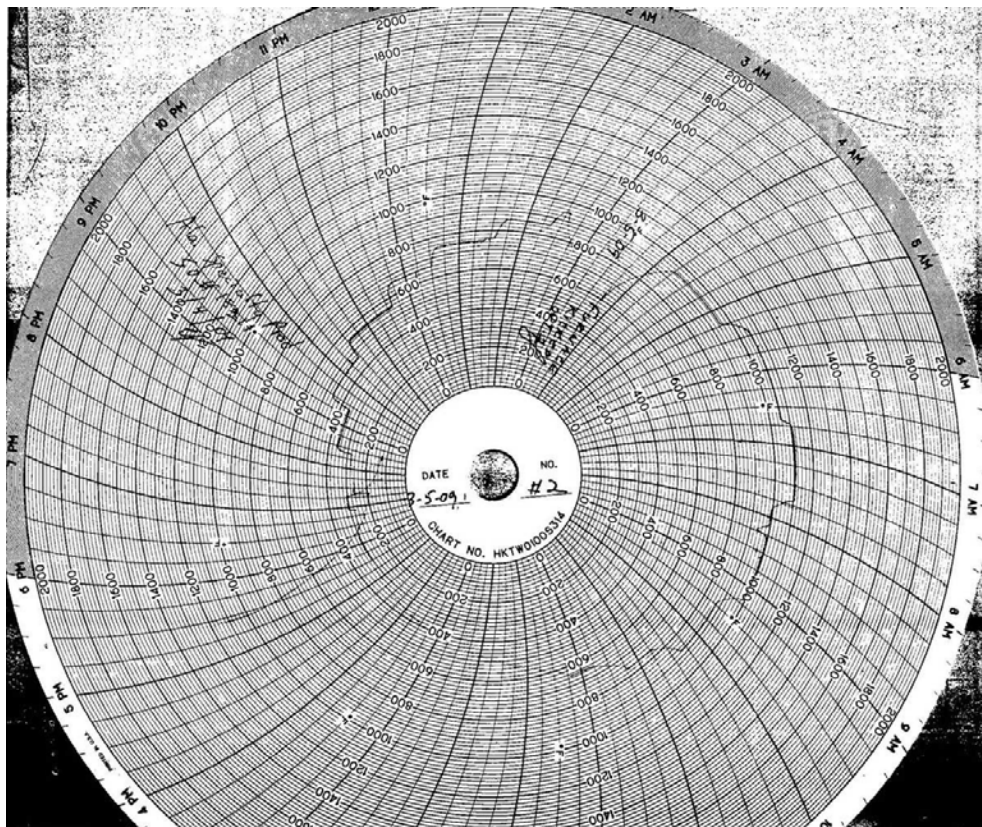
Figure 13 Heat treatment temperature history.

However, during the heat treatment at the vendor site, the oven was found to have lost power at about 950 °F during the ramp-up stage (from ambient to 1100 °F). It is estimated from the heat treatment chart (Fig. 13) that it took about 105 minutes to reheat to 950 °F (when the power failure occurred) and finally reached the maximum temperature, 1100 °F, in the next 150 minutes. Because the temperature excursion occurred in the heating stage, it is considered as non-detrimental and this plate specimen was not re-fabricated.

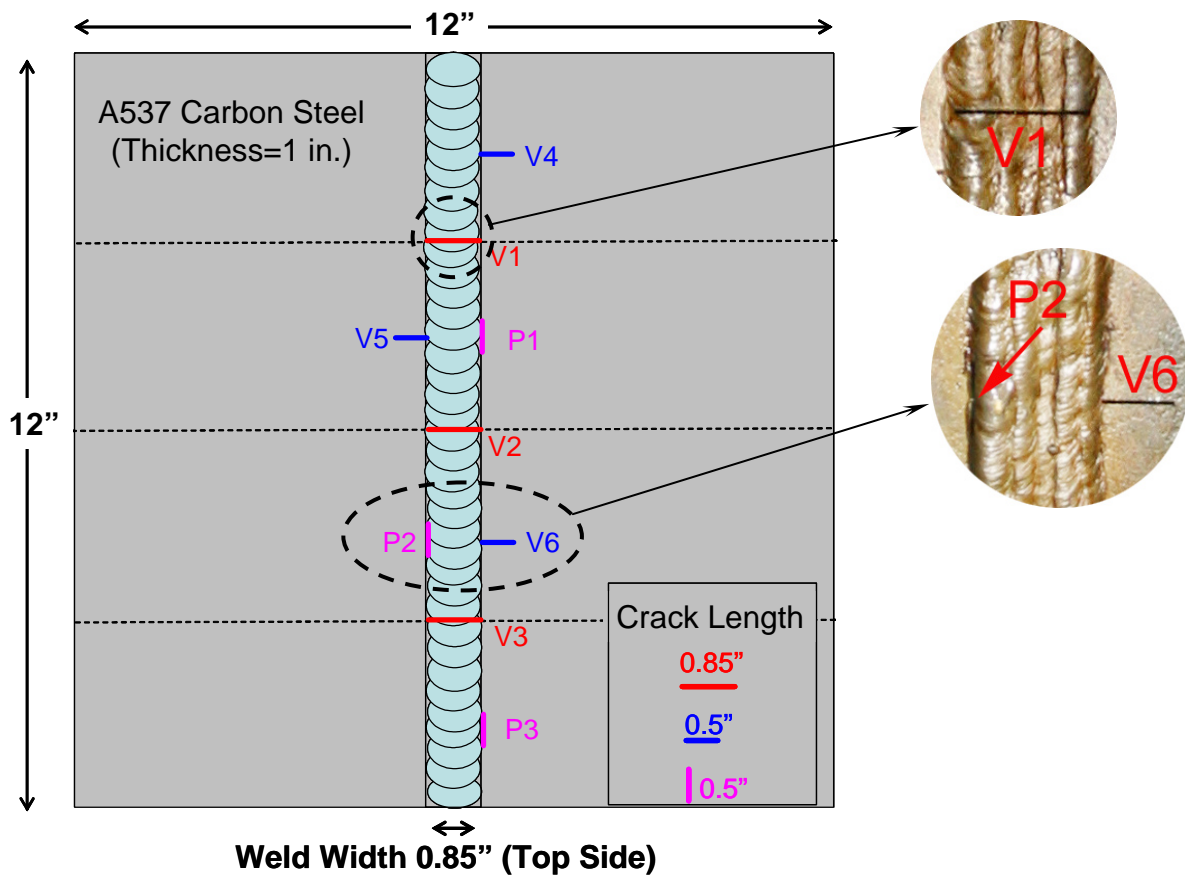
Figure 14 Welded large plate specimen with machined cracks.

The schematic seed crack placement and crack types can be seen in Figure 14. The actual seed cracks are shown in the insets of the figure. The electric discharge machining (EDM) was used to fabricate these cracks so the crack tips can be as sharp as possible. Due to the EDM wire or electrode size, the crack tip maintains a small but finite radius (e.g., 0.015 in.).

The three types of machined cracks are (see Figure 14):

- 1) V1, V2, and V3: vertical cracks through the thickness of the plate and across the weld (Fig. 15);
- 2) V4, V5, and V6: vertical cracks partly through plate in the heat affected zone perpendicular to the weld (Fig. 16); and
- 3) P1, P2, and P3: cracks parallel to the weld and partly through plate in the HAZ along the edge of the weld (Fig. 17).

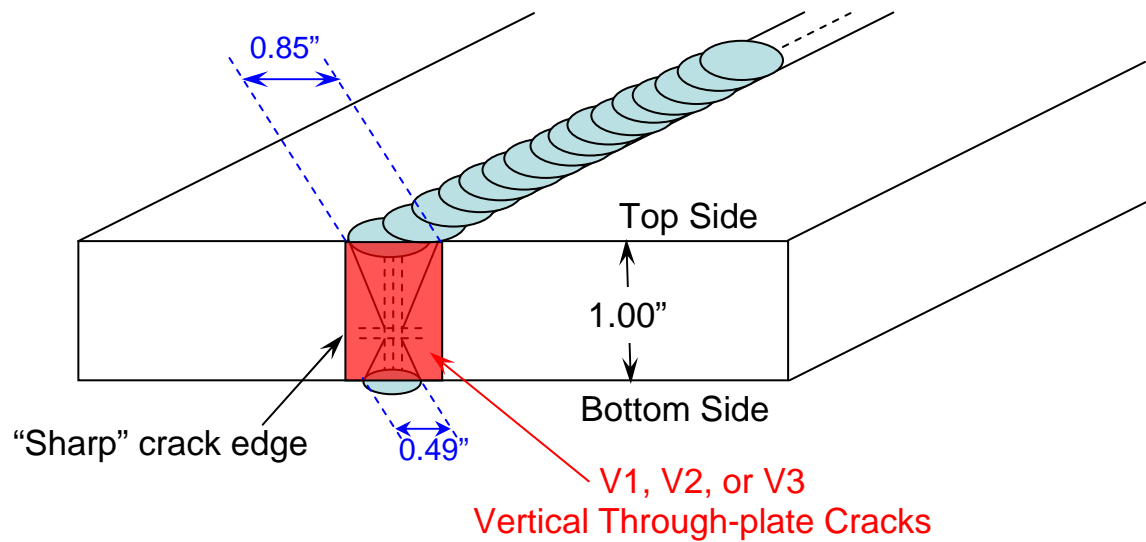
Figure 15 Through-the-plate cracks across the weld (V1, V2, and V3).

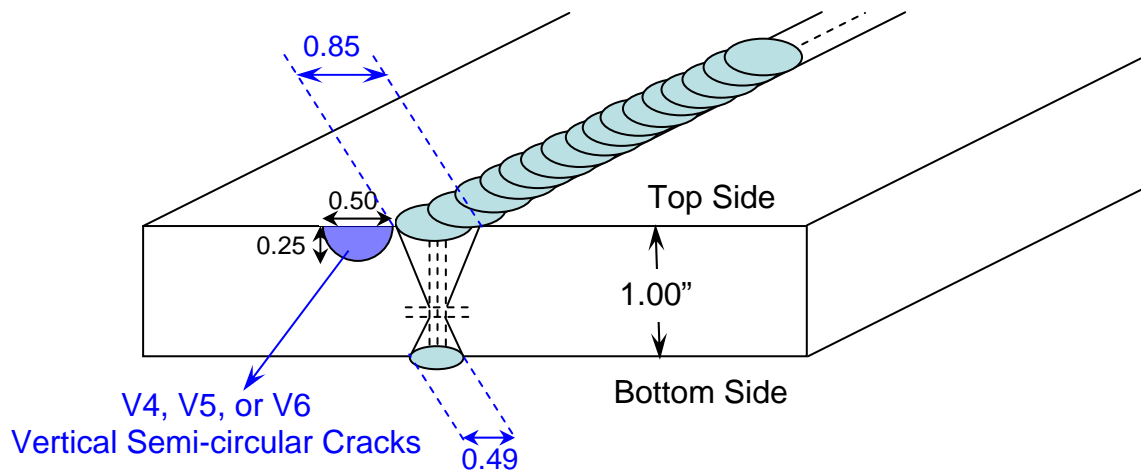
Figure 16 Semi-circular surface cracks perpendicular to the weld (V4, V5, and V6).

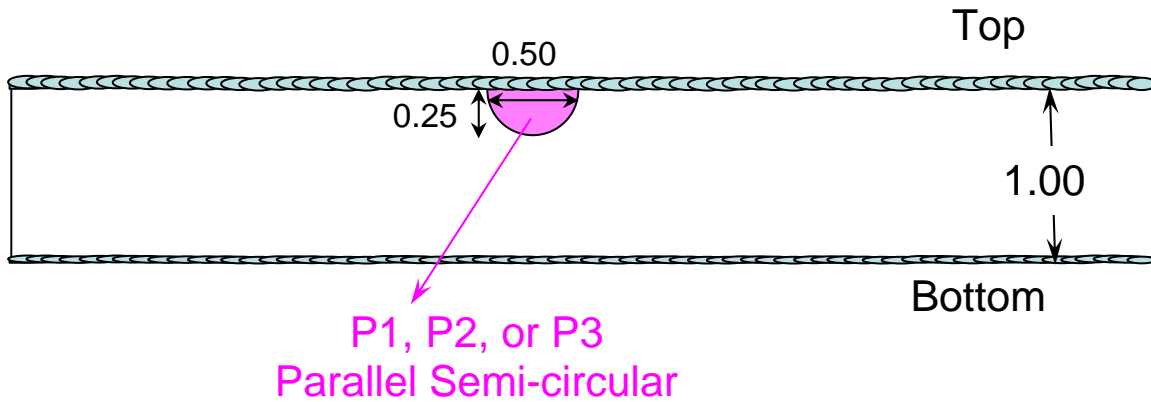
Figure 17 Semi-circular surface cracks parallel to the weld (P1, P2, and P3).

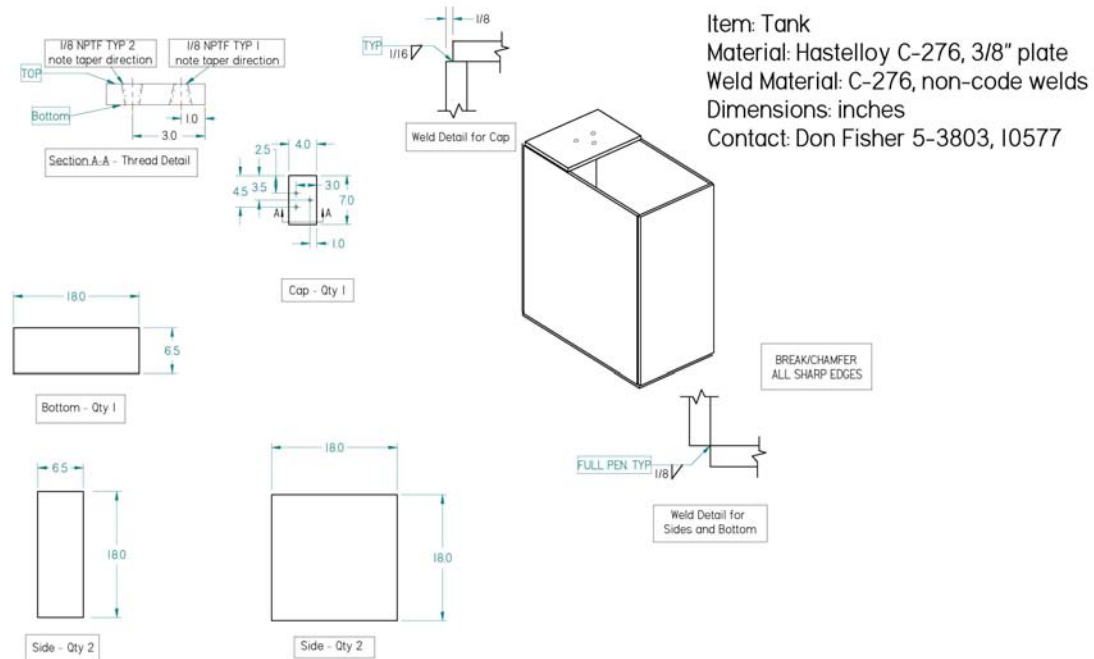
Figure 18 Construction drawing for the Hastelloy (Alloy C-276) immersion tank.

Typical stainless steels, especially their weldment, may corrode significantly during long exposure to highly caustic solutions at temperature as high as 125 °C (or slightly above, because the temperature control is of oscillatory nature). As a result, the nickel-molybdenum-chromium alloy, Hastelloy (i.e., C-276), was selected for constructing the immersion tank. This material, along with its welds, is known to be corrosion-resistant in highly caustic solutions at high temperatures. The design of the immersion tank was based on the specimen dimension (12 in. × 12 in. × 1 in.) and the ratio of solution volume to specimen surface area (i.e., 5 ml/cm² or 33 ml/in², suggested by ASTM G 123, see Section 2. 1). The tank is 18-in. high with a cross-section of 18 in. × 6.5 in. with a total volume of 34.5 liters (9.1 gallons) which could accommodate 6 gallons of the test solution required by ASTM G 123. The thickness of the tank wall is $\frac{3}{8}$ inches. The test tank was designed in such a manner that none of the C-276 plate edges (i.e., end-grains) would be exposed to the solution, which makes the test tank even more corrosion-resistant. An engineering drawing of the tank construction along with the welding requirements can be seen in Figure 18. The test solution is not filled to the top of the tank. A 2½ inch headspace is left when the test plates and hangers (racks) (Figure 19) are in position with a liquid volume of 25 liters (6.6 gallons).

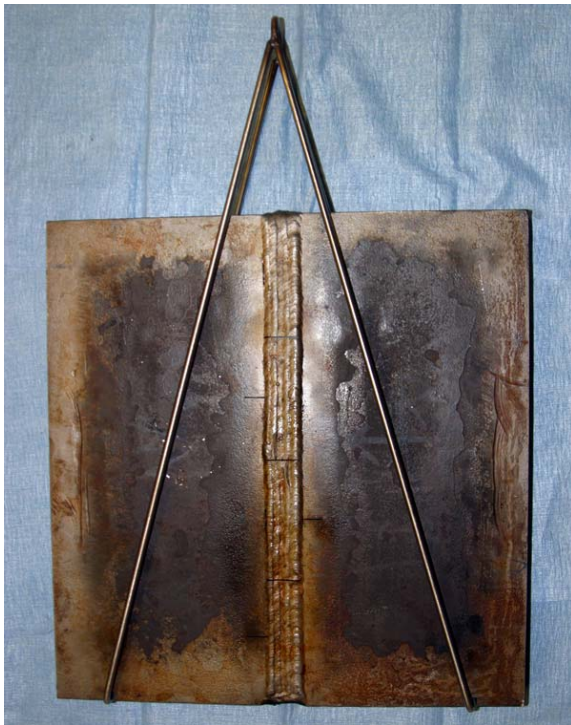
Figure 19 Positioning of the test plate on the rack (hanger).

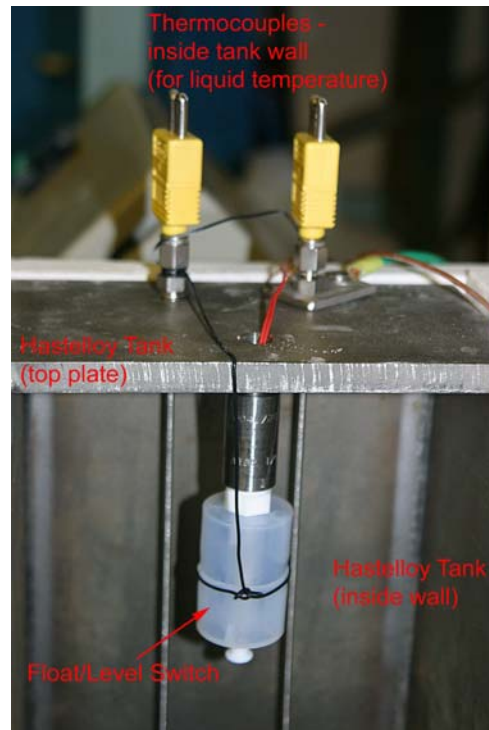
Figure 20 Thermocouples for monitoring the solution temperature and the level float switch (inside test tank).

The heaters operate simultaneously and are controlled by a simple temperature controller backed up by a programmable digital over-temperature controller. Each has an independent thermocouple input. A high temperature, corrosion resistant level sensor (float) will cut off the power supply to the heaters if the liquid level drops below 14 inches measured from the bottom. Figure 20 is the inside view of the tank where the thermocouples are used to monitor the solution temperature and the level switch (float) is visible.

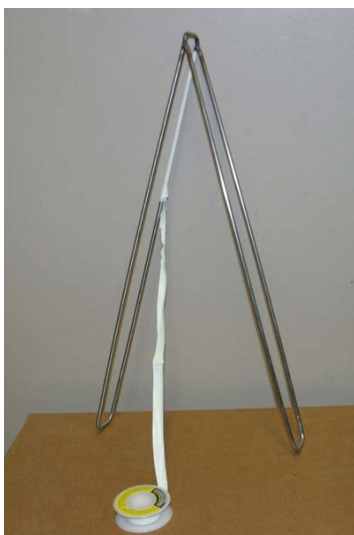
Figure 21 Insulating of rack with Teflon tapes.

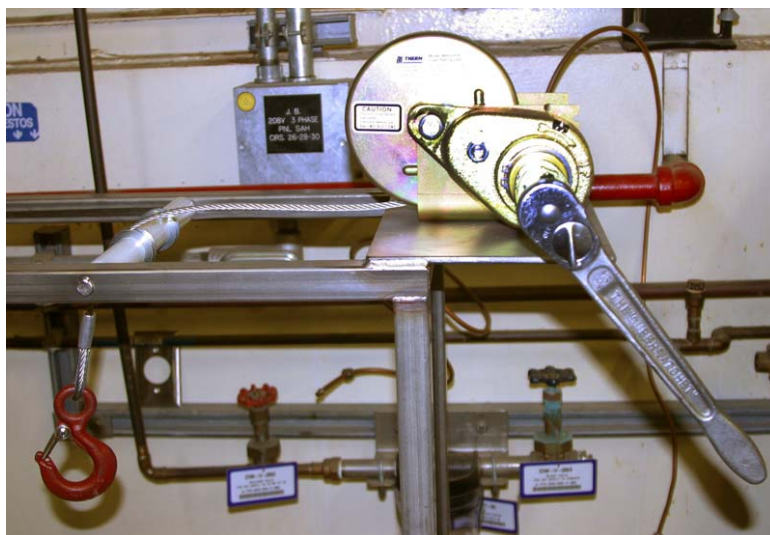
Figure 22 Winch assembly for lifting and lowering the plate specimens.

The test plate and the rack (holder) were designed to be lifted with a winch (Fig. 22) from or lowered into the solution in the test tank which has been filled with highly caustic solution and at high temperature. The winch is equipped with a brake and clutch and must be manually powered up and down. The test tank is supplied with a lid which may be replaced once one plate is brought above the top of the test tank. This eliminates the possibility of corrosive material splashing out if objects are accidentally dropped into the test solution.

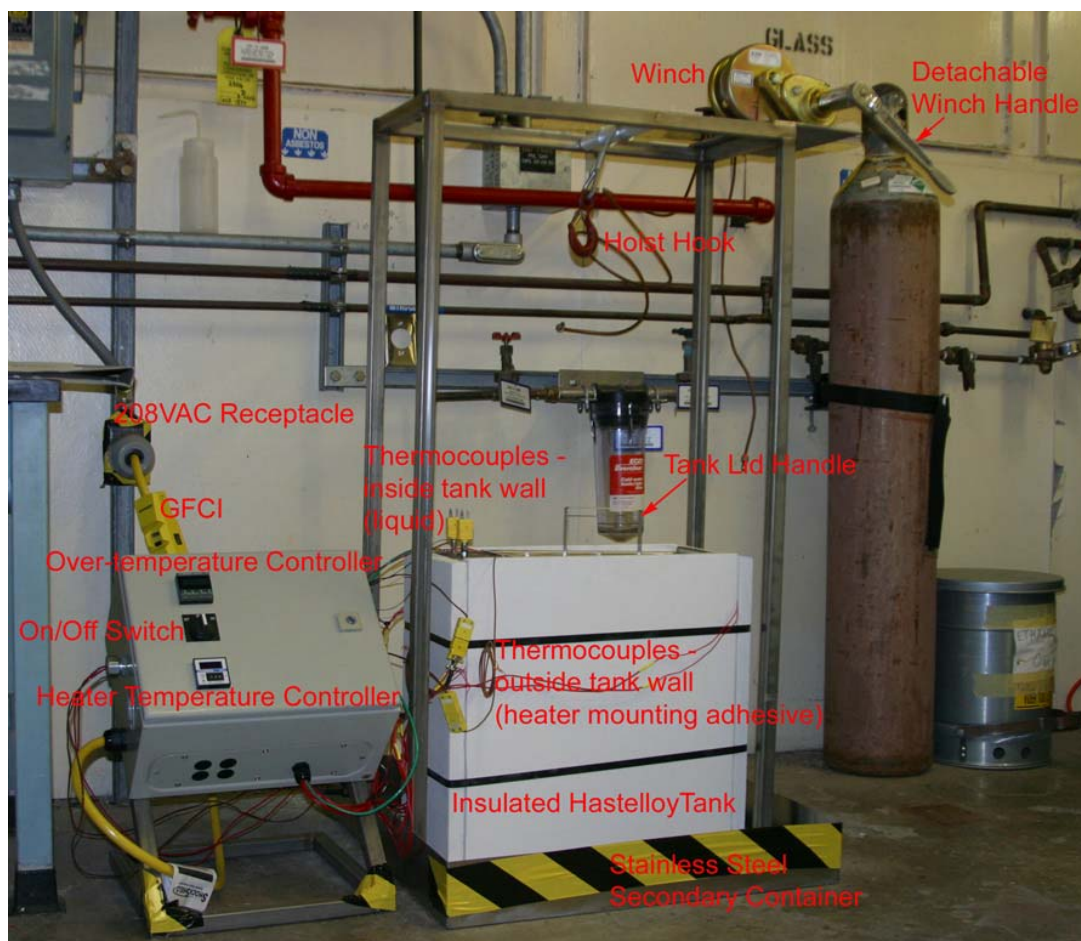
Figure 23 Large plate experimental station.

All the components of the large plate experimental station and the laboratory layout are shown in Figure 23.

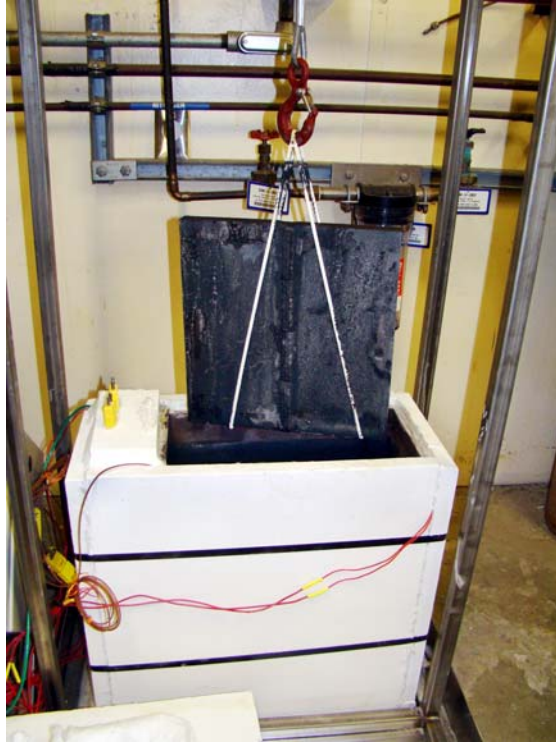
Figure 24 Periodic inspection for cracking by lifting plate above the test solution.

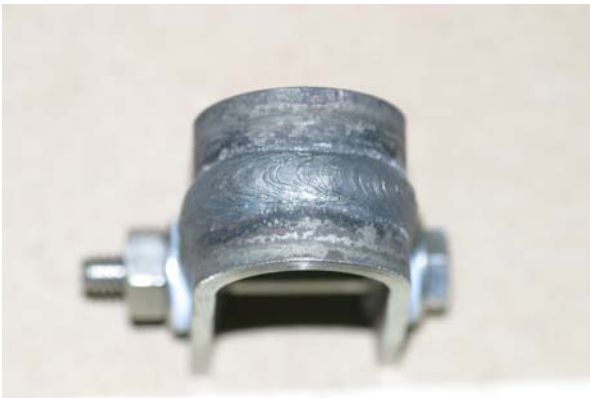
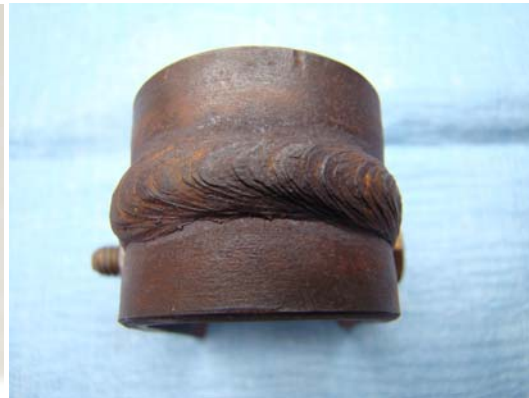
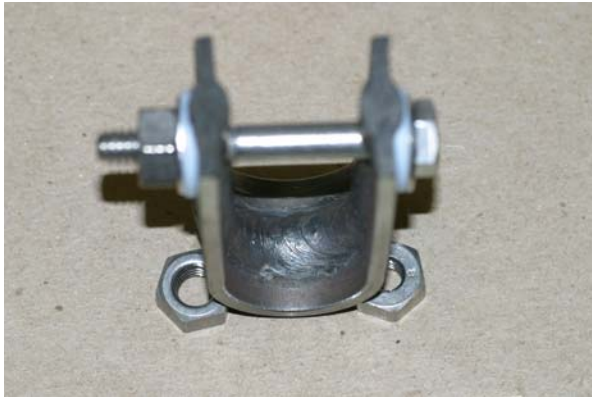
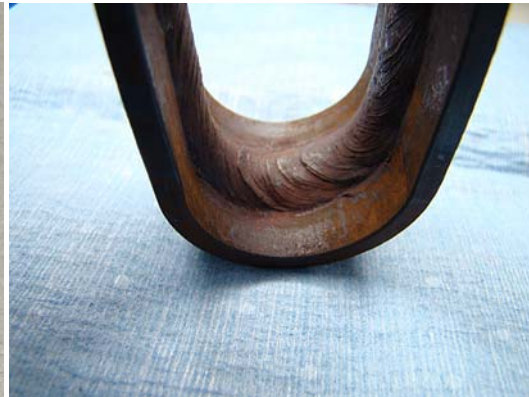
(a) Tensile side of U-bend before exposure

(b) Tensile side of U-bend after exposure

(c) Compressive side of U-bend
before exposure

(d) Compressive side of U-bend
after exposure

Figure 25 As-welded Specimen No. 246 exposed to caustic solution for 24 days.

The actual exposure time for these specimens in the caustic solution (12 M hydroxide) was 24 days, or more precisely, 558.5 hours. The test temperature was at least 125 °C. The pre- and post-exposure photographs of these specimens are placed side-by-side for comparison (Figs. 25-26). Both the outer side of the U-bend (tensile side) and the inner side (compressive) are documented. Although the SCC on the compressive side is highly improbable, it is reported here for completeness.

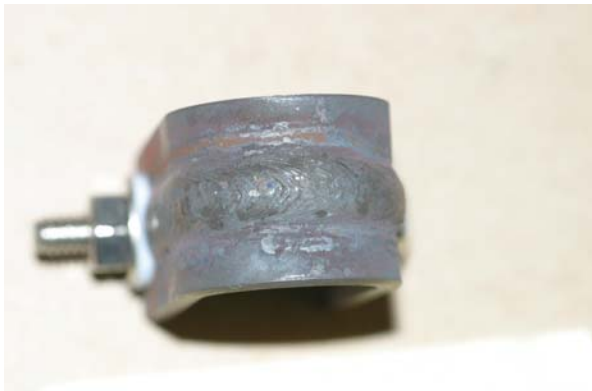
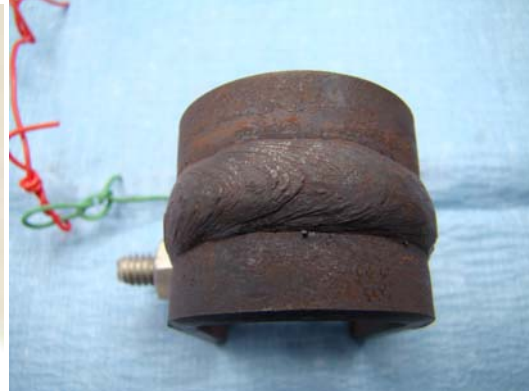
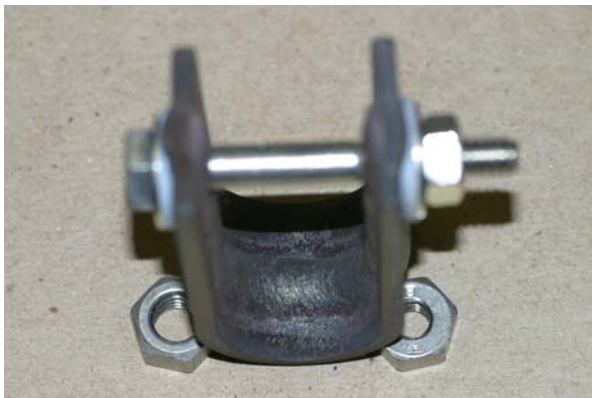
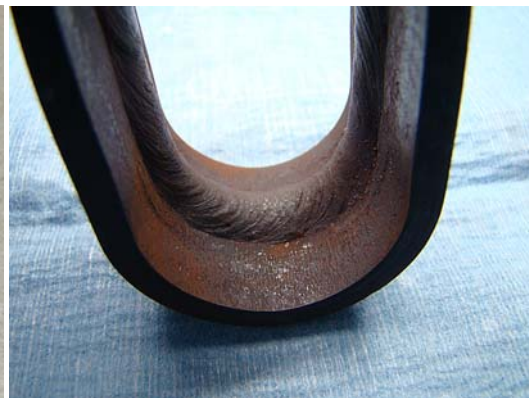
(a) Tensile side of U-bend before exposure

(b) Tensile side of U-bend after exposure

(c) Compressive side of U-bend
before exposure

(d) Compressive side of U-bend
after exposure

Figure 26 Heat-treated Specimen No. 241 exposed to caustic solution for 24 days.

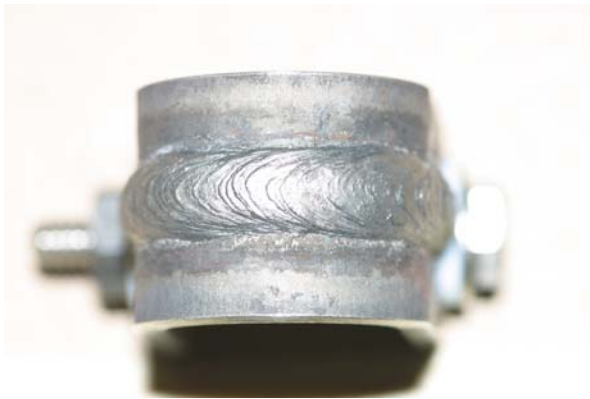
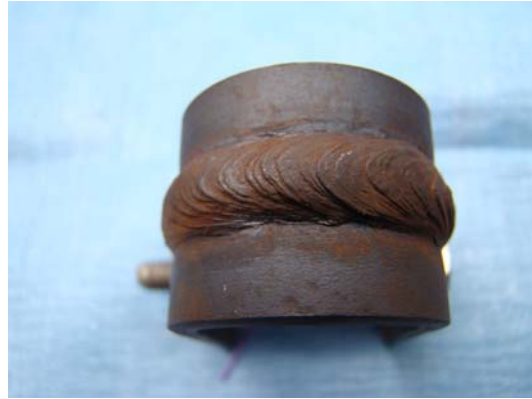
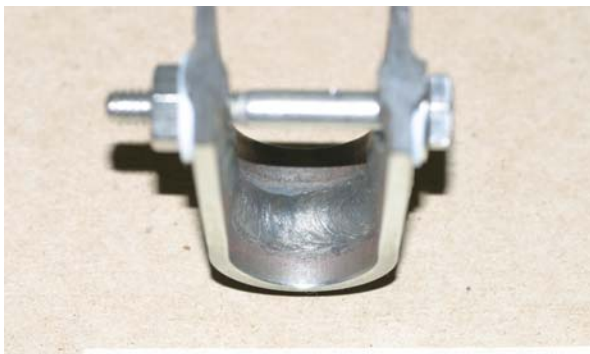
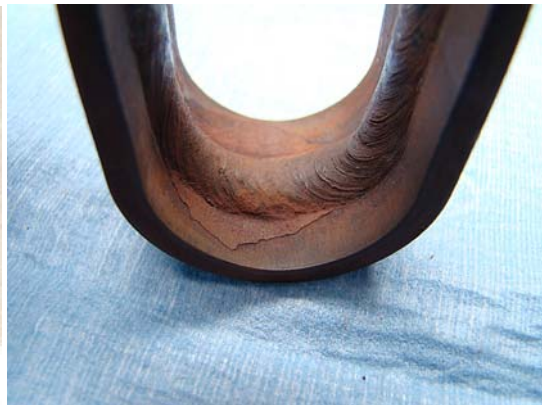
(a) Tensile side of U-bend before exposure

(b) Tensile side of U-bend after exposure

(c) Compressive side of U-bend
before exposure

(d) Compressive side of U-bend
after exposure

Figure 27 As-welded Specimen No. 248 exposed to caustic solution for 44 days.

The actual exposure time for specimens in the caustic solution was 44 days, or more precisely, 1039 hours. The test temperature was at least 125 °C. The pre- and post-exposure photographs of the specimens are placed side-by-side for comparison (Figs. 27-29). The outer side of the U-bend (tensile side) is shown below along with the inner side (compressive), although SCC is unlikely under compressive stress.

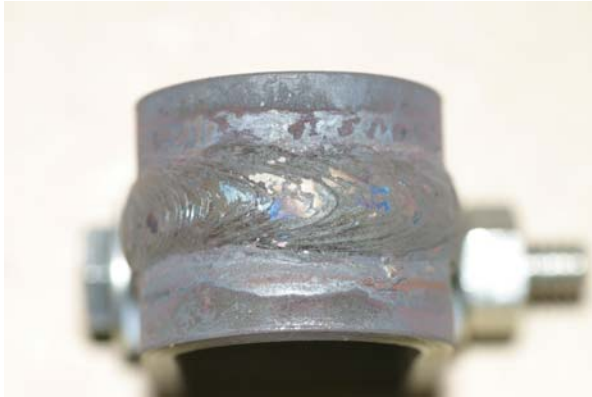
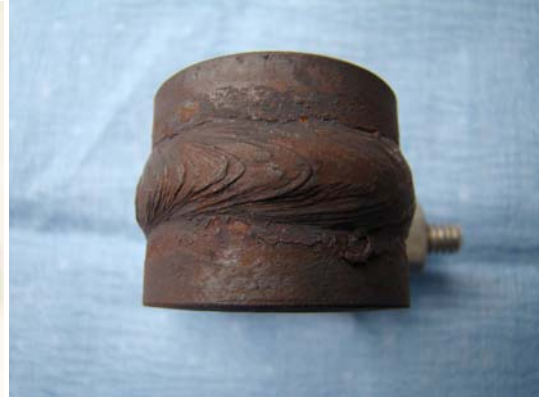
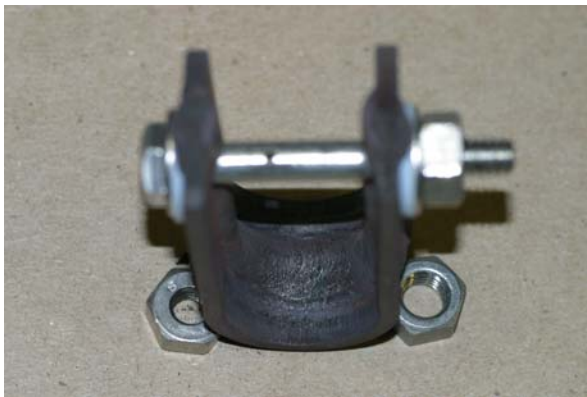
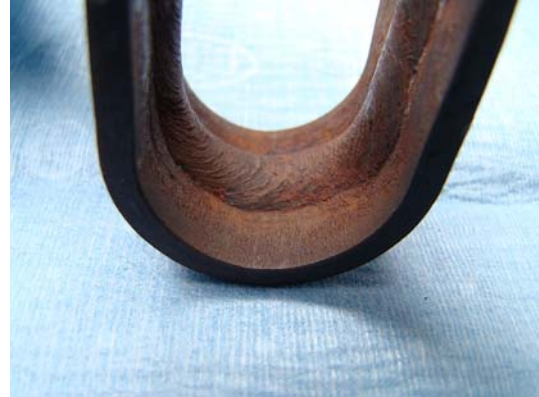
(a) Tensile side of U-bend before exposure

(b) Tensile side of U-bend after exposure

(c) Compressive side of U-bend before exposure

(d) Compressive side of U-bend after exposure

Figure 28 Heat-treated Specimen No. 242 exposed to caustic solution for 44 days.

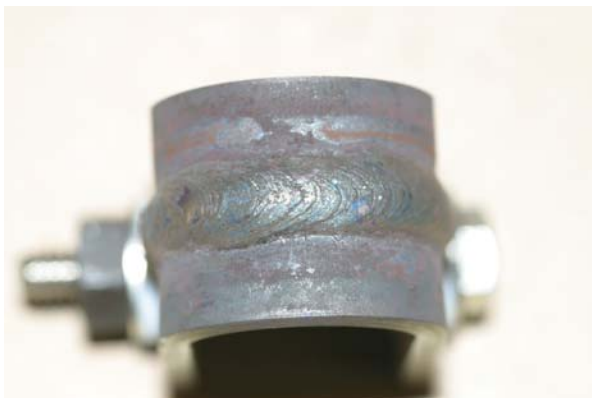
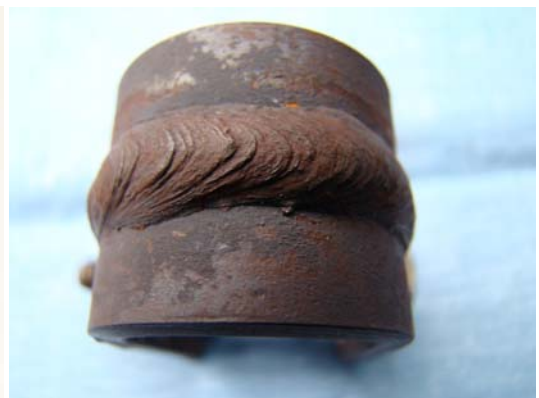
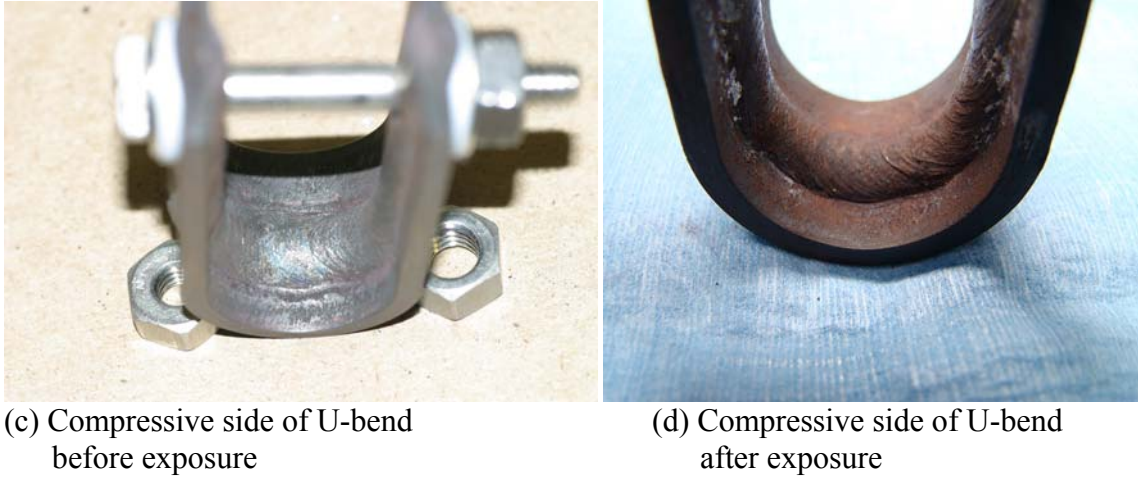
(a) Tensile side of U-bend before exposure

(b) Tensile side of U-bend after exposure

Figure 29 Heat-treated Specimen No. 244 exposed to caustic solution for 44 days.

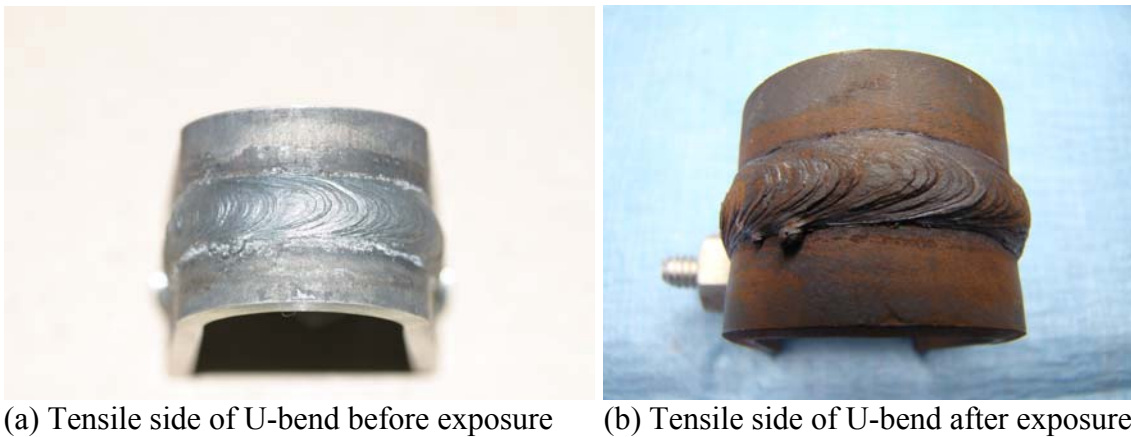
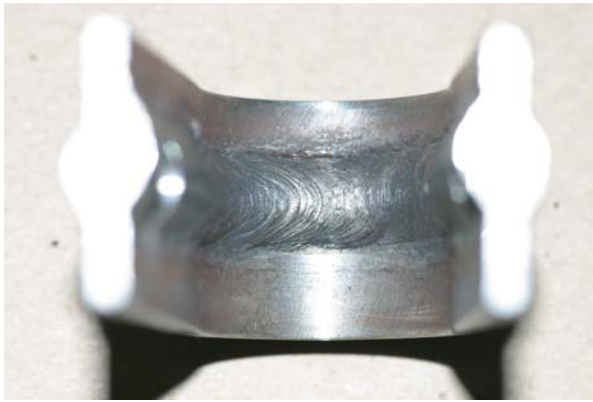
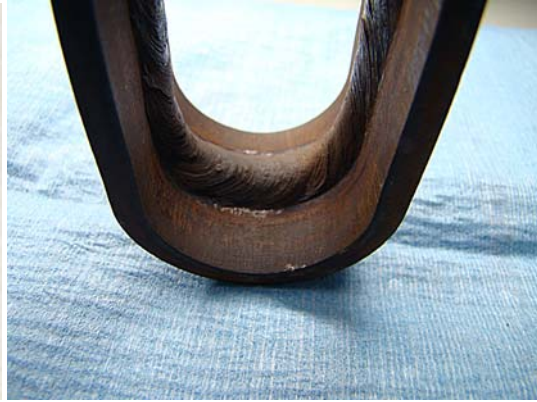
(c) Compressive side of U-bend
before exposure

(d) Compressive side of U-bend
after exposure

Figure 30 As-welded Specimen No. 245 exposed to caustic solution for 95 days.

The actual exposure time for specimens in the caustic solution was 95 days, or more precisely, 2255 hours. The test temperature was at least 125 °C. The pre- and post-exposure photographs of these specimens are placed side-by-side for comparison (Figs. 30-32). Both the outer side of the U-bend (tensile side) and the inner side (compressive) are reported. Although cracking is unlikely on the compressive stress field; the result is included in this section for completeness.
